**DEMOLITION SURVEY, ASSESSMENT AND REGISTER OF ASBESTOS  
CONTAINING MATERIALS**

**Islamic High School  
High Lane  
Chorlton  
Manchester  
M21 9FA**

**Cube Homes Limited**

| Project no: | A-20300 |

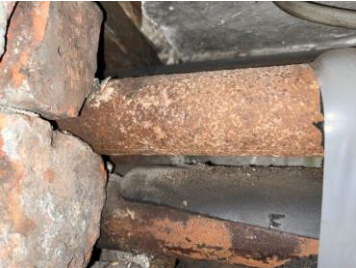
| | Inspection Date | Surveyor | Survey Type | Floor | Analysis | |
|---|---|---|---|---|---|---|
| Surveyor Comments | | Thermal insulation residues to wall | | | Review Date | 27/10/2023 |

| | Inspection Date | Surveyor | Survey Type | Floor | Analysis | |
|---|---|---|---|---|---|---|
| | 27/10/2022 | Paul Walker | Demolition | Basement | Chrysotile/Amosite | |

| | Inspection Date | Surveyor | Survey Type | Floor | Analysis | |
|---|---|---|---|---|---|---|
| Recommendations / Actions | | Notifiable product - to be removed by a licensed contractor under strict accordance with current and relevant legislation notes | | | | |

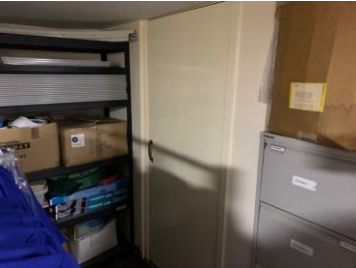
| | Inspection Date | Surveyor | Survey Type | Floor | Analysis | |
|---|---|---|---|---|---|---|
| Surveyor Comments | | Presumed thermal insulation to pipework within boxing due to no intrusive access | | | Review Date | 27/10/2023 |

| | Inspection Date | Surveyor | Survey Type | Floor | Analysis | |
|---|---|---|---|---|---|---|
| | 27/10/2022 | Sam Hendry | Demolition | Basement | <b>Presumed Asbestos</b> | |

| | Inspection Date | Surveyor | Survey Type | Floor | Analysis | |
|---|---|---|---|---|---|---|
| Recommendations / Actions | | Notifiable product - to be removed by a licensed contractor under strict accordance with current and relevant legislation notes | | | | |

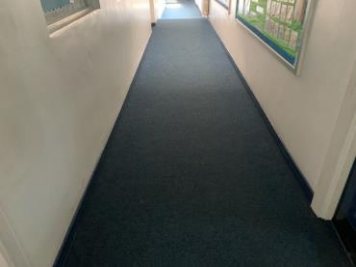
| | Inspection Date | Surveyor | Survey Type | Floor | Analysis | |
|---|---|---|---|---|---|---|
| Surveyor Comments | Bitumen adhesive to rear of parquet | | | | Review Date | 27/10/2023 |

| | Inspection Date | Surveyor | Survey Type | Floor | Analysis | |
|---|---|---|---|---|---|---|
| | 27/10/2022 | Paul Walker | Demolition | Ground Floor | NAD | |

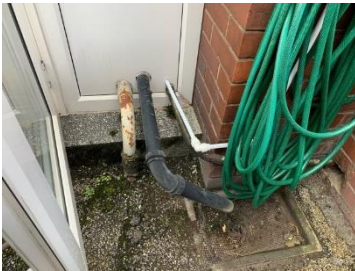
| | Inspection Date | Surveyor | Survey Type | Floor | Analysis | |
|---|---|---|---|---|---|---|
| Surveyor Comments | | Thermal insulation to pipe work within chimney originating from plant room | | | Review Date | 27/10/2023 |

| | Inspection Date | Surveyor | Survey Type | Floor | Analysis | |
|---|---|---|---|---|---|---|
| Recommendations / Actions | | Notifiable product - to be removed by a licensed contractor under strict accordance with current and relevant legislation notes | | | | |

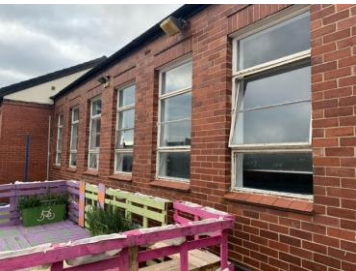
| | Inspection Date | Surveyor | Survey Type | Floor | Analysis | |
|---|---|---|---|---|---|---|
| Surveyor Comments | Bitumen damp proof course To all brick walls | | | | Review Date | Not required |

| | Inspection Date | Surveyor | Survey Type | Floor | Analysis | |
|---|---|---|---|---|---|---|
| | 27/10/2022 | Sam Hendry | Demolition | Ground Floor | NAD | |

| | Inspection Date | Surveyor | Survey Type | Floor | Analysis | |
|---|---|---|---|---|---|---|
| Recommendations / Actions | No action required | | | | | |
