**Project Name:** Premier House\_1

**Project Number:** GR/7771

**Project Date:** 08/09/2023

**Inspection Standard:** MSCC5 Sewers & Drainage GB (SRM5 Scoring)

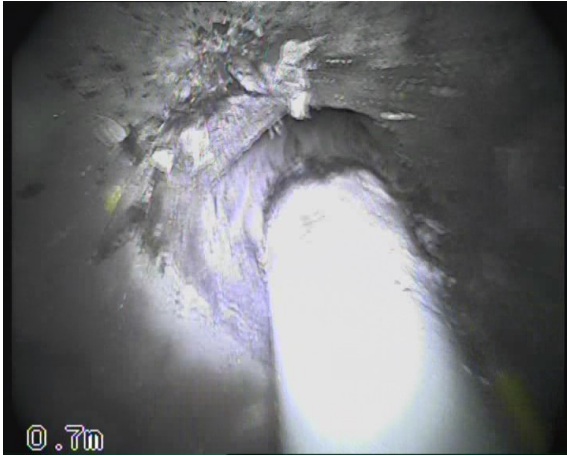
(L1)X\_3d9ff682-6224-418b-a84c-b42015fb200c\_20230908\_095500\_934.jpg, 00:00:00, 0.00 m  
Start node, major connection without manhole, reference:  
RWDP3 (F1)

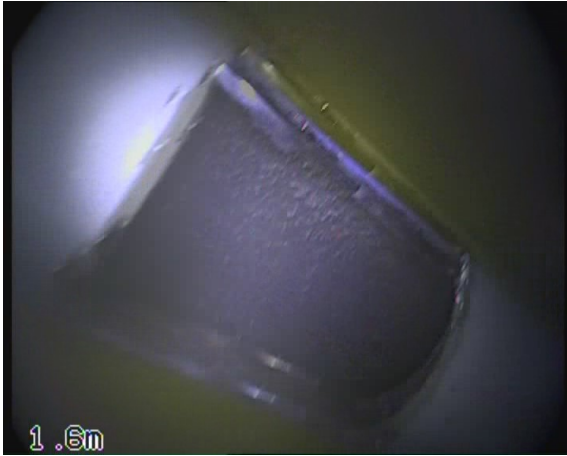
(L1)X\_b25b661d-ab60-4a39-bf4f-e1d31b51f394\_20230908\_1  
01129\_842.jpg, 00:00:00, 0.00 m  
Start node, major connection without manhole, reference:  
RWDP4 (F1)

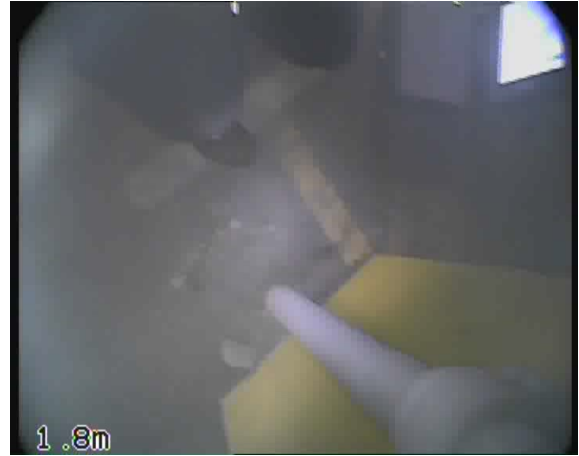
(L1)X\_5e020813-bf01-43e8-a484-a2c8e8337b2f\_20230908\_1  
01154\_726.jpg, 00:00:00, 0.00 m  
Start node, major connection without manhole, reference:  
RWDP4 (F1)

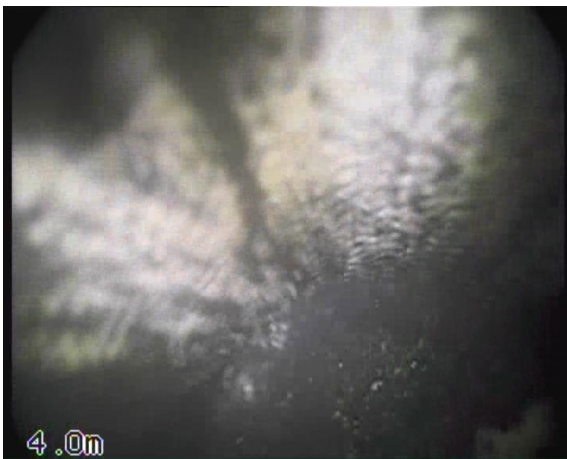
| Scale: | 1:50 | Position [m] | Code | Observation | MPEG | Photo | Grade |
|---|---|---|---|---|---|---|---|
| | | 4.00 | DES | Settled deposits, fine, 100% cross-sectional area loss | 00:00:46 | RWDP4 (L1)X_d65 d6fb4-3bd | 5 |
| | | 4.00 | SA | Survey abandoned: Unable to pass | 00:00:52 | | |

(L1)X\_d65d6fb4-3bd4-43c8-9f0d-3addbb825834\_20230908\_1  
01525\_687.jpg, 00:00:46, 4.00 m  
Settled deposits, fine, 100% cross-sectional area loss

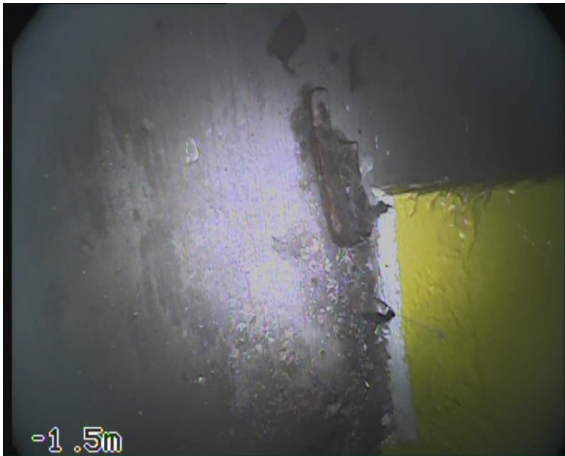
RWDP5  
(L1)X\_92c348e0-7695-4fff-a2c3-bedddaad3c2f\_20230908\_101718\_040.jpg, 00:00:00, 0.00 m  
Start node, major connection without manhole, reference:  
RWDP5 (L1)

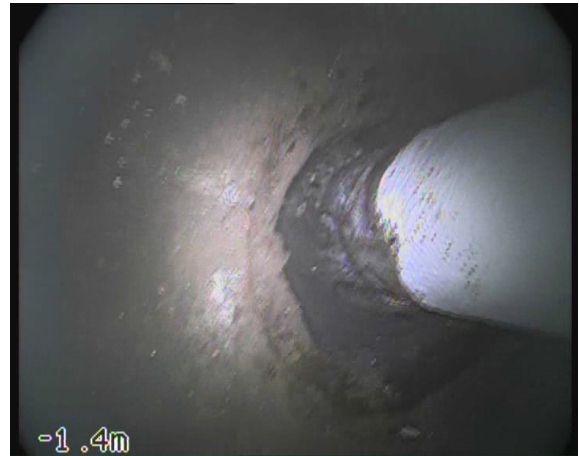
RWDP5  
(L1)X\_c49708bb-b0a7-49dd-b10f-ea25c05b995b\_20230908\_101722\_352.jpg, 00:00:00, 0.00 m  
Start node, major connection without manhole, reference:  
RWDP5 (L1)

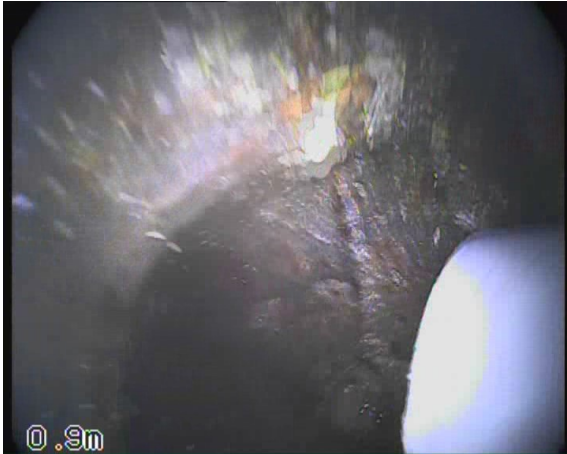
RWDP6  
(L1)X\_bc38c55f-aa92-4e3a-ba6f-69f6bb645067\_20230908\_1  
02352\_431.jpg, 00:00:00, 0.00 m  
Start node, major connection without manhole, reference:  
RWDP6 (F1)

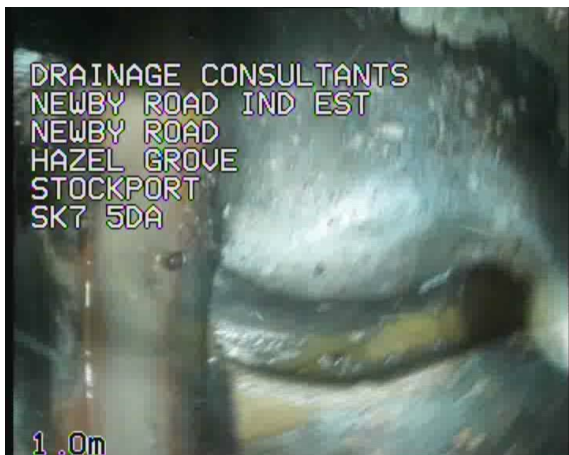
HOLX\_6a625c5e-44e9-4f11-8f06-334356a457ec\_20230908\_102704\_934.jpg, 00:00:00, 0.00 m  
Start node, manhole, reference: MH1 B1

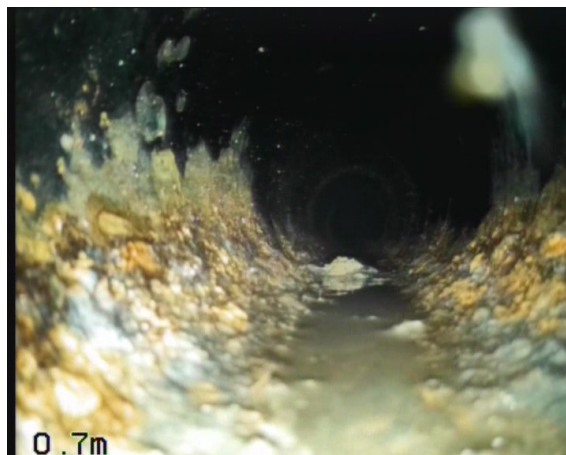
HOLX\_267a0624-395d-4c13-ac1f-ff0a4ed4e44a\_20230908\_103132\_502.jpg, 00:00:18, 0.20 m  
Pipe material changes to cast iron at this point

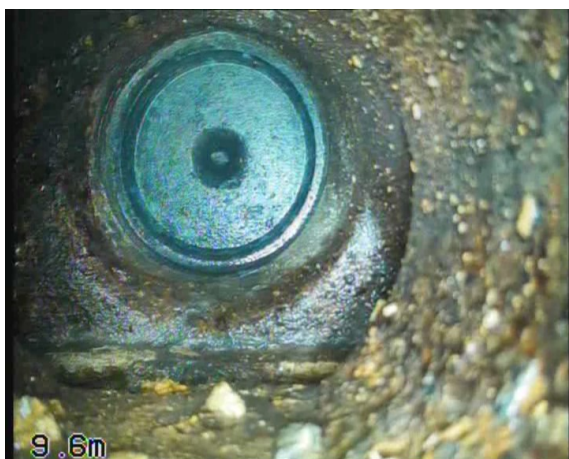
HOLX\_635b2e72-483c-4576-8c41-43bc37262ae1\_20230908\_103307\_029.jpg, 00:00:51, 9.80 m  
Finish node, gully, reference: HOL

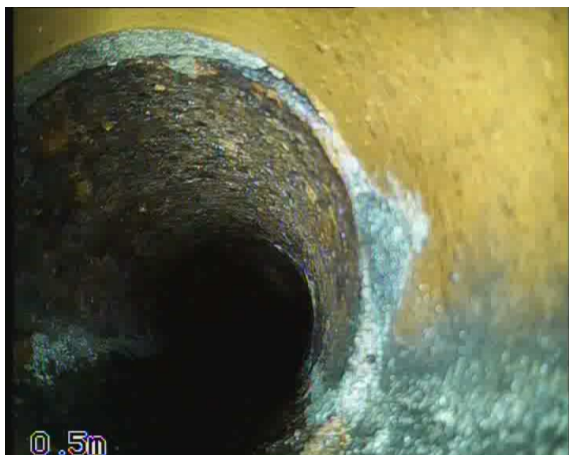
HOLX\_5b8bccbd-75d2-47b9-af72-7759db7d0753\_20230908\_103427\_669.jpg, 00:00:08, 0.50 m  
Pipe material changes to cast iron at this point

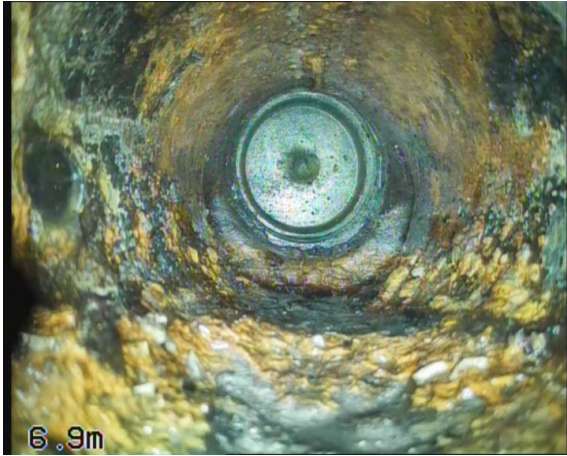
HOLX\_1e7107c5-0af4-4181-bd74-973604107363\_20230908\_  
104725\_938.jpg, 00:00:27, 7.10 m  
Finish node, gully, reference: HOL

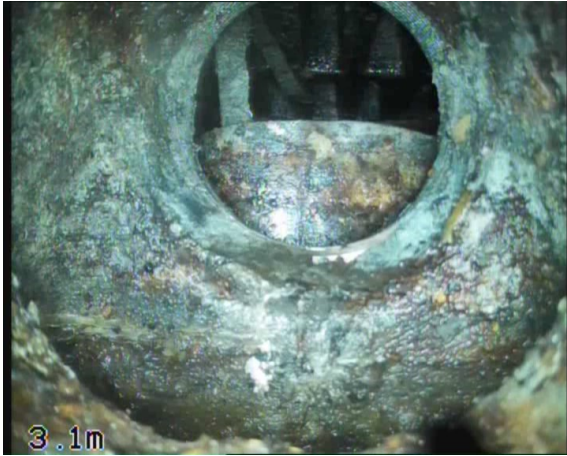
HOLX\_087c7e53-fa40-4c37-88a0-d4772cc9c07b\_20230908\_104841\_467.jpg, 00:00:19, 3.10 m  
Finish node, gully, reference: HOL

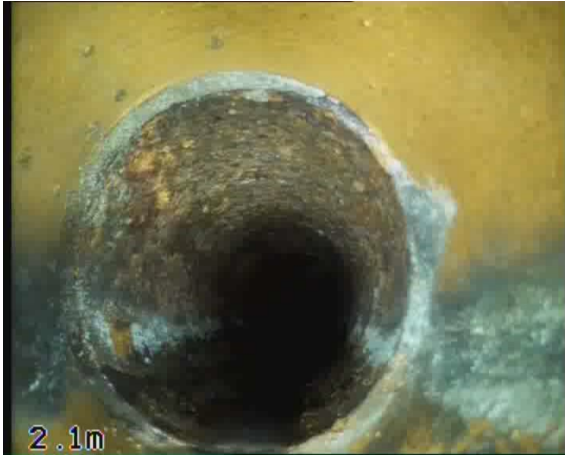
HOLX\_ebed43cd-c34f-4d7b-b7d4-5a171220b17d\_20230908\_105219\_386.jpg, 00:00:14, 0.20 m  
Pipe material changes to cast iron at this point

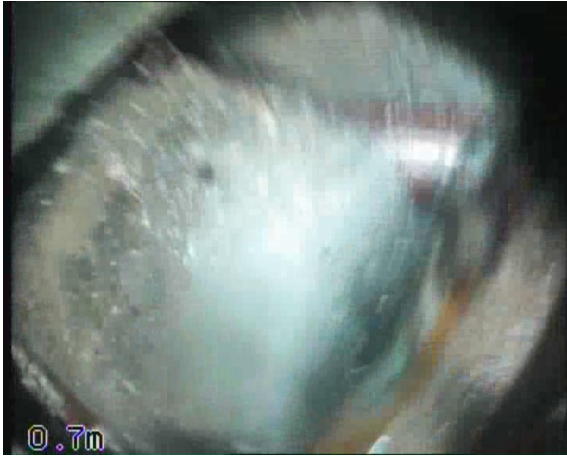
HOLX\_dbe31620-12ef-4f28-a341-15e7d463db7d\_20230908\_  
105659\_452.jpg, 00:00:00, 0.00 m  
Start node, manhole, reference: MH1 B2

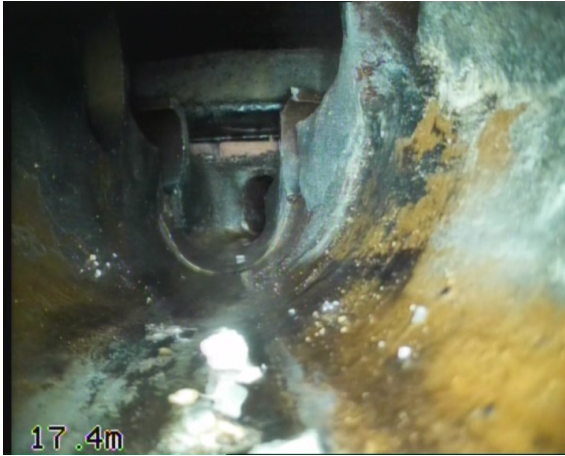
HOLX\_fe2b8aa3-7c99-4649-bb80-dc0acf9ba0a7\_20230908\_1  
10326\_113.jpg, 00:01:27, 17.50 m  
Finish node, manhole, reference: HOL, MH1

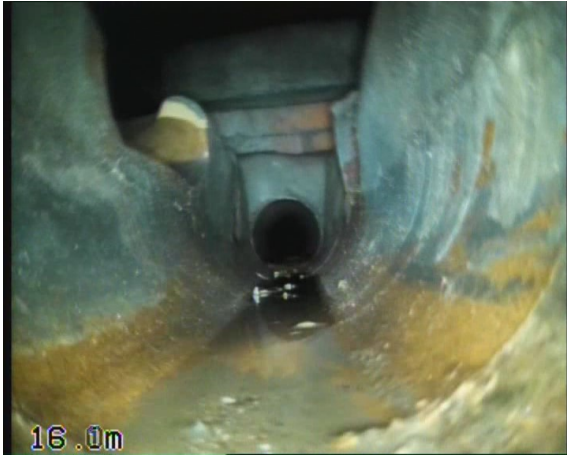
MH2X\_b1c7efed-4948-4f80-81f8-34ccf8402d40\_20230908\_1  
10716\_266.jpg, 00:01:06, 16.00 m  
Finish node, manhole, reference: MH2

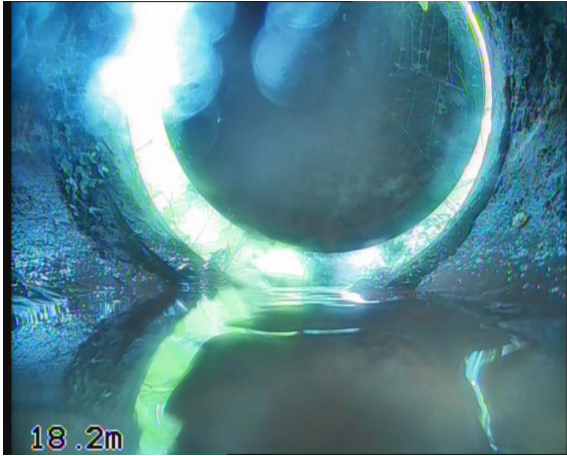
MH4X\_3d9fb9c0-3d0c-4a88-aac6-41b3c8c9c5ac\_20230908\_111303\_084.jpg, 00:01:49, 18.50 m  
Finish node, manhole, reference: Discharge

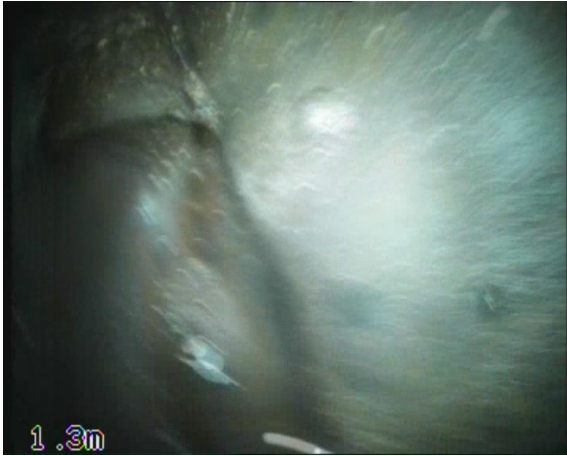
MH3X\_f5208d97-46b5-4169-ba97-00f470d1f974\_20230908\_11404\_738.jpg, 00:00:00, 0.00 m  
Start node, manhole, reference: MH3

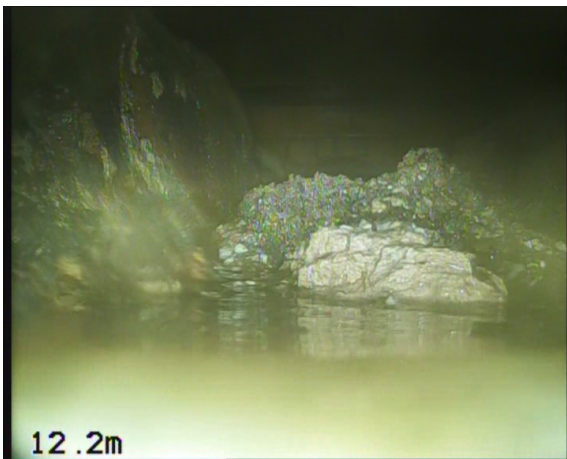
MH3X\_d22ab9fe-3e86-4866-ac3d-15849fd61493\_20230908\_111605\_552.jpg, 00:00:47, 12.30 m  
Finish node, manhole, reference: MH4

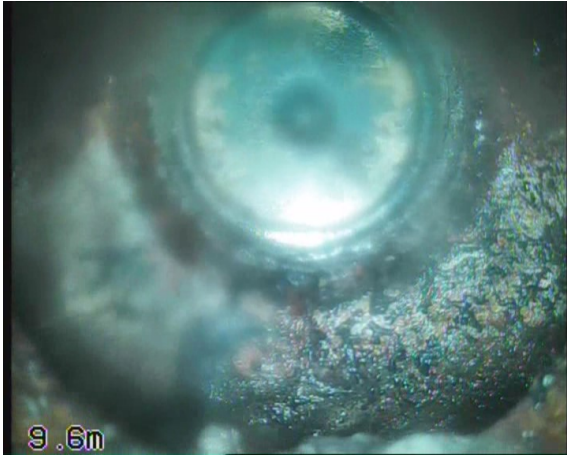
HOLX\_31257d95-39f7-44ca-b907-309fcab5ac4b\_20230908\_1  
11738\_161.jpg, 00:00:38, 9.60 m  
Finish node, gully, reference: HOL

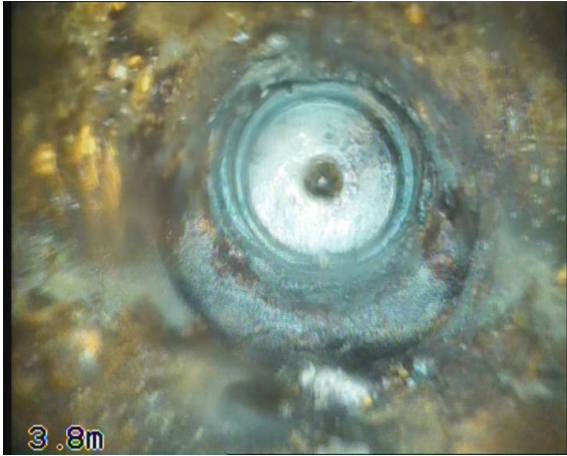
HOLX\_451c4044-f8df-42bc-9444-5f1dc2f7b555\_20230908\_11  
1945\_224.jpg, 00:00:22, 3.80 m  
Finish node, gully, reference: HOL

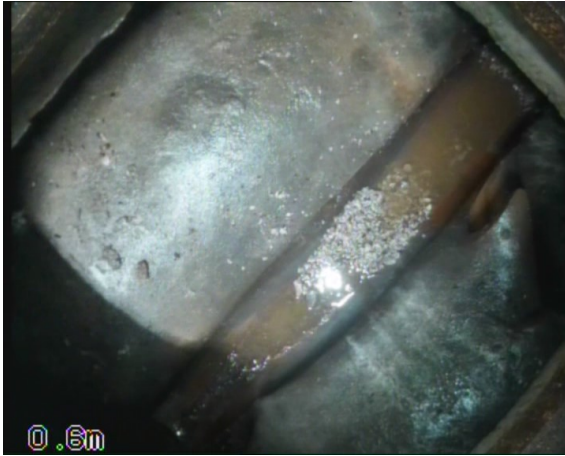
HOLX\_c2a7b354-6d06-4420-b5ee-66565ba5509a\_20230908\_112112\_610.jpg, 00:00:00, 0.00 m  
Start node, manhole, reference: MH5 B1

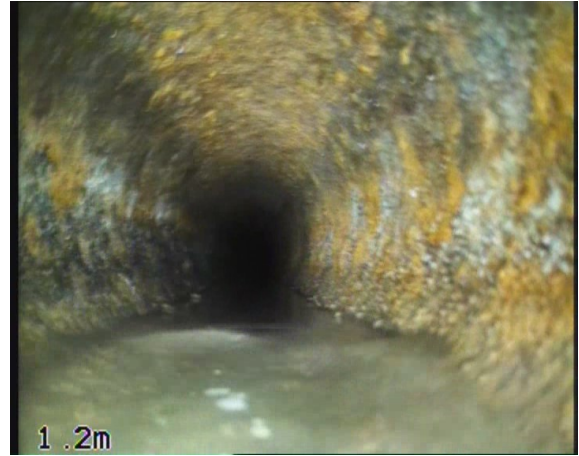
HOLX\_fceb4b2a-bd4d-4405-90a2-7a6b3a2bd031\_20230908\_112212\_976.jpg, 00:00:30, 0.10 m  
Pipe material changes to cast iron at this point

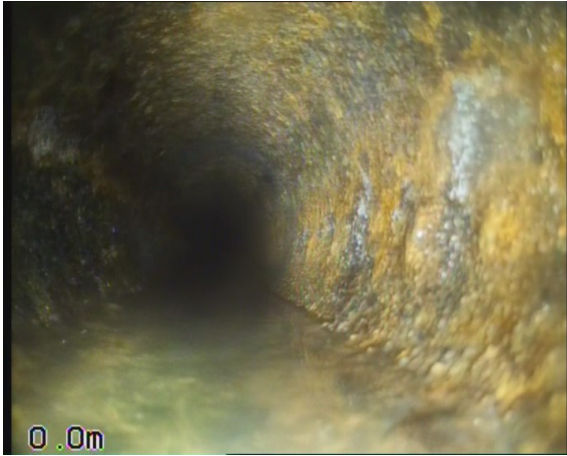
HOLX\_4557fe2f-fa25-4141-8423-8ac0f78c90b5\_20230908\_1  
13455\_551.jpg, 00:00:08, 0.10 m  
Pipe material changes to cast iron at this point

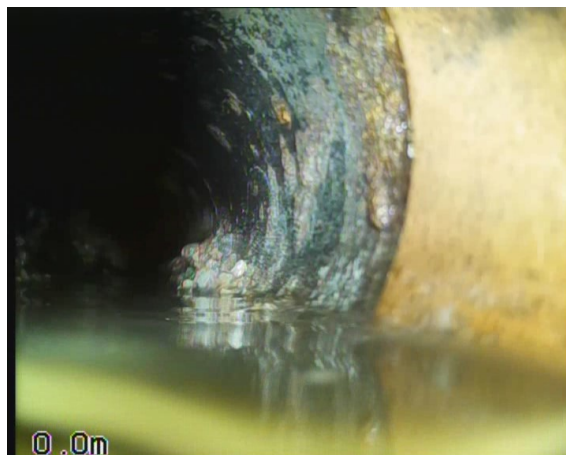
HOLX\_f8c91138-40f5-4b34-97c7-bbcc5eac1454\_20230911\_074113\_332.jpg, 00:00:08, 0.10 m  
Pipe material changes to cast iron at this point

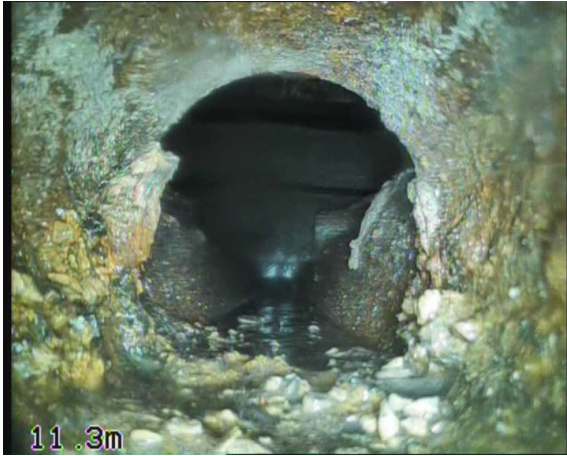
HOLX\_9c8a58df-63b3-4f94-8d09-97e615cff397\_20230911\_0  
74938\_778.jpg, 00:00:51, 11.50 m  
Finish node, manhole, reference: HOL, MH7

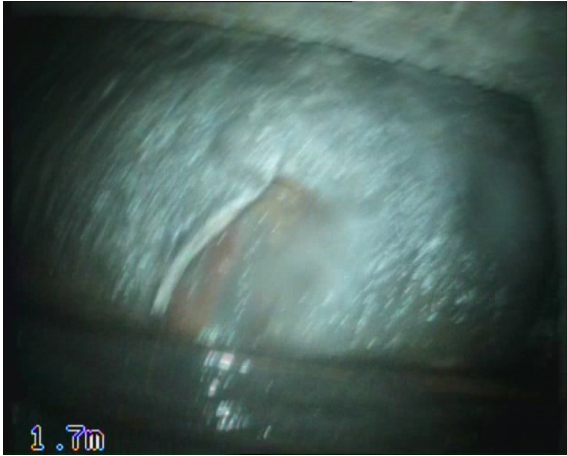
RWDP-7X\_d68a4710-d120-4c53-8a9f-088bab8dbcd\_b\_20230911\_075910\_663.jpg, 00:00:00, 0.00 m  
Start node, manhole, reference: MH7 B2

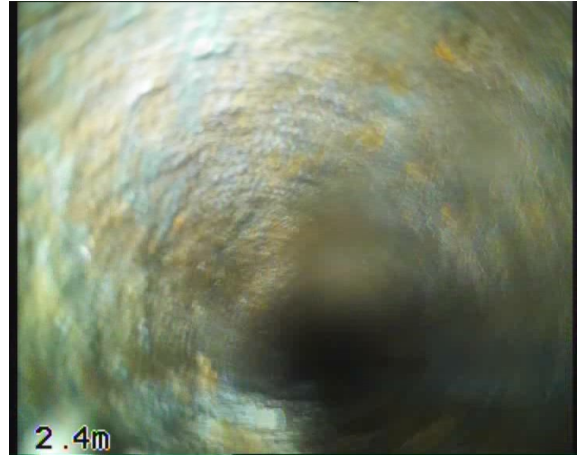
RWDP-7X\_d35755e1-e12f-429e-9ff6-1c84a06ac8cb\_20230911\_080207\_032.jpg, 00:00:24, 0.00 m  
Pipe material changes to cast iron at this point

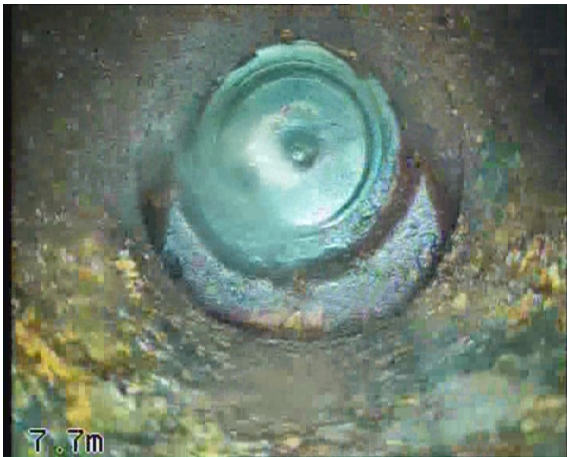
RWDP-7X\_c633b9e4-4f45-4081-8d6a-77aa8a96dea0\_20230911\_081644\_639.jpg, 00:01:02, 7.70 m  
Finish node, gully, reference: RWDP-7

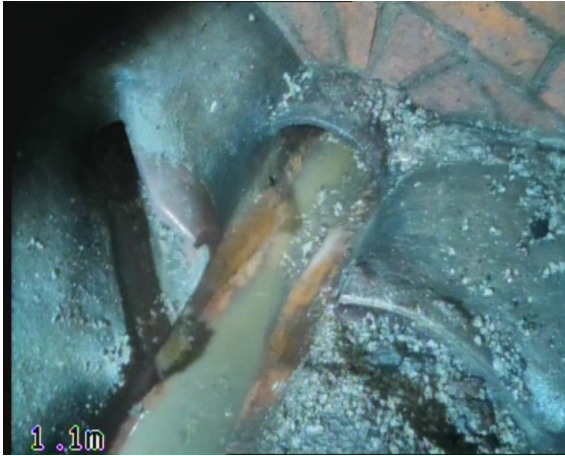
MH5X\_a83e40f5-09d1-4353-960f-f334f38e4df2\_20230911\_082225\_893.jpg, 00:00:00, 0.00 m  
Start node, manhole, reference: MH6

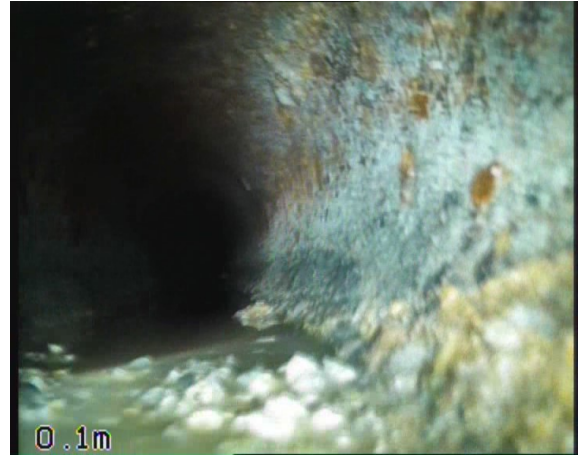
MH5X\_334aed50-00ad-43d0-90dd-790e8de689e2\_20230911\_082320\_725.jpg, 00:00:11, 0.10 m  
Pipe material changes to cast iron at this point

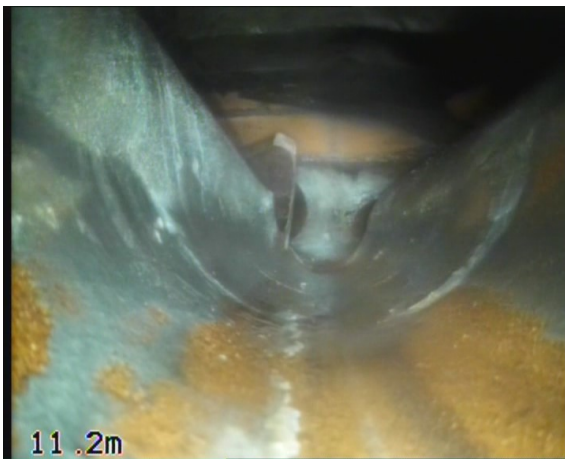
MH5X\_108ff4c1-89fc-4d78-8114-b7c3d11df538\_20230911\_082451\_477.jpg, 00:00:40, 11.20 m  
Finish node, manhole, reference: MH5

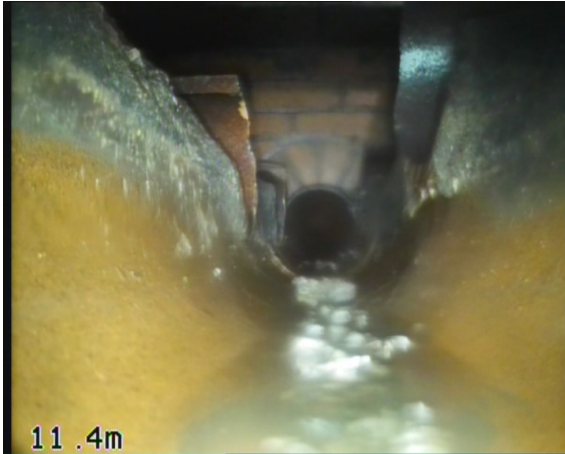
MH6X\_fa745684-24b9-4b5e-aa23-21504a6d6b04\_20230911\_082815\_771.jpg, 00:00:51, 11.50 m  
Finish node, manhole, reference: MH6

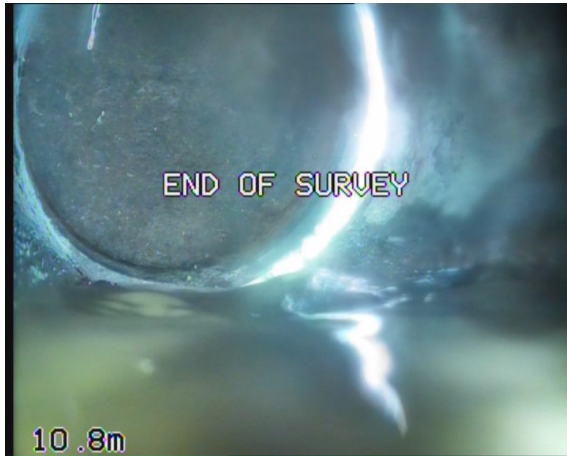
MH10X\_86ee0527-3ff9-4049-8b9c-5eebc3a12ce5\_20230911\_083704\_858.jpg, 00:00:59, 10.80 m  
Finish node, major connection without manhole, reference:  
Discharge

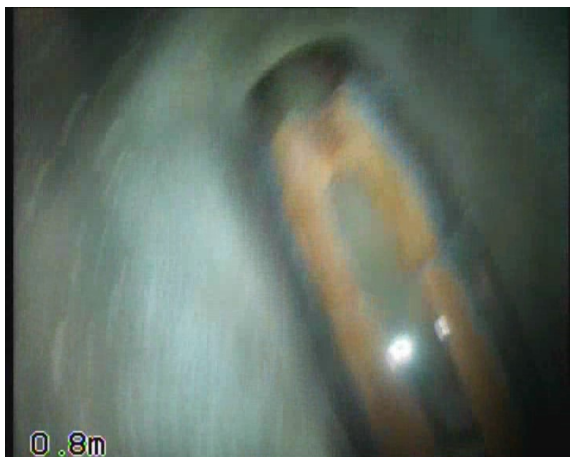
MH8X\_8ee096e4-1f54-4a10-8bcf-0c954238a106\_20230911\_083852\_284.jpg, 00:00:00, 0.00 m  
Start node, manhole, reference: MH8

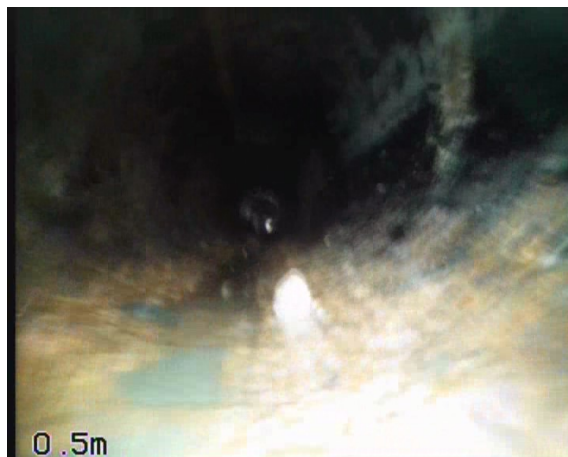
MH8X\_dc9d5da2-1d6a-4085-b7cd-2d089c56ff66\_20230911\_083916\_380.jpg, 00:00:20, 0.10 m  
Pipe material changes to cast iron at this point

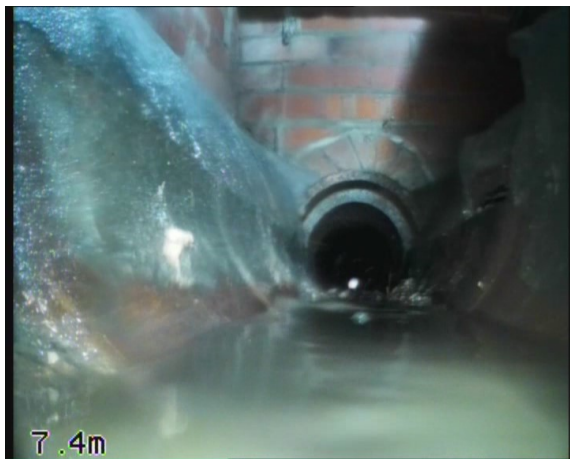
MH8X\_cb36dcc5-5a76-4fbc-97af-5f6b69628376\_20230911\_084007\_387.jpg, 00:00:35, 7.50 m  
Finish node, manhole, reference: MH9

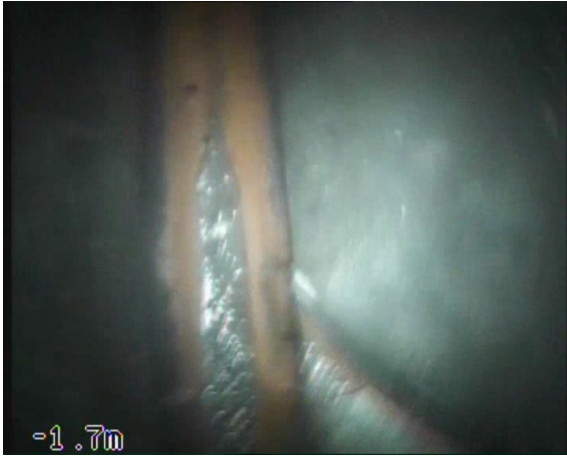
MH9X\_34789c8c-97bd-430f-9579-10f4cfc413de\_20230911\_084558\_940.jpg, 00:00:00, 0.00 m  
Start node, manhole, reference: MH9

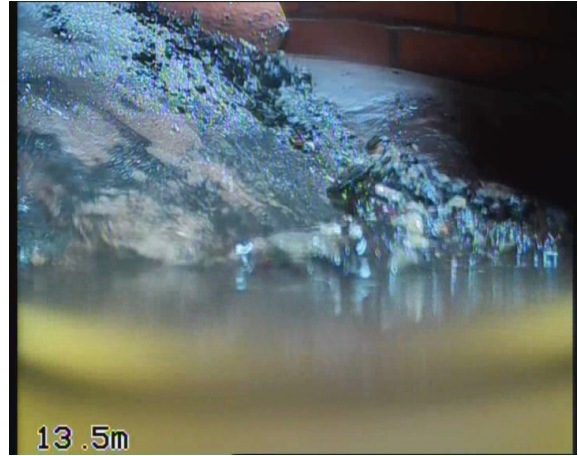
MH9X\_3832b18c-5303-4e09-b496-48c025d230f1\_20230911\_084833\_530.jpg, 00:01:09, 13.50 m  
Finish node, manhole, reference: MH10

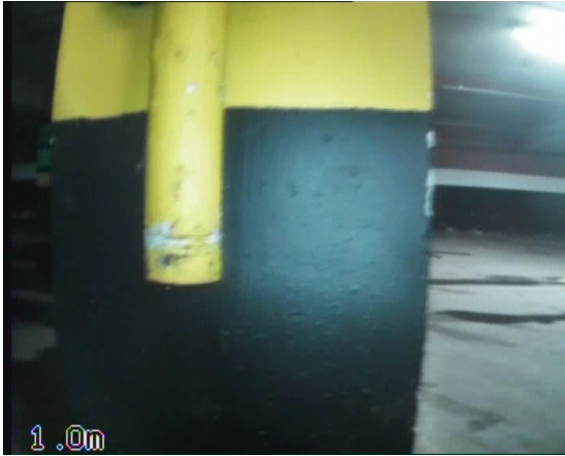
RWD7  
(F3)X\_d82e9535-0fad-4b1d-bd78-f495b189e8ed\_20230911\_085416\_170.jpg, 00:00:00, 0.00 m  
Start node, major connection without manhole, reference:  
RWDP7 (F3)

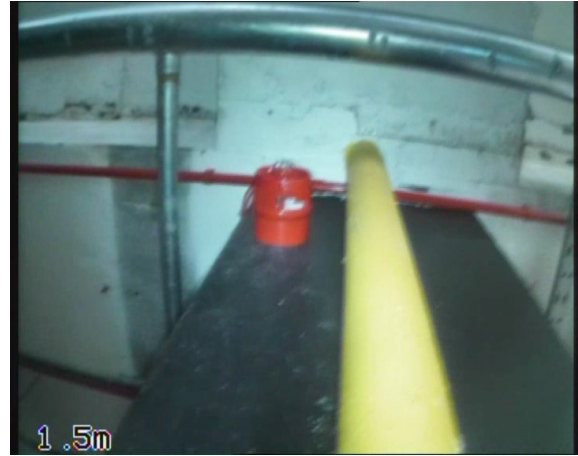
HOLX\_70a65193-43e0-47e6-9d45-4201420a63f1\_20230911\_085500\_314.jpg, 00:00:00, 0.00 m  
Start node, major connection without manhole, reference:  
RWDP7 (F3)

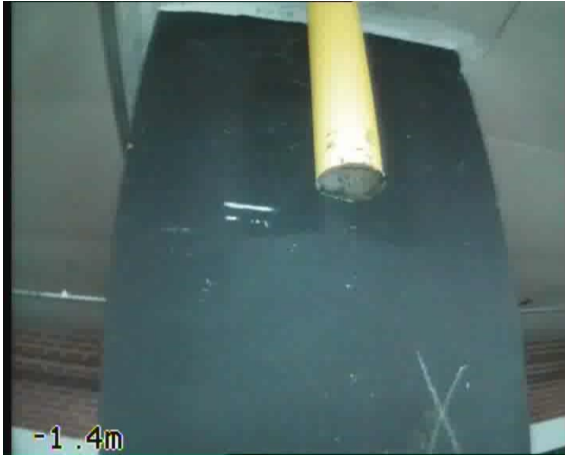
HOLX\_6af91b02-f8a4-4321-8599-413a96c28542\_20230911\_090431\_569.jpg, 00:00:00, 0.00 m  
Start node, major connection without manhole, reference:  
RWDP2 (F3)

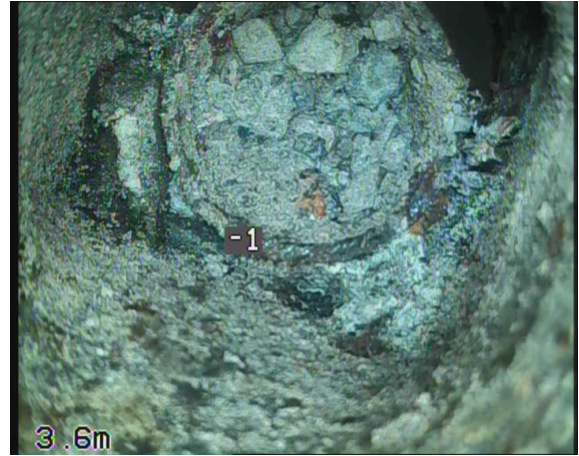
HOLX\_d7430d71-9515-436e-bcef-ad2dbcc7a75a\_20230911\_090507\_425.jpg, 00:00:34, 3.60 m  
Finish node, major connection without manhole, reference:  
HOL

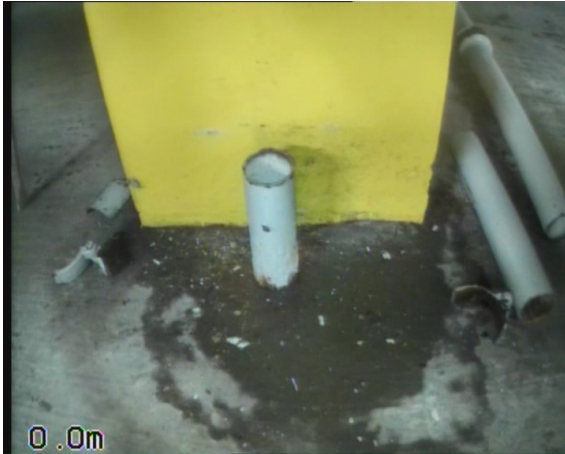
RWDP1  
(F1)X\_40fe3175-9ef0-43ae-b7bb-8f2c27771213\_20230911\_090739\_999.jpg, 00:00:00, 0.00 m  
Start node, major connection without manhole, reference:  
RWDP1 (F1)

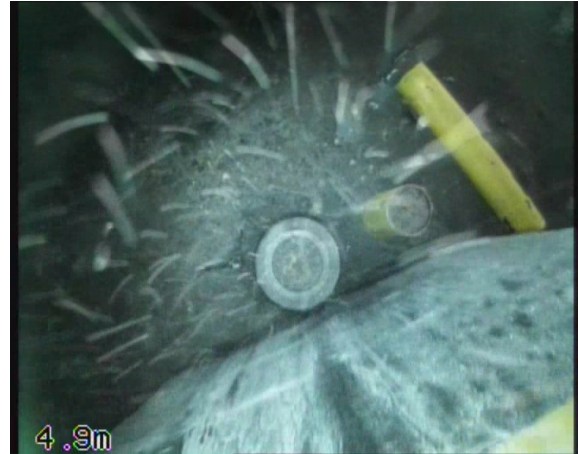
RWDP1  
(F1)X\_0fb32242-f7db-4981-ad34-1d9cf0192b31\_20230911\_090842\_456.jpg, 00:00:29, 4.90 m  
Finish node, major connection without manhole, reference:  
Discharge, (Floor-3)

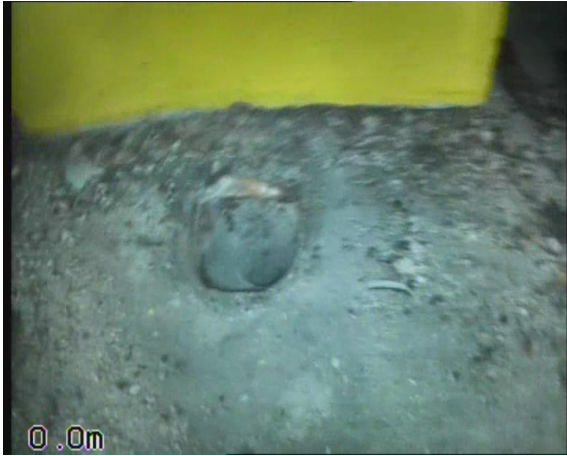
RWDP2  
(F1)X\_faa42265-3383-4f02-b723-bef4a6d77d94\_20230911\_0  
91016\_328.jpg, 00:00:00, 0.00 m  
Start node, major connection without manhole, reference:  
RWDP2 (F1)

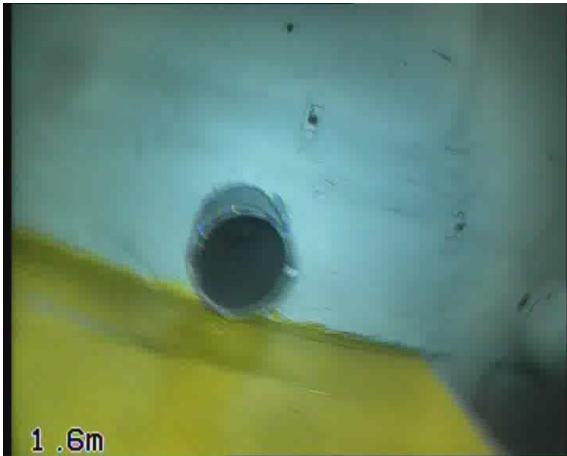
HOLX\_3f5dec2a-b118-4d63-a779-dbe6a11a6328\_20230911\_091508\_674.jpg, 00:00:00, 0.00 m  
Start node, major connection without manhole, reference: RWDP1 (F1)

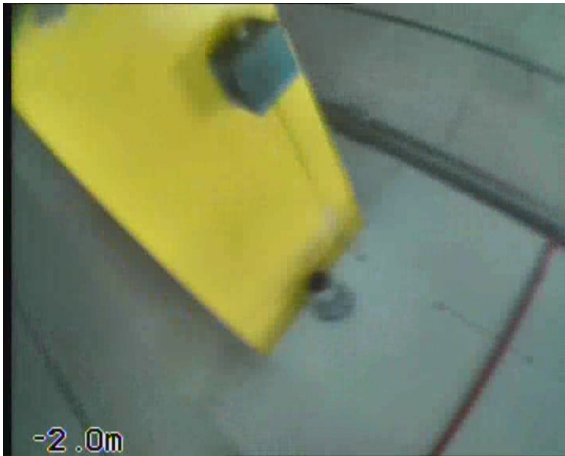
HOLX\_971db663-340b-43c1-ab77-c51e8f2cf3ec\_20230911\_092157\_832.jpg, 00:00:00, 0.00 m  
Start node, major connection without manhole, reference:  
RWDP2 (F1)

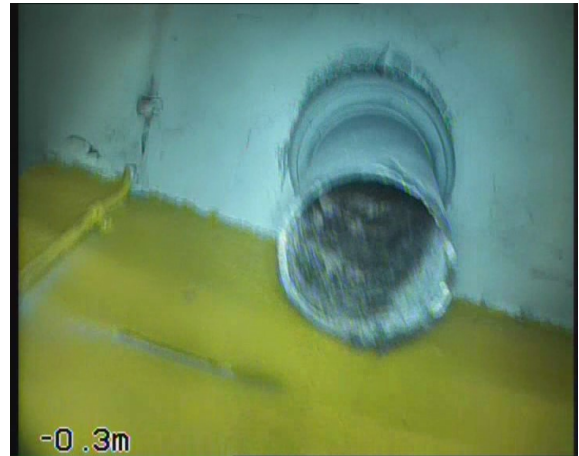
HOLX\_9e8fd359-af53-491b-af22-db7decb8ccaf\_20230911\_092207\_567.jpg, 00:00:00, 0.00 m  
Start node, major connection without manhole, reference:  
RWDP2 (F1)

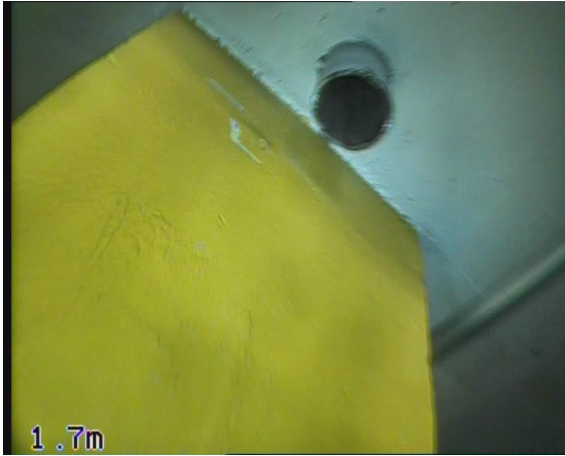
HOLX\_e9eb2554-0dd7-4104-a371-2bdc7db44553\_20230911\_092820\_111.jpg, 00:00:00, 0.00 m  
Start node, major connection without manhole, reference:  
RWDP5 (F1)

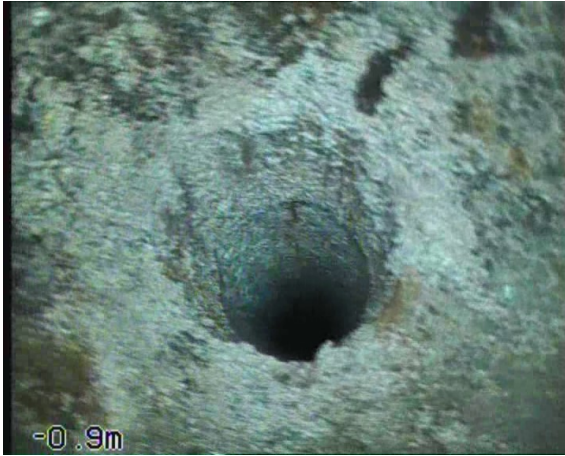
RWDP5  
(F1)X\_efb2363e-2886-444a-8997-af438b027e44\_20230911\_093240\_631.jpg, 00:00:00, 0.00 m  
Start node, major connection without manhole, reference:  
RWDP5 (F1)

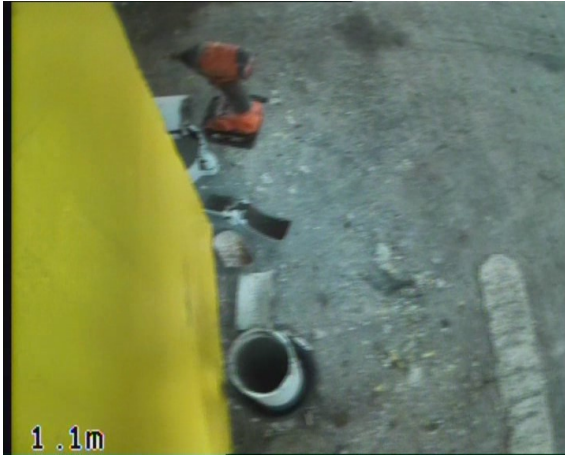
RWDP4

(F1)X\_0831db49-e591-4af9-b32b-e6e7754fbaba\_20230911\_0  
93650\_479.jpg, 00:00:00, 0.00 m  
Start node, major connection without manhole, reference:  
RWDP4 (F1)

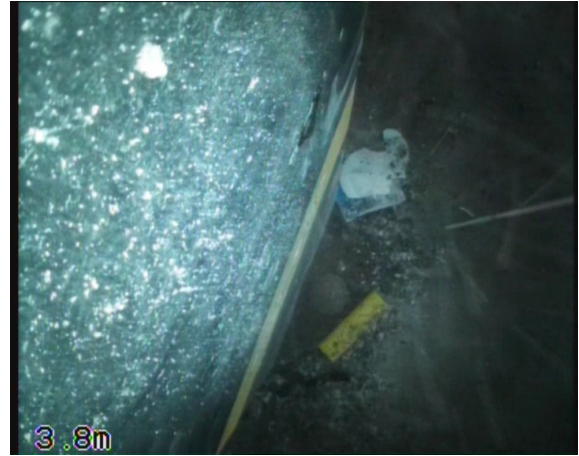
RWDP4

(F1)X\_321b7c71-ba1c-46f0-b110-fedf741a04b2\_20230911\_0  
93846\_677.jpg, 00:00:25, 4.00 m  
Finish node, major connection without manhole, reference:  
Discharge, Floor-3

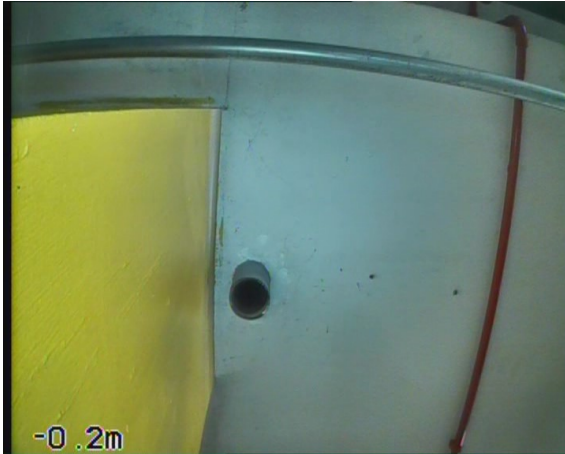
HOLX\_2aa38105-f84e-4440-b692-ddfa70b910a0\_20230911\_094042\_094.jpg, 00:00:00, 0.00 m  
Start node, major connection without manhole, reference: RWDP4 (F1)
