# Carriageway Condition Survey recorded on 28th July 2023

PICCADILLY GARDENS, MANCHESTER, M1 1AF

Friday, 28 July 2023

Prepared For L&G / Colliers

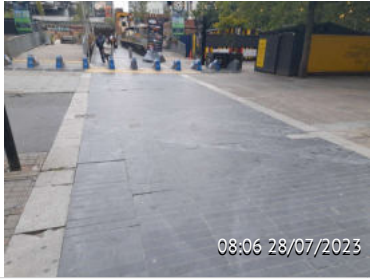
### Item 1

Assigned To Feature Paving Area at Piccadilly / Oldham St. junction

General condition, paving tiles and feature bands are in a poor state of repair.

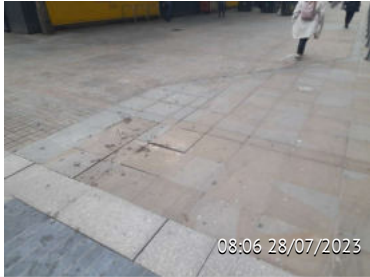
### Item 2

Assigned To Piccadilly pedestrian walkway

Area of paving suffering from movement, bedding material uneven, grout / sand missing from joints.

Paving flag edges are spalled / chipped.

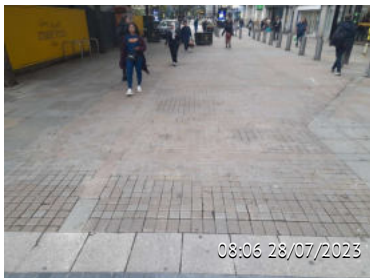
### Item 3

Assigned To Piccadilly pedestrian walkway

General condition: In a fair state of repair.

Paving grout / sand joint material missing to large areas and paving blocks / tiles are suffering movement.

Multiple spalled / chipped edges.

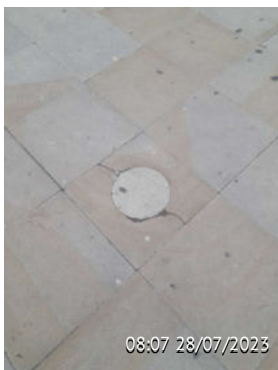
### Item 4

Assigned To Piccadilly pedestrian walkway

Paving flag cracked.

Historic repair where street furniture has been removed.

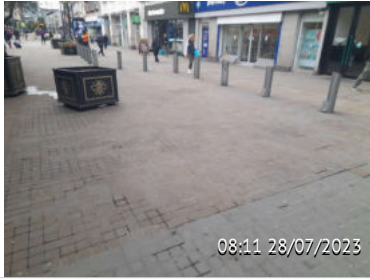
### Item 6

Assigned To Piccadilly pedestrian walkway

General condition: In a fair state of repair.  
Grout loss visible to cobble set joints.

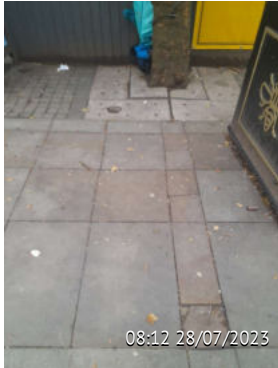
### Item 7

Assigned To Piccadilly pedestrian walkway

General condition: Paving flags in a poor state of repair.  
Narrow band of paving has several cracked flags, spalled / chipped edges.  
Tree planter suffering with movement and paving levels are very uneven.

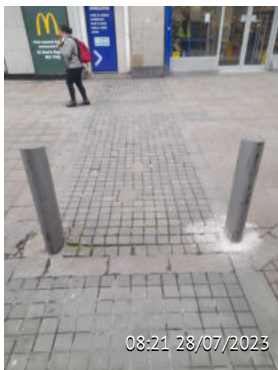
### Item 8

Assigned To Piccadilly pedestrain walkway

Feature band of cobble sets suffering from grout loss and movement.  
Paving levels are uneven and multiple historic repairs have been carried out.  
Repairs carried out around bollards with concrete and paving is badly damaged.

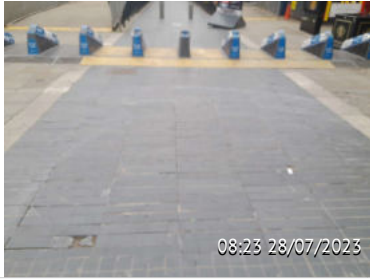
### Item 10

Assigned To Entrance to Piccadilly Gdns Main Walkway

Feature tile paving General Condition: In a poor state of repair.

Multiple loose tiles with spalled edges and cracks.

Grout missing from tile joints in multiple locations.

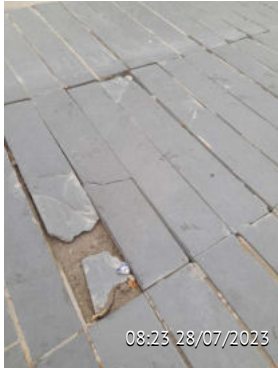
### Item 11

Assigned To Entrance to Main Walkway

Bedding and grout failure, cracked spalled tiles.

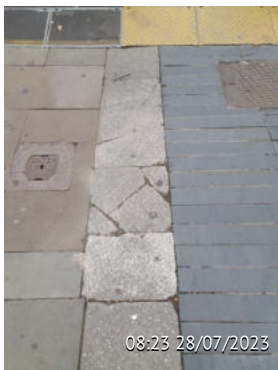
### Item 12

Assigned To Entrance to Main Walkway

Feature band flags cracked.

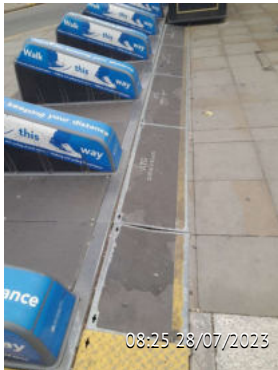
#### Item 15

Assigned To Entrance to Main Walkway  
Surface Guard ramps are buckled.

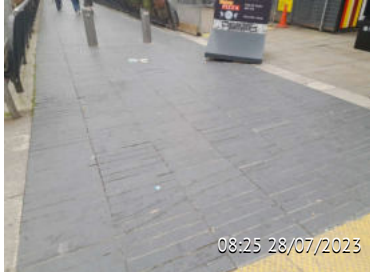
#### Item 16

Assigned To Main Walkway up to Bollards  
General Condition: Fair

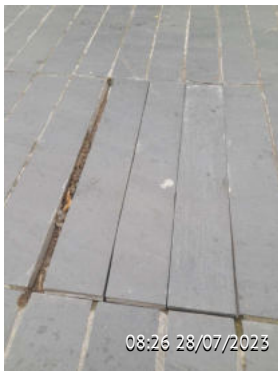
#### Item 17

Assigned To Main Walkway leading up to Bollards  
Bedding and grout failure to tiles causing movement resulting in spalled / damaged edges.

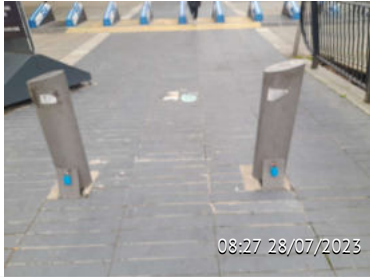
### Item 19

Assigned To Main Walkway bollards

General Condition: Fair

Paving tiles showing signs of bedding / grout failure resulting in movement and edge damage.

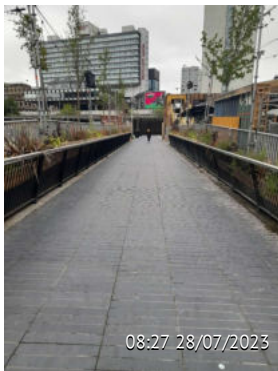
### Item 20

Assigned To Main Walkway through fountain

General Condition: Fair

Bedding material and grout loss causing movement resulting in edge damage and cracking.

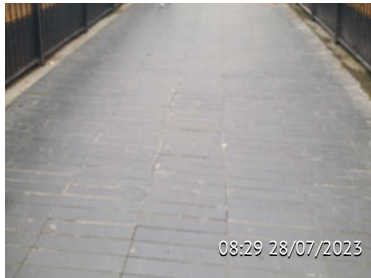
### Item 23

Assigned To Main Walkway through fountain area

General Condition: Fair

Paving tile grout failure throughout.

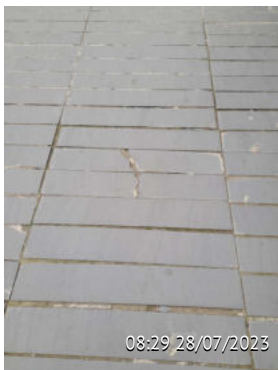
### Item 24

Assigned To Main Walkway through fountain

Paving tile bedding material and grout failure causing movement resulting in cracking, spalling and edge damage.

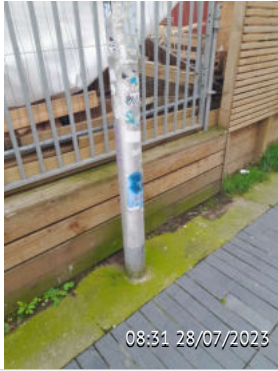
### Item 27

Assigned To Main walkway exiting fountain

Lighting column and feature band in poor condition.  
Cracked paving from LC core hole.

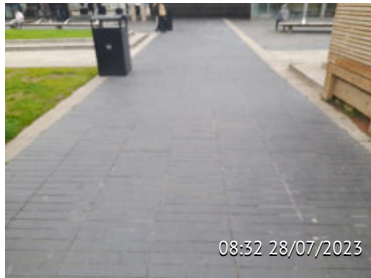
### Item 28

Assigned To Main Walkway leading to Pavilion

General Condition: Fair  
Bedding material and grout failure resulting in movement and edge damage.

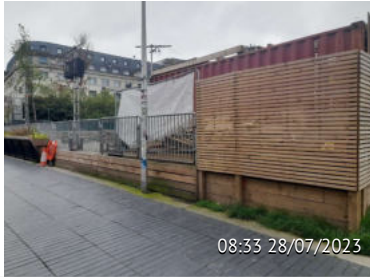
### Item 32

Assigned To Event space wall LHS of Main Walkway  
General condition: Good, no visible damage or disrepair.

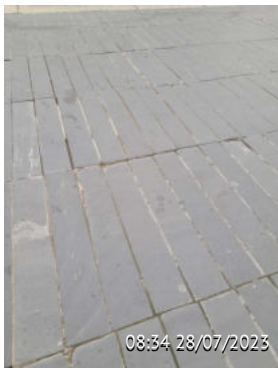
### Item 34

Assigned To Main Walkway  
Paving Tile bedding material and grout failure causing movement resulting in cracks, spalls and edge damage.

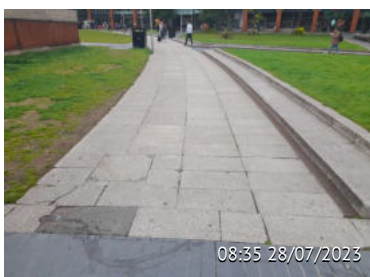
### Item 35

Assigned To Flag stone walkway  
General condition: Fair  
Multiple cracked paving flags at junction with main walkway.  
Signs of minor settlement / movement.

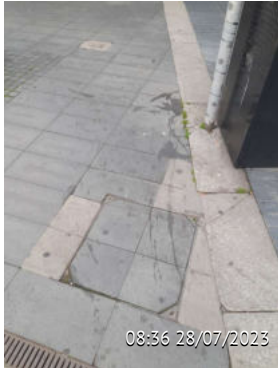
### Item 37

Assigned To Walkway leading to Mosley Street  
Paving to rear of Litter Bin showing signs of settlement and lipping.  
Feature band cracked flag has been repaired using a patch repair system.

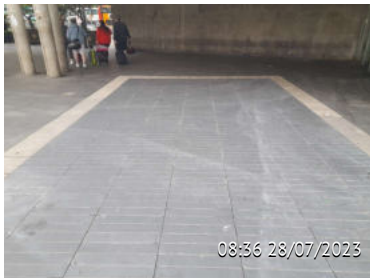
### Item 38

Assigned To Main Walkway leading under Pavilion roof  
General condition: Fair  
Bedding material and grout failure, causing movement leading to cracks, spalls and edge damage.

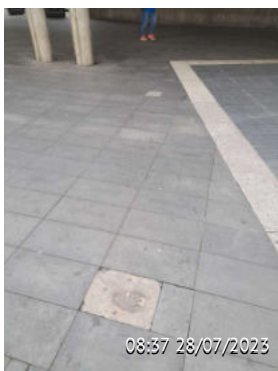
### Item 39

Assigned To Pavilion Terrace  
Historic repair

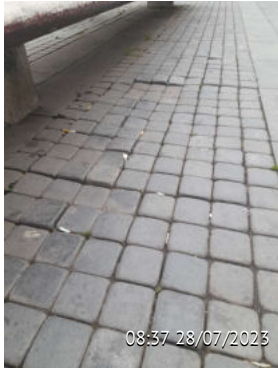
#### Item 41

Assigned To Pavilion Terrace

Cobble sets to perimeter of bench seating moving / settling due to bedding & joint material failure.

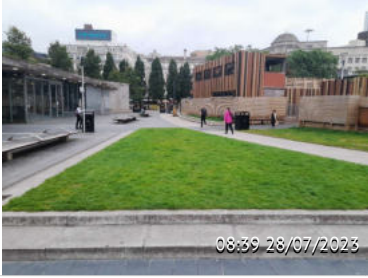
#### Item 44

Assigned To Soft Landscaping to front of Pavilion

General condition: Good

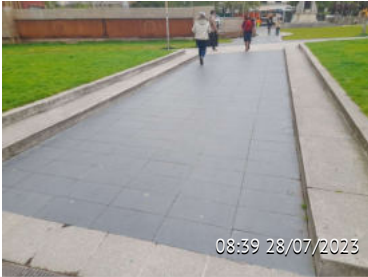
#### Item 45

Assigned To Walkway to front of Pavilion

General Condition: Good

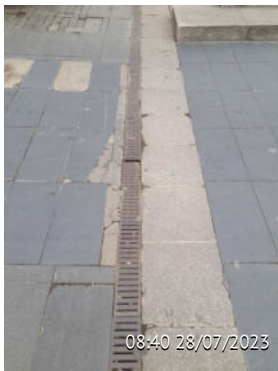
#### Item 46

Assigned To Walkway to front of Pavilion building

Channel drain and paving failure present along full length of drain.

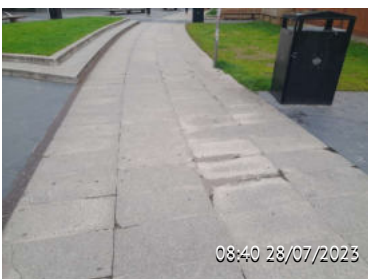
#### Item 47

Assigned To Flag Stone walkway junction

General condition: Fair

Paving Flags showing signs of movement and suffering from edge damage and spalling.

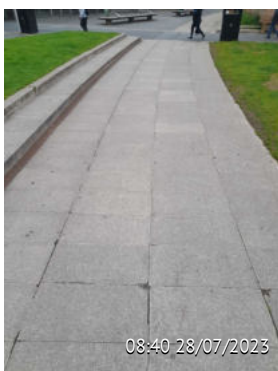
#### Item 48

Assigned To Flag Stone walkway

General Condition: Fair

Flags showing signs of movement with edge damage and spalls.

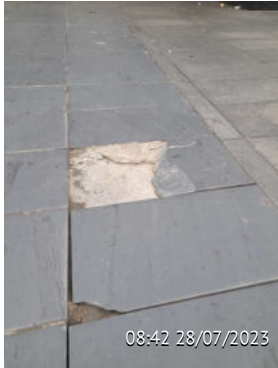
### Item 50

Assigned To Walkway to Tram Station

Paving tile damage in need of repair.

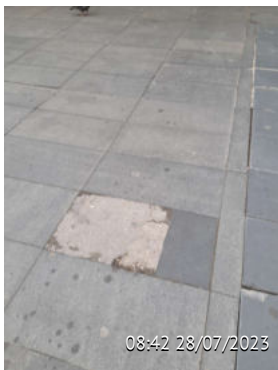
### Item 51

Assigned To Walkway to Tram Station

Paving flag repair using a patch repair system.

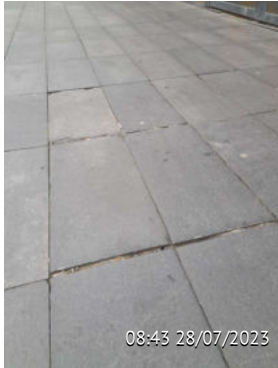
### Item 54

Assigned To Pavilion Terrace RHS

Paving Tile bedding / grout material failure causing movement resulting in edge damage and spalls.

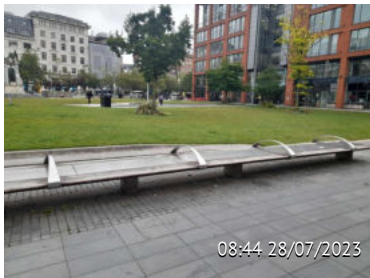
### Item 55

Assigned To Pavilion Terrace RHS

Bench Seating General Condition: Poor

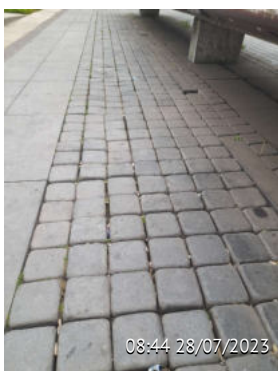
### Item 57

Assigned To Pavilion Terrace RHS

Cobble sets to perimeter of bench seating moving / settling due to bedding & joint material failure.

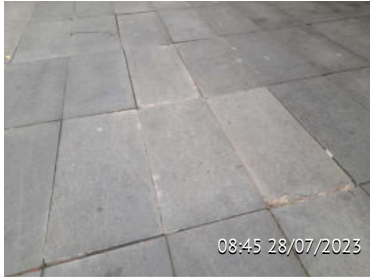
### Item 59

Assigned To Pavilion Terrace RHS  
Movement causing cracks and edge damage.

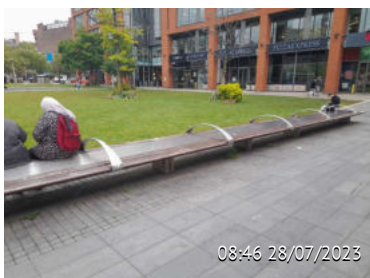
### Item 62

Assigned To Pavilion Terrace RHS  
Bench Seating General Condition: Poor

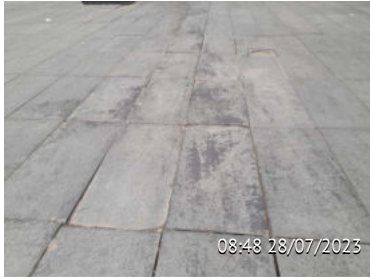
### Item 68

Assigned To Pavilion Terrace RHS

Movement causing cracking, spalling and edge damage.

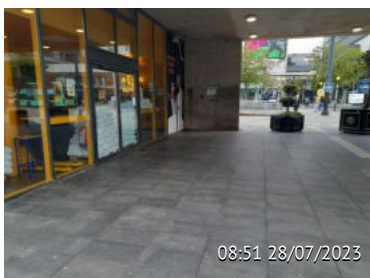
### Item 71

Assigned To Pavilion Terrace under roof area

General Condition: Fair

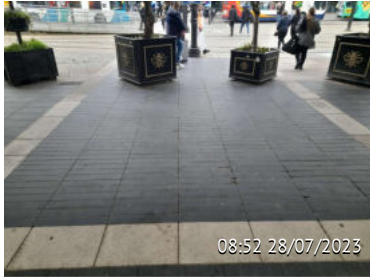
### Item 73

Assigned To Feature Walkway under Pavilion roof area  
General Condition: Poor  
Multiple cracked, spalled edge damaged tiles.

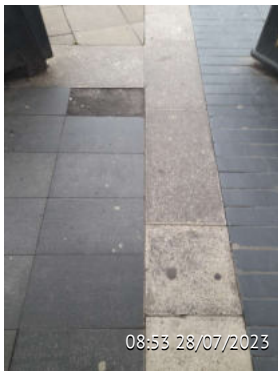
### Item 74

Assigned To Exit from Pavilion onto Tram Station  
Missing paving flag repair using patch repair system.

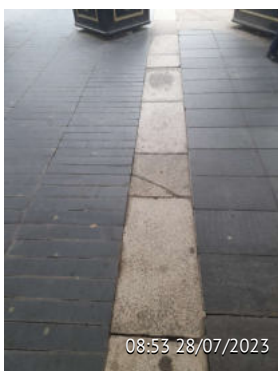
### Item 76

Assigned To Feature Walkway under Pavilion roof area  
Bedding / joint material failure causing movement resulting in cracks, spalls and edge damage.

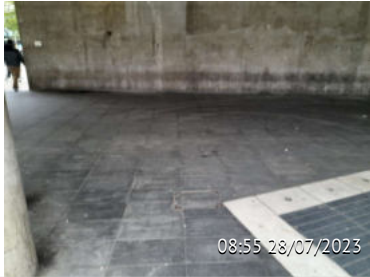
### Item 78

Assigned To Pavilion Terrace under roof area  
General Condition: Fair

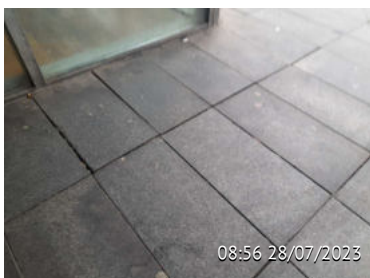
### Item 81

Assigned To Pavilion Terrace under roof area  
Movement causing excessive lipping.

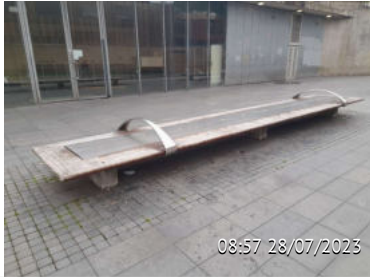
### Item 83

Assigned To Pavilion Terrace LHS  
Bench Seating Condition: Poor

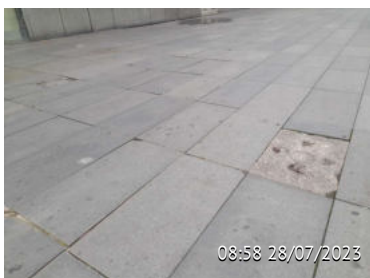
### Item 86

Assigned To Pavilion Terrace LHS  
Street furniture removal.  
Spalling and lipping to multiple tiles.

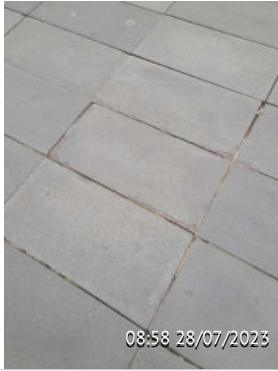
### Item 87

Assigned To Pavilion Terrace LHS  
Spalling and Lipping.

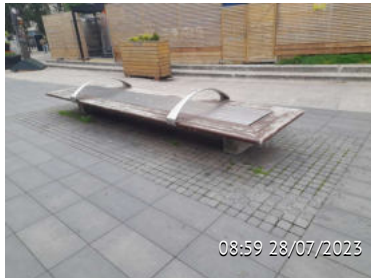
### Item 88

Assigned To Pavilion Terrace LHS  
Bench Seating General Condition: Poor

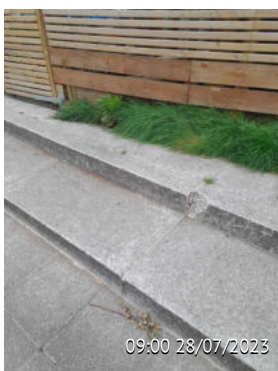
### Item 91

Assigned To Walkway to Mosley St  
Damage to steps up to soft landscape area (now event space).

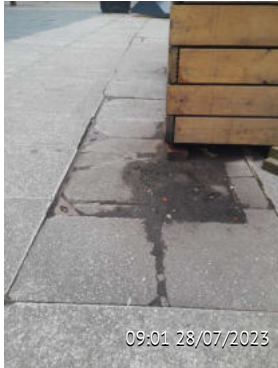
### Item 93

Settlement and lipping to paving around Access Chamber covers.

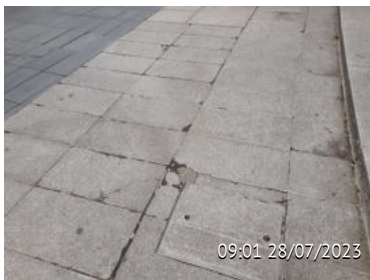
### Item 94

Paving flag general condition: Poor

Multiple flags with spalls and edge damage, lipping also present.

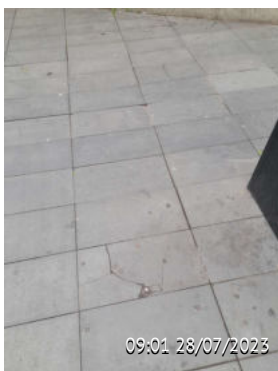
### Item 95

Cracks to paving tiles adjacent Litter Bin.

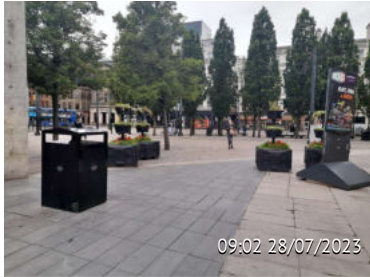
### Item 97

General Condition: Poor

Multiple areas of damaged flags and tiles, settlement causing lipping, spalling and edge damage.

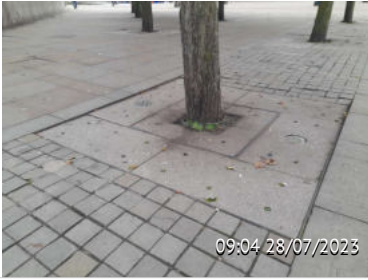
### Item 101

Assigned To Pedestrian Zone alongside Parker St tramway  
Tree pit paving unven with excessive lipping.  
Missing + movement in cobble sets.

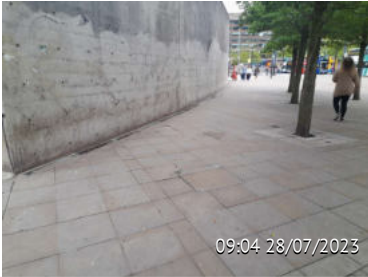
### Item 102

Assigned To Pedestrian Zone alongside Parker St tramway  
Paving General Condition: Fair

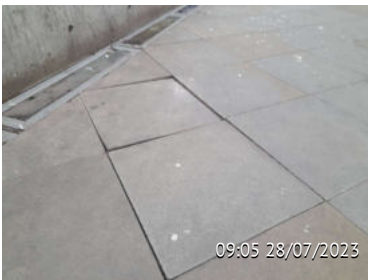
### Item 103

Assigned To Pedestrian Zone alongside Parker St tramway  
Movement in flags causing excessive lipping and edge damage.

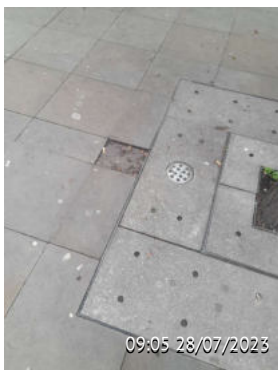
### Item 104

Assigned To Pedestrian Zone alongside Parker St tramway  
Tree Pit paving has settled causing excessive lipping.

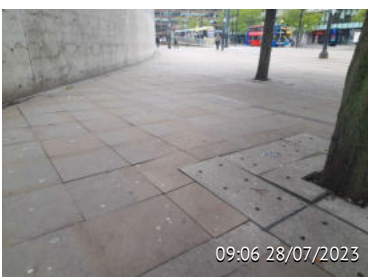
### Item 105

Assigned To Pedestrian Zone alongside Parker St tramway  
General Condition: Fair

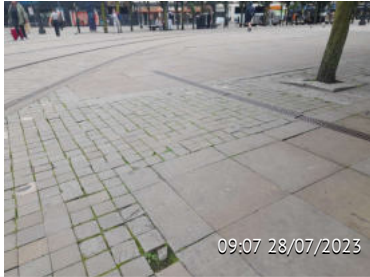
### Item 107

Feature Cobble Set areas are suffering from bedding / jointing material failure causing movement, edge damaged and missing cobble sets.

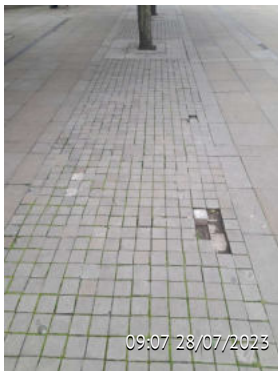
### Item 108

Feature Cobble Set areas are suffering from bedding / jointing material failure causing movement, edge damaged and missing cobble sets.

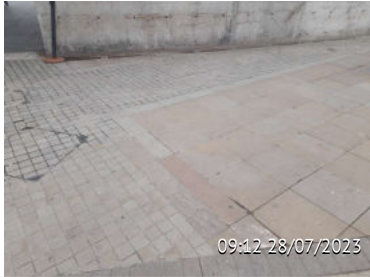
### Item 121

Feature Cobble Set areas are suffering from bedding / jointing material failure causing movement, edge damaged and missing cobble sets.

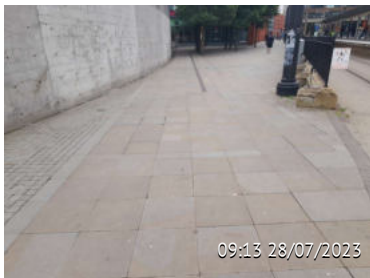
### Item 122

Paving General Condition: Fair

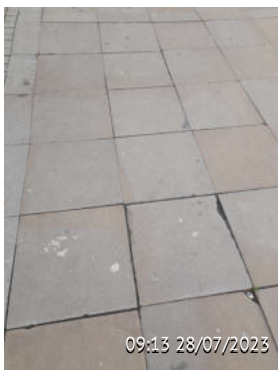
### Item 123

Movement causing lipping, spalling and edge damage.

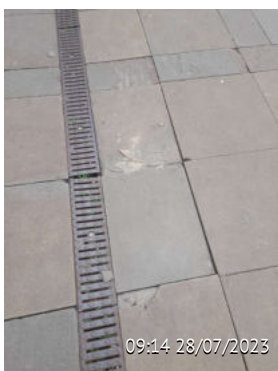
### Item 124

Movement causing lipping, spalling and edge damage.

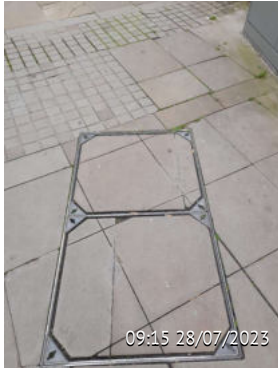
### Item 126

Access Chamber cover infill and perimeter paving in poor state or repair.

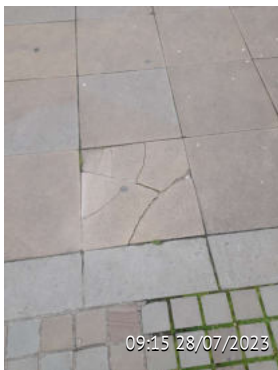
### Item 127

Severely cracked / damaged paving flag.

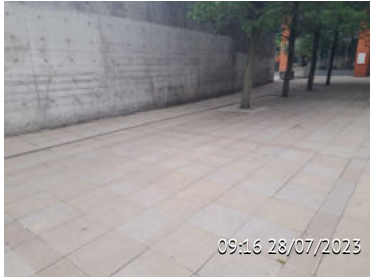
### Item 130

Assigned To Pedestrian Zone alongside Piccadilly Gdns tram station platform  
Paving General Condition: Fair

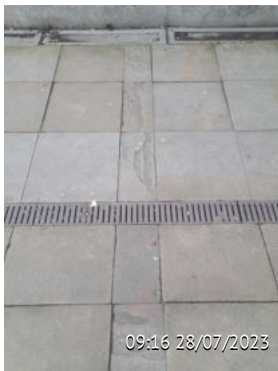
### Item 131

Assigned To Pedestrian Zone alongside Piccadilly Gdns tram station platform  
Feature band showing signs of heavy weathering.

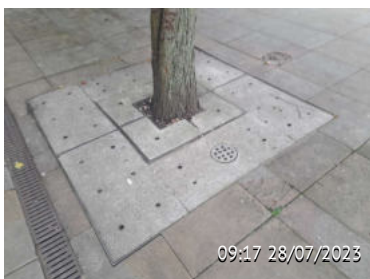
### Item 132

Assigned To Pedestrian Zone alongside Piccadilly Gdns tram station platform  
Tree pit paving settlement causing excessive lipping.

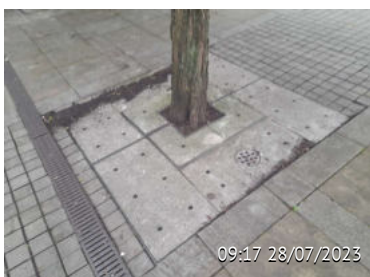
### Item 133

Assigned To Pedestrian Zone alongside Piccadilly Gdns tram station platform  
Tree pit paving settlement causing excessive lipping.

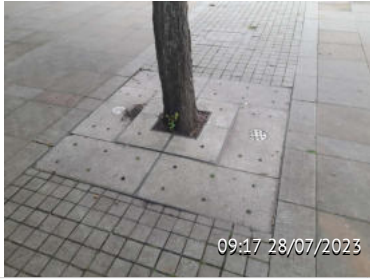
### Item 134

Assigned To Pedestrian Zone alongside Piccadilly Gdns tram station platform  
Tree pit paving settlement causing excessive lipping.

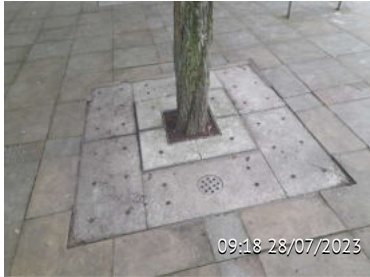
### Item 135

Assigned To Pedestrian Zone alongside Piccadilly Gdns tram station platform  
Tree pit paving settlement causing excessive lipping.

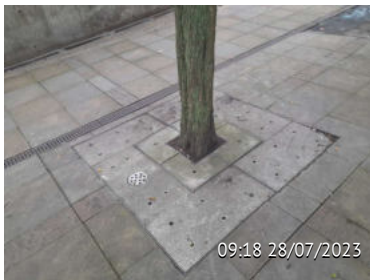
### Item 136

Assigned To Pedestrian Zone alongside Piccadilly Gdns tram station platform  
Tree pit paving settlement causing excessive lipping.

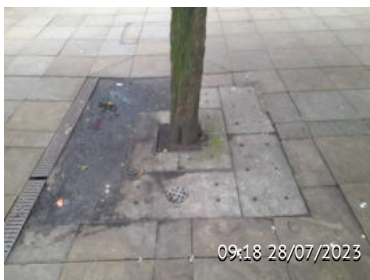
### Item 137

Assigned To Pedestrian Zone alongside Piccadilly Gdns tram station platform  
Tree pit paving settlement causing excessive lipping.

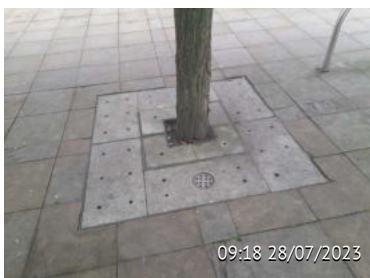
### Item 138

Assigned To Pedestrian Zone alongside Piccadilly Gdns tram station platform  
Tree pit paving settlement causing excessive lipping.

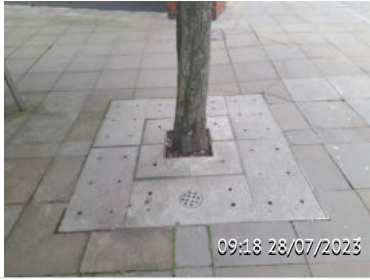
### Item 139

Assigned To Pedestrian Zone alongside Piccadilly Gdns tram station platform  
Tree pit paving settlement causing excessive lipping.

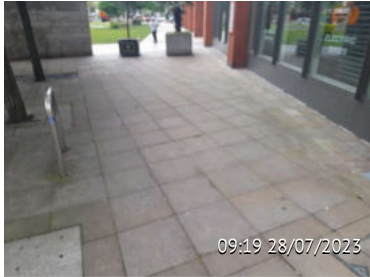
### Item 140

Assigned To Area leading through to Piccadilly Gardens  
Paving General Condition: Fair

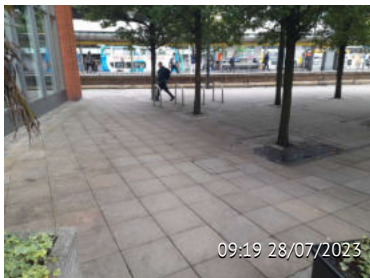
### Item 141

Assigned To Pedestrian Zone alongside Piccadilly Gdns tram station platform  
Paving General Condition: Fair

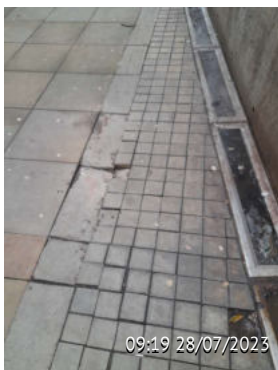
### Item 142

Assigned To Area to rear of Pavilion Building feature wall opposite tram station  
Feature Cobble Set areas are suffering from bedding / jointing material failure causing movement, edge damaged and missing cobble sets.  
Feature band settlement causing excessive lipping, spalling and edge damage.

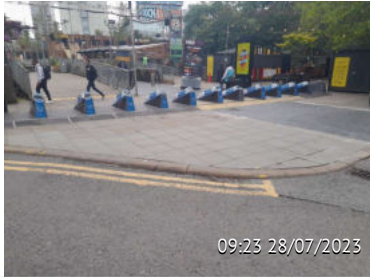
### Item 145

General Condition of paving, kerbs and street furniture: Fair

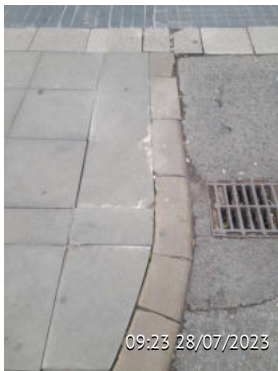
### Item 146

Paving flags and kerbs at entrance to pedestrianised zone in poor state of repair.

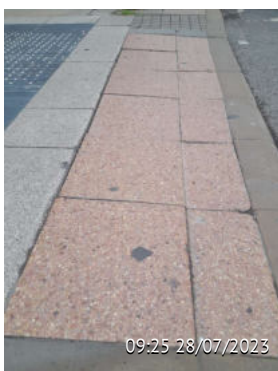
### Item 148

Paving condition: Poor

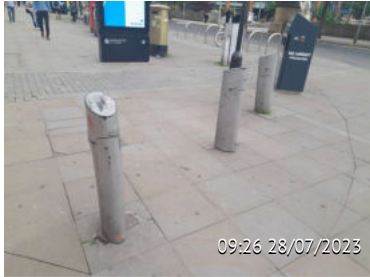
### Item 150

Multiple cracked, spalled and edge damaged paving flags.
