**LIVERPOOL ROAD HOTEL,  
MANCHESTER**

**STRUCTURAL SURVEY REPORT**

Project No 2205-02  
November 2022  
Rev: P01  
LRH-REN-XX-XX-RP-S-00002

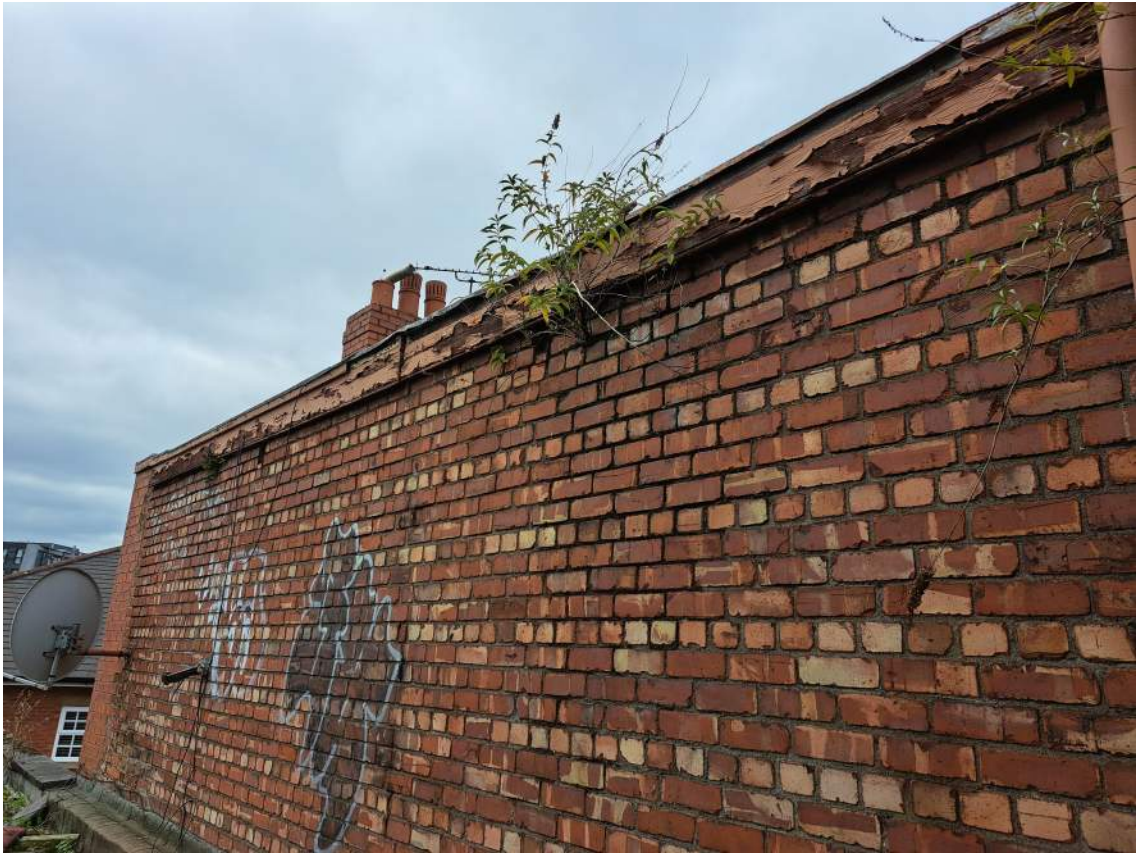
**E02/04:** The timber fascia at eaves level around the perimeter of the 19<sup>th</sup> century parts of the building is in poor condition in places. Rainwater goods are generally in poor condition.

**E04:** MASONRY ON EAST ELEVATION TO 19TH CENTURY WOOLLAM PLACE EXTENSION SHOWS NO OBVIOUS DEFECTS. TIMBER FASCIA IN NEED OF REPLACEMENT. VEGETATION PRESENT AT EAVES LEVEL.

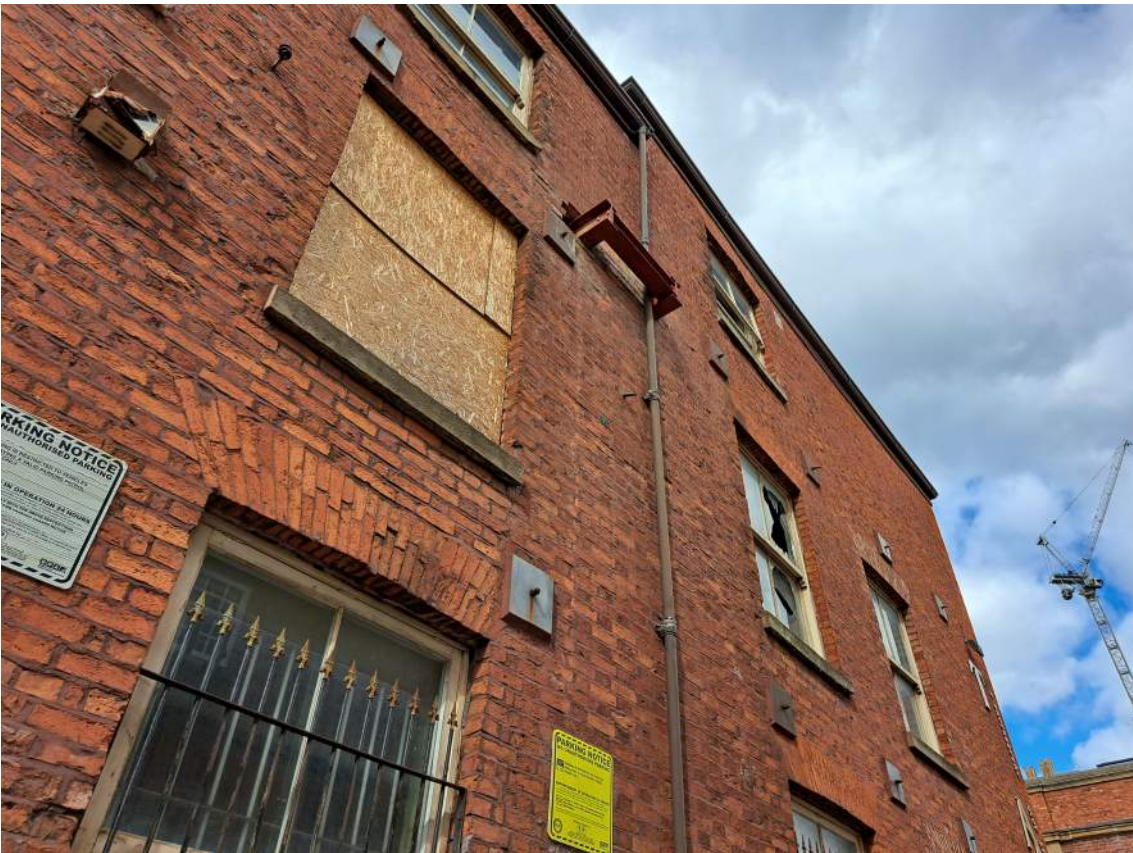
**E05:** There is a visible bow to the east elevation of the building on Old Medlock Street. Several pattress plates were visible across this elevation which will have been introduced to address the movement of the wall. However, due to a structural collapse which has occurred inside the building at ground, 1<sup>st</sup> and 2<sup>nd</sup> floor, some of the tie rods corresponding to the pattress plates have failed. The masonry and mortar joints across the east elevation of the building exhibit no obvious signs of distress which would suggest that the movement of the wall is not currently ongoing.

**E05:** EAST ELEVATION TO 123 LIVERPOOL ROAD. THERE IS A VISIBLE BOW TO THE GABLE WALL AS WELL AS SEVERAL PATTRESS PLATES BUT THERE ARE NO OBVIOUS SIGNS OF ONGOING MOVEMENT.

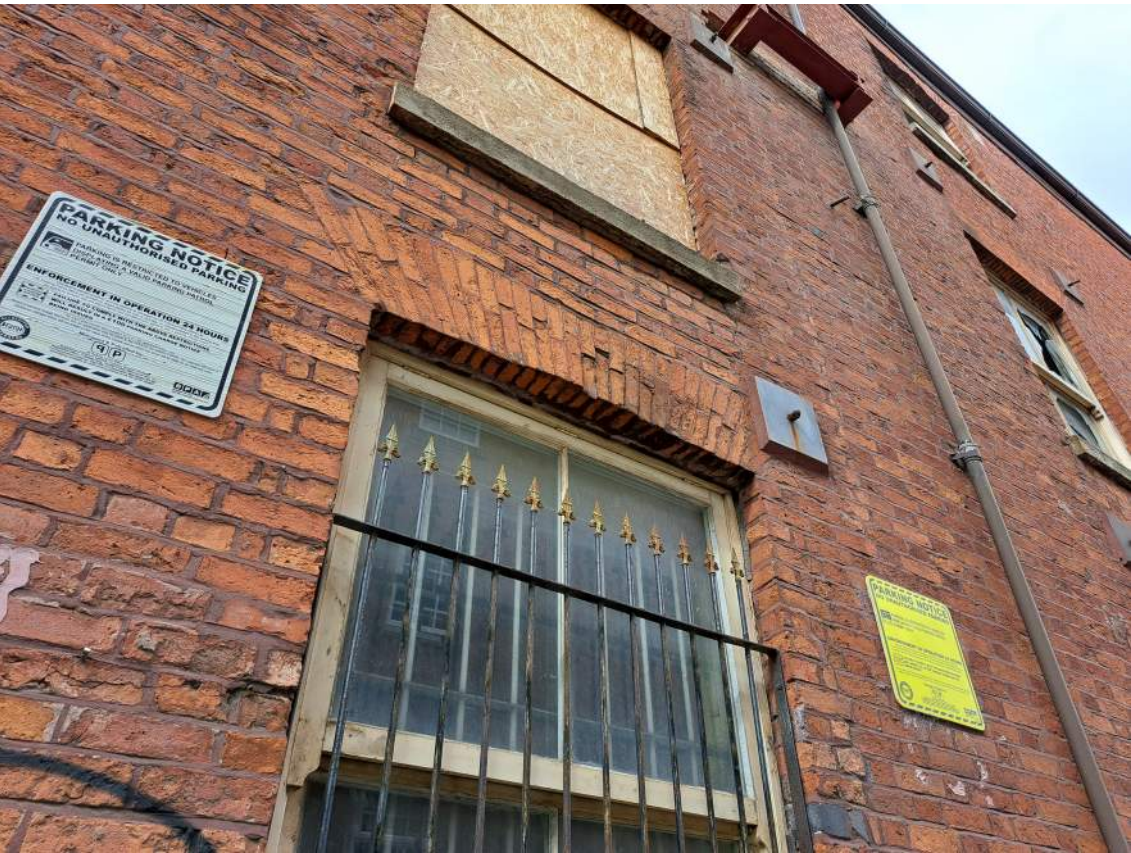
**E06:** DISPLACED BRICKS IN A FLAT ARCH ABOVE A WINDOW OPENING ON THE EAST ELEVATION TO 123 LIVERPOOL ROAD.

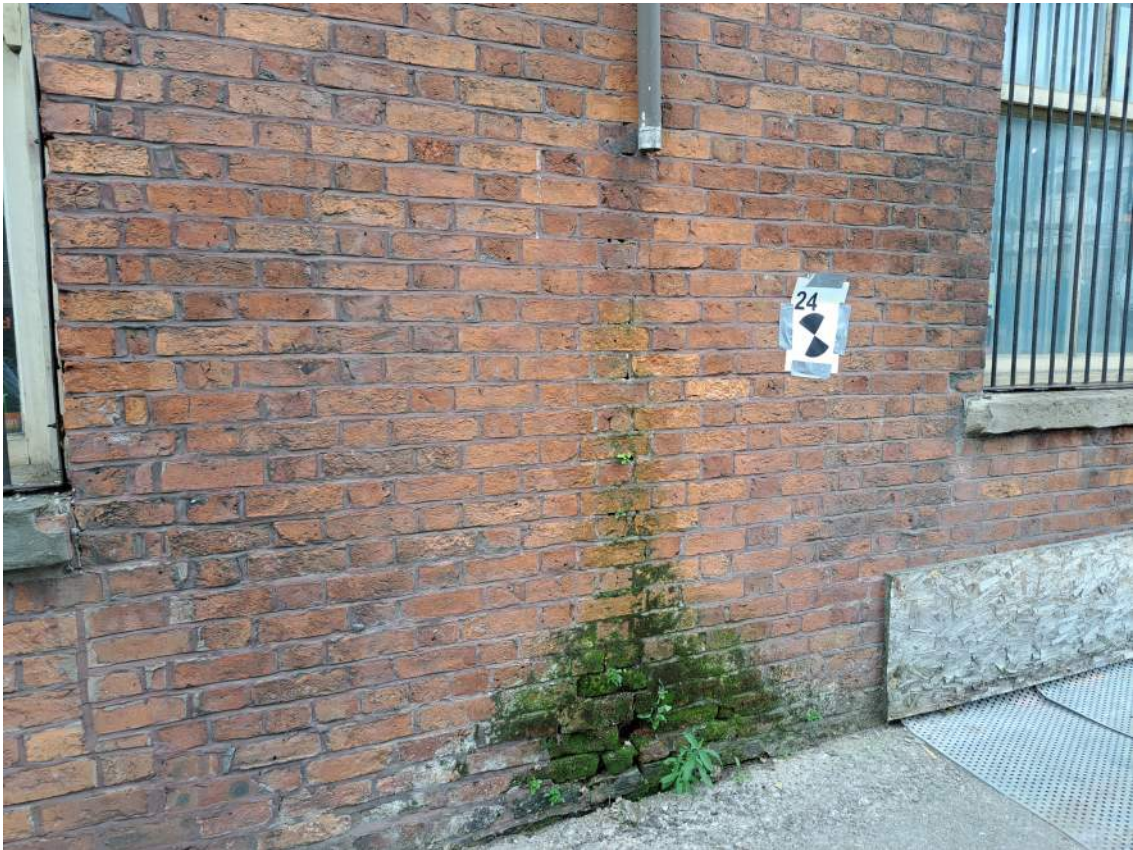
**E07:** A broken downpipe on the east elevation of the building is causing water to run down the face of the external brickwork resulting in it being saturated and loss of mortar from joints.

**E07:** WEATHERED MORTAR JOINTS, SATURATED BRICKWORK AND VEGETATION GROWTH UNDER A RAINWATER DOWNPIPE ON THE EAST ELEVATION TO 123 LIVERPOOL ROAD.

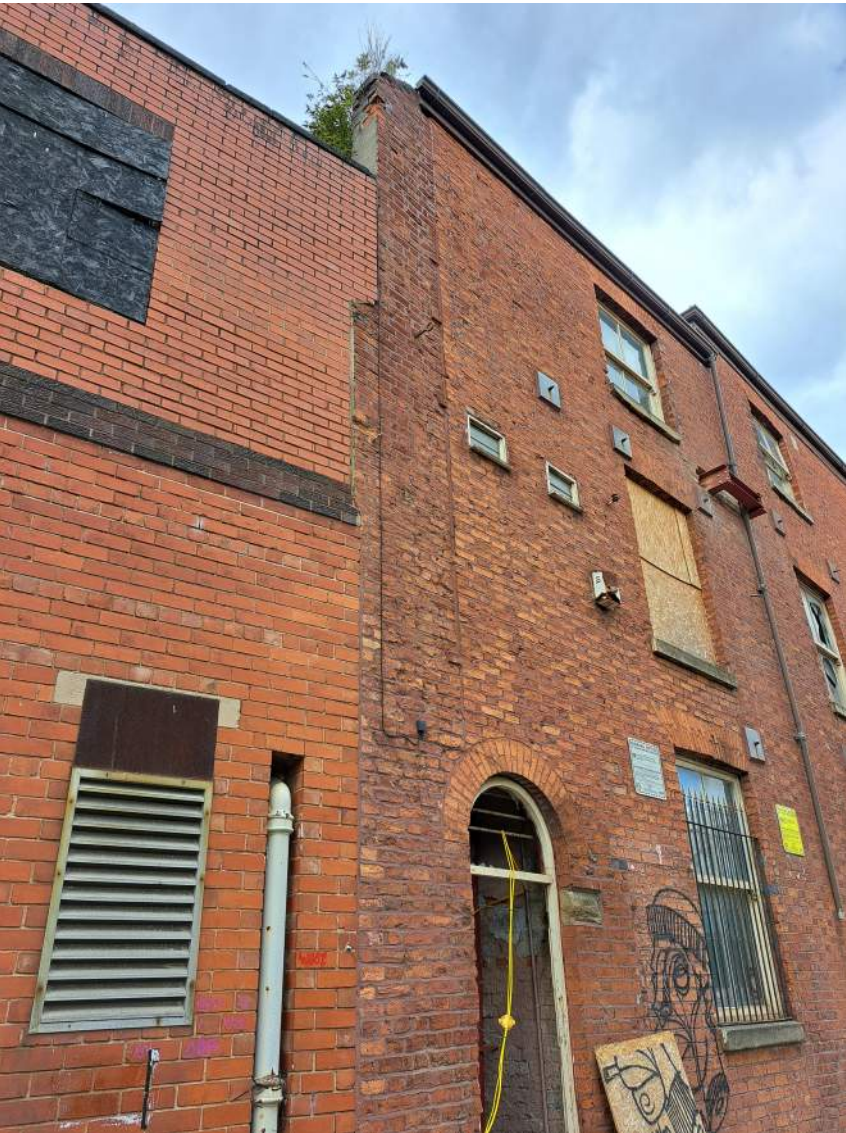
**E08:** JOINT BETWEEN 19TH AND 20TH CENTURY SECTIONS OF 123 LIVERPOOL ROAD ON OLD MEDLOCK STREET. VEGETATION GROWTH IS VISIBLE AT ROOF LEVEL.

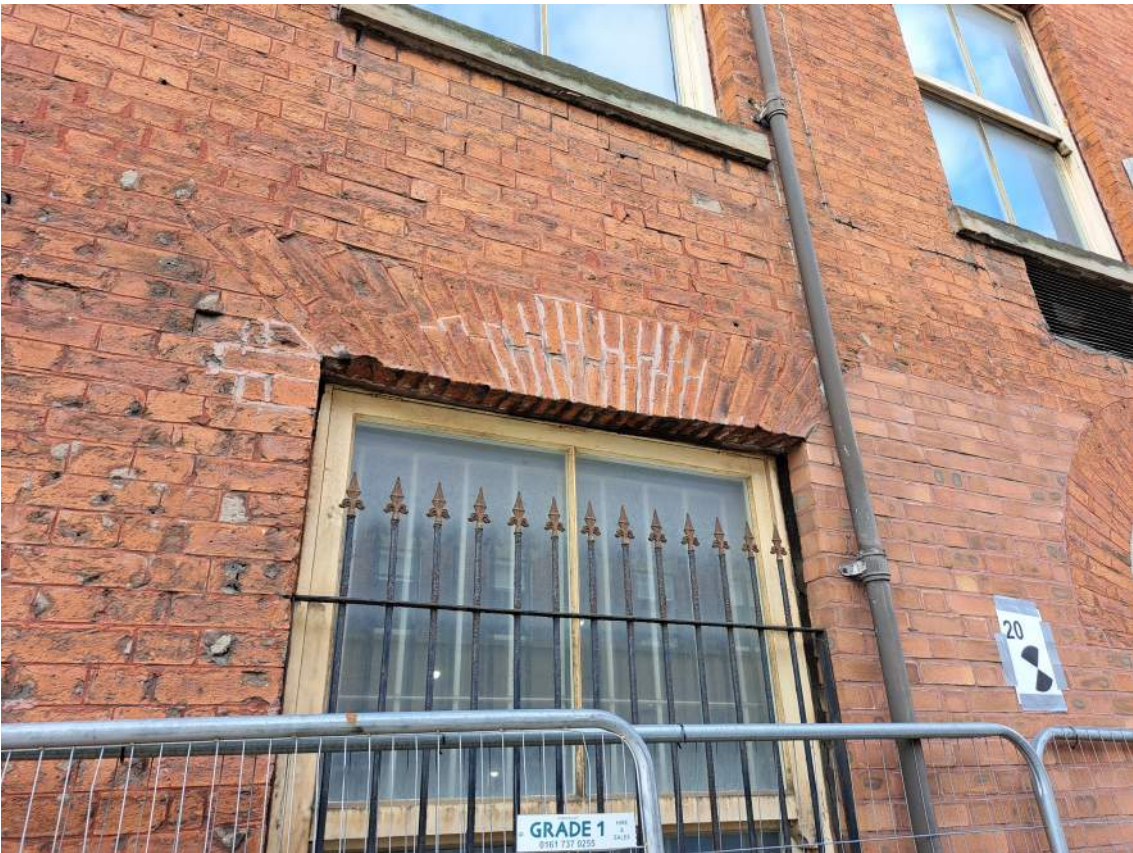
**E09:** DEFLECTION OF BRICKWORK OVER WINDOW OPENING ON NORTH ELEVATION TO 123 LIVERPOOL ROAD. THE MORTAR JOINTS HAVE BEEN RECENTLY RE-POINTED.

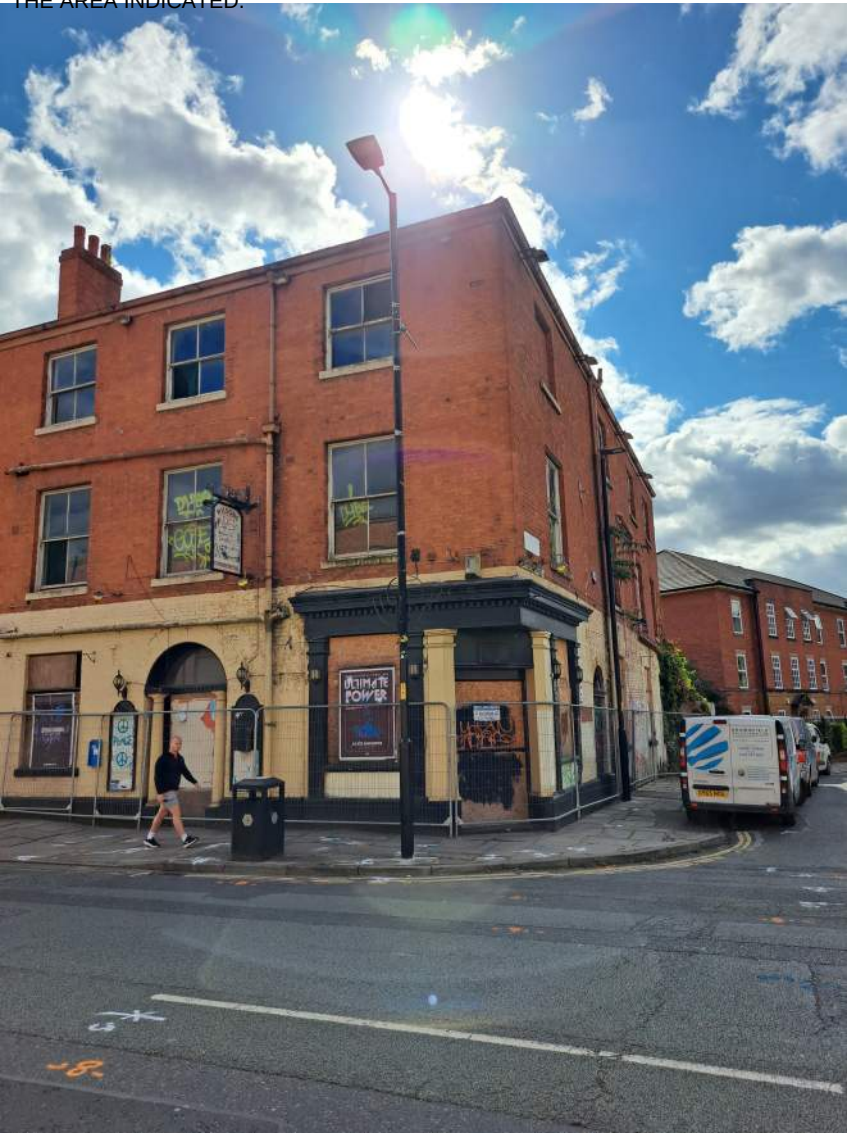
**E12:** GENERAL VIEW SHOWING THE RECESSED NORTH WEST CORNER AT GROUND FLOOR LEVEL OF 125 LIVERPOOL ROAD.

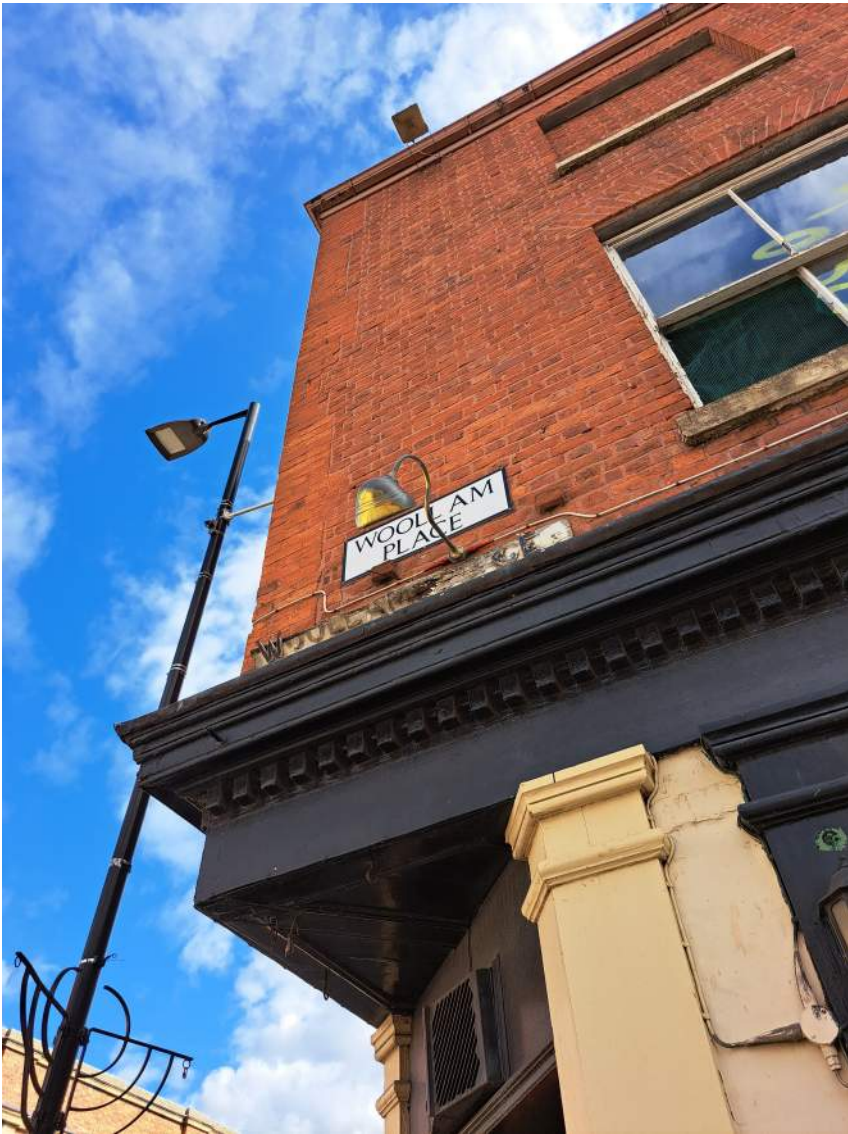
**E13:** PROJECTING CORNER ABOVE 1ST FLOOR ON THE NORTH WEST CORNER OF 125 LIVERPOOL ROAD. THERE ARE NO OBVIOUS SIGNS OF STRUCTURAL DISTRESS ABOVE.

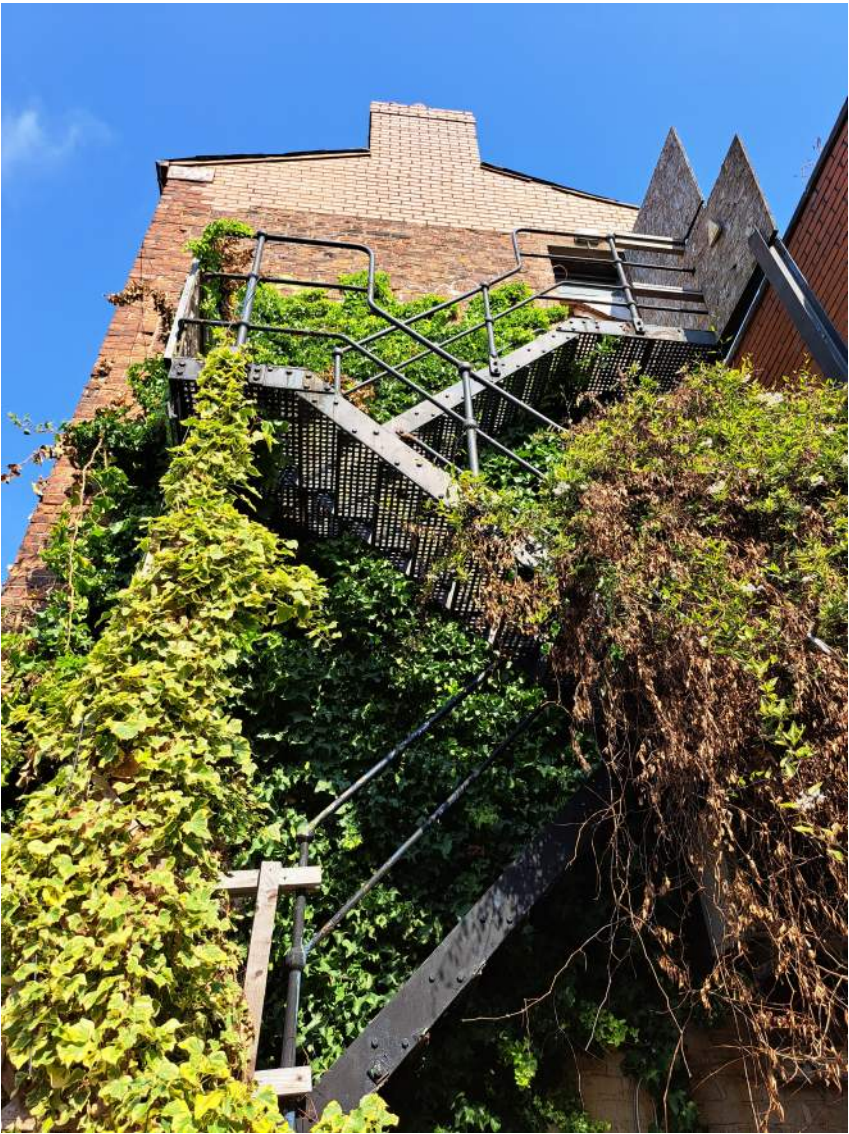
**E15:** VIEW OF SOUTH ELEVATION TO 19TH CENTURY WOOLLAM PLACE EXTENSION IS MAINLY OBSCURED DUE TO VEGETATION GROWTH. EVIDENCE OF RE-BUILDING ABOVE EAVES LEVEL. EXTERNAL FIRE ESCAPE APPEARS TO BE IN SERVICEABLE CONDITION.

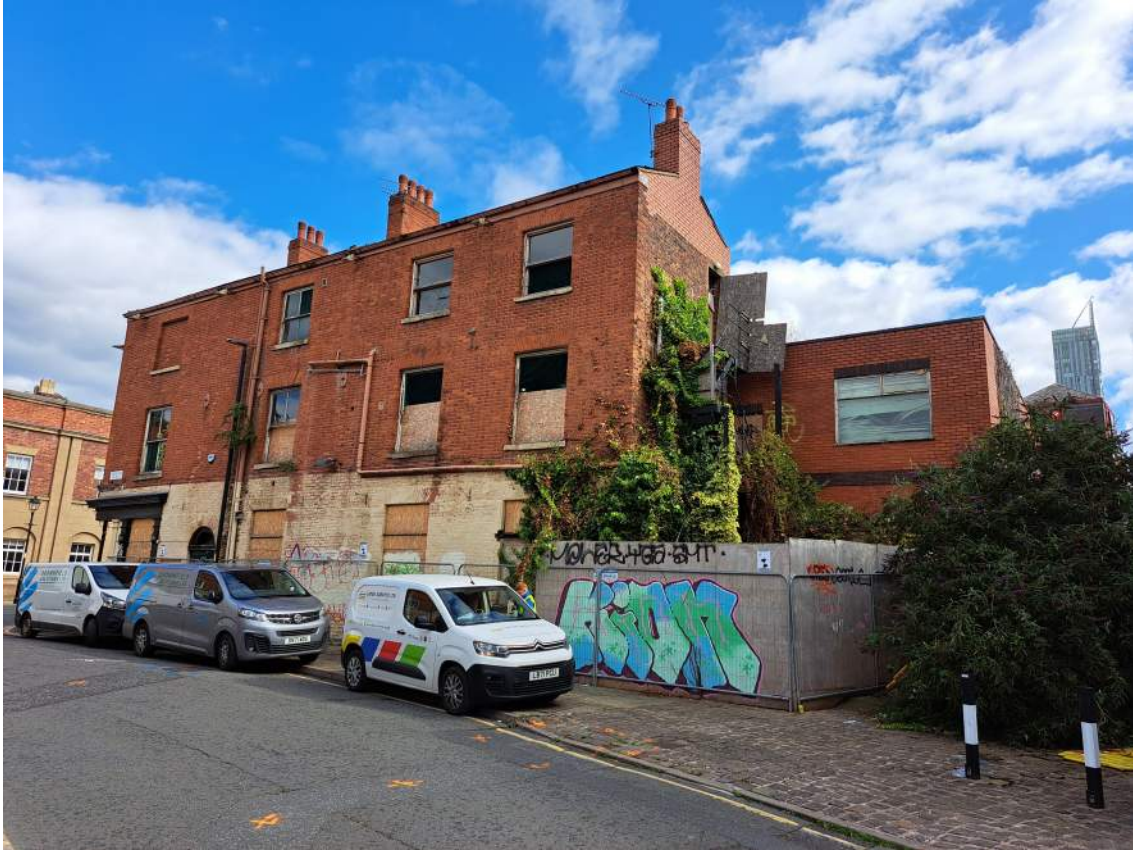
**E16:** GENERAL VIEW OF 125 LIVERPOOL ROAD FROM WOOLLAM PLACE.

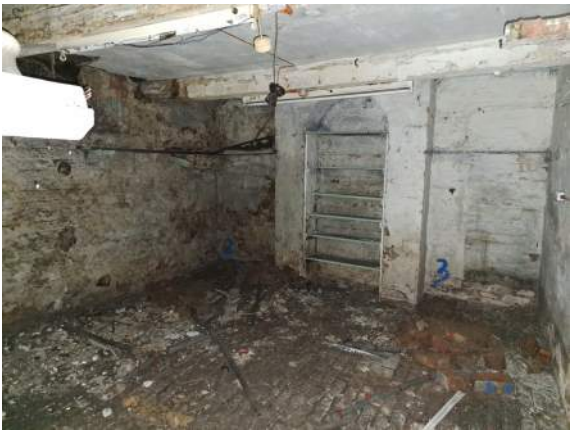
**B03:** GENERAL VIEW OF ROOM B02. THE BASEMENT FLOOR GENERALLY CONSISTS OF BRICK PAVING.

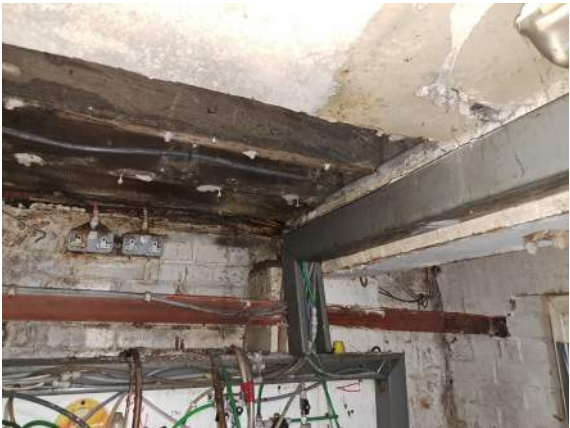
**B08:** REMEDIAL MASONRY PIER AT END OF TIMBER BEAM IN ROOM B08.

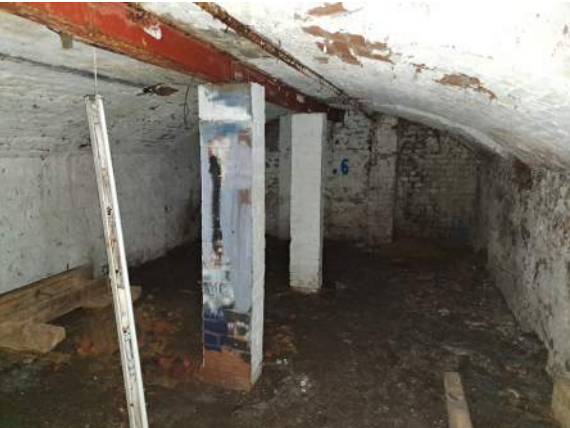
**B09/12/14:** Masonry piers and a line of steel beams have been introduced to the underside of the crown of the vaulted ceiling over room B07. This structure is likely to have been added as a remedial solution due to the crown of the vault dropping historically. There are areas where water ingress has occurred through the vaulted ceiling causing the steel beams to corrode.

**B09:** REMEDIAL MASONRY PIERS AND STEEL BEAMS ADDED TO SUPPORT THE CROWN OF THE VAULTED CEILING IN ROOM B07.

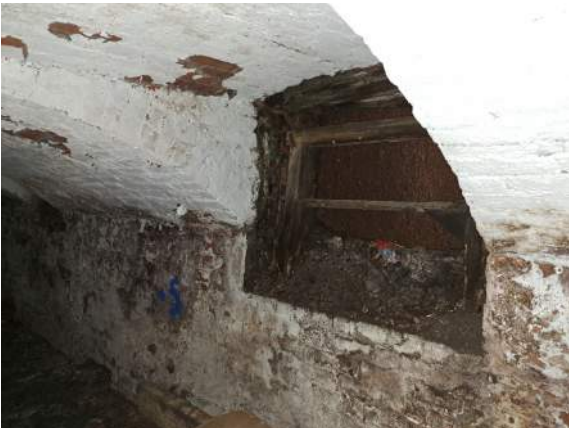
**B10:** INFILLED PAVEMENT LIGHT WITHIN ROOM B07. THERE ARE SIGNS OF WATER INGRESS THROUGH THE INFILL.

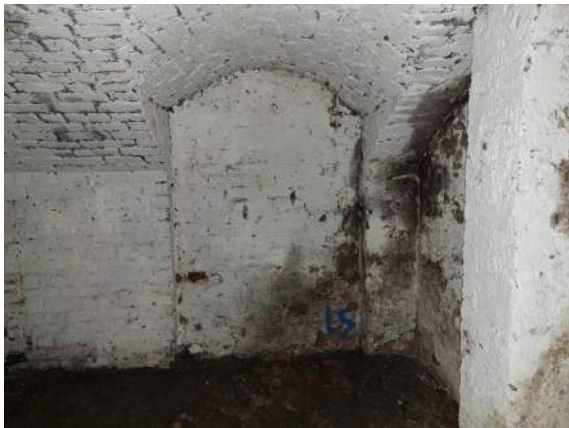
**B11:** There appears to be a door opening in the south-east corner of room B07 which has been historically infilled with brick. A pilot hole through the infill carried out as part of intrusive investigations being undertaken concurrently with the condition survey suggests that there is fill on the other side of the wall. The infilled historic basements underneath the factory extension at the rear of the site also do not appear to be present adjacent to room B07. This may suggest that the door opening is likely to have provided stepped access from ground level originally but has since been back filled.

**B11:** HISTORIC DOOR OPENING INFILLED WITH MASONRY IN THE SOUTH EAST CORNER OF ROOM B07.

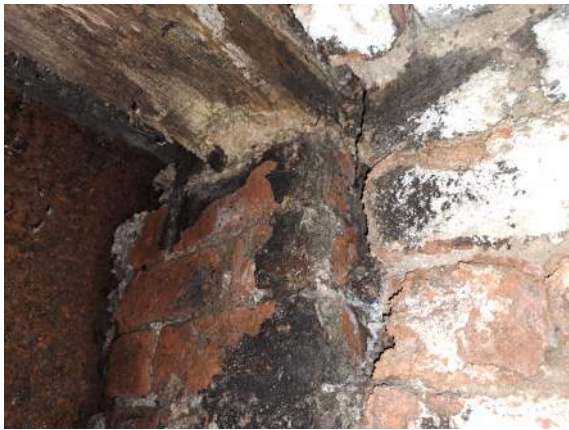
**B15:** JOINT BETWEEN SKINS OF MASONRY ADJACENT TO PAVEMENT LIGHT HAS OPENED UP ON THE WOOLLAM PLACE ELEVATION OF ROOM B07.

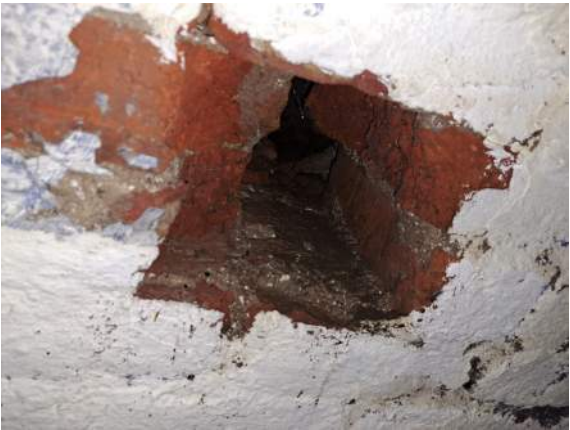
**B16:** HOLE FORMED THROUGH VAULTED MASONRY ABOVE ROOM B07.

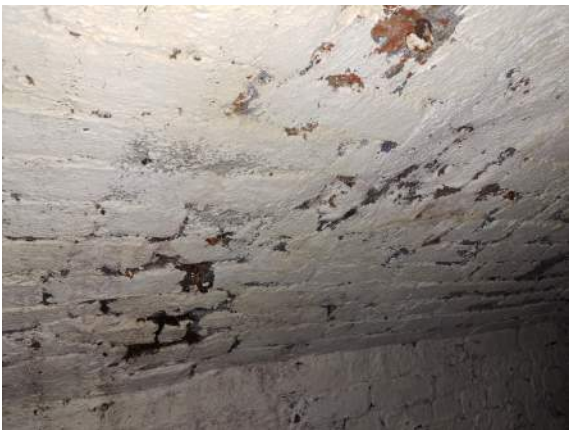
**B17:** LOCALISED DISPLACEMENT OF MASONRY ON UNDERSIDE OF VAULTED CEILING WITHIN ROOM B07.

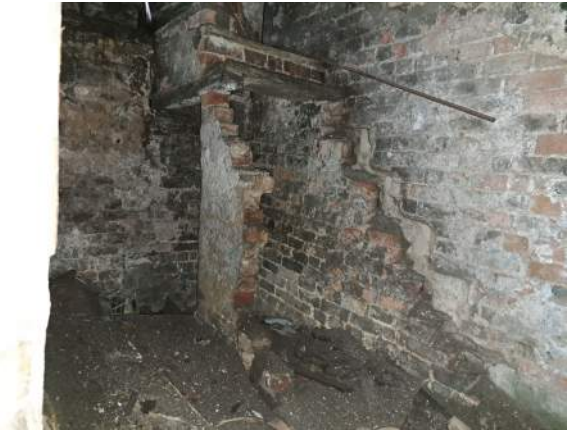
**B18:** COLLAPSED STAIRS FROM BASEMENT TO GROUND FLOOR WITHIN INACCESSIBLE PART OF BASEMENT TO 123 LIVERPOOL ROAD. VIEWED FROM DOOR OPENING FROM ROOM B10.

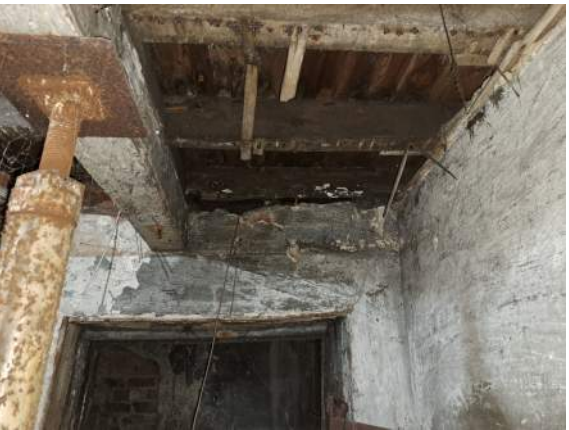
**B19:** LINTEL OVER DOOR OPENING FROM ROOM B10 TO INACCESSIBLE PART OF BASEMENT TO 123 LIVERPOOL ROAD HAS DEFLECTED AT BEARING POINT OF TIMBER BEAM.

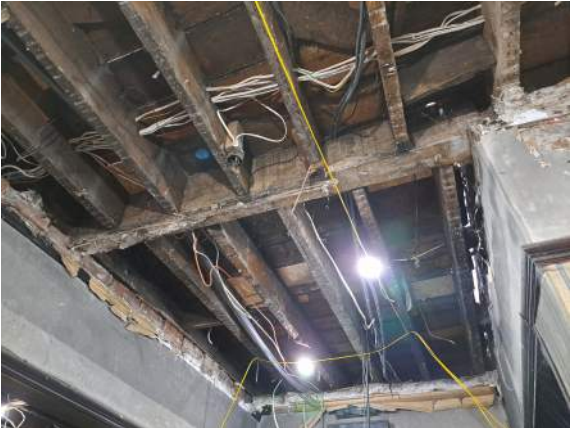
**G02:** TIMBER BEAM ABOVE ROOM G02. HOLES HAVE BEEN FORMED THROUGH THE BEAM TO ALLOW FOR SERVICES.

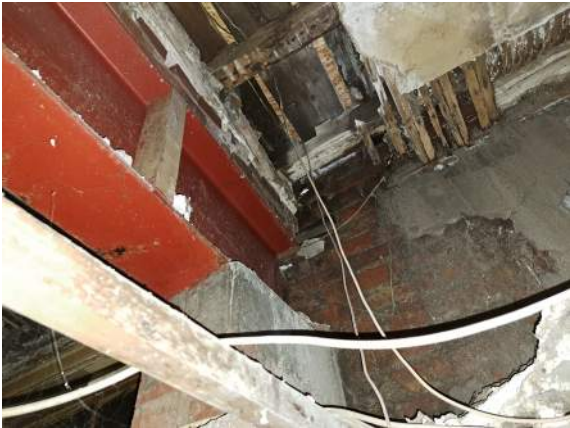
**G03:** STEEL BEAM BEARING ONTO MASONRY PIER BEHIND BAR IN ROOM G02.

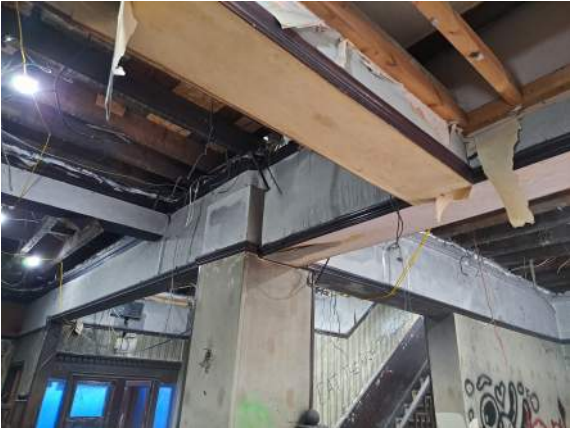
**G04:** DOWNSTAND BEAMS OVER ROOM G02. THESE HAVE LIKELY BEEN INTRODUCED TO ALLOW LOAD-BEARING WALLS TO BE REMOVED.

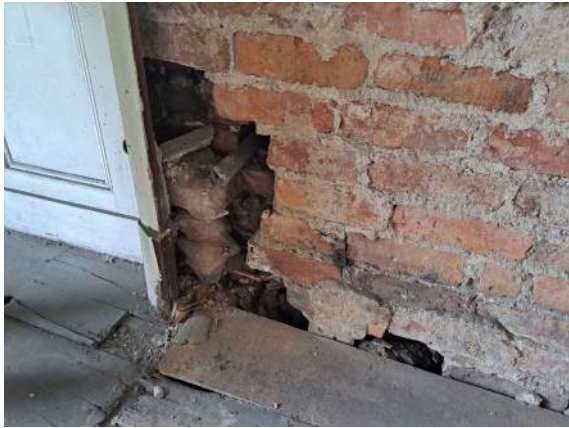
**101:** SECTION OF EXTERNAL WALL ON LIVERPOOL ROAD WITHIN ROOM 103 HAS BEEN OPENED UP TO ALLOW FOR SERVICE PENETRATIONS.

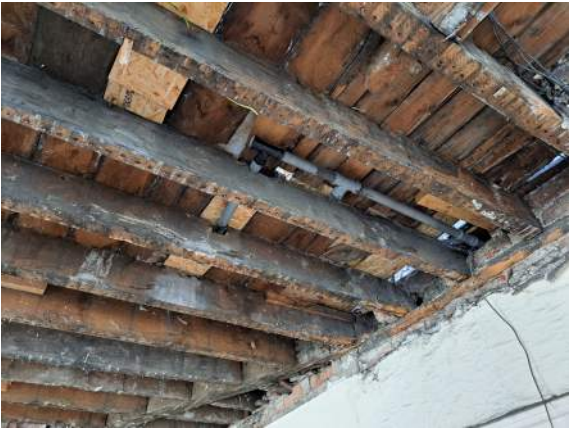
**102:** VARIOUS NOTCHES HAVE BEEN FORMED THROUGH TIMBER FLOOR JOISTS AT 2ND FLOOR OVER ROOM 103.

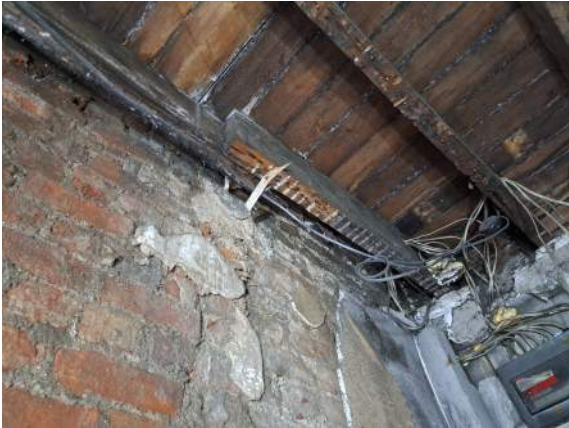
**105:** SPLICED SECTION OF TIMBER JOISTS ADJACENT TO EXTERNAL WALL ON WOOLLAM PLACE IN ROOM 104.

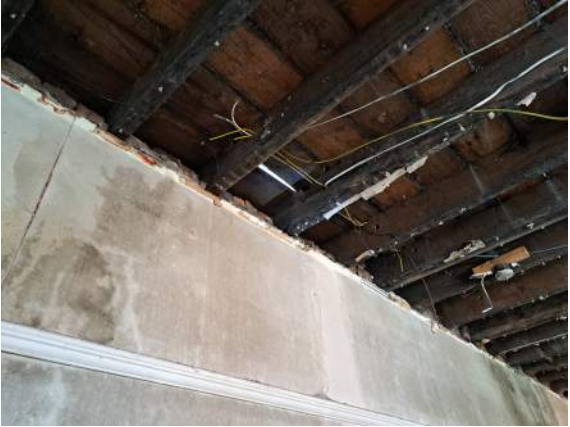
**109:** VARIOUS NOTCHES HAVE BEEN FORMED THROUGH END OF TIMBER FLOOR JOISTS OVER ROOM 105.

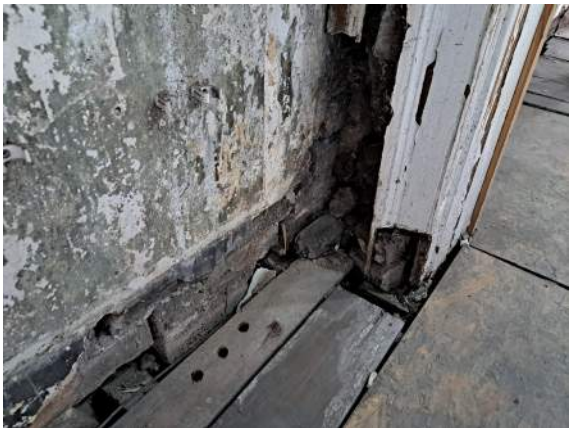
**112:** BASE OF DOOR FRAME BETWEEN ROOMS 104 AND 105. MAXIMUM HORIZONTAL DEFLECTION OF APPROXIMATELY 80mm OVER HEIGHT OF DOOR FRAME. GAP HAS ALSO OPENED UP BETWEEN TIMBER FLOOR AND EXTERNAL WALL.

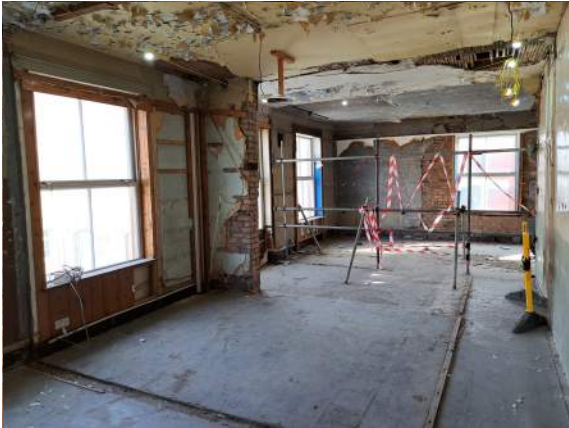
**119:** GENERAL VIEW OF ROOM 107.

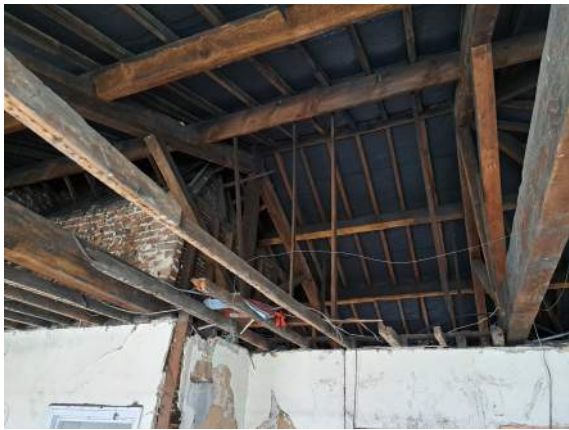
**201:** GENERAL VIEW OF ROOF TRUSSES OVER ORIGINAL PART OF 125 LIVERPOOL ROAD. THESE APPEAR TO BE IN GOOD CONDITION.

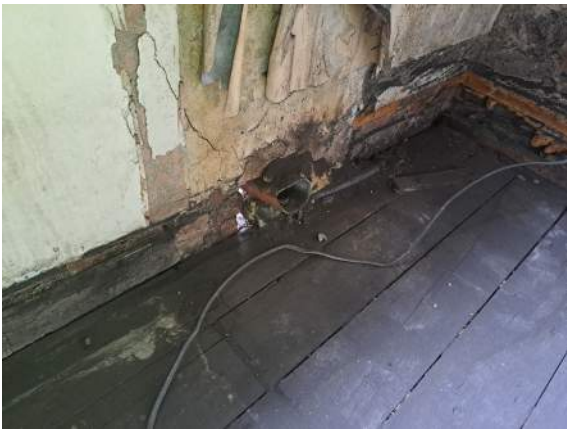
**203:** OPENING FORMED THROUGH EXTERNAL WALL ON LIVERPOOL ROAD IN ROOM 203 TO ALLOW FOR FOUL WATER PIPE.

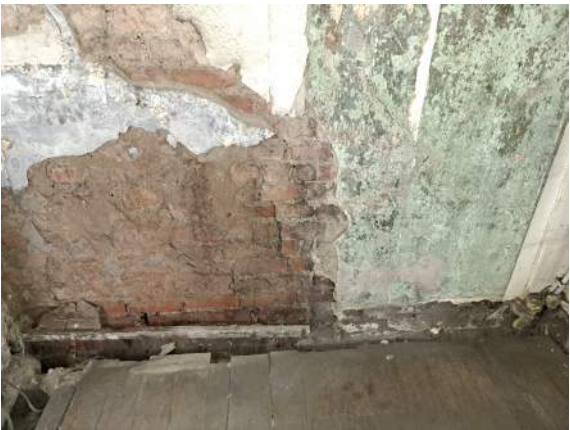
**204:** MINOR CRACKING OF EXTERNAL WALL OF WOOLLAM PLACE IN ROOM 202.

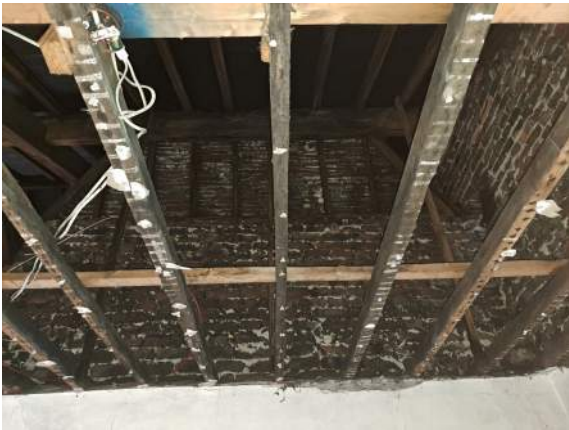
**205:** MASONRY/STUDWORK ENCLOSURE FORMING SKYLIGHT ABOVE THE STAIRWELL VIEWED FROM ROOM 201. SIGNS OF DAMP ON SURFACE OF TIMBER ROOF PURLIN ADJACENT TO ENCLOSURE.

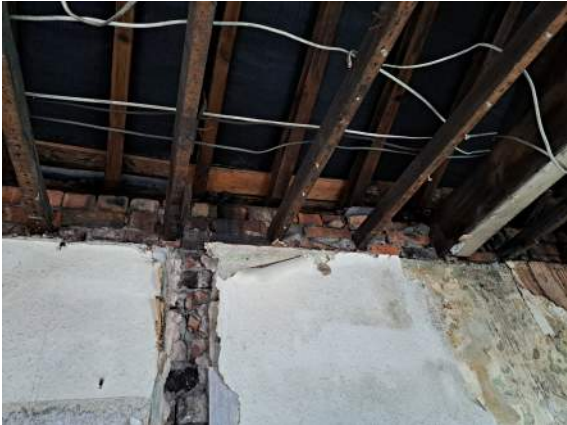
**208:** SIGNS OF DAMP AND WATER INGRESS THROUGH THE TIMBER WALL PLATE AT EAVES LEVEL OF ROOM 206.

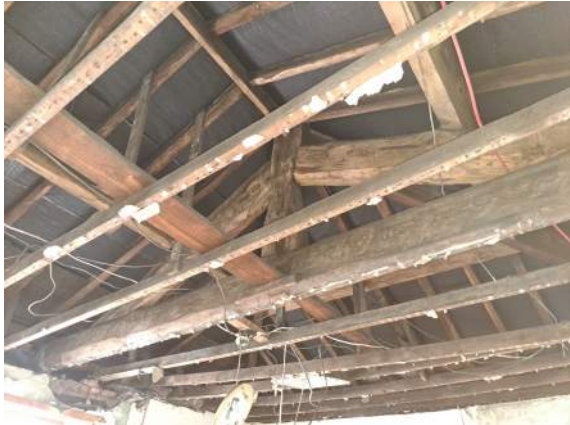
**209:** ROOF TRUSS OVER ROOM 206.

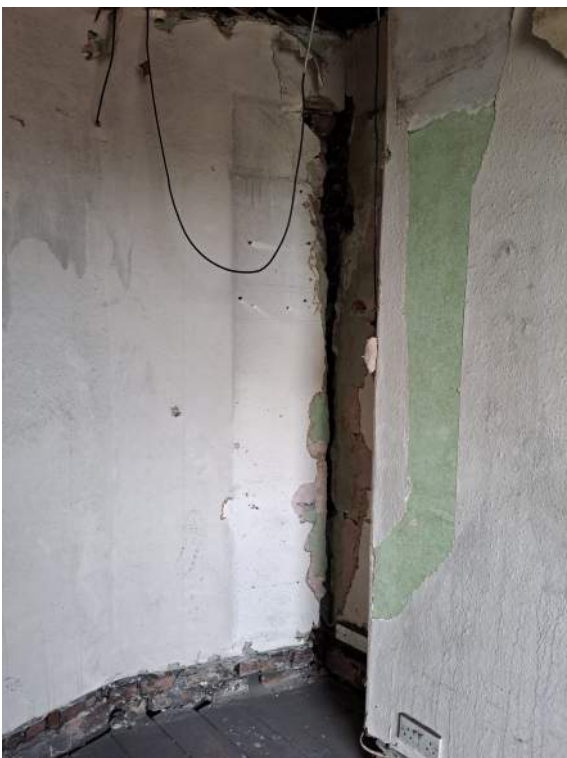
**213:** 100mm GAP BETWEEN WALLS IN SOUTH EAST CORNER OF ROOM 205. THERE IS ALSO AN OBVIOUS DIP IN THE TIMBER FLOOR OF THIS ROOM TOWARDS THE NORTH EAST CORNER.

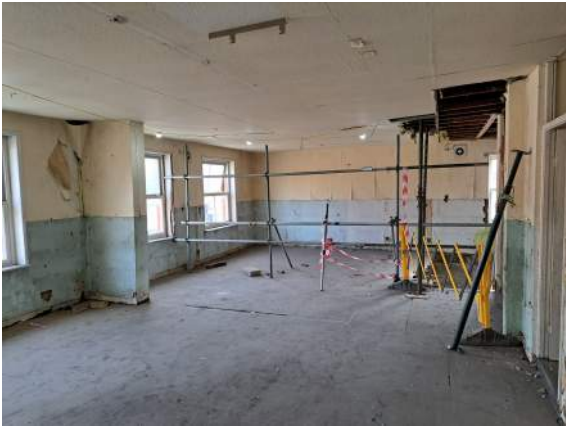
**215:** GENERAL VIEW OF ROOM 208. SECTION OF 2ND FLOOR IS INACCESSIBLE ON OLD MEDLOCK STREET SIDE OF BUILDING DUE TO COLLAPSE.

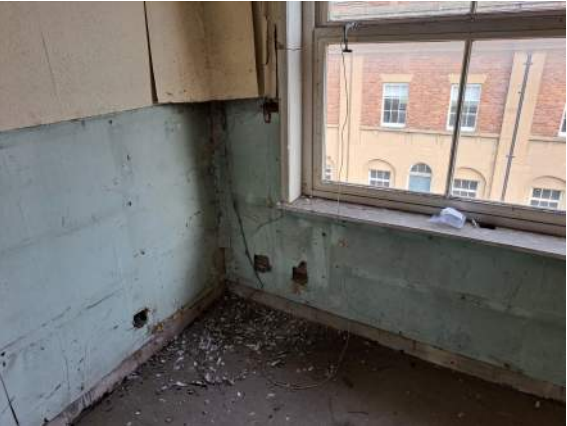
**218:** CRACKING OF FINISHES PROPAGATING FROM CORNER OF WINDOW OPENING ON LIVERPOOL ROAD ELEVATION IN ROOM 208.

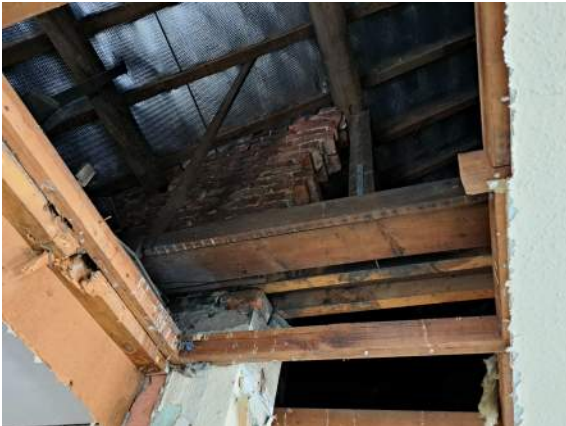
**219:** TIMBER BEAM AND POST SUPPORTING ROOF PURLINS IS VISIBLE FROM OPENING IN CEILING OVER ROOM 208. THIS APPEARS TO BE HAVE BEEN INSTALLED TO ALLOW FOR THE REMOVAL OF A LOAD-BEARING WALL WHICH WOULD HAVE HISTORICALLY SUB-DIVIDED THE ROOM.

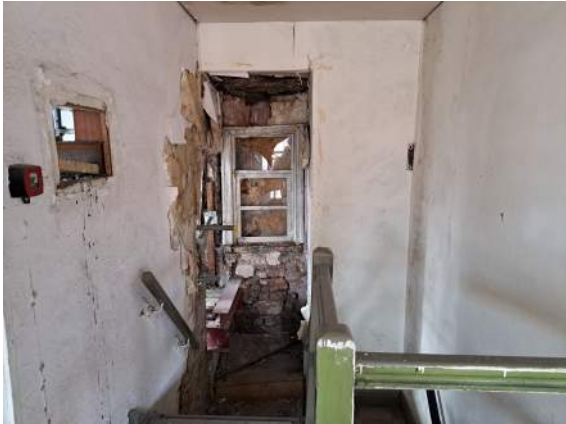
**220:** SECTION OF EXTERNAL WALL TO THE REAR OF THE INACCESSIBLE STAIR CORE ADJACENT TO ROOM 208 IS IN POOR CONDITION.

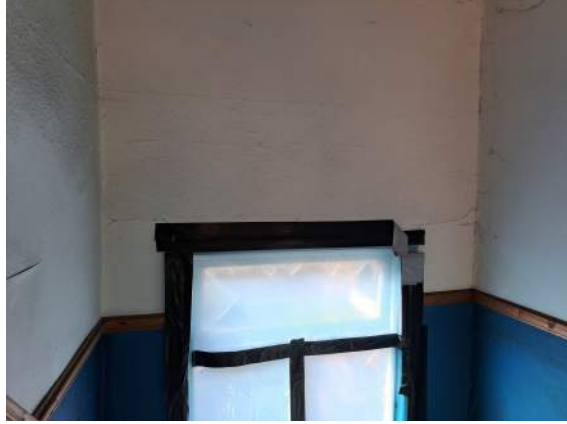
**221:** MINOR CRACKING OF FINISHES PROPAGATING FROM CORNERS OF WINDOW OPENING ON REAR ELEVATION OF ROOM 207.
