**Condition Report and Repair Schedule**  
27-33 King Street West, The Carriage Works and Warehouse

This Condition Report and Repair Schedule has been produced on behalf of Property Alliance Group to accompany the Planning and Listed Building Consent application for the redevelopment of 27-33 King Street West, The Carriage Works and Warehouse.

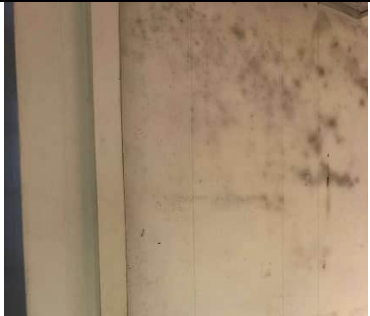
| X01 | Item | Mould growth to external walls | |
| | Description | Mould noted to modern timber lining along the internal face of the external wall | |
| | Condition | 02 | |

| | Recommendations | Further investigation by design team during strip out to ensure adequate ventilation to address this issue | |

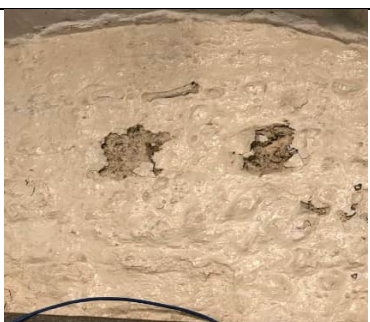
| X02 | Item | Spalling paint to existing brickwork | |
| | Description | Paintwork appears to be spalling to the west external walls and brick barrel arches | |
| | Condition | 02 | |

| | Recommendations | Remove existing paintwork,<br>Specialist contractor to inspect,<br>Apply masonry sealer<br>Apply paint finish to Architect's specification | |
| | Specification | <b>(PNT-100)</b> Remove paintwork<br><b>(SEL-002)</b> Masonry Sealer (internal masonry)<br>(Decorative paint finish to Architects specification) | |

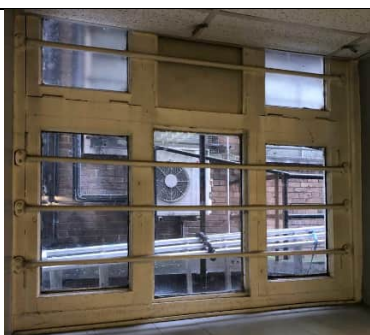
| X03 | Item | Bars fixed to inside of window | |
| | Description | Metal bars fixed to inside face of window | |

| | Recommendations | Remove as part of window replacement strategy | |
| | Specification | <b>(REM-100)</b> Item to be removed | |

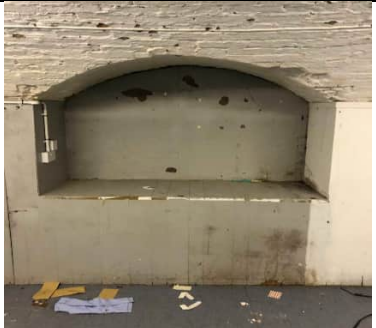
X04

| Item | Spalling paint to existing brickwork | |
| Description | Paintwork appears to be spalling to the brick vault | |
| Condition | 02 | |

| Recommendations | Remove existing paintwork,<br>Specialist contractor to inspect,<br>Apply masonry sealer<br>Apply paint finish to Architect's specification | |
| Specification | (PNT-100) Remove paintwork<br>(SEL-002) Masonry Sealer (internal masonry)<br>(Decorative paint finish to Architects specification) | |

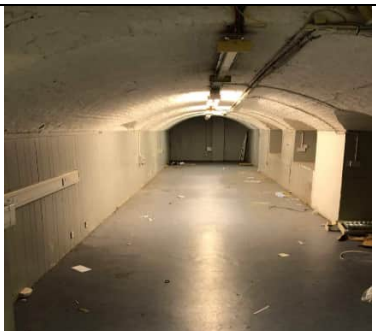
X05

| Item | Feature – Brick vault structure | |
| Description | Brick vault structure with transverse niches | |
| Condition | 02 | |

| Recommendations | Retain where possible. As item X04 | |
| Specification | As item X04 | |

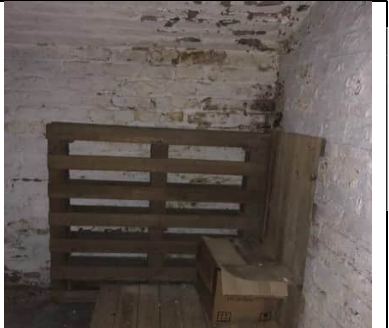
X06

| Item | Spalling paint to existing brickwork | |
| Description | Paintwork appears to be spalling to the brick walls and vault | |
| Condition | 02 | |

| Recommendations | Specialist contractor to advise if moisture exists within the building fabric, together with recommendations to remedy such as a drained cavity or other solution. Depending on the final decoration proposed, this may result in existing paintwork being removed. | |
| Specification | (PNT-100) Remove paintwork<br>(where Architect notes exposed brickwork) | |

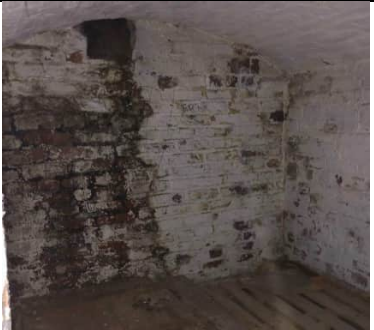
X07

| Item | Spalling paint to existing brickwork | |
| Description | Paintwork appears to be spalling to the brick walls and vault. Opening noted in the vault leading to water ingress. | |
| Condition | 02 | |

| Recommendations | Remove existing paintwork,<br>Specialist contractor to inspect,<br>Apply masonry sealer<br>Apply paint finish to Architect's specification | |
| Specification | (PNT-100) Remove paintwork<br>(SEL-002) Masonry Sealer (internal masonry)<br>(Decorative paint finish to Architects specification) | |

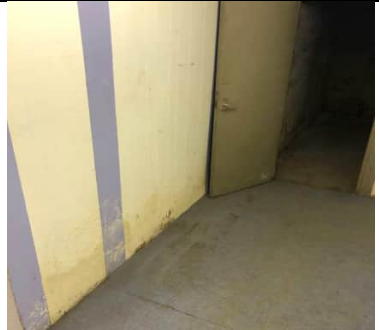
X08

| Item | Spalling paint to wall lining | |
| Description | Paintwork appears to be spalling to the walls, particularly at floor level, suggesting water ingress. | |
| Condition | 02 | |

| Recommendations | Remove existing paintwork,<br>Specialist contractor to inspect,<br>Apply masonry sealer<br>Apply paint finish to Architect's specification | |
| Specification | (PNT-100) Remove paintwork<br>(SEL-002) Masonry Sealer (internal masonry)<br>(Decorative paint finish to Architects specification) | |

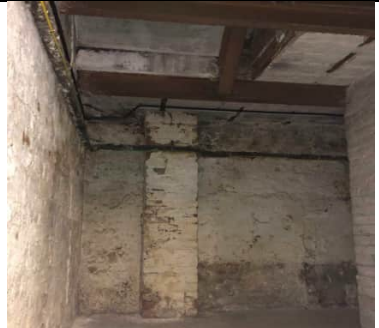
X09

| Item | Spalling paint to existing brickwork | |
| Description | Paintwork appears to be spalling to the brick walls | |
| Condition | 02 | |

| Recommendations | Remove existing paintwork,<br>Specialist contractor to inspect,<br>Apply masonry sealer<br>Apply paint finish to Architect's specification | |
| Specification | (PNT-100) Remove paintwork<br>(SEL-002) Masonry Sealer (internal masonry)<br>(Decorative paint finish to Architects specification) | |

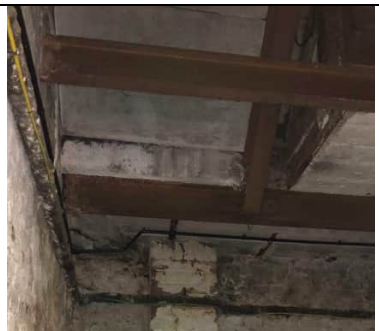
X10

| Item | Structure showing corrosion | |
| Description | Existing steel beams supporting the floor above appear to show corrosion. | |
| Condition | 02 | |

| Recommendations | Further investigation by structural engineer | |
| Specification | structural engineer to assess and advise<br>(Decorative paint finish to Architects specification) | |

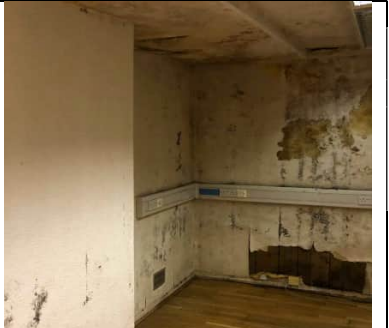
X11

| Item | Moisture ingress | |
| Description | Moisture noted to walls and floor causing damage to the building fabric | |
| Condition | 03 | |

| Recommendations | Remove existing paintwork,<br>Specialist contractor to inspect,<br>Apply masonry sealer<br>Apply paint finish to Architect's specification | |
| Specification | (PNT-100) Remove paintwork<br>(SEL-002) Masonry Sealer (internal masonry)<br>(Decorative paint finish to Architects specification) | |

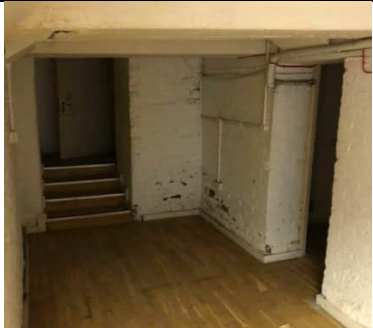
X12

| Item | Spalling paint to existing brickwork | |
| Description | Paintwork appears to be spalling to the brick walls at low level | |
| Condition | 02 | |

| Recommendations | Remove existing paintwork,<br>Specialist contractor to inspect,<br>Apply masonry sealer<br>Apply paint finish to Architect's specification | |
| Specification | (PNT-100) Remove paintwork<br>(SEL-002) Masonry Sealer (internal masonry)<br>(Decorative paint finish to Architects specification) | |

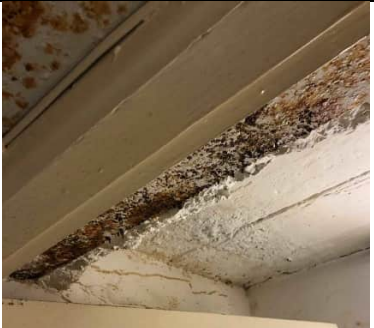
X13

| Item | Steelwork corrosion | |
| Description | Corrosion noted to steel soffit beam | |
| Condition | 02 | |

| Recommendations | Further investigation by structural engineer | |
| Specification | tbc by structural engineer | |

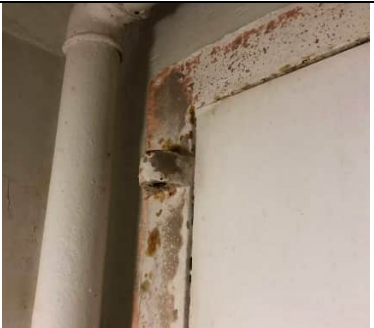
X14

| Item | Feature - Iron door frame | |
| Description | Historic iron door frame into redundant goods hoist remains intact. | |
| Condition | 02 | |

| Recommendations | Architect to consider retaining as part of the current proposals.<br><br>Existing paint and residual corrosion removed prior to Architect's redecoration. | |
| Specification | (PNT-100) Remove paintwork | |

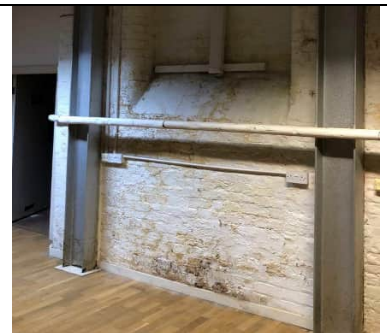
X17

| Item | Feature – Historic warehouse door opening<br><i>(refer to room B1.20 for proposed works)</i> |
| Condition | 1 |

| Recommendations | <i>(refer to room B1.20 for proposed works)</i> |

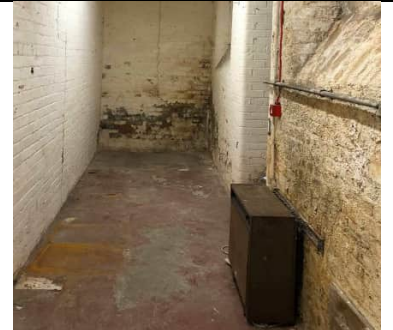
X19

| Item | Timber wall fascia |
| Condition | 02 |

| Recommendations | Panel removed to assess its requirement. If deemed redundant then infill brickwork to match |
| Specification | (MAS-001) Masonry repair |

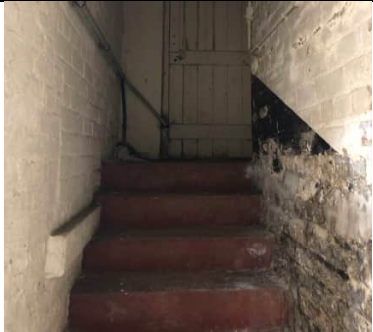
X20

| Item | Spalling paint to existing brickwork | |
| Description | Paintwork appears to be spalling to the external brick walls | |
| Condition | 02 | |

| Recommendations | Specialist contractor to advise if moisture exists within the building fabric, together with recommendations to remedy such as a drained cavity or other solution. Depending on the final decoration proposed, this may result in existing paintwork being removed.<br><br>It is noted this area is redundant on the proposed plans, so recommend any specialist waterproofing undertaken prior to closing up works. | |

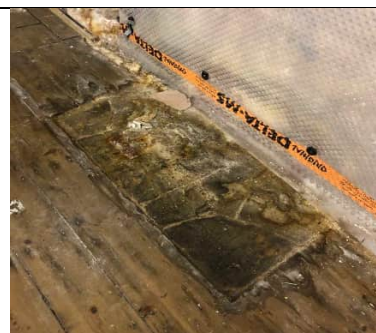
X30

| Item | Water ingress |
| Description | Drained cavity membrane noted to the East and South wall, but no drain channel observed. Water staining at low level may be historic. |
| Condition | 01 |

| Recommendations | Specialist contractor to advise if moisture exists within the building fabric, together with recommendations to remedy such as a reinstalling the current drained cavity or other solution. |
| Specification | Specialist contractor to advise |

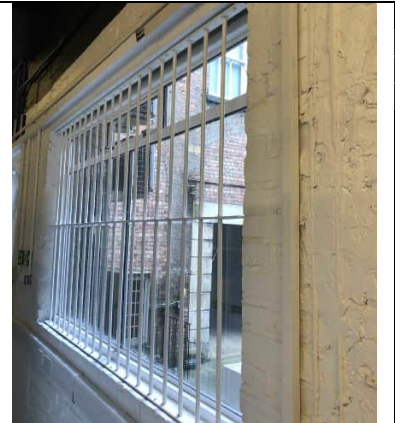
G02

| Item | Spalling paint to existing brickwork |
| Description | Paintwork appears to be spalling to the external wall |
| Condition | 02 |

| Recommendations | Remove existing paintwork,<br>Specialist contractor to inspect,<br>Apply masonry sealer<br>Apply paint finish to Architect's specification |
| Specification | <b>(PNT-100)</b> Remove paintwork<br><b>(SEL-002)</b> Masonry Sealer (internal masonry)<br>(Decorative paint finish to Architects specification) |

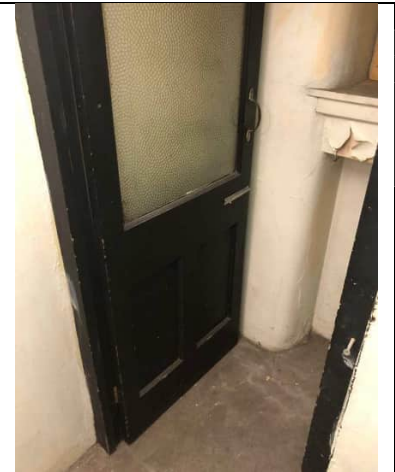
G15

| Item | Feature - Timber door |
| Condition | 01 |

| Recommendations | It is noted the current proposals show this doorway to be closed. Recommendation to refurbish this door and leave in position, though fixed shut. Including the historic bakelite toggle light switch. Remove modern timber sheet fixed to the pull side of the door. |
| Specification | (DOR-001) – Repair / Refurbish door |

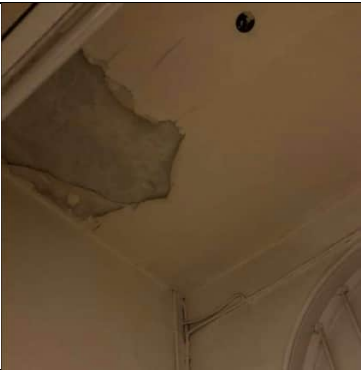
G21

| Item | Plaster deterioration | |
| Description | Sections of ceiling plaster have become de-bonded and have deteriorated. | |
| Condition | 02 | |

| Recommendations | Loose plaster to be removed, replaster local area to match existing, ready for Architect's decoration. | |
| Specification | (PLS-001) Plaster repair | |

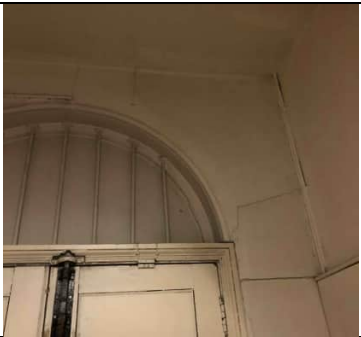
G22

| Item | Plaster cracks | |
| Description | Cracks in the historic plaster have appeared above the fan light and between the door frame and the south wall. | |
| Condition | 02 | |

| Recommendations | Loose plaster to be removed, cracks to be filled to match existing, ready for Architect's decoration. | |
| Specification | (PLS-001) Plaster repair | |

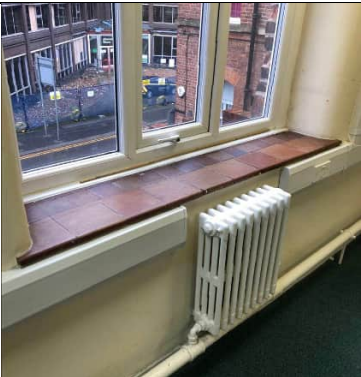
1.01

| Item | Tiled window cills | |
| Description | Tiles laid to all window cills, some being cut to radiused jambs<br>Unlikely original. | |
| Condition | 01 | |

| Recommendations | Removed as part of the proposals for exposed brick walls and cills. | |
| Specification | n/a | |

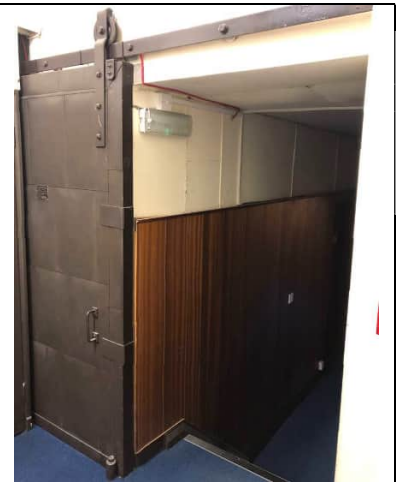
| Condition | 01 |

| Recommendations | It is noted the current proposals look to place toilet cubicles in front of the opening. Developer wishes to relocate and reuse elsewhere in the development, location to be agreed on site. |
| Specification | <b>(REM-100)</b> Remove door / to be relocated |

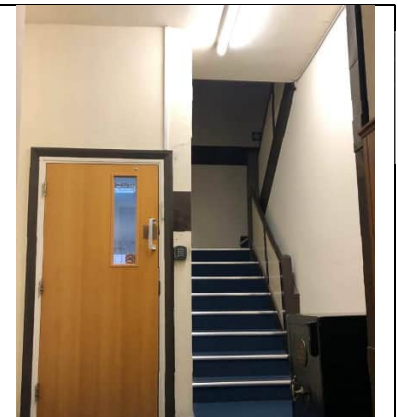
2.03

| Item | Stair |
| Condition | 01 |

| Recommendations | It is noted the current proposals look to remove this recent addition. Infill flooring to second floor should match existing, subject to fire and acoustic requirements. |
| Specification | <b>(REM-100)</b> Remove stair<br><b>(FLR-001)</b> Infill flooring |

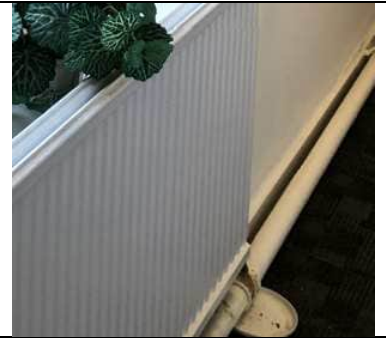
| Item | Heating pipe leaking |
| Description | Evidence of heating pipe leak |
| Condition | 02 |

| Recommendations | It should be established during opening up works if this has caused damage to the underlying building fabric. |

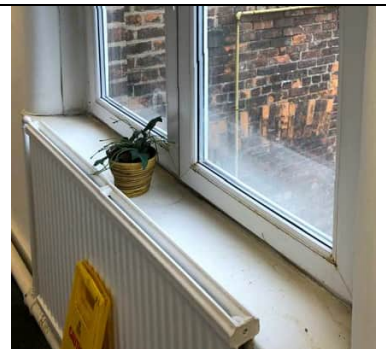
3.02

| Item | Window cill staining |
| Description | Water staining to window cills. |
| Condition | 02 |
| Recommendations | It was not evident if the water ingress was through the upvc frame or the building fabric. This should be established during opening up works. |

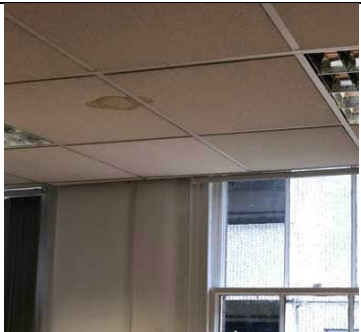
3.03

| Item | Ceiling staining | |
| Description | Staining to lay in grid ceiling tile, suggesting a leak above | |
| Condition | 02 | |

| Recommendations | It was not evident if the water ingress was historic or remained due to damage or failure of the roof above. This should be established during opening up works. | |

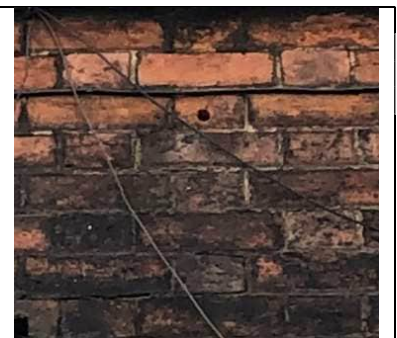
E  
104

| Item | Missing brick / brick damaged (typical) |
| Description | Brick appears to be missing, or is damaged |
| Condition | 02 |

| Recommendations | Replace brick where repair is not possible. Mortar to match existing. |
| Specification | (MAS-001) Masonry repair<br>(MAS-002) Masonry repointing |

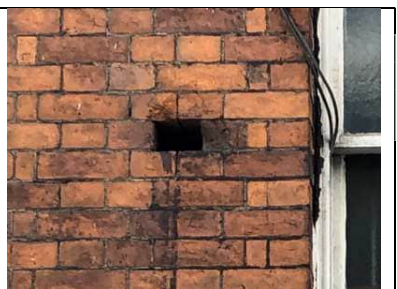
E  
105

| Item | Façade mounted fixture (typical) |
| Condition | 02 |

| Recommendations | Remove and infill any holes |
| Specification | (REM-100) Remove fixture<br>(MAS-001) Masonry repair<br>(MAS-002) Masonry repointing |

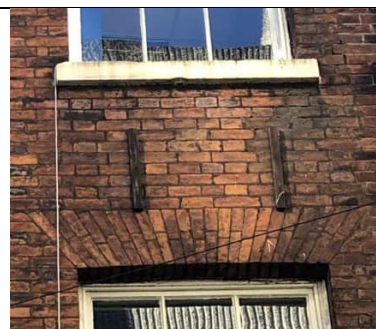
E  
106

| Item | Damaged stonework / spalling paint |
| Description | Stone appears damaged, with paint spalling in some locations |
| Condition | 02 |

| Recommendations | Remove paintwork, repair stonework |
| Specification | (MAS-001) Masonry repair<br>(MAS-002) Masonry repointing<br>(PNT-100) Remove paintwork |

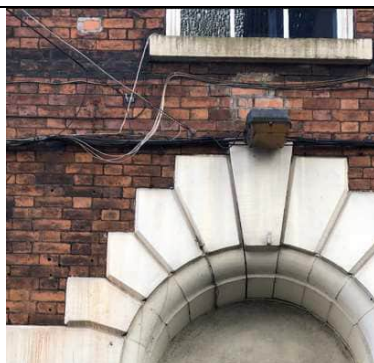
E  
112

| Item | Spalled stone coping |
| Description | Coping appears to have spalled in locations |
| Condition | 02 |

| Recommendations | Specialist stone repair to prevent further erosion and retain structural integrity of the coping. |
| Specification | <b>(MAS-001)</b> Masonry repair |

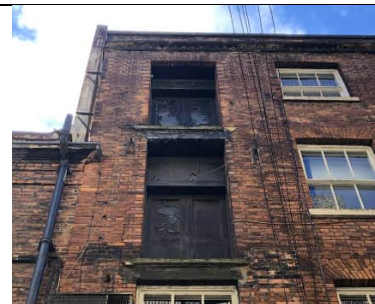
E  
114

| Item | Paintwork to base |
| Condition | 01 / 02 |

| Recommendations | Remove paintwork, if any masonry repair or repointing then becomes necessary, these should be undertaken. |
| Specification | <b>(PNT-100)</b> Remove paintwork<br><br><b>(MAS-001)</b> Masonry repair<br><b>(MAS-002)</b> Masonry repointing<br><i>(where discovered necessary to unstable masonry following removal of paint)</i> |

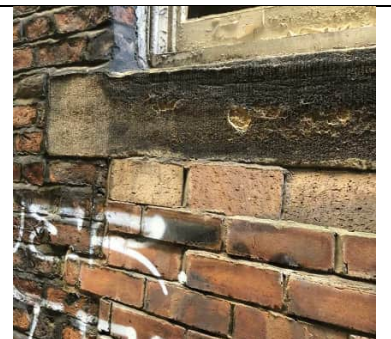
E  
203

| Item | Hole in brickwork (<50mm dia) |
| Condition | 02 |

| Recommendations | Repair with colour match mortar |
| Specification | (MAS-002) Masonry repointing |

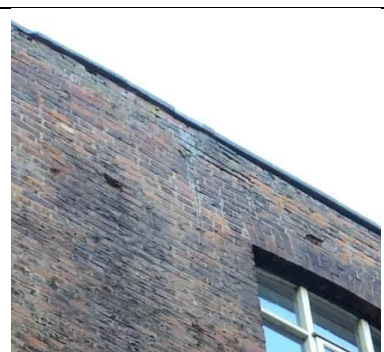
E  
212

| Item | Stone coping and mortar deteriorated |
| Description | Stone coping and mortar joints directly below and then running behind the rainwater pipes appear to have deteriorated. |
| Condition | 02 / 03 |

| Recommendations | Specialist stone repair to coping and associated joints. Brickwork joints repointed. |
| Specification | (MAS-001) Masonry repair<br>(MAS-002) Masonry repointing |

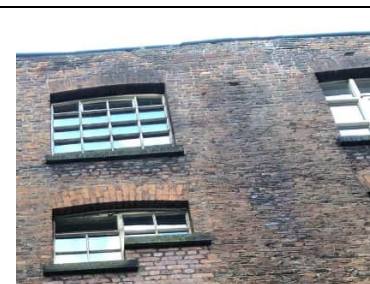
E  
213

| Item | Pipe penetration through brickwork |
| Condition | 02 |

| Recommendations | Rainwater and drainage strategy to be reviewed by Design Team, where any redundant pipes are removed, all voids in brickwork to be replaced to match. |
| Specification | (MAS-001) Masonry repair<br>(MAS-002) Masonry repointing |

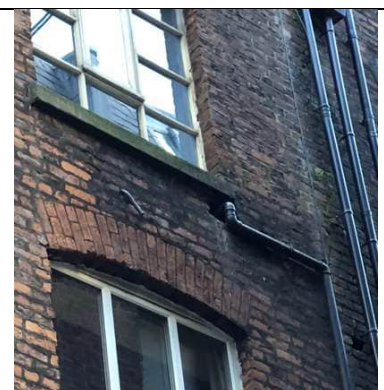
E  
214

| Item | Rainwater pipes upvc / Iron |
| Description | A mixture of upvc and Iron rainwater pipes in the same vertical run, with rainwater leaking noted at numerous connections. |
| Condition | 02 / 03 |

| Recommendations | Replace upvc pipes with iron |
| Specification | (REM-100) Remove pipework<br>(IRN-100) Replacement iron pipework |

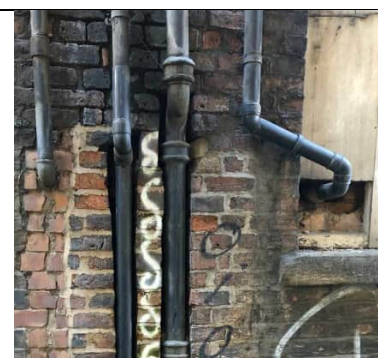
E  
215

| Item | Pipe penetration |
| Condition | 02 |

| Recommendations | Remove and infill any holes |
| Specification | (REM-100) Remove fixture<br>(MAS-001) Masonry repair<br>(MAS-002) Masonry repointing |

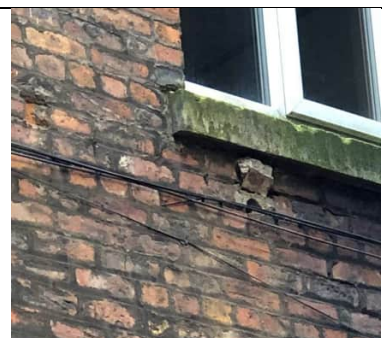
E  
217

| Item | Lintel |
| Description | Concrete faced metal lintel with damage to the front face and soffit. Exposed fixings bars and aggregate. |
| Condition | 02 / 03 |

| Recommendations | Specialist repair |
| Specification | (MAS-001) Masonry repair |

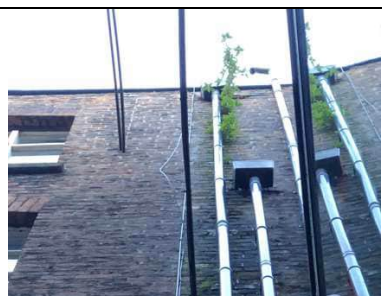
| Item | Bridge removal |
| Description | The current design proposal includes the removal of the link bridge, localised brickwork infill up to the established cill line, with stone cill and windows to match existing. |

| Recommendations | Brickwork and mortar to match existing, any localised brick or mortar damage discovered following demolition to be remediated to match. New stone cills and windows to match existing examples adjacent. |
| Specification | (MAS-001) Masonry repair<br>(MAS-002) Masonry repointing<br>(MAS-003) New masonry<br>(WIN-100) Replacement Window |

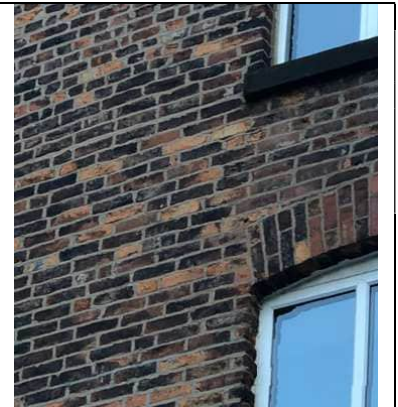
E  
301

| Item | Façade mounted fixture |
| Condition | 02 |

| Recommendations | Remove and infill any holes |
| Specification | (REM-100) Remove fixture<br>(MAS-001) Masonry repair<br>(MAS-002) Masonry repointing |

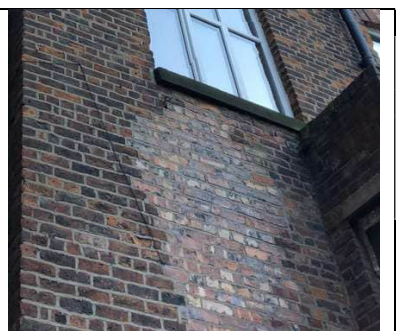
E  
303

| Item | upvc rainwater pipes and accessories |
| Condition | 01 |

| Recommendations | It is noted the current design proposes these are replaced with iron to match the original existing pipework. Following removal any existing holes should be filled. |
| Specification | <b>(REM-100)</b> Remove pipework<br><b>(IRN-100)</b> Replacement iron pipework<br><br>Replacement pipework to be specified by others |

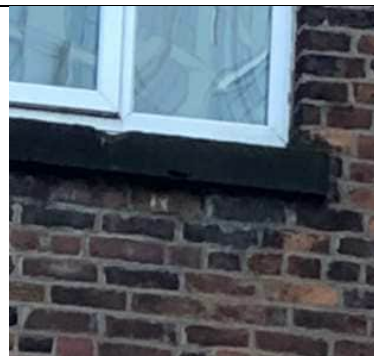
E  
306

| Item | Window cill flashing |
| Condition | 02 |

| Recommendations | Remove flashing to establish if there is a defective cill beneath. Repair where necessary |
| Specification | <b>(MAS-001)</b> Masonry repair |

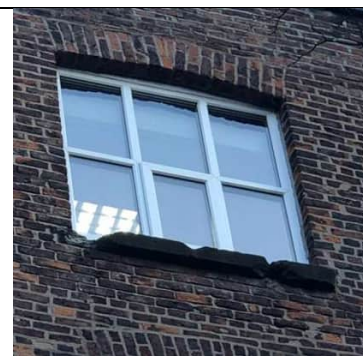
E  
308

| Item | Damage to external stone cill |
| Description | The leading edge of the cill showed signs of damaged. |
| Condition | 02 |

| Recommendations | Specialist stone repair to match existing |
| Specification | (MAS-001) Masonry repair |

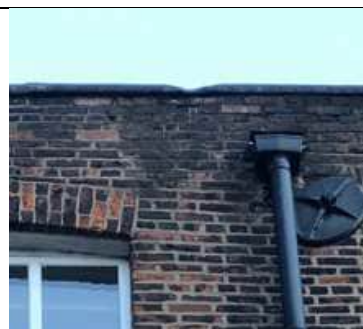
E  
310

| Item | Façade mounted fixture |
| Condition | 02 |

| Recommendations | Remove and infill any holes |
| Specification | (REM-100) Remove fixture<br>(MAS-001) Masonry repair<br>(MAS-002) Masonry repointing |

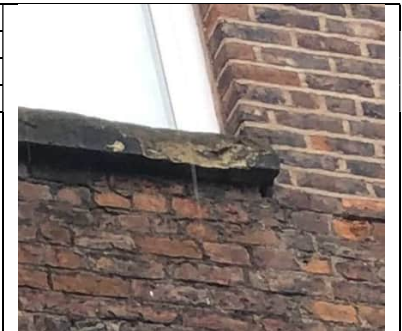
E  
603

| Item | Spalling brickwork |
| Description | Localised spalling brickwork |
| Condition | 01 / 02 |

| Recommendations | It is understood this window will be within a newly created internal environment, so further deterioration would be limited. |
| Specification | (MAS-001) Masonry repair<br>(MAS-002) Masonry repointing |

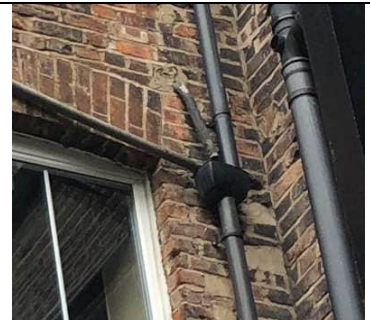
E  
701

| Item | Façade mounted fixture (typical example) |
| Condition | 02 |

| Recommendations | Remove and infill any holes |
| Specification | (REM-100) Remove fixture<br>(MAS-001) Masonry repair<br>(MAS-002) Masonry repointing |

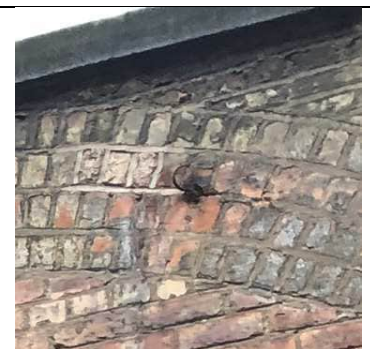
E  
702

| Item | Service penetrations |
| Condition | 02 |

| Recommendations | Wherever services are deemed redundant, openings should be closed using brickwork and mortar to match existing. |
| Specification | (MAS-001) Masonry repair<br>(MAS-002) Masonry repointing |

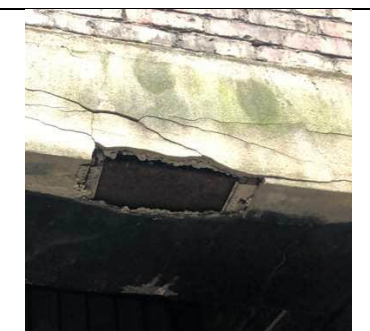
E  
704

| Item | Render to stonework |
| Description | It appears the existing stonework has been rendered in this location. Localised spalling has occurred. |
| Condition | 02 / 03 |

| Recommendations | Specialist repair assessment to be undertaken. It may become advisable to remove the entirety of the existing render where this cannot be adequately repaired. |
| Specification | (MAS-001) Masonry repair<br>(MAS-002) Masonry repointing |

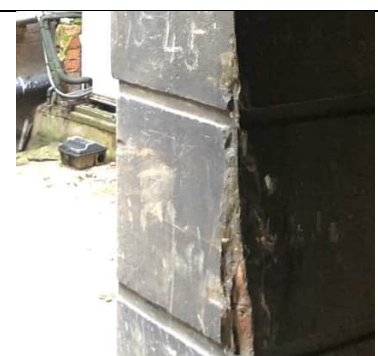
E  
706

| Item | Render to stonework |
| Description | Minor damage to rendered corners. |
| Condition | 01 / 02 |

| Recommendations | It may be desirable to maintain these less damaging instances, subject to Architect's review. |
| Specification | (MAS-001) Masonry repair<br>(MAS-002) Masonry repointing<br>(where deemed necessary) |

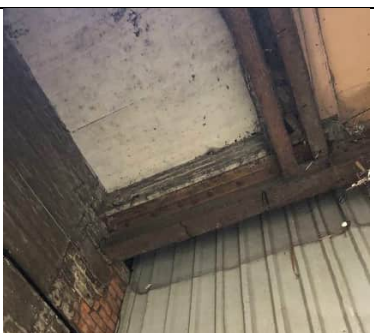
| E<br>709 | Item | Exposed structure | |
| | Description | Existing exposed structure with bird netting. Plasterboard lining to some areas of the soffit | |
| | Condition | 02 | |

| | Recommendations | n/a - Current proposal is to conceal this area with a new soffit. | |

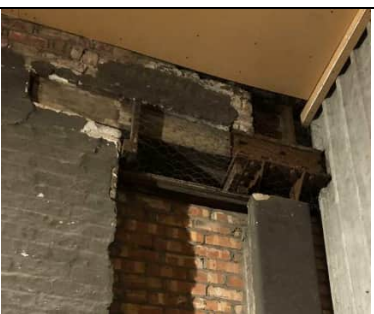
| E<br>710 | Item | Exposed structure | |
| | Description | Existing exposed structure with bird netting. | |
| | Condition | 02 | |

| | Recommendations | n/a - Current proposal is to conceal this area with a new soffit. | |

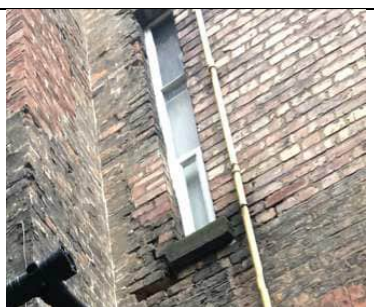
| E<br>711 | Item | Deterioration of brick pointing | |
| | Description | Mortar appears to have eroded to the western side of the window | |
| | Condition | 02 | |

| | Recommendations | Remove loose mortar and repoint to match existing | |
| | Specification | (MAS-001) Masonry repair<br>(MAS-002) Masonry repointing | |

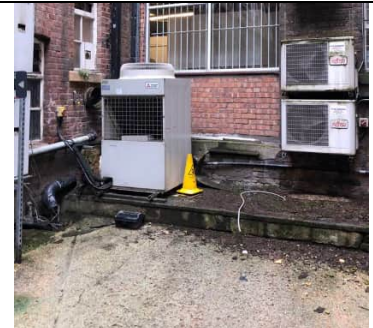
G26

| Item | Chequer plate and iron grille |
| Condition | 01 |

| Recommendations | Developer advised the intention to retain the grille. Clean and integrate as part of the floor finish in this area.<br><i>It was noted the subterranean space below had standing water, this should be further investigated</i> |
| Specification | <b>(CLN-001)</b> – Cleaning |

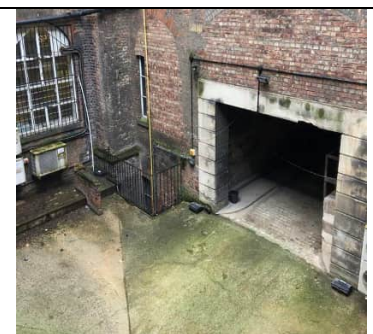
G28

| Item | Drain discharge positions |
| Condition | n/a |

| Recommendations | Drainage engineer to review rainwater system and determine the extent of redundant pipes that may be removed as part of the Architect's proposals. |
