# 40 – 46 Princess Street, Manchester

## Conservation Condition/Repair Report

### Windows 2023 update

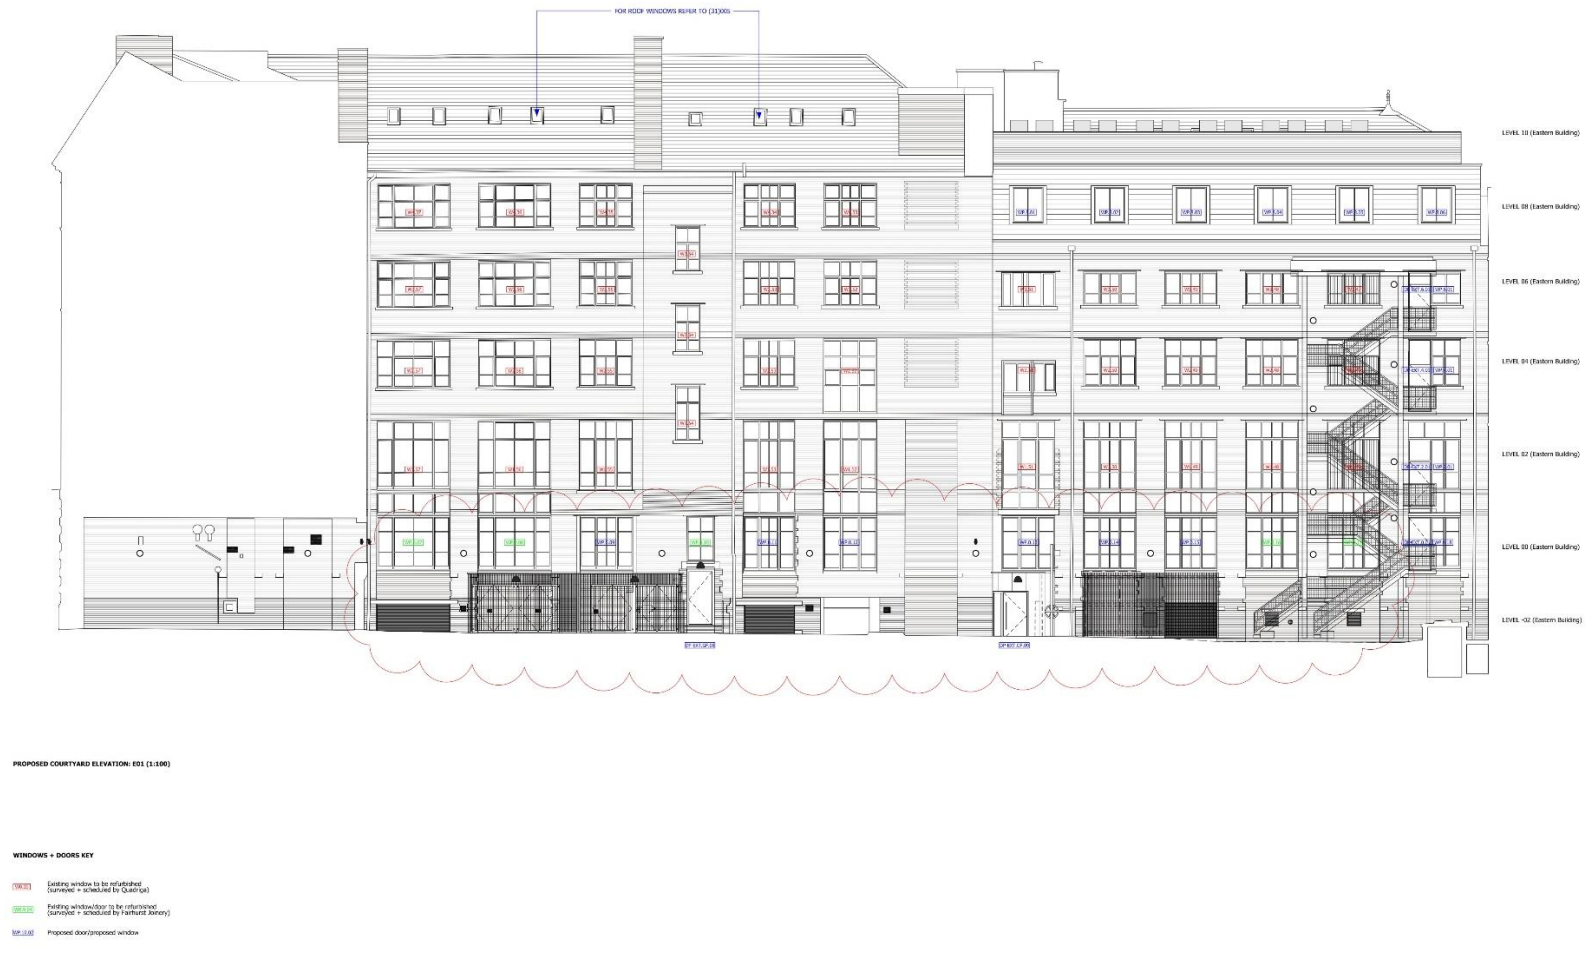
Figure 2: Courtyard Elevation Highlighting Windows WP.0.07 – WP.0.12 (Credit Bridge Architects 2021)

Figure 2 shows the location of Window level 00 that are to be replaced and repaired on the courtyard elevation.

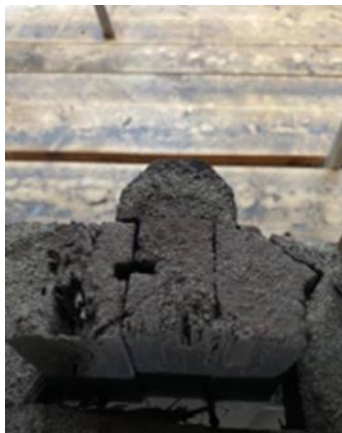
Figure 4: WP.0.07 Internal (Credit Fairhurst 2022)

Figures 3 - 8 below show a visual representation of the 7th window located on the courtyard elevation, the bullet points below explain the current condition;
