**RE: RENAISSANCE HOTEL, BLACKFRIARS STREET, MANCHESTER, M3 2EQ**

**CCTV SURVEY – VAULTS DRAINAGE**

**blackfriars st manchester alliance group - CCTV Survey Report : 06/07/21**

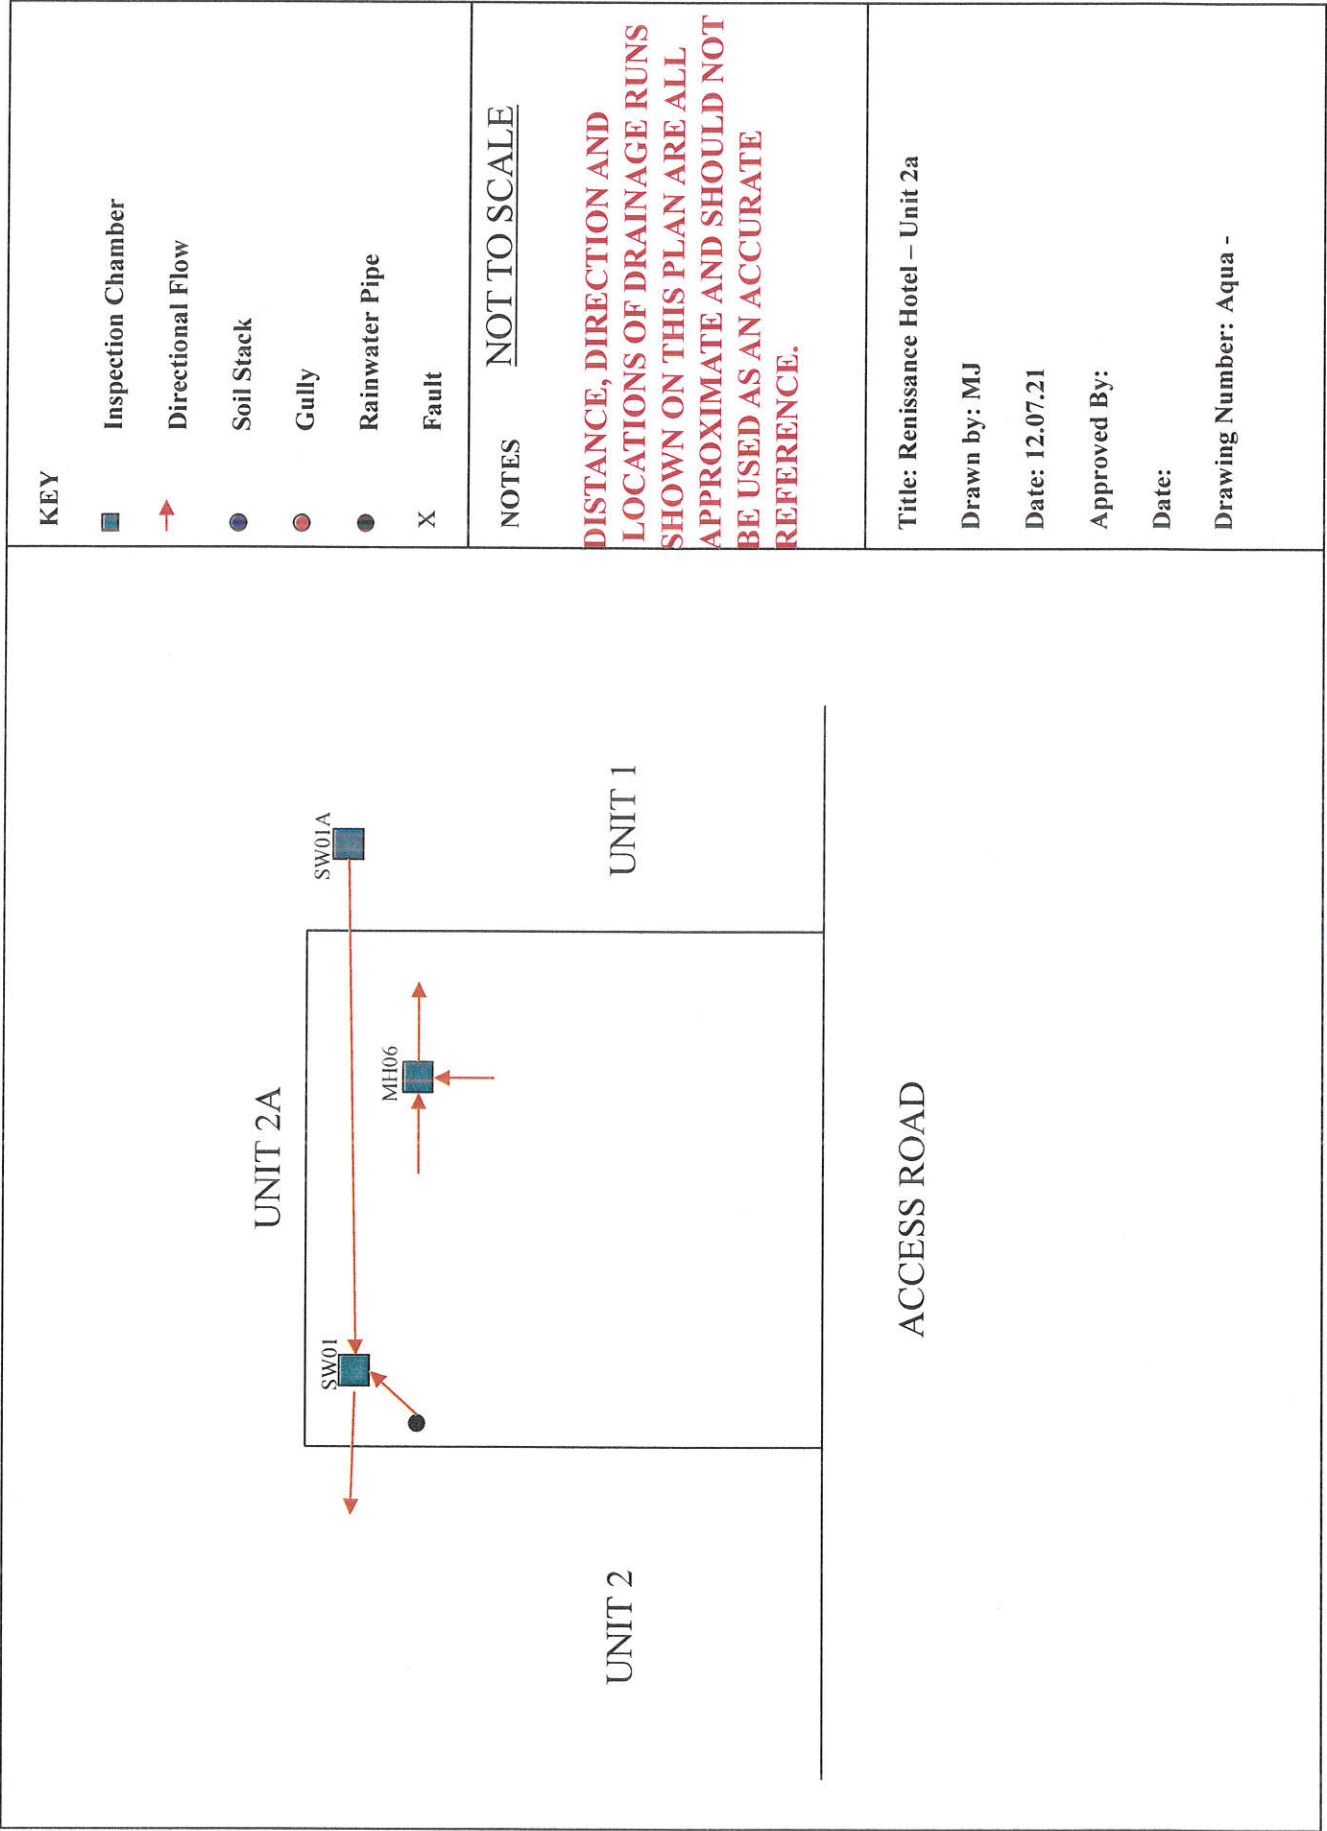
For the surface water system, we were unable to complete a visual survey due to severe bends in the 100mm diameter cast drain from SW06 [located in the plant room]. We did however dye test the system, to find it runs down to the underground car park to SW02 & then out to the river.

| Pos | Video Ref | Code | Description | Image |
|---|---|---|---|---|
| 08.54m | | SA | Survey abandoned<br>unable to push rodder due to severe bends, dye tested and found all surface water in units goes to sw02 in under ground car park | |

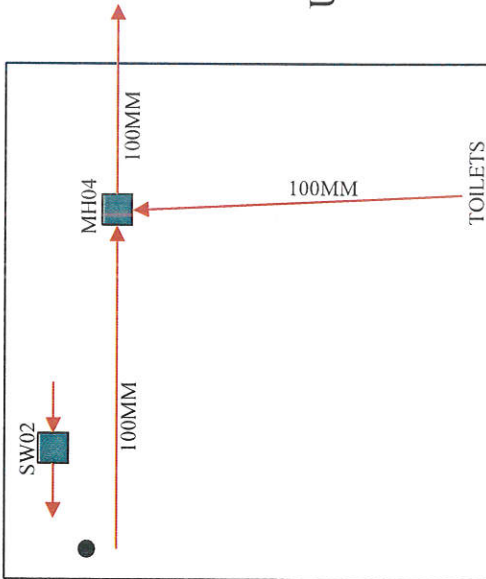
UNIT 3

SW02 located in unit 7 could not be lifted due to ant-terrorist locks.

UNABLE TO LIFT SW02 [LOCKED]
