# **Asbestos Risk Management**

## **Asbestos Refurbishment and Demolition Survey Report**

**Victoria Park Probation Centre  
Laindon Road  
Manchester  
M14 5YJ**

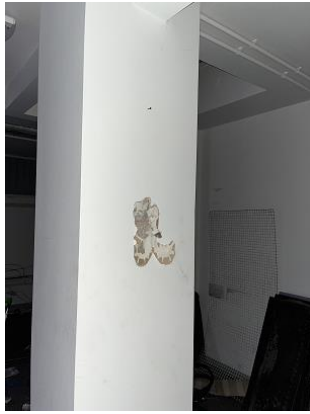
Plasterboard dry-lining to central pillar

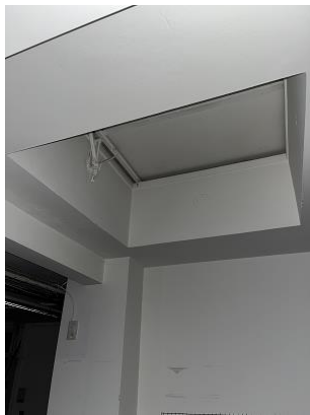
Concrete upstands/reveals to roof lights

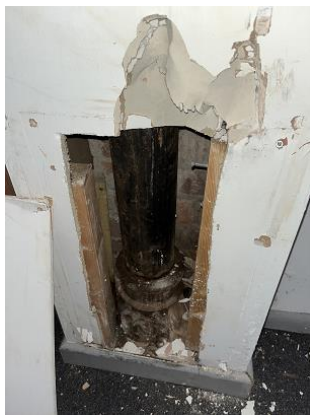
Plastered boxing to cast downpipe

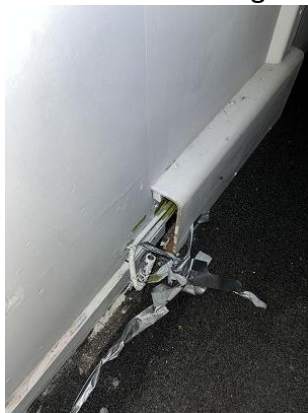
Timber boxing to low level pipework

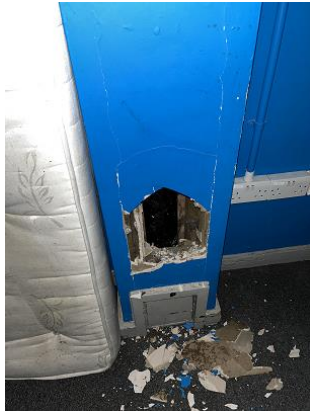
Plasterboard boxing to cast downpipe

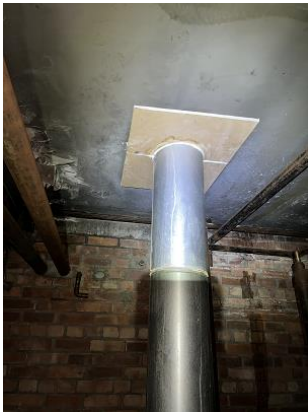
Plasterboard around flue by ceiling penetration

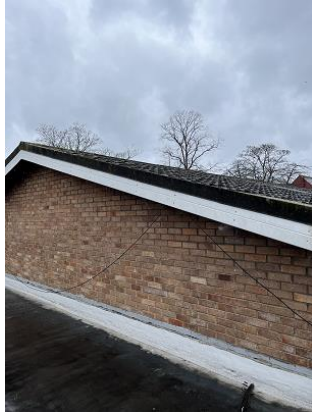
Tile effect steel roofing sheets on timber battens over original bitumen felt roof  
(Sample LR07 and LR08, bitumen felt, NADIS)
