## **Mayfield Regeneration**

### **Geoenvironmental and Geotechnical Desk Study Report**

**035548**

10 August 2017

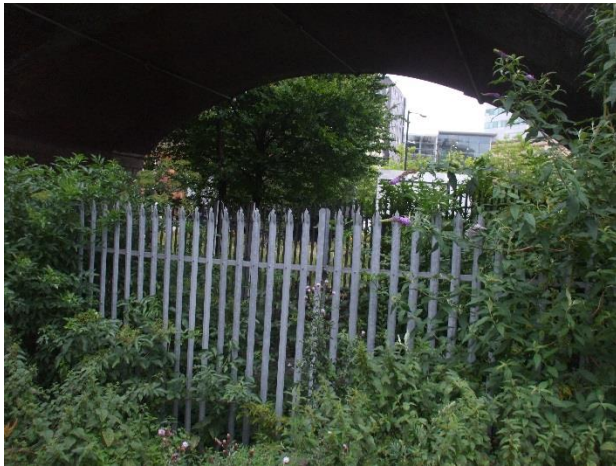
Photograph 1

- Area west of Wyre Street / north of arches: Overgrown with long grass and birch trees, Heras fenced off
- Under arches: Full of rubble / overgrown (Photograph 1)

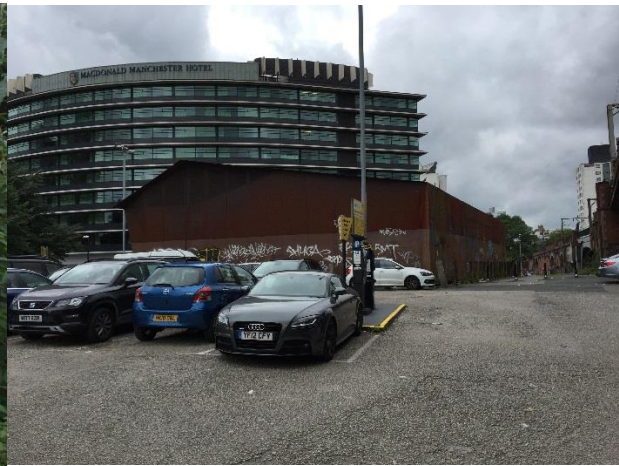
Photograph 2

- Between Wyre Street, Travis Street and Baring Street: Car park with tarmac surface. Brown metal building in western area – substation. A GIP 2009 borehole was undertaken in this car park, but unable to locate well cover. (Photograph 2)

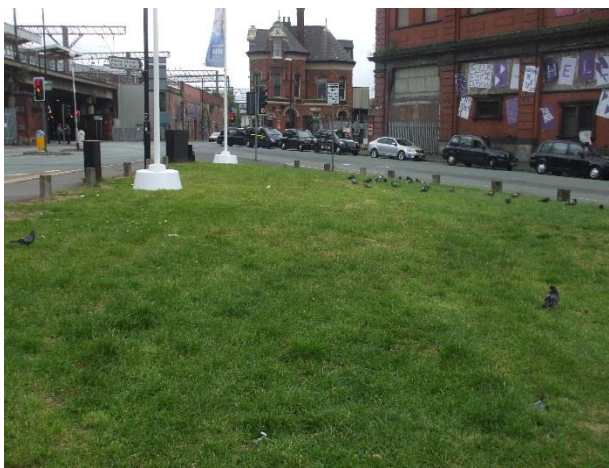
Photograph 3

- Triangular parcel of land to north of Travis Street and east of Baring Street. Grassed area. Historical maps indicate that a garage was historically present, and obstructions (thought to be the garage slab) were encountered during the GIP 2009 GI. Well cover present from GIP 2009 GI. (Photograph 3)

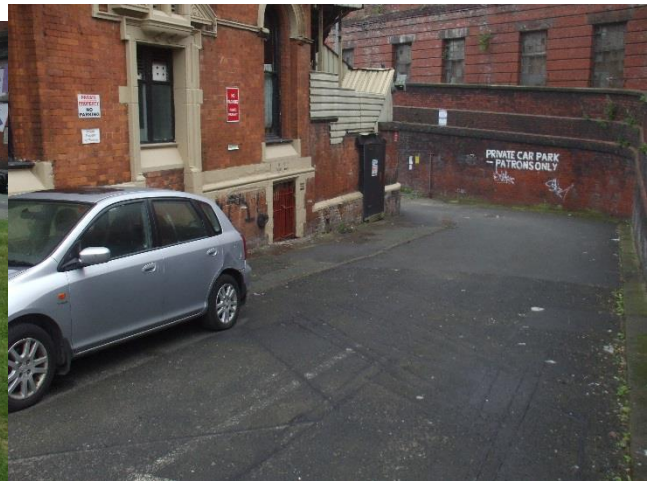
Photograph 4

- Area to the north of former Mayfield Station building:
  - Western side: Star and Garter pub, still in use – listed building. Tarmac car park to the east (access via Neild Street). GIP 2009 borehole cover present in car park. (Photograph 4)

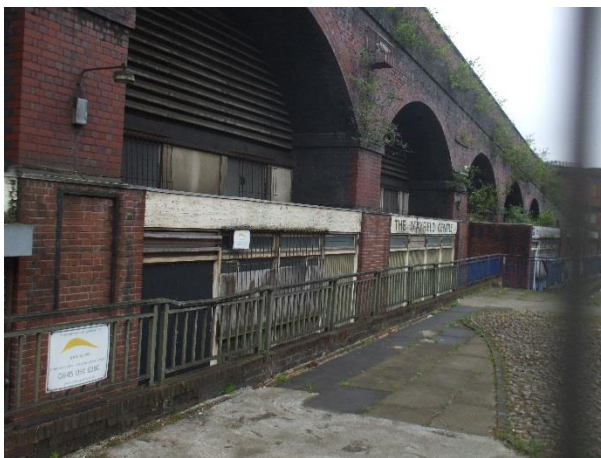
Photograph 5

- Row of 1 storey units present against the Mayfield Station building. Uses include a garage, storage, substation. (Photograph 5)
- Temperance Street: Series of arches on both sides of the road, however only the southern set are onSite.

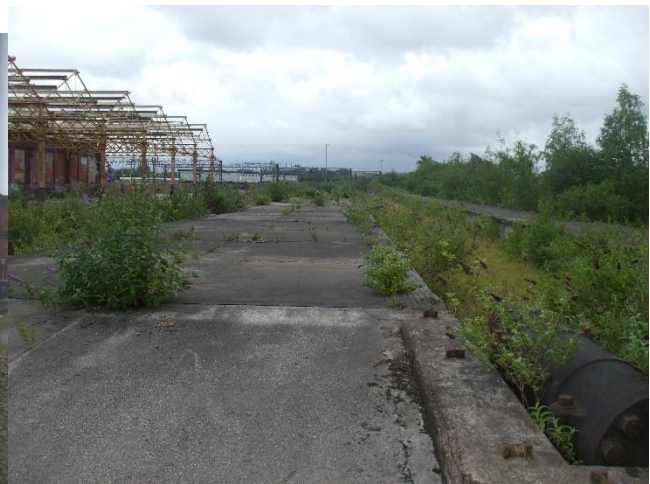
Photograph 6

- Arch 6: U+I security offices
  - Arch 7: Art exhibition company
  - Arch 8: Theatre set manufacturer
- Upper level of old Mayfield Station building (Photograph 6):

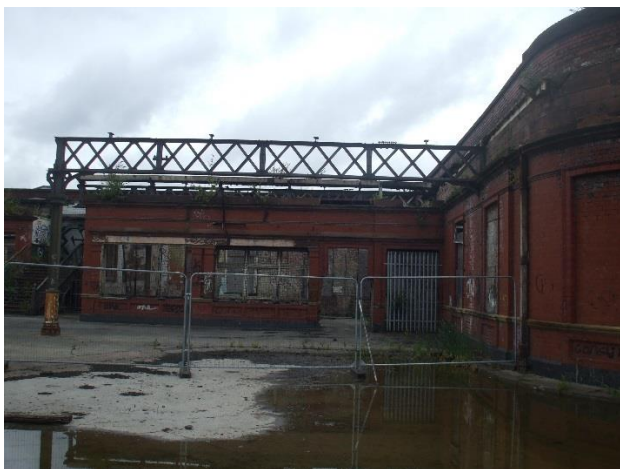
Photograph 7

- Dilapidated old station buildings in western corner of platform. Heras fenced off. (Photograph 7)
  - 2 No. tracks with stoppers at western end. Overgrown.

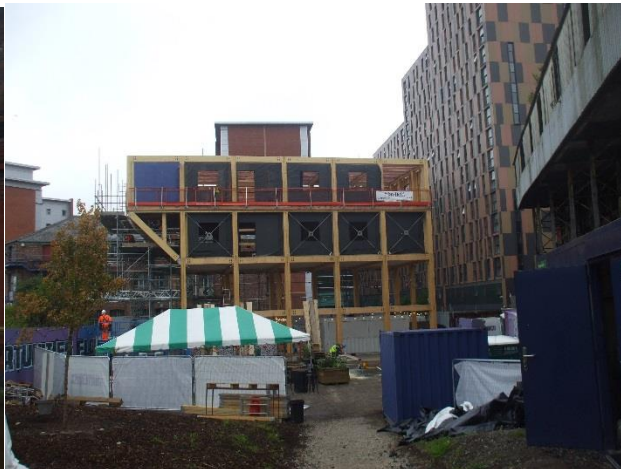
Photograph 8

- Compound where U+I temporary offices are currently under construction (wooden frame up at time of walkover). (Photograph 8)
- Temporary landscaped area in southern portion of compound, surfaced with wood chips directly on top of Made Ground. 2 No. trees in poor health (brown leaves). (Photograph 9)

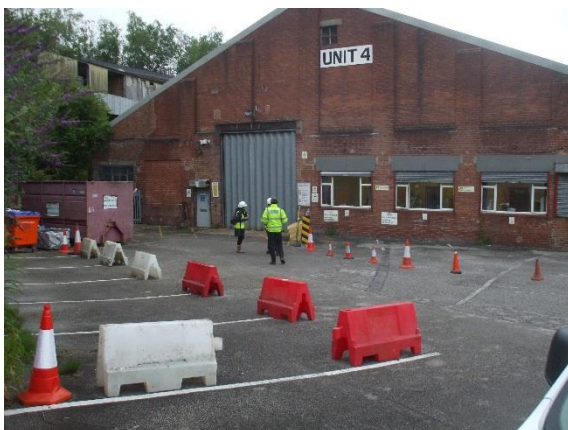
Photograph 13

- Transport for Greater Manchester (TFGM) building area
  - River Medlock is culverted under the car park area.
  - 1 storey brick/steel industrial building (Photograph 13). River Medlock is culverted under the building (Photograph 14). Multiple units:

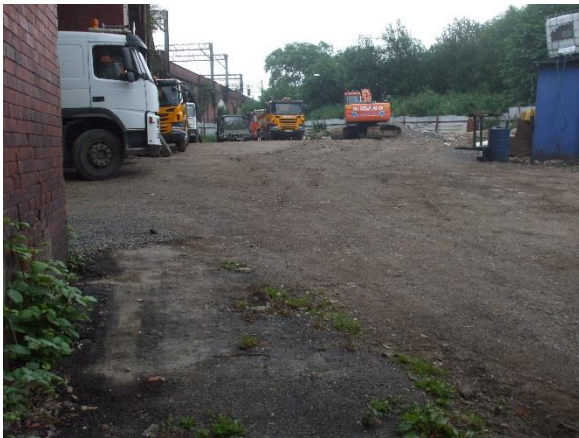
Photograph 17

- Void recently opened up in car park outside Unit 4 (Section 3.5 refers). Cordoned off by barriers at time of walkover. (Photograph 16)
- Area north of Chapelfield Road and east/south of Hoyle Street: Yard with vehicles parked (including tracked excavators). Sign outside advertising 'Free tipping of clean hardcore'. River culverted under this yard. (Photograph 17)

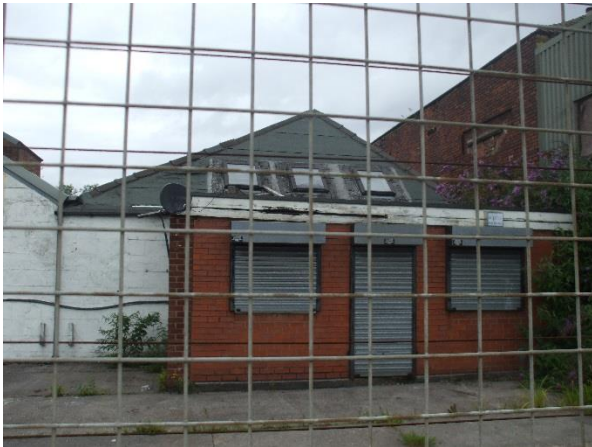
Photograph 18

- West of Baring Street: Row of buildings and concrete yards (not currently owned by U+I) (Photograph 18)
  - Southernmost building = Mayfield Works (disused); formerly clothing works. Yard/car park area to north of building.

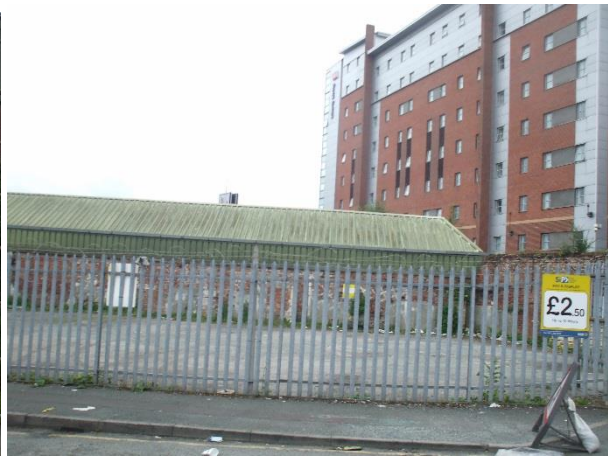
Photograph 19

- Area between Baring Street and Nether Street:
  - 3 No. conjoined buildings (west to east): Tow bar and trailer shop; Historic church (with basement – advised by JS); sock factory (still in use; JS advised that it has been there for >20 years). Concrete yard present to south of buildings. (Photograph 19)

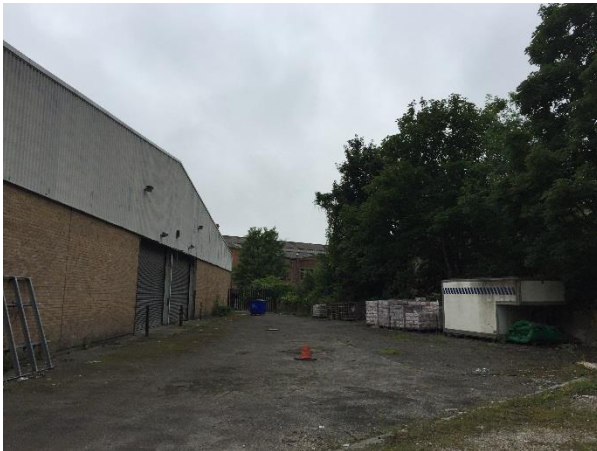
Photograph 20

- Square warehouse building, north of Hilclare car park and surrounded by meandering River Medlock: (Photograph 20)
  - JS advised that the building is to be vacated in mid-July 2017. Mixed boxes stored. Current tenant has occupied the building for ~1 year.

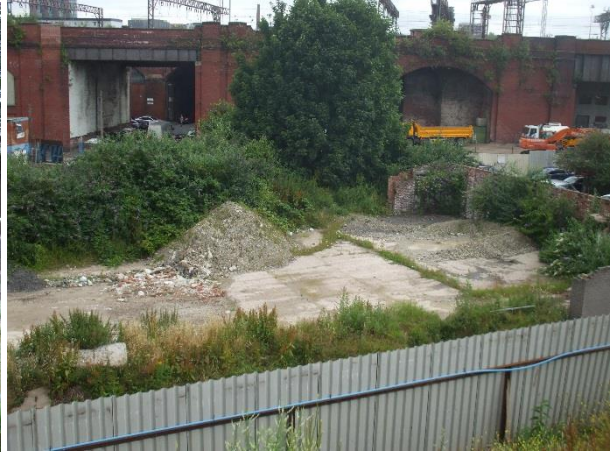
Photograph 23

- East of square warehouse: Unoccupied yard with piles of demolition rubble and brick walls of historic buildings. (Photograph 23)
- South of square warehouse: Concrete retaining wall with Hilclare car park and skips beyond.

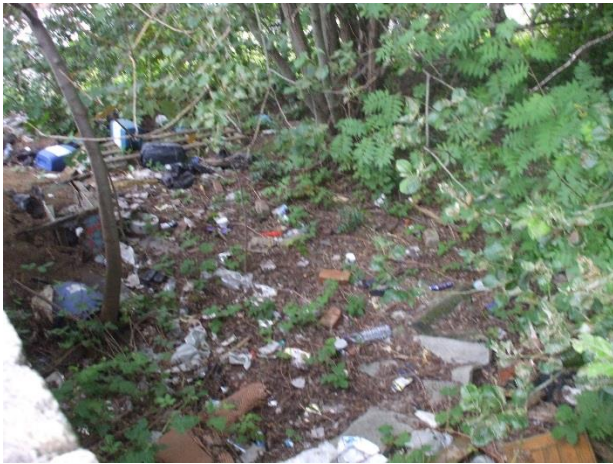
Photograph 24

- East of Manor Street: Wooded area with large amount of fly tipping (Photograph 24)
- East of Hilclare car park and west of Hoyle Street: 'Delaney' Site. Yard area, hoarded off. Material stockpiles ~3 to 5 m high comprising both apparently screened and unscreened material, demolition rubble, piles of whole bricks (Photograph 25)

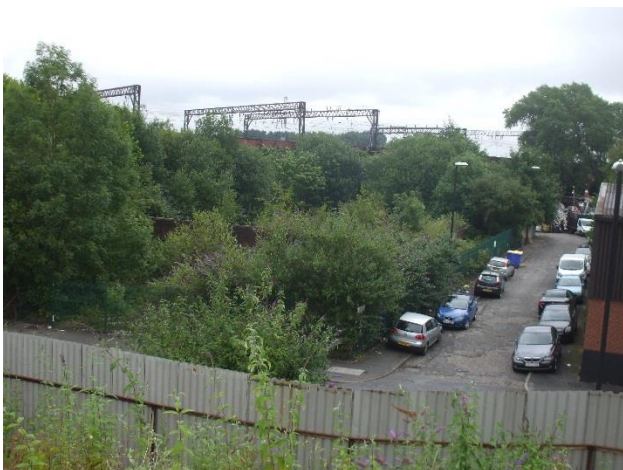
Photograph 26

- Between Hoyle Street, Chapelfield Road, River Street and Rachel Street
  - Former morgue. Extremely overgrown; no access. Fenced off. (Photograph 26)
  - Brick walls of derelict building visible
