Eagle House, Manchester  
Second Floor Photographic Survey  
May 2023

## 2.0 – Second floor room key

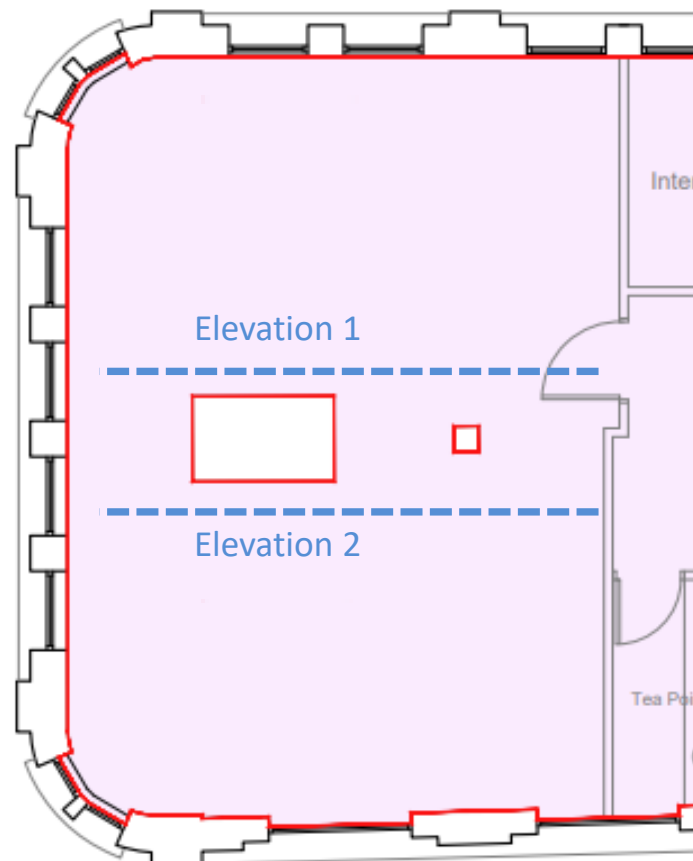
From archival research this partition is original to the building, but at some stage crude openings have been formed at low level. Cornicing exists to the top of these high level partitions which ties in with and continues around the remainder of the space. It is therefore proposed to retain this partition and incorporate it into the design proposals so as to not further erode the historic fabric of the building

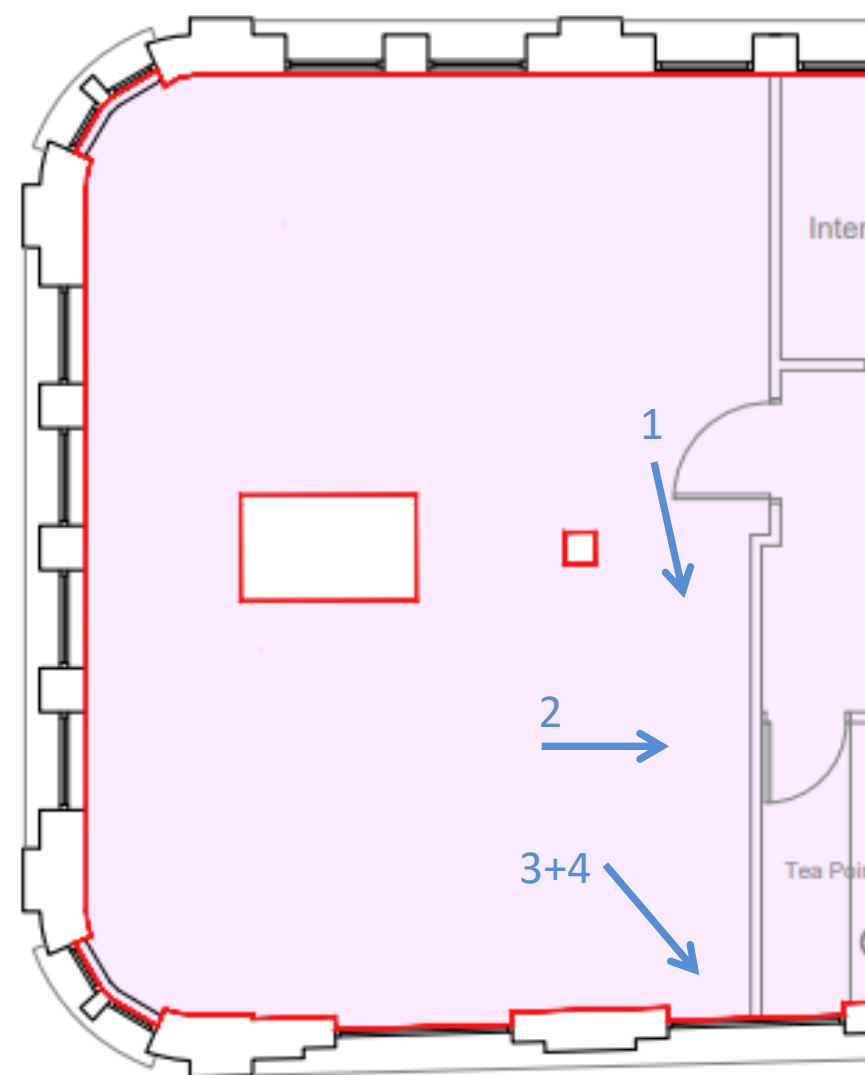
These photographs focus on the dividing wall between the current main office and the tea prep area. The partition is not original to the building and junctions crudely with the window mullion. The partition also has an awkwardly placed glazed screen, the skirting does not match that to the perimeter and has no cornicing.

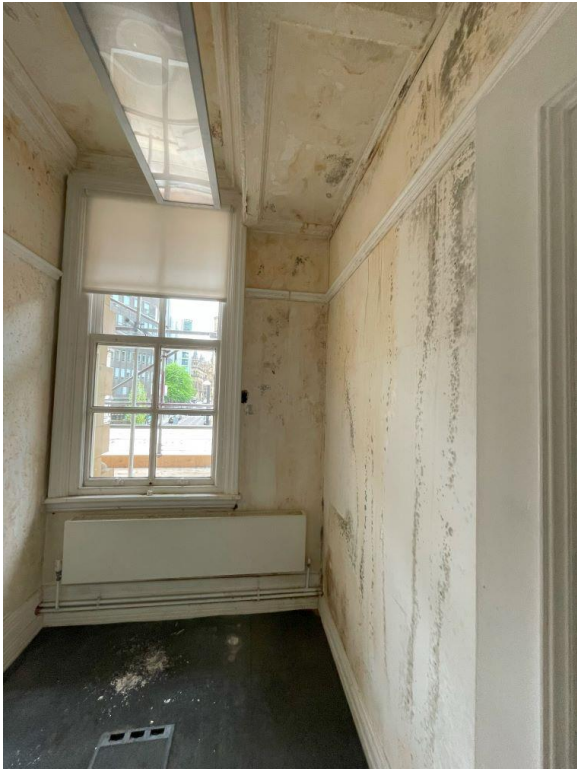
Photo 3

Photos 1 and 2 focus on the ceiling and the junction with the ceiling. Photograph 4 shows the corridor wall with smaller skirting than original and no visible cornicing

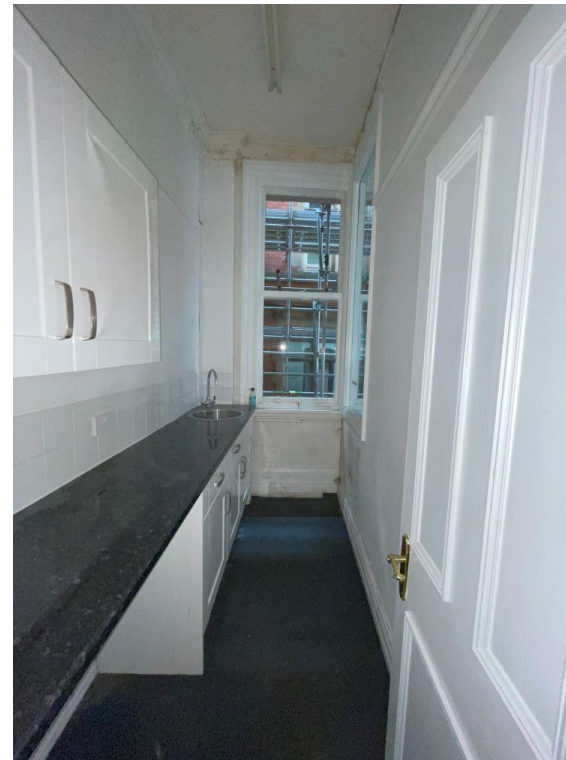
Photo 1

Photos 1 and 2 look towards the external wall and window. Photo 2 shows the window between the tea prep area and the main office which junctions crudely with the window mullion. This wall and the corridor wall shown in photo 4 have no cornicing present.

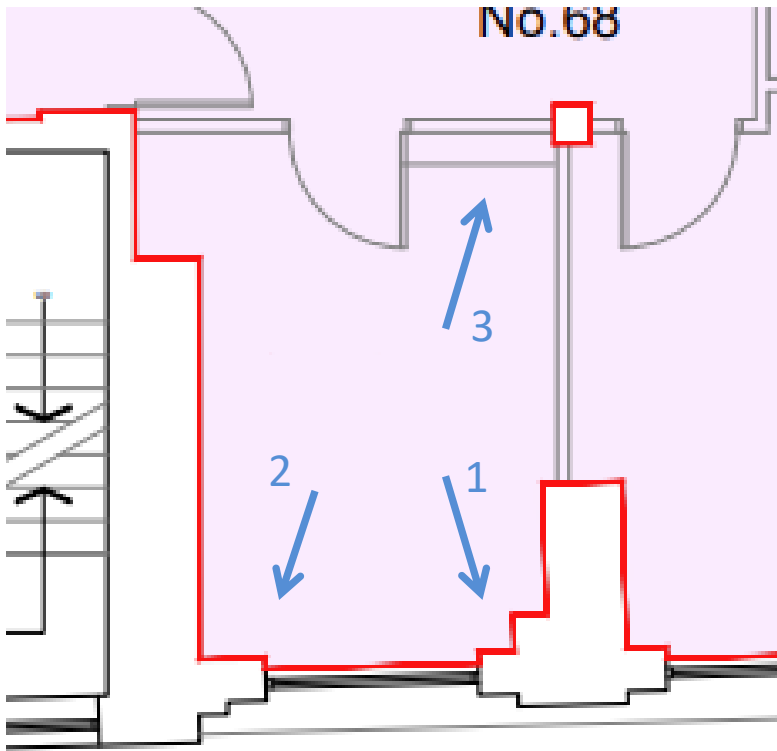
From disruptive survey this partition appears to be an older addition to the building. Through consultation with City of Manchester council it has been determined that this partition should remain and has been incorporated into the design proposals.

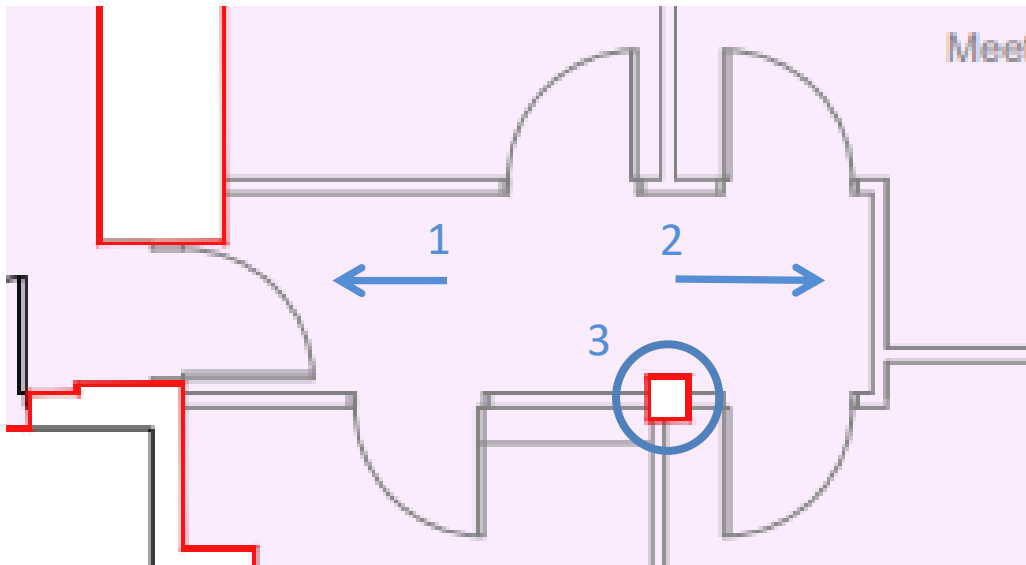
Photos show modern plasterboard partitions to the majority of the corridor.
