Eagle House, Manchester  
First Floor Photographic Survey  
May 2023

# 1.0 – First Floor Key Plan

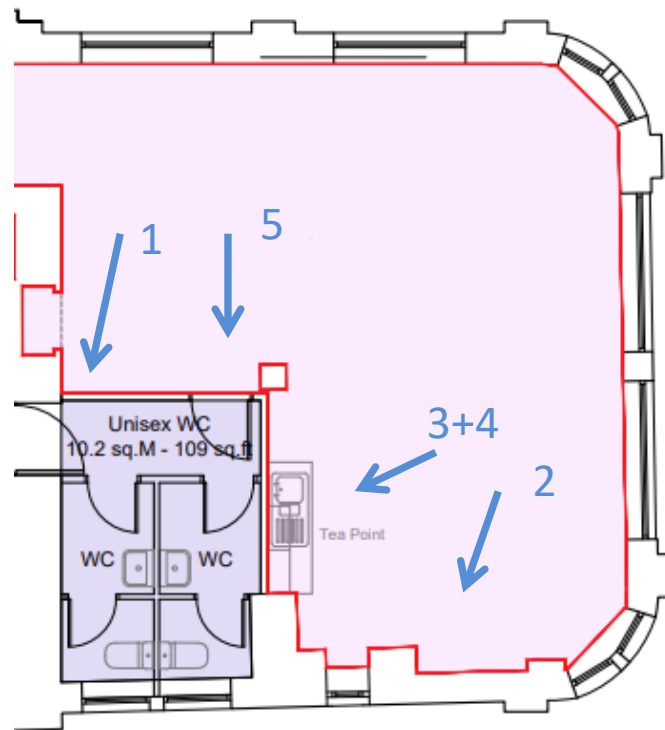
Photo 1 shows the junction between new partition to the front of toilets and original wall. Picture rail recreated, but cornicing absent from new partition. Photograph 5 shows door into toilets which is proposed to be relocated to adjacent wall

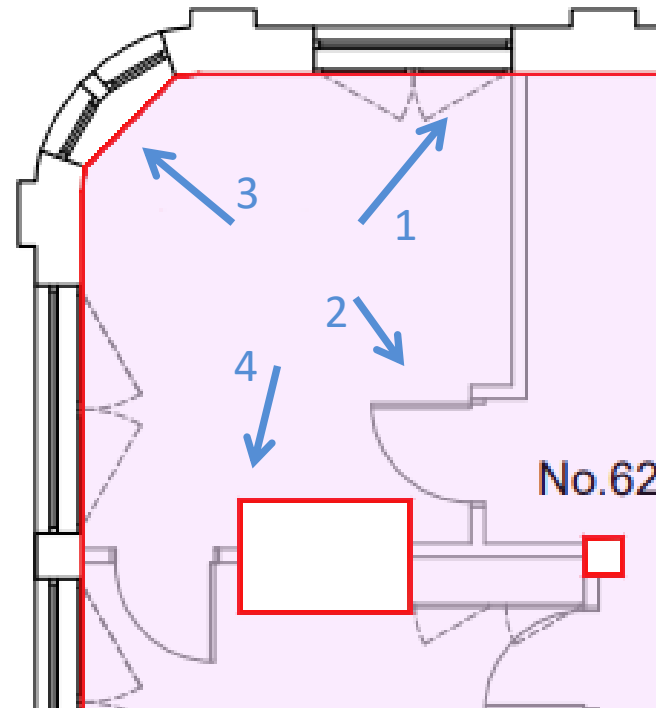
Photo 1

Photograph 1 and 2 show new partition to meeting room installed as part of planning application 075013/LO/2005/C1. This partition does not have cornicing which ties into the existing walls of the room

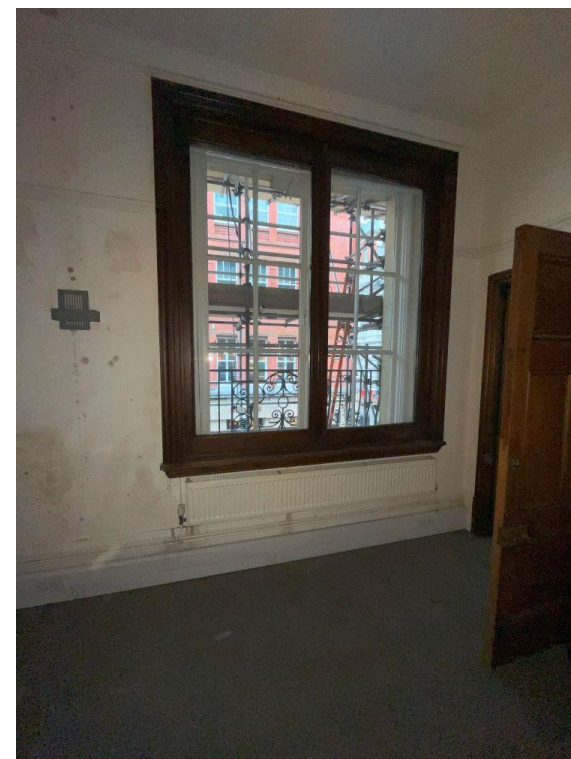
Photo 3

This room is one of the more historically characterful of the building with timber doors, original cupboard and fireplace. There is some damage to the external walls. It is only proposed to replaster walls and decorate.

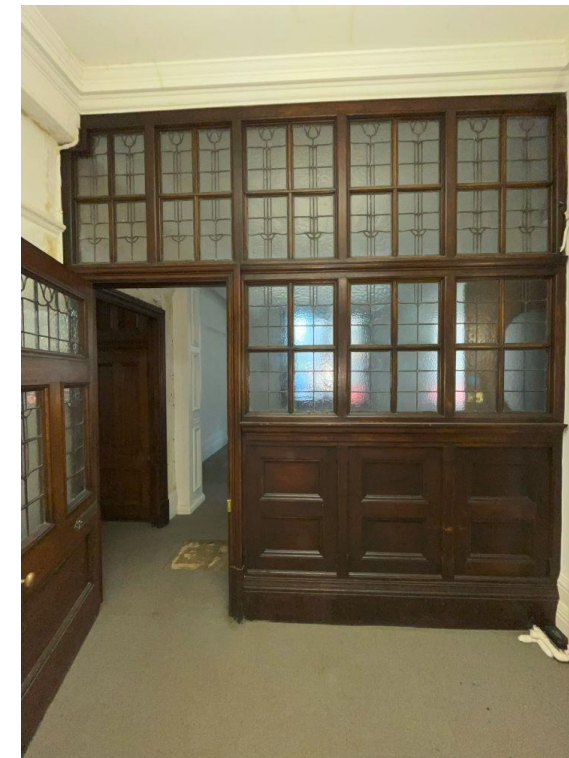
Photo 1

The timber and glazed screen to this room provide some historic character to this room along with the fireplace and timber store cupboard. There is some damage to the walls of this room. The cable management is not neatly contained as can be seen in photos 3 and 4. This will be improved as part of the works.
