# LORETO COLLEGE, MANCHESTER

CONDITION SURVEY REPORT  
APRIL 2023

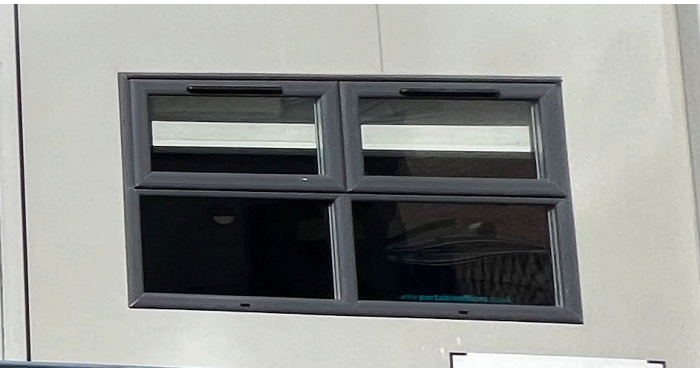
All windows are double glazed units with anthracite outer and white inner uPVC frames, top-hung openers, trickle vents and white lockable handles, with a white finish internally and anthracite externally. The college have confirmed that all openable windows are working properly and have required no maintenance whilst on site.

Unit C - External Window Finish in Anthracite

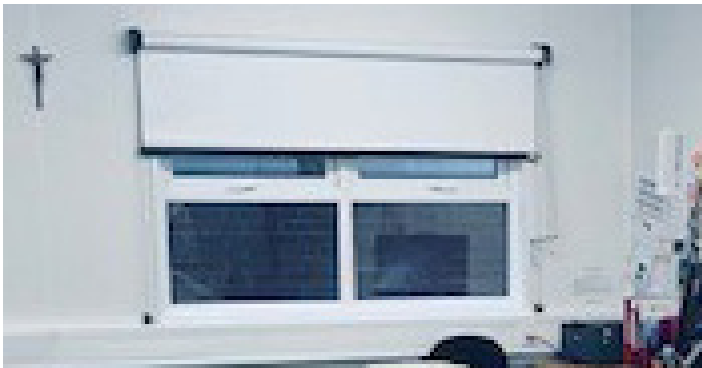
Unit C - External Window Finish in White
