Gazetteer  
November 2004

## **GAZETTEER**

### **Victoria Baths**

## Listed Building Description

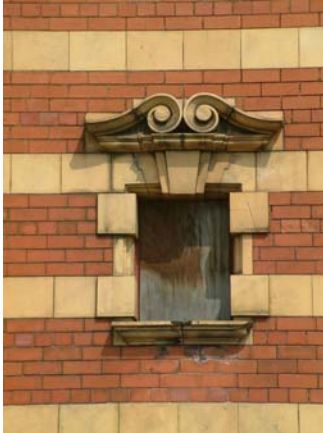
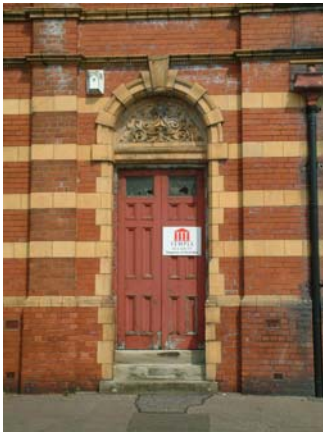
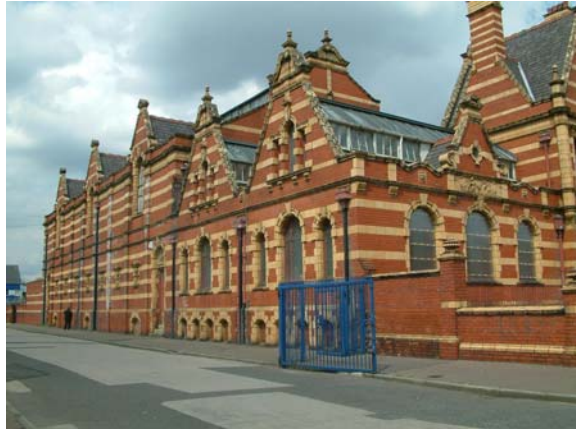
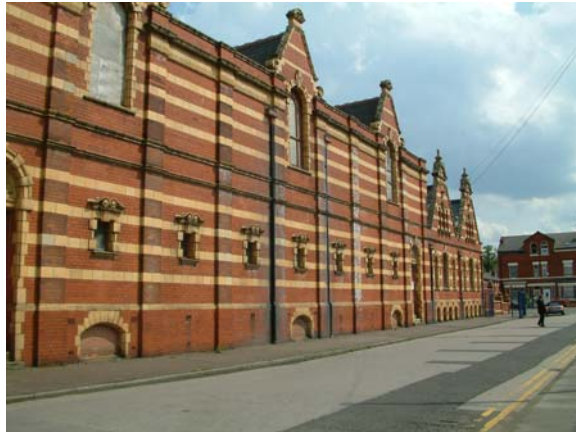
**GAZETTEER NO: EX2**

| <b>Vulnerability:</b><br>The condition survey identifies problems with steelwork to the pool halls, movement to the south west corner and rainwater failures amongst other defects. |

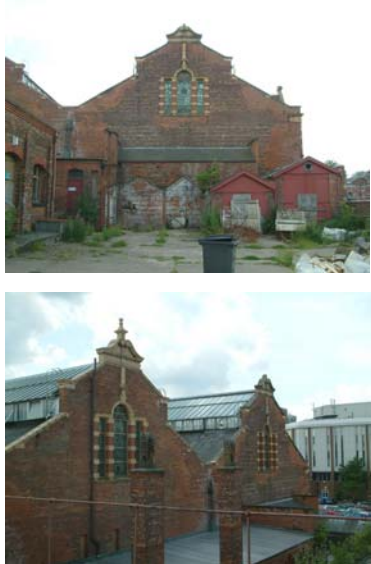
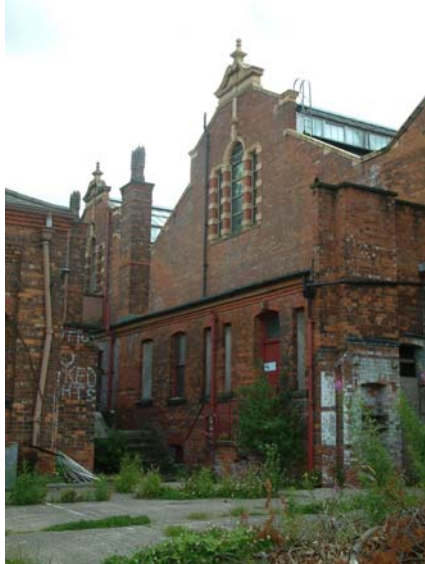
| <p><b>Vulnerability:</b><br/> The outbuildings and lean to areas behind the pool halls are generally in a very poor state of repair.</p> | |

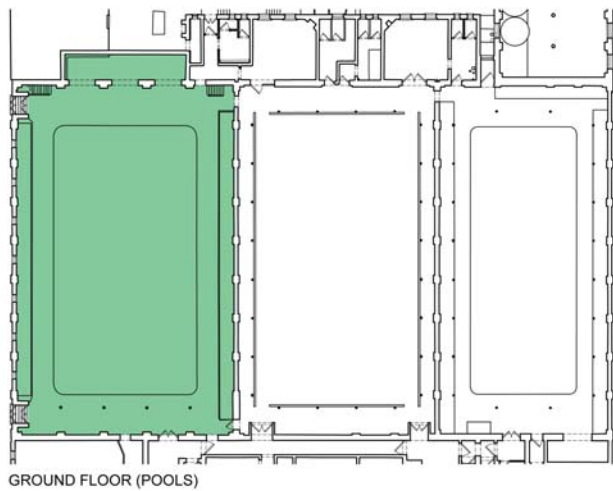
**GAZETTEER NO: G4**

The future of this magnificent pool hall is unclear. It is faced with structural defects, maintenance problems and the difficulty of upgrading the facility to contemporary standards.

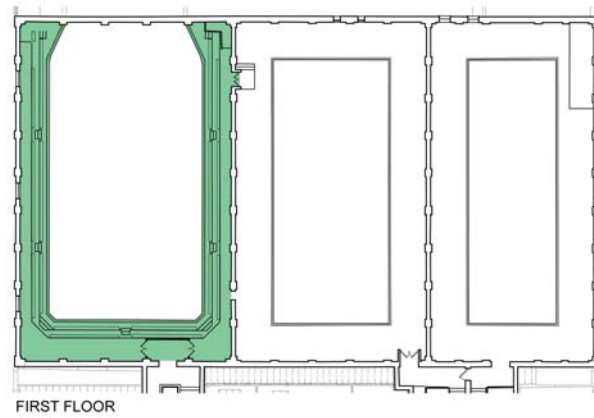
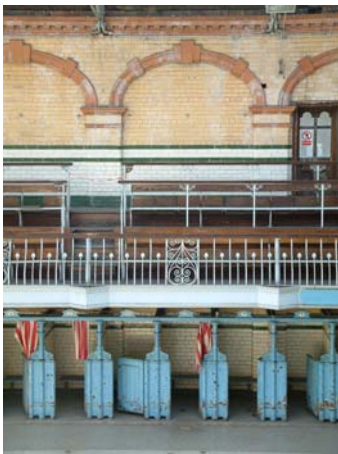
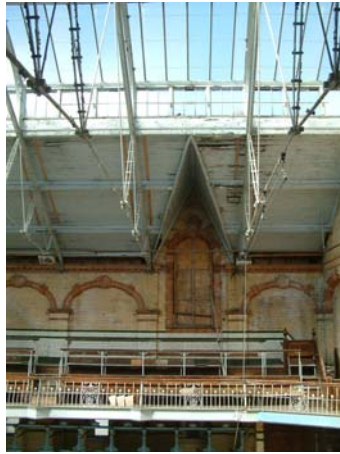
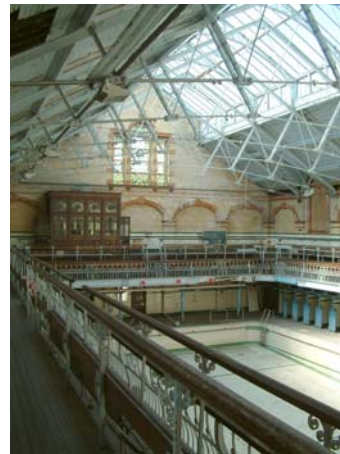
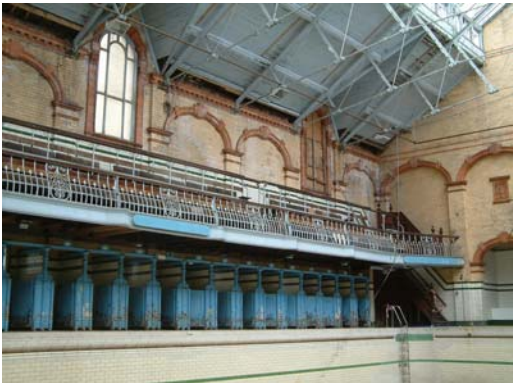
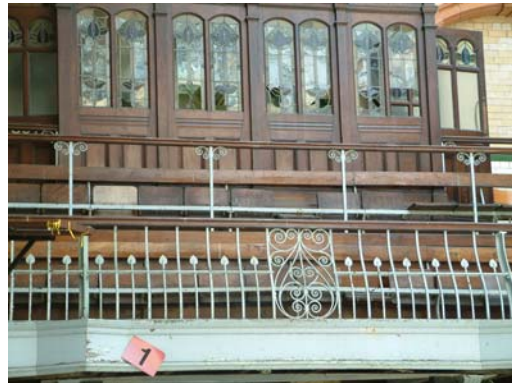
**GAZETTEER NO: G5**

This is the only timber gallery in the baths. It is supported from the built in stanchions which are corroding. It has been seriously affected by dry rot.

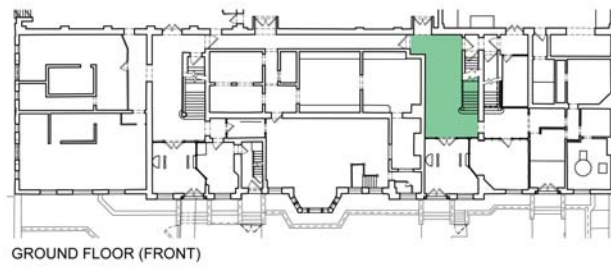
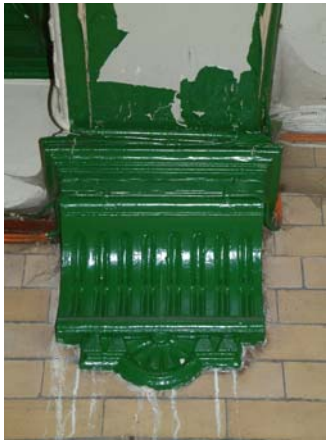
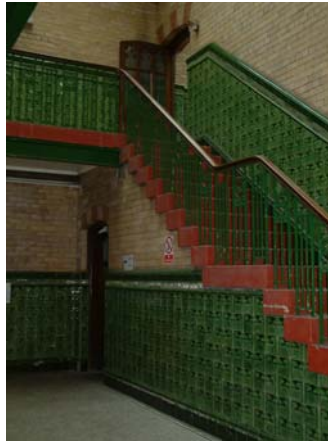
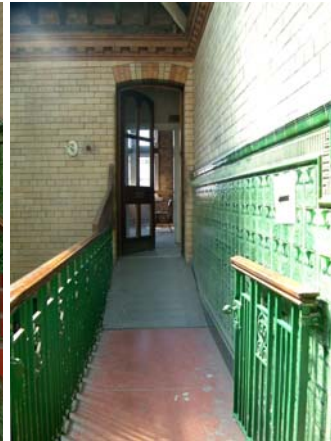
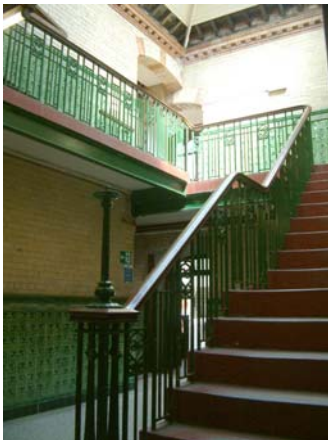
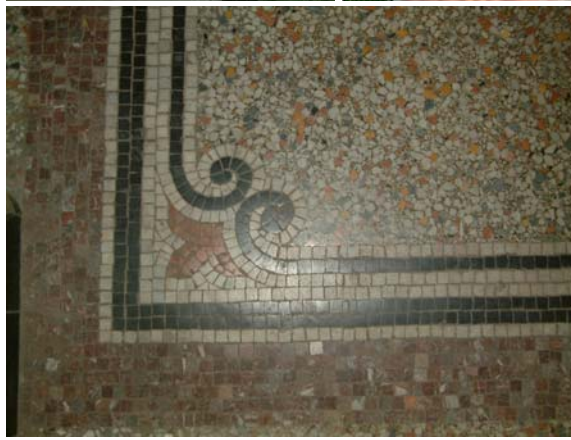
**GAZETTEER NO: G9**

- Hall with top lit stairs and entrances off.
- The floor is terrazzo with a mosaic border.
- The skirting is glazed tile, with a two-tone green dado and plaster cornice at ground floor level to the south. There is a terracotta dentilled cornice above the stairs. The wall surface is brick.
- The ground floor ceiling is plaster, and there is a glazed lantern over the stairs with wooden ceiling, partly removed.
- The doors are Baltic pine with glazed panels.
- The stairs are painted stone with an iron newel post and lamp fittings and decorative balustrade.

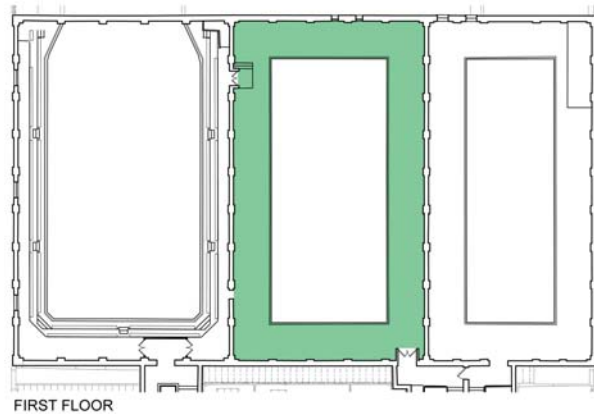
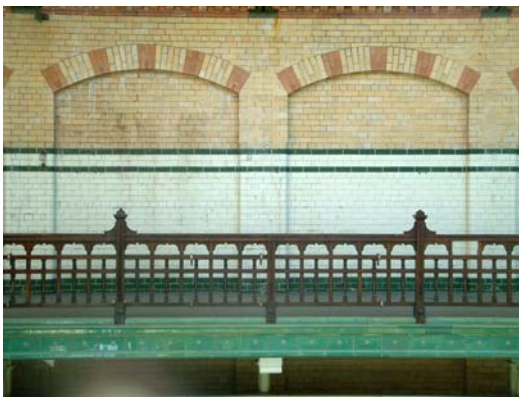
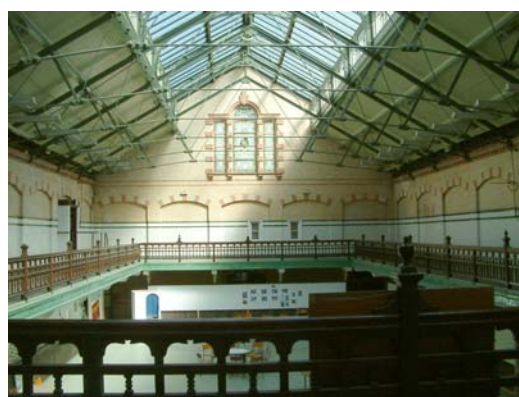
**GAZETTEER NO: G11**

- There is a concrete balcony round all four walls, supported by cast iron columns with decorative brackets. The balustrade is timber with a green tile band at floor level. The balcony wall is glazed brick to a height of approximately six feet with blind brick arches above. The gallery was used for slipper baths.
- There is a dentilled brick cornice on east and west walls.

The appropriate reuse for this large open volume is difficult to determine. This, with the condition of the structure makes this hall one of the most threatened spaces.

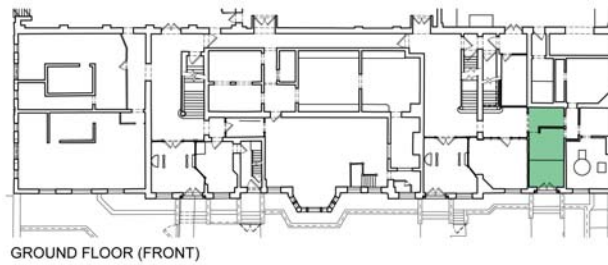
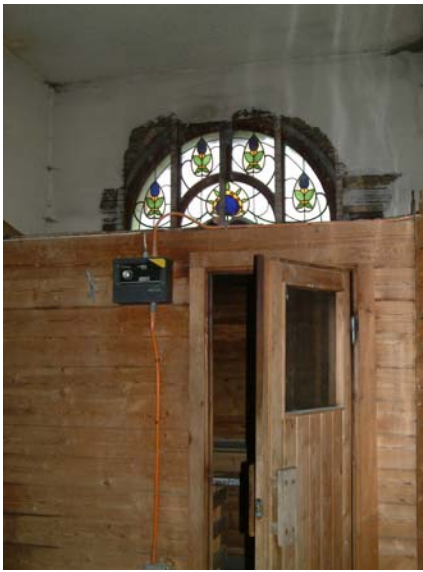
**GAZETTEER NO: G12**

- Sub-divided space converted to a sauna.
- The floor is mosaic with a border decoration.
- The wall surface is late 20<sup>th</sup> century white tiles with no skirting, dado or cornice. The sauna surround has been artexed.
- There is a 20th century opening with no door. The front door, apart from the coloured glass overlight, has been obscured.
- There are two late 20<sup>th</sup> century showers with basins and a Bedford sink.
- Repair work has revealed that the screen and decoration may survive in part beneath the alterations.

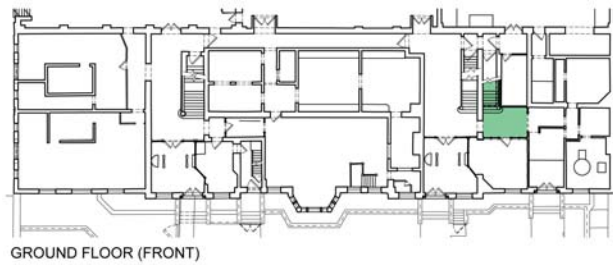
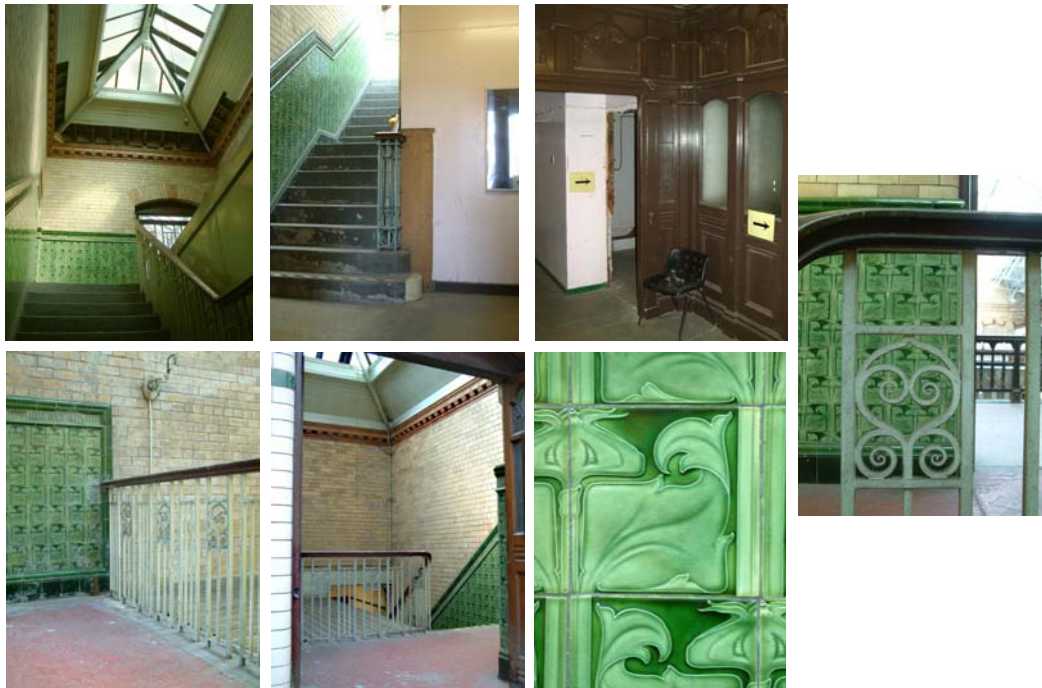
**GAZETTEER NO: G13**

- Hall and corridor with a partial terrazzo floor with damaged mosaic border. The wall surface is brick and plaster with green glazed tile skirting, a two-tone green glazed tile dado and a plaster cornice. The wall above the pay booth is plaster.
- The ceiling in the hall is flat plaster. There is a glazed lantern over the stairwell with a wooden ceiling and a terracotta dentilled cornice.
- There are no doors.
- The stairs are stone with a cast iron newel and balustrade
- The space has been altered by the insertion of partitions behind which are WCs and the First Aid Room.

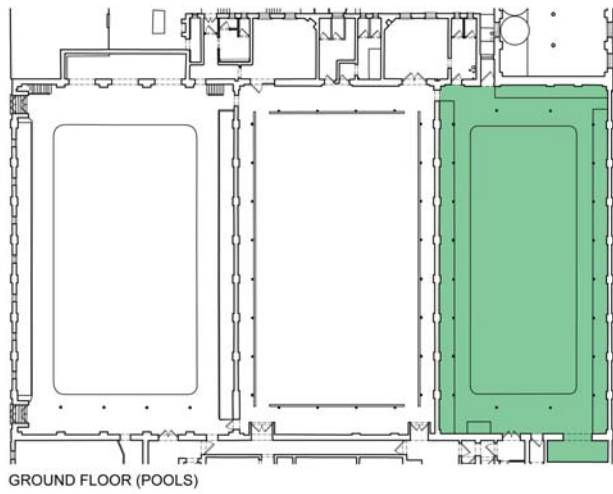
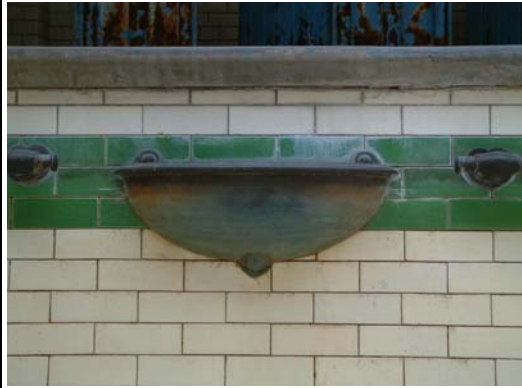
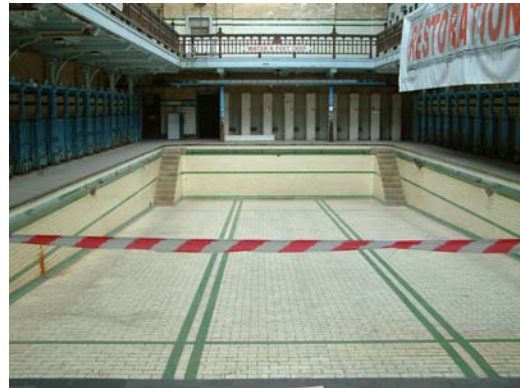
**GAZETTEER NO: G14**

- Double height hall and pool with the four galleries supported on cast iron columns.
- The floor is terrazzo, with a stone surround to the pool. The pool surface is glazed tiles or brick.
- The wall surface is brick and glazed brick, with no skirting, but a green and white glazed brick dado.
- The ceiling is timber with a glazed, pitched central section and clerestory. The supports are iron with decorated spandrels.
- There are Venetian windows to north and south with stained glass, damaged in places.
- The doors are Baltic pine with glass panels.
- There are 53 cast iron cubicles on east and west walls, with glazed brick dividers and wooden seats and doors. On the north wall are later 20<sup>th</sup> century “composition” cubicles.
- The pool has four sets of original stone and glazed brick steps, and bronze handrail. There is a timber attendant’s cubicle on the southern poolside.

This pool is the most complete of the three pool halls. It is also the most threatened given its remoteness from the Turkish Baths. The gallery is structurally failing and will require removal. Reconstruction is possible.

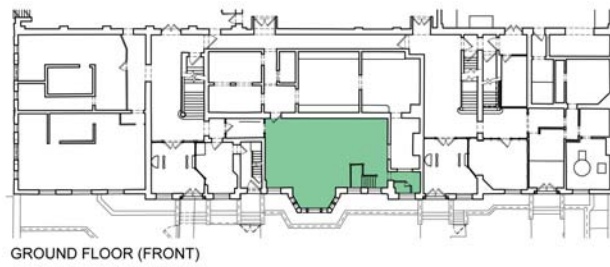
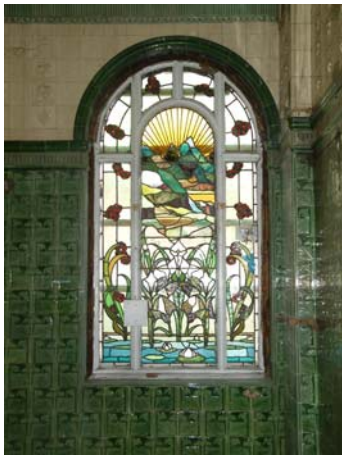
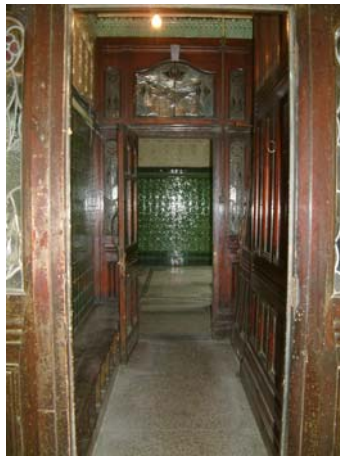
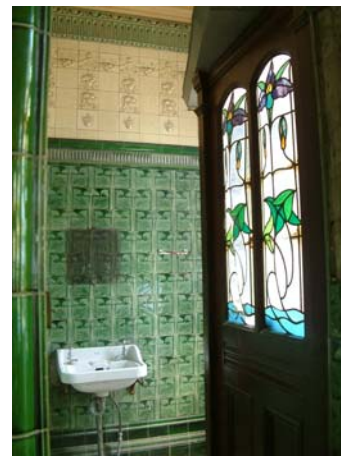
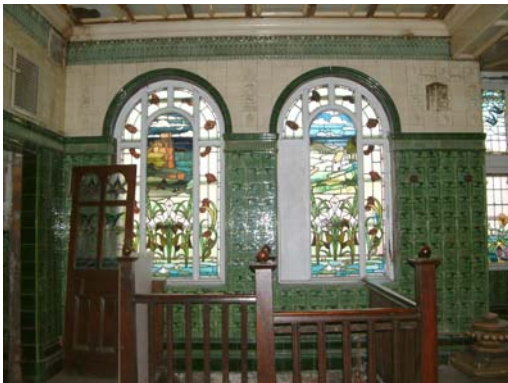
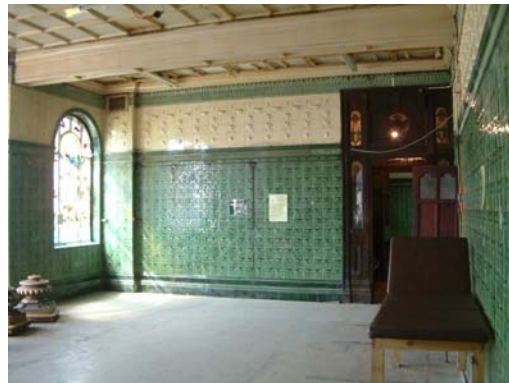
**GAZETTEER NO: G16**

- A rectangular room with a canted window bay on the south wall, and stairs to the basement, now partially removed, and WC in a separate room in the south-east corner.

- The floor is concrete with a lino overlay. Original finish not known.
- The ceiling is opaque glass in square frames with two beams running north/south. It may possibly have been back-lit although no evidence has been found to support this.

- Six terracotta finials, some damaged, from the front wall, are stored in the room.

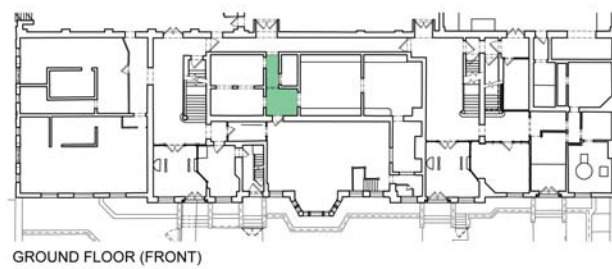
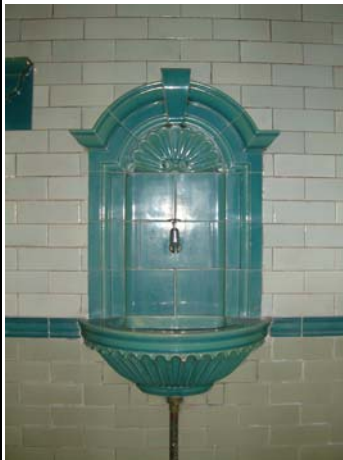
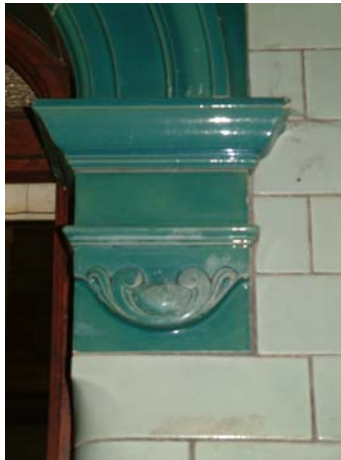
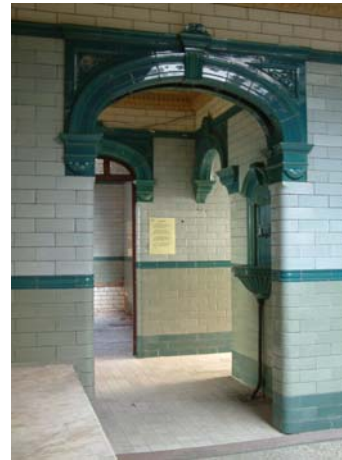
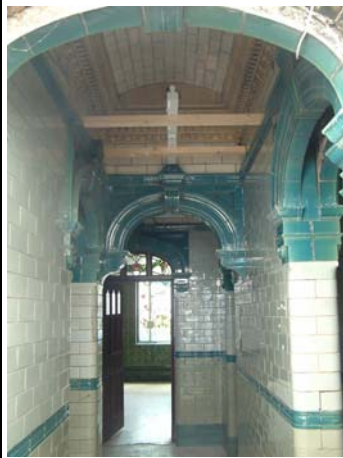
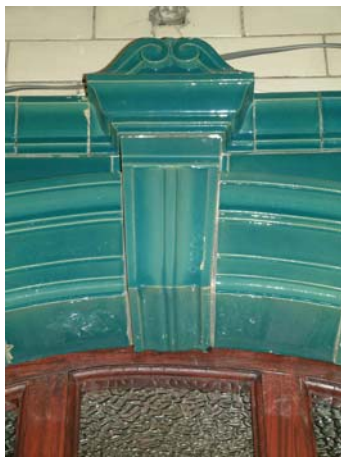
**GAZETTEER NO: G17**

- Entrance lobby to Tepidarium with a white tiled floor.
- The walls are glazed bricks or tiles, greeny-blue up to dado level, with light grey blue above. The cornice is cream glazed tiles with dentils and egg and dart decoration.
- The ceiling is white tiles or brick jack arches between cream glazed beam mouldings.
- There is a drinking fountain in dark greeny-blue tile on the north wall.

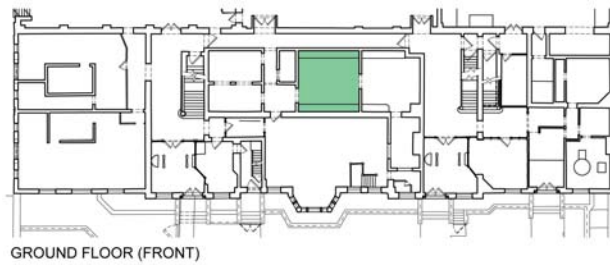
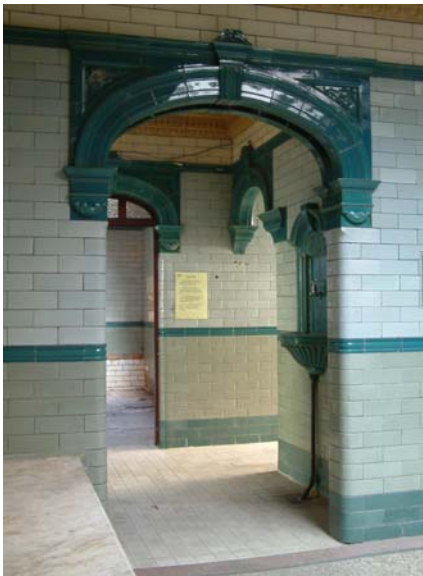
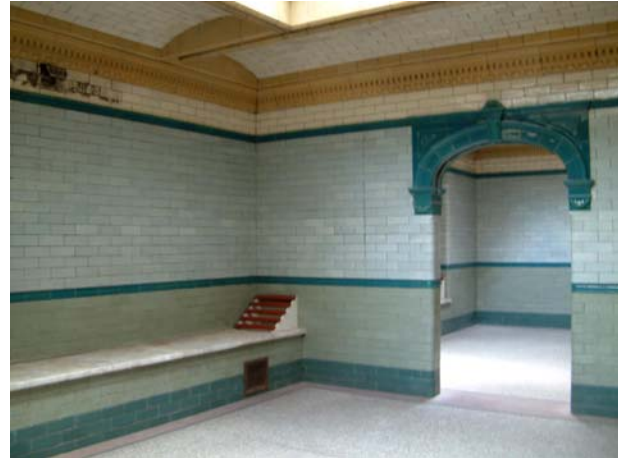
**GAZETTEER NO: G18**

- The first of a series of three rooms; entered through a segmental, doorless, arched opening of greeny-blue glazed tiles with a decorative key stone.
- The floor is terrazzo.
- The walls are glazed bricks or tiles, dark greeny-blue up to dado level, with light green above. The cornice is cream glazed tiles with dentils and egg and dart decoration.
- There are no windows, but the Tepidarium is lit by a large central glazed skylight.
- The ceiling is white tiles jack arches between cream glazed terracotta beam mouldings.
- There are tiled benches with air vents and marble seats on north and south walls.

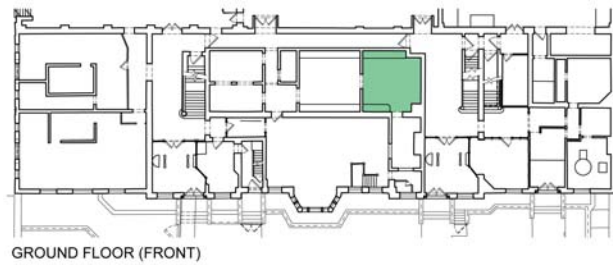
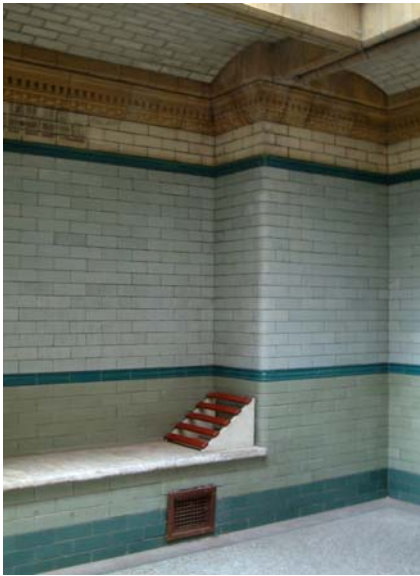
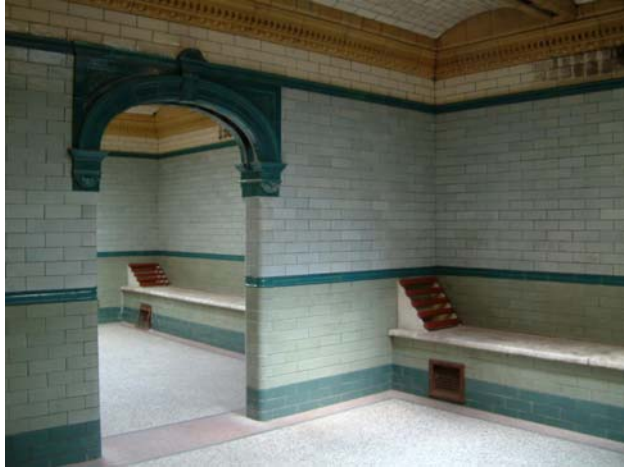
**GAZETTEER NO: G19**

- The second of a series of three rooms; entered through a segmental, doorless, arched opening of dark greeny-blue glazed tiles with a decorative key stone.
- The walls are glazed bricks or tiles, dark greeny-blue up to dado level, with light green above. The cornice is cream glazed tiles with dentils and egg and dart decoration.
- There are no windows, but the Calidarium is lit by a large central glazed skylight.
- The ceiling is white tiles jack arches with glazed cream terracotta beam moulding.
- There are tiled benches with air vents and marble seats on north and south walls.

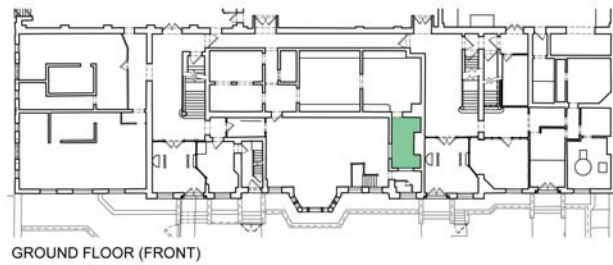
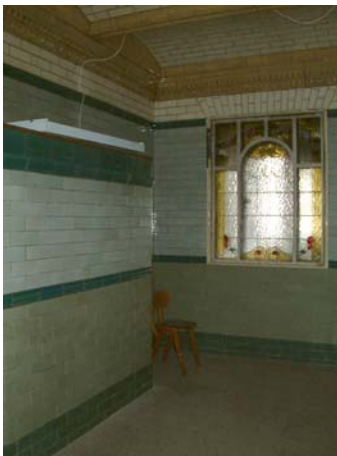
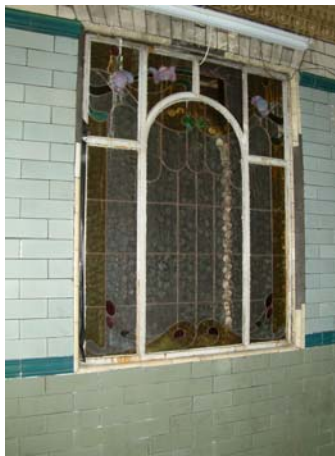
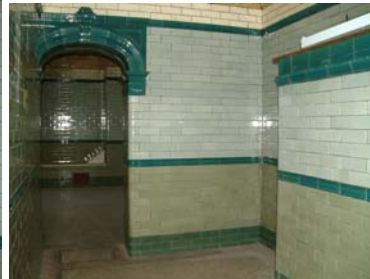
**GAZETTEER NO: G20**

- The third of a series of three rooms; entered through a segmental, doorless, arched opening of dark green glazed tiles with a decorative key stone.
- The walls are glazed bricks or tiles, dark greeny-blue up to dado level, with light green above. The cornice is cream glazed tiles with dentils and egg and dart decoration.
- There are double glazed windows with coloured glass to the Rest Room and the Rest Room WC.
- The ceiling is white tiles jack arches with glazed cream terracotta beam mouldings.
- On the east wall is a large chimney vent for ingress of hot air from the basement boiler.

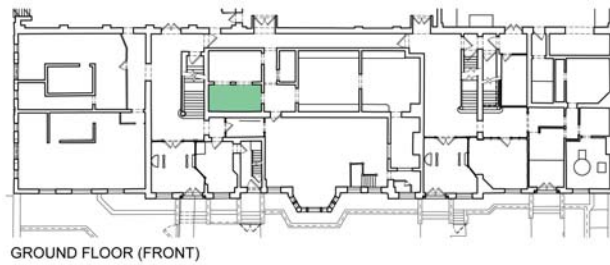
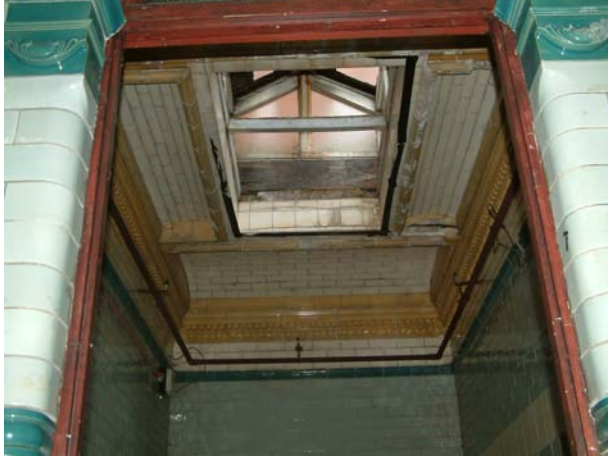
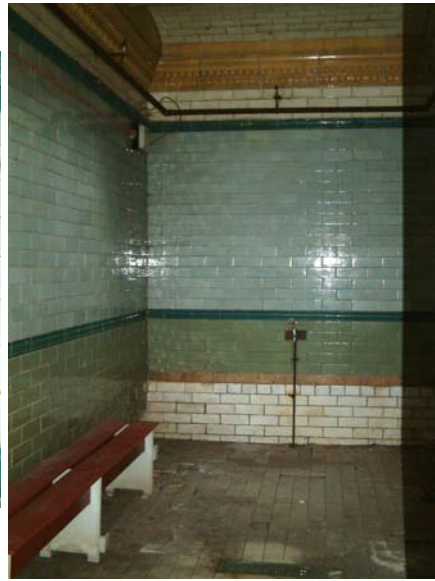
**GAZETTEER NO: G21**

- Wet, hot steam room with a modern tiled floor.
- The walls are glazed bricks or tiles, dark greeny-blue up to dado level, with light green above. The cornice is cream glazed tiles with dentils and egg and dart decoration.
- There are narrow plastic glazed slit windows to the adjoining shampoo room.
- There is a small, pitched roof, central skylight.
- The door has been removed.
- The ceiling is of white tiled jack arches with glazed cream terracotta beam mouldings.

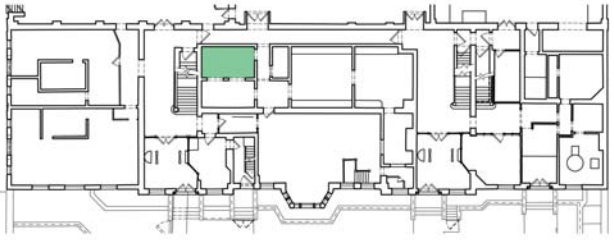
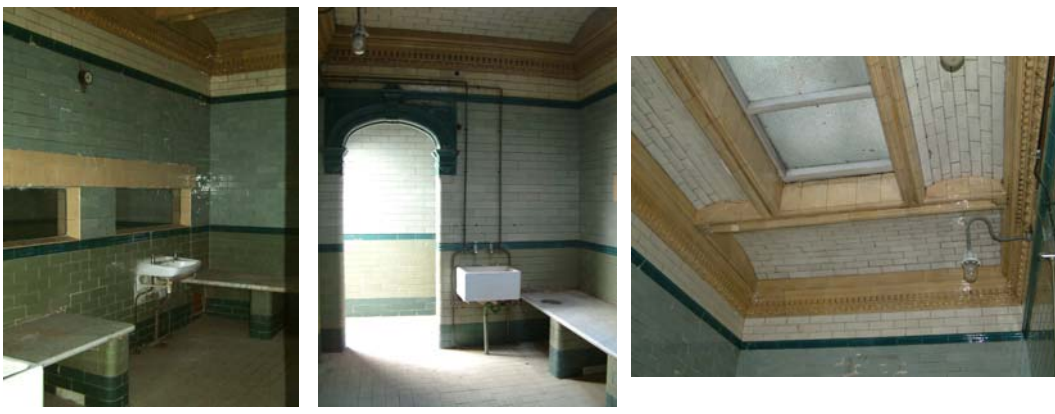
| <p><b>Description</b></p> <ul style="list-style-type: none"> <li>• Shampooing room with two marble benches on tiled supports on modern tiled floor.</li> <li>• The walls are glazed bricks or tiles, dark greeny-blue up to dado level, with light green above. The cornice is cream glazed tiles with dentils and egg and dart decoration.</li> <li>• The ceiling is of white tiled jack arches, with a flat glazed skylight and glazed cream terracotta beam mouldings.</li> </ul> | |

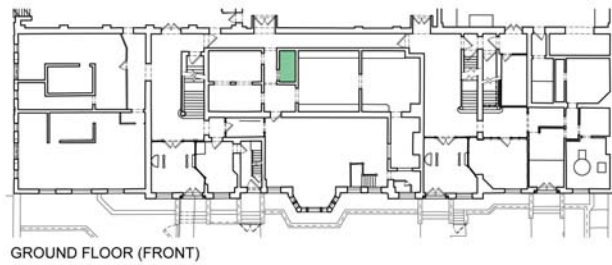
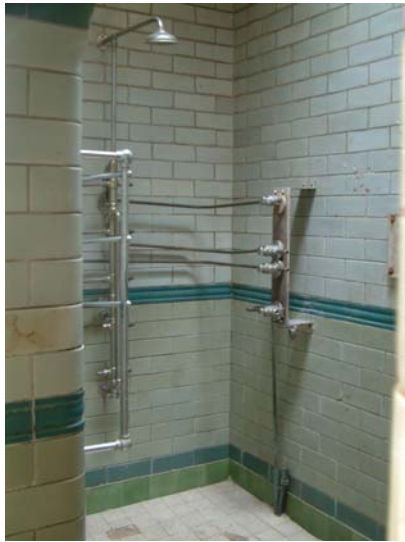
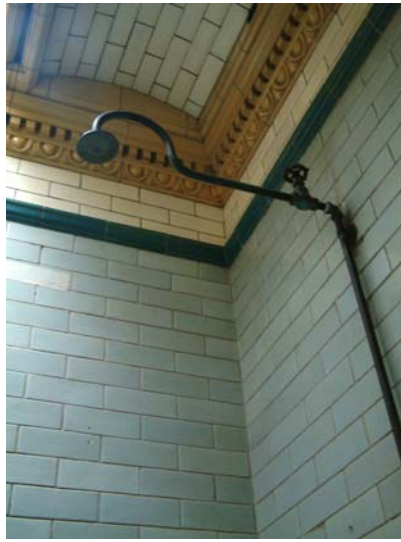
**GAZETTEER NO: G23**

- The walls are glazed bricks or tiles, dark greeny-blue up to dado level, with light green above. The cornice is cream glazed tiles with dentils and egg and dart decoration. The ceiling is of white tiled jack arches with a flat glazed skylight and glazed cream terracotta beam mouldings.
- The floor is modern tile.
- The room has two shower units, one with jets, one a simple shower head.

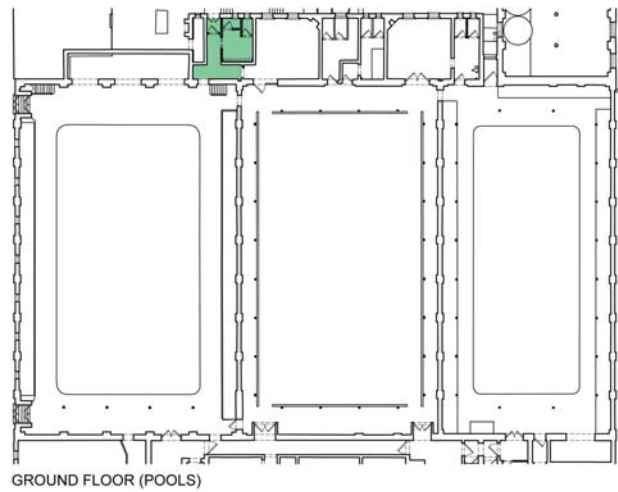
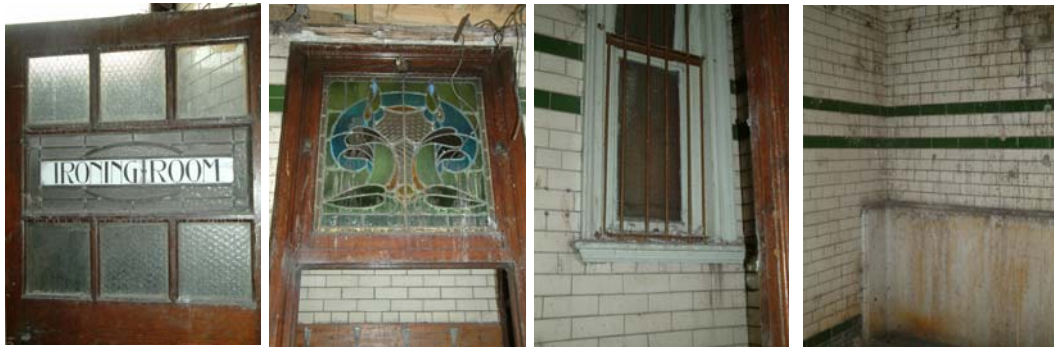
**GAZETTEER NO: G24**

- The room has a terrazzo floor and a glazed cream brick wall surface with green at floor level and three strips higher up. There is no skirting, dado or cornice.
- There is a temporary roof.
- There are two barred sash windows, one over one glazing.
- The northern exterior entrance door is two leafed, each one panel over one. The cubicle doors are 6-panel. There is an internal two panel door with glazed upper panels marked 'ironing room'. This was the route to the laundry beyond. Entrance to cubicles through wooden door frame with art nouveau glass above.
- There are two WCs in cubicles and a 4 bay slab urinal.
- Exit to 1<sup>st</sup> class pool through pedimented arch.

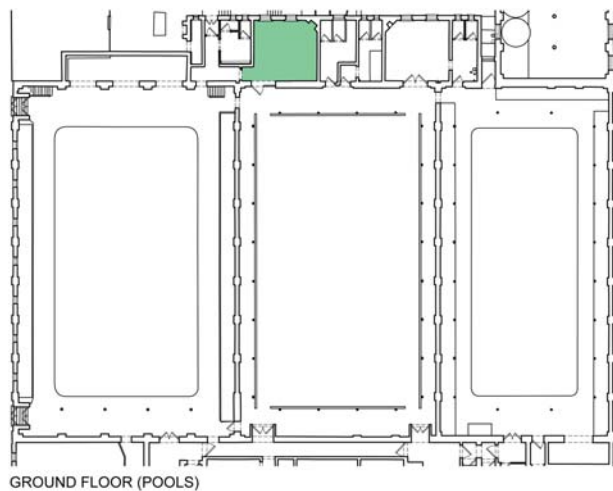
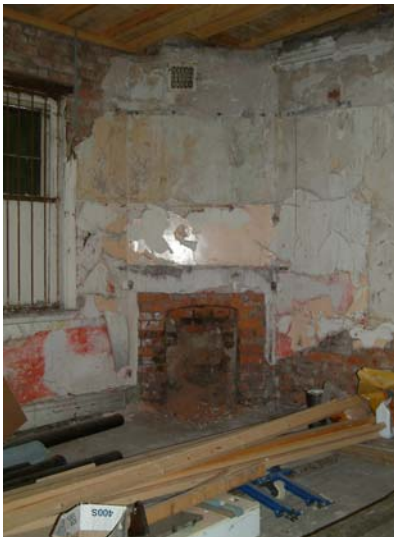
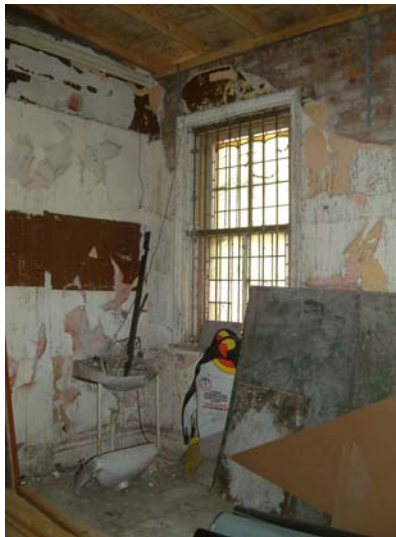
**GAZETTEER NO: G25**

- The floor is narrow tongue and grooved boards.
- The wall surface is plaster with 9 inch softwood skirting, no dado or cornice. The picture rail has been partly removed.
- There are two sash windows, two-over-two, with green, yellow and clear patterned glass. The door is missing.
- There was a fireplace in the north east corner, now removed.
- There is a temporary ceiling.
- There is a broken wash-hand basin.

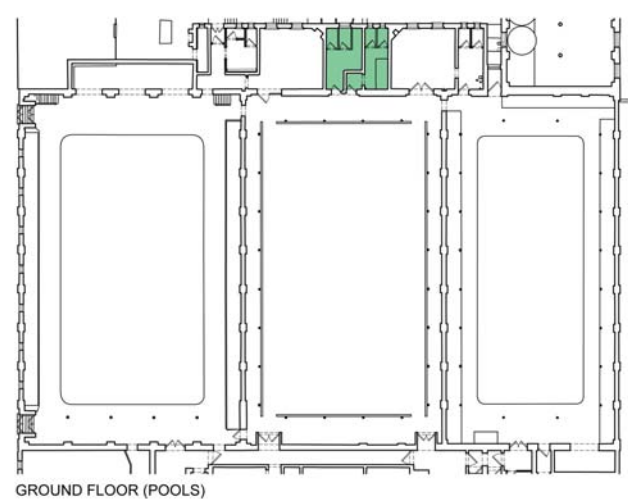
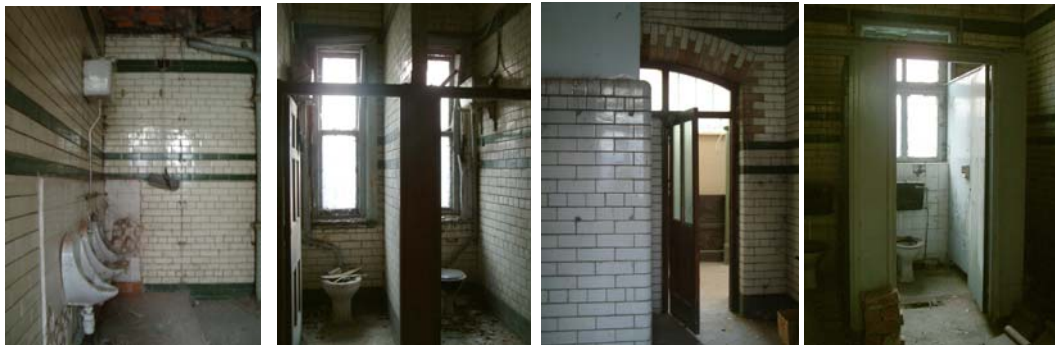
**GAZETTEER NO: G26**

- The wall surface is glazed brick, cream and green. There is no skirting, dado last remnants of cornice.
- The floor is terrazzo with raised tiled plinth to urinals.
- There are two sash windows, one over one top glazed (probably original).
- The cubicle doors are softwood with six panels; the bath-side door is four top glazed panel, the ladies cubicle doors are flush. There are two large loose nine panel doors.
- There are two WCs and three urinals in the male area.

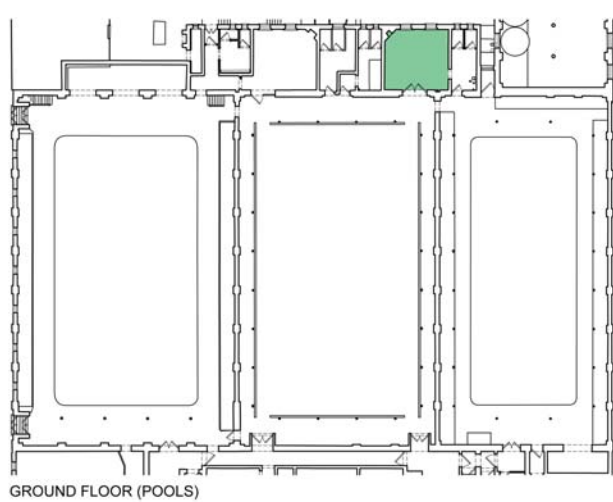
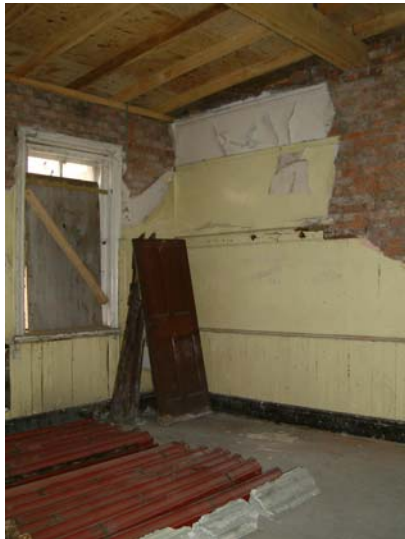
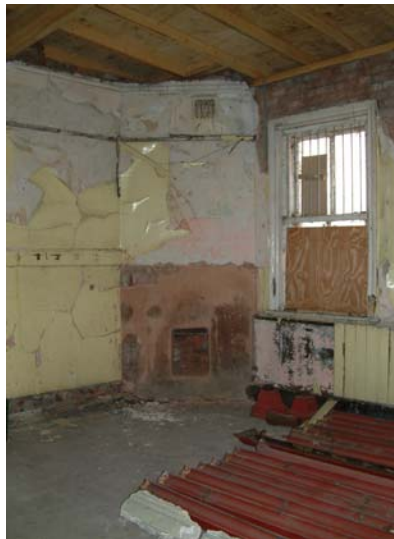
**GAZETTEER NO: G27**

- The floor is covered with plywood sheeting. The wall surface is plaster and exposed brick, with 9 inch softwood skirting. Matchboard dado on all except west wall, picture rail and 3-ridge plaster cornice.
- The ceiling is missing. There are two sash windows, two over two, (now boarded up.)
- The room has a corner fireplace in the north west corner but the chimneypiece has been removed.
- The door is Baltic pine with glazed panels, 3 over 3 over 3, upper two series glazed. Coat hooks on east and west walls.
- Recent entrance to former ladies toilets in east wall.

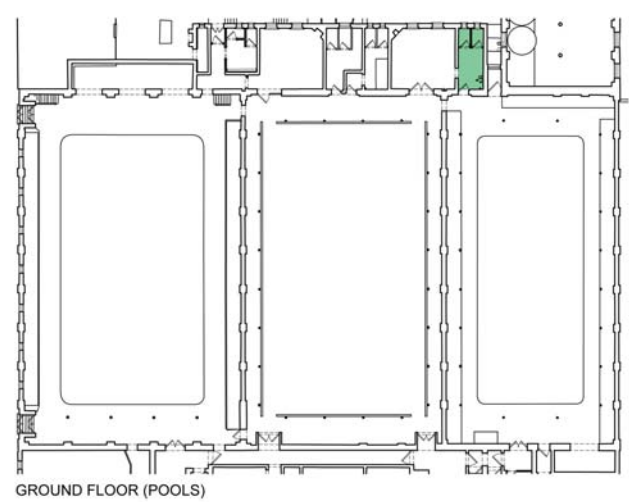
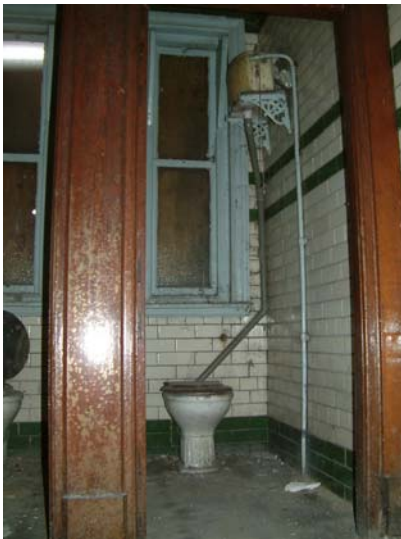
**GAZETTEER NO: G28**

- The floor is terrazzo.
- The wall surface is glazed brick, with no remaining skirting, dado or cornice.
- The two sash windows are one over one. The door has nine panels, the upper six glazed with wired glass but with remnants of coloured glass panel
- There is a temporary roof.
- There are two WCs; WC to east has original timber seat on original WC bowl. Original cistern brackets in both cubicles.
- Doors to WCs are original, timber 3 over 3 over 3 with 'WC' in glazed upper series.

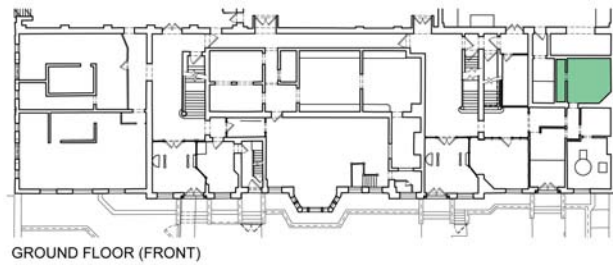
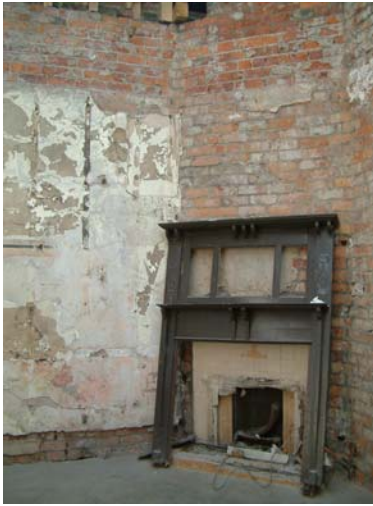
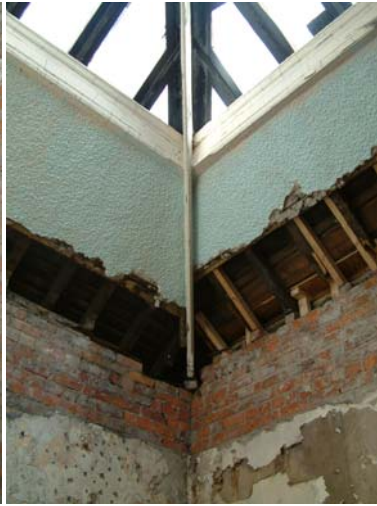
**GAZETTEER NO: G29**

- The wall surface is plaster and exposed brick, with no remaining skirting, dado, or cornice.
- The ceiling is artexed timber with glazed lantern. There are no windows.
- The door has been removed.
- The fireplace is tiled, and the timber surround with art nouveau detail has been detached.
- A partition has been inserted to contain a late 20<sup>th</sup> century toilet.

This space is in poor condition but may be suitable for alternative uses.

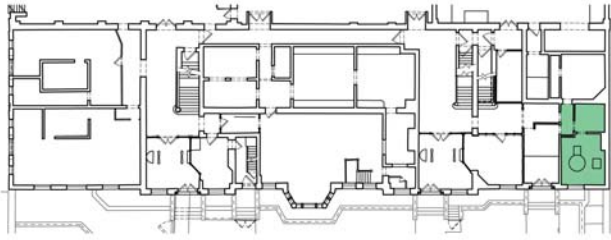
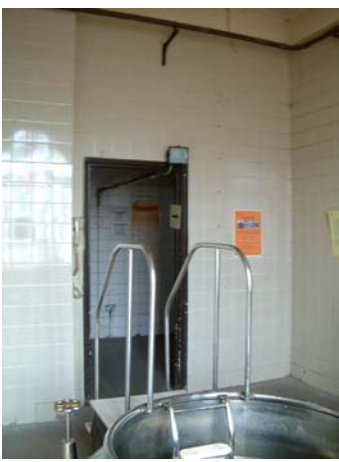
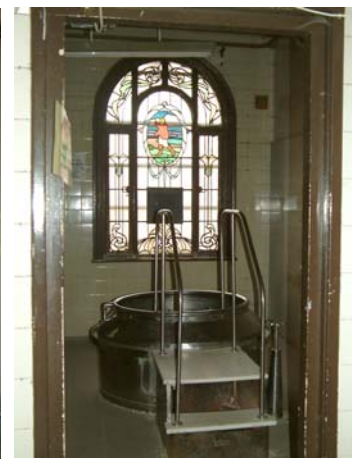
| <p><b>Description</b></p> <ul style="list-style-type: none"> <li>• This space has been created out of part of the Female Entrance area.</li> <li>• The floor is solid with lino overlay. The wall surface is late 20<sup>th</sup> century white glazed tiles and Formica panelling.</li> <li>• There is an arched window with painted and stained glass depicting a golfer.</li> <li>• The door has been removed.</li> <li>• The room contains a sunken Aerotone bath.</li> </ul> | |

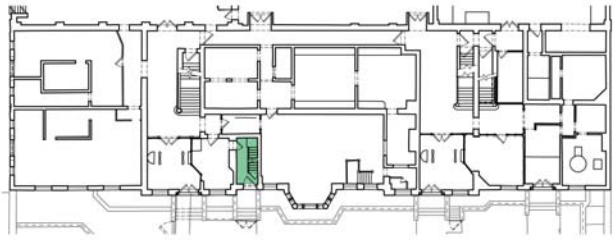
| <b>Description</b> <ul style="list-style-type: none"><li>• Entrance at ground floor level next to the Male First Class pay office.</li><li>• The floor is wood with lino tiles.</li><li>• The wall surface is plaster with painted paper, but this has been stripped back to the brick in the area near the front door.</li><li>• The ceiling is plasterboard but has been removed under the upper run of stairs.</li><li>• The stairs are wood with a moulded baluster and newel.</li><li>• The front door is wood (three panels over three over three) with a further wooden door to the pay booth.</li><li>• There are two-light windows at the first landing level, plain glass with black floral pattern, and two similar but smaller windows at second landing level.</li></ul> | |

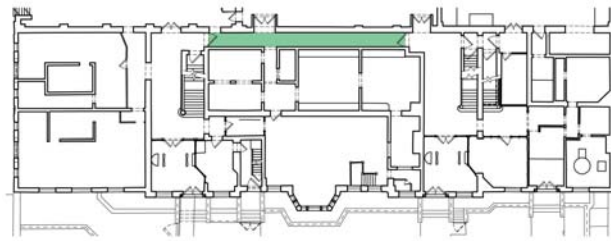
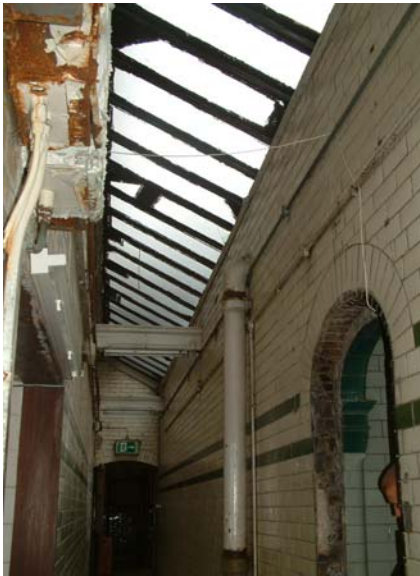
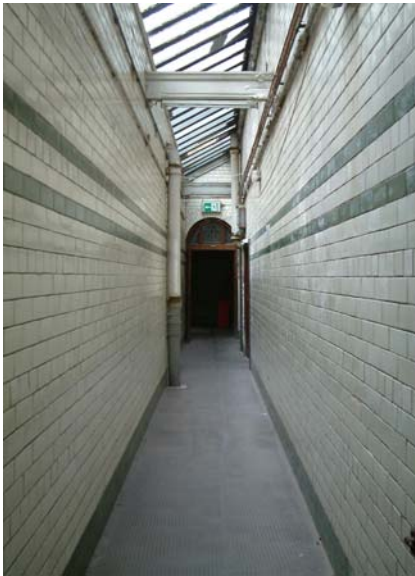
**GAZETTEER NO: G32**

- Corridor to the immediate south of the pools.
- The floor is studded asphalt, covering glass blocks, in 'pavement light' construction.
- The wall surface is green and white glazed brick.
- The ceiling is angled glazing, probably late 20<sup>th</sup> century replacement.
- There are timber doors at each end of the Second Class Male Pool with glazed panels, a door opening to the Turkish Baths and a door into the Males first class lobby.

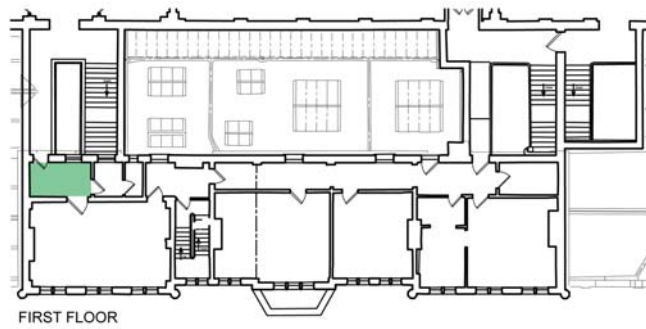
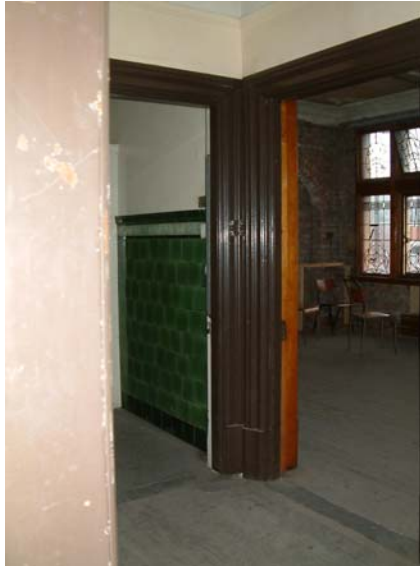
**GAZETTEER NO: F1**

- The floor is timber boarded.
- The walls are painted plaster, with a moulded skirting, simple dado, picture rail, and plaster moulded cornice. There are clothes hooks on south and west walls.
- The ceiling is flat plaster.
- The door to the staircase hall is modern, wood, with 2 panes of clear reinforced glass.
- There is a window into the first class males stair hall.

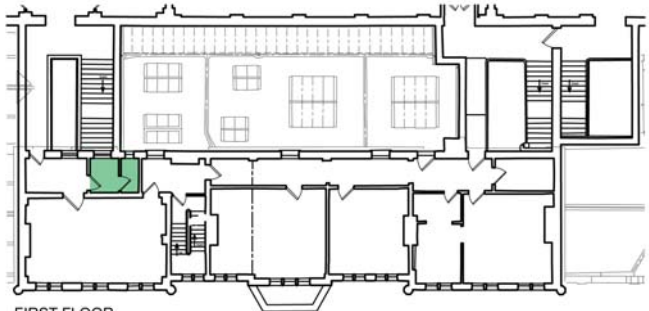
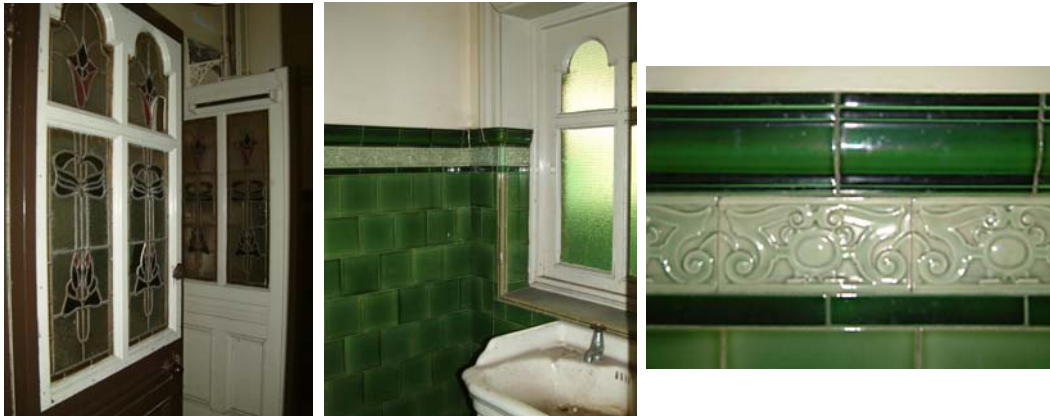
| <p><b>Description</b></p> <ul style="list-style-type: none"> <li>• Tiled to approximately 5' 6". Terrazzo floor. The WC cubicle is two thirds height timber with coloured glass.</li> <li>• There is a sash window with coloured glass in the cubicle and a non-opening frosted glass window over the only remaining original hand basin.</li> <li>• The WC tank has been removed but the brackets survive.</li> </ul> | |
