Gazetteer  
November 2004

## **GAZETTEER**

### **Victoria Baths**

## Listed Building Description

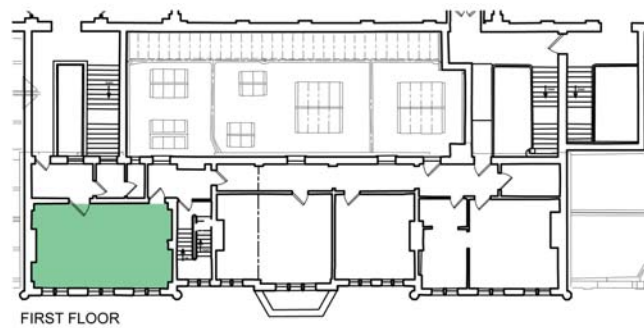
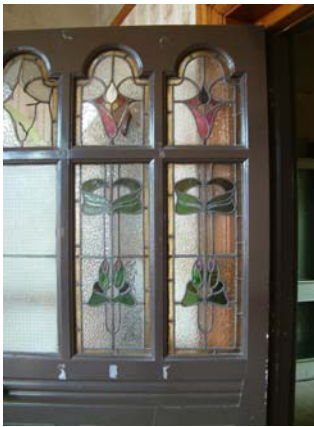
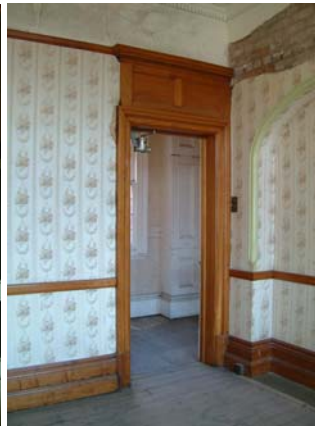
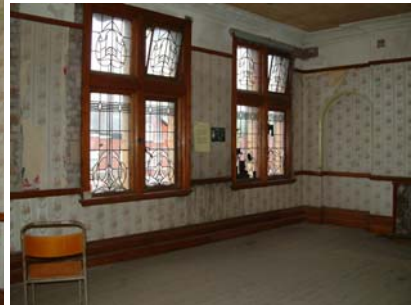
**GAZETTEER NO: F3**

- The room has wooden floor boards, east/west.
- The wall surface is plaster with floral paper, but the east wall has been partially stripped back to the brick. The skirting is double moulded Baltic pine; the dado is similar, moulded on the underside and there is a picture rail. The cornice is plaster, dentilled with patterned plaster bordering the ceiling. There are two arched alcoves in the east wall.

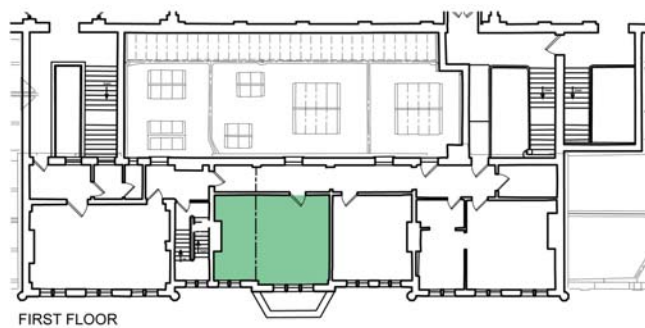
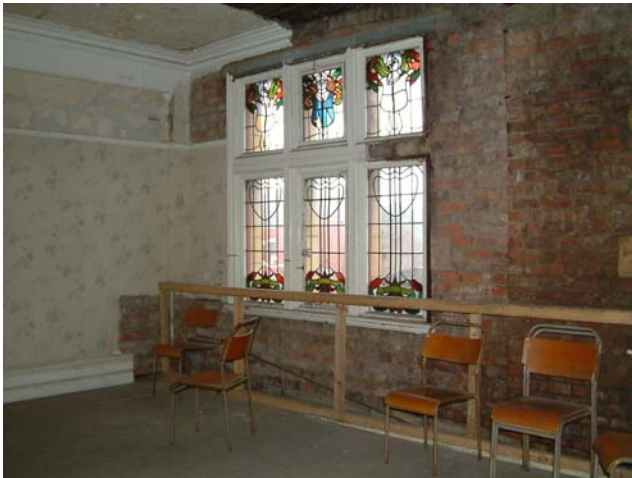
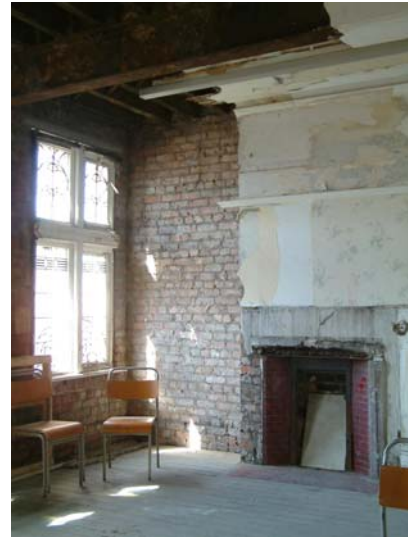
**GAZETTEER NO: F4**

- The east window in this room is immediately behind the coat of arms of the City of Manchester displayed on the southern, principal elevation.
- The floor is wood boards, laid north/south.

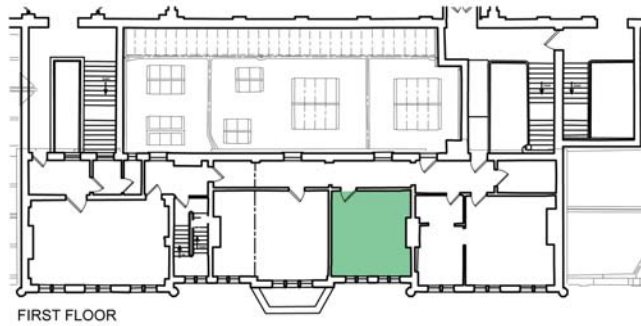
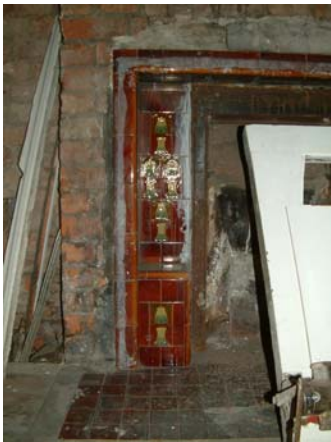
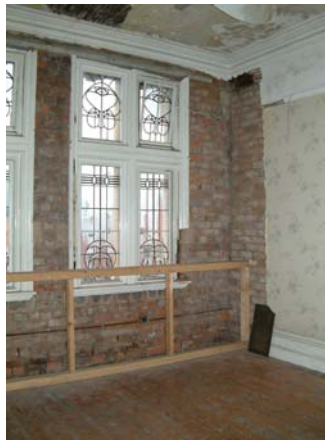
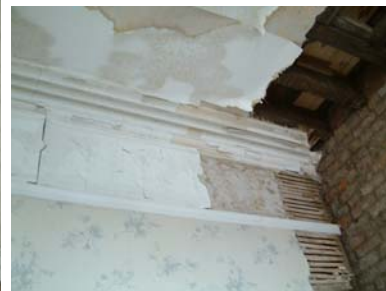
**GAZETTEER NO: F5**

- The floor is wood boards, laid north/south.
- The wall surface is plaster with floral paper, but the east and south walls have been partially stripped back to the brick. The skirting is double moulded softwood, painted white; there is no dado. There is a picture rail and a simple moulded cornice.
- The ceiling is papered plaster.
- There are 2 two-light window, one over one, with leaded plain glass art nouveau design.
- The door is wood with fielded panels, painted white in a white painted timber surround.
- The chimneypiece has been removed, leaving a tiled fireplace with a floral pattern and part of the cast iron insert.

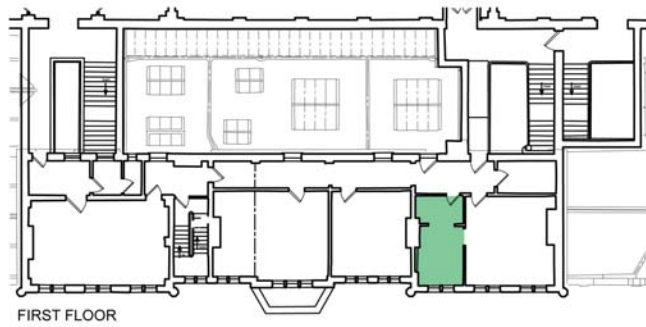
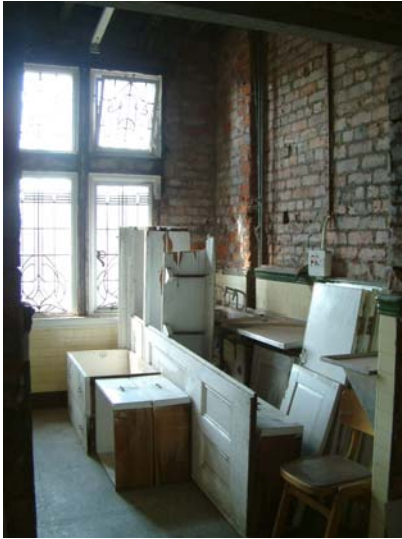
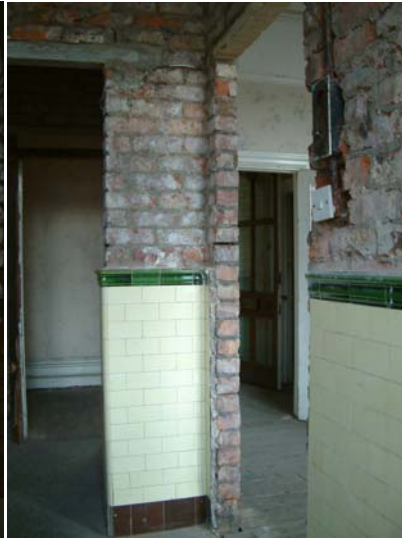
**GAZETTEER NO: F6**

- The floor is terrazzo.
- The wall is tiled to dado level with cream glazed tiles, with brown glazed tiles at skirting level, and dark green at dado height. The wall surface above, originally plaster, has been removed.
- The lath and plaster has been removed from the ceiling.
- The window is two-light, one over one, with leaded plain glass art nouveau decoration.
- There is a modern metal sink.

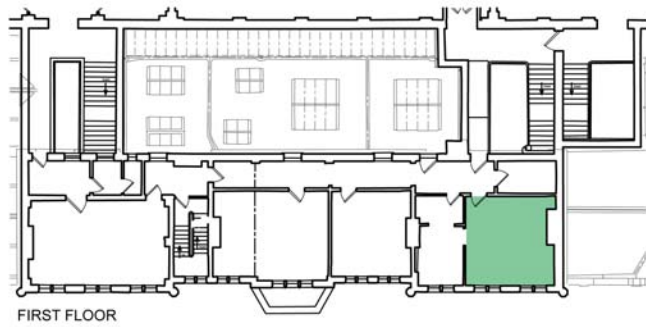
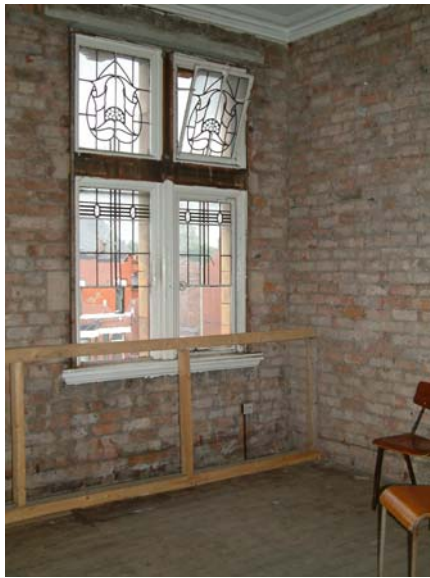
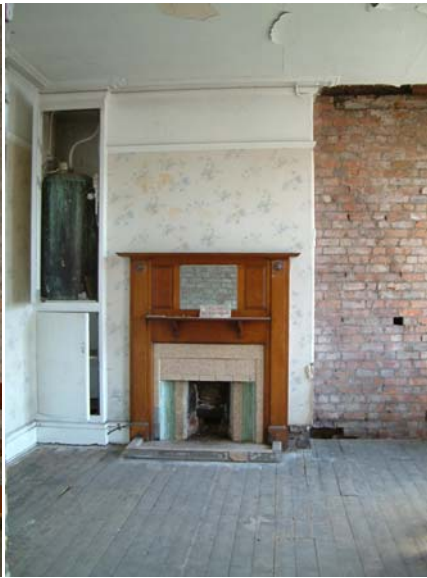
**GAZETTEER NO: F7**

- Wooden boarded floor laid east/west.
- The wall surface was plaster, but this has been removed on west and south walls. The skirting has been removed except for the north wall; it is moulded softwood painted white.
- There are 2 two-light window, one over one, with leaded plain glass art nouveau design. The window is damaged at the lower level.
- The door is wood with fielded panels, painted white in a white painted timber surround, partially removed.
- The tiled fireplace, probably 1930s, has a wood surround with a mirror over.
- A timber drawer and cupboard range was removed from the east wall during the emergency works. The remains are stored in the scullery.

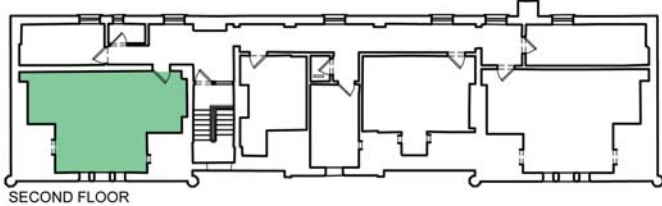
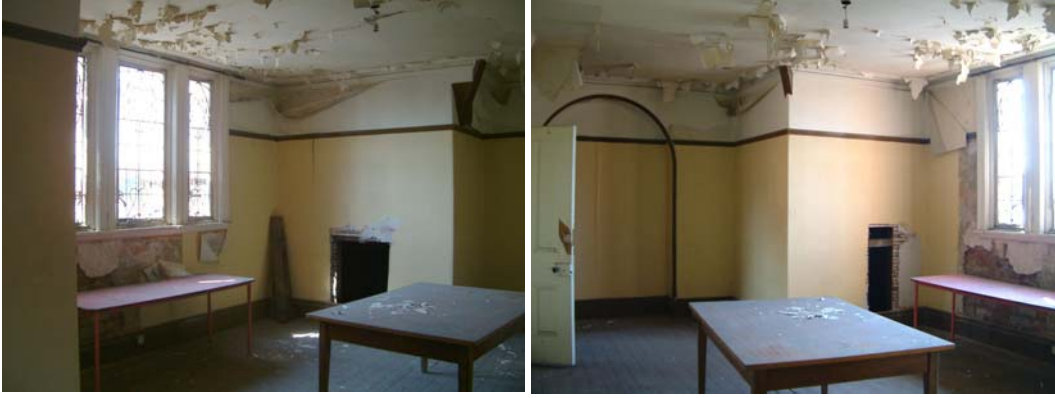
| <p><b>Description</b></p> <ul style="list-style-type: none"> <li>• Wooden floorboards laid east/west.</li> <li>• Plaster wall surface with remains of paper; simple moulded skirting, picture rail, moulded cornice. There is a blind arch in the east wall.</li> <li>• Plaster ceiling.</li> <li>• The door is wood with 4 fielded panels.</li> <li>• There is a 3-light window in the south wall, with leaded clear glass art nouveau design. The fire surround has been removed entirely but the tiled hearth remains.</li> </ul> | |

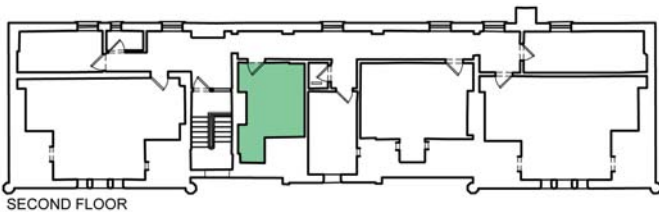
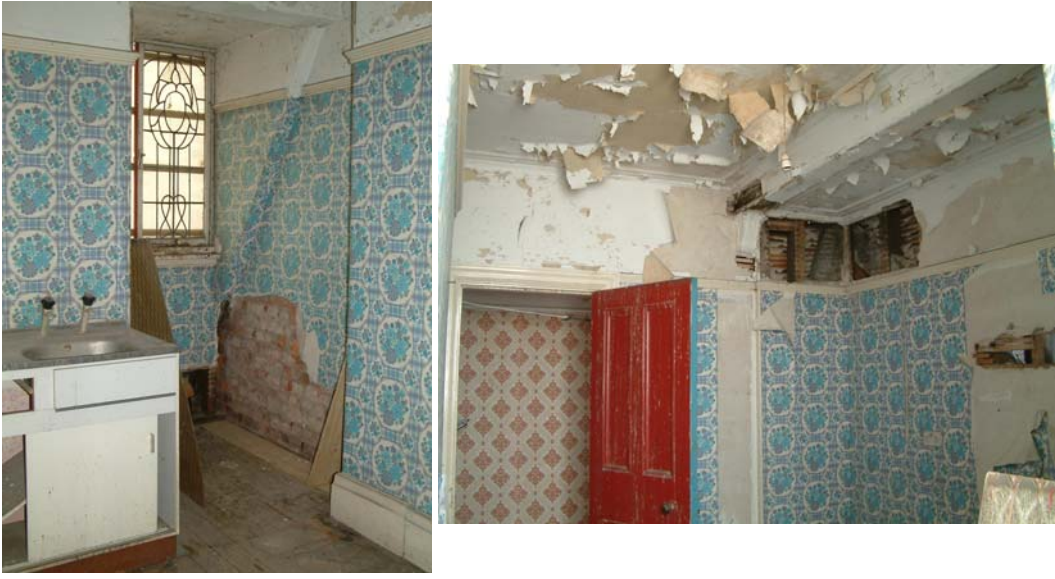
| <p><b>Description</b></p> <ul style="list-style-type: none"> <li>• Wooden floorboards laid north/south.</li> <li>• Plaster wall surface with remains of paper; simple moulded skirting, picture rail, moulded cornice. There is a corbelled beam 750 mm from the east wall.</li> <li>• Plaster ceiling.</li> <li>• The door is wood with 4 fielded panels.</li> <li>• There is a 2-light window in the south wall, with leaded clear glass art nouveau design.</li> <li>• A tiled hearth remains.</li> </ul> | |

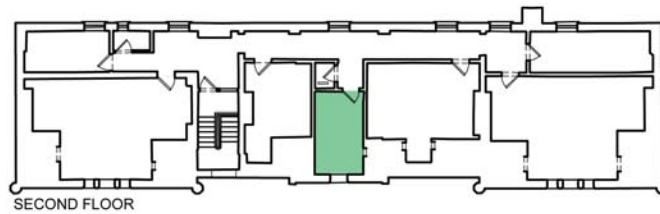
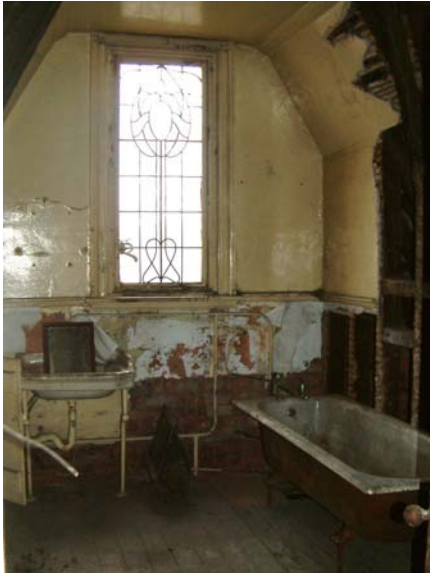
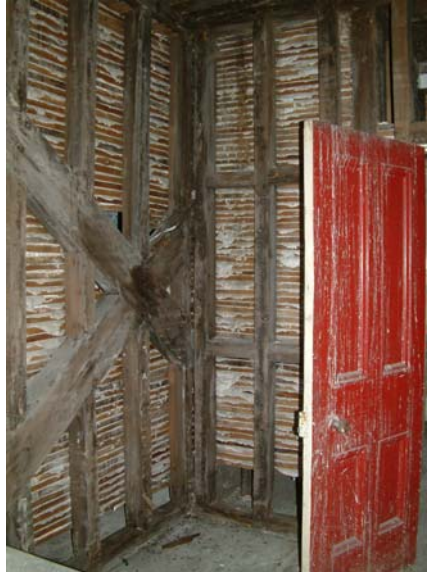
**GAZETTEER NO: S3**

- Wooden floorboards laid north/south.
- Plaster wall on stud partition, the plaster removed on west and north walls and partially removed on east wall. There is simple moulded wood skirting, only partially remaining on the east and south, and a moulded plaster cornice, mostly removed.
- Plaster ceiling, mainly removed.
- The door is wood with 4 fielded panels.
- There is a window in the south wall, with leaded clear glass art nouveau design.
- There is a bath and an original wash basin.
- To the immediate north is a partitioned area with access by ladder to the loft.

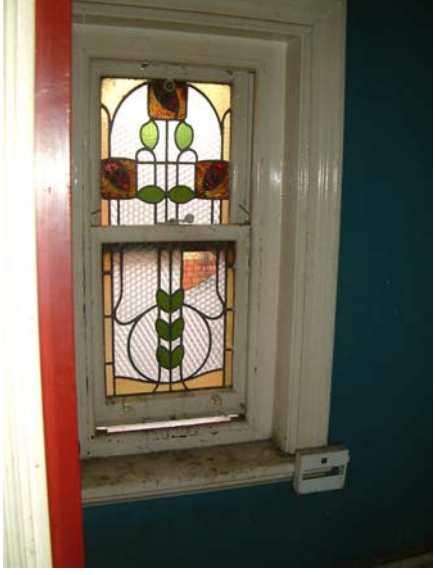
| <p><b>Description</b></p> <ul style="list-style-type: none"> <li>• Wooden floorboards laid east/west.</li> <li>• Papered plaster wall surface. Simple moulded skirting.</li> <li>• Plaster ceiling.</li> <li>• The door is wood with 4 fielded panels.</li> <li>• There is a sash window with coloured glass in the north wall.</li> </ul> | |

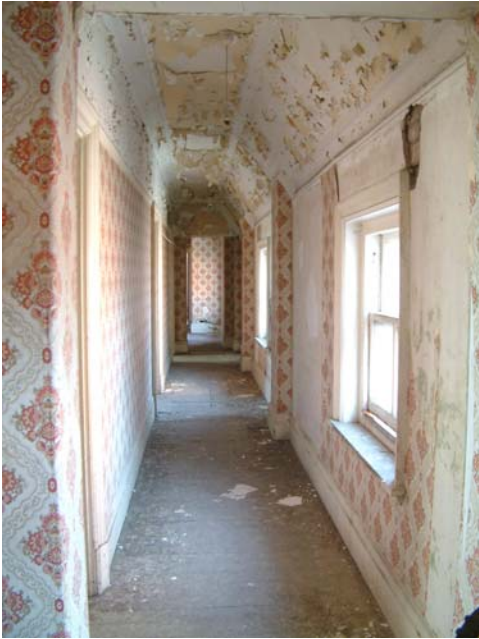
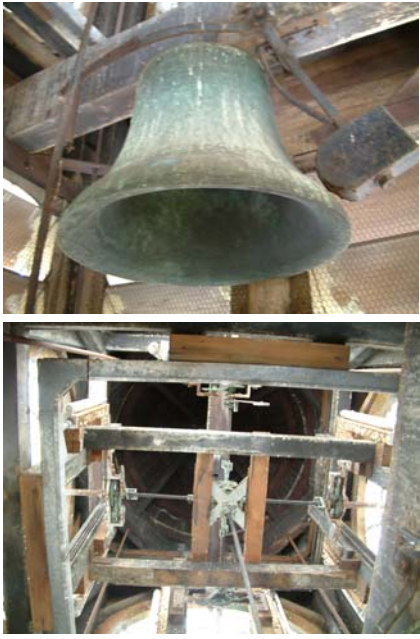
| <p><b>Description</b></p> <ul style="list-style-type: none"> <li>• The Corridor runs along the north of the Superintendent's Flat at second floor level.</li> <li>• The floor is boards laid north/south.</li> <li>• The wall surface is plaster with paper. The skirting is moulded wood, painted white and the cornice simple moulded. There is no dado.</li> <li>• There are four sash windows overlooking the light well.</li> <li>• Above the corridor and over the bathroom is the clock turret described in gazetteer entry EX1, South Elevation to Hathersage Road. There is a steep access ladder into a space which houses the large timbers that form the turret. These timbers sit on primary support beams which rest on the masonry structure. The original clock mechanism has been replaced with a modern electric drive.</li> <li>• It is possible to gain access to the balustrade level of the turret from the north face of the turret.</li> </ul> | |

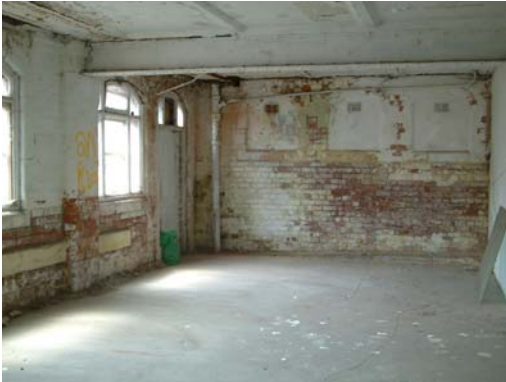
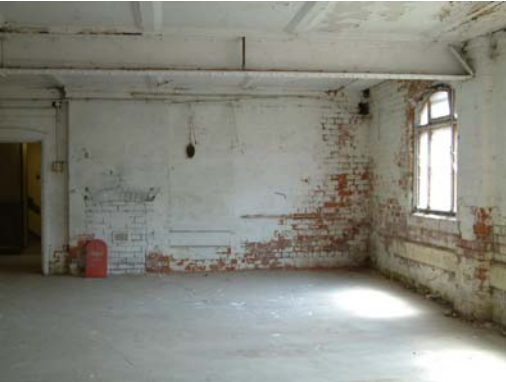
| <p><b>Description</b></p> <ul style="list-style-type: none"> <li>• The wall surface is painted brick and the ceiling painted plaster.</li> <li>• There are 3 three-light windows, one over one, in segmental frames. The centre top opens.</li> <li>• There is a partitioned area in the west corner for switchgear.</li> <li>• There is evidence of a former door, now blocked with breeze blocks to the former Coffee Room.</li> <li>• There is a blocked fireplace on the east wall.</li> </ul> | |

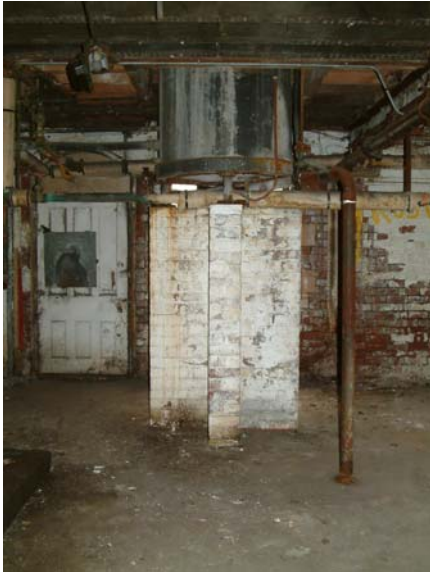
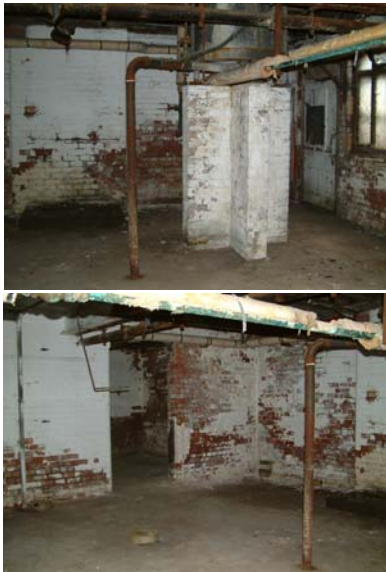
| <p><b>Description</b></p> <ul style="list-style-type: none"> <li>• Concrete floor and white painted brick wall surface. It would appear that the timber floor over was inserted when the aerotone was added. The ceiling has been partly removed, the remainder is plasterboard.</li> <li>• There is one three-light arched widow.</li> <li>• The underside of the aerotone which sits on a cross shaped pillar connected to a pump on the west wall.</li> </ul> | |

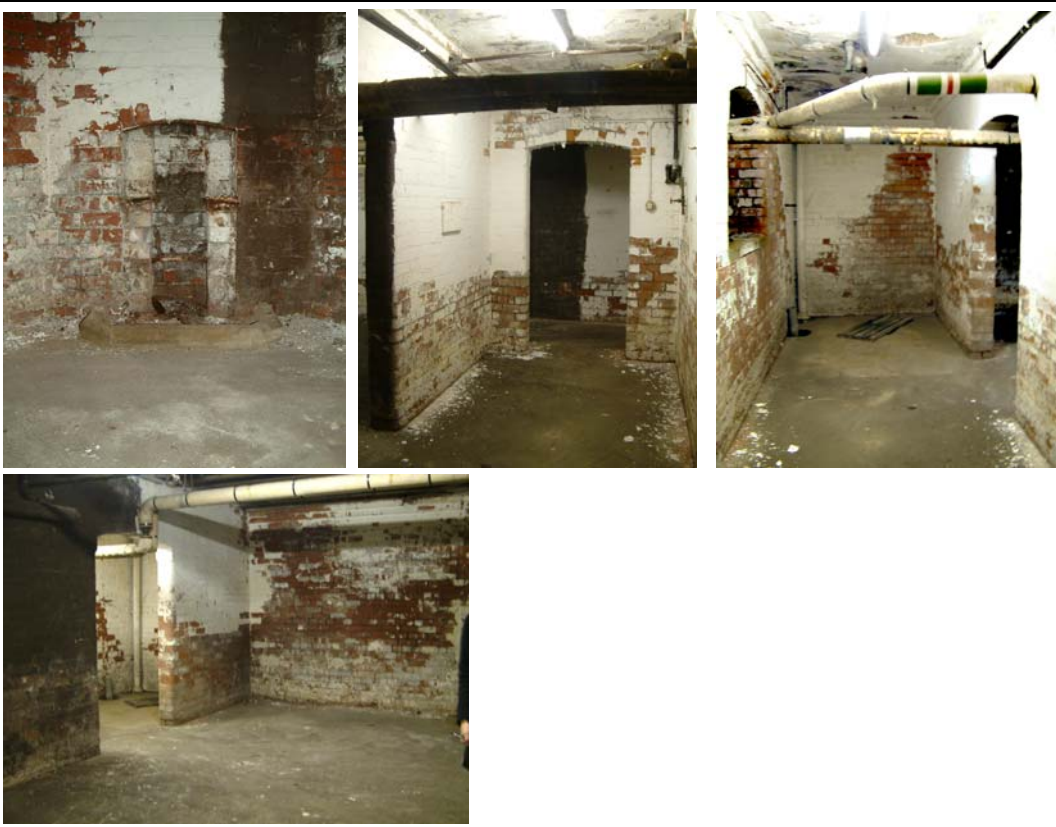
| <p><b>GAZETTEER NO: B4</b></p> <p><b>Name: Basement</b><br/><b>Store Room No. 7</b></p> | <p>BASEMENT</p> |

| <p><b>Description</b></p> <ul style="list-style-type: none"> <li>• Concrete floor and brick wall surface. The ceiling is flat plaster, part timber, part concrete structure to floor over.</li> <li>• There is a corner fireplace.</li> </ul> | |

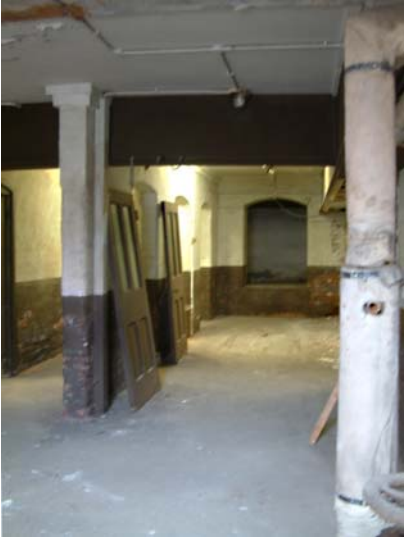
| <p><b>Description</b></p> <ul style="list-style-type: none"> <li>• Concrete floor and brown and cream painted brick wall surface. The ceiling is plaster.</li> <li>• There is one three-light arched widow.</li> <li>• The door, loose, is 4-panel, the upper panels glazed.</li> <li>• There is an iron grate in a corner fireplace.</li> <li>• Water main entry; Belfast sink with integral drainer.</li> </ul> | |

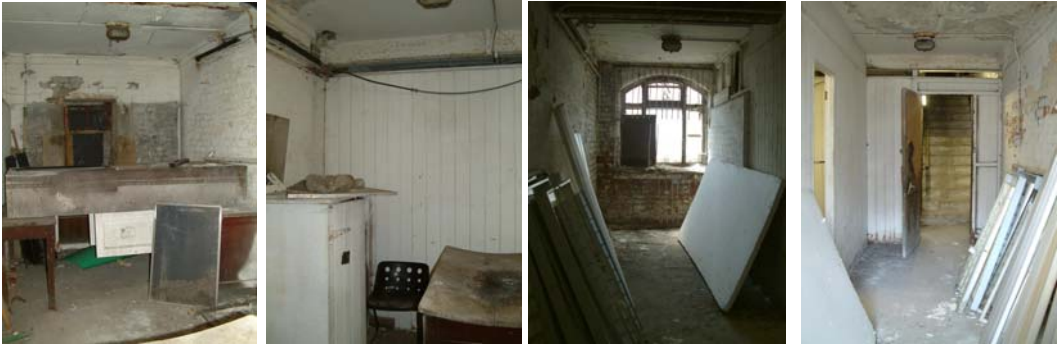
| <p><b>Description</b></p> <ul style="list-style-type: none"> <li>• Concrete floor and white brick wall surface with tongue and grooved partitioning. The ceiling is plaster/concrete.</li> <li>• There is one three-light arched one over one window and one smaller boarded up opening.</li> <li>• The door is four panel with top glazing.</li> <li>• Access staircase to ground floor.</li> </ul> | |

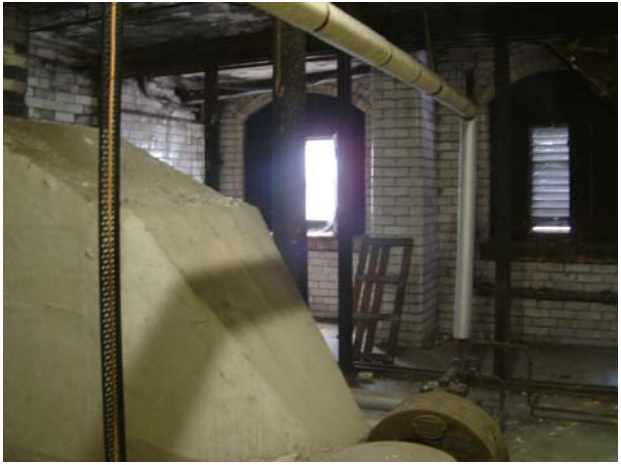
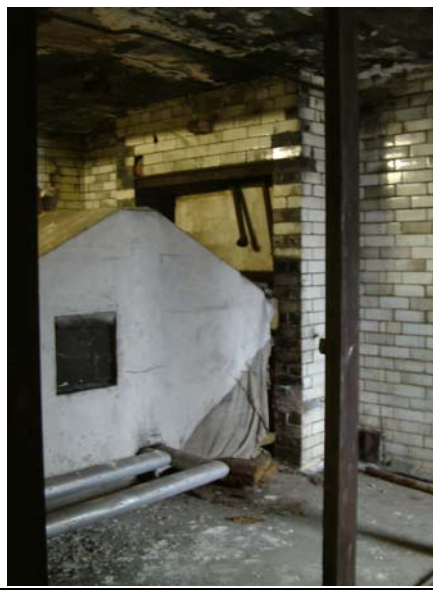
| <p><b>Description</b></p> <ul style="list-style-type: none"> <li>• Concrete floor and white glazed brick wall surface. The ceiling is concrete supported by iron beams and one cast iron column.</li> <li>• There are two arched 3 panel, one over one windows partly blocked.</li> <li>• The door is four-panel with satisfying robust door stay ironmongery.</li> <li>• There is an air handling unit and lagged pipe work.</li> <li>• The ventilation arrangement to the Turkish Baths may be in part dating from the original installation.</li> </ul> | |

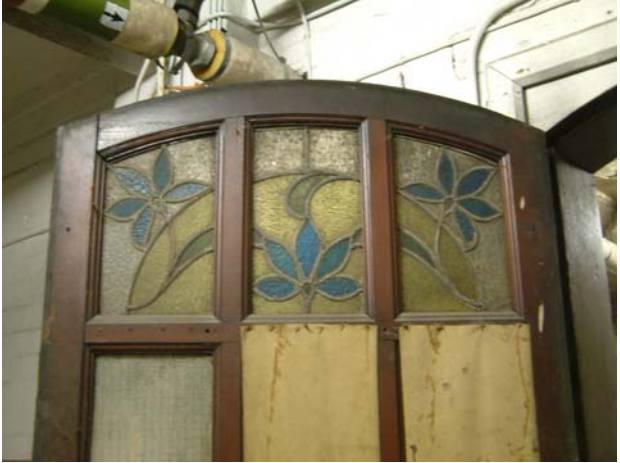
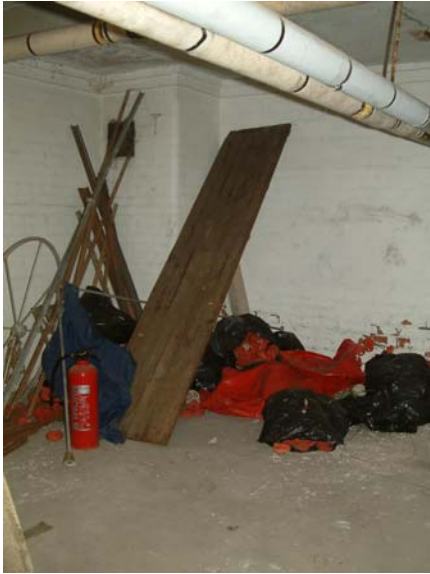
| <p><b>Description</b></p> <ul style="list-style-type: none"> <li>• Concrete floor and brick wall surface. The ceiling is plaster.</li> <li>• There is one four-panel door and one nine-panel the upper panels being stained glass.</li> <li>• At the north end of this and other rooms to the west is a circulation corridor. This has the glazed 'pavement' light construction for ceiling, painted brick walls and window openings into the pool surrounds at this level.</li> <li>• The floor is concrete.</li> <li>• This corridor space opens into an 'arcaded' storage space beneath the Russian bath, shampooing and shower rooms.</li> </ul> | |

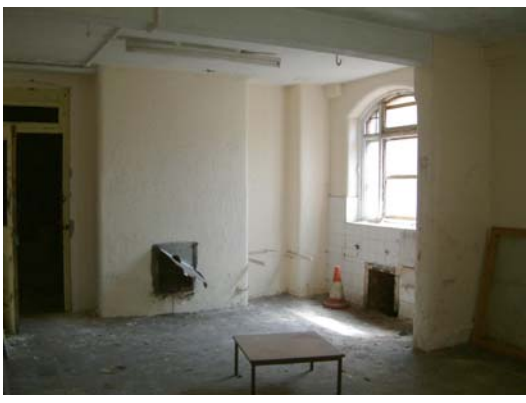
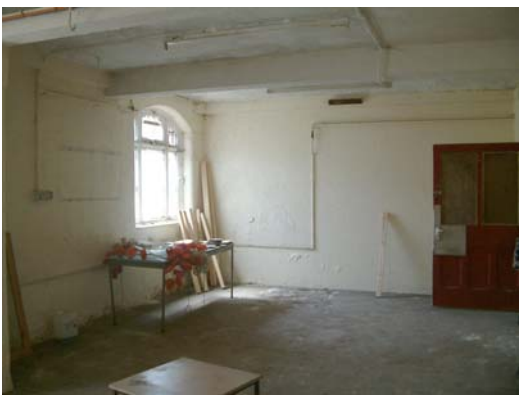
| <p><b>Description</b></p> <ul style="list-style-type: none"> <li>• Concrete floor and textured wall surface</li> <li>• Ceiling is also textured.</li> <li>• Two arched windows.</li> <li>• The doors are panelled, the upper panels glazed, now boarded.</li> <li>• There is a private staircase leading to the private vestibule and staircase up to the Superintendent's Flat.</li> <li>• Beyond this room is the stair down from the first class males entrance area. The surfaces are concealed here by polystyrene tiles to the ceiling and chipboard panels to the walls. There remains a plaster cornice and it is likely the walls are plastered with a painted dado height line. This circulation space gives access to the coffee room, male bicycle store and pools above.</li> </ul> | |

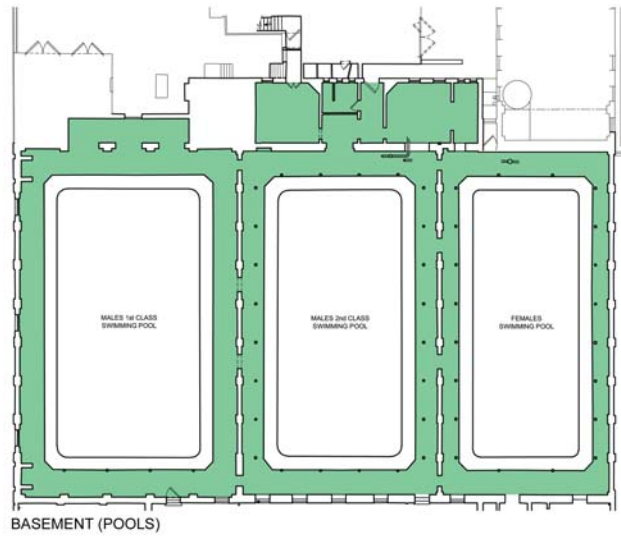
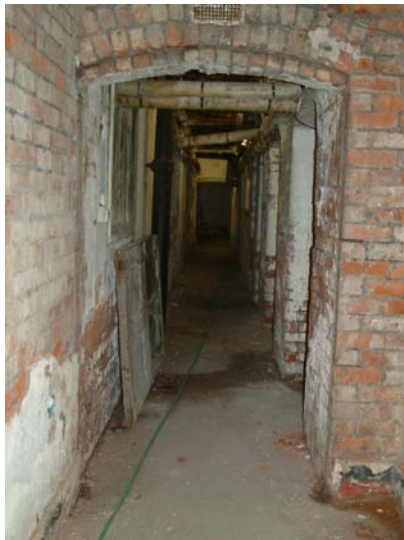
**GAZETTEER NO: B11**

- Running north from the main basement spine corridor are four subways:
  - subway east of female pool.
  - Double subway between female and male 2<sup>nd</sup> class pools.
  - Double subway between male 2<sup>nd</sup> and male 1<sup>st</sup> class pools.
  - Subway west of male 1<sup>st</sup> class pool.
- A spine corridor the north connects these corridors.
- To the north of the above is a series of former store rooms and work rooms under the extension containing the ground floor WC and male club rooms.
- The exterior and the two dividing walls of the subway are of painted brick, the three pools have concrete walls.

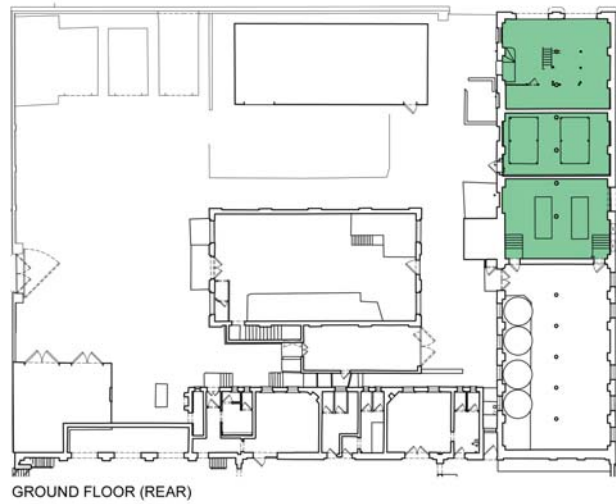
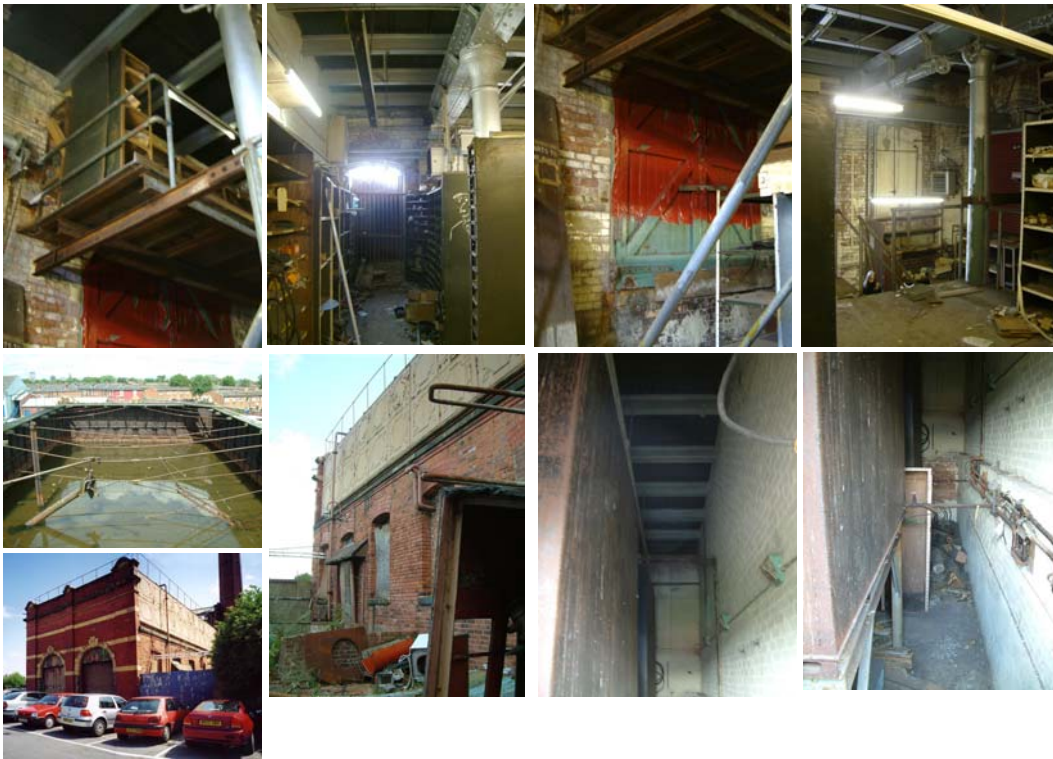
**Name: Boiler House and  
Calorifier House**

- External: East side: The pump and calorifier house and boiler house blocks have cast iron water tanks at the top and a central projecting narrow gabled bay between them. The pump house has five small windows, and there are inserted openings to the boiler house.
- North Side: The end wall of the boiler house, is of red brick with yellow terracotta detailing and large paired entrances with arched heads

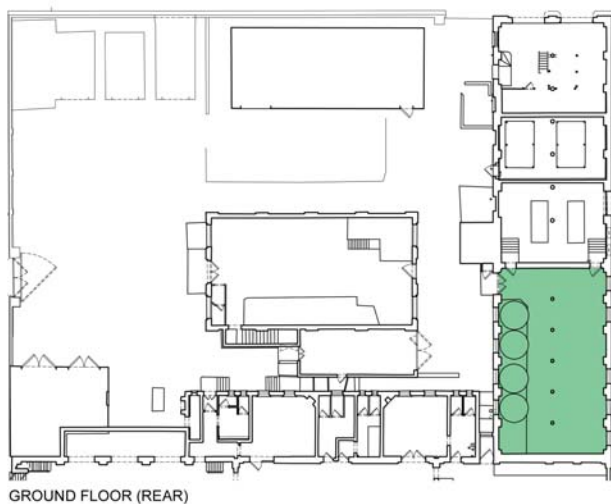
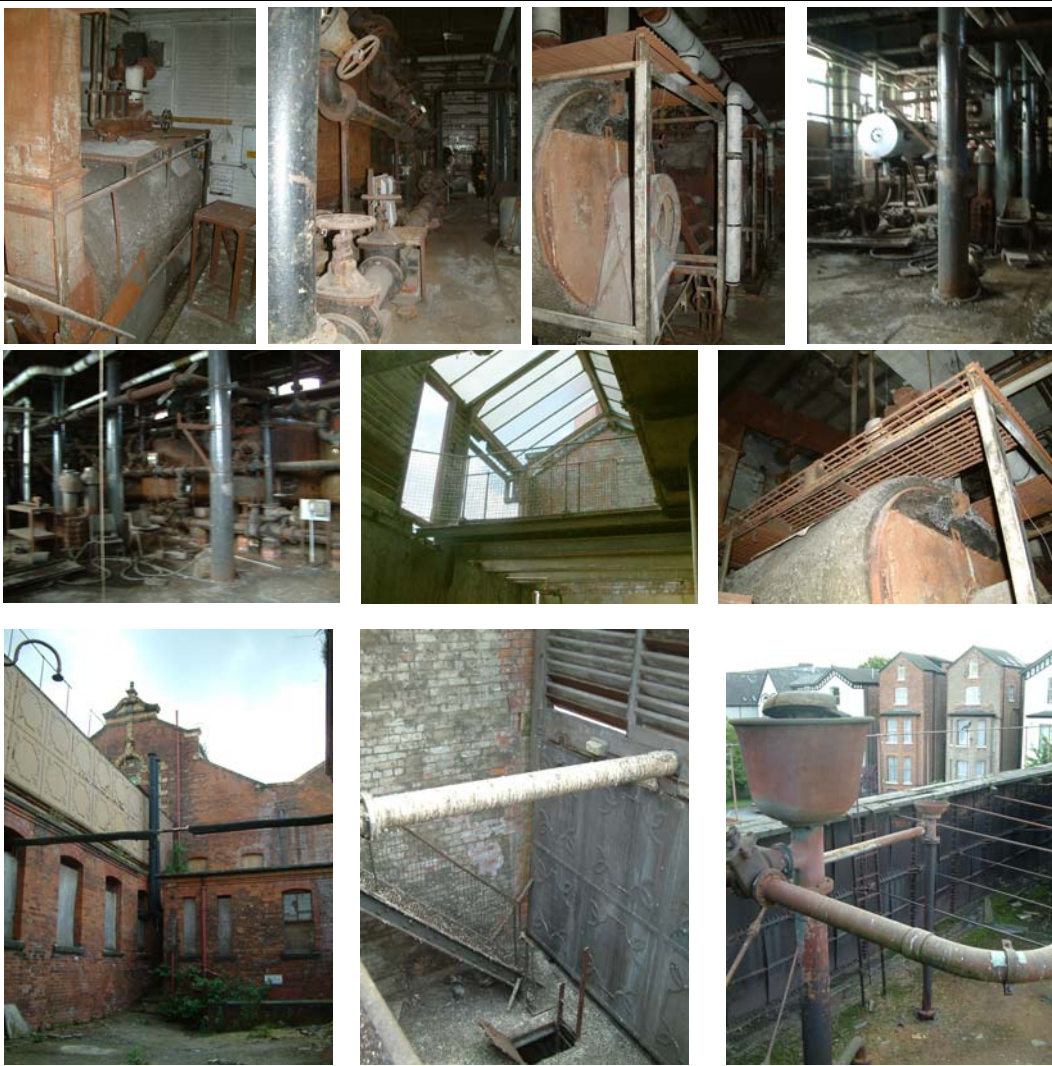
**Name: Pump & Calorifier House**

- Tiled walls, white and brown, no cornice, dado, skirting.
- Five segmental 2 over 2 over 2 windows on east wall and 4 on west wall.
- Double timber doors 2 over 2 over 2 upper 2 series glazed and 6 light glazed fanlights over.
- The four vertical sand filters in this space are of interest. However it is known that there are examples of similar filters still in use in other buildings and as such these filters are not unique. The context of the installation of the filters has changed significantly due to additions and modifications to both the filters and the plant room as a whole.
- Roof supported by 5 central iron columns concrete floor. Boiler house down 6 steps.

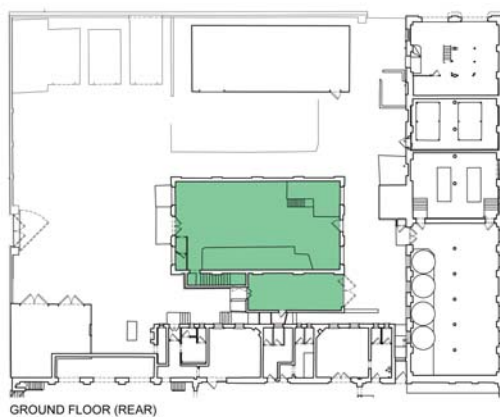
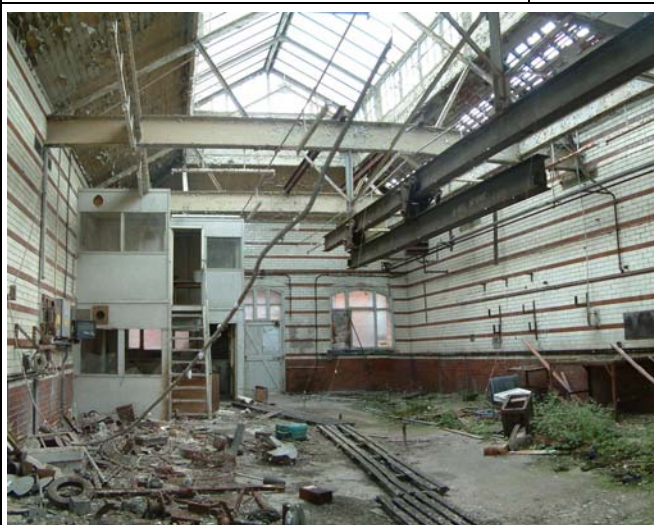
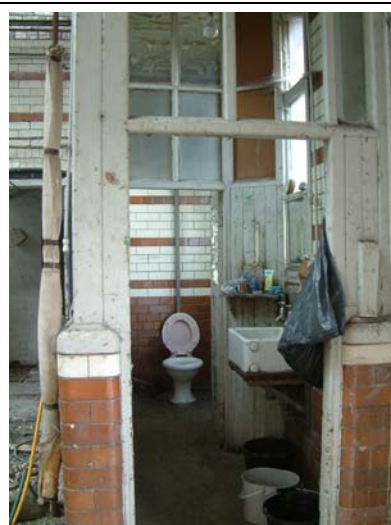
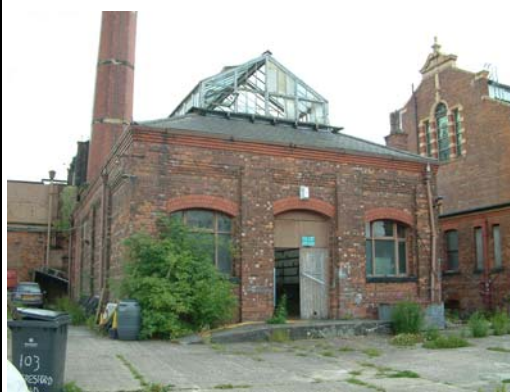
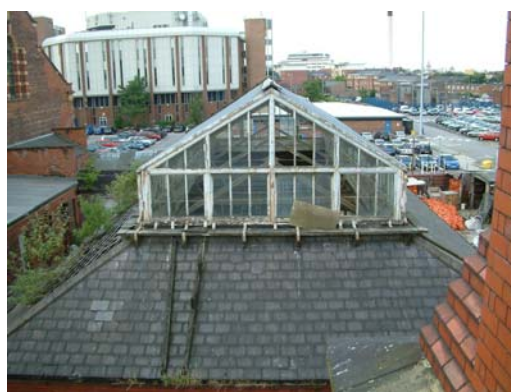
**Name: Laundry**

- The floor is terrazzo. The wall surface is brown and white glazed brick with no skirting, dado or cornice.
- The roof is slate on the exterior with interior boards top glazed with a clerestory.
- There are 3-light arched windows to east and west and at east and west with fanlight.
- Steel trusses with substantial horizontal ties for lifting purposes.
- There is a lean-to extension to the south. There is a lifting beam crane from the western bay to the centre.
- There is a two storey temporary office suite in the north-east corner and a WC with basin in the south west corner, brick glazed to half height, with glazed boarding above.
- Stairs down to a tunnel (now bricked up) which led to Baths buildings.
- The cellar is accessed by steps by the south wall.
