## PRELIMINARY DAMP AND TIMBER CONDITION

51-53 RICHMOND STREET, MANCHESTER

JOB NO. 213-41

12 SEPTEMBER 2022

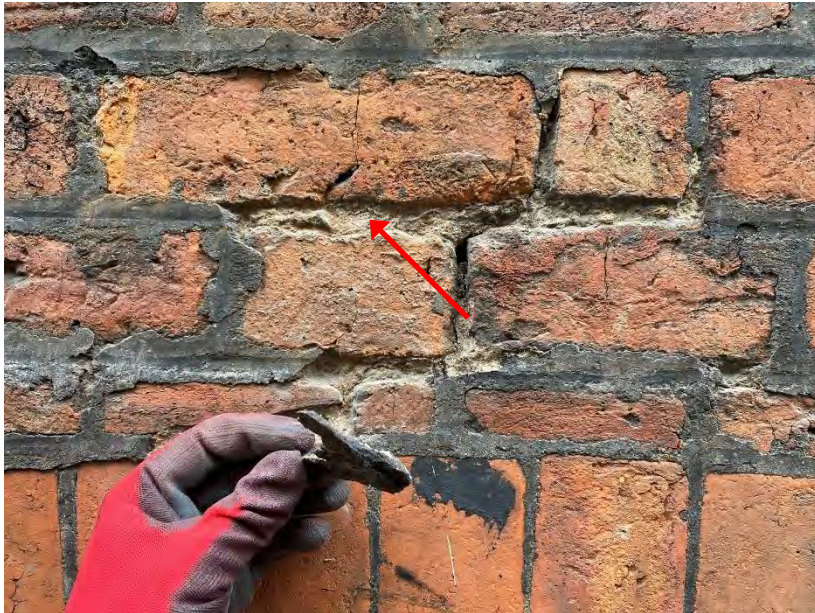
**Fig 5:**

- 4 External masonry: External walls were constructed of solid red brick. Windows were spanned by brick arches and windowsills were of sandstone. Partial removal of the cementitious repointing mortar identified that the earlier/original lime mortar behind was in fair condition. Both gable walls have been rebuilt from Second floor level and H+R understand this this was bomb damage sustained during the 'Manchester Blitz' (September 1940-May 1941). The 3 no. pattress plates at Second floor level which correspond with tie rods concealed at floor level presumably date from this period. There was step cracking between the central window at ground-first floor level to the front elevation which had reopened following repointing. This suggested the cracking may be progressive. Inspection of the rear elevation was limited but the masonry was wet and supporting biological growth in the 2 no. areas of water penetration. There was widespread craze cracking in the render to the south-west elevation which appears to be due to original shrinkage. However, some cracks were supporting plant growth and tap-testing revealed pockets of render were poorly bonded to the brick substrate

North-west elevation; showing original lime mortar behind the 20th Century cementitious repointing. The cement was only applied as veneer and no raking-out appears to have been done to the lime mortar

*Allow for a detailed inspection of the external masonry and render. It may be possible to carefully remove the existing cementitious repointing mortar without causing damage to the brickwork. Future repointing should be undertaken using a suitably specified lime mortar where required. The Structural Engineer should assess the significance of the step cracking and condition of the pattress plate/tie rod installation*

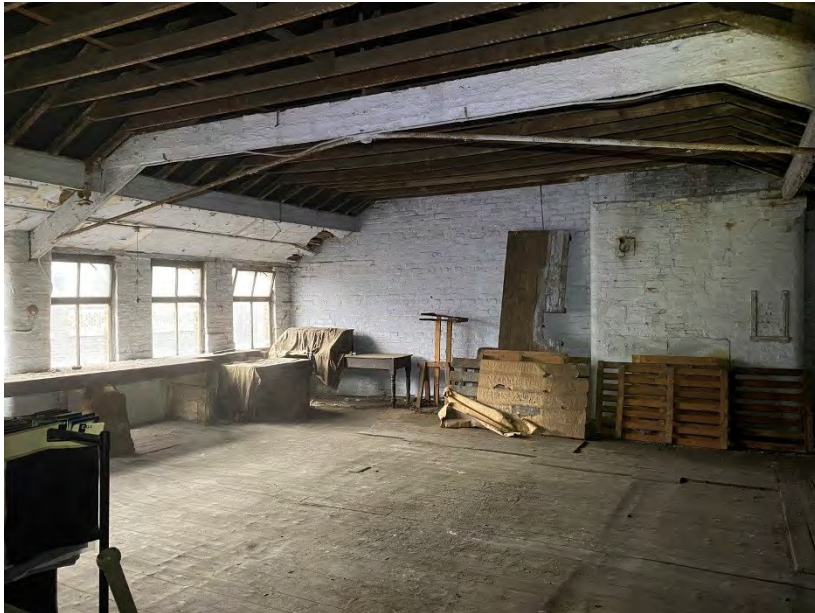
**Fig 15:**

Second floor; showing a view of the central roof truss which included tie rods. An earlier lath and plaster ceiling had been removed from the ceiling joists

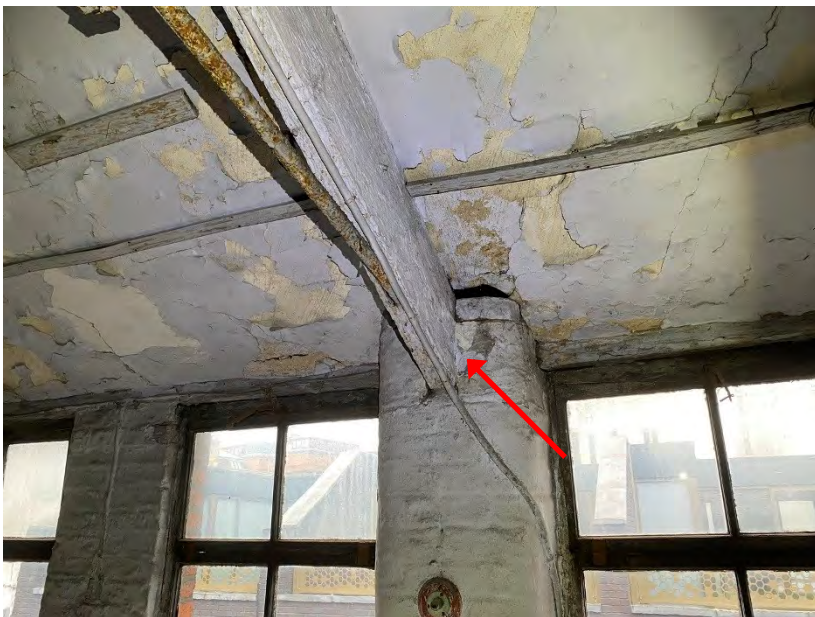
**Fig 18:**

Second floor; showing the north-west bearing end of the truss. No decay was detected and the bearing end of the principal rafter was dry

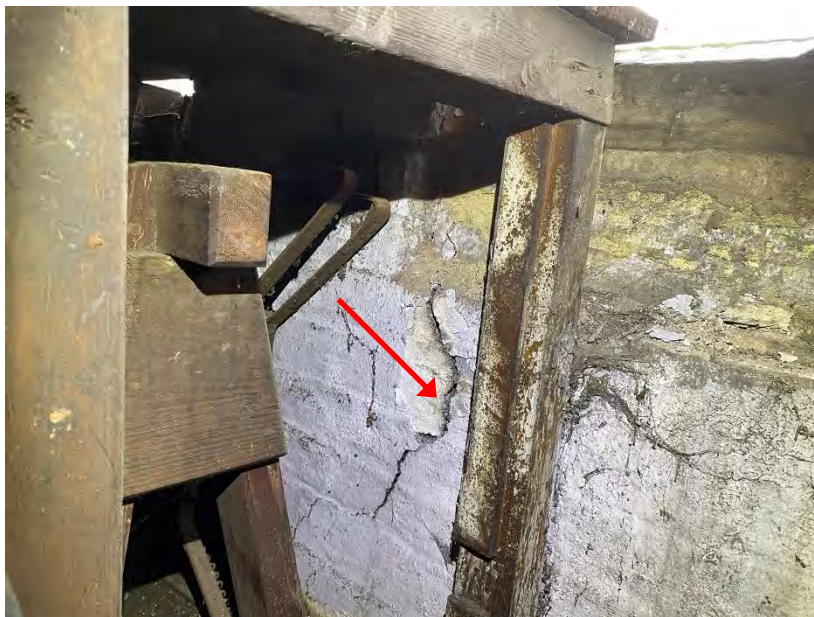
**Fig 20:**

- 3 Walls: There was no evidence that leakage from the rear gutters was causing dampness in the masonry walls at Second floor level. However, there was widespread cracking in the brickwork which generally correlated with the locations of the tie-rods. In addition, corrosion of embedded metal in the chimneystack had caused jacking of the brickwork beneath the upper purlin to the south-east pitch. The brickwork was loose in these areas of cracking and daylight was also visible through the chimneystack cracking

Second floor; showing cracking through the brickwork directly over the location of the pattress plate and tie bar passing through the floor

*Structural Engineer to inspect and assess the significance of the cracking in the brickwork*

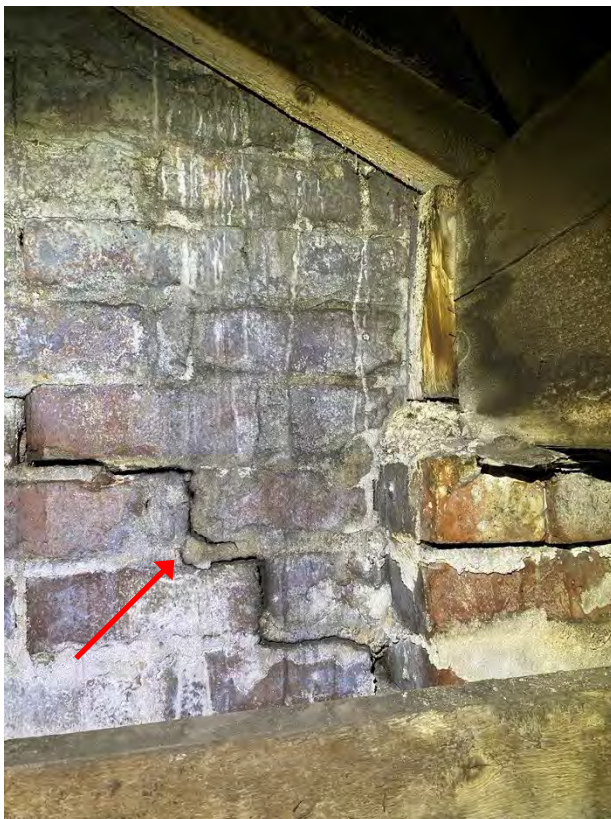
**Fig 22:**

Second floor; showing step cracking through the gable brickwork caused by corrosion of metal beneath the purlin brick corbel

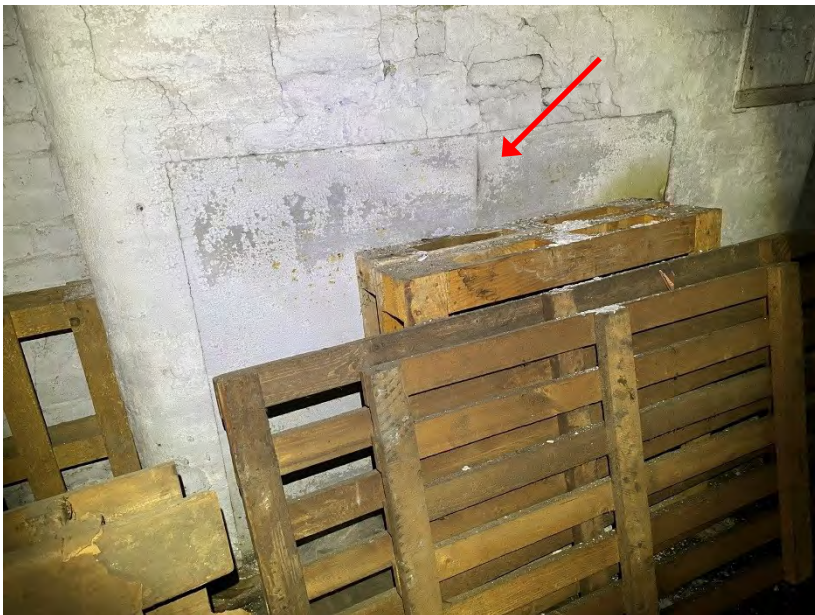
**Fig 24:**

Second floor; showing a cement board applied over the fireplace opening.  
**This may be an asbestos containing material (ACM)**

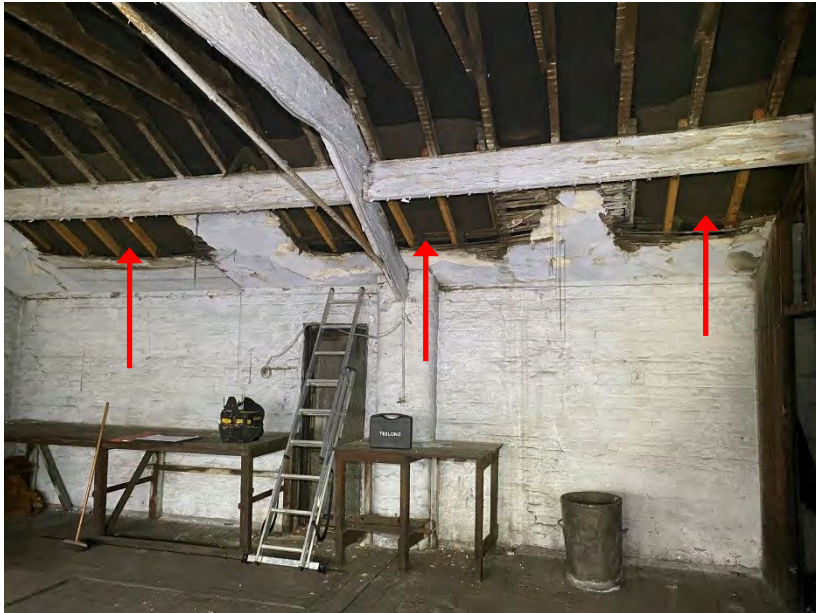
**Fig 25:**

Second floor; showing non-original rafters which appear to have been used to roof over earlier skylight openings

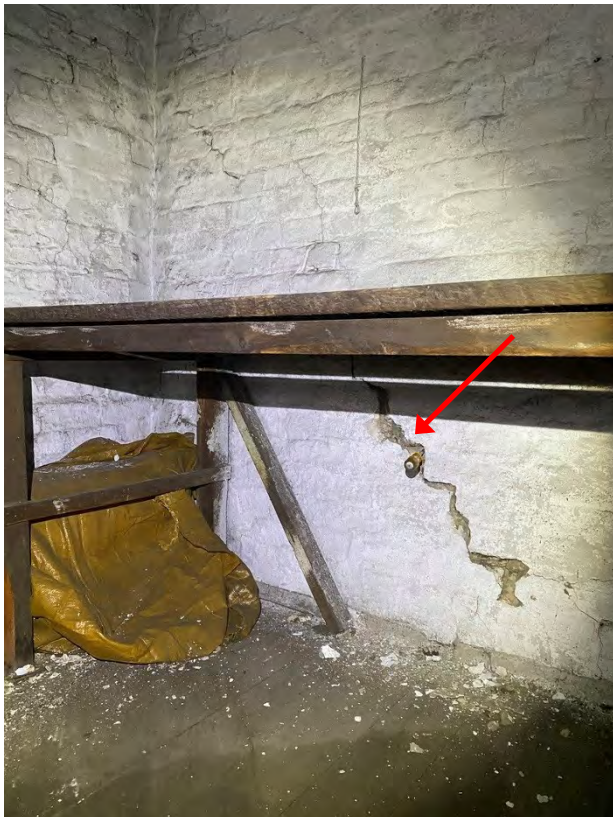
**Fig 26:**

Second floor; showing cracking through the brickwork directly over the location of the patten plate and tie bar passing through the floor

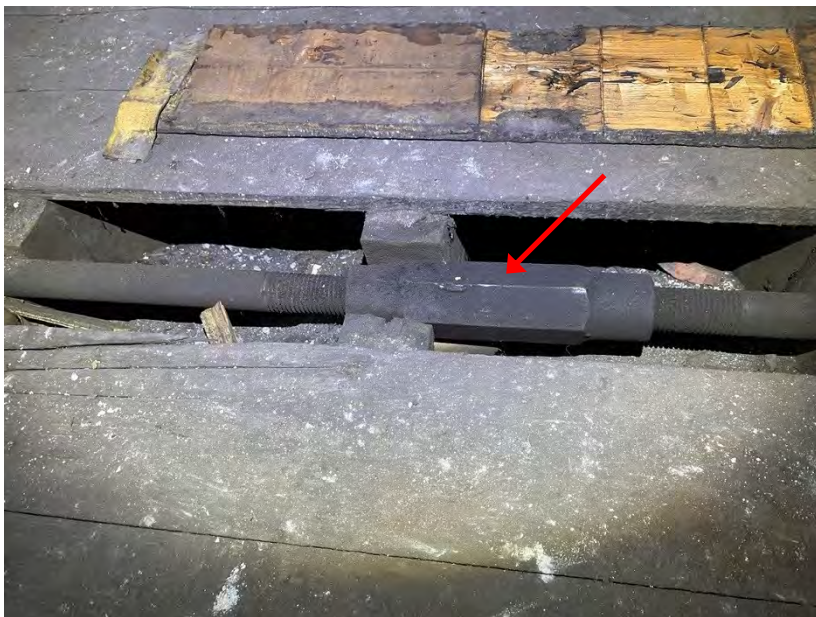
**Fig 32:**

Second floor; showing the central hexagonal coupling nut used for tensioning the tie bar

*No timber decay related repairs identified at this time. Structural Engineer to inspect and assess the performance of the lateral restrain tie bars*

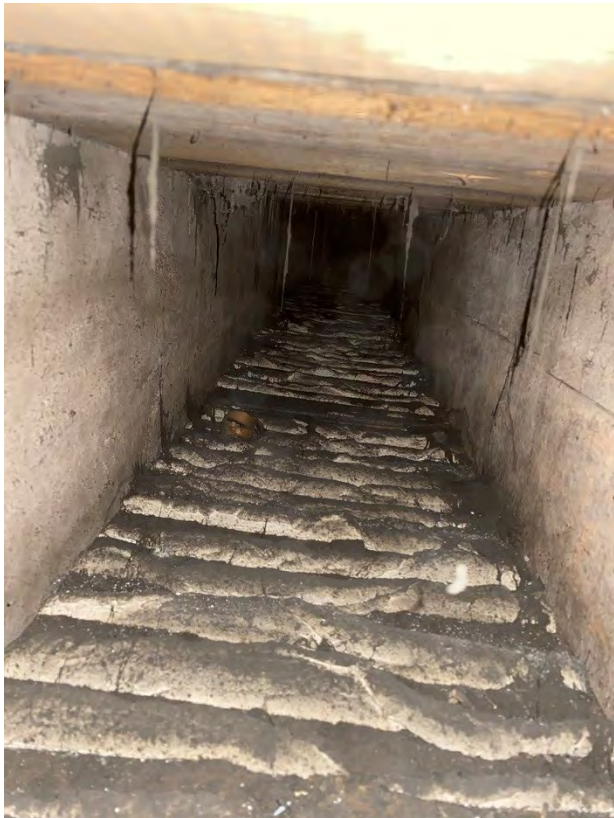
**Fig 33:**

Second floor; showing a view through the suspended timber floor. There was some dust and cobwebs but the ceiling void was relatively clean

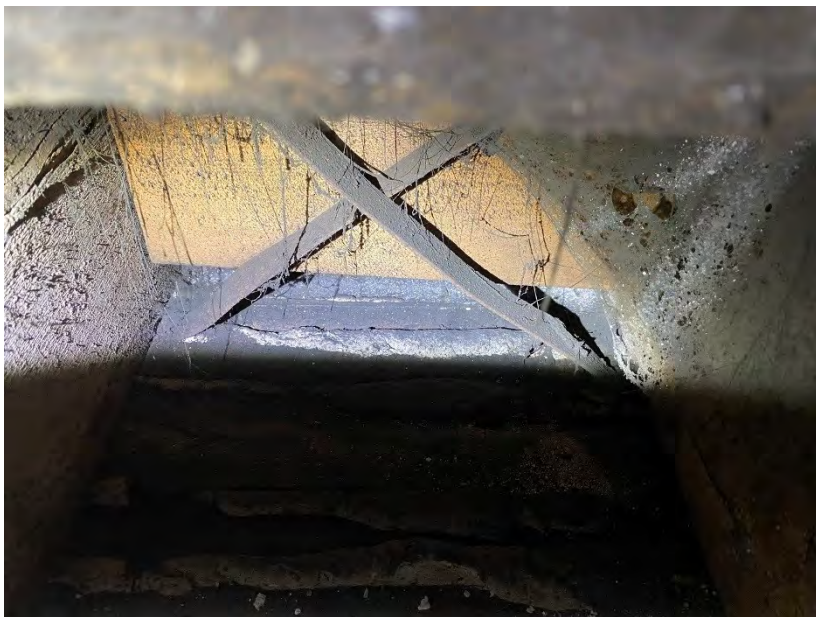
**Fig 34:**

rods. Where inspected, the notching had only removed the upper 1/6<sup>th</sup> from the joists and this was unlikely to be of any structural significance. Inspection within the floor void revealed mild steel herringbone strutting 'X' bridging had been used for floor stiffening. No significant damp or decay was detected in the floor structure

Second floor; showing mild steel herringbone strutting 'X' bridging and later timber blocking used for floor stiffening

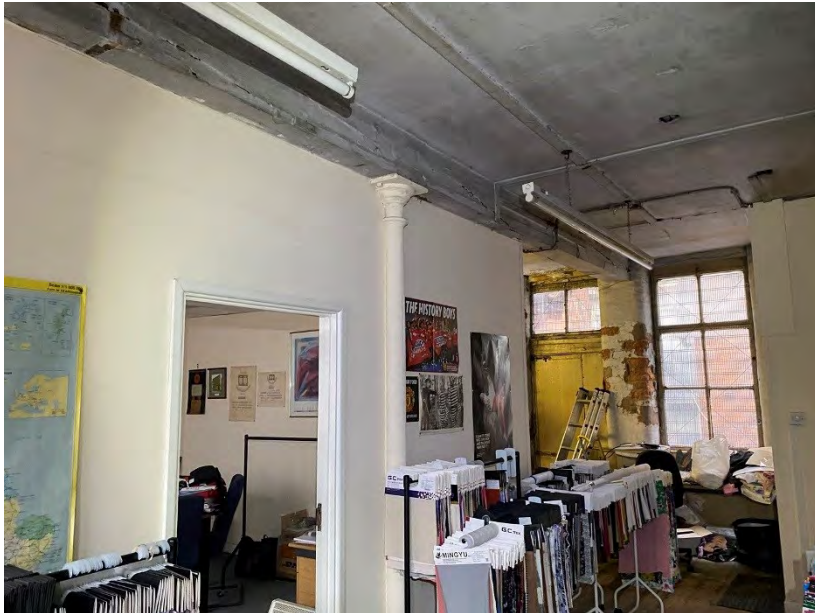
**Fig 35:**

First floor; showing the central floor beam which supports the Second floor joists. The office was formed of modern plasterboard on studwork

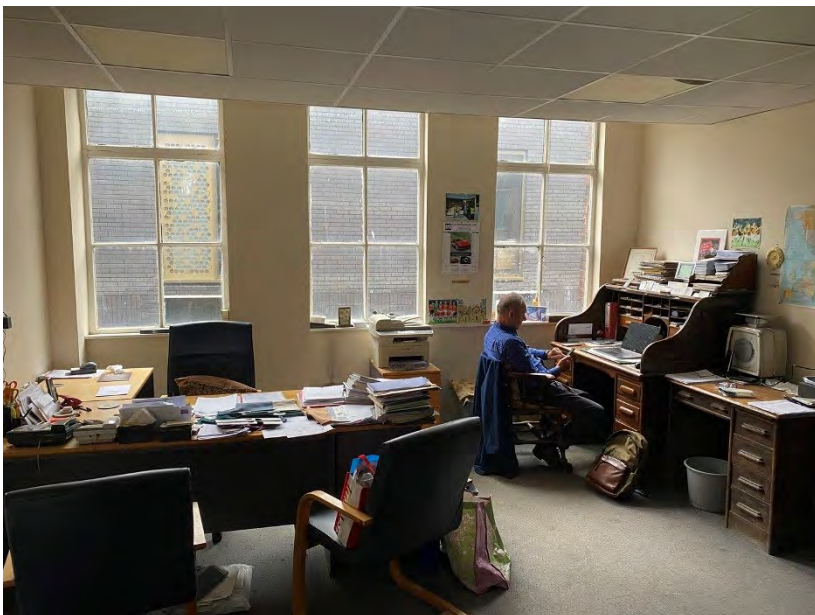
**Fig 36:**

First floor; showing a view of the office which included a modern suspended ceiling. This concealed the earlier lath and plaster ceiling

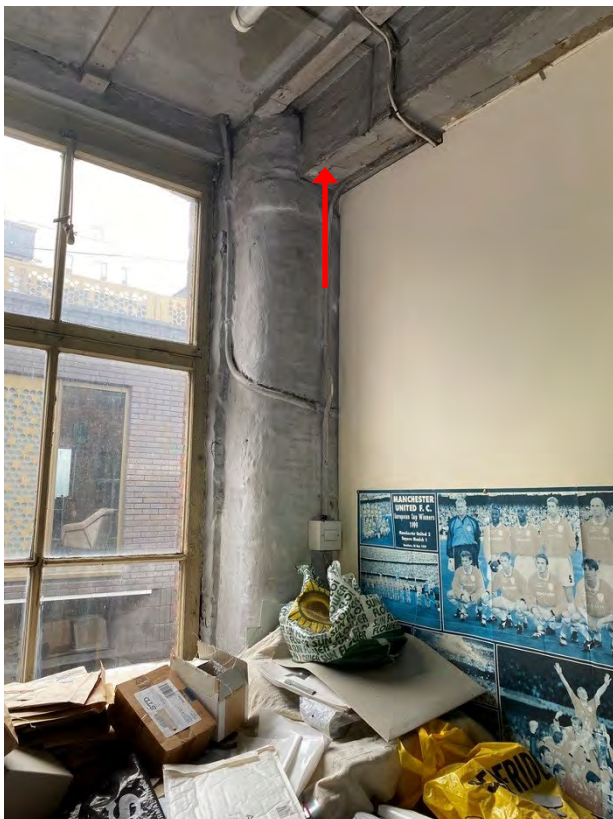
**Fig 38:**

First floor; showing the north-west bearing end of the central floor beam. The bearing was inaccessible for testing due to stored goods. However, there was no visual evidence of damp or decay

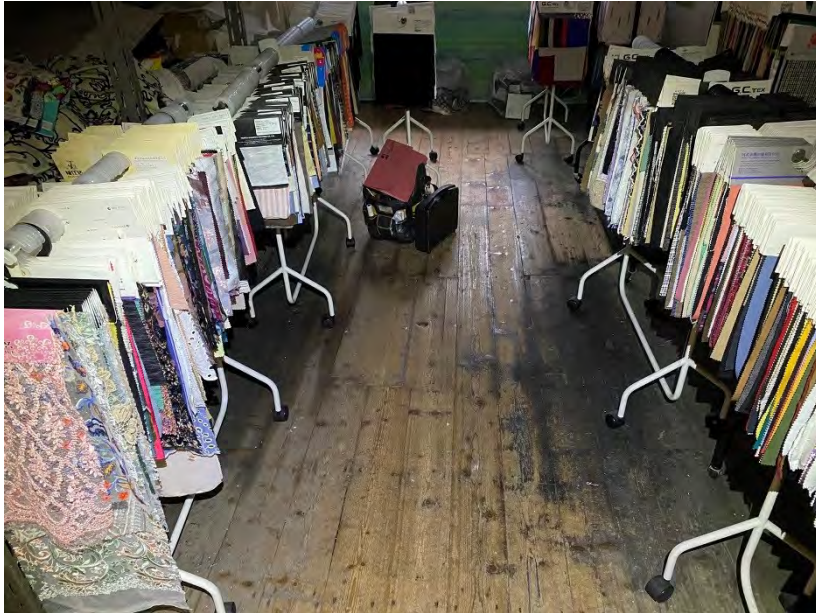
**Fig 39:**

First floor; showing heavy use of the softwood floorboards which had partially exposed the metal tongues within

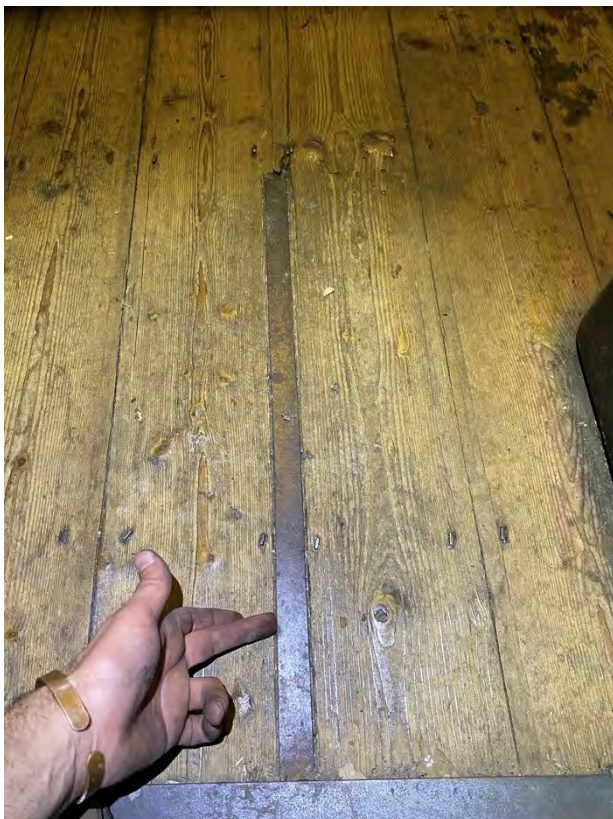
**Fig 40:**

First floor; showing an exposed metal tongue

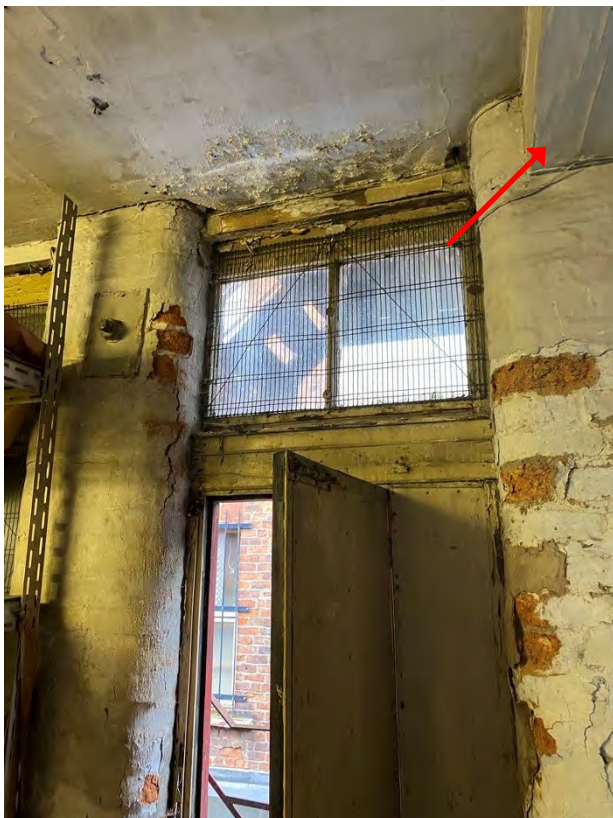
**Fig 42:**

First floor; showing staining at ceiling level caused by the gutter leak. No decay was detected in the south-east bearing end of the central floor beam and the timbers above were dry

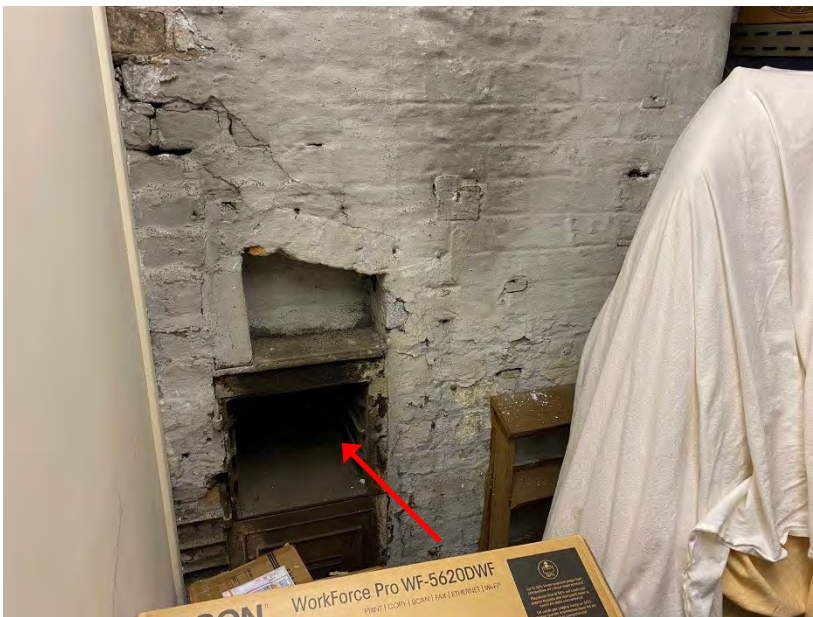
**Fig 44:**

First floor; showing a cast-iron oven within the fireplace. This was of historic interest. The chimney flue was unventilated

*Allow for a detailed inspection of the chimneystack following the provision of safe high-level access. All chimneys not in use should be capped so as to minimise water ingress but so as to allow maximum ventilation of the flues. Flues should be cleared and cleaned to remove blockages. Fireplaces and chimneybreasts should be opened or vented to allow through-ventilation of the flues. This prevents moisture build-up in the flues and helps interior ventilation by the stack effect*

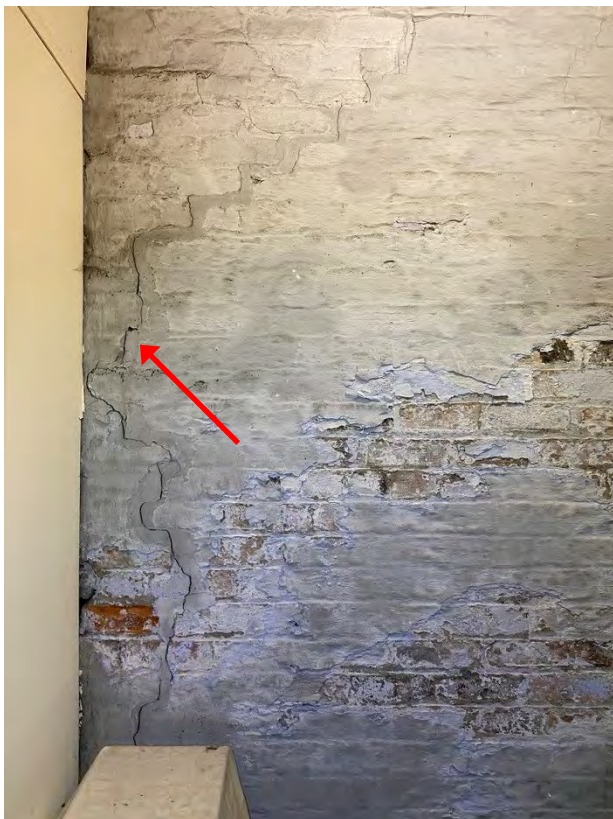
**Fig 46:**

- 3 Walls: There was vertical cracking at either end of the south-west gable wall

First floor; showing cracking in the south-west gable wall

*Structural Engineer to inspect and assess the significance of the cracking in the brickwork*

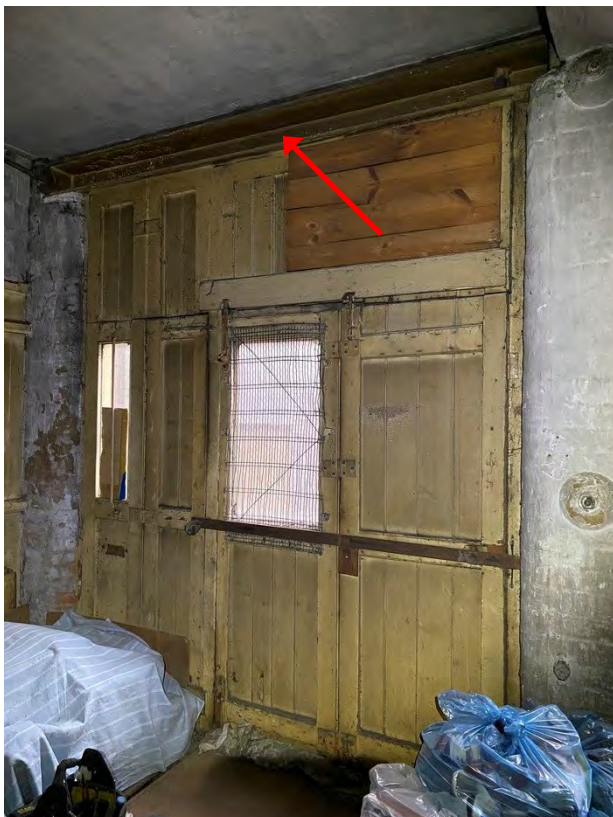
**Fig 48:**

Ground floor; showing the loading doors to the front elevation that were spanned by a metal lintel internally

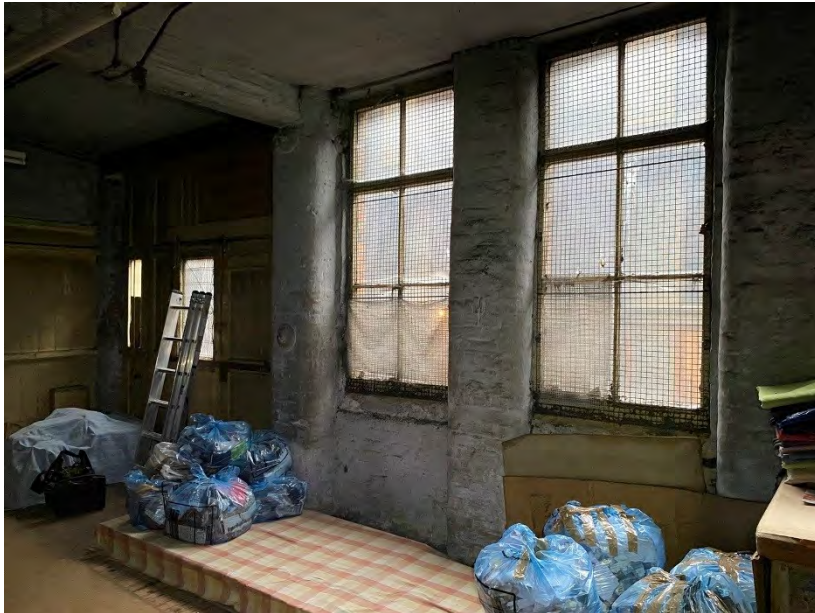
**Fig 49:**

- 2 Lintels: All window openings were spanned by softwood timber lintels internally. No significant damp or decay was identified where accessible

Ground floor; showing windows spanned by softwood timber lintels. No damp or decay was detected in these lintels where accessible

*No timber decay related repairs identified at this time*

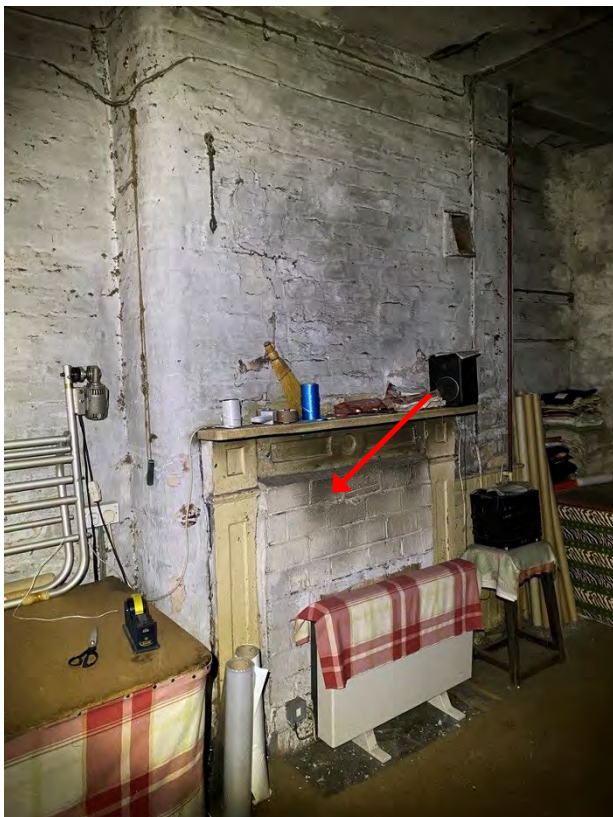
**Fig 50:**

Ground floor; showing the bricked-up fireplace which was unventilated

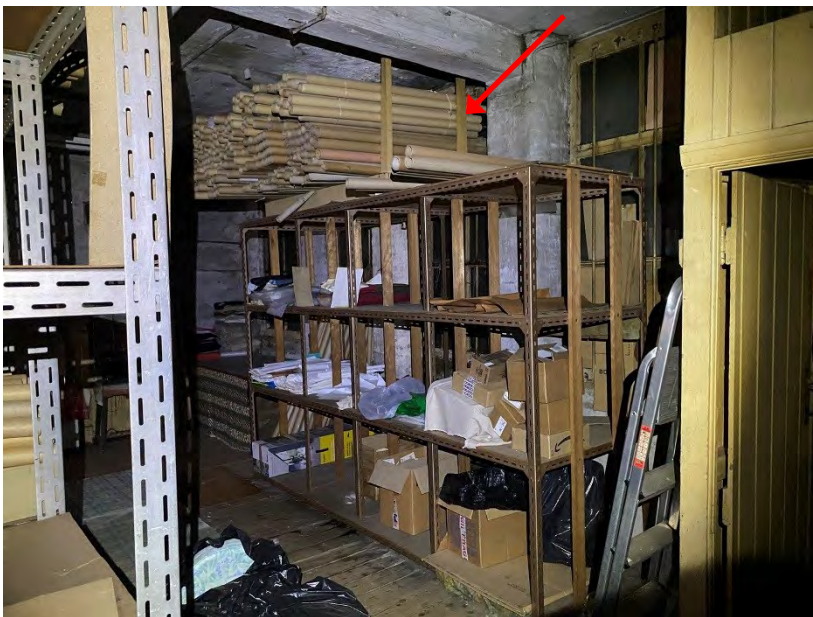
**Fig 52:**

- 2 Lintels: All window openings were spanned by softwood timber lintels internally. The lintel immediately adjacent to the damp floor beam was damp and vulnerable to decay. Access was generally impeded by shelving and stored items at this level

Ground floor; showing shelving and stored goods which inhibited close inspection of the lintel directly beneath the damp floorboards (Fig 41)

*No timber decay related repairs identified at this time. However, whilst water penetration continues, and residual moisture remains in the structure the lintel was vulnerable to decay. The extent of decay can be confirmed by H+R following purchase*

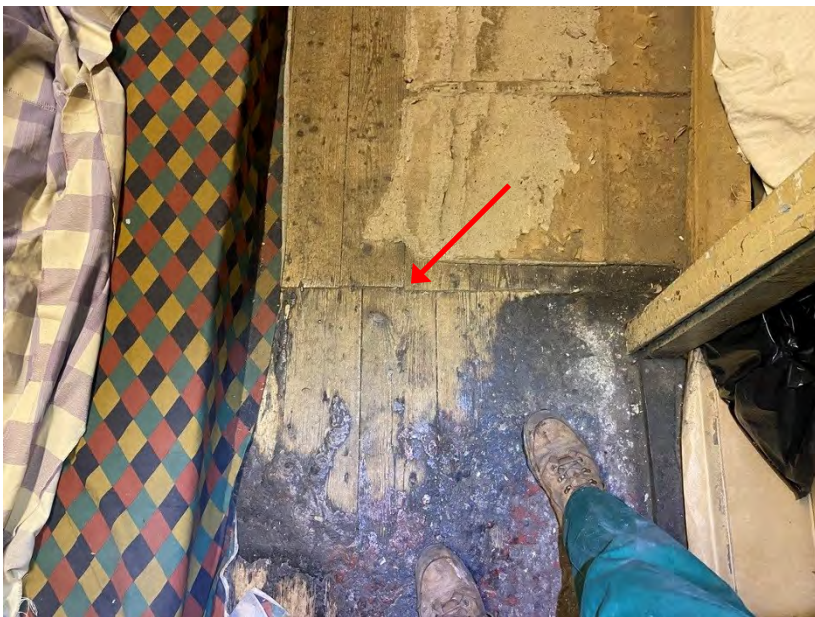
**Fig 54:**

Ground floor; showing the transition from original metal tongued softwood floorboards to tongue and groove floorboards. Inspection at basement level revealed repairs were in response to historical fire damage

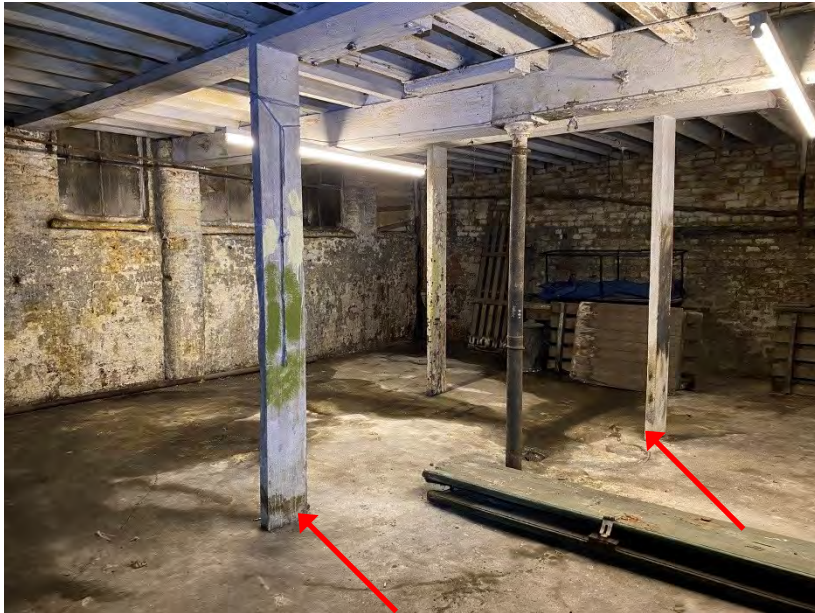
**Fig 55:**

Lower ground floor; showing softwood plank and post propping/strengthening beneath the repaired area of floor. No significant decay was detected in the base of the posts. As they were in contact with the damp ground they were presumably pre-treated

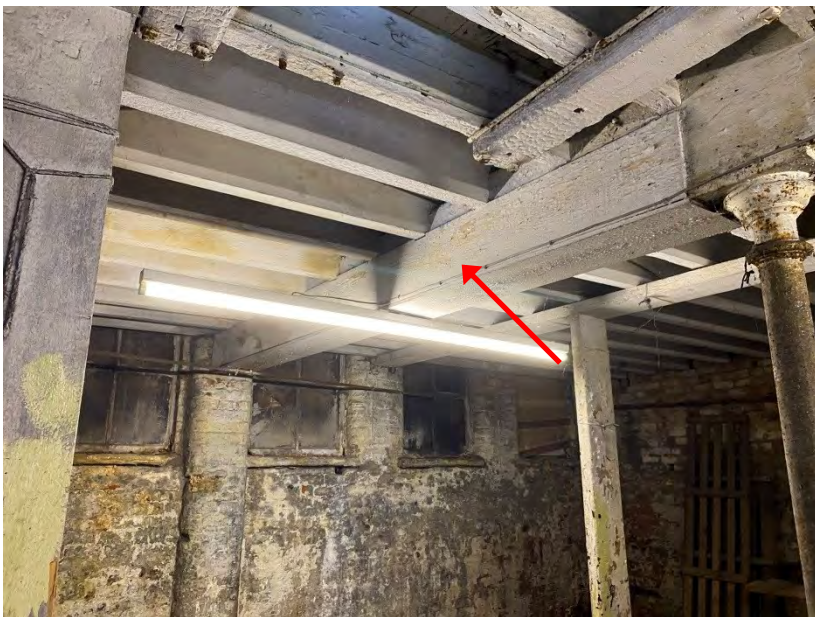
**Fig 56:**

damage. The central floor beam had been encased in timber boards and partial exposure revealed that the boards were concealing fire damage charring to the beam. The significance of the charring could not be assessed without exposure but there was no obvious evidence of structural failure in the beam. The repaired section of floor had received propping from pre-treated softwood posts and planks. The beam, planks and joists were all damp at their bearing end where embedded in the south-east wall but no significant decay had yet occurred.

Lower ground floor; showing timber boxing around the south-east half of the central floor beam. This has been applied to conceal charring from fire damage. Note the transition in the floor joists from original to new

*No timber decay related repairs identified at this time. However, whilst water penetration continues, and residual moisture remains in the structure the bearing ends of floor timbers are vulnerable to decay. The extent of decay can be confirmed by H+R following purchase. However, at this stage, allow for repairs to the bearing end of the floor beam, say 5 no. joists and 4m<sup>2</sup> of floorboards*

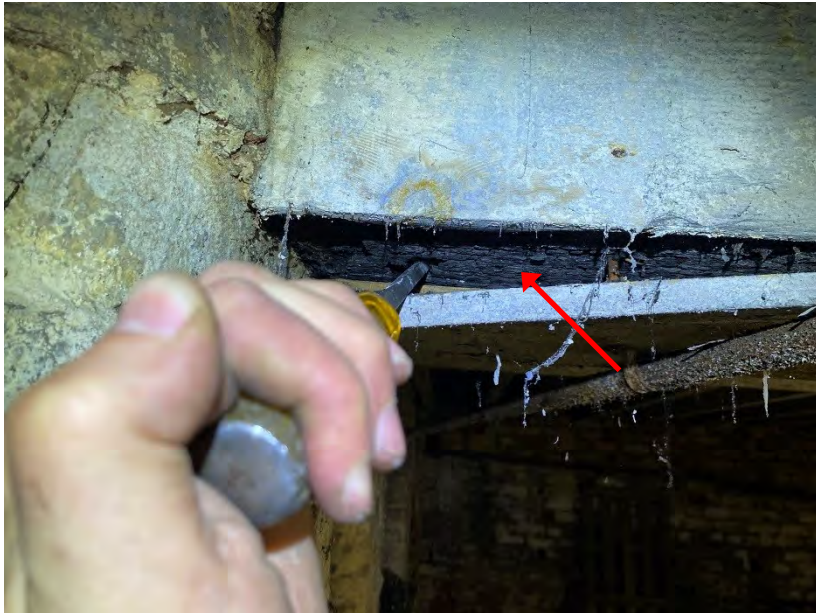
**Fig 57:**

Lower ground floor; showing exposure of the central beam revealing charring of the timber

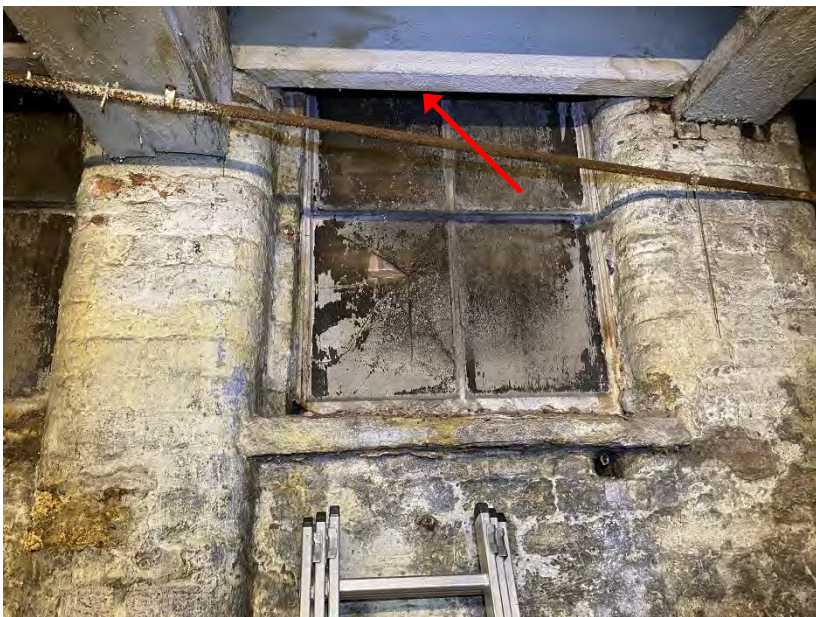
**Fig 58:**

Lower ground floor; showing the bearing end of the 2 no. planks supporting the floor structure. The timbers were damp where touching the wall

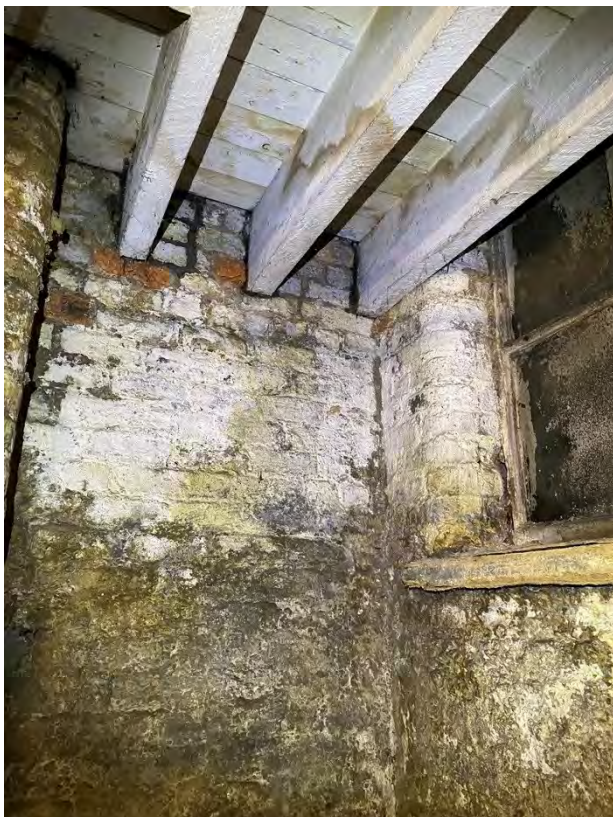
**Fig 60:**

Lower ground floor; showing the bearing end of the new floor joists in the east corner. The timbers were damp but no significant timber decay was detected

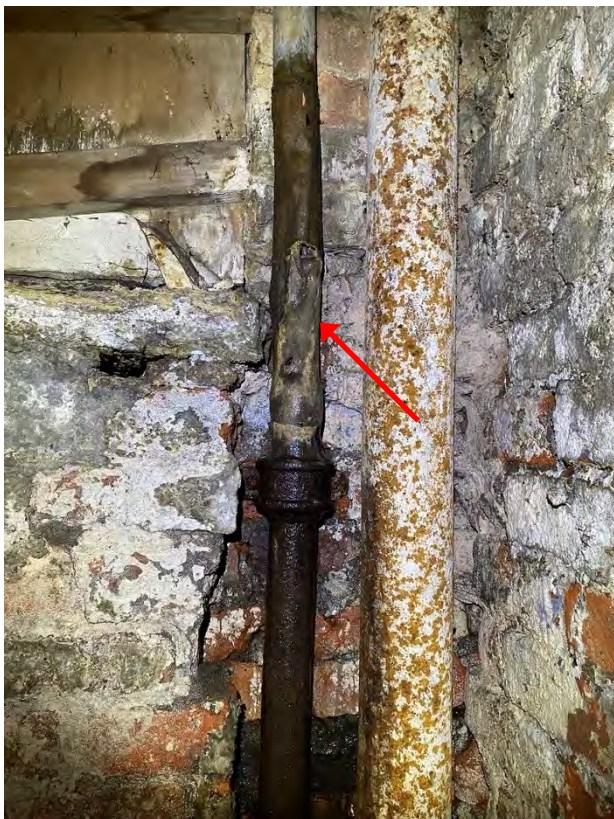
**Fig 62:**

- 4 Drainage: The downpipe to the rear elevation entered the building and discharged into a drain in the lower ground floor. The soil vent pipe also appeared to be blocked and leaking sewage into the lower ground floor

Lower ground floor; showing leakage from the lead pipe. This may be foul water

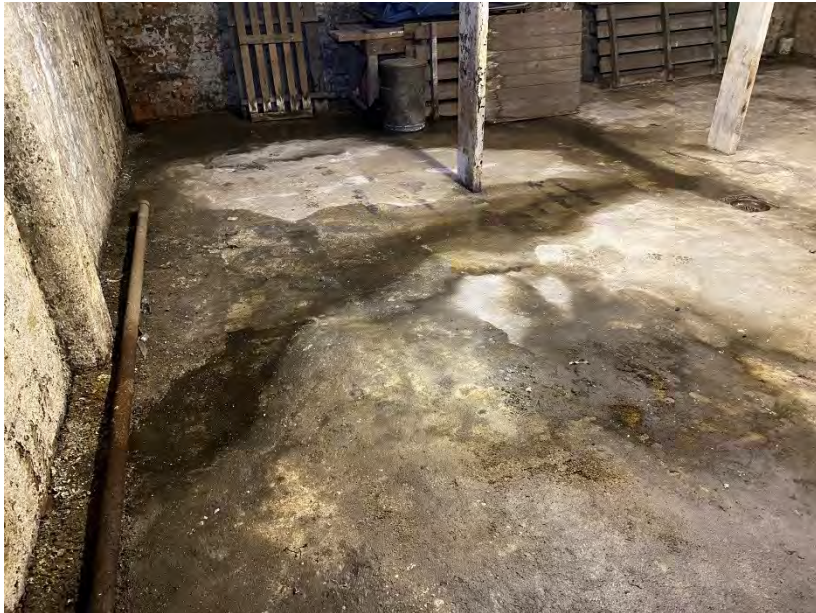
**Fig 63:**

Lower ground floor; showing the water draining towards a central floor drain. The floor was probably contaminated with foul water. There were rat droppings throughout the floor

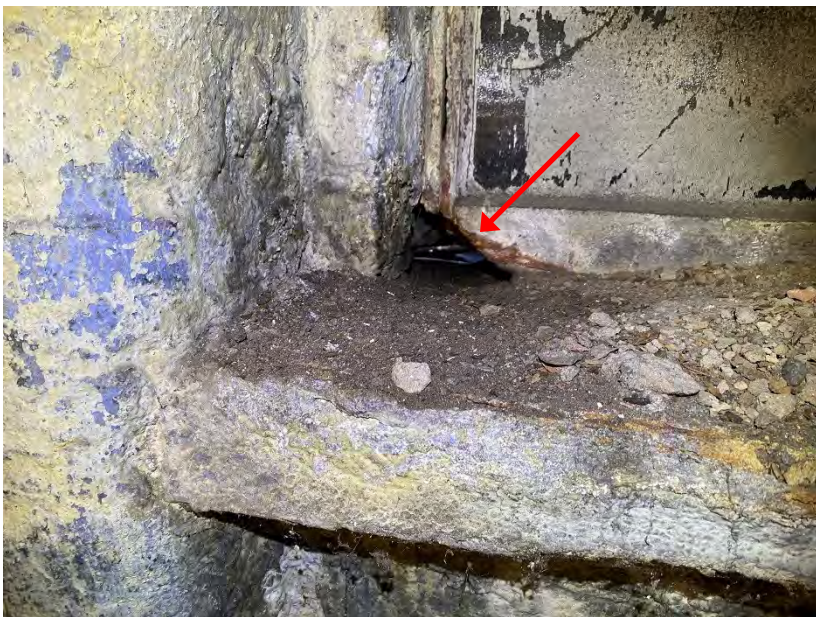
**Fig 64:**

Lower ground floor; showing a rat entry location at the base of a decayed window frame

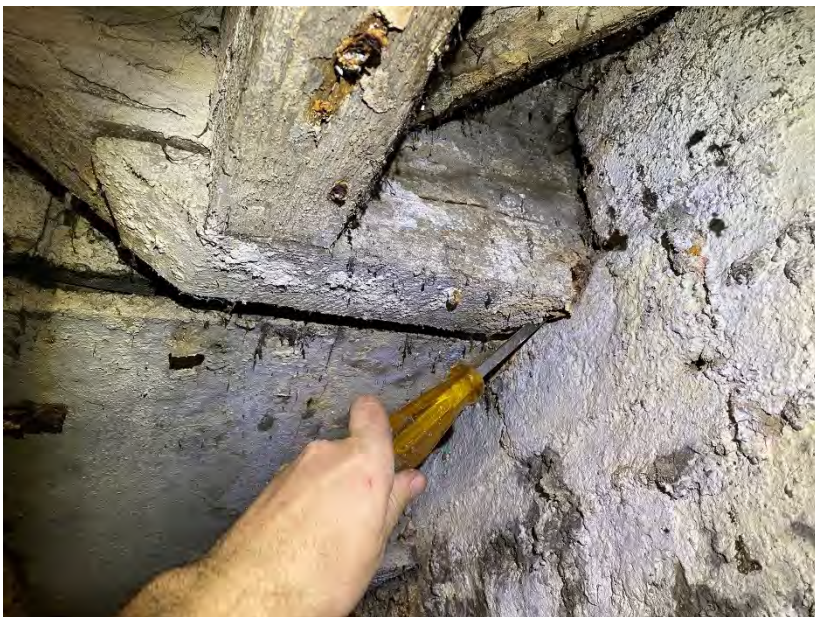
**Fig 66:**

Lower ground floor; showing decay in the bearing end of a staircase joist. The timbers were below ground level so therefore susceptible to damp and decay

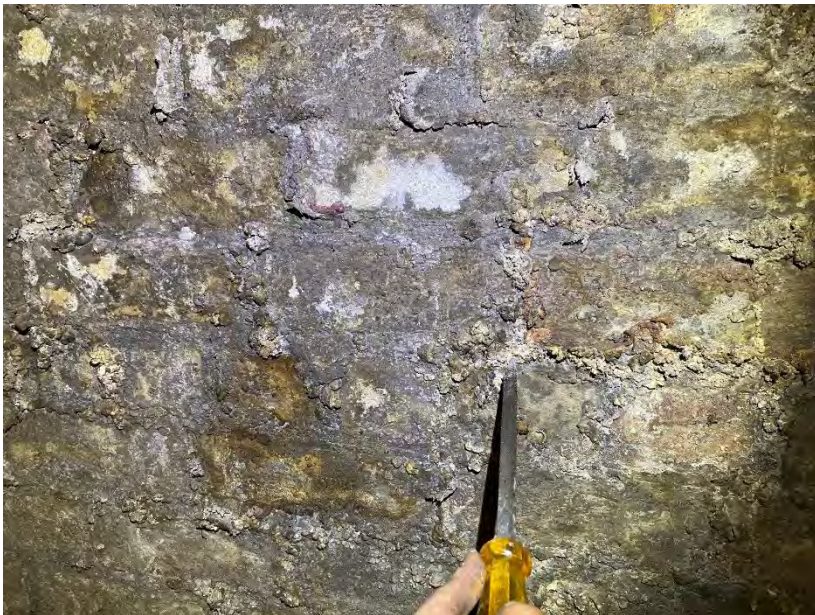
**Fig 68:**

Lower ground floor; showing repointing of the brickwork using a cementitious mortar. This had encouraged spalling in a number of the softer bricks below ground level

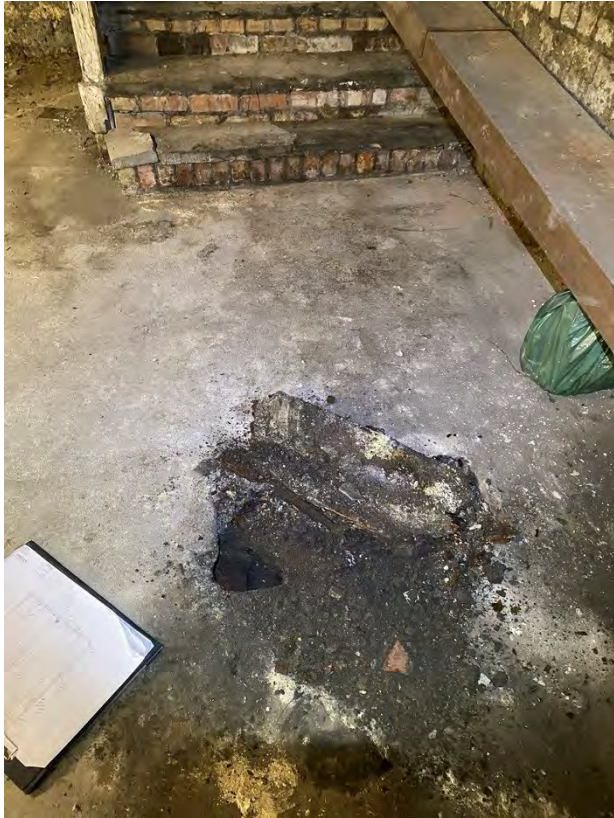
**Fig 69:**

Lower ground floor; showing investigation through the cement screed and concrete slab

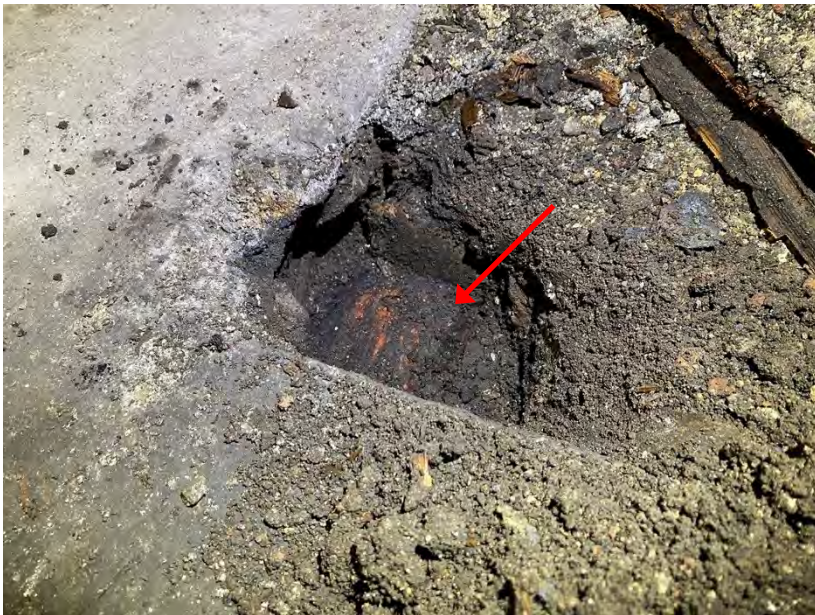
**Fig 70:**

Lower ground floor; showing what appears to be an earlier/original brick floor beneath
