## PRELIMINARY DAMP AND TIMBER CONDITION

51-53 RICHMOND STREET, MANCHESTER

JOB NO. 213-41

12 SEPTEMBER 2022

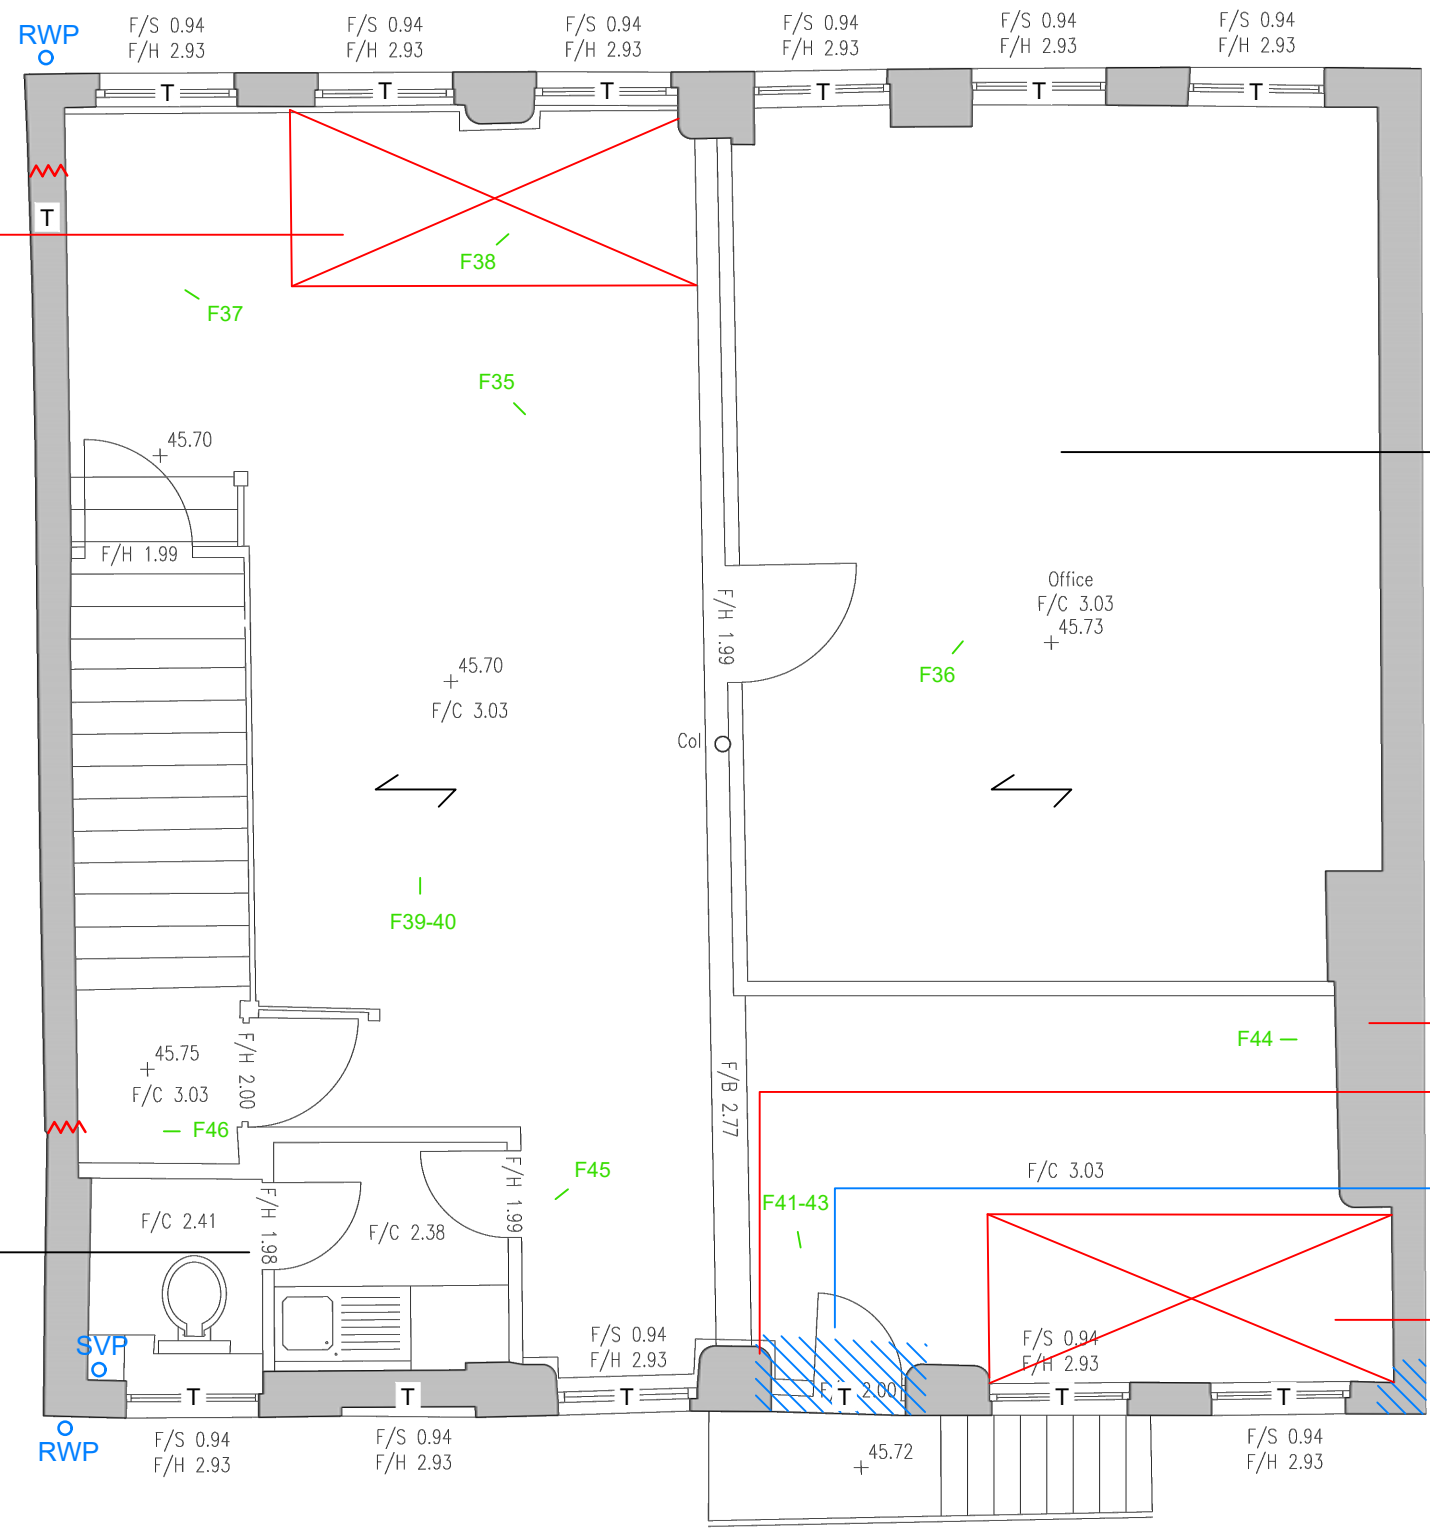
**51-53 Richmond Street, Manchester - First Floor**  
**PRELIMINARY INVESTIGATION OF DAMP AND TIMBER CONDITION**  
**12 September 2022**

Access inhibited by stored goods. Bearing end of floor beam inaccessible for testing. No evidence of significant damp or timber decay

Brickwork pier spalled where repointed and plastered with cement mortar

Softwood floorboards and joists damp and at risk of decay. 30%DMC

Access inhibited by stored goods. Floorboards and joists at risk of decay at corner of building
