**Condition Report and Repair Schedule**  
27-33 King Street West, The Carriage Works and Warehouse

This Condition Report and Repair Schedule has been produced on behalf of Property Alliance Group to accompany the Planning and Listed Building Consent application for the redevelopment of 27-33 King Street West, The Carriage Works and Warehouse.

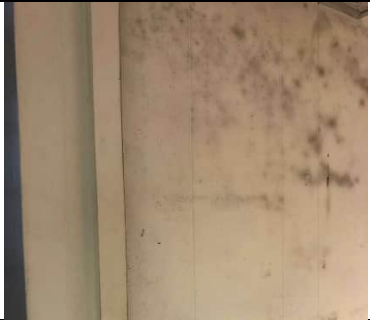
X01

| Item | Mould growth to external walls | |
| Description | Mould noted to modern timber lining along the internal face of the external wall | |
| Condition | 02 | |

| Recommendations | Further investigation by design team during strip out to ensure adequate ventilation to address this issue | |

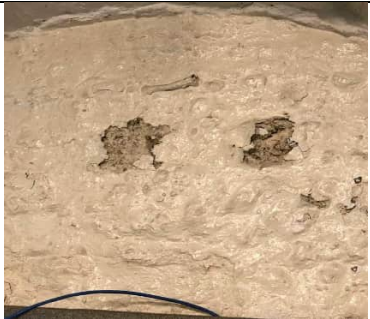
X02

| Item | Spalling paint to existing brickwork | |
| Description | Paintwork appears to be spalling to the west external walls and brick barrel arches | |
| Condition | 02 | |

| Recommendations | Remove existing paintwork,<br>Specialist contractor to inspect<br>Apply masonry sealer | |
| Specification | (PNT-100) Remove paintwork<br>(SEL-002) Masonry Sealer (internal masonry) | |

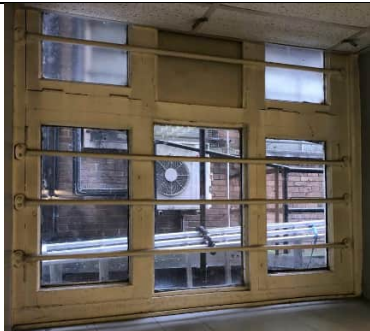
X03

| Item | Bars fixed to inside of window | |
| Description | Metal bars fixed to inside face of window | |

| Recommendations | Remove as part of window replacement strategy | |
| Specification | (REM-100) Item to be removed | |

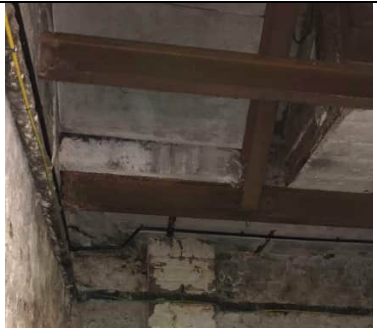
X10

| Item | Structure showing corrosion | |
| Description | Existing steel beams supporting the floor above appear to show corrosion. | |
| Condition | 02 | |

| Recommendations | Further investigation by structural engineer | |
| Specification | structural engineer to assess and advise | |

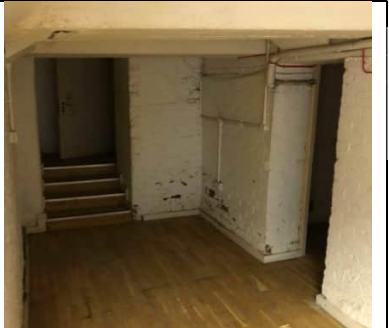
X12

| Item | Spalling paint to existing brickwork | |
| Description | Paintwork appears to be spalling to the brick walls at low level | |
| Condition | 02 | |

| Recommendations | Remove existing paintwork,<br>Specialist contractor to inspect,<br>Apply masonry sealer | |
| Specification | (PNT-100) Remove paintwork<br>(SEL-002) Masonry Sealer (internal masonry) | |

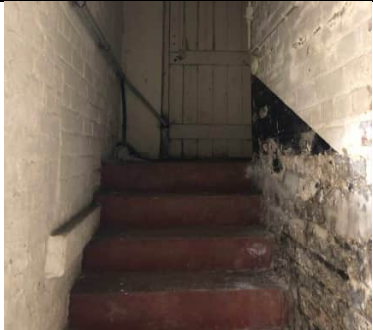
X20

| Item | Spalling paint to existing brickwork | |
| Description | Paintwork appears to be spalling to the external brick walls | |
| Condition | 02 | |

| Recommendations | Remove existing paintwork<br><br>Specialist contractor to advise if moisture exists within the building fabric, together with recommendations to remedy that may include-<br><br>Applying masonry sealer | |

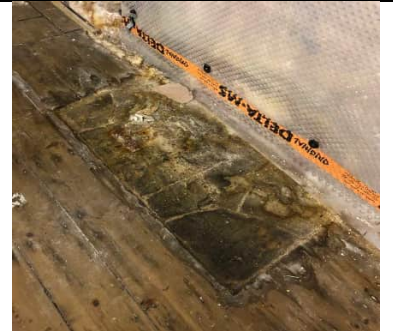
X30

| Item | Water ingress |
| Description | Drained cavity membrane noted to the East and South wall, but no drain channel observed. Water staining at low level may be historic. |
| Condition | 01 |

| Recommendations | Specialist contractor to advise if moisture exists within the building fabric, together with recommendations to remedy such as a reinstalling the current drained cavity or other solution. |
| Specification | Specialist contractor to advise |

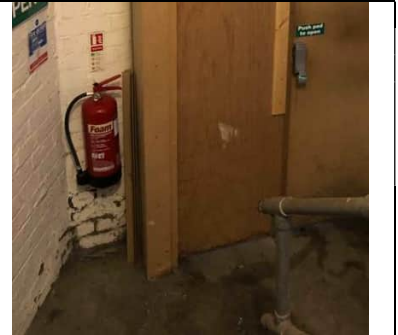
| Item | Spalling paint to base of external brickwork wall |
| Description | Paintwork appears to be spalling to the external brick walls |
| Condition | 02 |

| Recommendations | Remove existing paintwork,<br>Specialist contractor to inspect,<br>Apply masonry sealer |
| Specification | (PNT-100) Remove paintwork<br>(SEL-002) Masonry Sealer (internal masonry) |

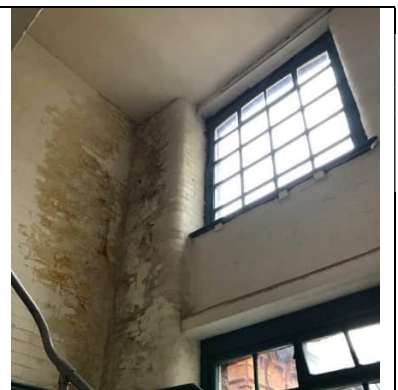
| Item | Spalling paint to external brickwork wall |
| Description | Paintwork appears to be spalling to the external brick walls, noted from level 1 to level 3 |
| Condition | 02 |

| Recommendations | Remove existing paintwork,<br>Specialist contractor to inspect,<br>Apply masonry sealer |
| Specification | (PNT-100) Remove paintwork<br>(SEL-002) Masonry Sealer (internal masonry) |

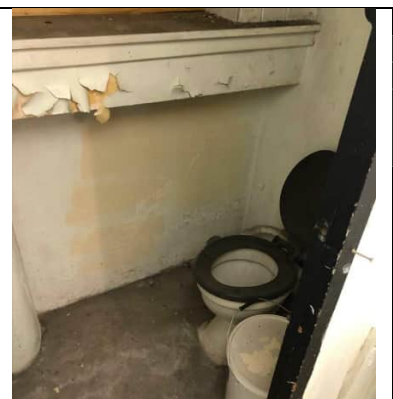
| Item | Spalling paint to base of external brickwork wall |
| Description | Paintwork appears to be spalling to the external brick walls |
| Condition | 02 |

| Recommendations | Remove existing paintwork,<br>Specialist contractor to inspect,<br>Apply masonry sealer |
| Specification | (PNT-100) Remove paintwork<br>(SEL-002) Masonry Sealer (internal masonry) |

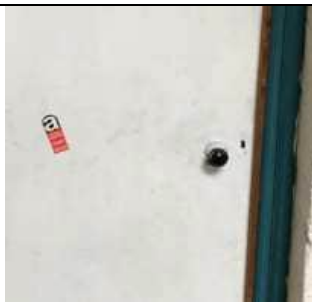
3.05

| Item | Overclad door (possible original door behind) | |
| Description | Door overclad with asbestos. | |
| Condition | 01 | |

| Recommendations | Following asbestos removal works the uncovered door should be presented to the planners and conservation officers. If the door is deemed original then retain and refurbish door where possible, subject to fire and acoustic performances being achieved. Replace current ironmongery with a specification to match other original internal doors. | |
| Specification | (DOR-001) – Repair / Refurbish door | |

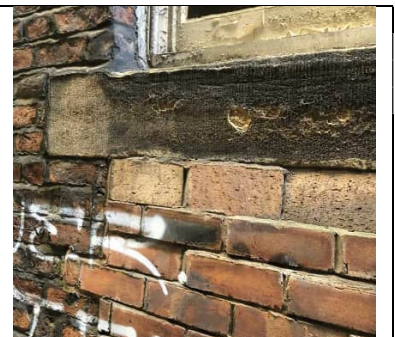
E  
203

| Item | Hole in brickwork (<50mm dia) |
| Condition | 02 |

| Recommendations | Repair with colour match mortar |
| Specification | (MAS-002) Masonry repointing |

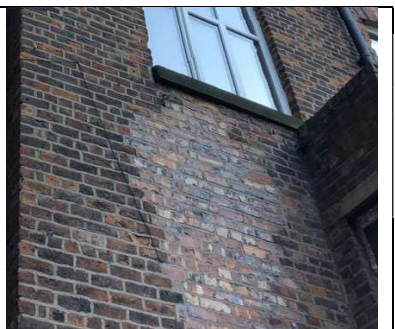
E  
303

| Item | upvc rainwater pipes and accessories |
| Condition | 01 |

| Recommendations | It is noted the current design proposes these are replaced with iron to match the original existing pipework. Following removal any existing holes should be filled. |
| Specification | <b>(REM-100)</b> Remove pipework<br><b>(IRN-100)</b> Replacement iron pipework<br><br>Replacement pipework to be specified by others |

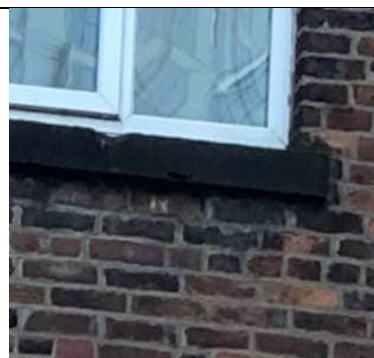
E  
306

| Item | Window cill flashing |
| Condition | 02 |

| Recommendations | Remove flashing to establish if there is a defective cill beneath. Repair where necessary |
| Specification | <b>(MAS-001)</b> Masonry repair |

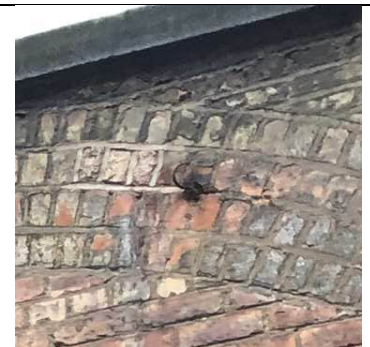
E  
702

| Item | Service penetrations |
| Condition | 02 |

| Recommendations | Wherever services are deemed redundant, openings should be closed using brickwork and mortar to match existing. |
| Specification | (MAS-001) Masonry repair<br>(MAS-002) Masonry repointing |
