# Heritage Statement

1830 Warehouse  
essential repairs to  
the roof, Museum of  
Science and Industry  
Manchester

March 2023 | Project Ref 4700I

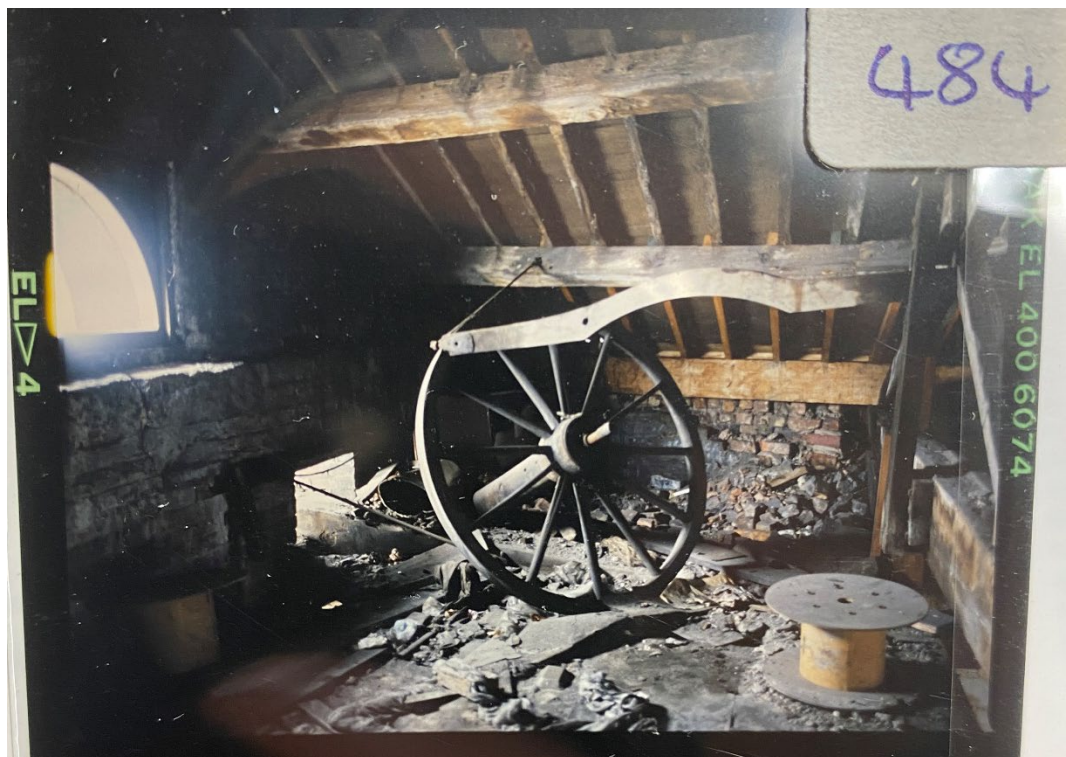
Figure 9: GMAU photographic archive contact sheet ref: 48 4.484. Bay 2 close to one of the lunette windows showing sarking boards over the common rafters, an alternate finish beneath the slates.
