# **P1212 Ormond Building, Manchester**

## **Structural Investigation Report**

**02/04/2022**

| <b>Report Reference:</b> | P1212/Report/001/R1 |

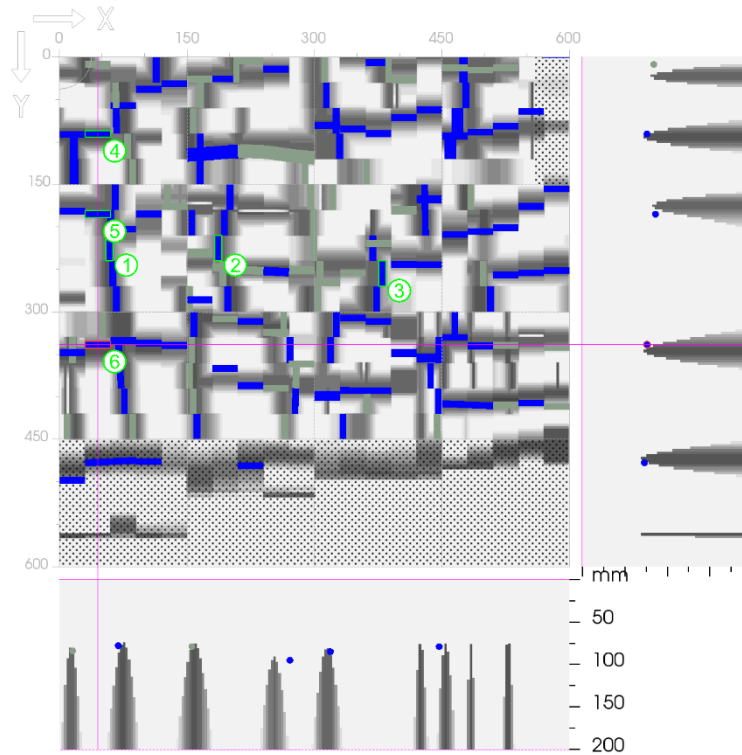
Scan File: Room 2 Soffit of Ground Floor Slab.fscan  
 Serial number: 310200011  
 Date / Time: 2022-04-02 07:08:08  
 Comment: -

x: 45 mm      y: 339 mm      z: 0 mm      Thickness: 200 mm  
 Overlay: - mm
