# Essential Repairs to the Roof

## 1830 Warehouse

Science & Industry Museum

Design and Access Statement

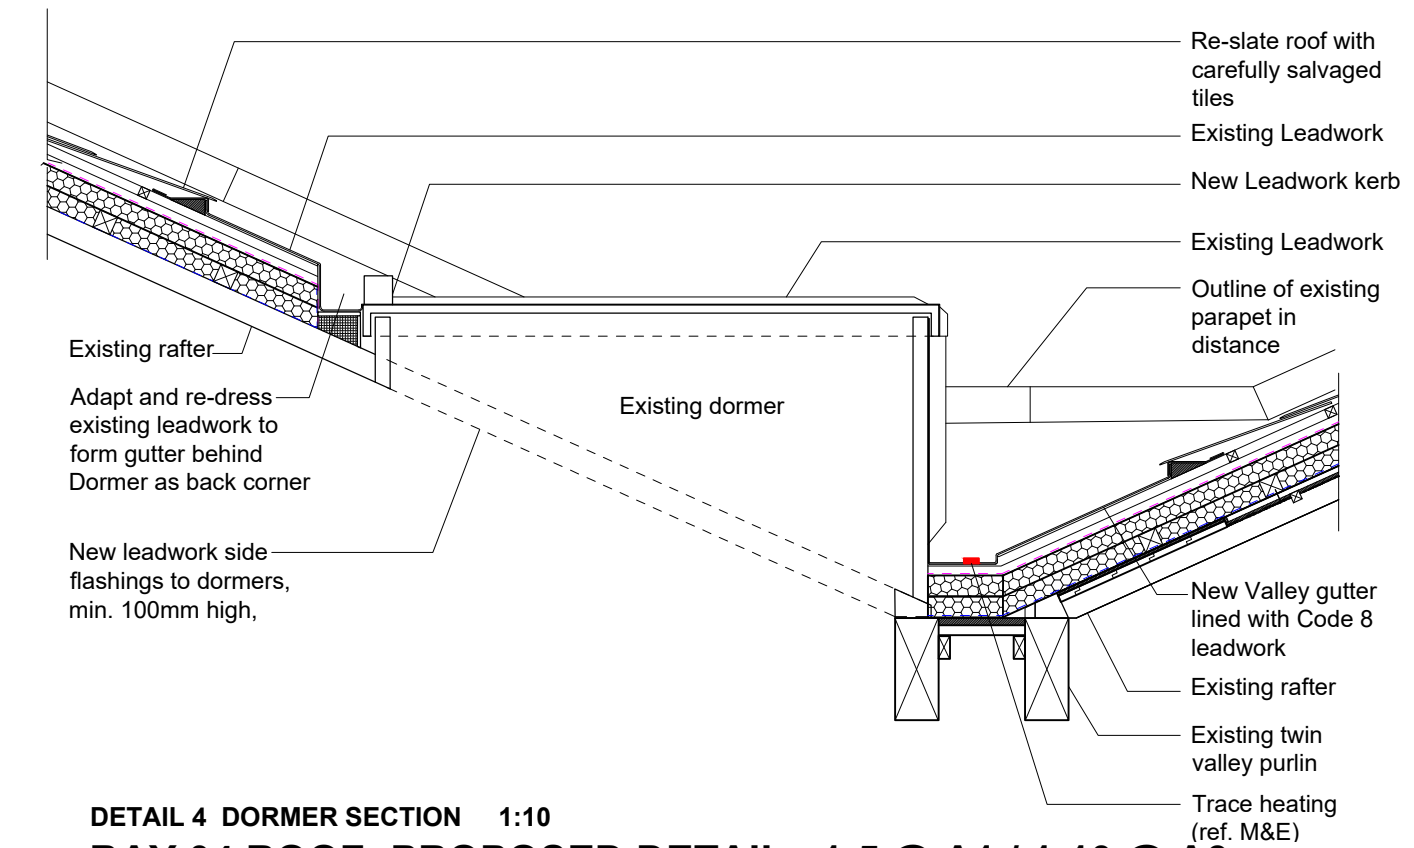
DETAIL 4 DORMER SECTION 1:10  
BAY 04 ROOF: PROPOSED DETAIL 1:5 @ A1 / 1:10 @ A3

| | DEFECTIVE CONDITION | APPROACH TO PROPOSED REPAIR SOLUTION | KEY DRAWINGS |
|--|---|---|---|
| | <p>Bay 4 torching installed in the 1990's is not properly mixed and loose pieces of varying sizes are falling out and dropping to the floor.</p> | <p>The approach is to remove the 1990's torching and install insulation to the roof similar to what has been installed in the Bays 1-3 and Bay 5. New weatherproof breathable membranes will be installed. Behind the parapet, the roofline will be raised by between 25mm and 100mm.</p> <p>The works will involve the removal of the 1990's torching, de-slating the salvaged slates and setting slates aside for checking for re-use. The installation will comprise new eco-friendly and breathable wood fibre insulation, weatherproof breathable membranes, new treated slate battens, re-slating with salvaged slates. The valley gutters will be detailed in lead consistently as mentioned above. The internal finish would be a lime putty carefully applied to a suitable substrate in between the existing rafters.</p> | <p><a href="#">275/PD/130 Bay 04 Roof: Existing detail</a><br/><a href="#">275/PD/330 Bay 04 Roof: Proposed Works</a></p> |

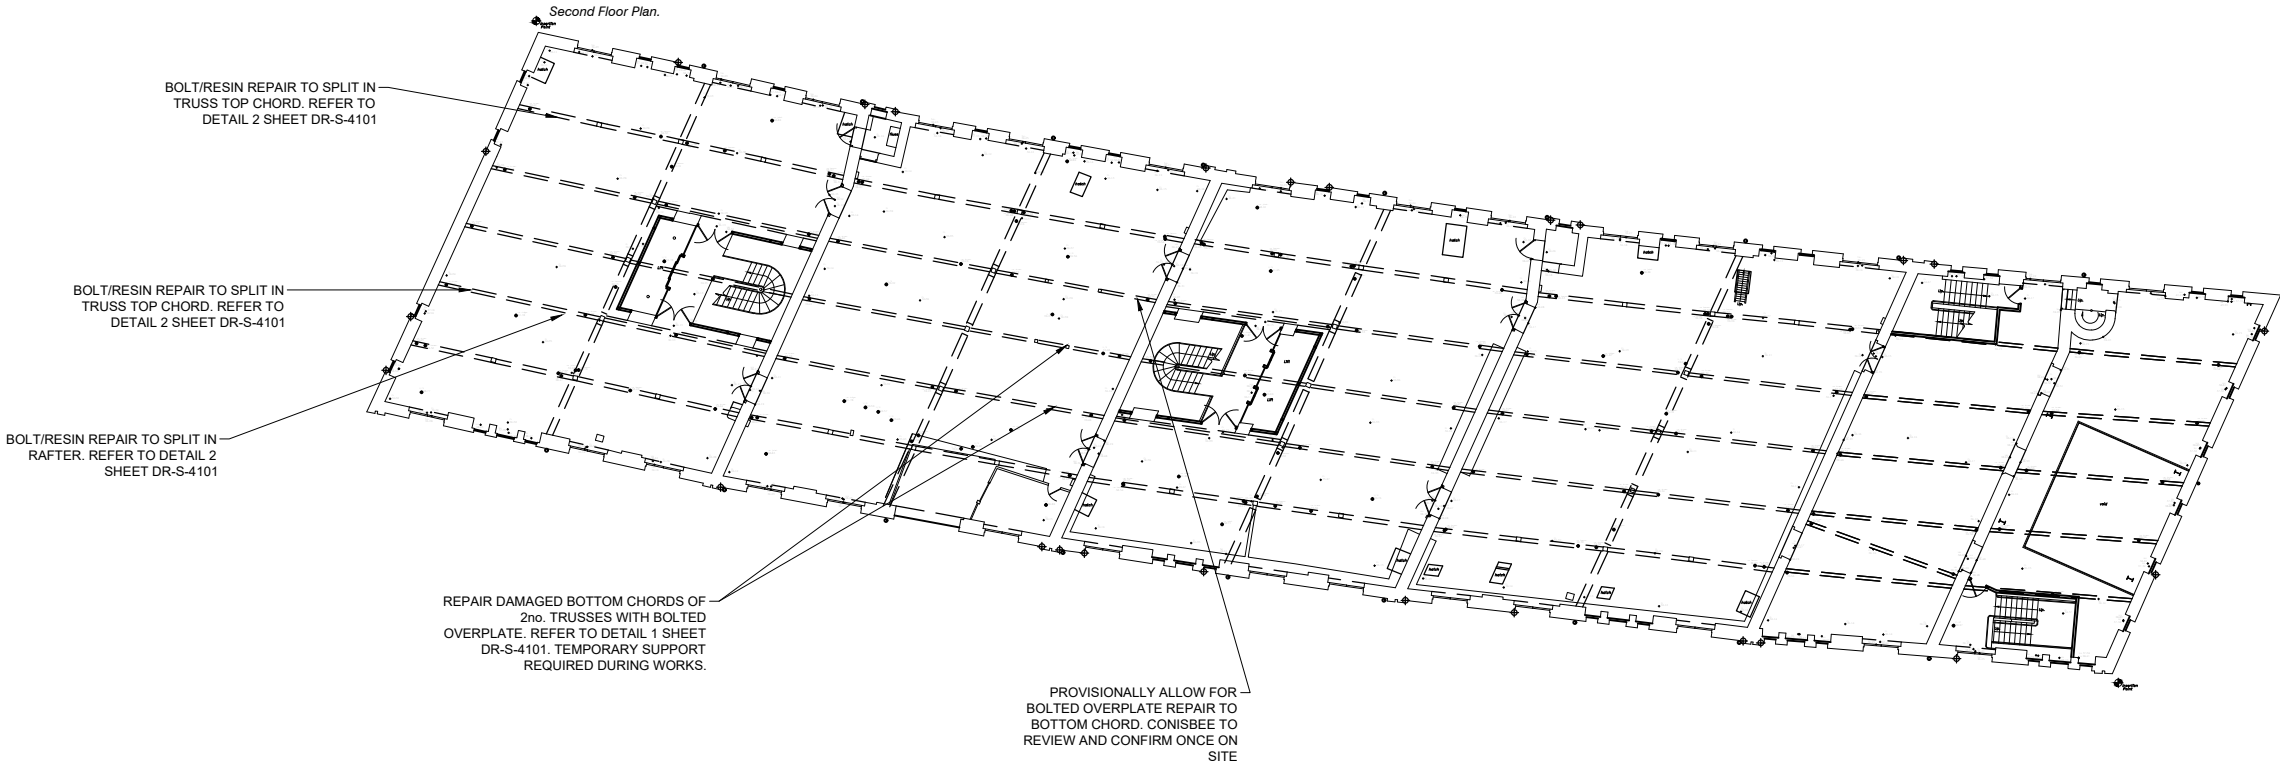
| SECOND FLOOR PLAN<br>STRUCTURAL REPAIRS | Project No<br>220627 |

- Deflection of the bottom chord of the primary longitudinal roof trusses was noted in multiple locations, suggestive of under-sizing and/or overloading. The deflection is most pronounced at Bay 2, where there has been historic overloading of the trusses during goods movement into and out the 1830 Warehouse. In 2 No. locations, the tie beam (bottom chord) has actually snapped.

- Square Hollow Section (SHS) steel posts (4No) have been installed (likely in 1992) to prop the failed trusses as well as the adjacent truss to the North, which receives the other end of the old lifting beam. Tracking the location of these SHS props through the floor, it was noted that the columns are sat on the boards between joists, and away from primary North-South beams.

- The tie beam of a primary truss to the south of the two locations noted above has also failed. The failure in the southern truss is close to the position of a knot which is a natural weak point, as well as being close to the king post tension rod, from which the tie beam is effectively hung.

- Semi-permanent propping in the form of SHS posts have been installed and serve to transfer the roof load to the floorboards and joists of the 2nd floor, and away from primary structure. The failure of the tie beam in this Bay 2 truss means that the post at this location will be receiving the majority of the roof load, and the floorboards and joists under are not suitable to receive such loading in the long term. Whilst no failure is evident in the boarding, minor stress fractures were seen in the joist directly below the prop that is beneath the failed truss. A repair should be implemented to re-establish the structural integrity of this tie beam thereby re-instating the original load path down the primary timber posts.

- Bay 2:
  - Repair damaged bottom chords of 3no. trusses with spliced timber repair or bolted overplate. Temporary support required during works.
  - The failure of the bottom chord of the southern truss in Bay 2 should be addressed using localised plate repairs.
  - To facilitate removing the propping, the bottom chord of the truss should be strengthened across the length of the failed chord using new steel plate details. A repair detail would involve plates bolted either side of the bottom chord to span from primary valley beam to wall. Failure and significant bowing of existing bottom chords makes member recovery difficult. Careful consideration of temporary works would be required for all remediation options.
- Bay 1:
  - Bolt/resin repair to split in truss top chord.
- Refer to Methodology Appendix B.3.

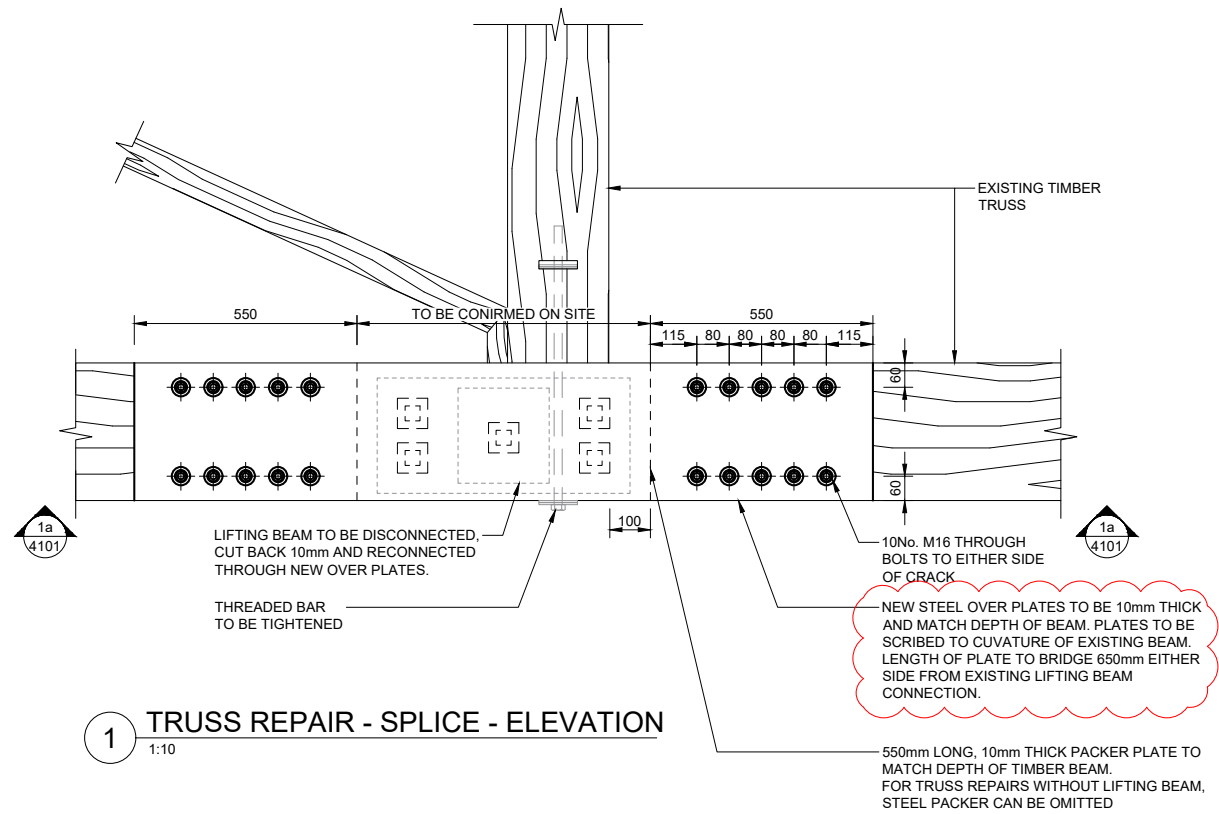
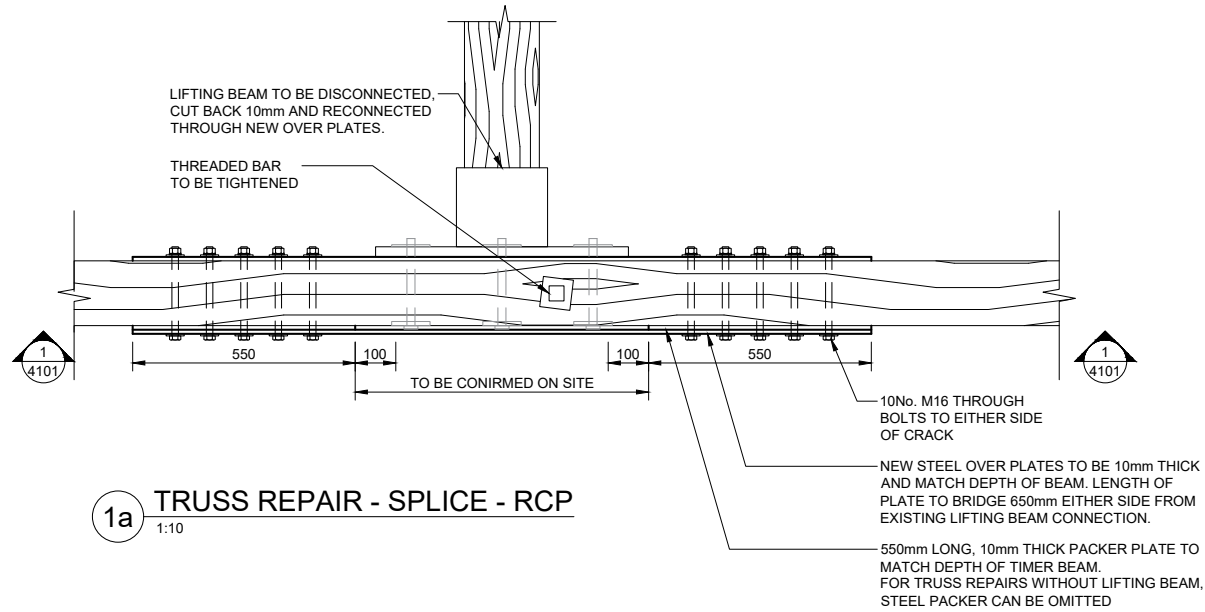
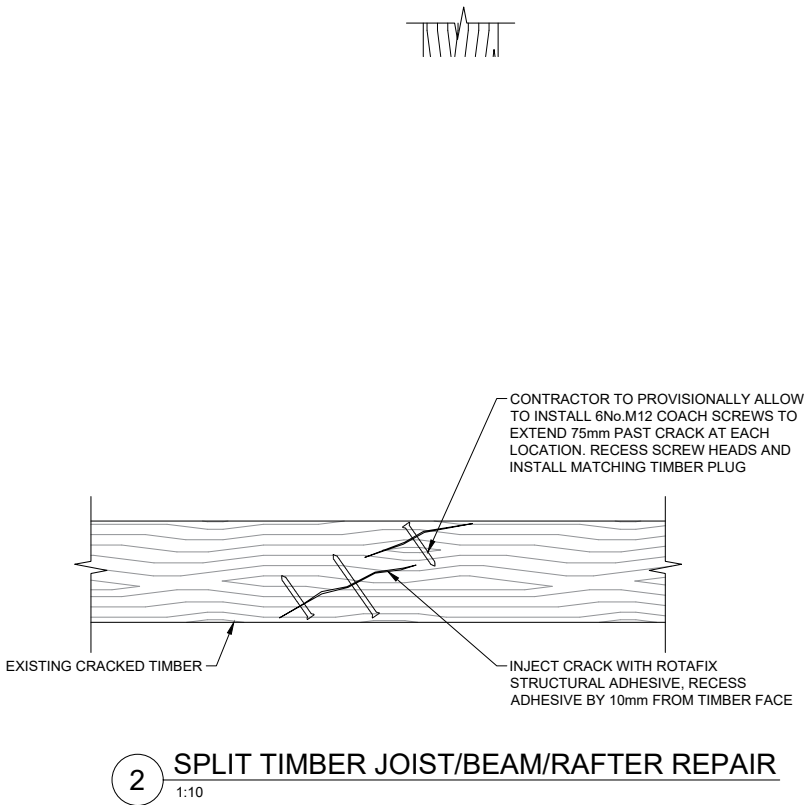
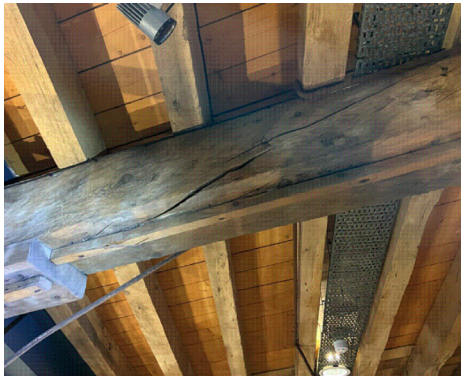
| TYPICAL STRUCTURAL REPAIRS | |

- The truss bottom chord immediately to the south of the propped trusses has also failed with vertical cracking observed. The failure in the tie beam is close to the king post tension rod, which is the location of the greatest vertical load in the truss. As such a repair should be implemented to enhance the shear capacity of the tie beam and enhance the robustness of the truss.

- Due to the nature of repairs it was felt a splice repair would be too intrusive with quite complex temporary works. The best technical solution is to overplate rather than cut out the historic timber. This would reduce the loss of fabric and would avoid risk of temporary works to cut out key structural elements of the roof which could cause further harm.

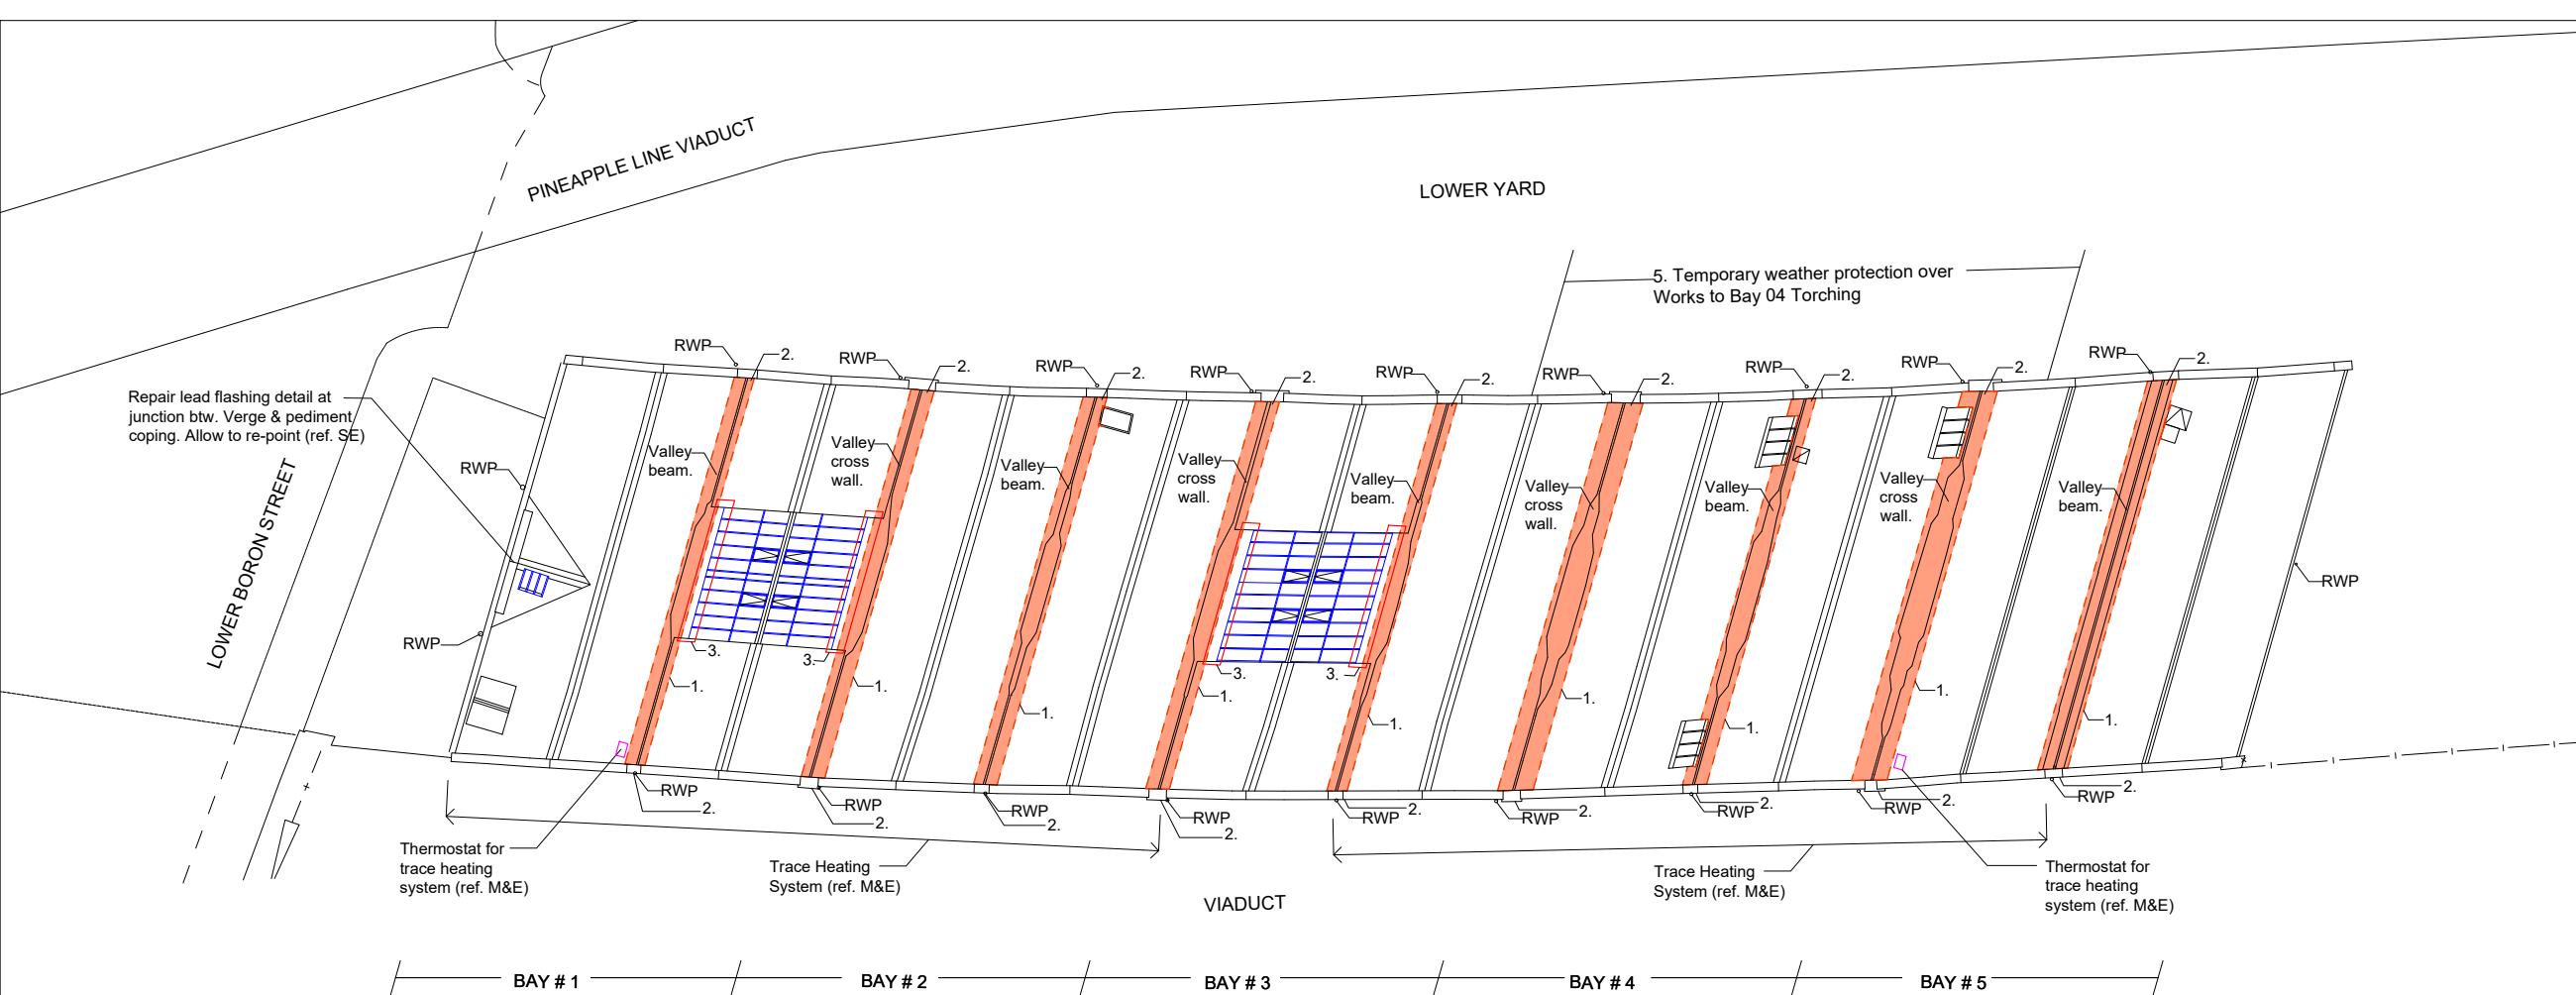
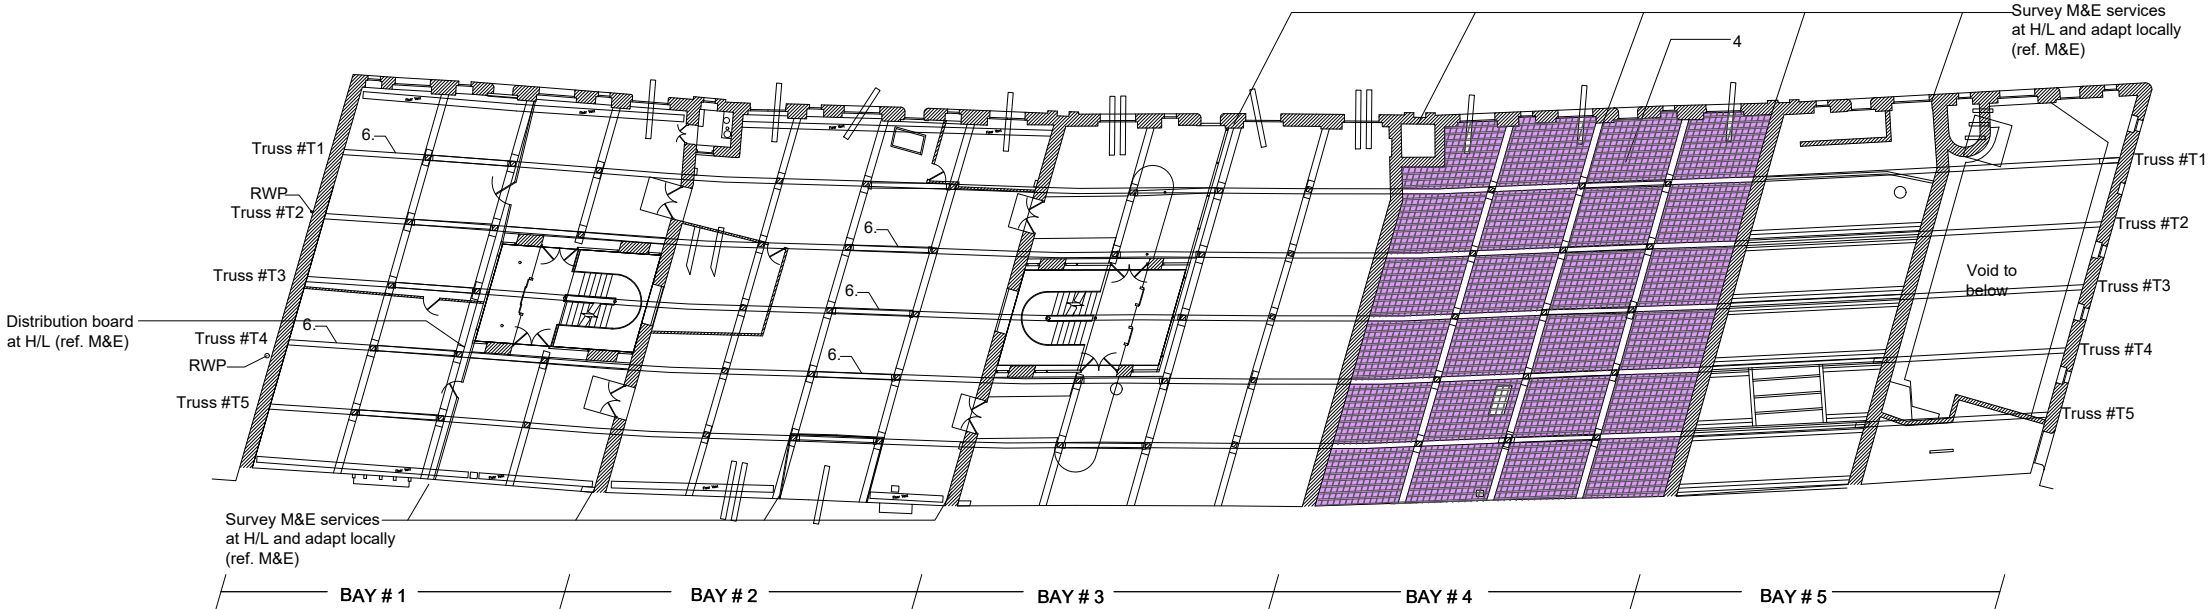
PROPOSED WORKS TO EXISTING BUILDING: ROOF PLAN & REFLECTED ROOF 1:400 @ A3 1:200 @ A1

| | DEFECTIVE CONDITION | APPROACH TO PROPOSED REPAIR SOLUTION | KEY DRAWINGS |
|--|---|---|---|
| | <p>Truss chords are cracked in both Bay 1 (2no.) and Bay 2 (3no.).</p> | <p>Bay 1:<br/>Bolt/resin repair to split in truss top chord</p> <p>Bay 2:<br/>Repair damaged bottom chords of 3no. trusses with spliced timber repair or bolted overplate (TBC). Temporary support required during works</p> | <p><a href="#">220627-CON-XX-02-DR-S-1103 SECOND FLOOR PLAN STRUCTURAL REPAIRS</a><br/><a href="#">220627-CON-XX-ZZ-DR-S-4101 TYPICAL STRUCTURAL REPAIRS ROOF DETAILS SHEET 1</a></p> |

**INTERNAL TIMBER REPAIRS:**  
Ref. Conisbee Drwg 220627-CON-XX-02-DR-S-1103 and 220627-CON-XX-ZZ-DR-S-4101

6. Repair to Bay 1 and Bay 2 trusses (ref SE). instruction.
