**Condition Report and Repair Schedule**  
27-33 King Street West, The Carriage Works and Warehouse

This Condition Report and Repair Schedule has been produced on behalf of Property Alliance Group to accompany the Planning and Listed Building Consent application for the redevelopment of 27-33 King Street West, The Carriage Works and Warehouse.

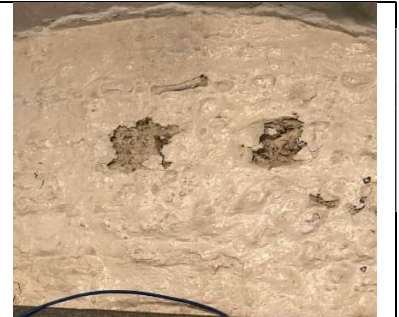
X02

| Item | Spalling paint to existing brickwork |
| Description | Paintwork appears to be spalling to the west external walls and brick barrel arches |
| Condition | 02 |

| Recommendations | Remove existing paintwork,<br>Specialist contractor to inspect<br>Apply masonry sealer |
| Specification | <b>(PNT-100)</b> Remove paintwork<br><b>(SEL-002)</b> Masonry Sealer (internal masonry) |

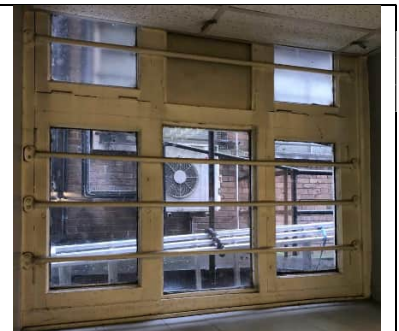
X03

| Item | Bars fixed to inside of window |
| Condition | n/a |

| Recommendations | Remove as part of window replacement strategy |
| Specification | <b>(REM-100)</b> Item to be removed |

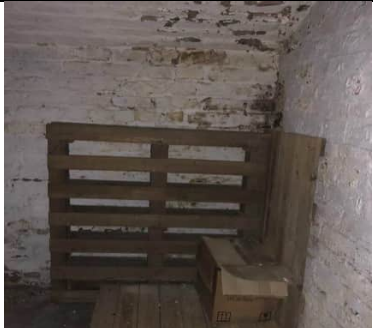
X06

| Item | Spalling paint to existing brickwork | |
| Description | Paintwork appears to be spalling to the brick walls and vault | |
| Condition | 02 | |

| Recommendations | Remove existing paintwork,<br>Specialist contractor to inspect,<br>Apply masonry sealer | |
| Specification | (PNT-100) Remove paintwork<br>(SEL-002) Masonry Sealer (internal masonry) | |

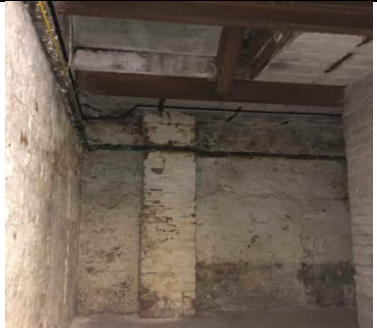
X09

| Item | Spalling paint to existing brickwork | |
| Description | Paintwork appears to be spalling to the brick walls | |
| Condition | 02 | |

| Recommendations | Remove existing paintwork,<br>Specialist contractor to inspect,<br>Apply masonry sealer | |
| Specification | (PNT-100) Remove paintwork<br>(SEL-002) Masonry Sealer (internal masonry) | |

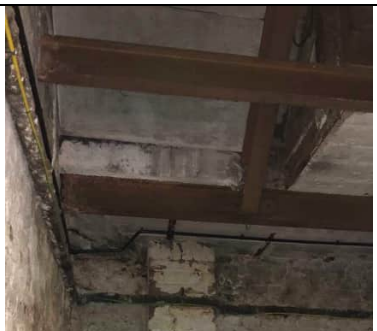
X10

| Item | Structure showing corrosion | |
| Description | Existing steel beams supporting the floor above appear to show corrosion. | |
| Condition | 02 | |

| Recommendations | Further investigation by structural engineer | |
| Specification | structural engineer to assess and advise | |

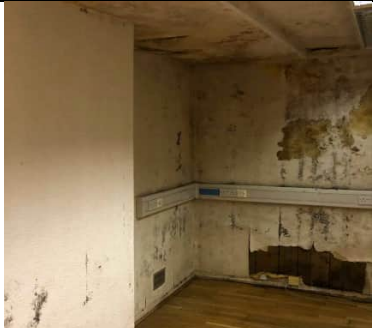
X11

| Item | Moisture ingress | |
| Description | Moisture noted to walls and floor causing damage to the building fabric | |
| Condition | 03 | |

| Recommendations | Remove existing paintwork,<br>Specialist contractor to inspect,<br>Apply masonry sealer | |
| Specification | (PNT-100) Remove paintwork<br>(SEL-002) Masonry Sealer (internal masonry) | |

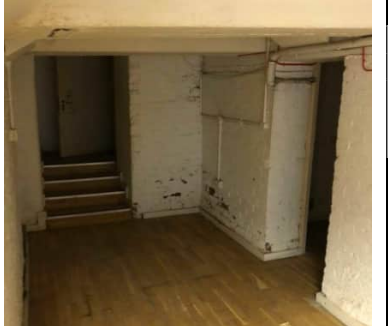
X12

| Item | Spalling paint to existing brickwork | |
| Description | Paintwork appears to be spalling to the brick walls at low level | |
| Condition | 02 | |

| Recommendations | Remove existing paintwork,<br>Specialist contractor to inspect,<br>Apply masonry sealer | |
| Specification | (PNT-100) Remove paintwork<br>(SEL-002) Masonry Sealer (internal masonry) | |

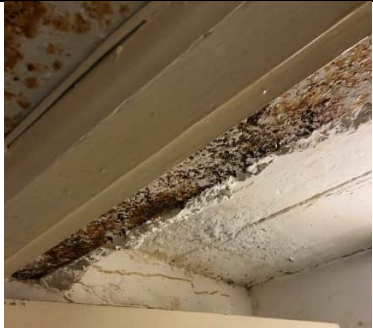
X13

| Item | Steelwork corrosion | |
| Description | Corrosion noted to steel soffit beam | |
| Condition | 02 | |

| Recommendations | Further investigation by structural engineer | |
| Specification | tbc by structural engineer | |

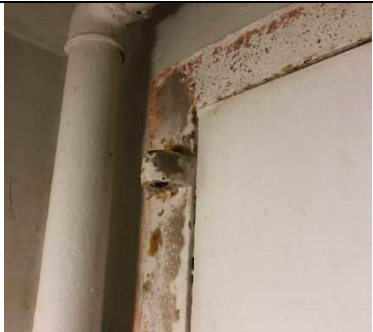
X14

| Item | Feature - Iron door frame | |
| Description | Historic iron door frame remains intact. | |
| Condition | 02 | |

| Recommendations | Existing damaged paint and residual corrosion removed prior to redecoration with paint to match existing through sampling.<br><br>During strip out works if any hoist is discovered behind the door it should be presented to the planners and conservation officers to agree how it can be integrated into the works together with any proposed works to refurbish. | |
| Specification | (PNT-100) Remove paintwork | |

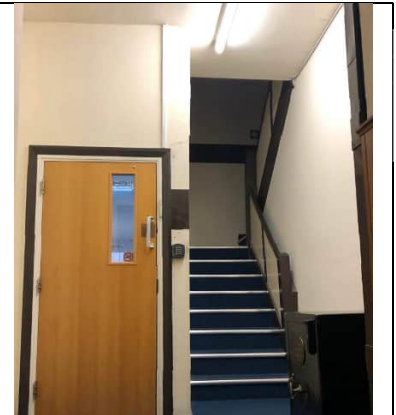
2.03

| Item | Stair |
| Condition | 01 |

| Recommendations | It is noted the current proposals look to remove this recent addition. Infill flooring to second floor should match existing, subject to fire and acoustic requirements. |
| Specification | (REM-100) Remove stair<br>(FLR-001) Infill flooring |

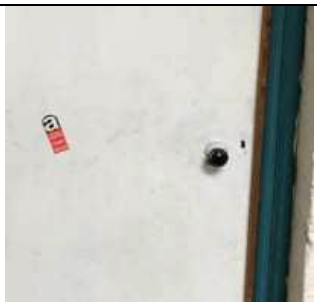
3.05

| Item | Overclad door (possible original door behind) | |
| Description | Door overclad with asbestos. | |
| Condition | 01 | |

| Recommendations | Following asbestos removal works the uncovered door should be presented to the planners and conservation officers. If the door is deemed original then retain and refurbish door where possible, subject to fire and acoustic performances being achieved. Replace current ironmongery with a specification to match other original internal doors. | |
| Specification | (DOR-001) – Repair / Refurbish door | |

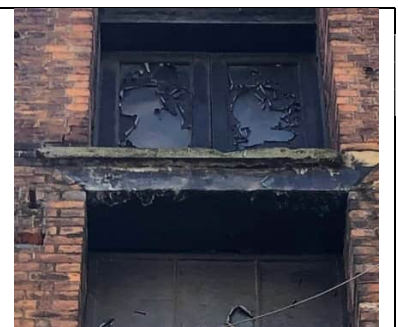
| Item | Damaged stone cills |
| Description | Stone cills appear damaged to their edges |
| Condition | 02 |

| Recommendations | Specialist stone repair |
| Specification | (MAS-001) Masonry repair |

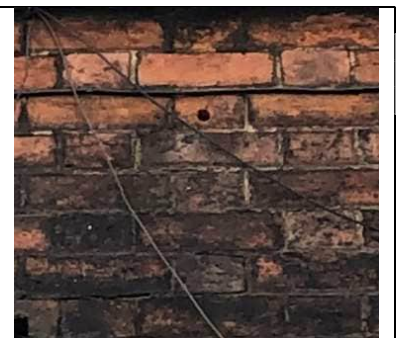
E  
103

| Item | Hole in brickwork (<50mm dia) |
| Condition | 02 |

| Recommendations | Repair with colour match mortar |
| Specification | (MAS-002) Masonry repointing |

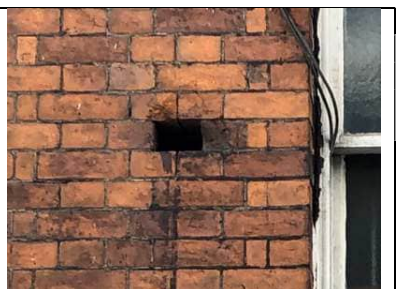
E  
104

| Item | Missing brick / brick damaged (typical) |
| Description | Brick appears to be missing, or is damaged |
| Condition | 02 |

| Recommendations | Replace brick where repair is not possible. Mortar to match existing. |
| Specification | (MAS-001) Masonry repair<br>(MAS-002) Masonry repointing |

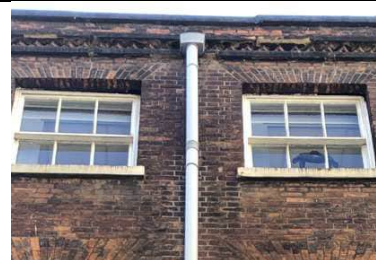
E  
109

| Item | upvc pipework |
| Condition | 01 |

| Recommendations | It is noted the current design proposes these are replaced with iron to match the original existing pipework. Following removal any existing holes should be filled. |
| Specification | <b>(REM-100)</b> Remove pipework<br><b>(IRN-100)</b> Replacement iron pipework |

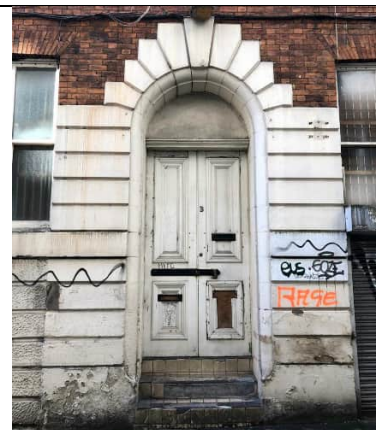
E  
110

| Item | Timber entrance door |
| Condition | 02 |

| Recommendations | Overpanel to be reglazed, damage to timber panelling to be repaired, redundant ironmongery to be removed before door prepared for Architect's decoration. Damaged floor tiles to external steps to be removed to allow Architect's finishes. |
| Specification | <b>(REM-100)</b> Remove floor tiles to step<br><b>(DOR-001)</b> Repair door |

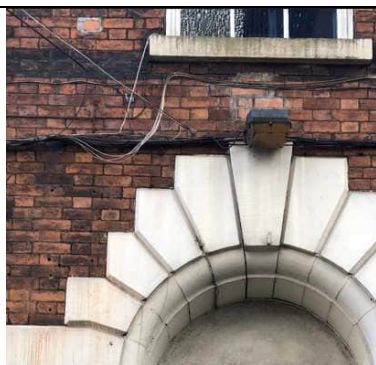
E  
111

| Item | Masonry pointing |
| Description | Cement mortar appeared to have been used for patch repair. Incorrectly matched bricks. |
| Condition | 02 |

| Recommendations | Replace bricks with better match, repoint to match surrounding masonry |
| Specification | <b>(MAS-001)</b> Masonry repair<br><b>(MAS-002)</b> Masonry repointing |

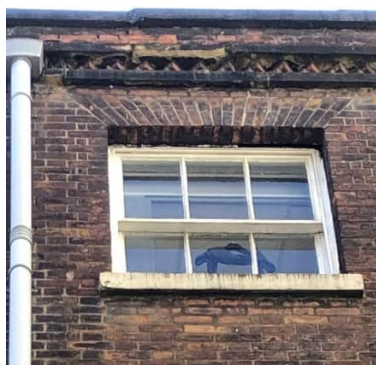
E  
112

| Item | Spalled stone coping |
| Description | Coping appears to have spalled in locations |
| Condition | 02 |

| Recommendations | Specialist stone repair to prevent further erosion and retain structural integrity of the coping. |
| Specification | <b>(MAS-001)</b> Masonry repair |

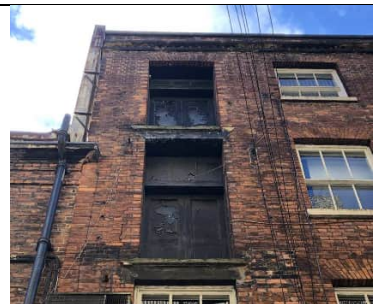
E  
113

| Item | Loading slot doors |
| Condition | 02 |
| Recommendations | Badly deteriorated paintwork. The current design proposals show these removed and replaced with louvres. |

| Specification | <b>(REM-100)</b> Remove doors and frame |

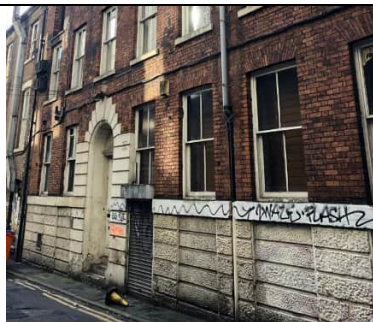
E  
114

| Item | Paintwork to base |
| Condition | 01 / 02 |

| Recommendations | Remove paintwork, if any masonry repair or repointing then becomes necessary, these should be undertaken. |
| Specification | <b>(PNT-100)</b> Remove paintwork<br><br><b>(MAS-001)</b> Masonry repair<br><b>(MAS-002)</b> Masonry repointing<br><i>(where discovered necessary to unstable masonry following removal of paint)</i> |

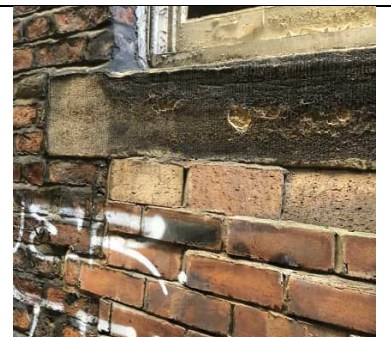
| Item | Stone cill spalling |
| Description | Vertical face of stone cill shows localised spalling |
| Condition | 02 |

| Recommendations | Specialist stone repair to prevent further deterioration |
| Specification | (MAS-001) Masonry repair<br>(MAS-002) Masonry repointing |

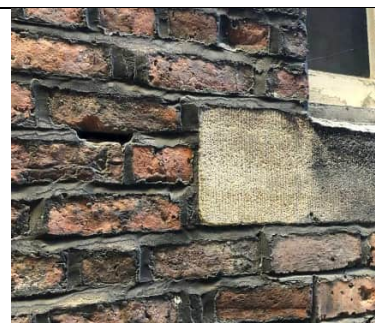
E  
203

| Item | Hole in brickwork (<50mm dia) |
| Condition | 02 |

| Recommendations | Repair with colour match mortar |
| Specification | (MAS-002) Masonry repointing |

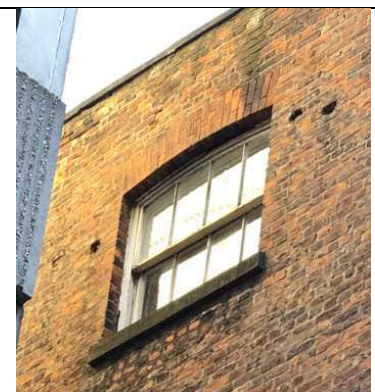
| Item | Missing bricks |
| Description | Bricks appears to be missing to either side of the window |
| Condition | 02 |

| Recommendations | Replacement bricks and mortar to be installed to match existing. |
| Specification | (MAS-001) Masonry repair<br>(MAS-002) Masonry repointing |

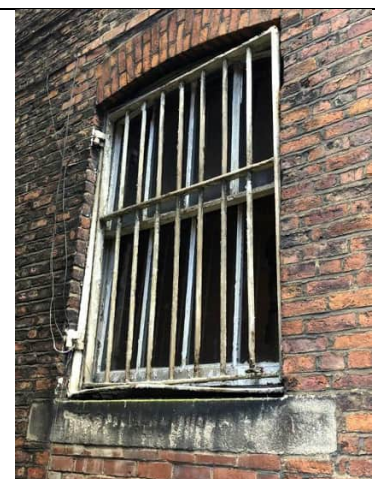
E  
206

| Item | Security bars |
| Condition | 02 |

| Recommendations | Remove bars, repair any redundant fixings points in the masonry. |
| Specification | (REM-100) Item to be removed<br>(MAS-001) Masonry repair |

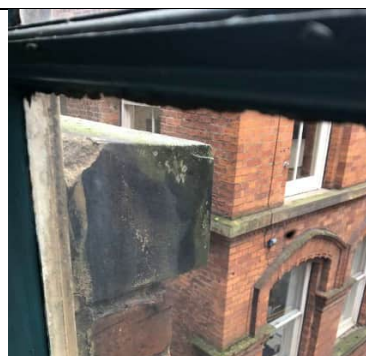
E  
210

| Item | Damage to external stone cill |
| Description | The corner of the stone cill supporting the 4 pane window on the landing between level 2 and level 3 was damaged. |
| Condition | 02 |

| Recommendations | Specialist stone repair to match existing |
| Specification | (MAS-001) Masonry repair |

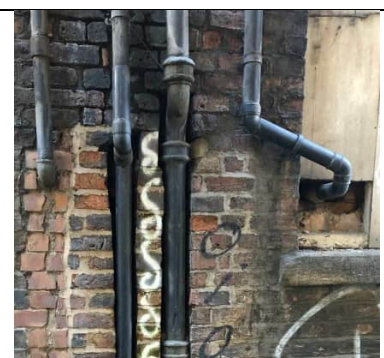
E  
214

| Item | Rainwater pipes upvc / Iron |
| Description | A mixture of upvc and Iron rainwater pipes in the same vertical run, with rainwater leaking noted at numerous connections. |
| Condition | 02 / 03 |

| Recommendations | Replace upvc pipes with iron |
| Specification | (REM-100) Remove pipework<br>(IRN-100) Replacement iron pipework |

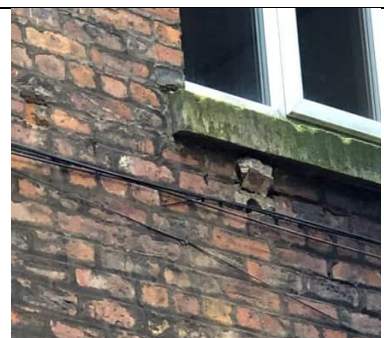
| Item | Loose brickwork |
| Description | Brick below cill appeared to be loose and projects beyond the face of brickwork |
| Condition | 02 |

| Recommendations | Remove and reset brick within mortar to match. |
| Specification | (MAS-001) Masonry repair<br>(MAS-002) Masonry repointing |

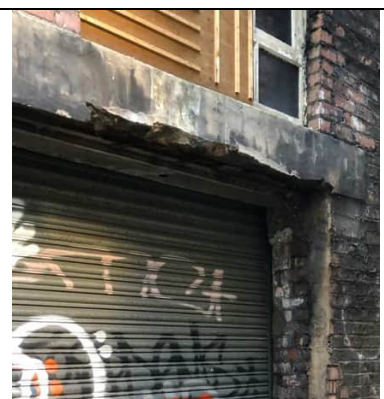
E  
217

| Item | Lintel |
| Description | Concrete faced metal lintel with damage to the front face and soffit. Exposed fixings bars and aggregate. |
| Condition | 02 / 03 |

| Recommendations | Specialist repair |
| Specification | (MAS-001) Masonry repair |

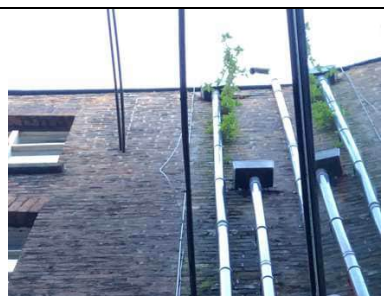
E  
218

| Item | Vegetation |
| Description | Vegetation noted to rainwater outlet, suggesting gutters and outlets are not fully discharging leading to silt buildup. |
| Condition | 02 / 03 |

| Recommendations | Remove vegetation |

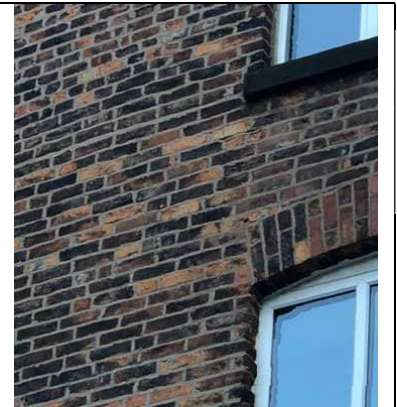
| Item | Widespread brick spalling |
| Description | Spalling observed, likely due to cement mortar repointing across the entire elevation. |
| Condition | 02 / 03 |

| Recommendations | Remove cement pointing. Any bricks with deterioration or spalling deeper than 10mm to be replaced to match. Repoint with mortar to match subject to analysis, likely lime mortar. Final application of a clear, breathable and waterproof sealer. |
| Specification | (REM-100) Remove cement mortar pointing<br>(MAS-001) Masonry repair<br>(MAS-002) Masonry repointing<br>(SEL-001) Masonry sealer |

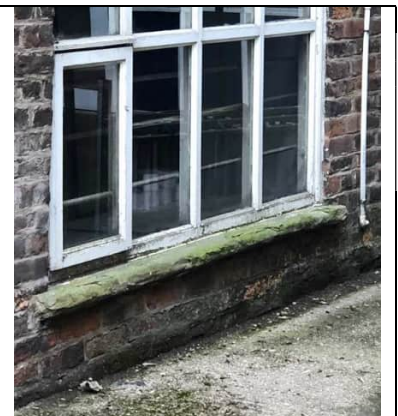
E  
403

| Item | Stone cill spalling |
| Description | All faces of the stone cill show localised spalling |
| Condition | 02 |

| Recommendations | It is understood this window will be within a newly created internal environment, so further cill deterioration would be limited. The option to refurbish the cill can be determined on site. |
| Specification | (MAS-001) Masonry repair<br>(MAS-002) Masonry repointing |

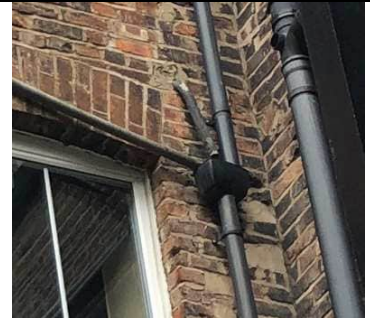
E  
701

| Item | Façade mounted fixture (typical example) |
| Condition | 02 |

| Recommendations | Remove and infill any holes |
| Specification | (REM-100) Remove fixture<br>(MAS-001) Masonry repair<br>(MAS-002) Masonry repointing |

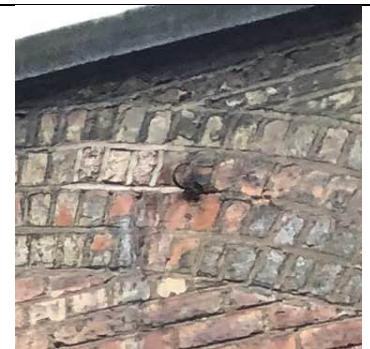
E  
702

| Item | Service penetrations |
| Condition | 02 |

| Recommendations | Wherever services are deemed redundant, openings should be closed using brickwork and mortar to match existing. |
| Specification | (MAS-001) Masonry repair<br>(MAS-002) Masonry repointing |

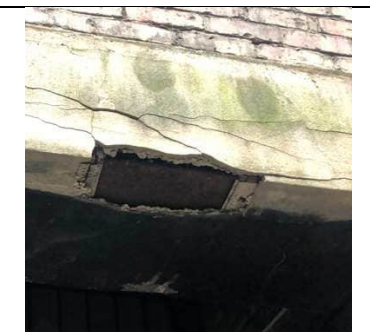
E  
704

| Item | Render to stonework |
| Description | It appears the existing stonework has been rendered in this location. Localised spalling has occurred. |
| Condition | 02 / 03 |

| Recommendations | Specialist repair assessment to be undertaken. It may become advisable to remove the entirety of the existing render where this cannot be adequately repaired. |
| Specification | (MAS-001) Masonry repair<br>(MAS-002) Masonry repointing |

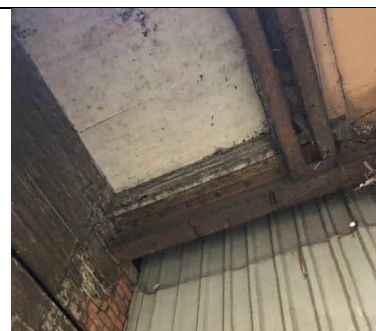
E  
710

| Item | Exposed structure |
| Condition | 02 |

| Recommendations | n/a - Current proposal is to conceal this area with a new soffit. |

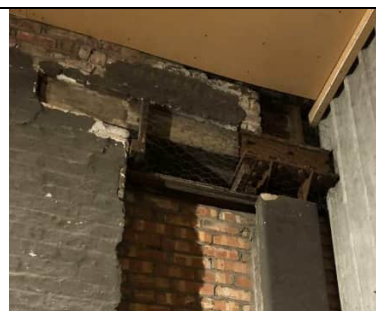
E  
711

| Item | Deterioration of brick pointing |
| Condition | 02 |

| Recommendations | Remove loose mortar and repoint to match existing |
| Specification | (MAS-001) Masonry repair<br>(MAS-002) Masonry repointing |
