# Hutton + Rostron Environmental Investigations Limited

## 11 Bloom Street, Manchester: Plaster condition survey

Site note 5 for 17 April and 26 July 2021, job no. 212.57  
REVISION A - 25.04.22

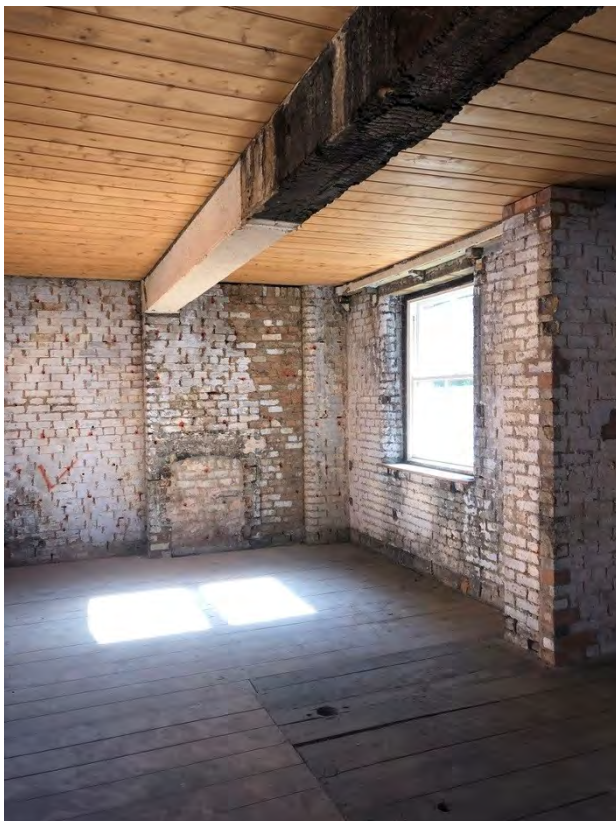
**Fig 9:**

Third floor; showing white paint to the south east wall and plasterboard to the southern staircase partition

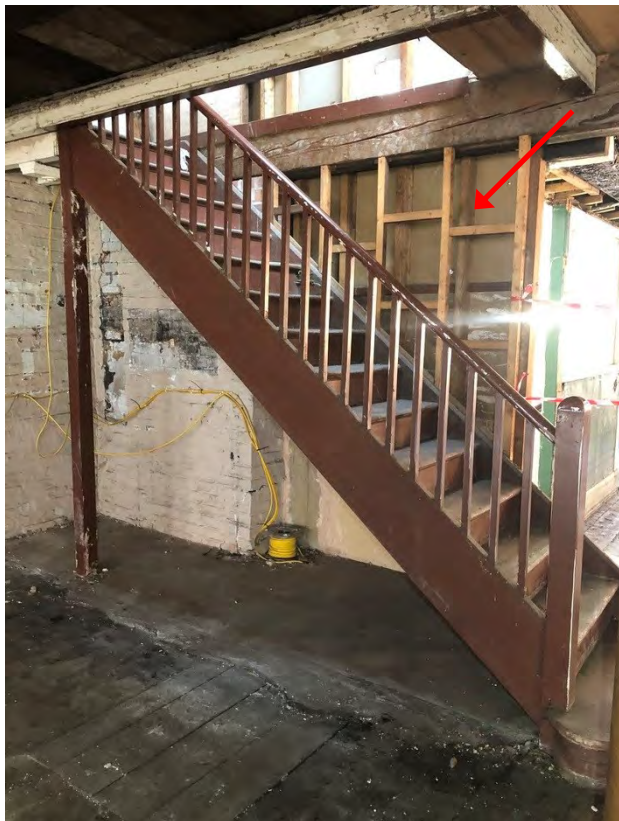
**Fig 11:**

Third floor, South staircase; showing softwood stud partitions lined with insulated plasterboard. This partition post-dates the fire

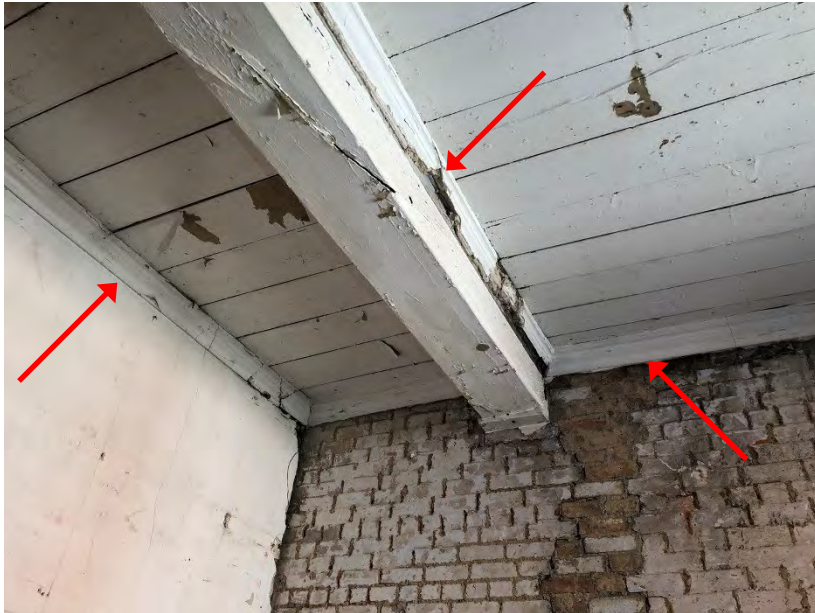
**Fig 17:**

Second floor, West corner; showing remnants of a moulded plaster cornice. The cornice was cracked and mechanically damaged and sections had debonded from the substrate. The cornice had been secured to the timber beams with nails but the nails had largely corroded

Note that the brickwork beneath has had its lime plaster removed but that it had previously been painted a blue/white colour

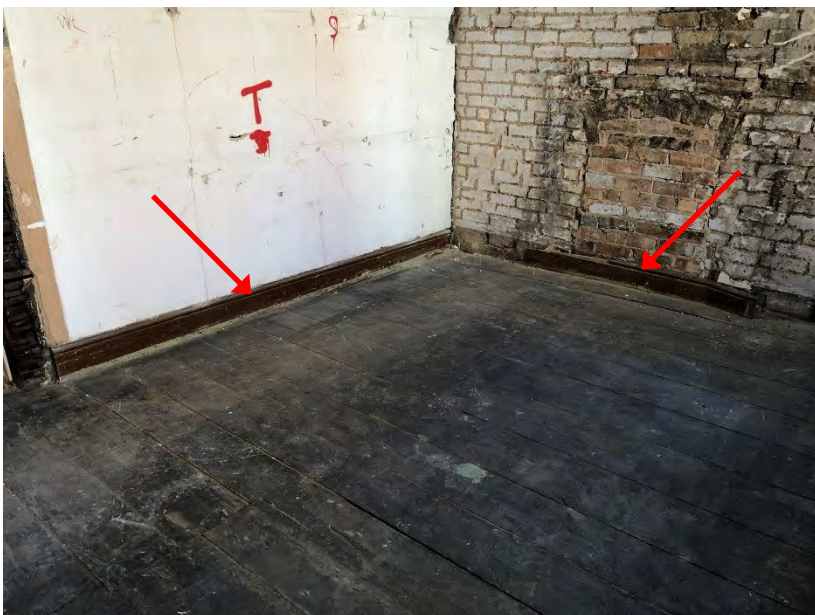
**Fig 18:**

Second floor, West corner; showing remnants of a softwood timber skirting board. Note that the existing skirting boards post date the blocking-up of the fireplace and therefore almost certainly non-original

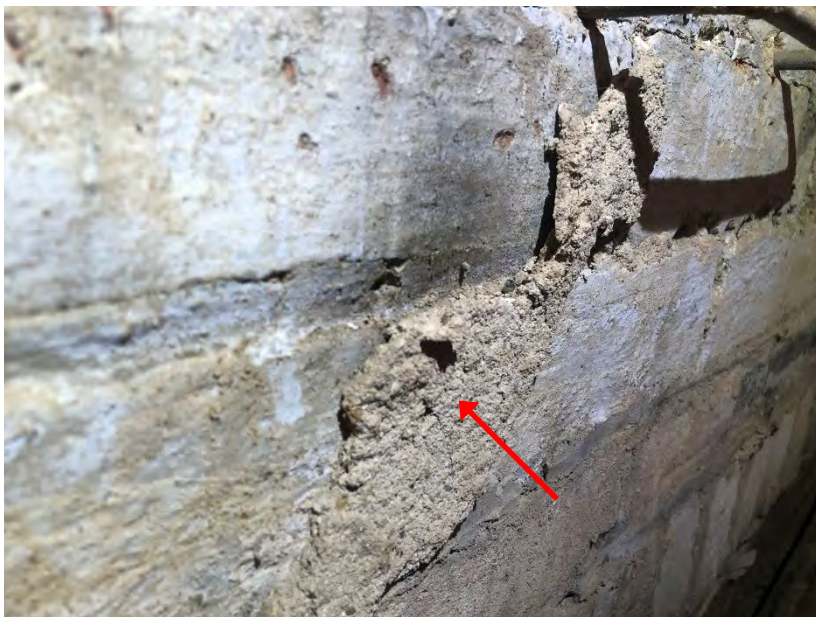
**Fig 20:**

Second floor, West corner; showing remnants of lime plaster applied over the earlier painted decorative scheme

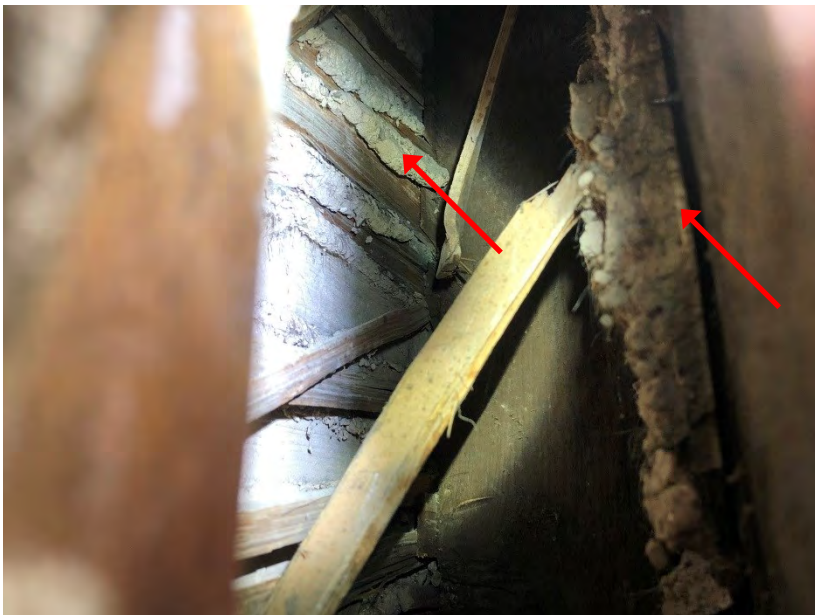
**Fig 22:**

Second floor, South staircase; showing a view inside the stud partition. Note lath and plaster had been applied to either side of the studwork

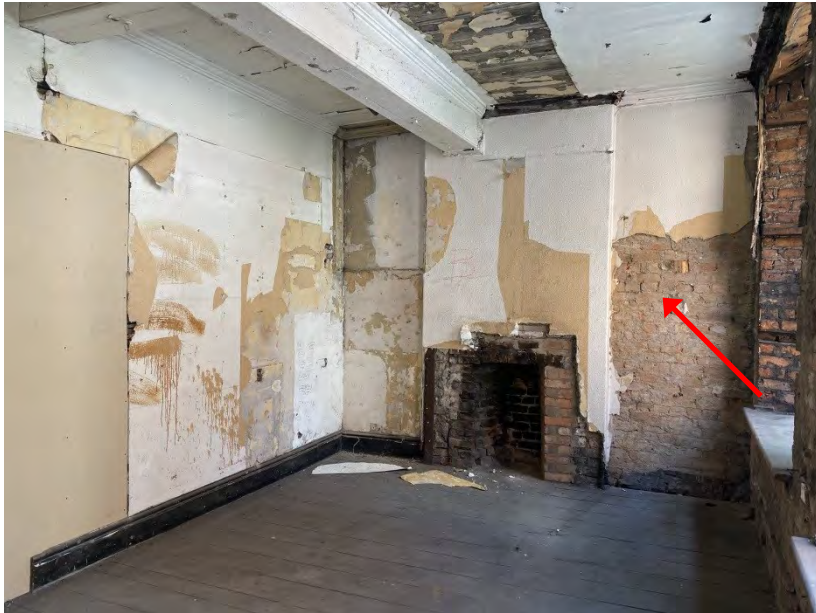
**Fig 25:**

First floor, West corner; showing remnants of lime plaster to the external walls. Plaster was in poor condition and largely debonded

Note that there was no evidence of previous decorative schemes to the brickwork

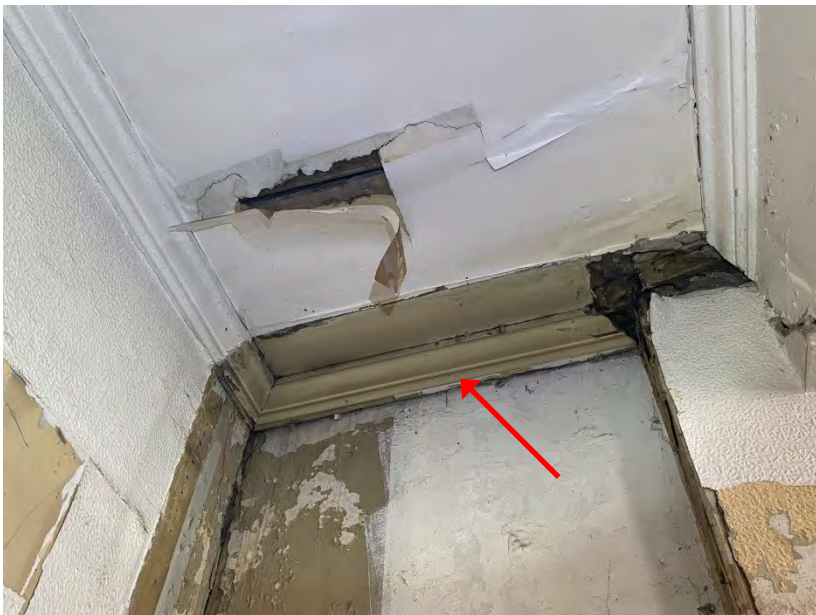
**Fig 26:**

First floor, West corner; showing remnants of lime plaster cornice applied to the underside of the floor timbers

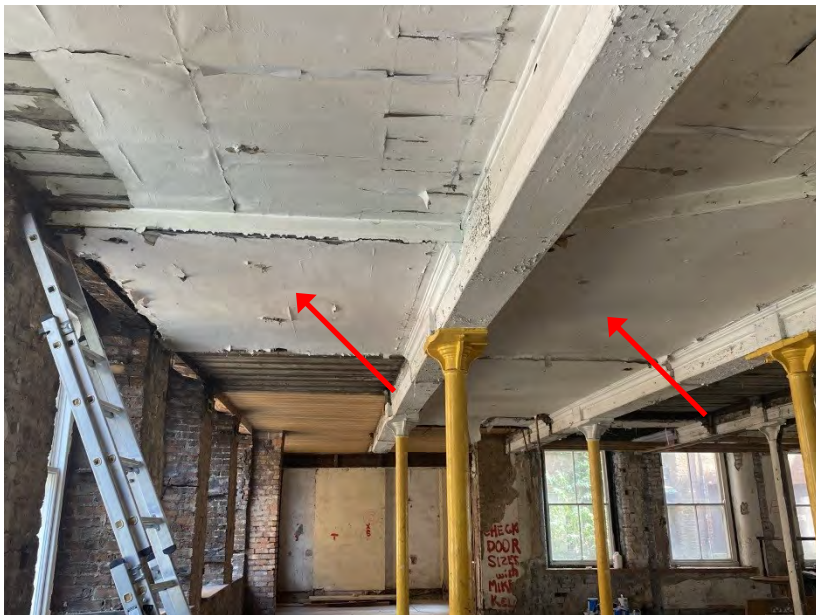
**Fig 28:**

First floor; showing small areas of surviving lath and plaster from bays no.7-10. The lath and plaster was non-original

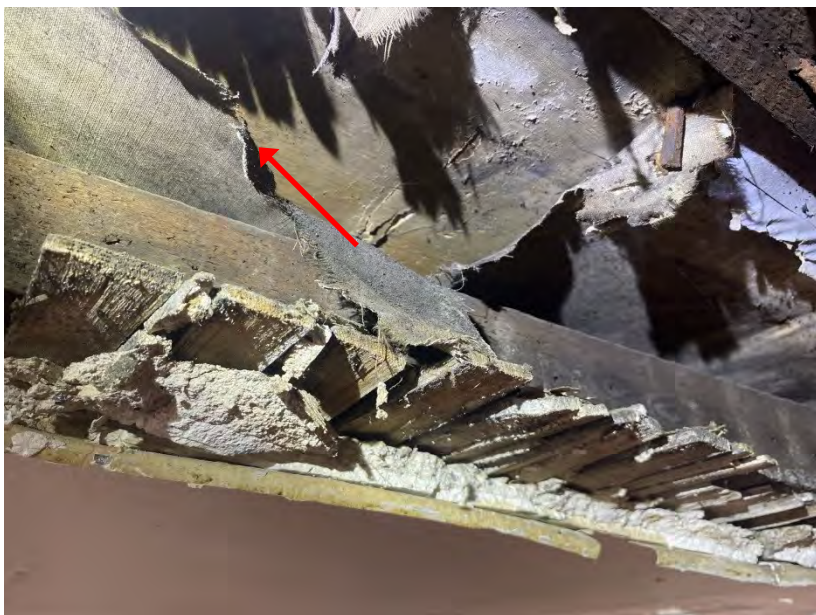
**Fig 30:**

First floor, Bay no.8-9; showing lath and plaster applied to the underside of ceiling joists that span from floor beam to beam. Note the earlier printed wallpapers applied to a machine made open-weave linen backing fixed to the underside of the floor above the lath and plaster ceiling

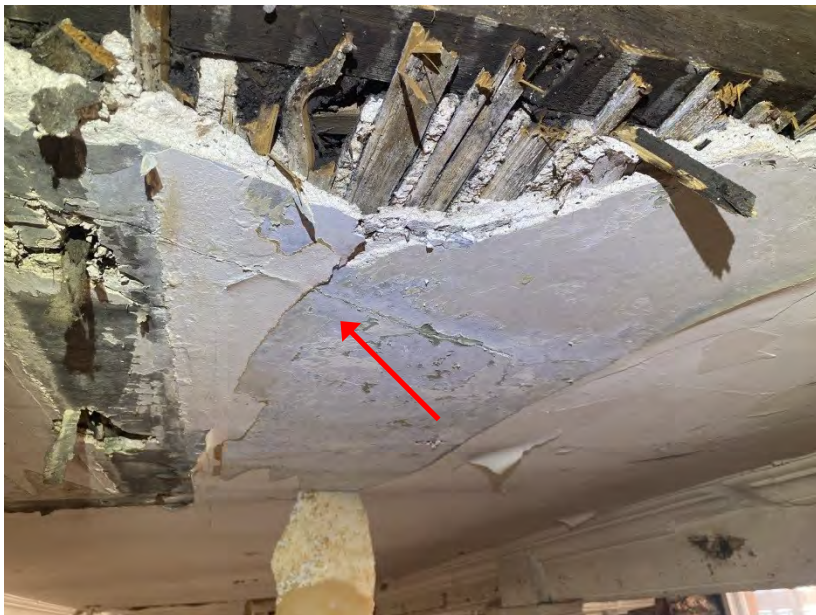
**Fig 32:**

First floor, Bay no.8-9; showing extensive cracking and failure of the lath and plaster ceiling

- 3 Lath and plaster to partitions and ceilings: Decayed or damaged laths should be replaced with new machine sawn laths and lime plaster reinstated as per above

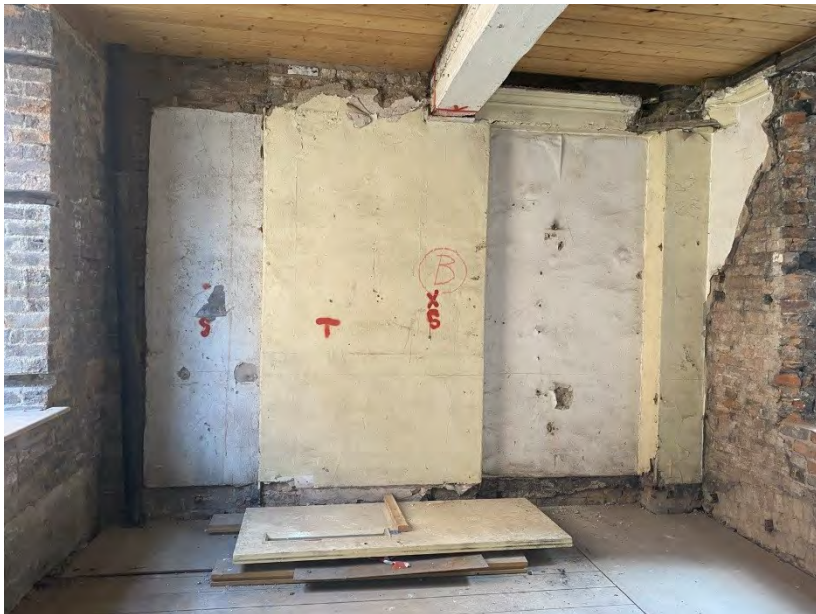
**Fig 33:**

First floor, North corner; showing remnants of lime plaster to the external walls. Plaster was in poor condition and largely debonded. Repair had also been undertaken with gypsum plaster in this area. A small section of plaster cornice survived here

Note that there was no evidence of previous decorative schemes to the brickwork

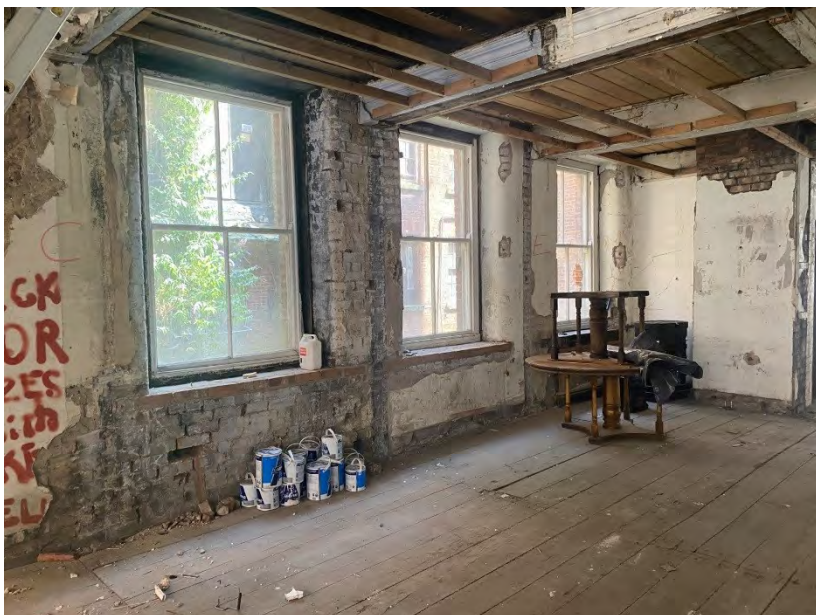
**Fig 34:**

First floor, Lift area; showing remnants of plaster to the external wall and lift wall. The plaster was non-original and in very poor condition in this area

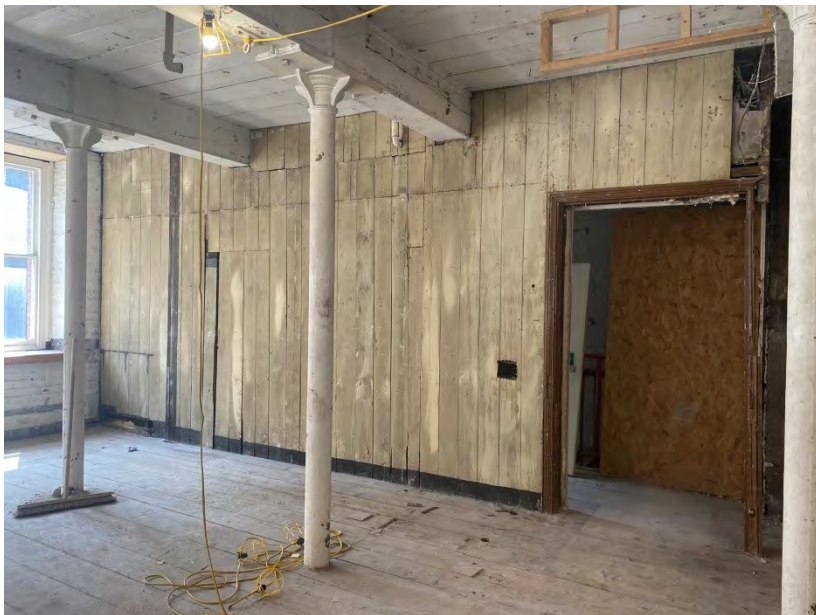
**Fig 36:**

First floor, South staircase; showing non-original softwood timber panelling to the staircase partition

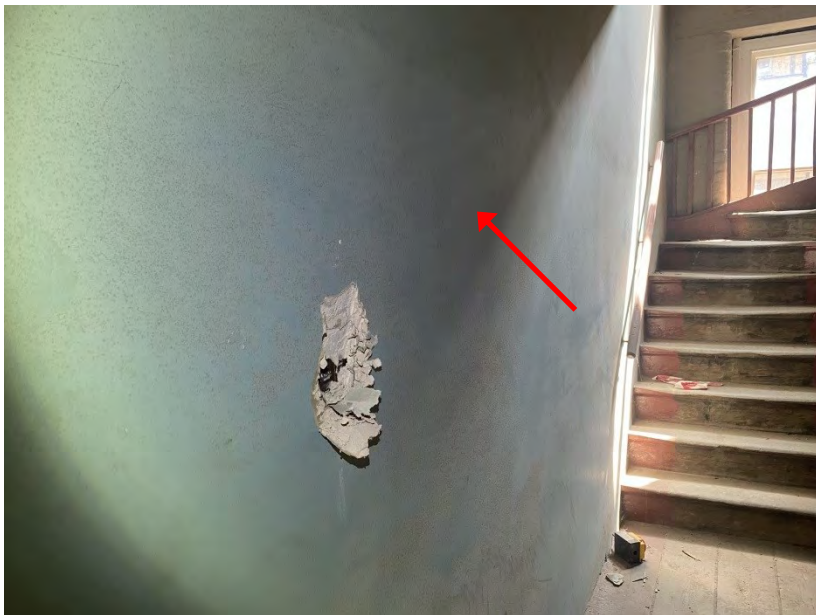
**Fig 38:**

First floor, South staircase; showing modern plasterboard applied over the lath and plaster in the stairwell. The condition of the lath and plaster behind is unknown

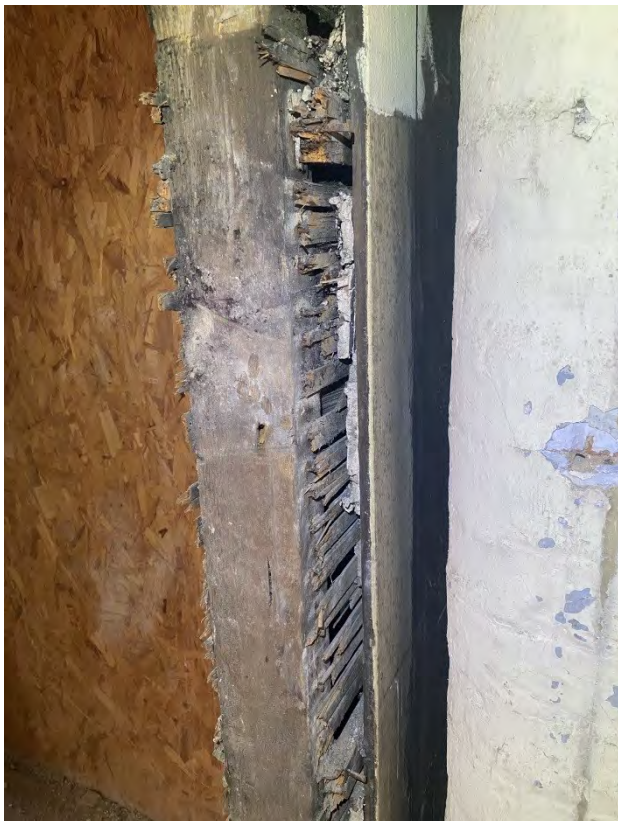
**Fig 40:**

First floor, South staircase; showing timber panelling applied over the lath and plaster. Note that these finishes predate the insertion of the lift shaft brickwork

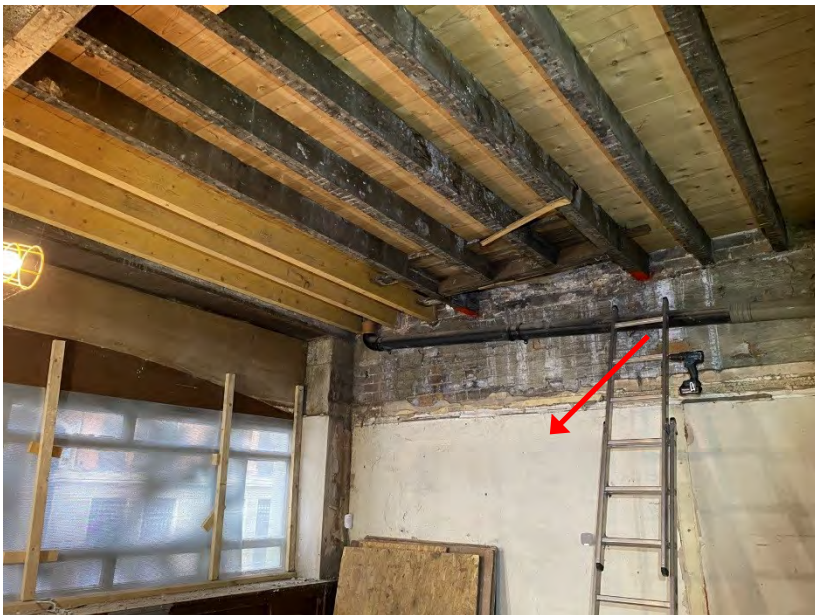
**Fig 44:**

Upper ground floor, North entrance lobby; showing modern plasterboard and non-original gypsum plaster finishes

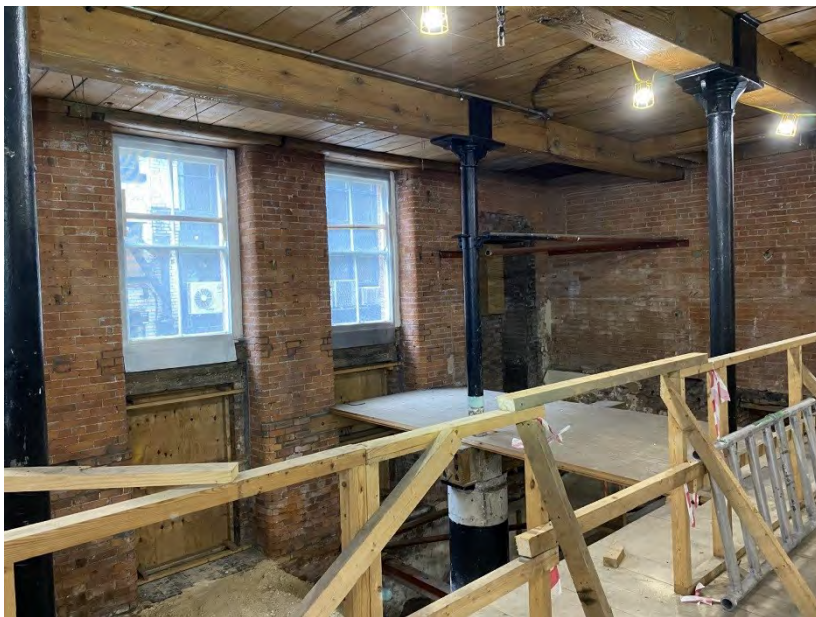
**Fig 46:**

Upper ground floor, south east corner; showing no decorative finishes to the external brickwork

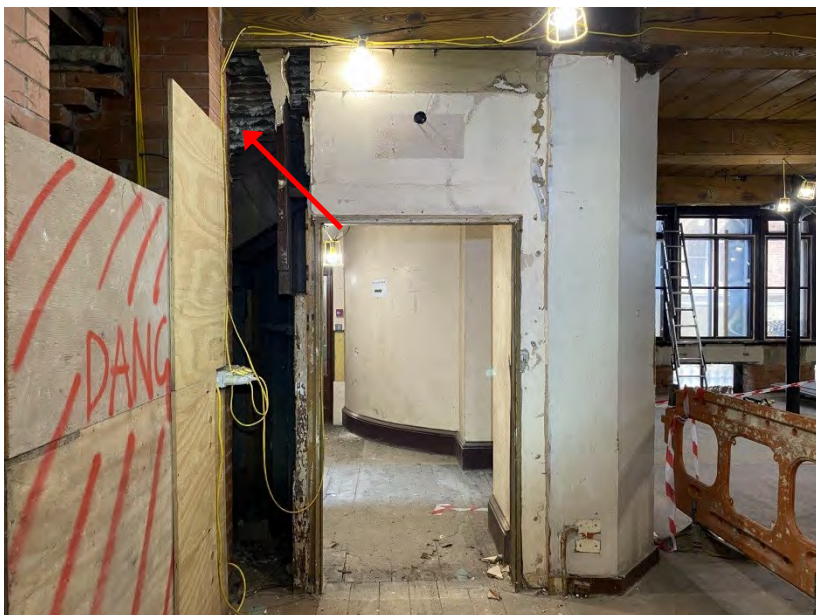
**Fig 48:**

Upper ground floor, West staircase lobby; showing the backside of the lath and plaster to the staircase. The plaster 'keys' were in good condition where visible

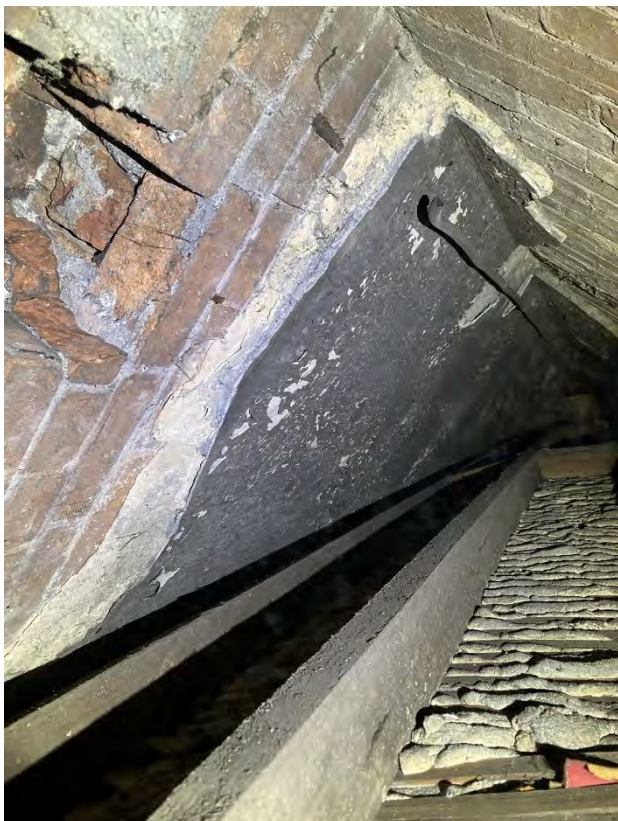
**Fig 50:**

Upper ground floor, West staircase;  
showing a view of the void behind the  
lath and plaster staircase. Note the  
original/early lime plaster to the  
external wall

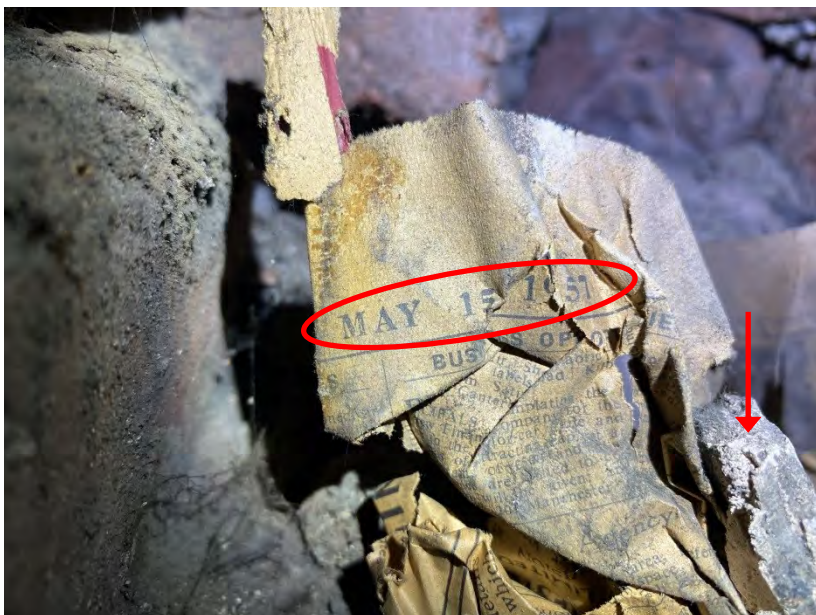
**Fig 52:**

Upper ground floor, West staircase; showing the date (1957) on the newspaper which probably dates from the period the staircase was constructed. Note that the section of lime plaster had been applied over the newspaper

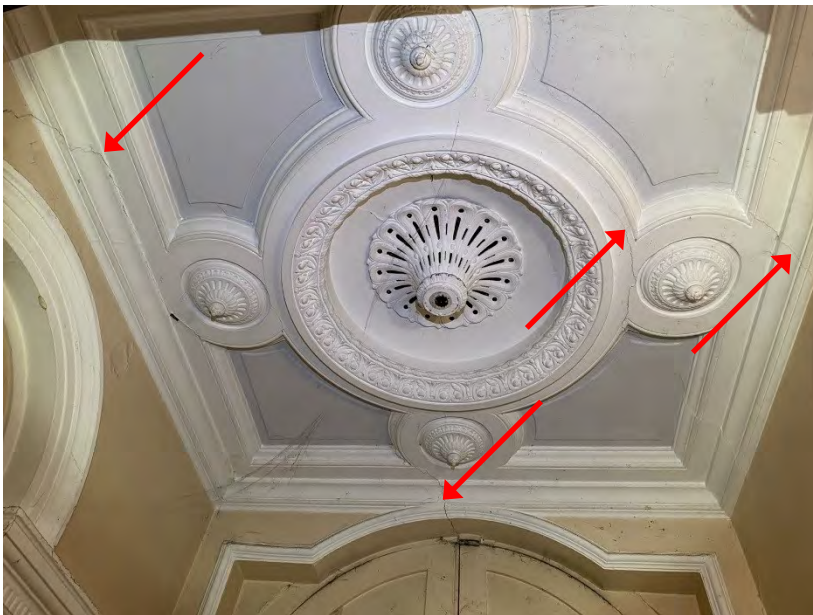
**Fig 56:**

Upper ground floor, West entrance lobby; showing examples of minor cracking in the decorative ceiling, mouldings and cornice

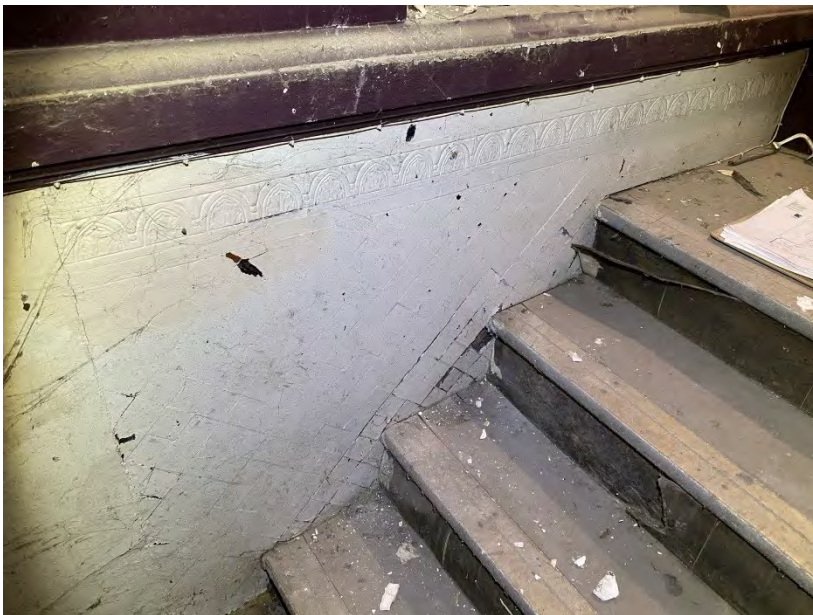
**Fig 58:**

Upper ground floor, West entrance lobby; showing painted glazed tiling at low level. A proportion of the tiles were loose and a small number were missing

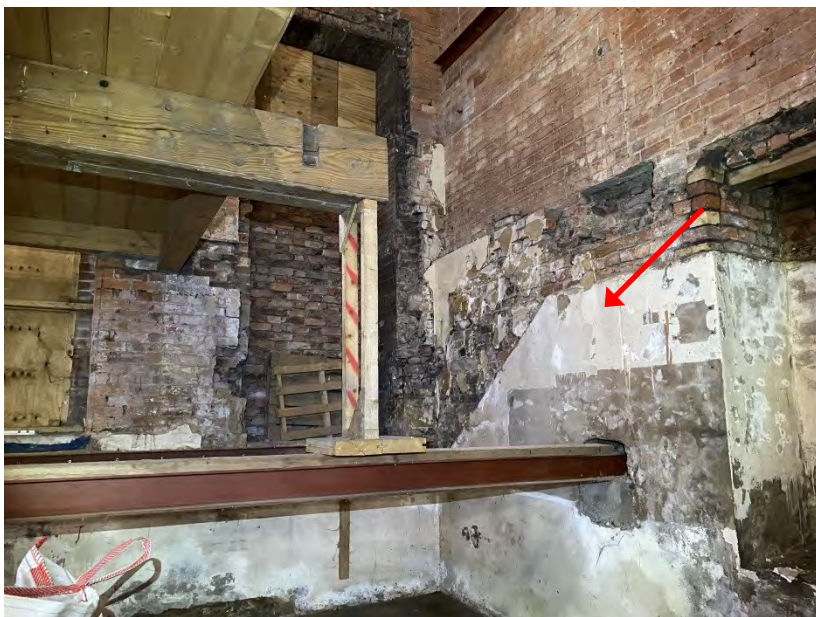
**Fig 60:**

Lower ground floor, South east corner; showing use of cementitious plaster tanking to the external walls. The plaster had largely debonded

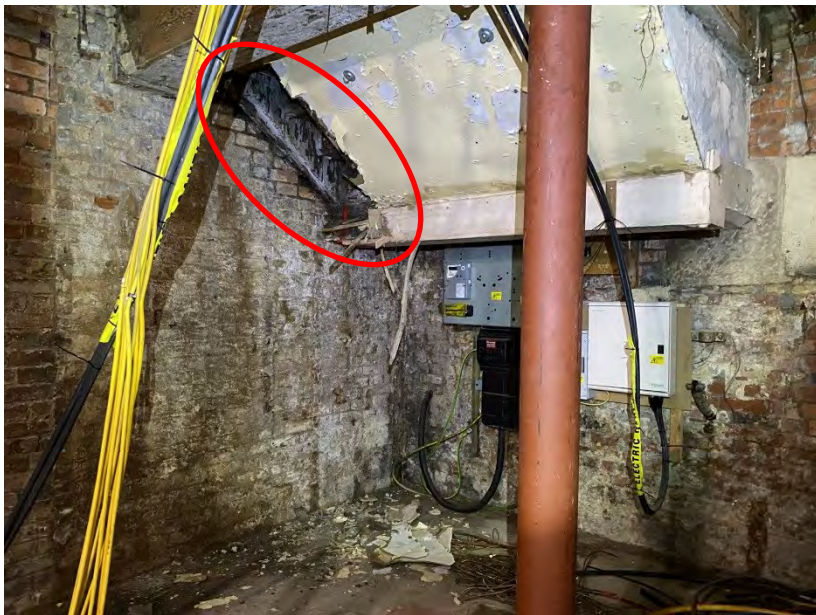
**Fig 62:**

Lower ground floor, West entrance stairs; showing the use of lath and plaster to the underside of the stairs. The area was subject to water penetration and the lath and plaster was damp and partially decayed

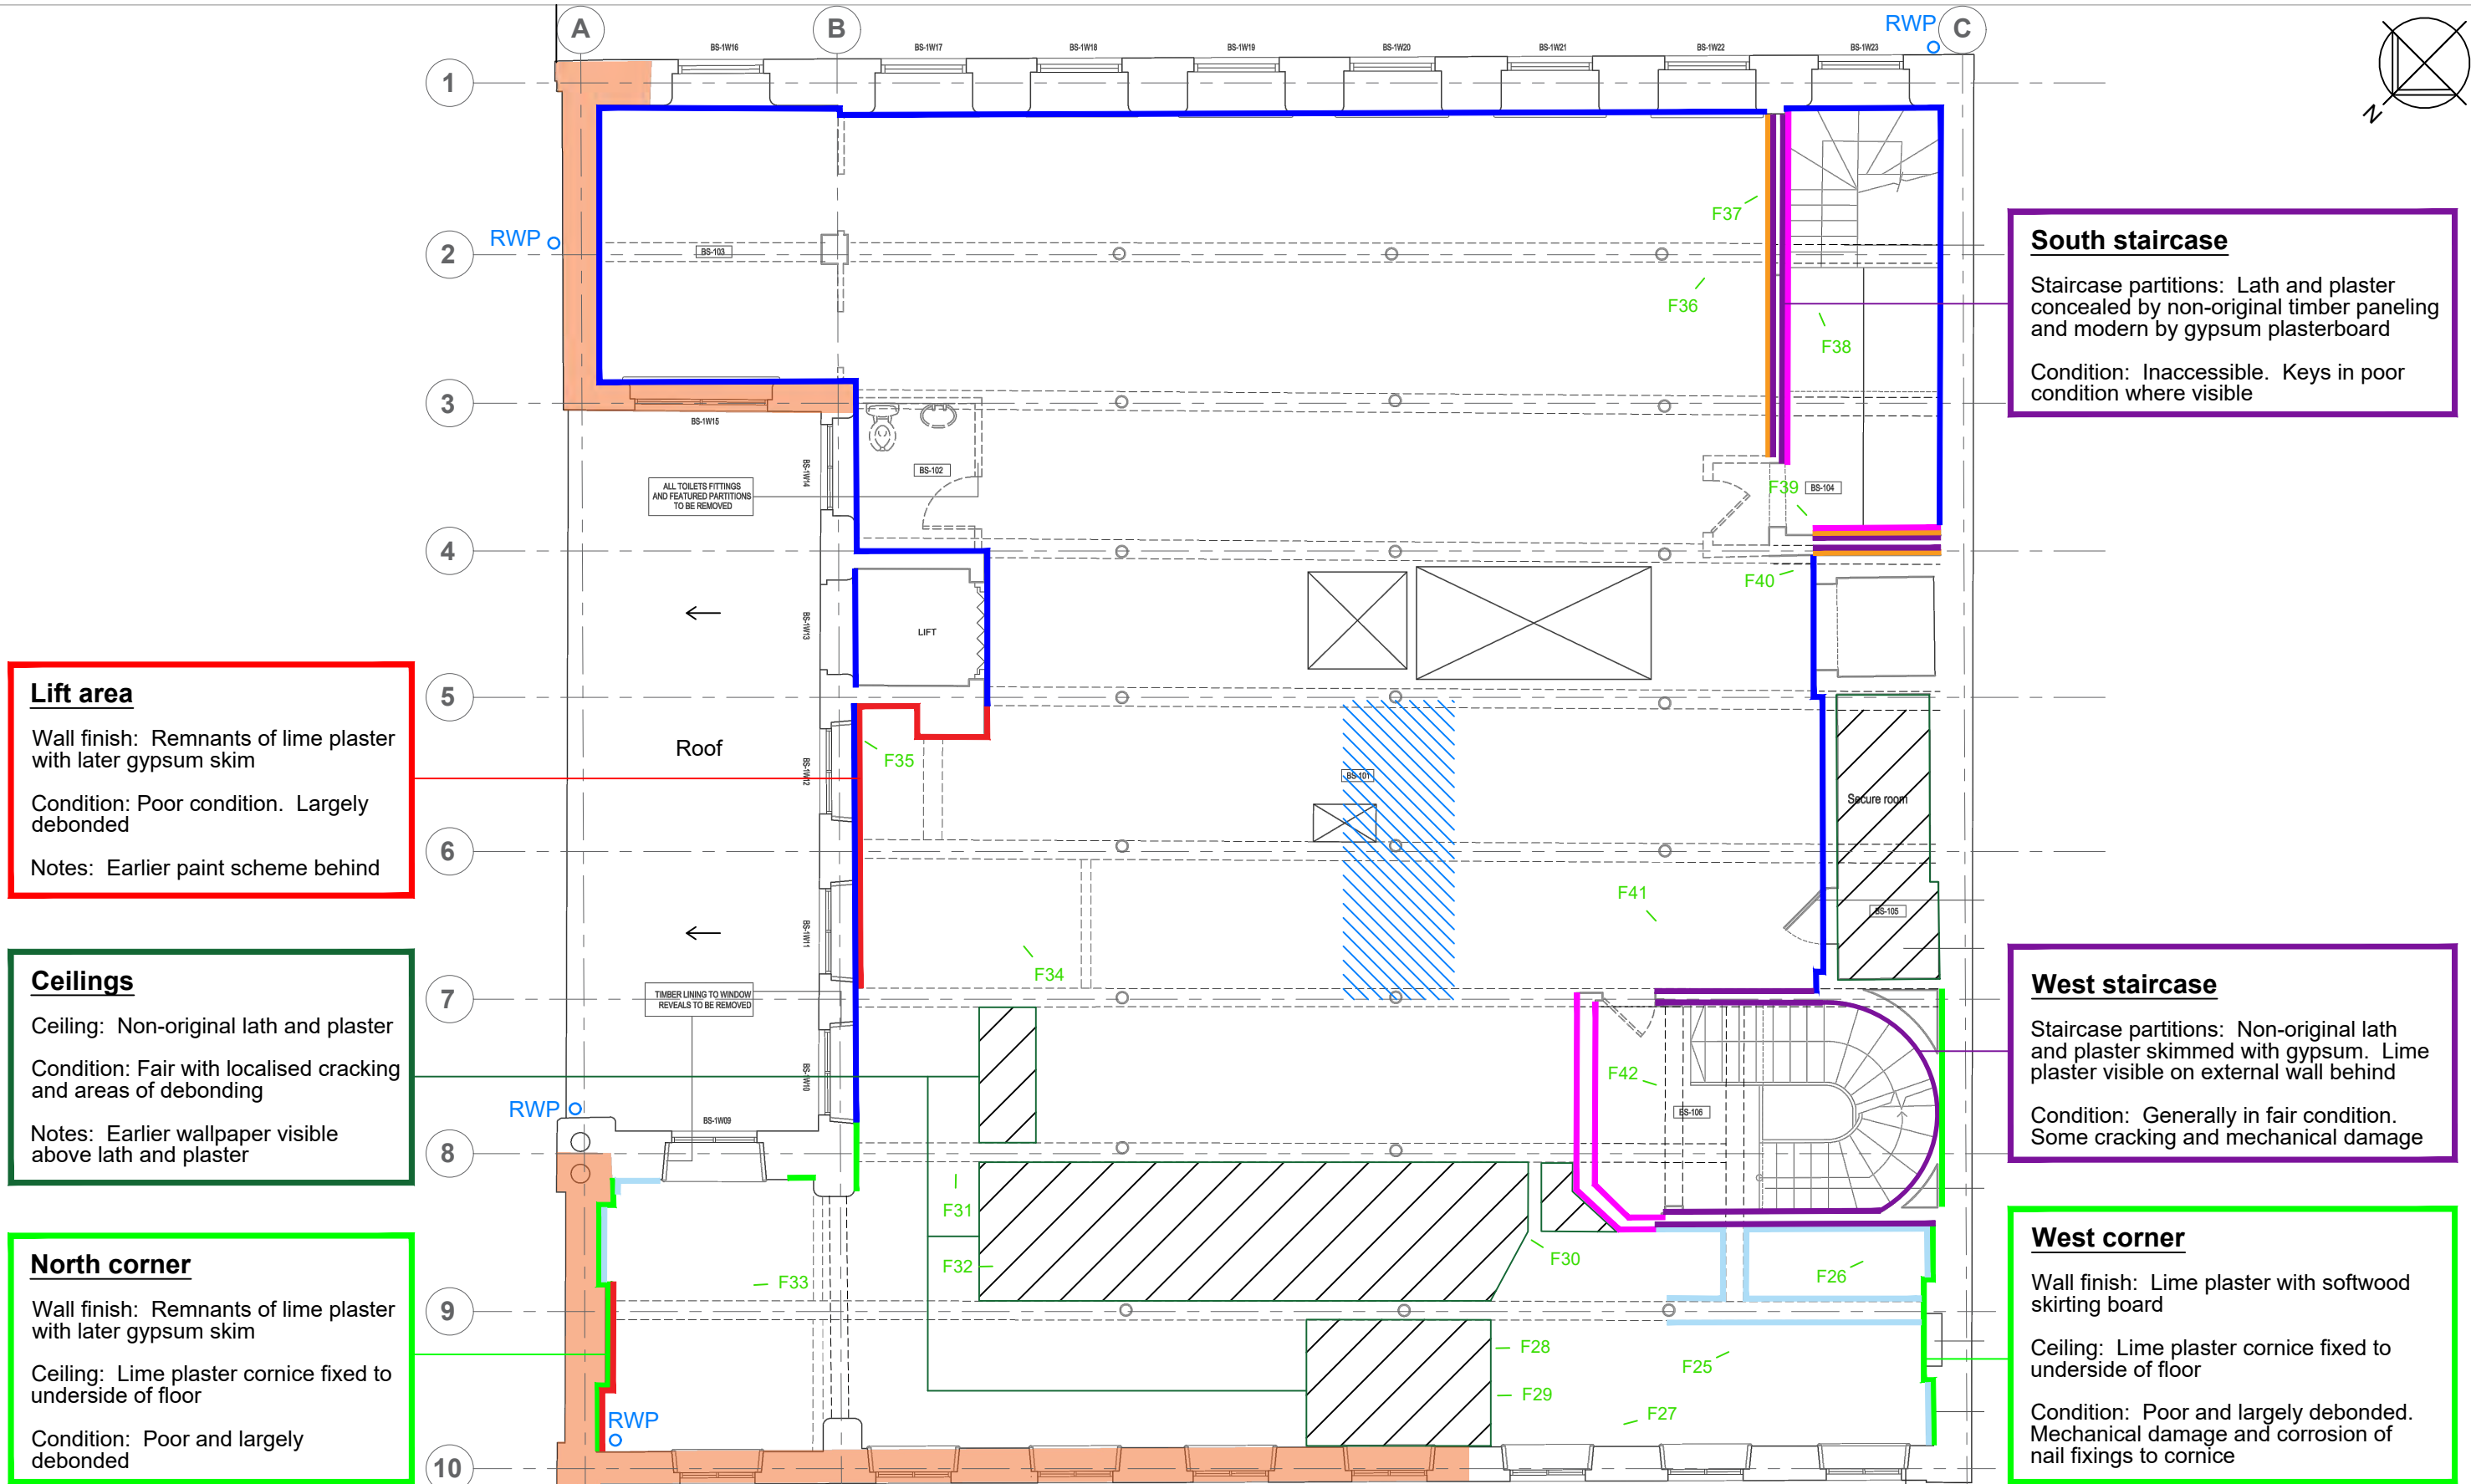
**Lift area**

Wall finish: Remnants of lime plaster with later gypsum skim

Condition: Poor condition. Largely debonded

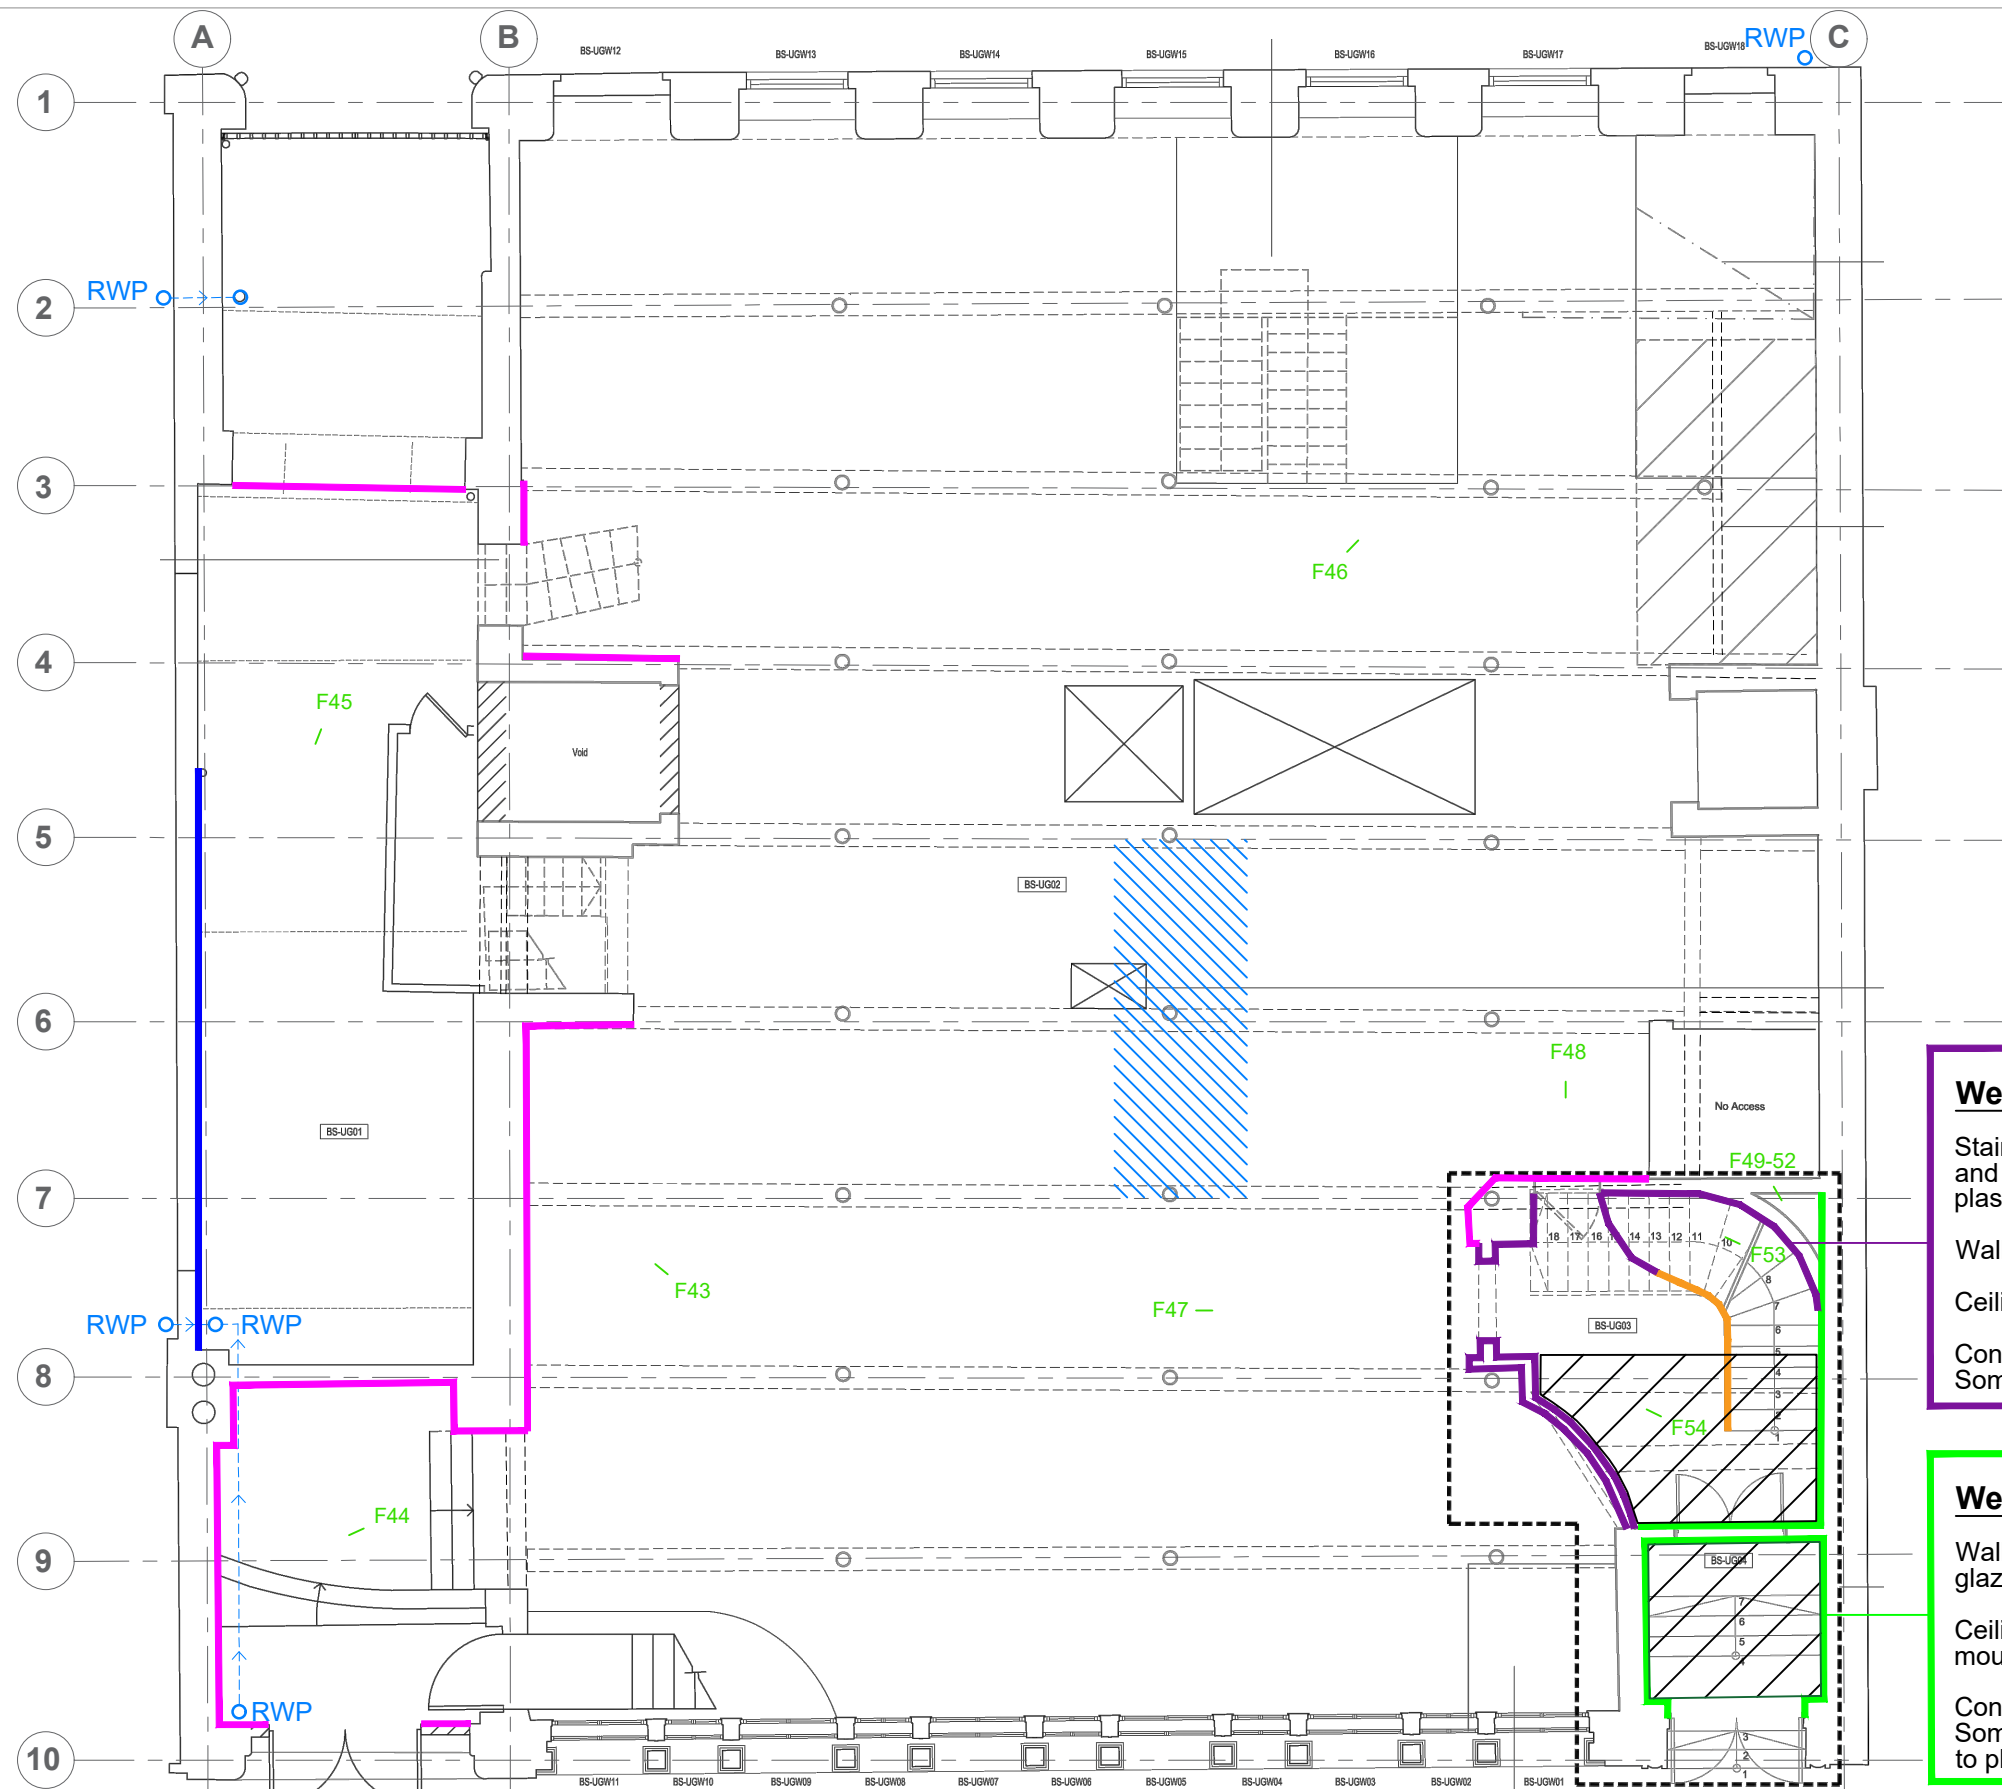
**West staircase and lobby**

Staircase partitions: Non-original lath and plaster skimmed with gypsum. Lime plaster visible on external wall behind

Condition: Generally in good condition. Some cracking and mechanical damage

Condition: Generally in fair condition. Some cracking and mechanical damage to plaster. Some missing/loose tiles
