# Hutton + Rostron Environmental Investigations Limited

## 11 Bloom Street, Manchester: Plaster condition survey

Site note 5 for 17 April and 26 July 2021, job no. 212.57  
REVISION A - 25.04.22

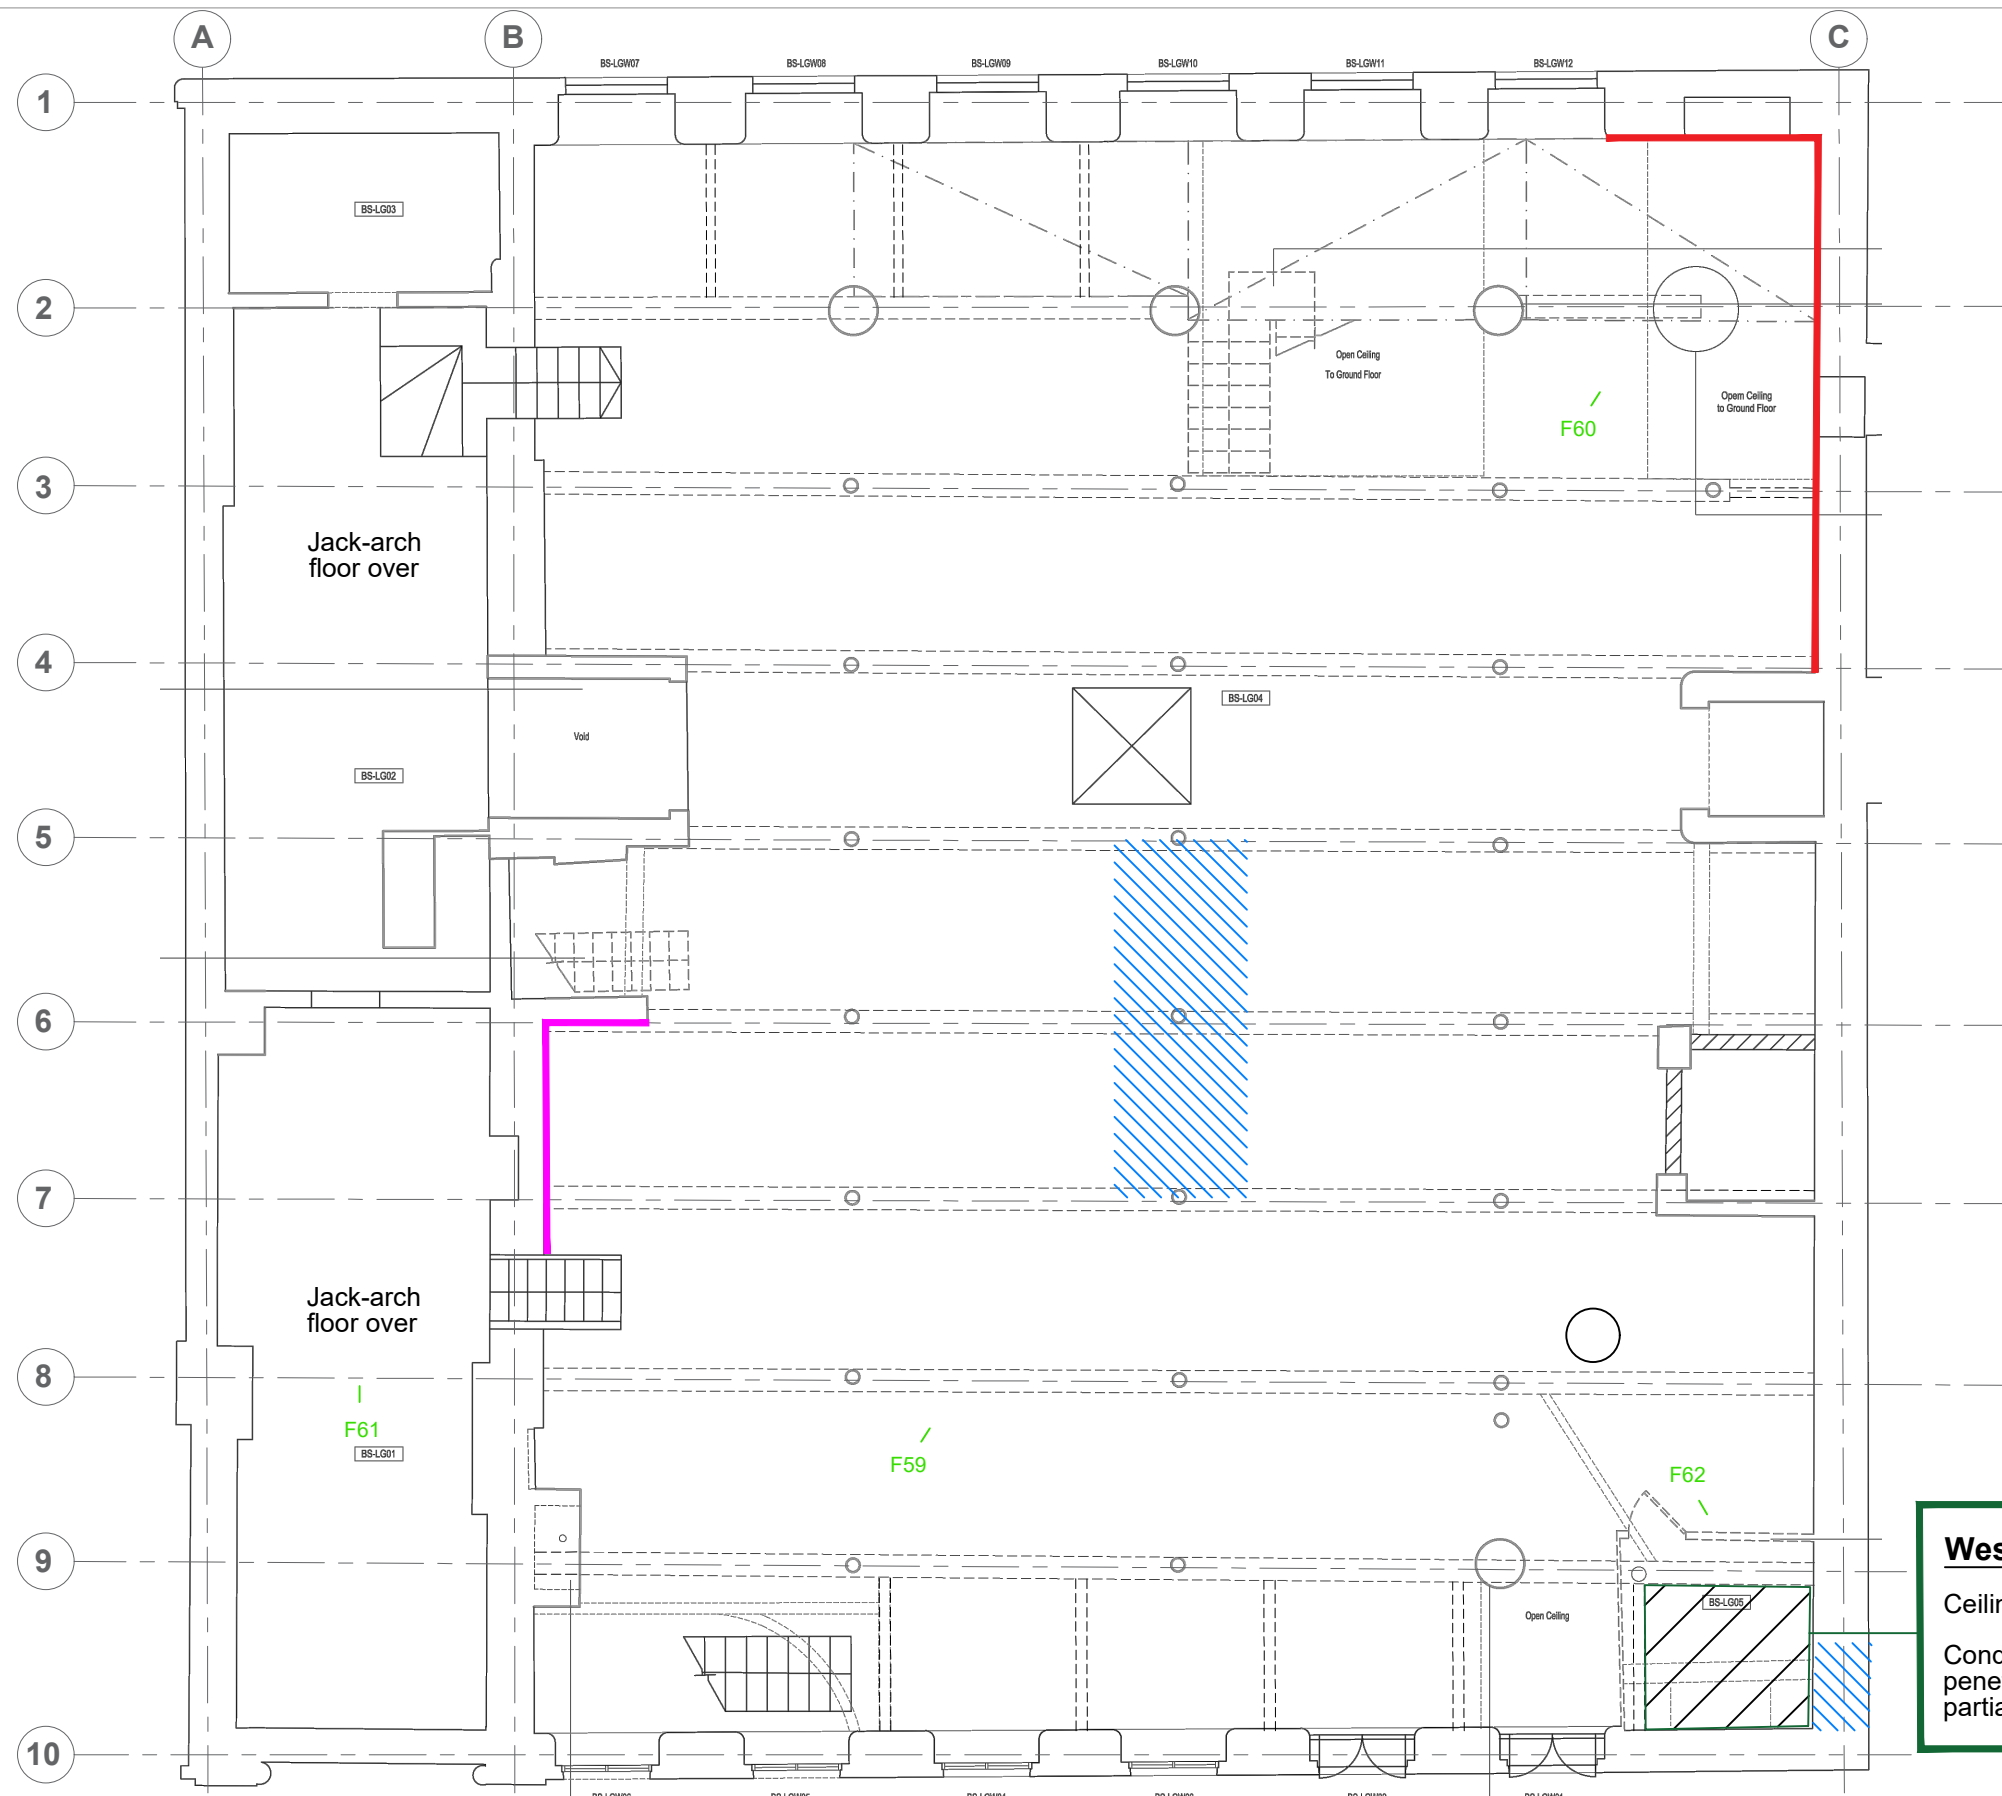
**West entrance stairs**

Ceiling: Lath and plaster beneath stair

Condition: Area subject to water penetration. Lath and plaster damp and partially decayed
