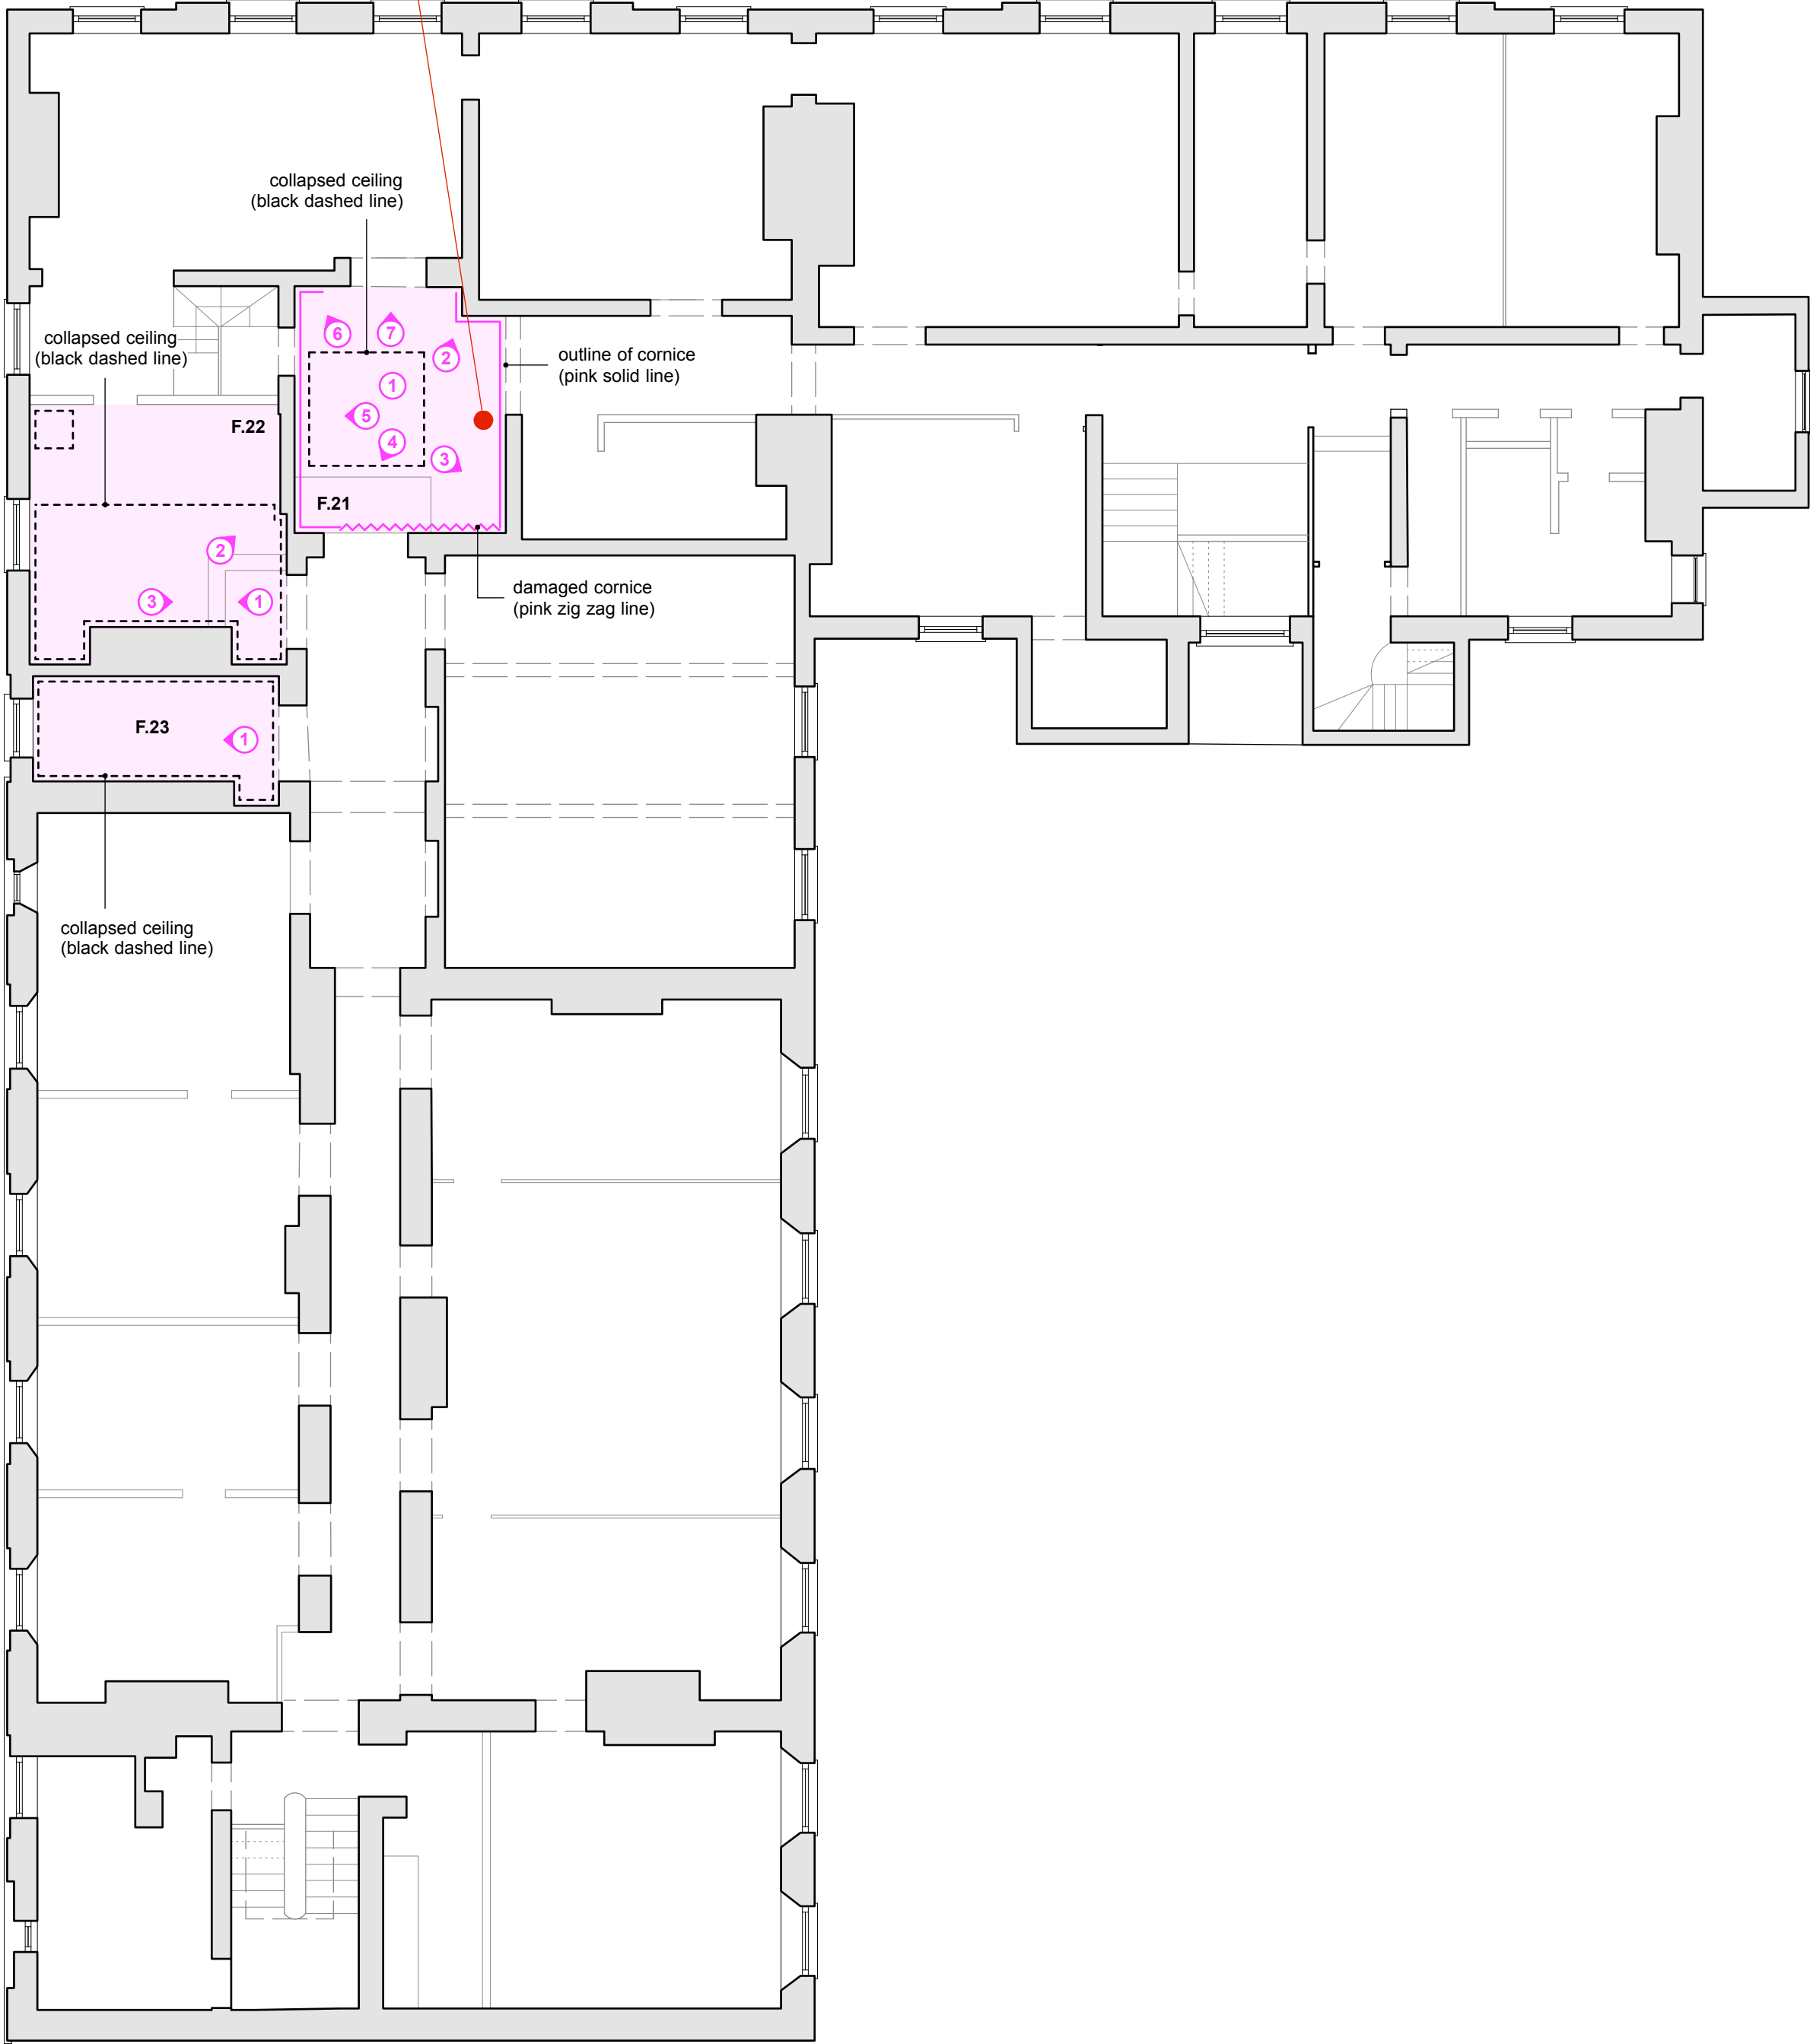
ROOM F.21

- Cornice as noted on the plan
- Some of the cornice is damaged and/or missing
- Partially collapsed ceiling as noted on the plan
- Plasterboard ceiling
- Bad water damage to ceiling

existing lathe and plaster ceiling  
to be underboarded  
[with 2 layers of fire board]  
existing cornice to be retained  
repaired as necessary  
[where cornice is missing  
remold will take place]
