# Drainage Report

**27 Dale Street**  
**Manchester**  
**Manchester**

**Dale Street Manchester - CCTV Survey Report : 27/01/22**

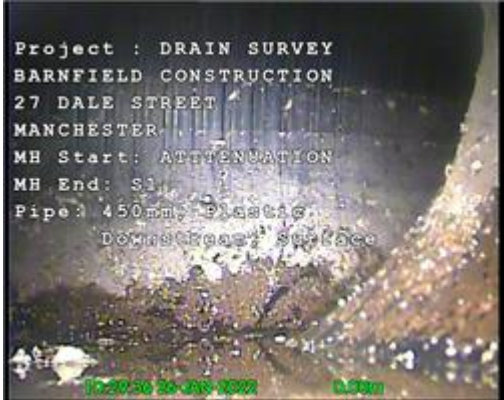
| Pos | Video Ref | Code | Description | Image |
|---|---|---|---|---|
| 00.00m | | MH | Start node type, manhole Attenuation 1 | <p>Image Provided - Ref: 0_0</p> |

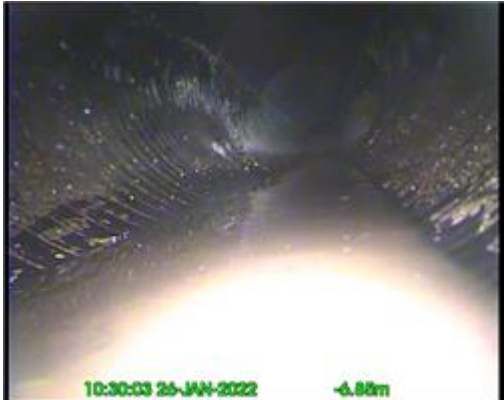
| Pos | Video Ref | Code | Description | Image |
|---|---|---|---|---|
| 06.85m | | MHF | Finish node type, manhole S1 | <p>Image Provided - Ref: 0_9999</p> |

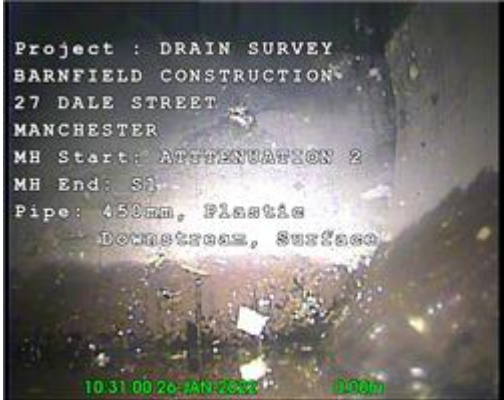
| Pos | Video Ref | Code | Description | Image |
|---|---|---|---|---|
| 00.00m | | MH | Start node type, manhole Attenuation 2 | <p>Image Provided - Ref: 1_0</p> |

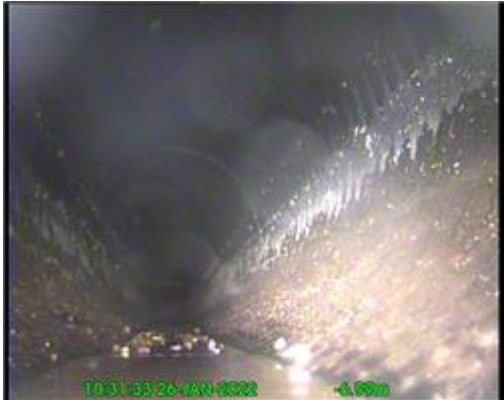
| Pos | Video Ref | Code | Description | Image |
|---|---|---|---|---|
| 06.99m | | MHF | Finish node type, manhole S1 | <p>Image Provided - Ref: 1_9999</p> |

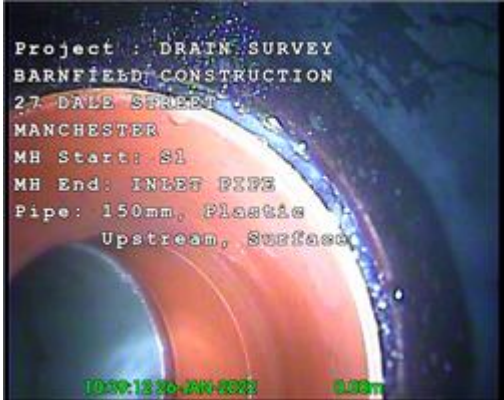
| Pos | Video Ref | Code | Description | Image |
|---|---|---|---|---|
| 00.00m | | MH | Start node type, manhole S1 | <p>Image Provided - Ref: 2_0</p> |

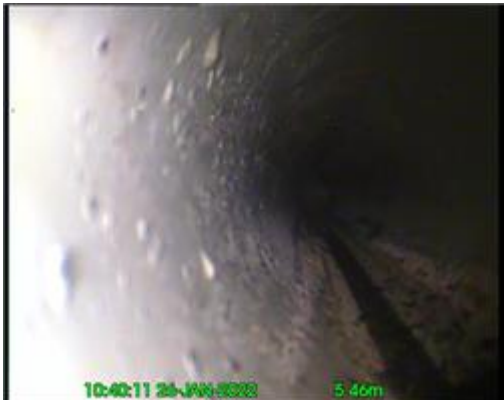
| Pos | Video Ref | Code | Description | Image |
|---|---|---|---|---|
| 05.46m | | BRF | Finish node type, major connection without manhole Inlet Pipes | <p>Image Provided - Ref: 2_9999</p> |

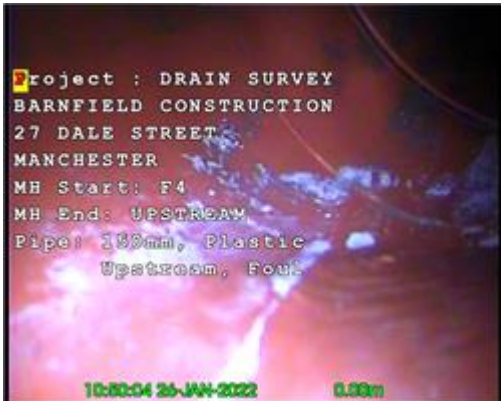
| Pos | Video Ref | Code | Description | Image |
|---|---|---|---|---|
| 00.00m | | MH | Start node type, manhole F4 | <p>Image Provided - Ref: 3_0</p> |

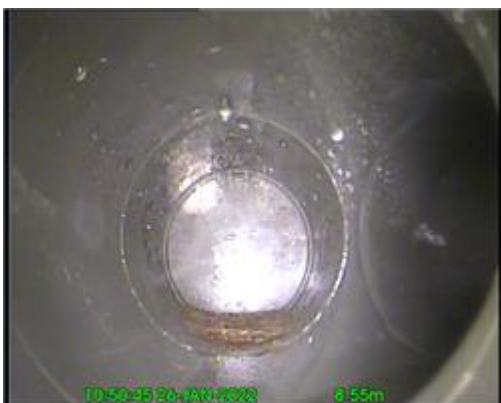
| Pos | Video Ref | Code | Description | Image |
|---|---|---|---|---|
| 08.60m | | BRF | Finish node type, major connection without manhole Upstream | <p>Image Provided - Ref: 3_9999</p> |

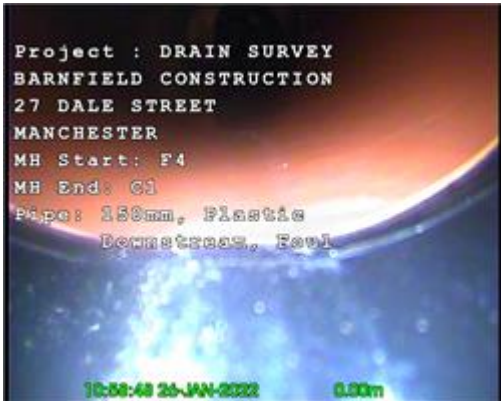
| Pos | Video Ref | Code | Description | Image |
|---|---|---|---|---|
| 00.00m | | MH | Start node type, manhole F4 | <p>Image Provided - Ref: 4_0</p> |

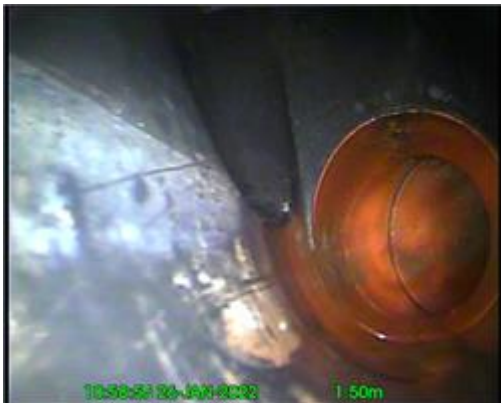
| Pos | Video Ref | Code | Description | Image |
|---|---|---|---|---|
| 01.50m | | MHF | Finish node type, manhole C1 | <p>Image Provided - Ref: 4_9999</p> |

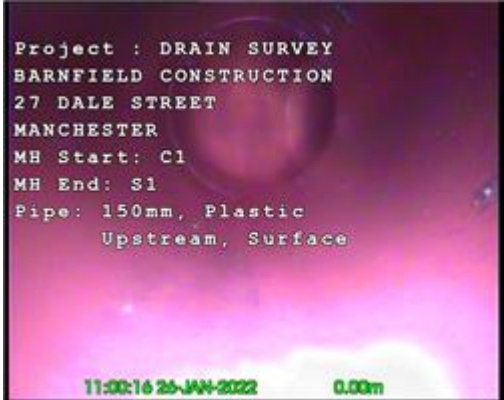
| Pos | Video Ref | Code | Description | Image |
|---|---|---|---|---|
| 00.00m | | MH | Start node type, manhole C1 | <p>Image Provided - Ref: 5_0</p> |

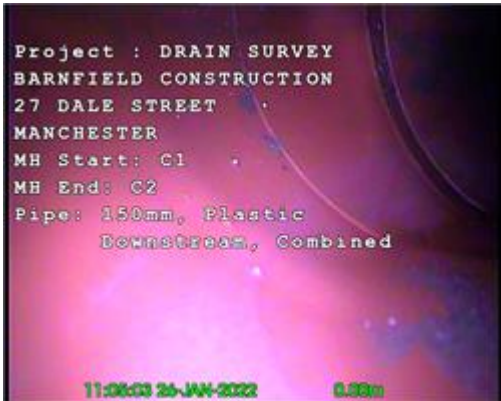
| Pos | Video Ref | Code | Description | Image |
|---|---|---|---|---|
| 00.00m | | MH | Start node type, manhole C1 | <p>Image Provided - Ref: 6_0</p> |

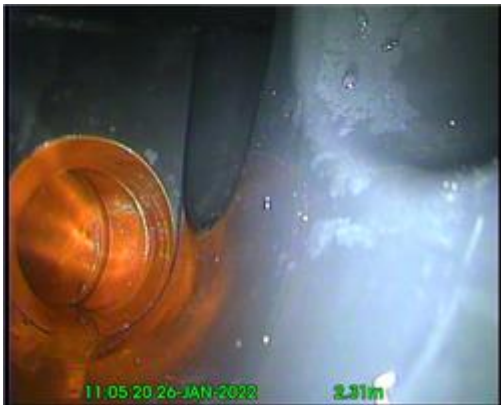
| Pos | Video Ref | Code | Description | Image |
|---|---|---|---|---|
| 02.31m | | MHF | Finish node type, manhole C2 | <p>Image Provided - Ref: 6_9999</p> |

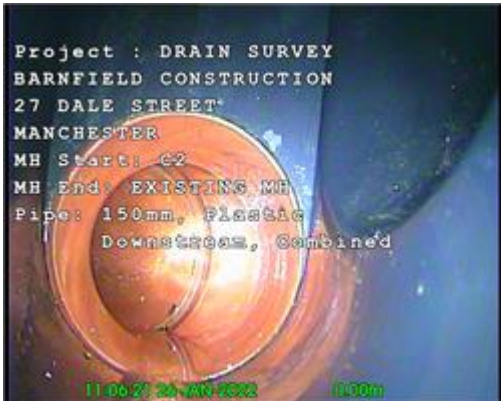
| Pos | Video Ref | Code | Description | Image |
|---|---|---|---|---|
| 00.00m | | MH | Start node type, manhole C2 | <p>Image Provided - Ref: 7_0</p> |

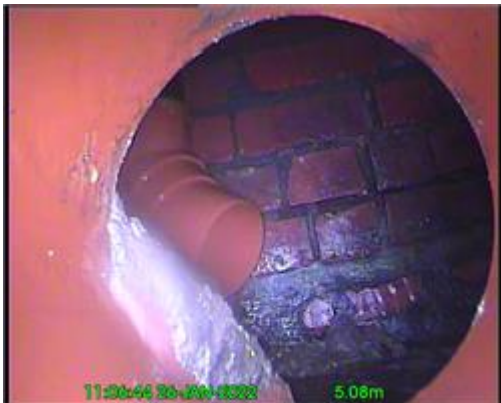
| Pos | Video Ref | Code | Description | Image |
|---|---|---|---|---|
| 05.08m | | MHF | Finish node type, manhole Existing MH | <p>Image Provided - Ref: 7_9999</p> |

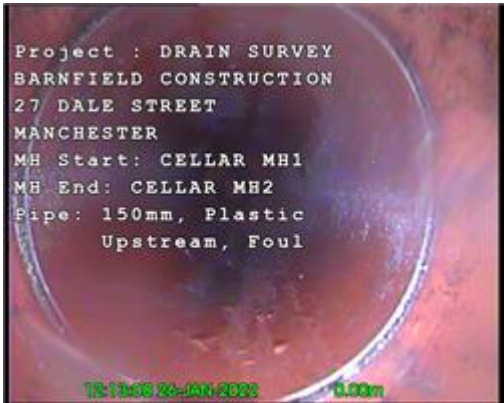
| Pos | Video Ref | Code | Description | Image |
|---|---|---|---|---|
| 00.00m | | MH | Start node type, manhole<br>Cellar MH1 | <p>Image Provided - Ref: 8_0</p> |

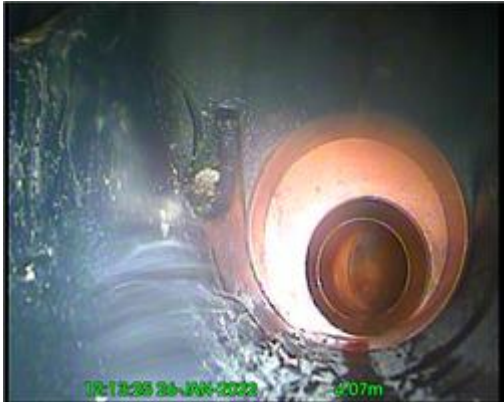
| Pos | Video Ref | Code | Description | Image |
|---|---|---|---|---|
| 04.07m | | MHF | Finish node type, manhole<br>Cellar MH2 | <p>Image Provided - Ref: 8_9999</p> |

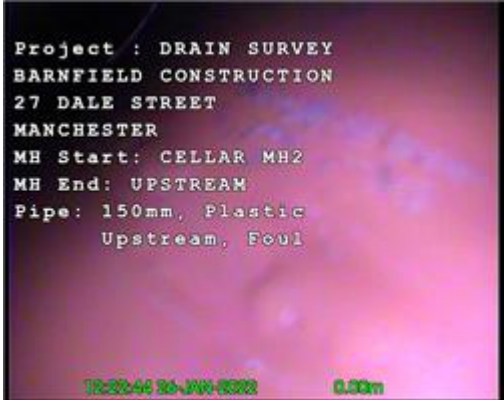
| Pos | Video Ref | Code | Description | Image |
|---|---|---|---|---|
| 00.00m | | MH | Start node type, manhole<br>Cellar MH2 | Image Provided - Ref: 9_0<br> |

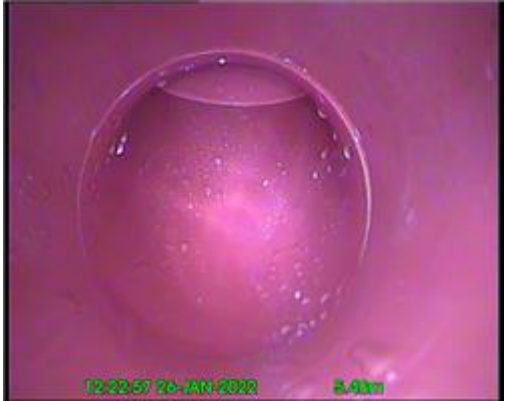
| Pos | Video Ref | Code | Description | Image |
|---|---|---|---|---|
| 05.40m | | BRF | Finish node type, major connection without manhole Upstream | <p>Image Provided - Ref: 9_9999</p> |

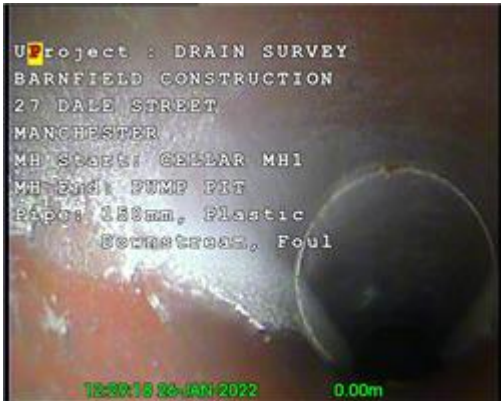
| Pos | Video Ref | Code | Description | Image |
|---|---|---|---|---|
| 00.00m | | MH | Start node type, manhole<br>Cellar MH1 | Image Provided - Ref: 10_0<br> |

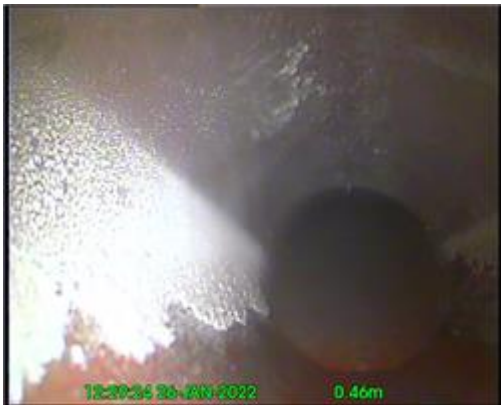
| Pos | Video Ref | Code | Description | Image |
|---|---|---|---|---|
| 00.46m | | BRF | Finish node type, major<br>connection without manhole<br>Pump Pit | Image Provided - Ref: 10_9999<br> |

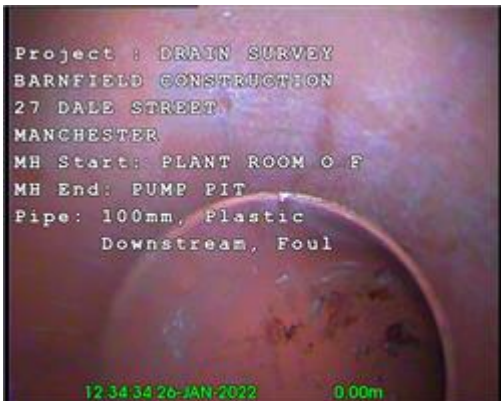
| Pos | Video Ref | Code | Description | Image |
|---|---|---|---|---|
| 00.00m | | MH | Start node type, manhole<br>PlantRoom Drain | <p>Image Provided - Ref: 11_0</p> |

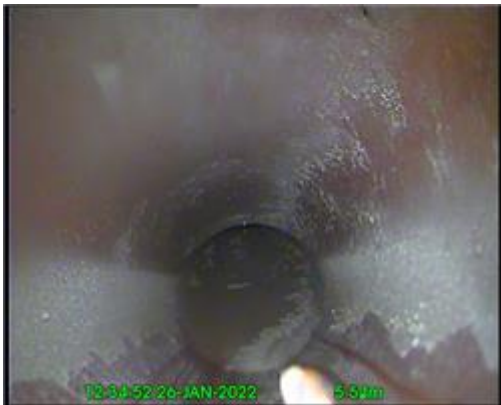
| Pos | Video Ref | Code | Description | Image |
|---|---|---|---|---|
| 05.64m | | MHF | Finish node type, manhole<br>Pump Pit | <p>Image Provided - Ref: 11_9999</p> |
