## Additional Ground Investigation & Revised Remediation Strategy

LK Consult (LKC) has been retained by Torsion Construction Ltd to carry out additional ground investigation works at the proposed development at Mirabel Street, Manchester. Location and proposed development plans are provided in Appendix A.

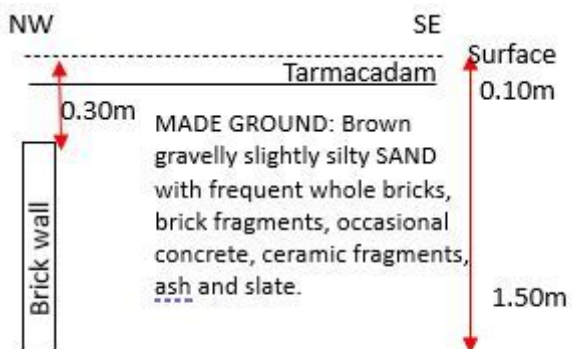
TT101C (centre) Cross section S1. Not to scale.

| Depth<br>(m) | Sample / Tests | Water<br>Depth<br>(m) | Field Records | Level<br>(mOD) | Depth<br>(m)<br>(Thickness) | Description | Legend | Water |
|---|---|---|---|---|---|---|---|---|
| | | | | | (1.40) | MADE GROUND: Brown gravelly slightly silty SAND with frequent whole bricks, brick fragments, occasional concrete, ceramic fragments, ash and slate. Sand is fine to coarse. Gravel is fine to coarse, sub-angular to sub-rounded comprising sandstone.<br>Wall encountered at 0.30mbgl running approximately south west - north east. Base of wall not encountered as made ground collapsing into pit. Cables run along wall at approximately 0.80mbgl. | | |

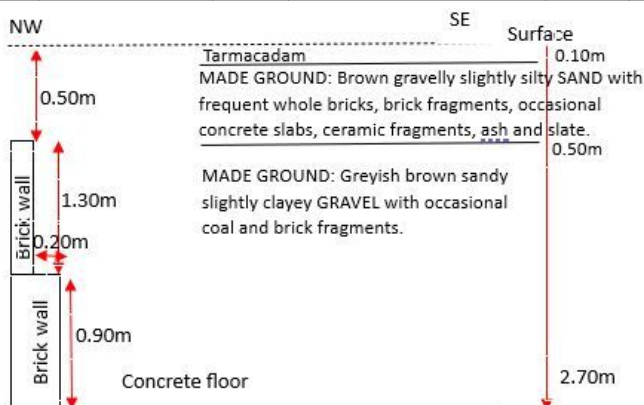
TT101S (south) Cross section S1. Not to scale.

| Depth<br>(m) | Sample / Tests | Water<br>Depth<br>(m) | Field Records | Level<br>(mOD) | Depth<br>(m)<br>(Thickness) | Description | Legend | Water |
|---|---|---|---|---|---|---|---|---|
| | | | | | 2.70 | Concrete floor encountered at 2.70mbgl.<br>Complete at 2.70m | | |
