# Site Investigation Report

97980.1.USI

| Brief | Auger were commissioned by Crawford & Co to undertake a site investigation and CCTV inspection of the underground drainage within the area of concern at the property. |

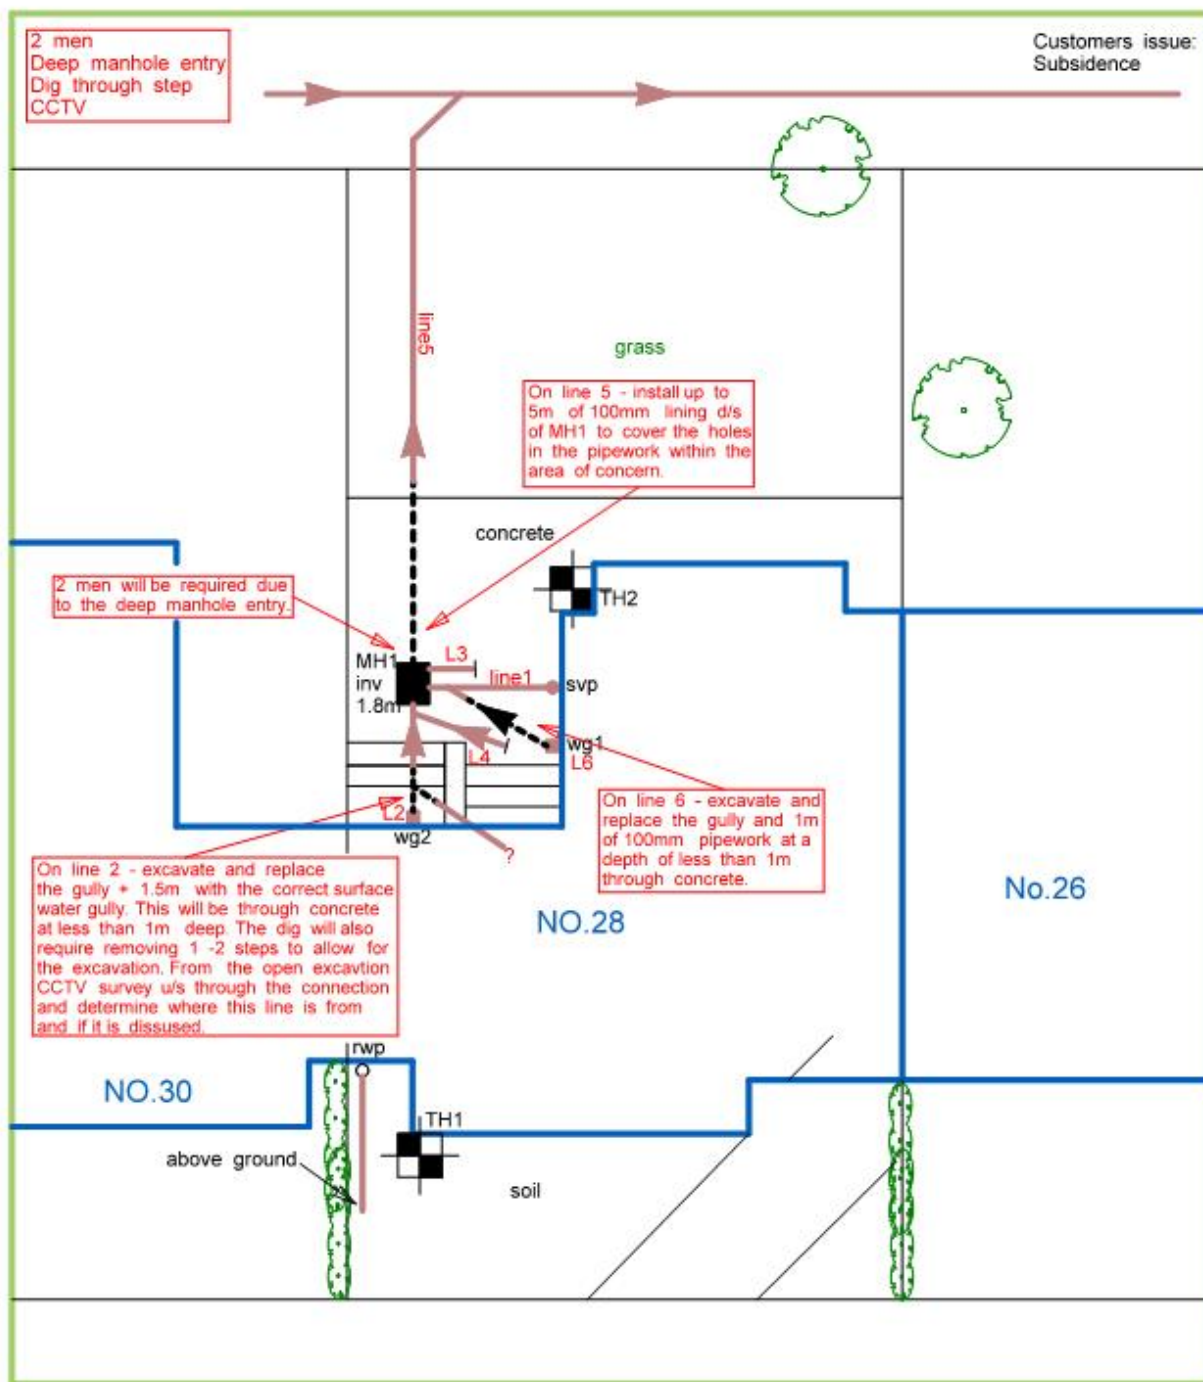
This drawing should be used for diagrammatic purposes only. Auger are not responsible or liable for any 3rd party works undertaken using the details outlined in this drawing. Confirmation of the drainage configuration can only be confirmed by excavation or detailed technical survey.
