# AquaSPEED

**RE: RENAISSANCE HOTEL, BLACKFRIARS STREET, MANCHESTER, M3 2EQ**

### **CCTV SURVEY**

## BLACKFRIARS STREET MANCHESTER - CCTV Survey Report : 15/06/21

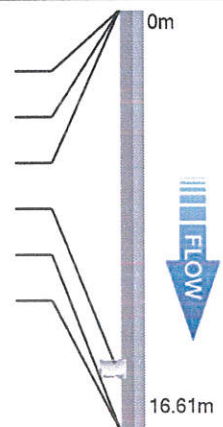
| Position | Code | Description | CD | Pic | Video Ref | |
|---|---|---|---|---|---|--|
| 16.61m | LDF | Line of drain/sewer deviates down [full] | | 0_2 | 0:02:09 | |
| 16.61m | SA | Survey abandoned | | 0_99 | | |

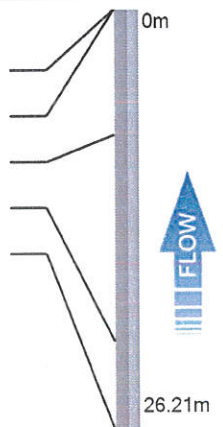
| Position | Code | Description | CD | Pic | Video Ref | |
|---|---|---|---|---|---|--|
| 20.66m | WL | Water level 5% | | | 0:03:35 | |
| 26.21m | MHF | Finish node type, manhole | | 1_99 | | |

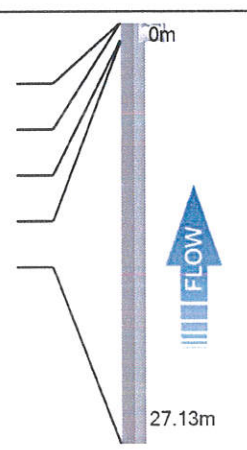
| Position | Code | Description | CD | Pic | Video Ref | |
|---|---|---|---|---|---|--|
| 01.25m | JN | Junction 09 : 100mm Diameter | | 2_3 | 0:00:16 | |
| 27.13m | SA | Survey abandoned | | 2_99 | | |

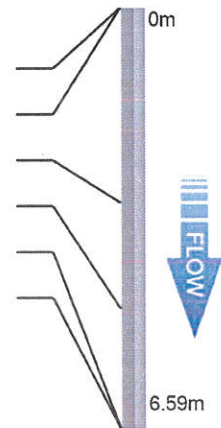
| Position | Code | Description | CD | Pic | Video Ref | |
|---|---|---|---|---|---|--|
| 06.59m | WL | Water level 10% | | 3_4 | 0:00:52 | |
| 06.59m | MHF | Finish node type, manhole | | 3_99 | | |

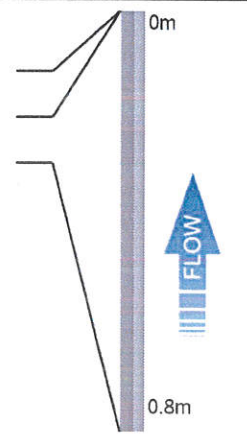
| Position | Code | Description | CD | Pic | Video Ref | |
|---|---|---|---|---|---|--|
| 00.00m | WL | Water level 0% | | | 0:00:00 | |
| 00.80m | SA | Survey abandoned | | 5_99 | | |

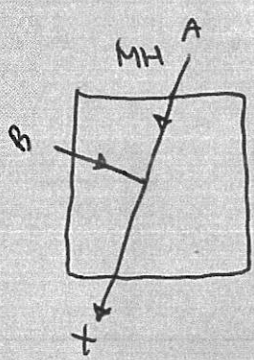
CHANNEL  
OK

BENCHING  
OK
