# Essential Repairs including Replacement Wagon Arch Glazing

## 1830 Warehouse

Science & Industry Museum

Design and Access Statement

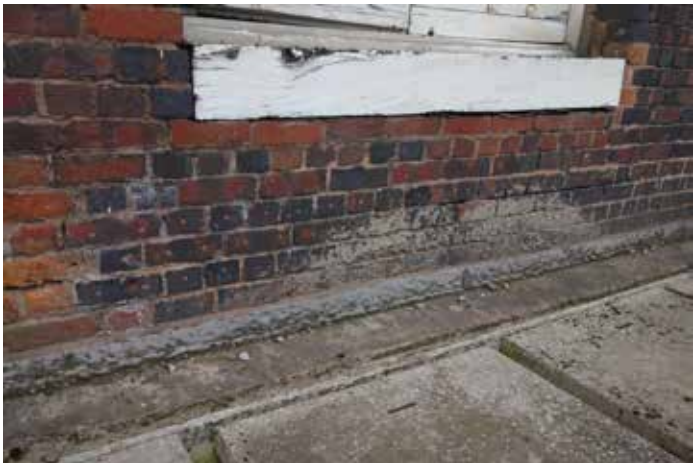
Patches of eroded pointing. Repoint using lime mortar.

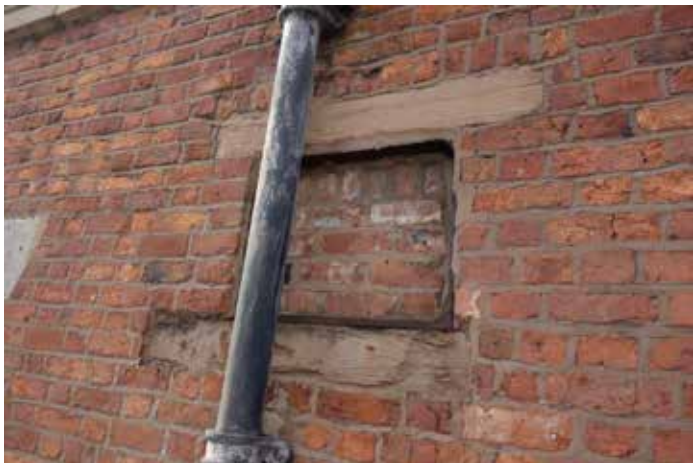
Metal duct frame is corroded. Cut out and brick in the opening. Material loss/spall. Indent repair to stone cill.

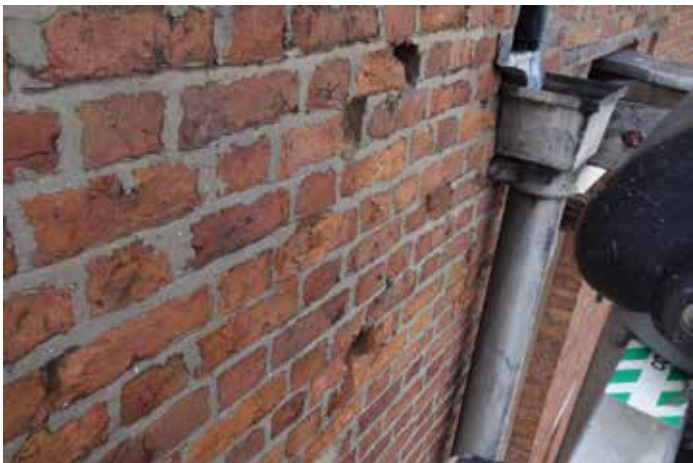
Spalled bricks. Cut out and replace bricks where erosion exceeds 15mm depth. Repoint using lime mortar.

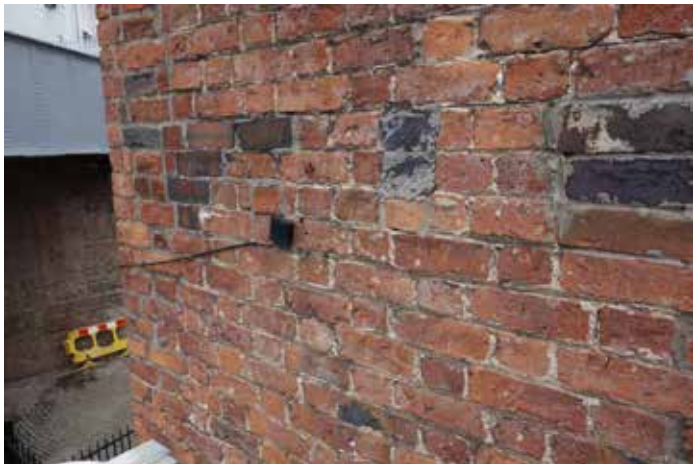
West elevation. Multiple vertical cracks in brickwork.Repair using helical bar stitching. Repoint using lime mortar.

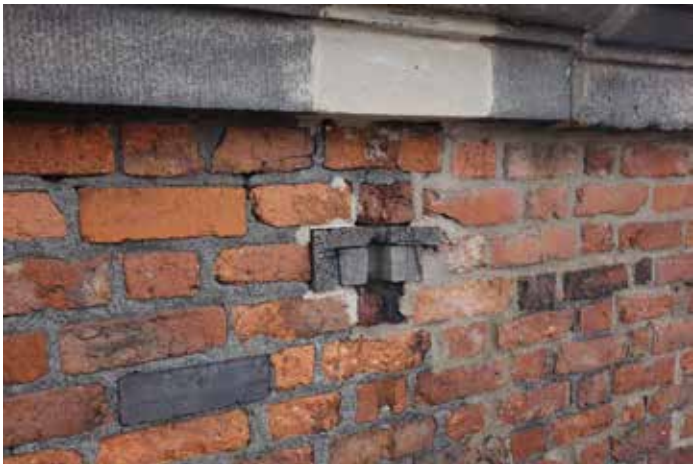
Decayed embedded timber. Remove timber and brick-in void.

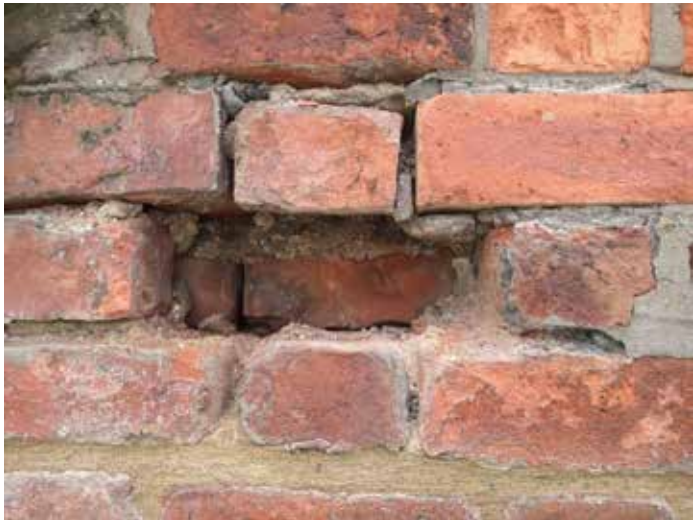
Failed brick removed. Remaining adjacent masonry is not disturbed, marked or damaged during this process. All joint surfaces to be left in a suitable condition to receive the replacement brick.

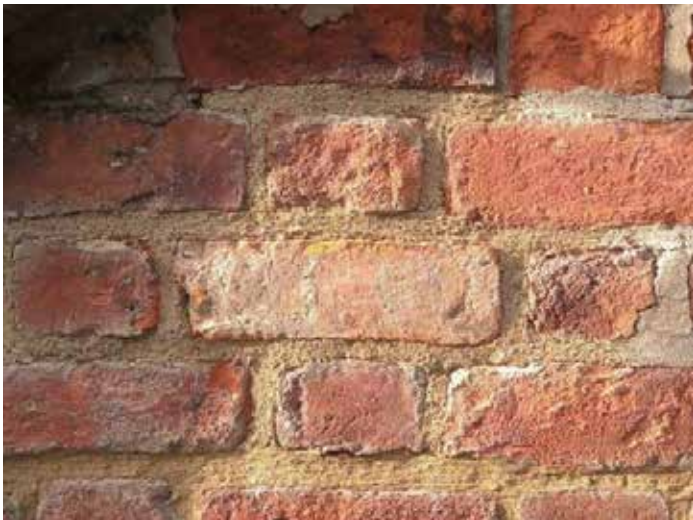
Salvaged brick from client stocks on site. The replacement brick has been set out and aligned carefully to ensure interfaces and junctions with existing masonry is maintained. Joint widths have been maintained and replicated. The salvaged brick has been laid will be laid and sighted on a full bed of mortar with all joints filled.

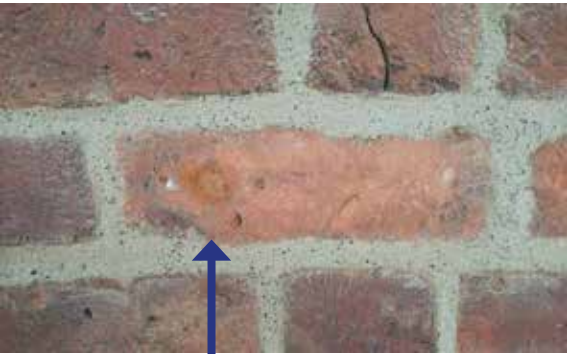
Example of hole repair to brick after removal of redundant fixing, Filled with brick dust and mortar mix to blend with adjacent brick colour.

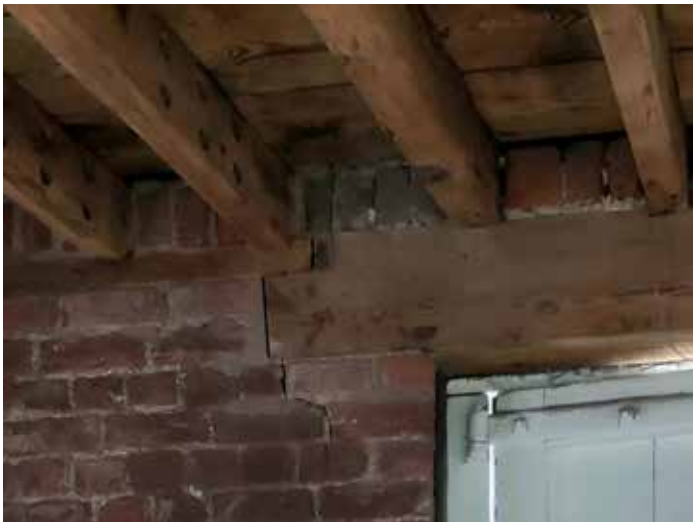
Brickwall crack. Brick repair required.

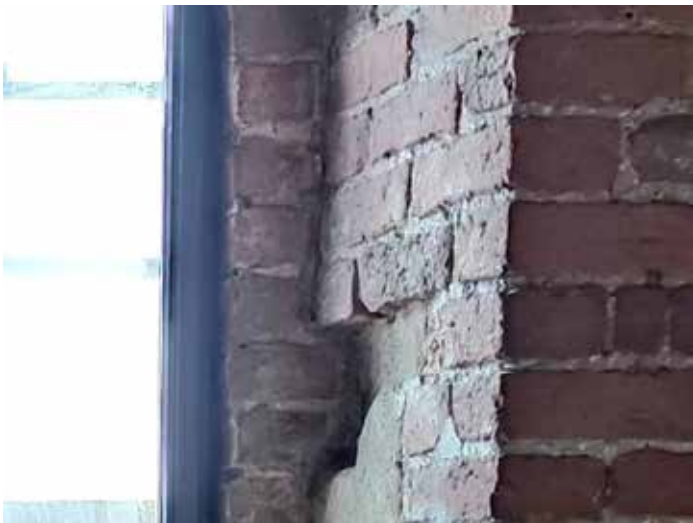
Missing masonry. Masonry repair required.

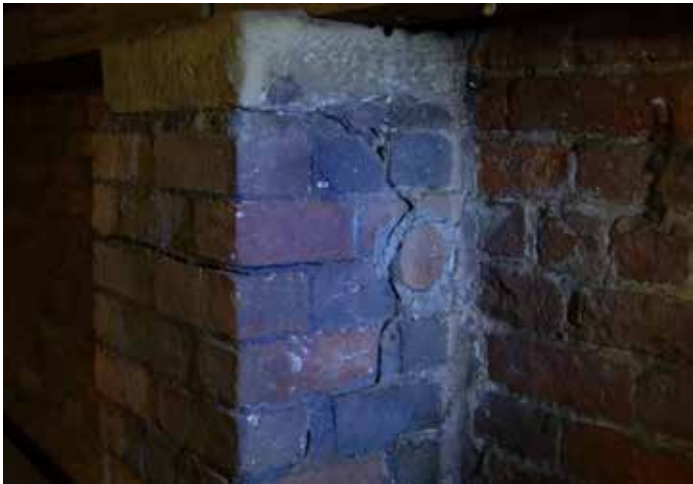
Vertical cracking through a primary beam support pier at the South wall at basement level.

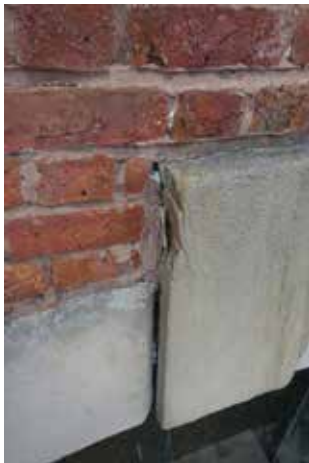
Material loss to keystone. Indent repair to stone block. Repoint using lime mortar.

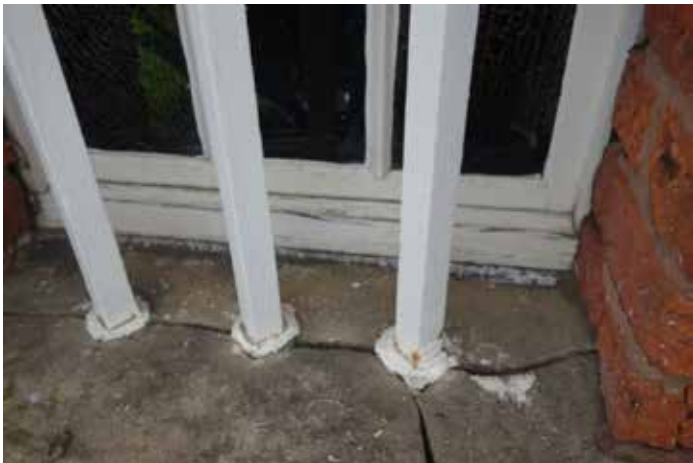
Corrosion of iron bar ends and cracks to cill. Cut out around bar embedments and treat iron. Repoint cracks using lime mortar.

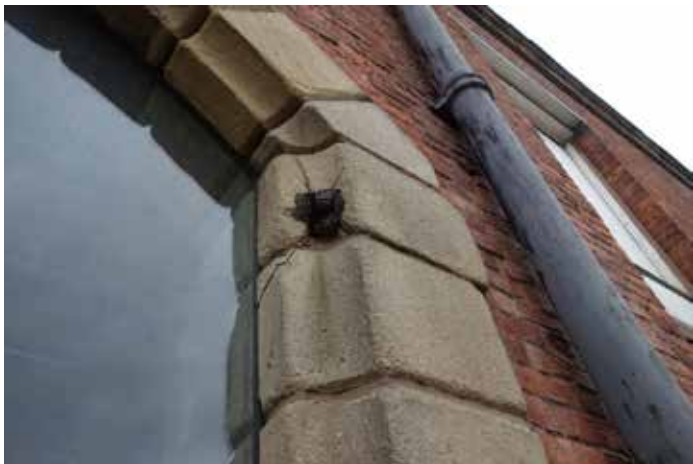
Crack/spall to block at hinge fixing. Treat ironwork, indent repair to stone block.

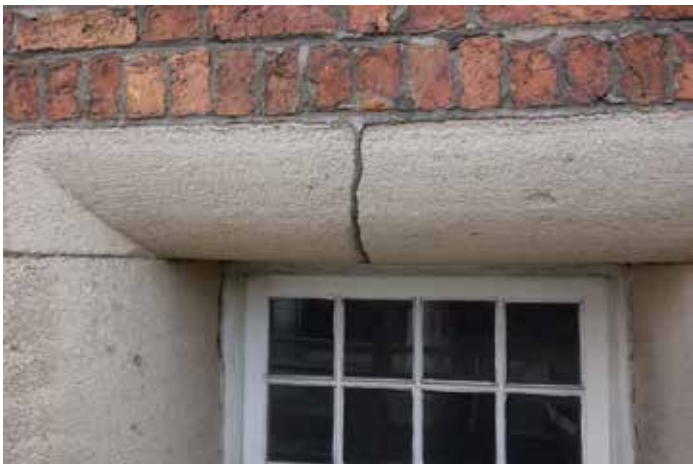
Vertical crack, c7mm width.Repoint using lime mortar.

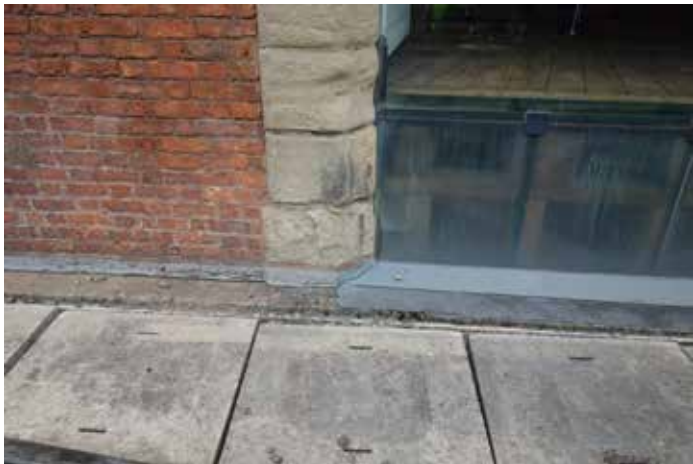
Material loss/spall. Indent repair to stone block.

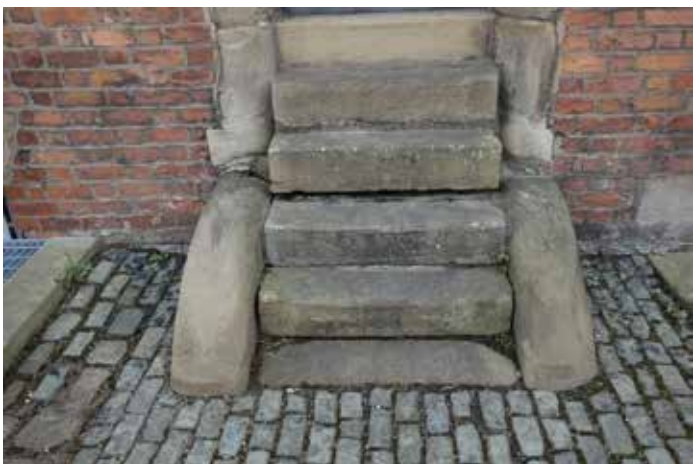
Settlement of steps. Dismantle and rebuild on new foundation.

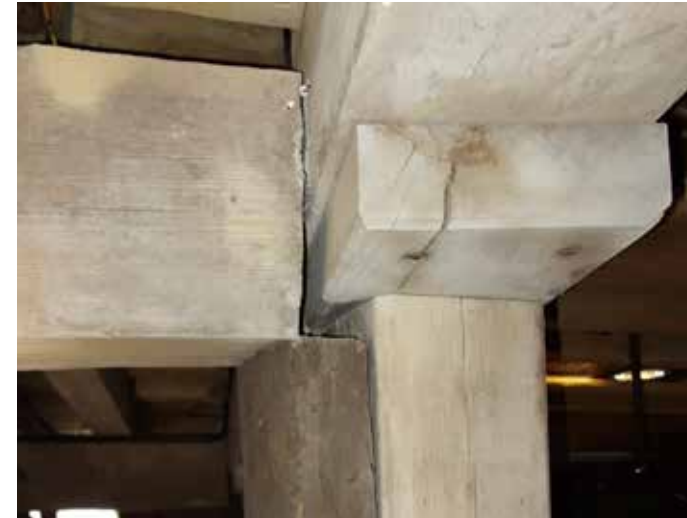
View from ground floor mezzanine of east west beams with limited bearing on vertical plate. Vertical plate bolted to column using single M20 bolt. Shrinkage and frame racking has pulled the timber off this bearing and it now very little contact remains.

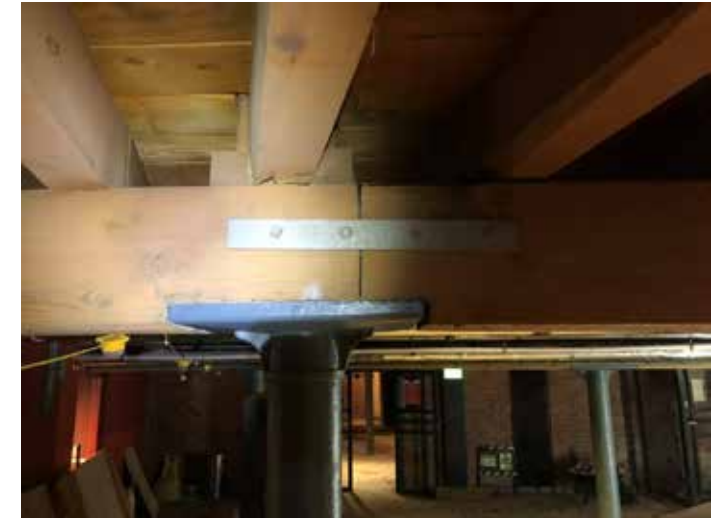
Floor beam 'but' connection off centre overcast iron columns. floor beam eccentrically loading cast iron plate.

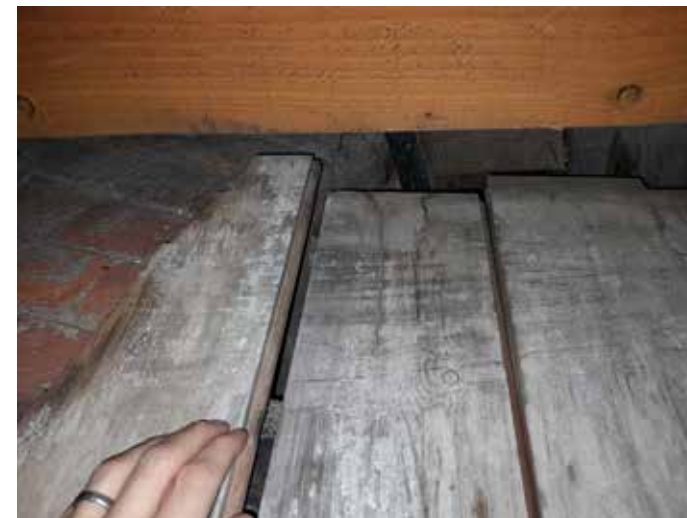
Loose floorboard. Re-fix, repair , make good.

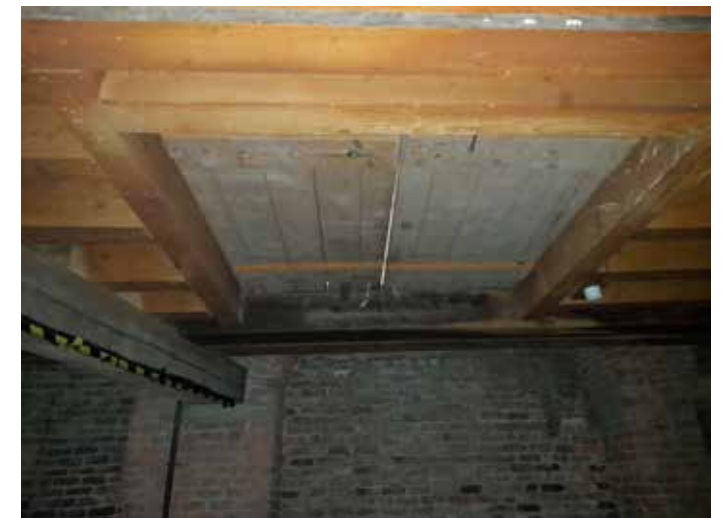
.Check stability. Review with Structural engineer. Reinforce

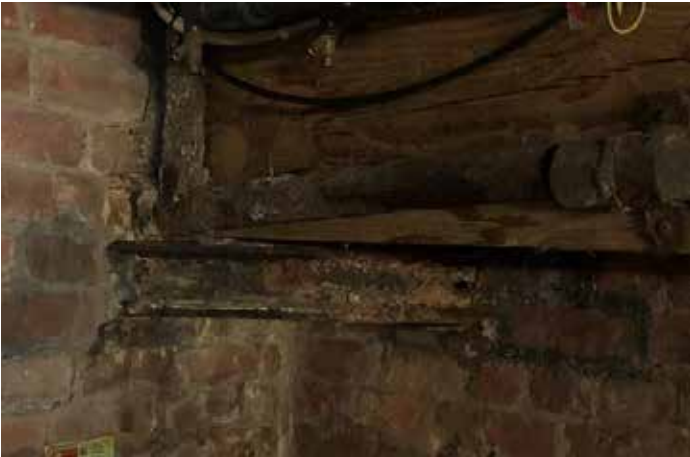
Looking at the southwest corner. corrosion in corner support to ground floor timber floor beam

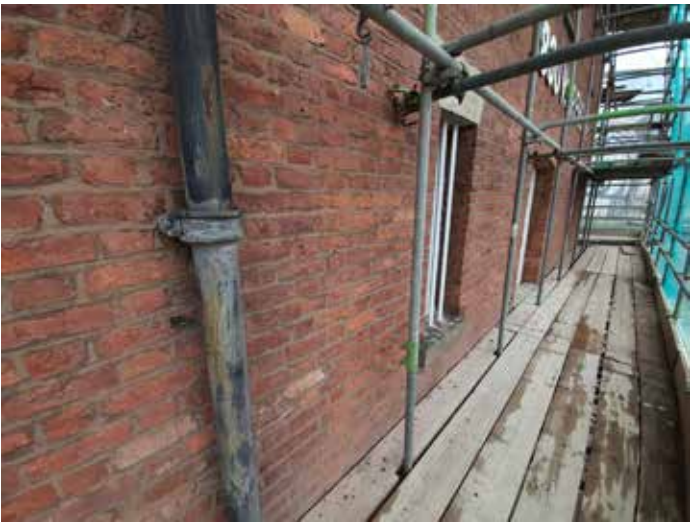
Heavily weathered rainwater downpipe

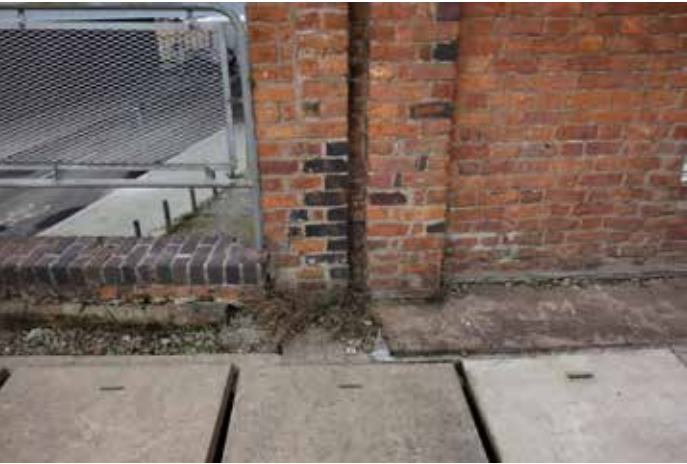
S1001: Patches of eroded pointing. Repoint using lime mortar.

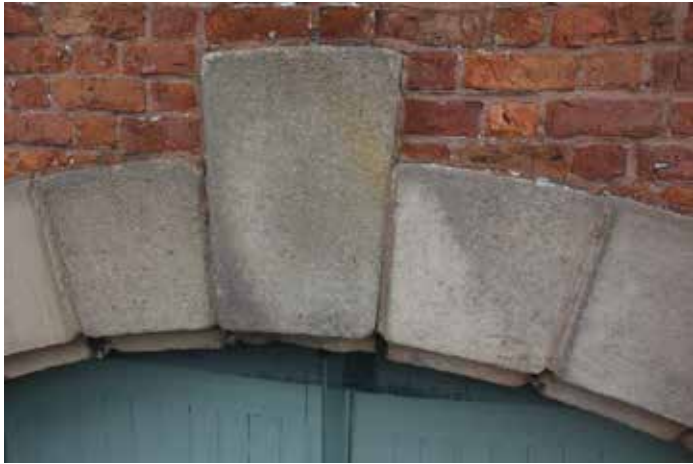
S1003: Open joint at keystone. Repoint using lime mortar.

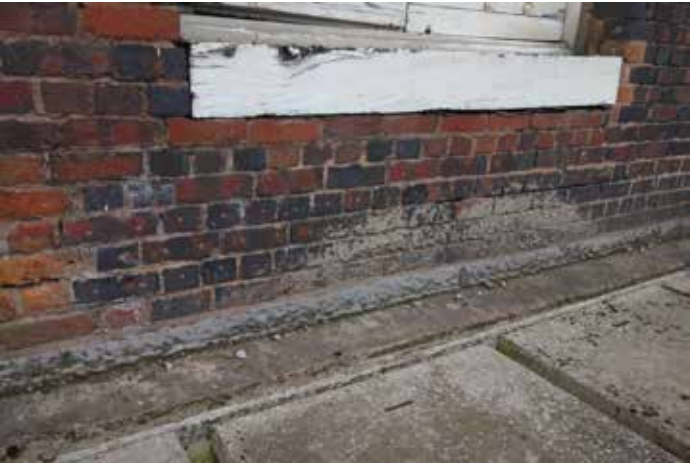
S1004: Patches of eroded pointing. Repoint using lime mortar.

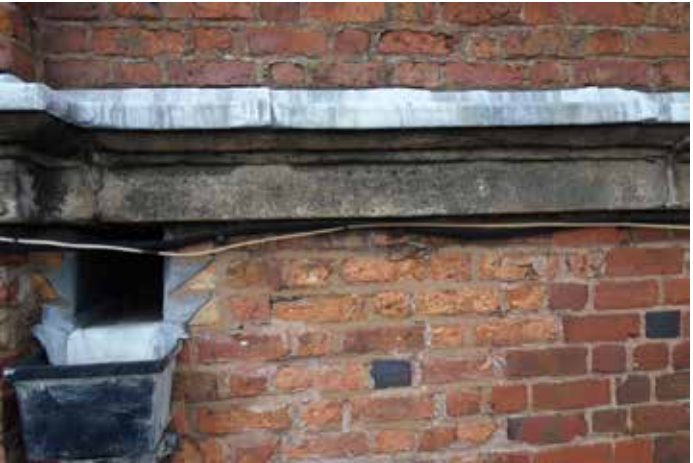
S1008: Bolt shell and adjacent spall. Remove bolt shell and undertake indent repair to cornice.

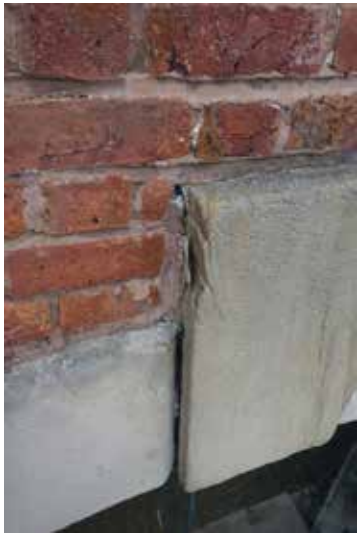
S1011: Material loss to keystone. Indent repair to stone block.

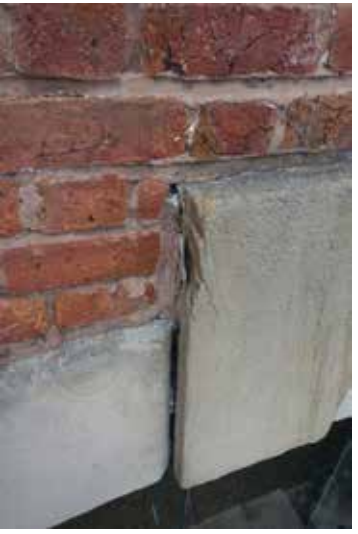
S1012: Open joints at keystone. Repoint using lime mortar.

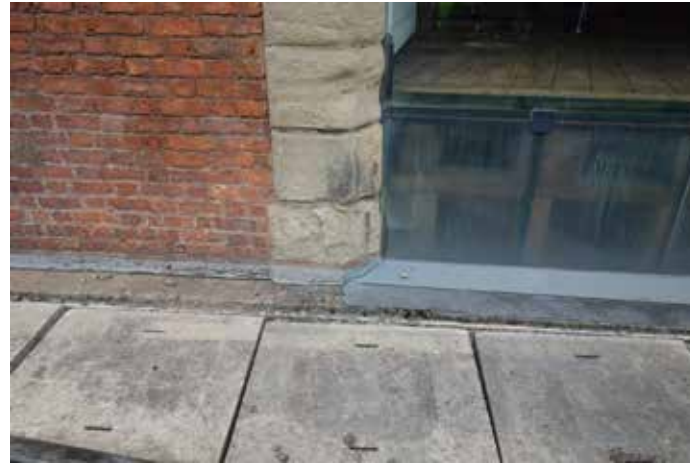
S1014: Material loss/spall. Indent repair to stone block.

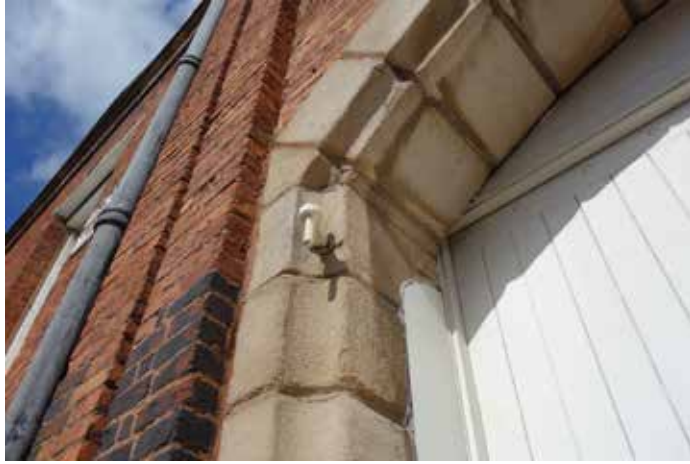
S1025: Spall at hinge fixing. Indent repair to stone block.

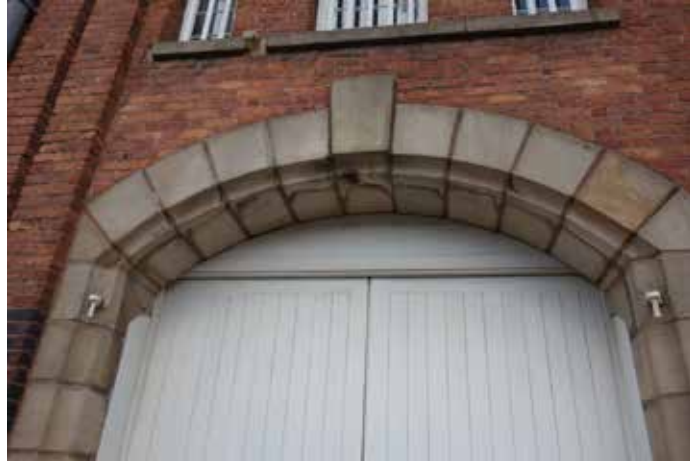
S1026: Spall at hinge fixing. Indent repair to stone block.

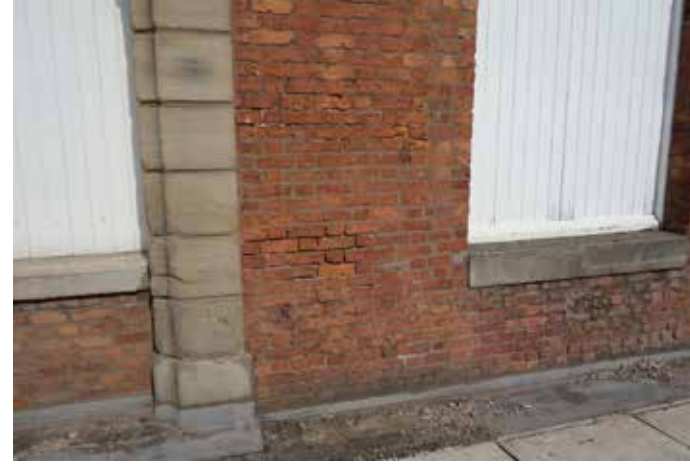
S1027: Patches of eroded pointing. Repoint using lime mortar.

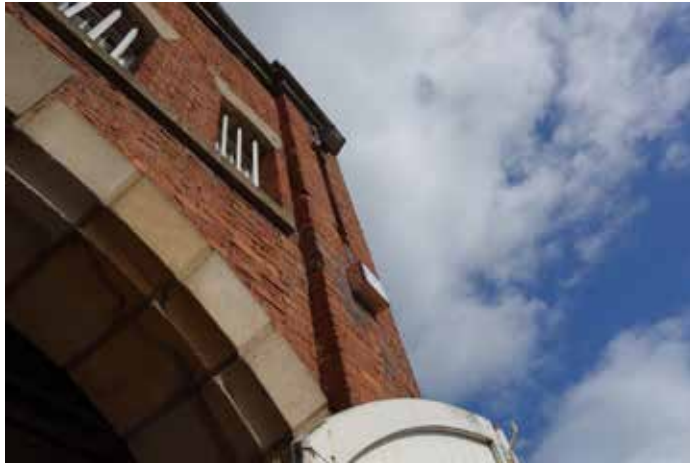
S1029: Material loss/spall. Indent repair to stone block.

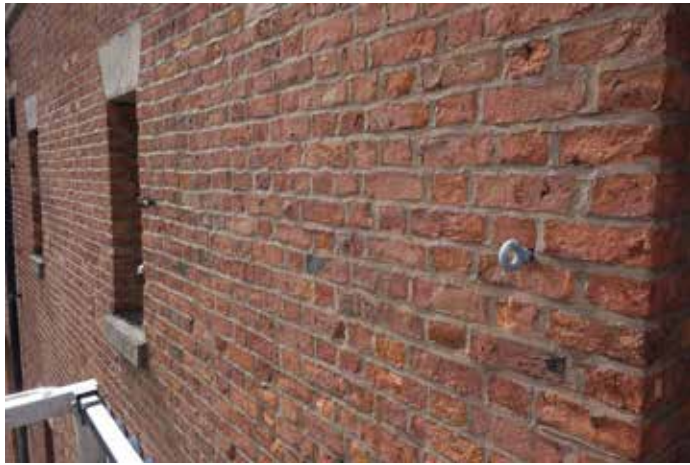
S1033: Various redundant metal bolts and fixings. Remove and infill holes using lime mortar.

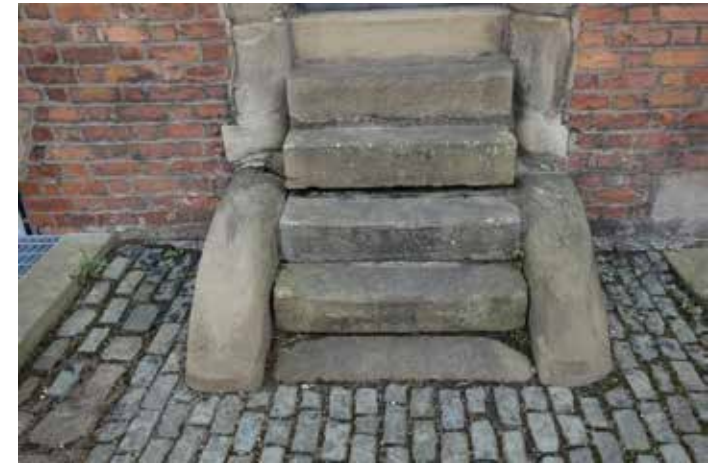
S1036: Settlement of steps. Dismantle and rebuild on new foundation.

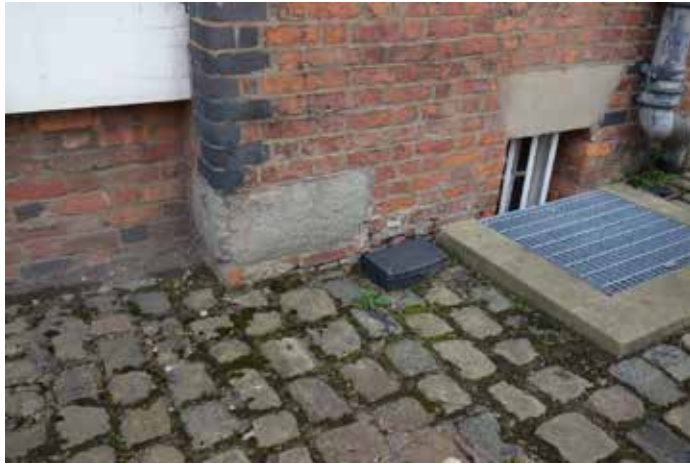
S1037: Patches of eroded pointing. Repoint using lime mortar.

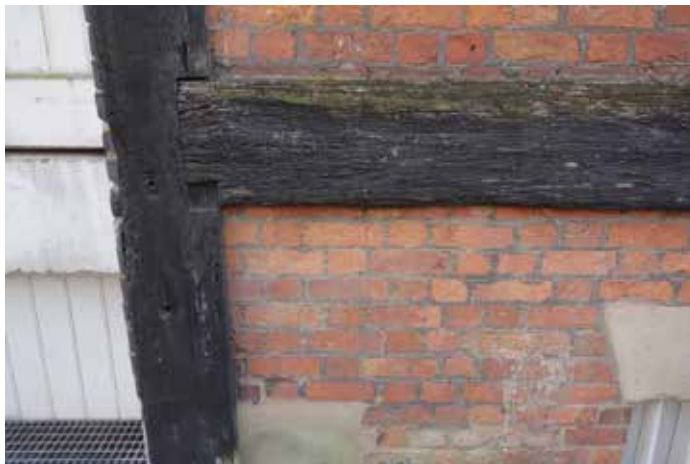
S1041: Vertical crack due to corroded fixing. Remove fixing and replace with stainless steel. Repoint crack with lime mortar.

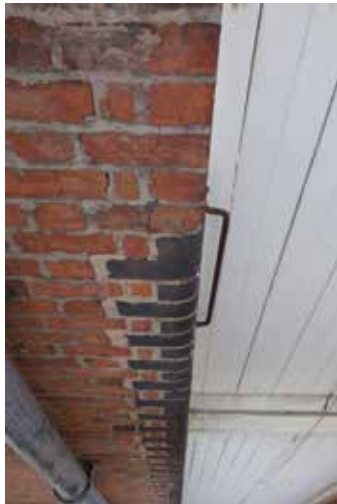
S1045: Vertical crack, 1-2mm width Pin bricks with Cemties. Repoint crack with lime mortar

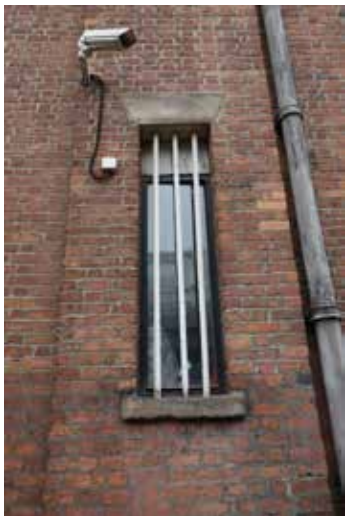
S1059: Corrosion of iron bar ends and cracks to cill and lintel. Cut out around bar embedments and treat iron. Repoint cracks using lime mortar.

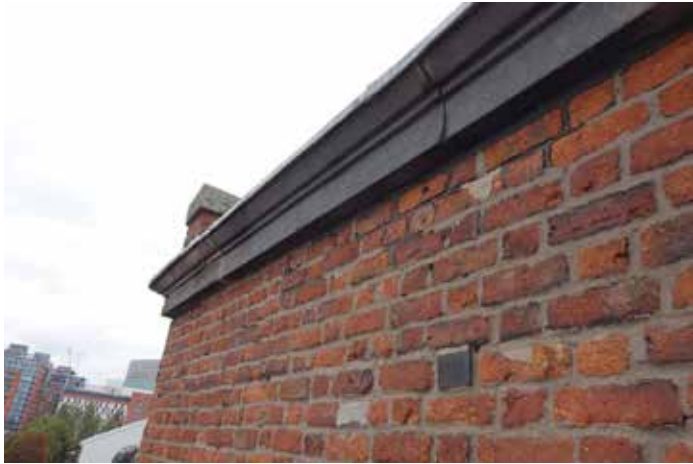
S1063: Open joints to cornice. Repoint using lime mortar.

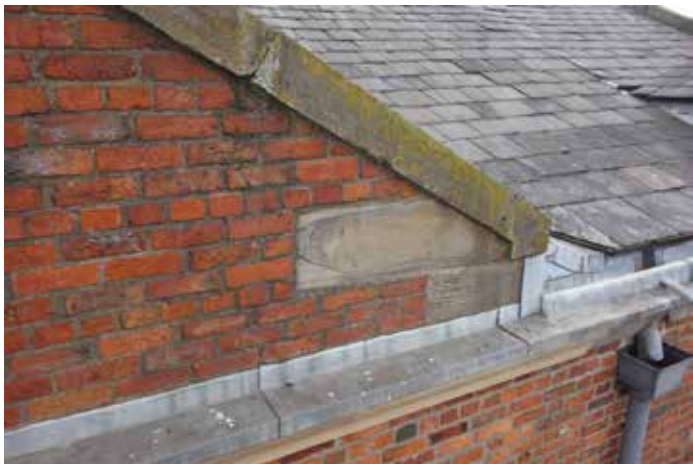
S1067: Delamination of RHS pediment block face. Indent repair to restore lost section.

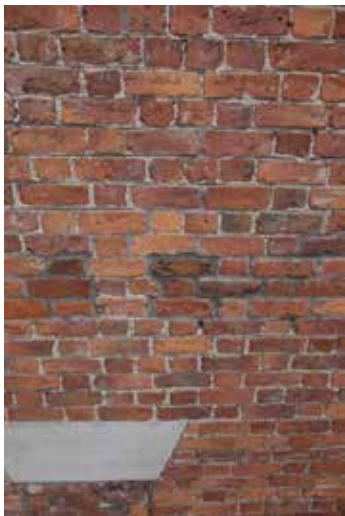
S1071: Diagonal cracks, 2mm width. Repoint using lime mortar.

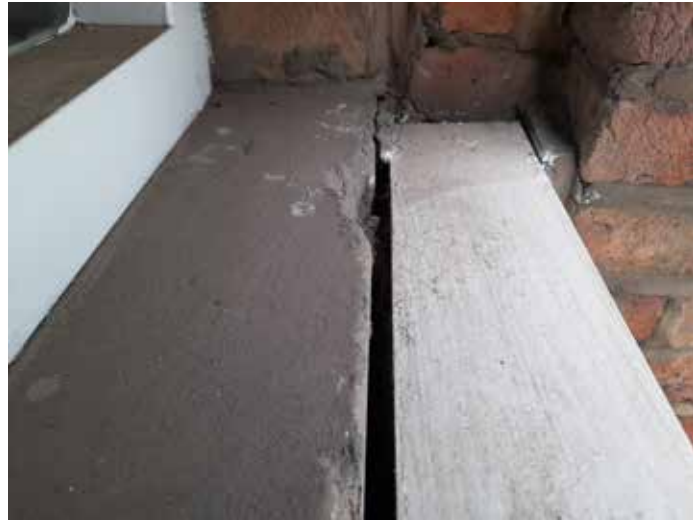
A1001: Loose sill. Check sill stability/replace sill

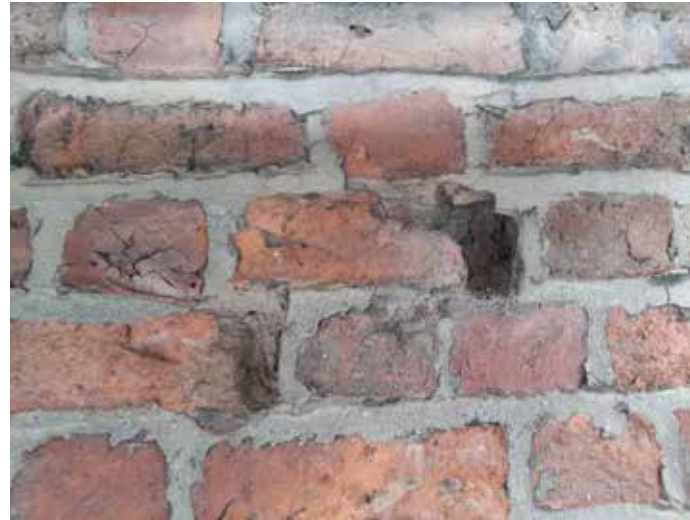
A1002: Damaged Brick. Brick repair required

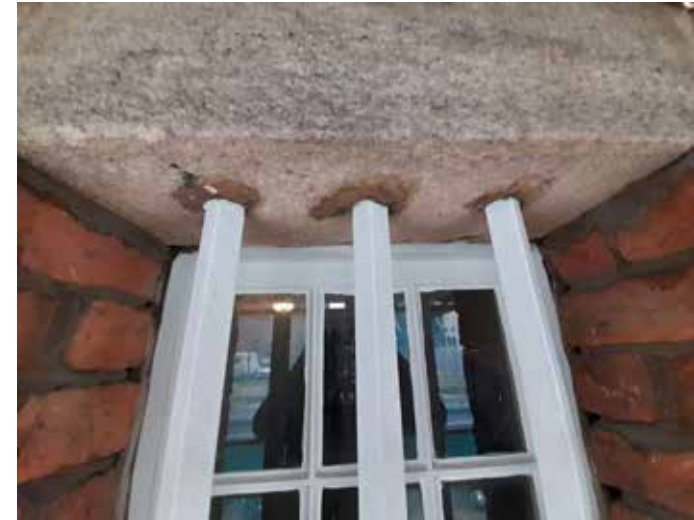
A1003: Lintel damaged. Lintel repair required, associated anti corrosion works to security bars.

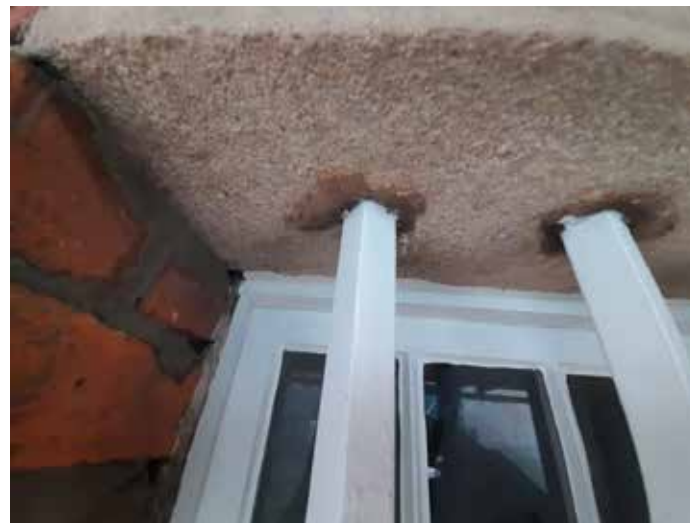
A1006: Lintel damaged. Header head repair required

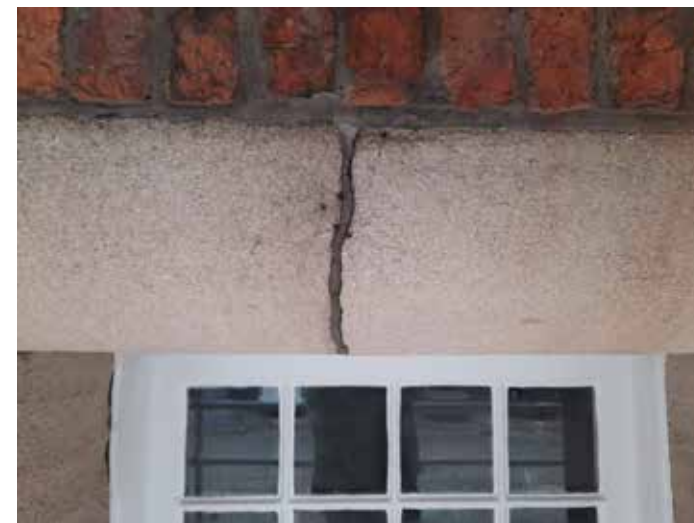
A1007: Lintel damaged. Structural engineer to review

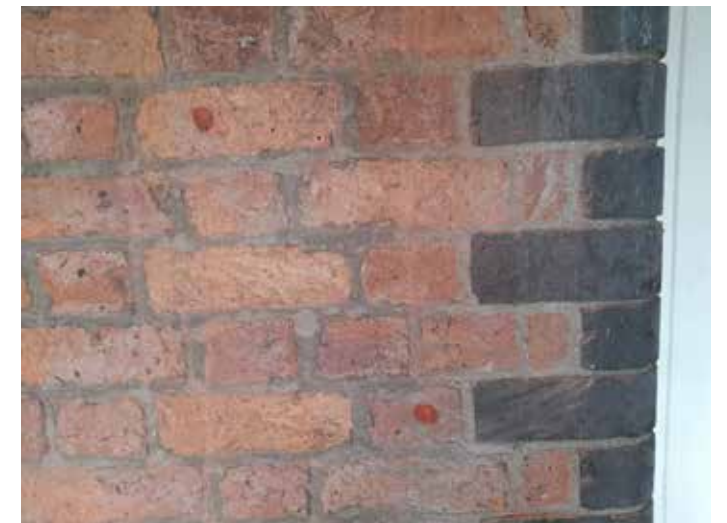
A1008: Poor repair. Repair brick repairs with brick dust

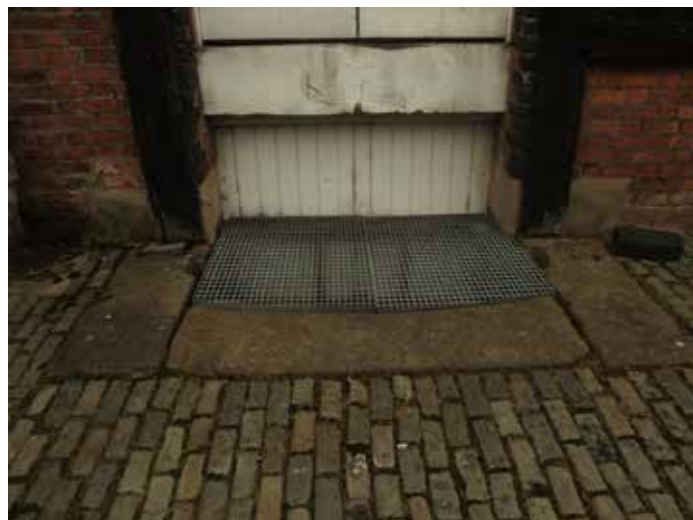
A1009: Stone step worn, grating is not level. Level grating

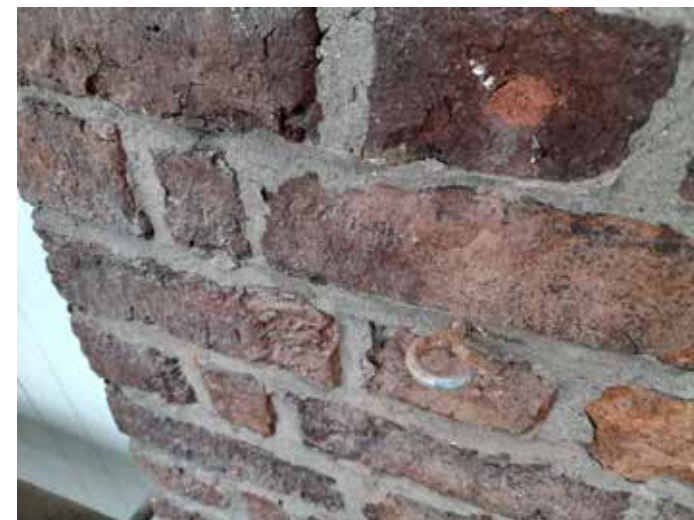
A1011: Metal hooks fixed to wall. Remove hooks and repair

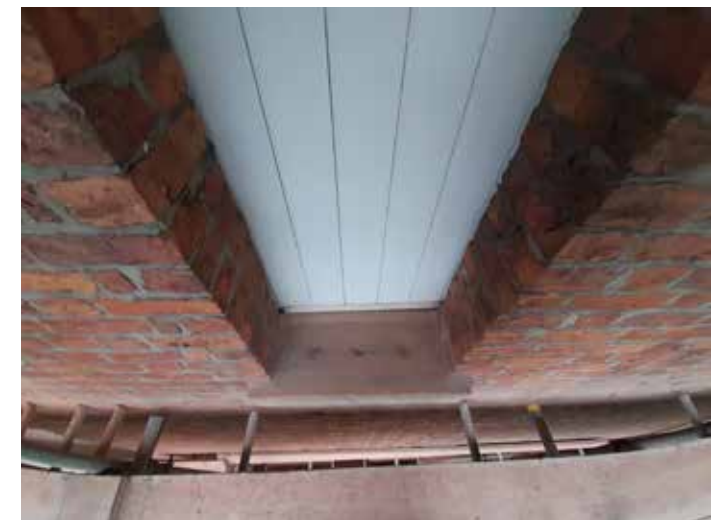
A1012: Sill damaged. Sill repair required

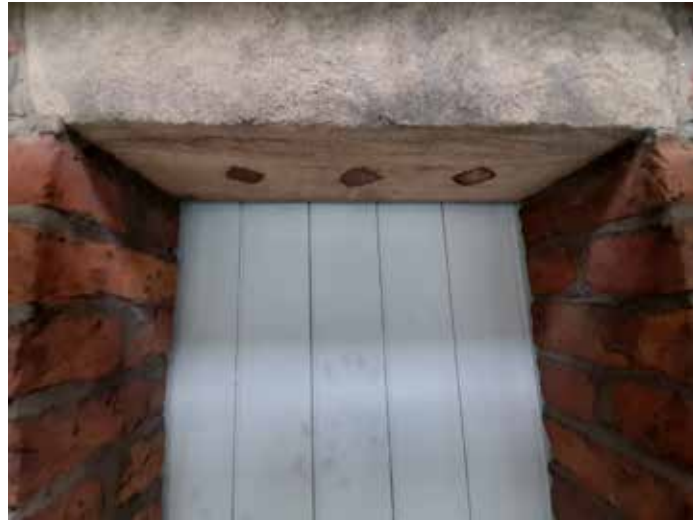
A1013: Lintel damaged. Header brick repair required

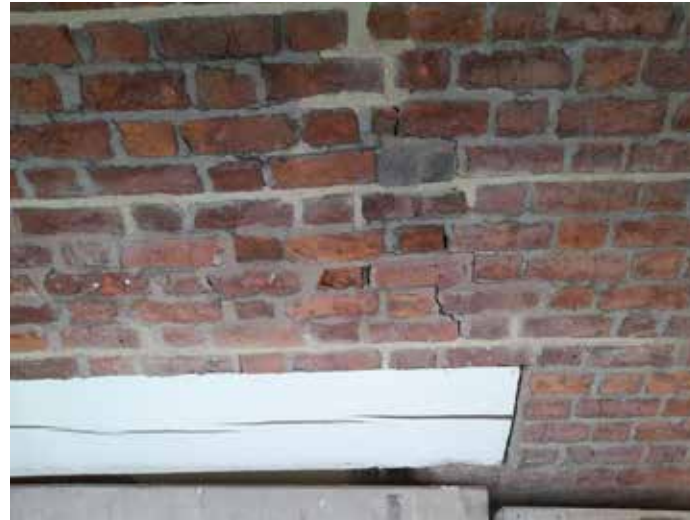
A1014: Movement in brick. Brick repair required

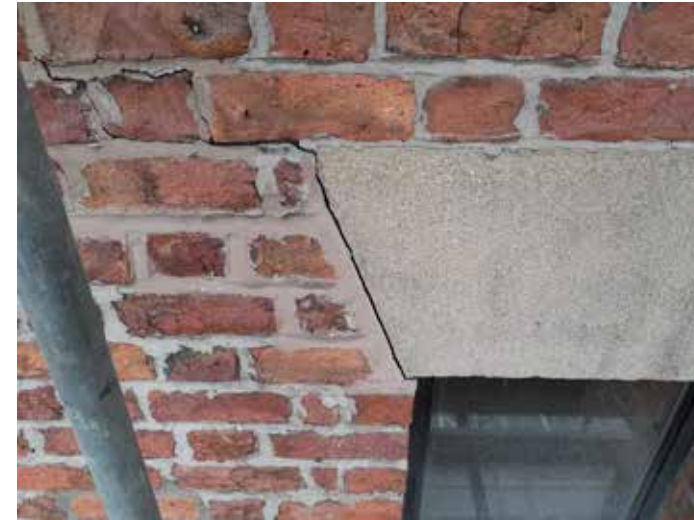
A1015: Lintel movement. Structural engineer to review

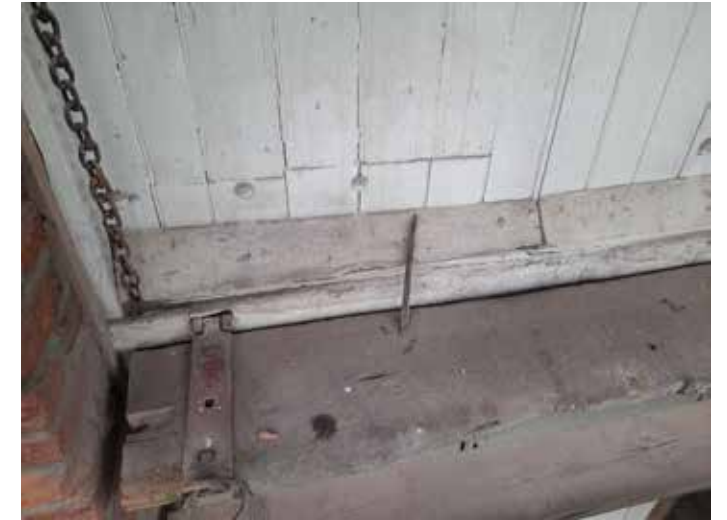
A1016: Loose sill. Check sill stability/replace sill (historic detail)

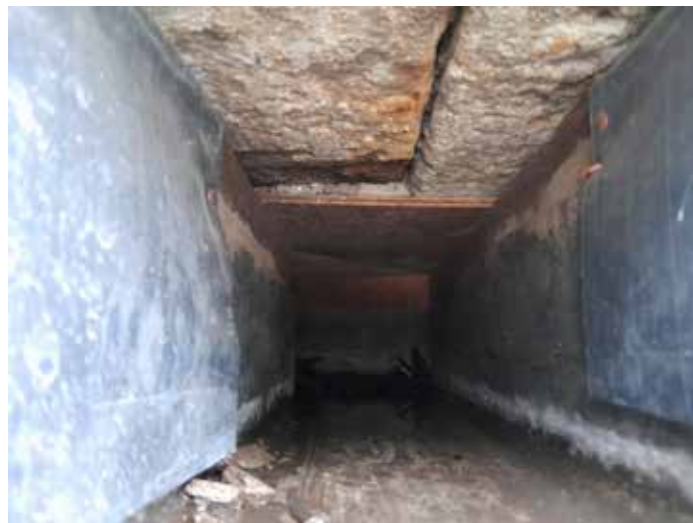
A1017: Damaged leadwork. Replace lead lining to chute (generally)

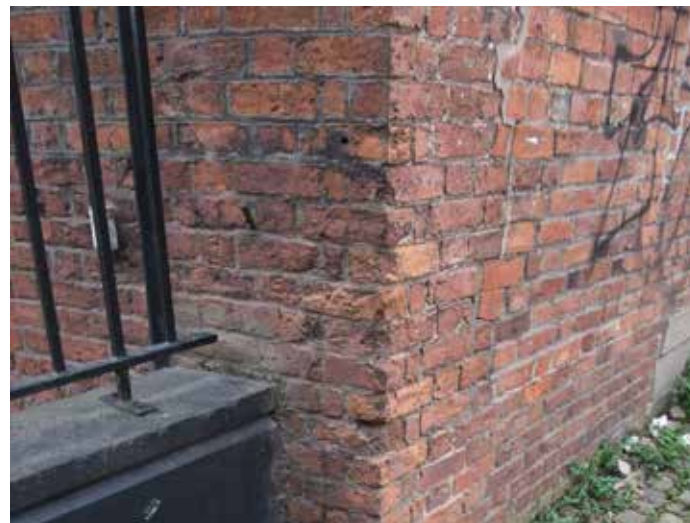
A1018: Damaged brick: Loss of brickwork at base. Loss of corners

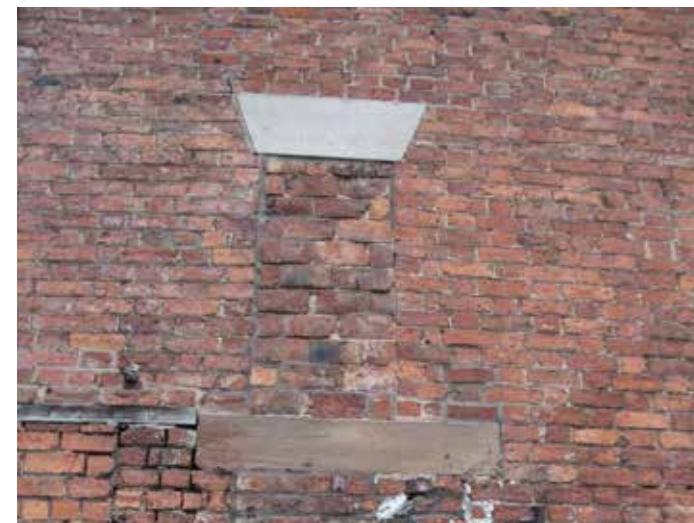
A1019: Extensive movement to brickwork, loss of mortar under timber lintel. Check lintel stability and repoint

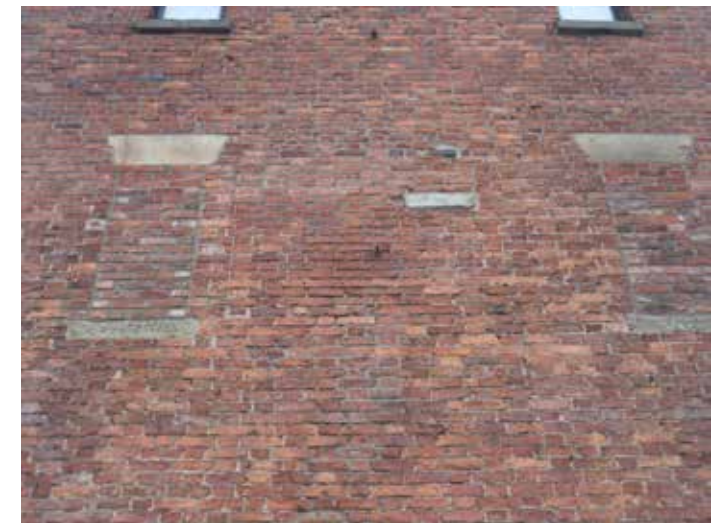
A1020: Vertical line of metal brackets, poor pointing in brick. Remove metal fixed to wall and repoint

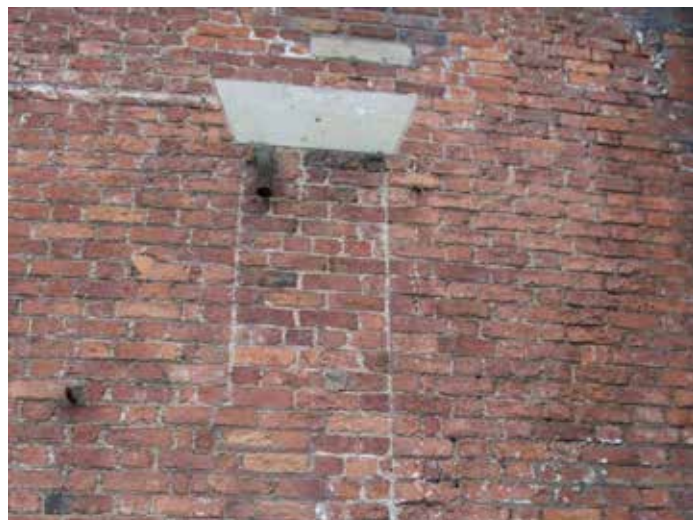
A1021: hole at lower right of GFL infilled window, extensive cracking to brickwork, loss mortar, mid-left iron protruding. Brick repair required

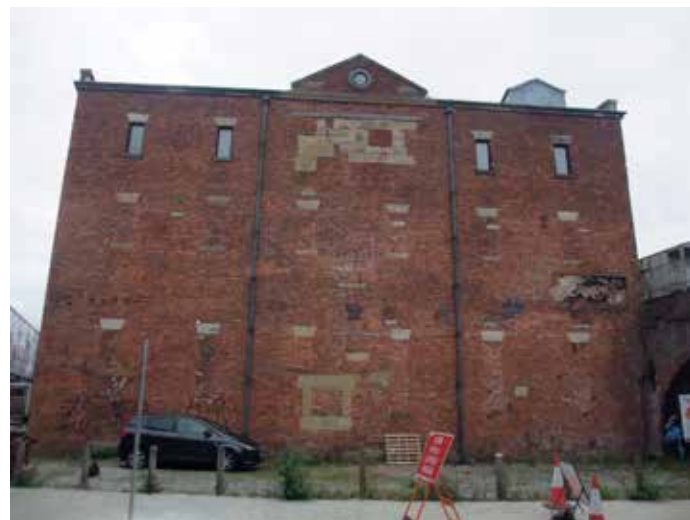
A1022.1: Forecourt area hardcore - rough surface with vegetation, water leak damp from overflowing (hopper blocked by vegetation). Clean/ replace RWP to Viaduct.

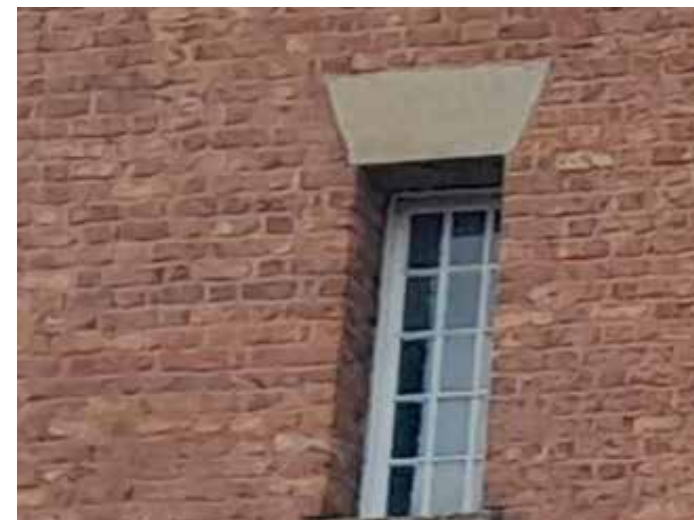
A1023: East elevation frames to be redecorated.

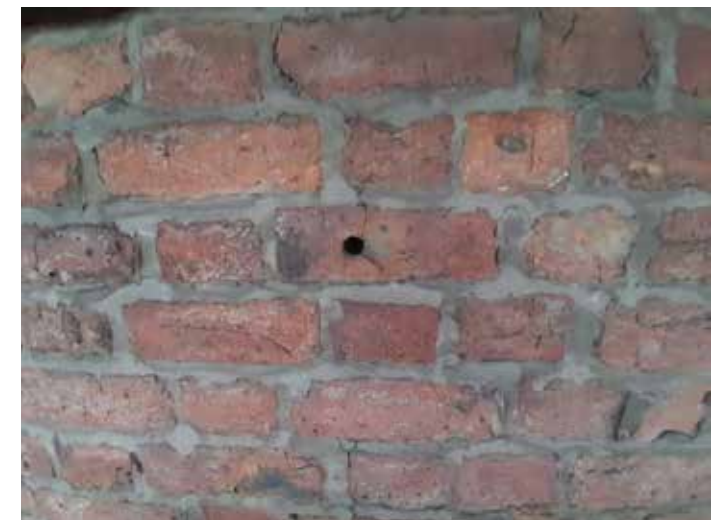
A1024: Hole in brickwall. Brick repairs correctly with brick dust

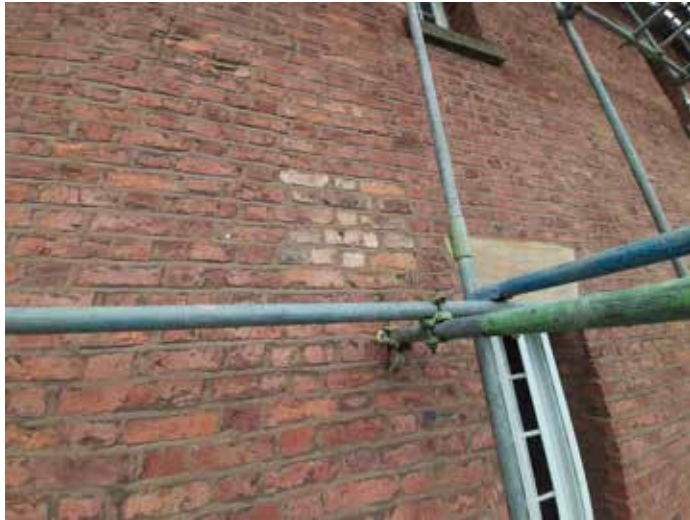
A1025: Modern brickwork. Replace with salvaged brick

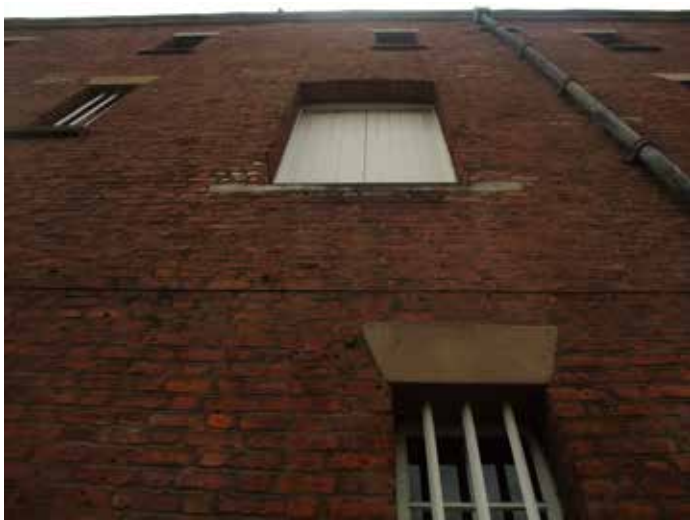
A1026: No drip detail to concrete sill, stain to brick below. Replace concrete sill.
