# Essential Repairs including Replacement Wagon Arch Glazing

## 1830 Warehouse

Science & Industry Museum

Design and Access Statement

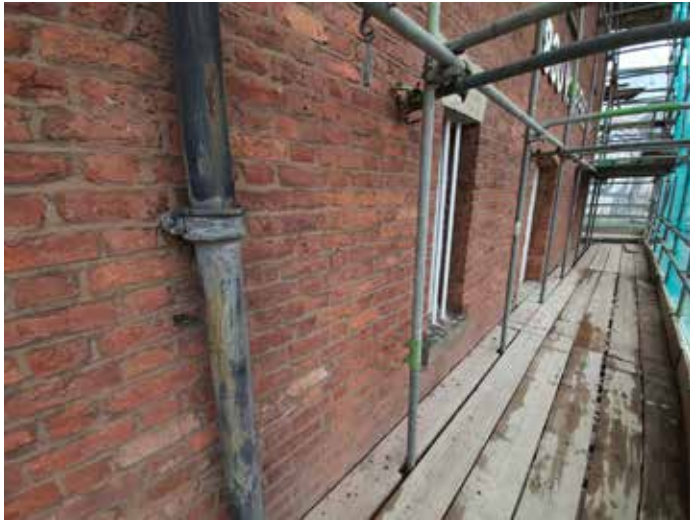
A1027: Damaged RWP. RWP to be redecorated or replaced

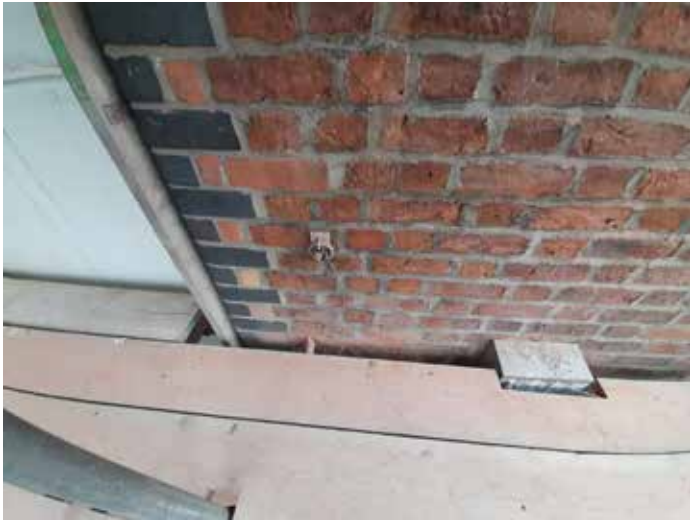
A1028: Metal fixed to wall. Remove redundant metalwork and fill hole with brick dust

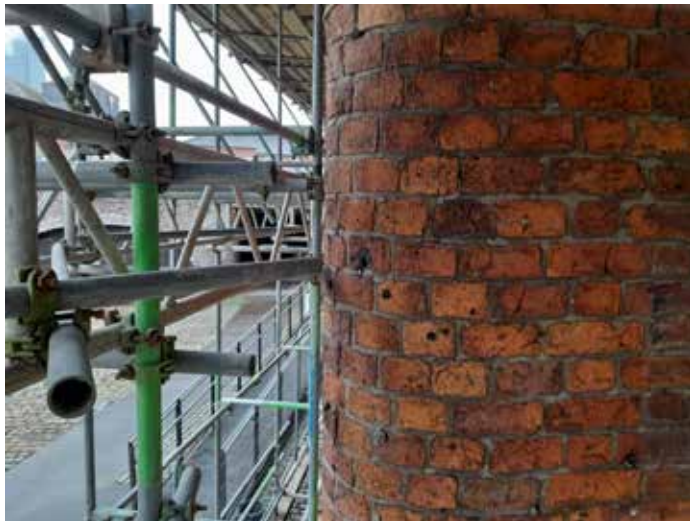
A1029: Metal sockets inserted to wall. Remove sockets

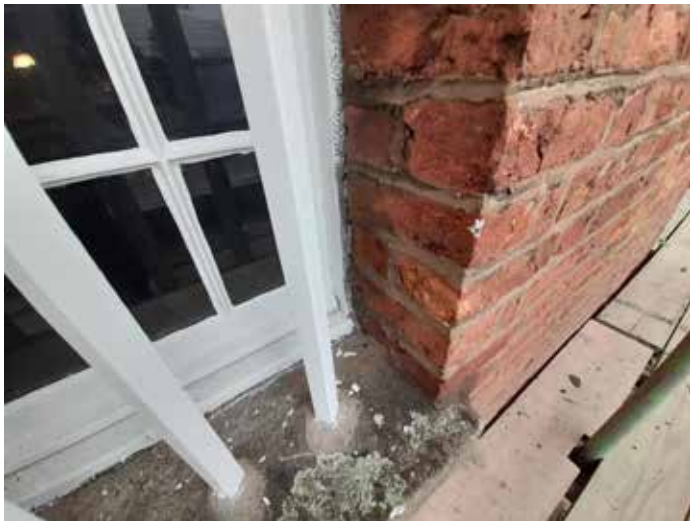
A1030: Sill damaged. Sill repair required. Associated anticorrosion works to security bars, rub down and redecorate)

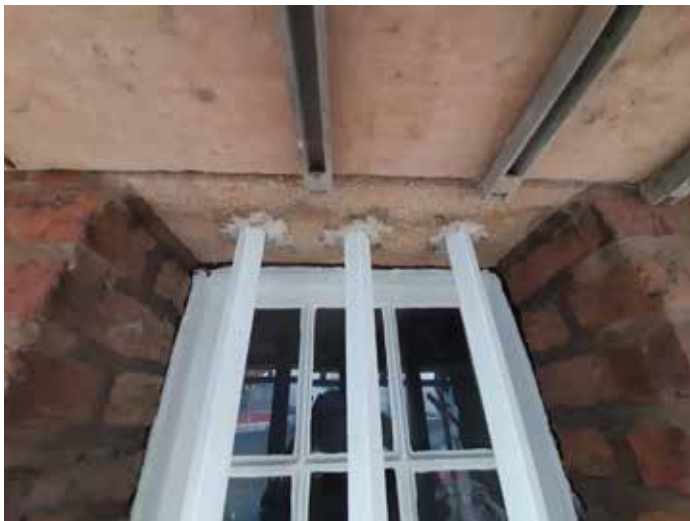
A1031: Lintel damaged: Header repair required. anticorrosion works to security bars, rub down and redecorate)

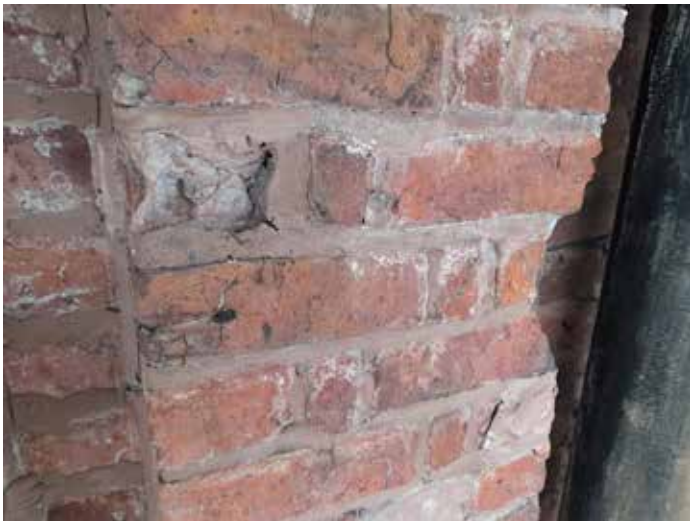
A1034: Damaged brick. Brick repair required

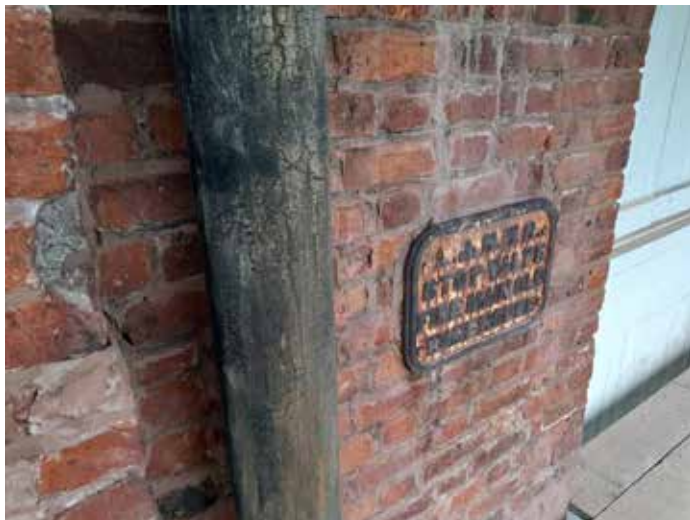
A1035: Damaged brick. Brick repair required

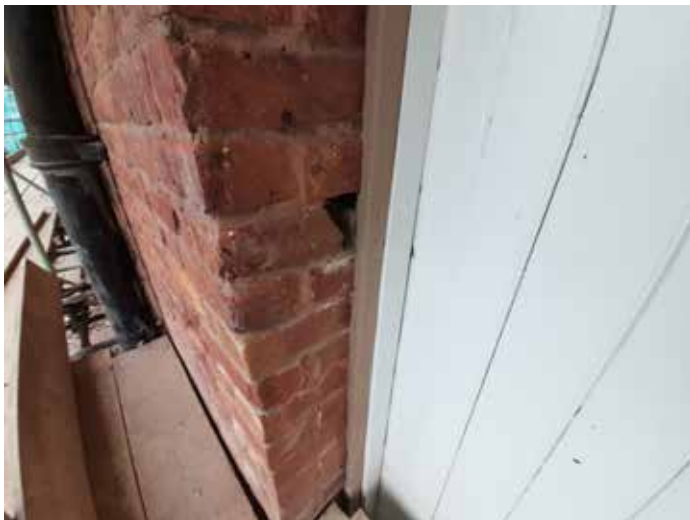
A1036: Broken brick. Brick repair required

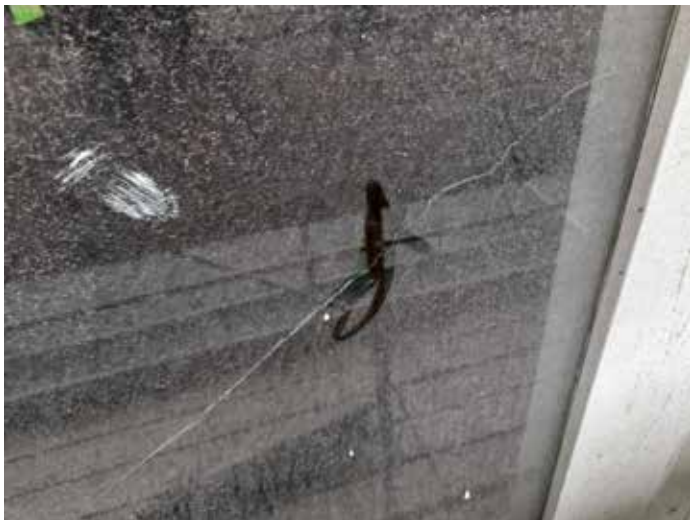
A1038: Cracked glazing. Replace glass or coat in anti-shatter film.

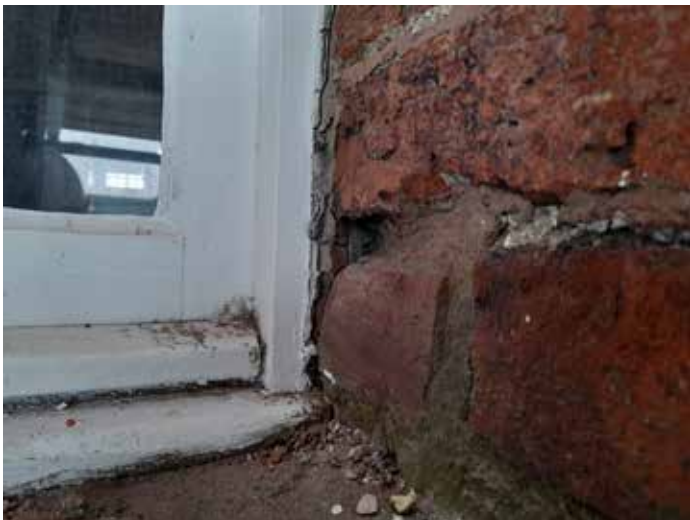
A1039: Defective pointing: Repoint

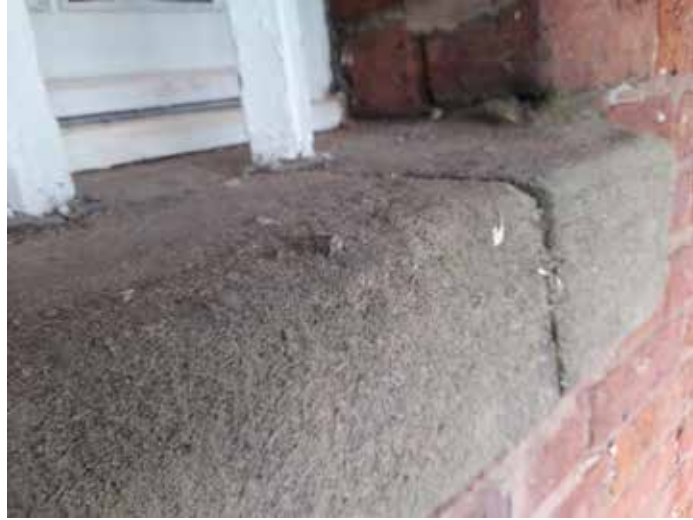
A1041: Sill damaged. Sill repair required

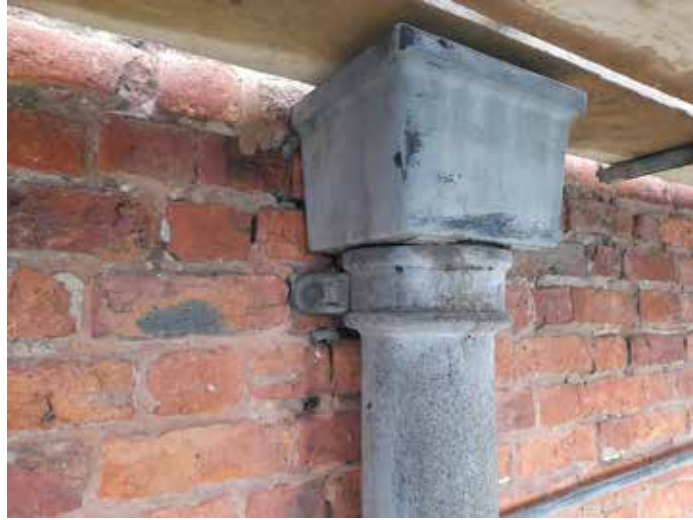
A1042: Defective pointing. Repoint

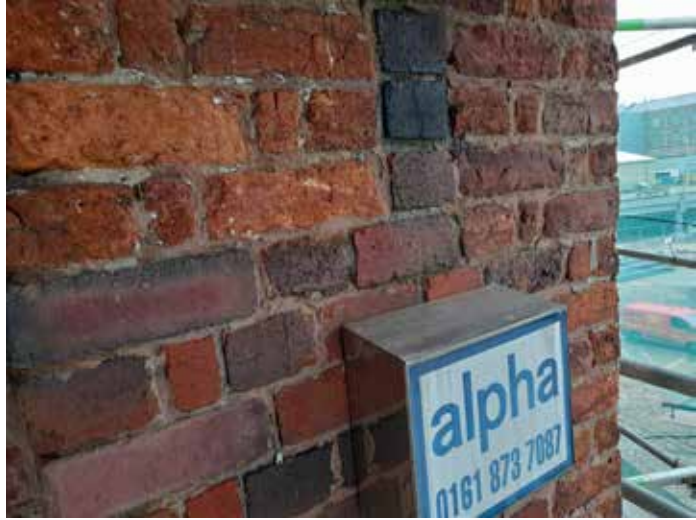
A1043: Modern brickwork. Replaced with salvaged brick

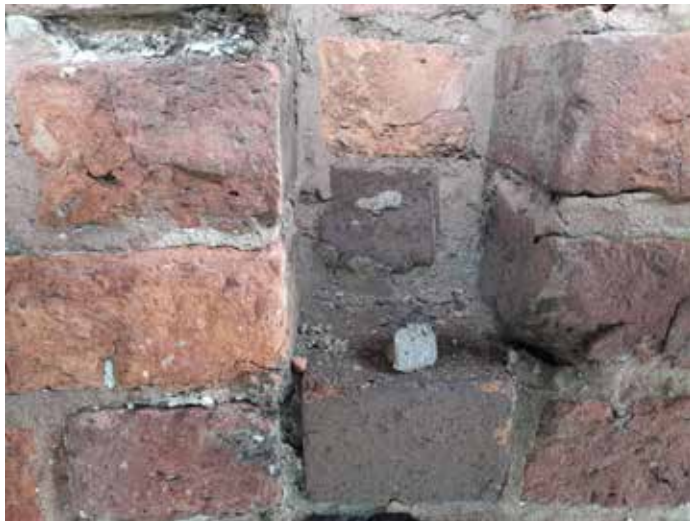
A1044: Defective pointing: Repoint

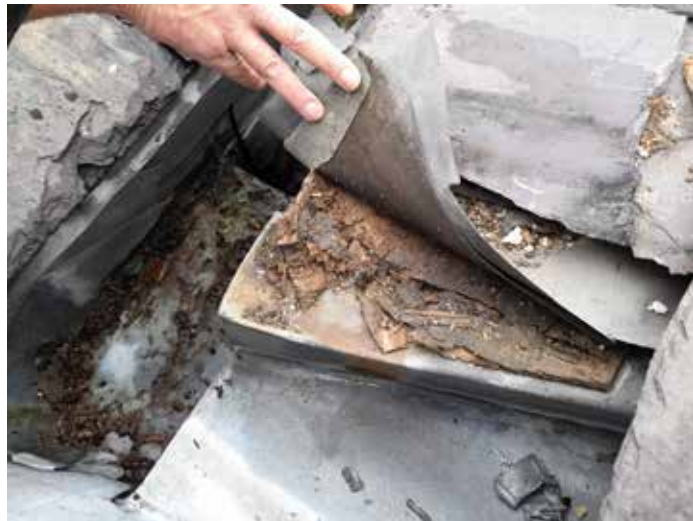
A1052: Valley gutter poor damp and friable. Timber repair required and make good. Slate battens or pegs to underside could be decay

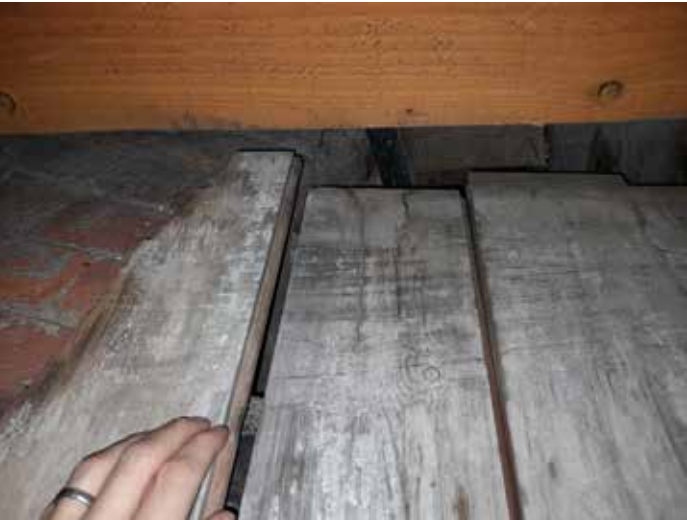
A0004: Loose floorboard. Re-fix / Repair / Make good

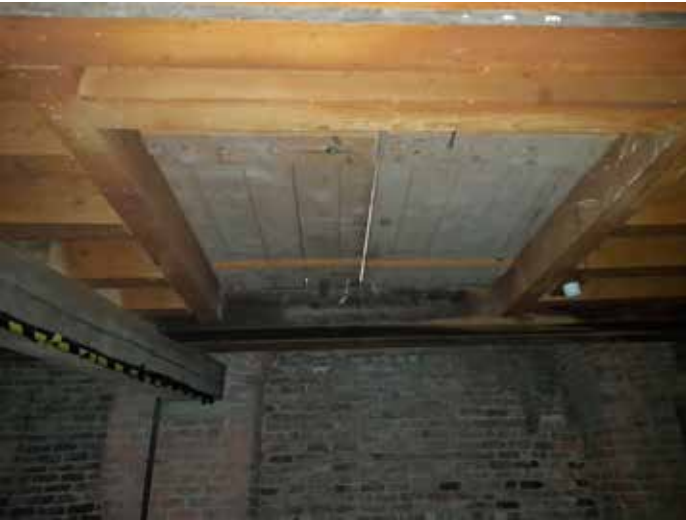
A0005: Check stability. Review with Structural engineer- Rein-force

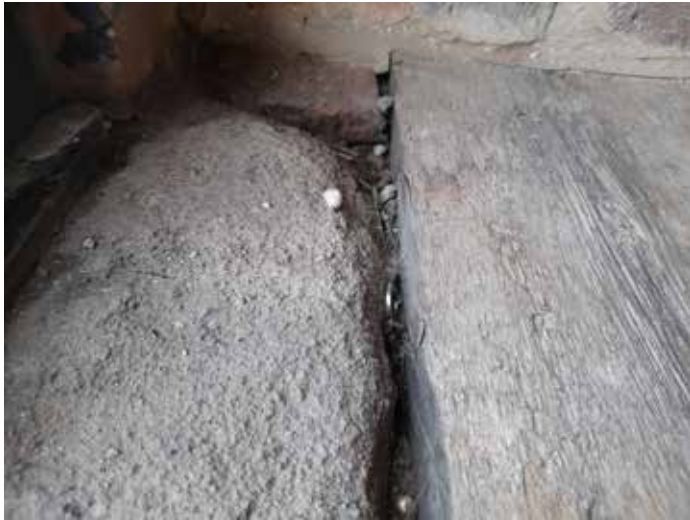
A0012: Damage timber. Repair sill (historic detail)

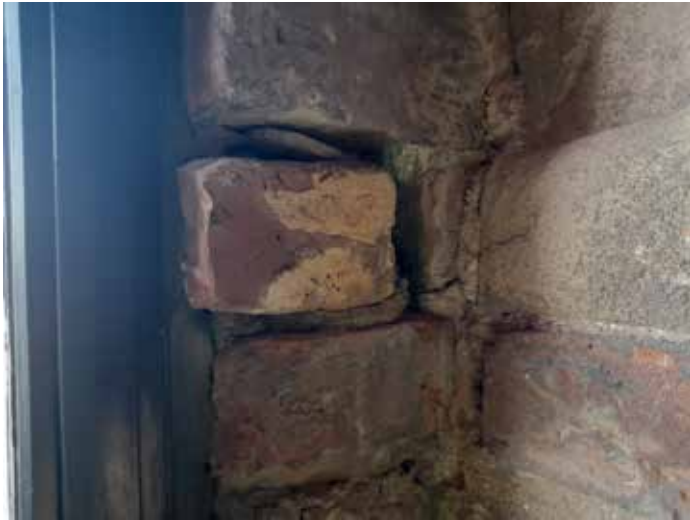
A0013: Damaged brick. Repair brick required

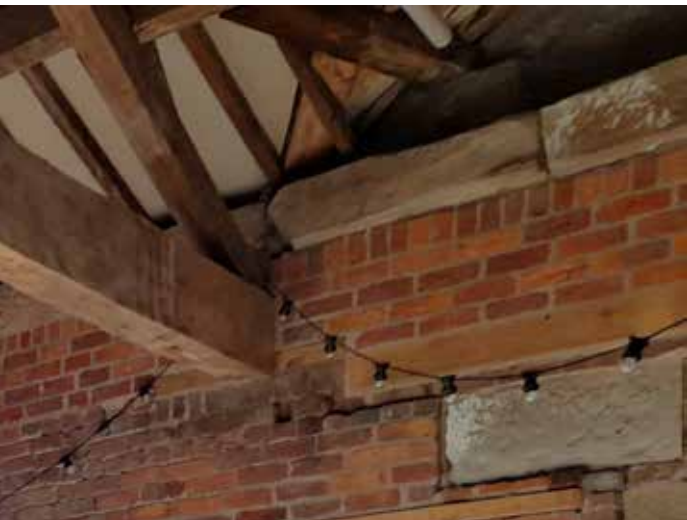
A0015: Brickwork damaged. Brick repair required

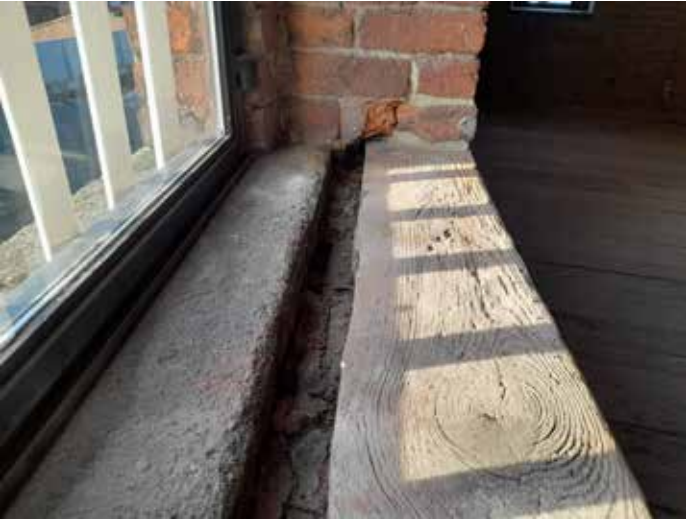
A0016: Damaged timber or deteriorate. Repair sill (historic detail)

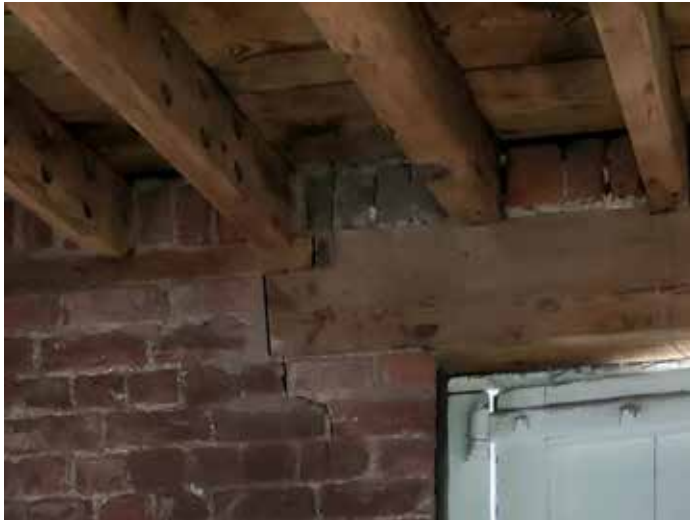
A0025. Brick wall crack. Brick repair required

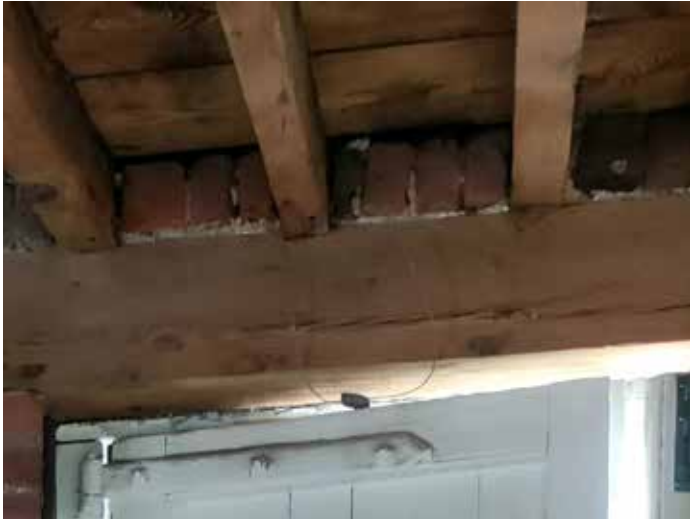
A0026: Defective pointing. Re-point

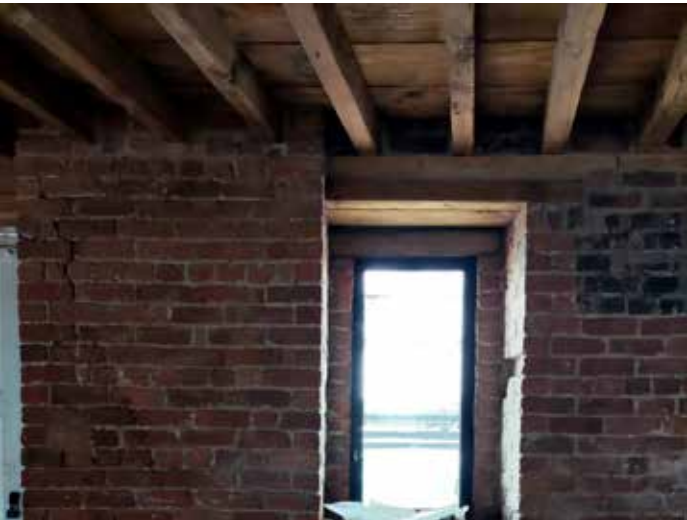
A0028: Brickwork damaged. Brick repair required

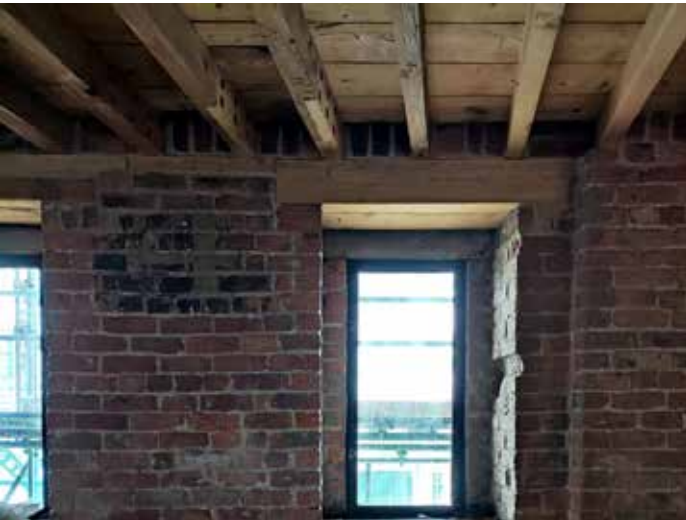
A0029: Brickwork damaged. Brick repair required

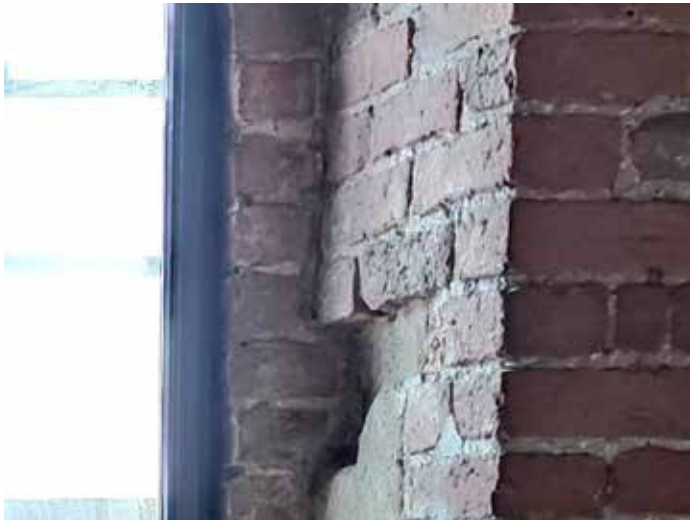
A0031: Missing masonry. Masonry repair required

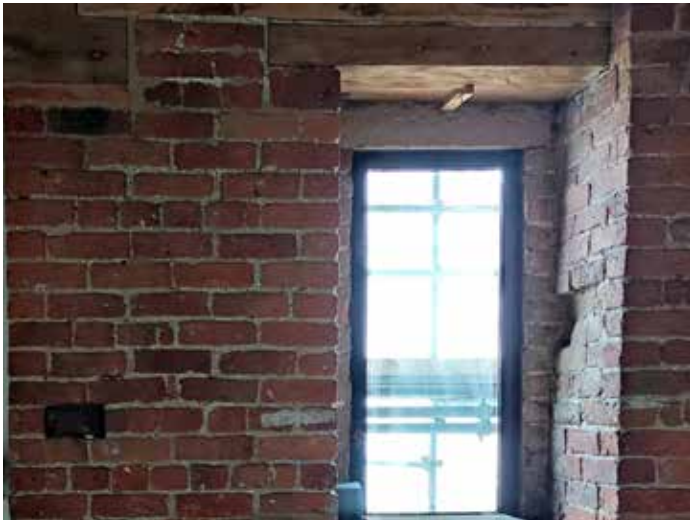
A0032. Brickwork damaged. Brick repair required

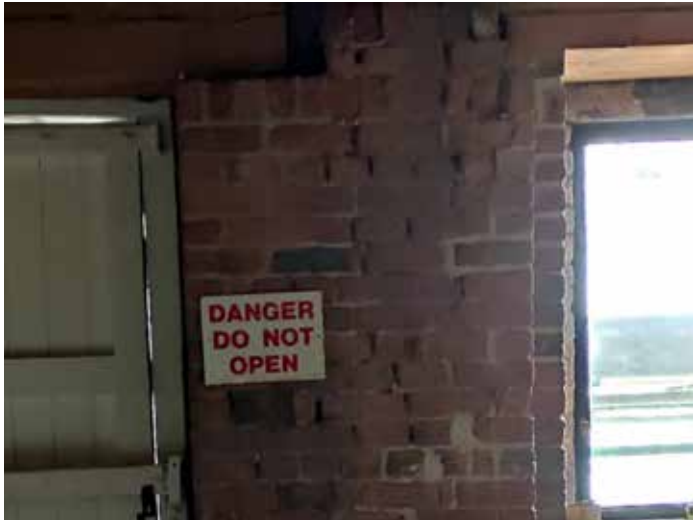
A0036: Defective pointing. Re-point

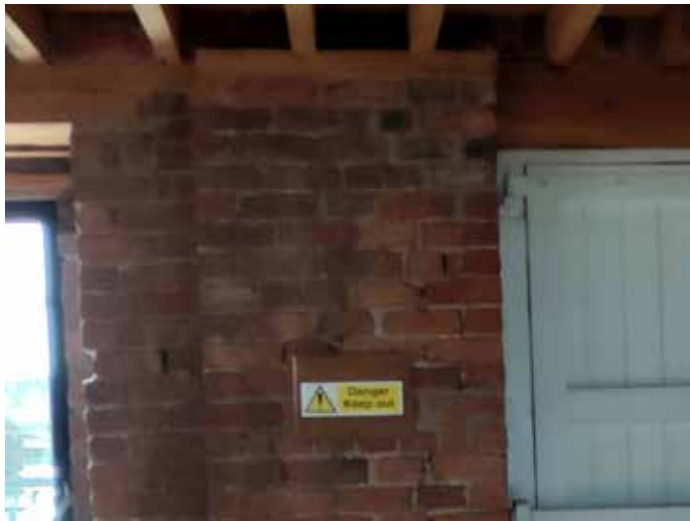
A0043 Defective pointing. Re-point

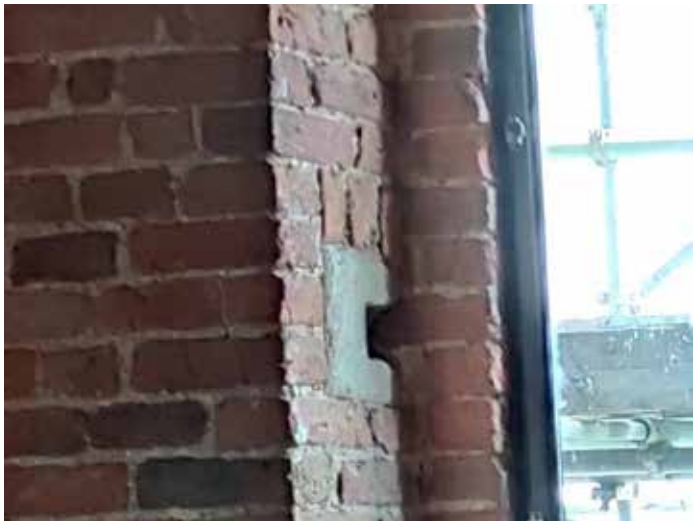
A0044: Brickwork damaged. Brick repair required

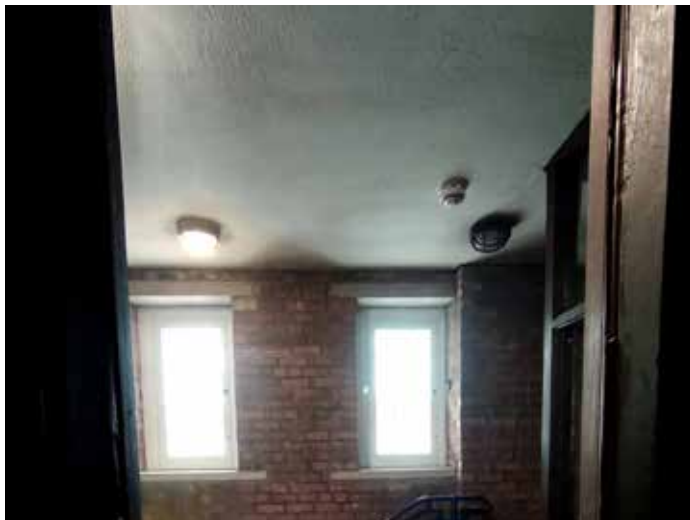
A0050: Brickwork damaged. Brick repair required

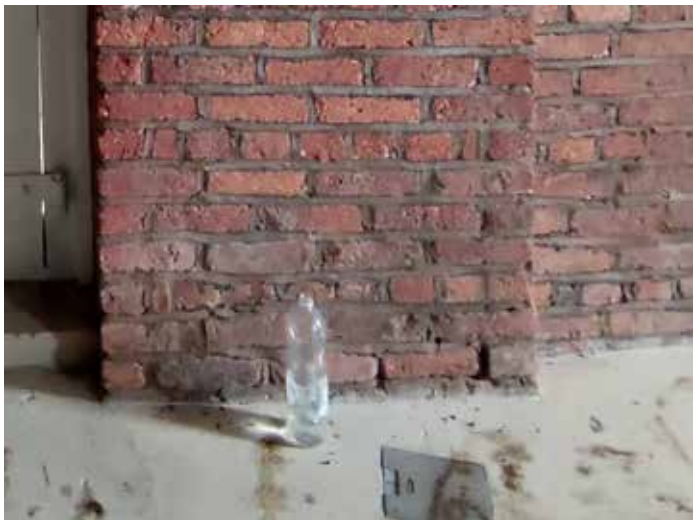
A0051 Defective pointing. Re-point

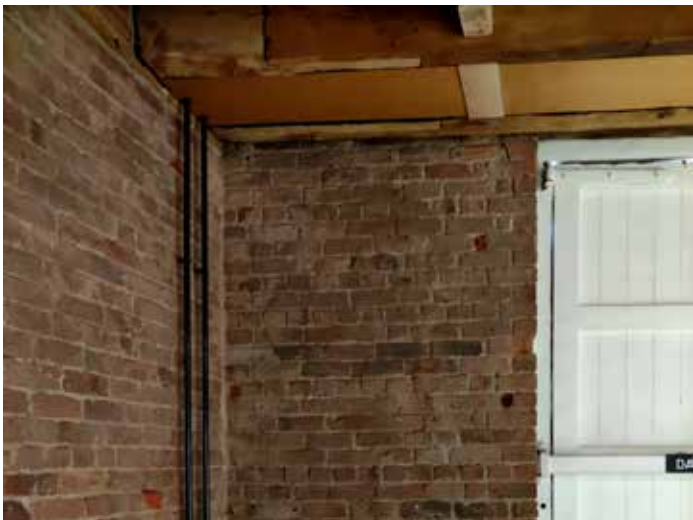
A0053 Brickwork damaged. Brick repair required

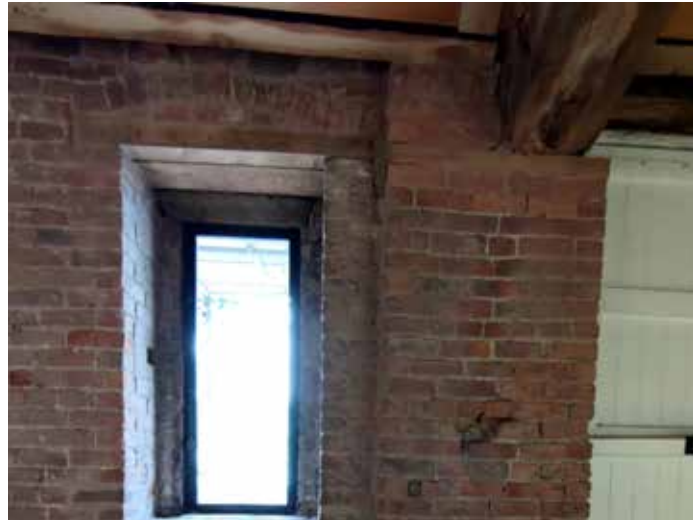
A0054: Brickwork damaged. Brick repair required

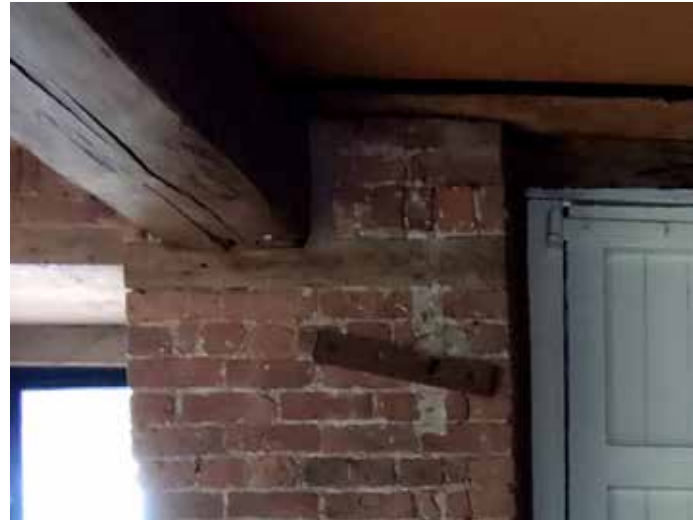
A0055.1: Defective pointing. Re-point

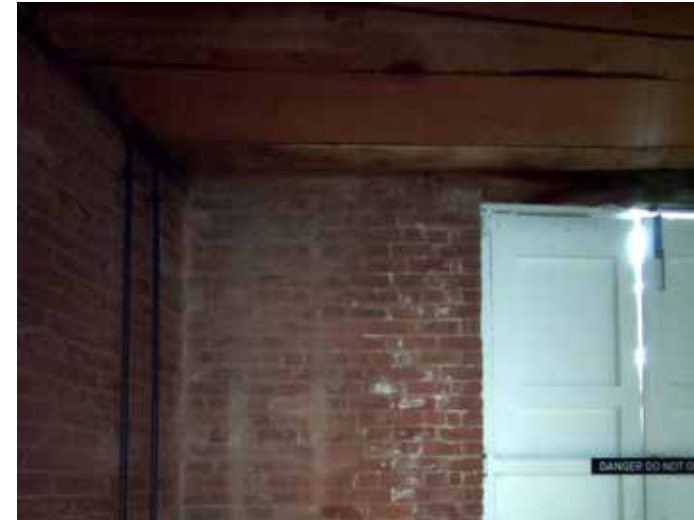
A0059: Wall stains. remove stains

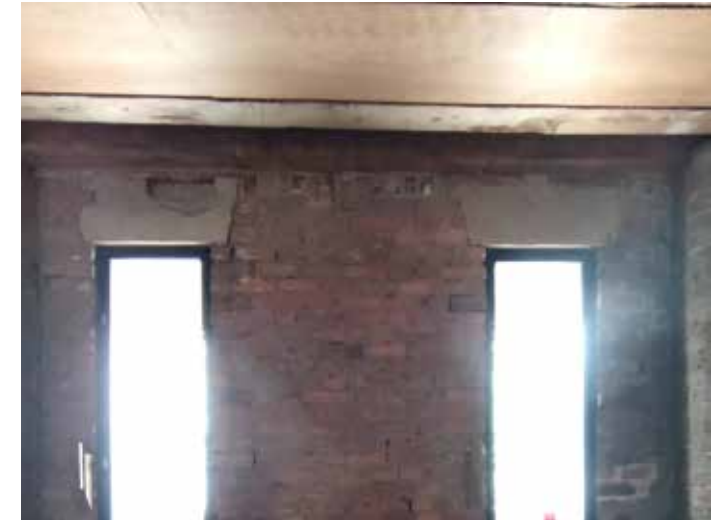
A0060: Stone lintel damaged. Repair lintel

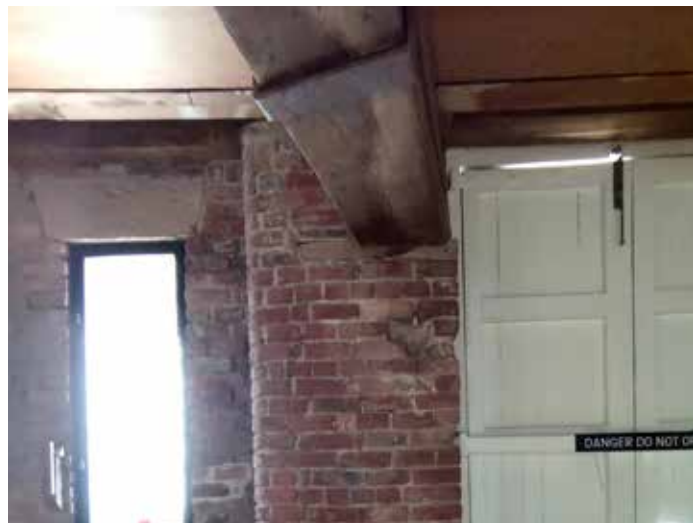
A0061 Brickwork damaged. Brick repair required

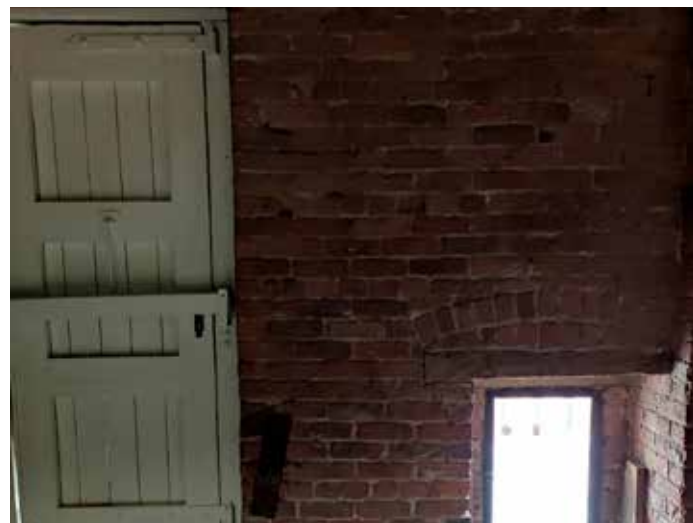
A0067: Wood piece fixed to wall. Remove and replace with salvaged brick

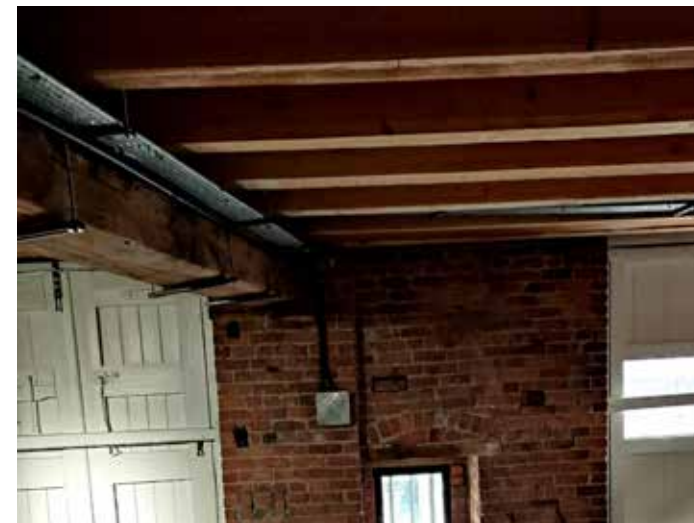
A0068: Wood blocks inserted to wall. Remove and replaced with salvaged bricks

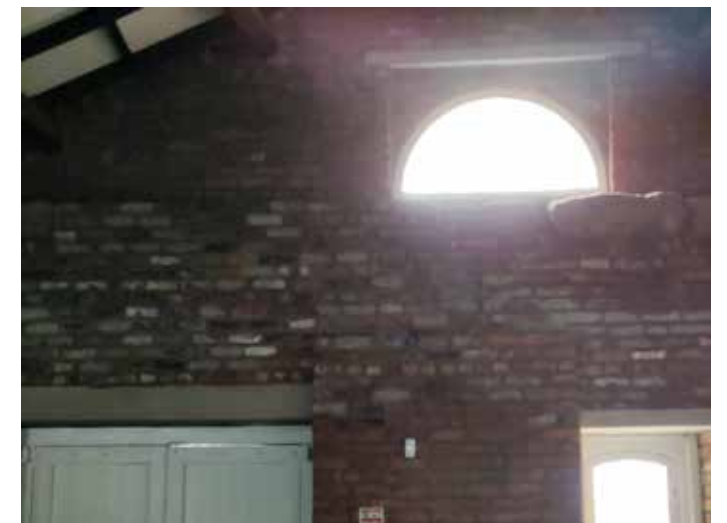
A0069: Wall stains. Remove white stains to wall

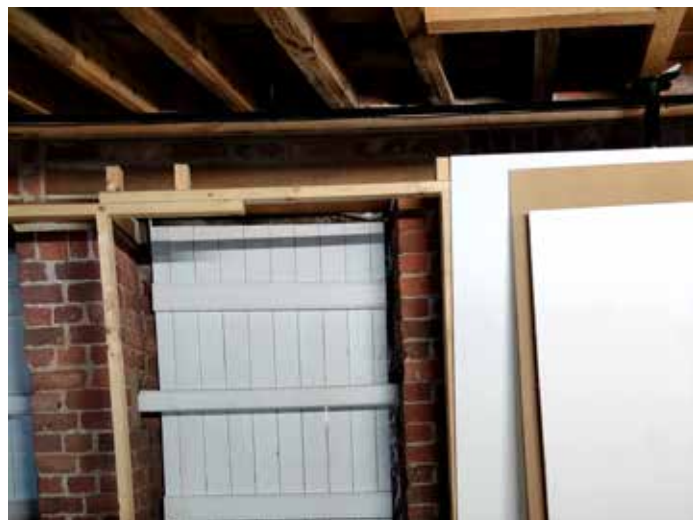
A0070: Loose sill. Check sill stability and repair.

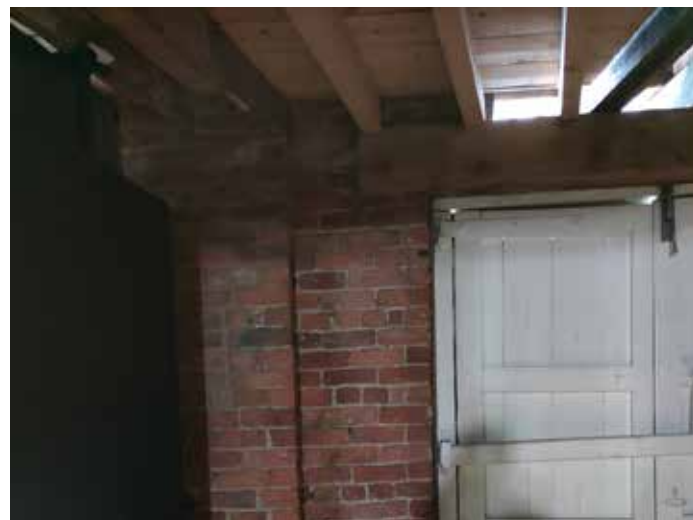
A0071: Brickwork damaged. Brick repair required

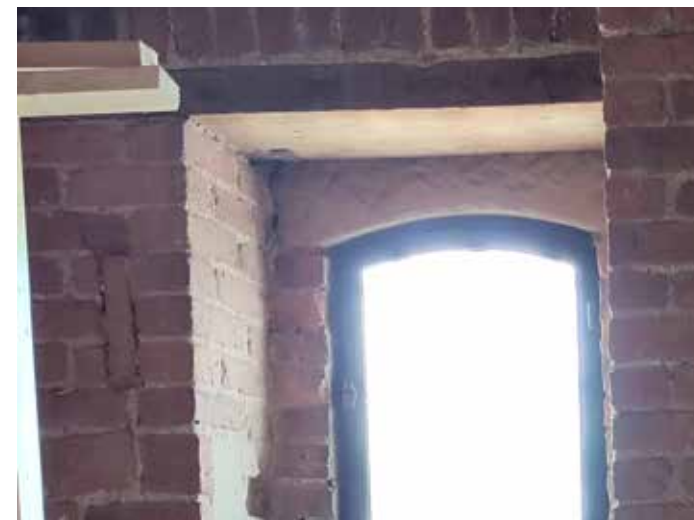
A0072: Brickwork damaged. Brick repair required

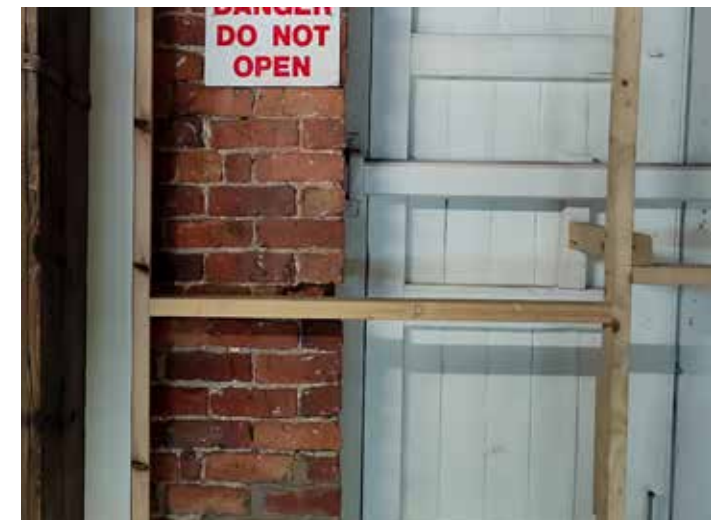
A0073: Brickwork damaged. Brick repair required

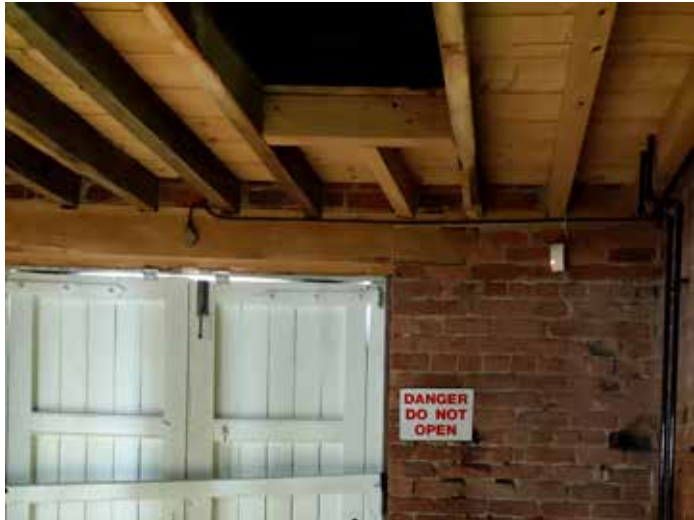
A0076: Defective pointing. Re-point

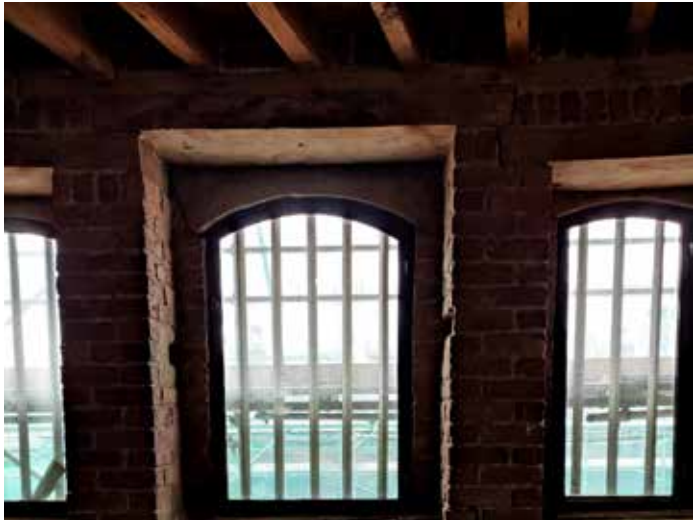
A0077: Brickwork damaged. Brick repair required

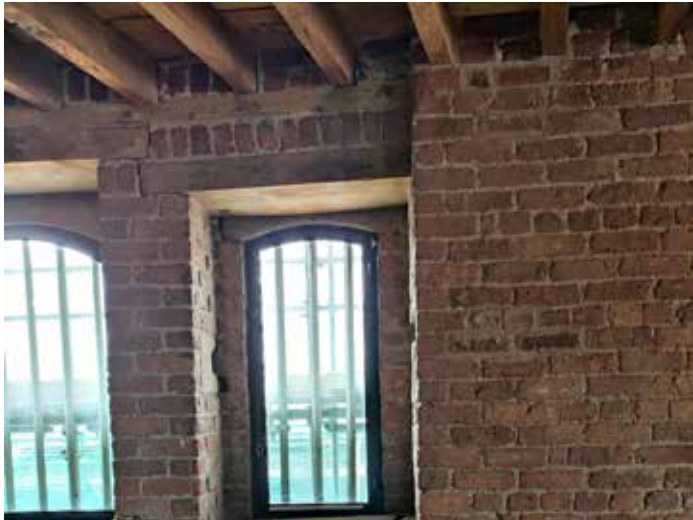
A0078: Brickwork damaged. Re-point check brick movement and repair

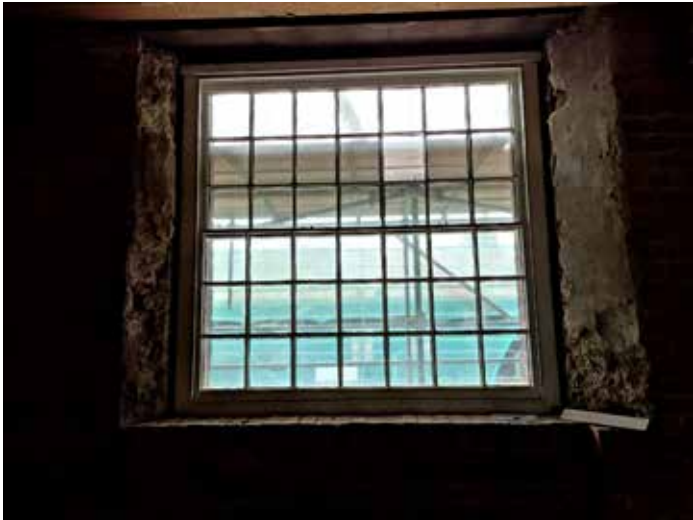
A0080: Damaged window reveal. Repair window reveal.

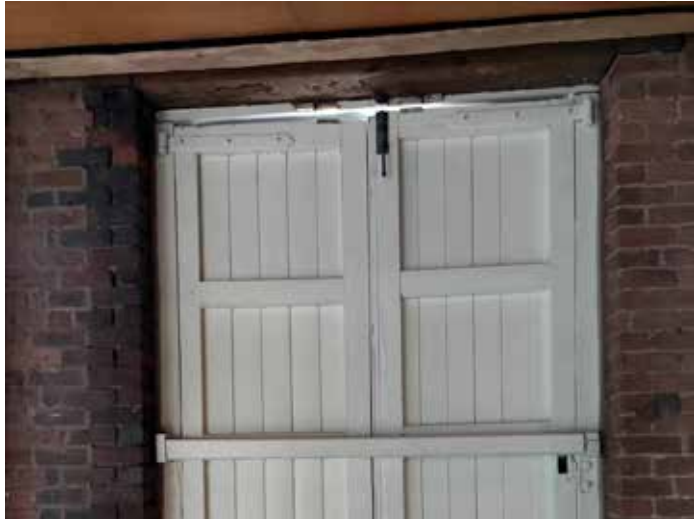
A0082. Defective pointing. Re-point

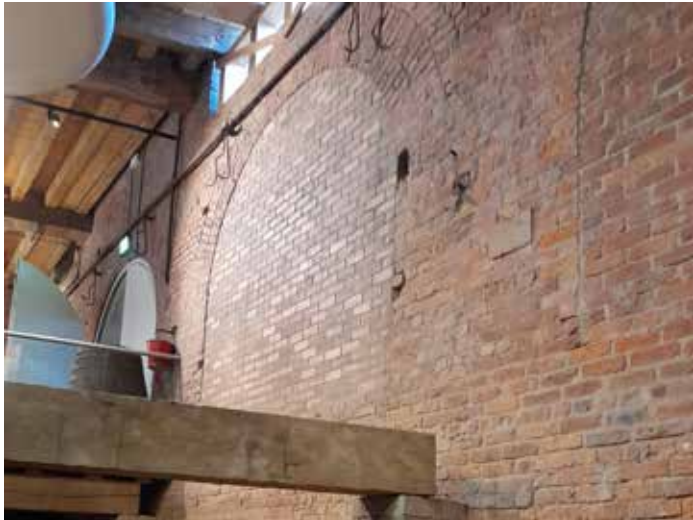
A0083. Defective pointing. Re-point

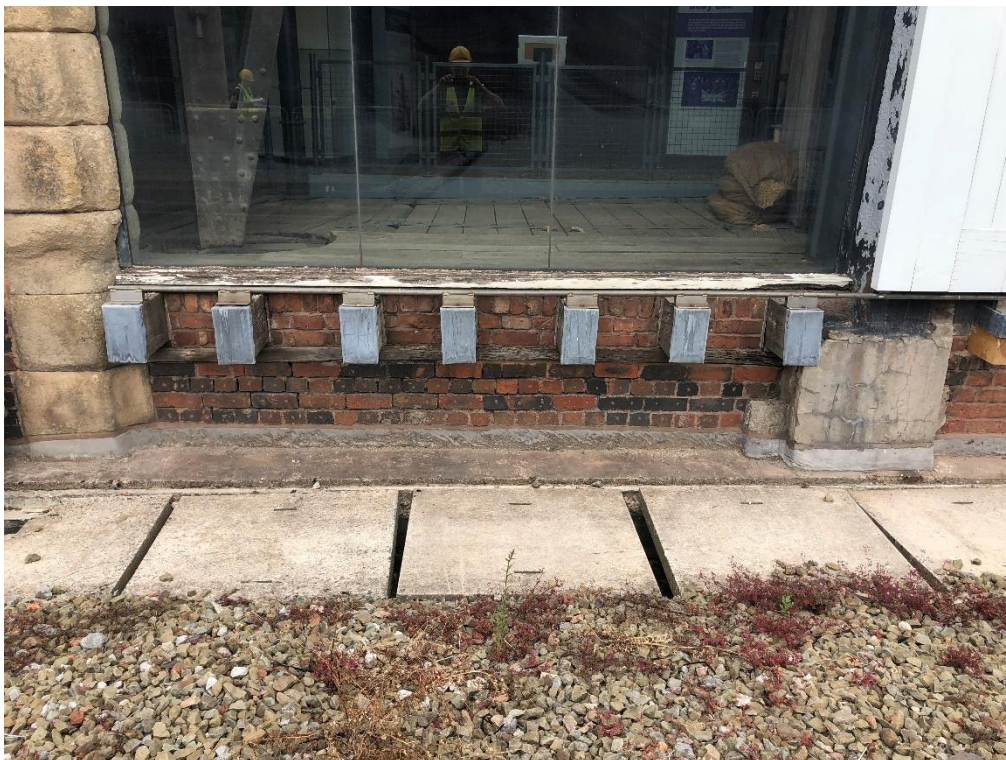
- 4.1 The cargo door at this Bay is fully glazed. The lower level floor has been removed and infilled internally with the revised timber floor structure extending to and bearing onto the external brickwork. This brickwork appears to have been retrofitted to support the timber structure.
- 4.2 The timber framing arrangements vary slightly due to the presence of a crane internally but most of the floor joists extend through the wall and project to provide support for a (now defunct) sliding door externally (Photographs 4, 5 and 6).

**Photograph 4: General external view of the base of the glazing showing floor joists projecting through the wall.**

- 4.7 The structural works at this location will involve extraction and like for like replacement of the decayed timber elements. Some localised rebuilding of brickwork will also be needed, and bricks would be reused wherever possible. This work will need to undertaken in tandem with improvements to waterproofing details and flashings to prevent the problem from recurring in future.

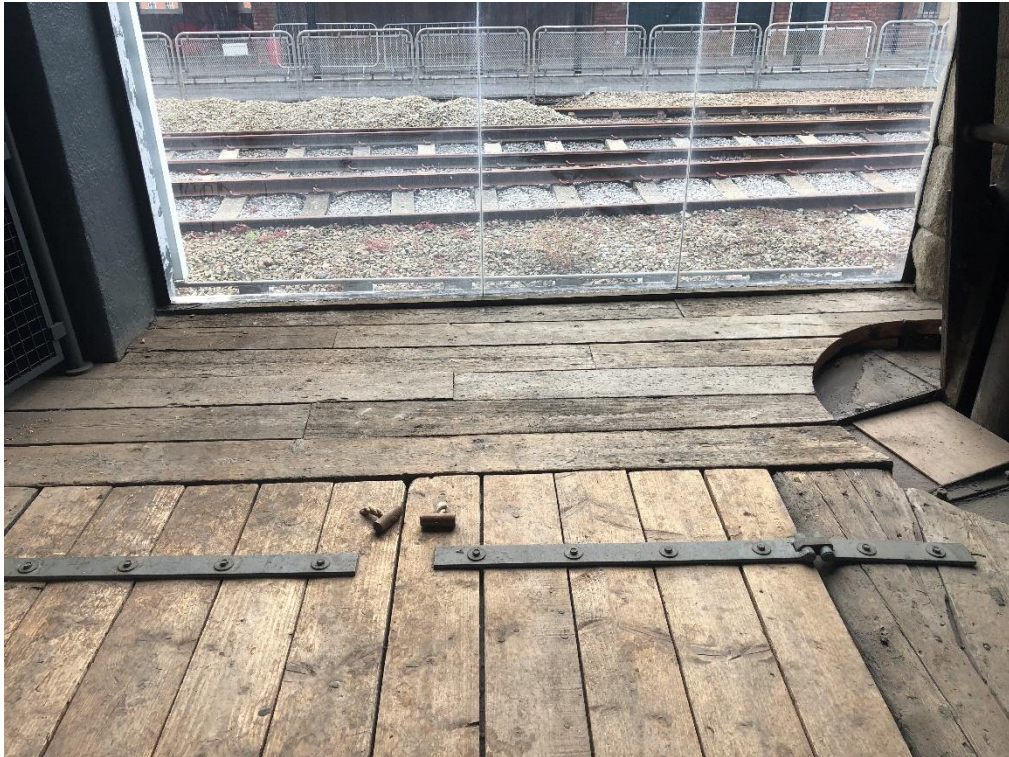
**Photograph 5: General internal view of the glazed opening.**

- 4.3 The glazing has also dropped at this bay and it is assumed that this is due to decay of a timber sill, although confirmation through intrusive investigation will be needed.
- 4.4 Extensive decay has also occurred to the timber joists passing through the wall (Photograph 7) as well as to the timber plate externally below the joists (see Photograph 5).

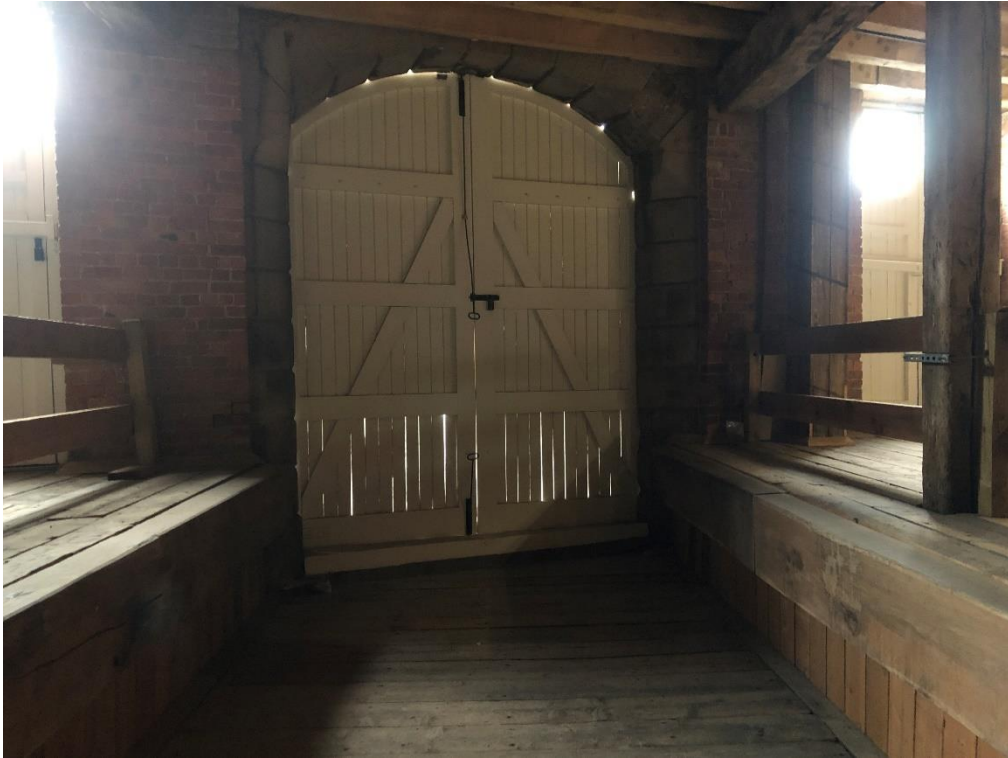
- 6.1 Bay 4 is generally considered to have retained the most 'original' arrangements within the building both structurally and architecturally. The lower level floor structure at track level is still present internally (Photograph 10) and a timber door remains present to cover the structural opening in the external wall (Photograph 11).

**Photograph 10: General internal view at Bay 4 showing locally lowered floor structure to allow goods wagons to enter.**

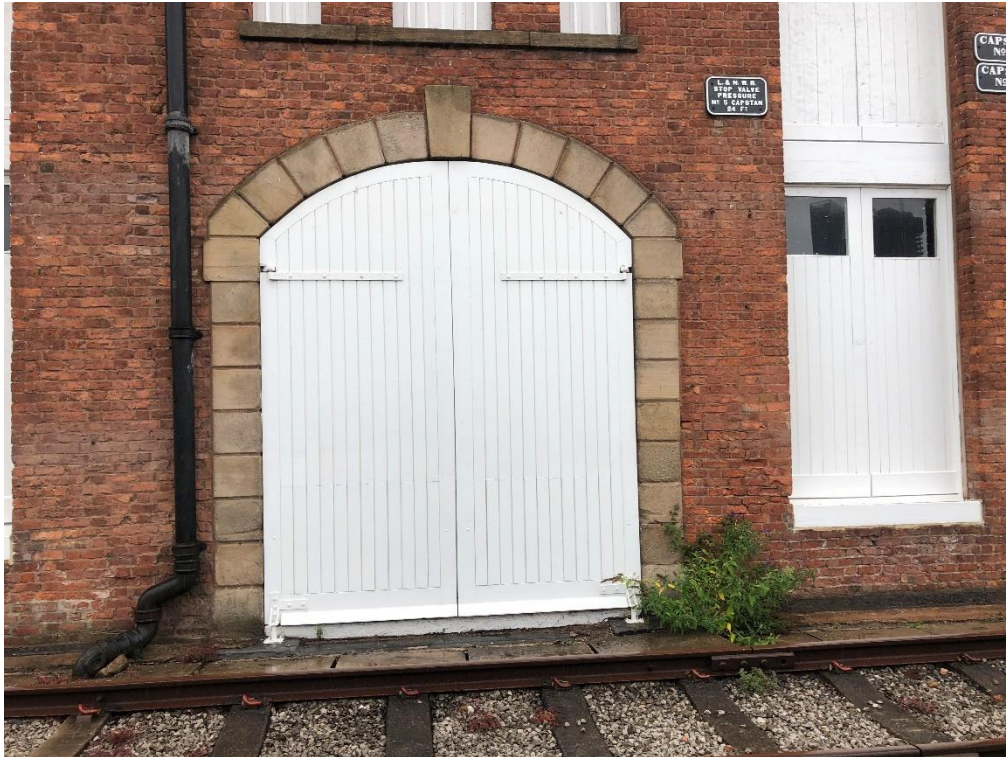
**Photograph 11: General external view showing timber door and sill.**

- 6.2 A timber sill of circa 150mm height is provided at the base of the opening, presumably for weather protection, but it is not known whether this replicates the original detail as the historic track level at the time of construction cannot be conclusively confirmed. This sill is in any event non-structural as the doors bear onto pins externally which are presumed to be set into mass concrete pads. The upper hinges are fixed to ironwork set into the stone architrave blocks.
