# Essential Repairs including Replacement Wagon Arch Glazing

## 1830 Warehouse

Science & Industry Museum

Design and Access Statement

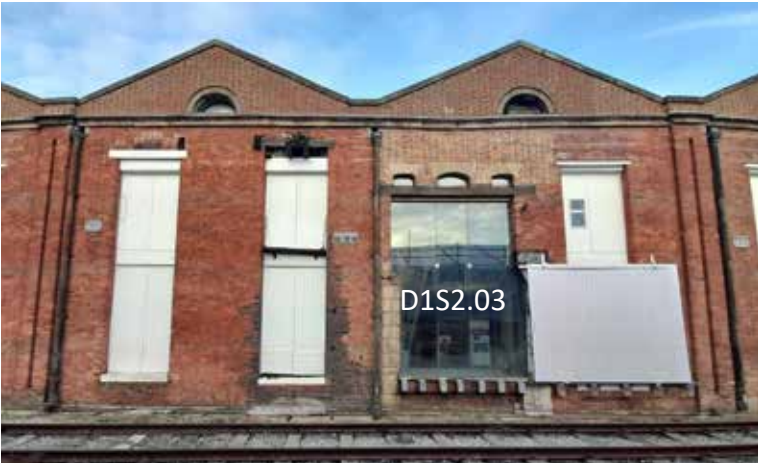
Wagon Arch D1S2.03  
Externally:

- Glass window\_double height.
- Straight wood lintel to head,
- Stone reveal in part, brick reveal.
- Decayed cut short joist ends
- Brickwork below sill

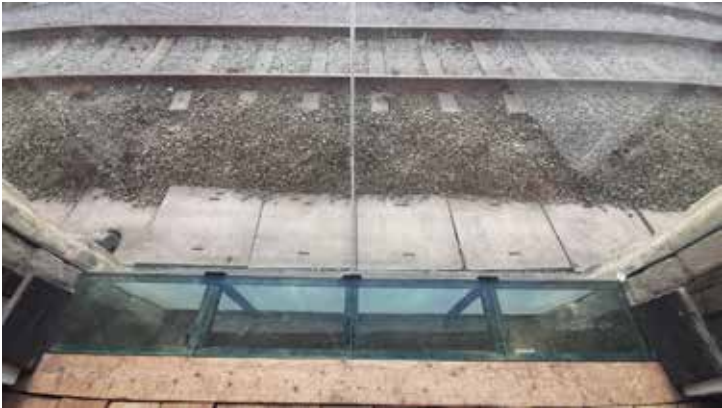
The glazing detail is very similar to the failed detail at Bay 1

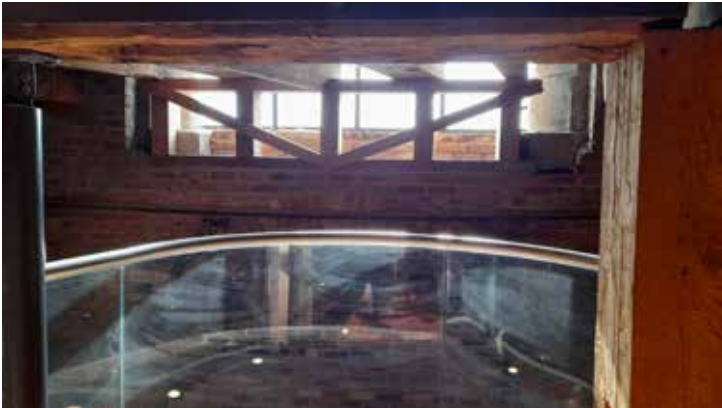
As with Bay 1, Bay has a glass floor with structure bearing down on a timber batten

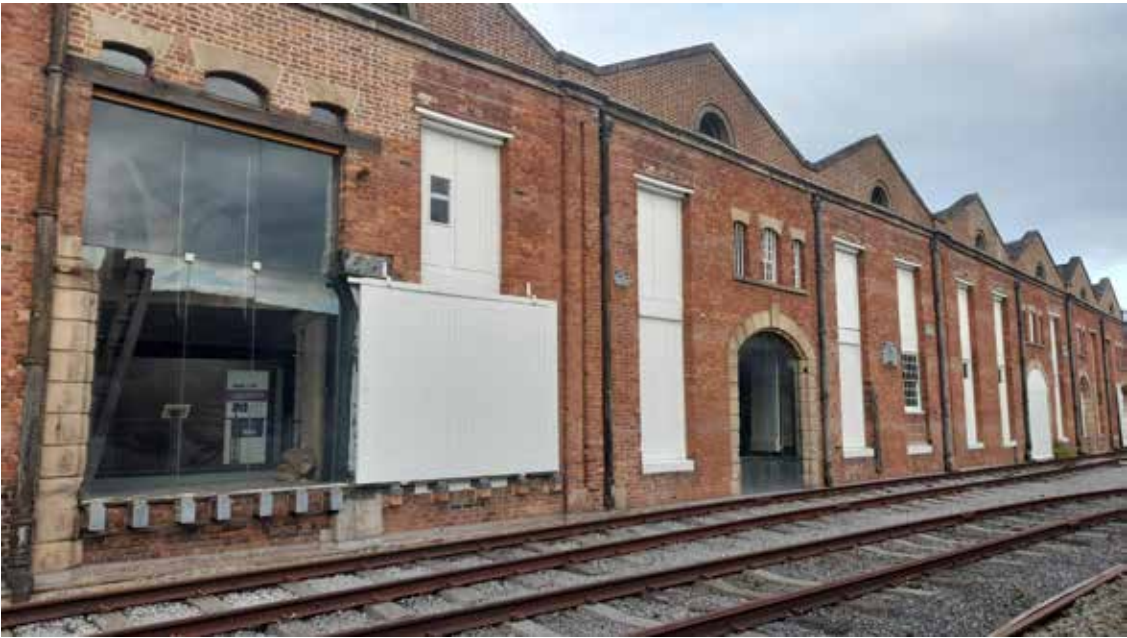
Bay 2 foreground, and Bay 3 to the right. The Bay 3 detail to the viaduct is the same as Bay 1
