**FENTON HOUSE, HIGHER ARDWICK, MANCHESTER**

**CONDITION COMPLIANCE:**

**Room by Room Schedule of Works  
(Condition 5)**

*Peter Jones-Hughes and Huw Davies  
MIHBC; BSc Hons Town Planning; PG Dip Blg Cons [RICS]  
Prepared November 2021*

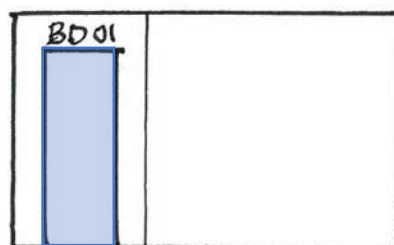
## WEST

West elevation- Existing: Temporary boarded external door. Fanlight and side panel also boarded – no architrave

Proposed: Complete and fit new door/frame (see door and window schedule). No coving and – modern Torus skirting boards throughout

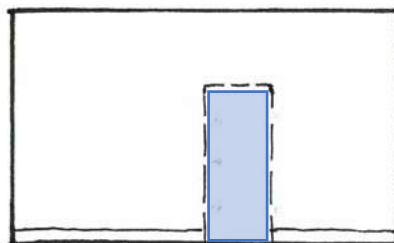
## SOUTH

South elevation- Existing: New door with historic architrave to lobby – low Torus skirting boards

Proposed: Retain existing skirting boards. Replace existing modern door with new internal panel door (see door and window schedule) – no coving required.

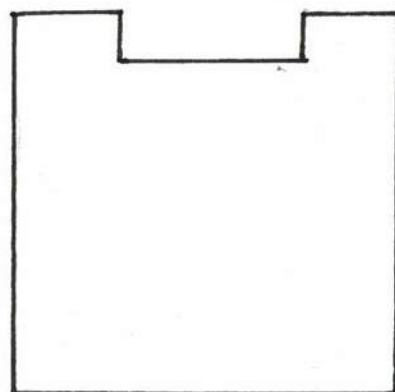
CEILING

| <p>Room B08 – Dining room.</p> <p><u>Ceiling Plan - Existing:</u> Low artexed ceiling with modern coving on all walls apart from south of west wall. Central partition</p> <p><u>Proposed:</u> Skim over artex – retain existing coving. No coving required to both sides of new central partition.</p> |

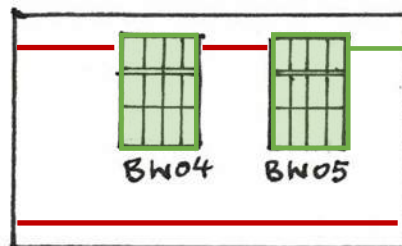
WEST

| <p><u>West elevation- Existing:</u> Two modern sashes – original boxes remain to north but rotten. Modern coving and skirting. Modern coving to north parts over windows. (Missing to south part). Modern Torus skirting</p> <p><u>Proposed:</u> Retain skirting and coving – instal matching coving where missing. Replace both windows with 4/8 sashes (see door and window schedule)</p> |

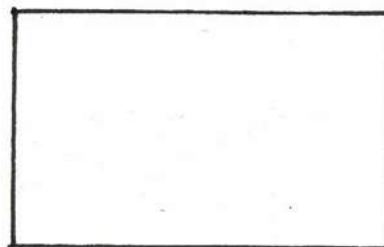
### NORTH

North elevation- Existing: Blank plain Plastered wall, dry rot to west upper parts? also dry rot evident in lower northeast corner. Low Torus skirting board.

Proposed: Investigate and treat dry rot in plaster to upper west parts and east corner.

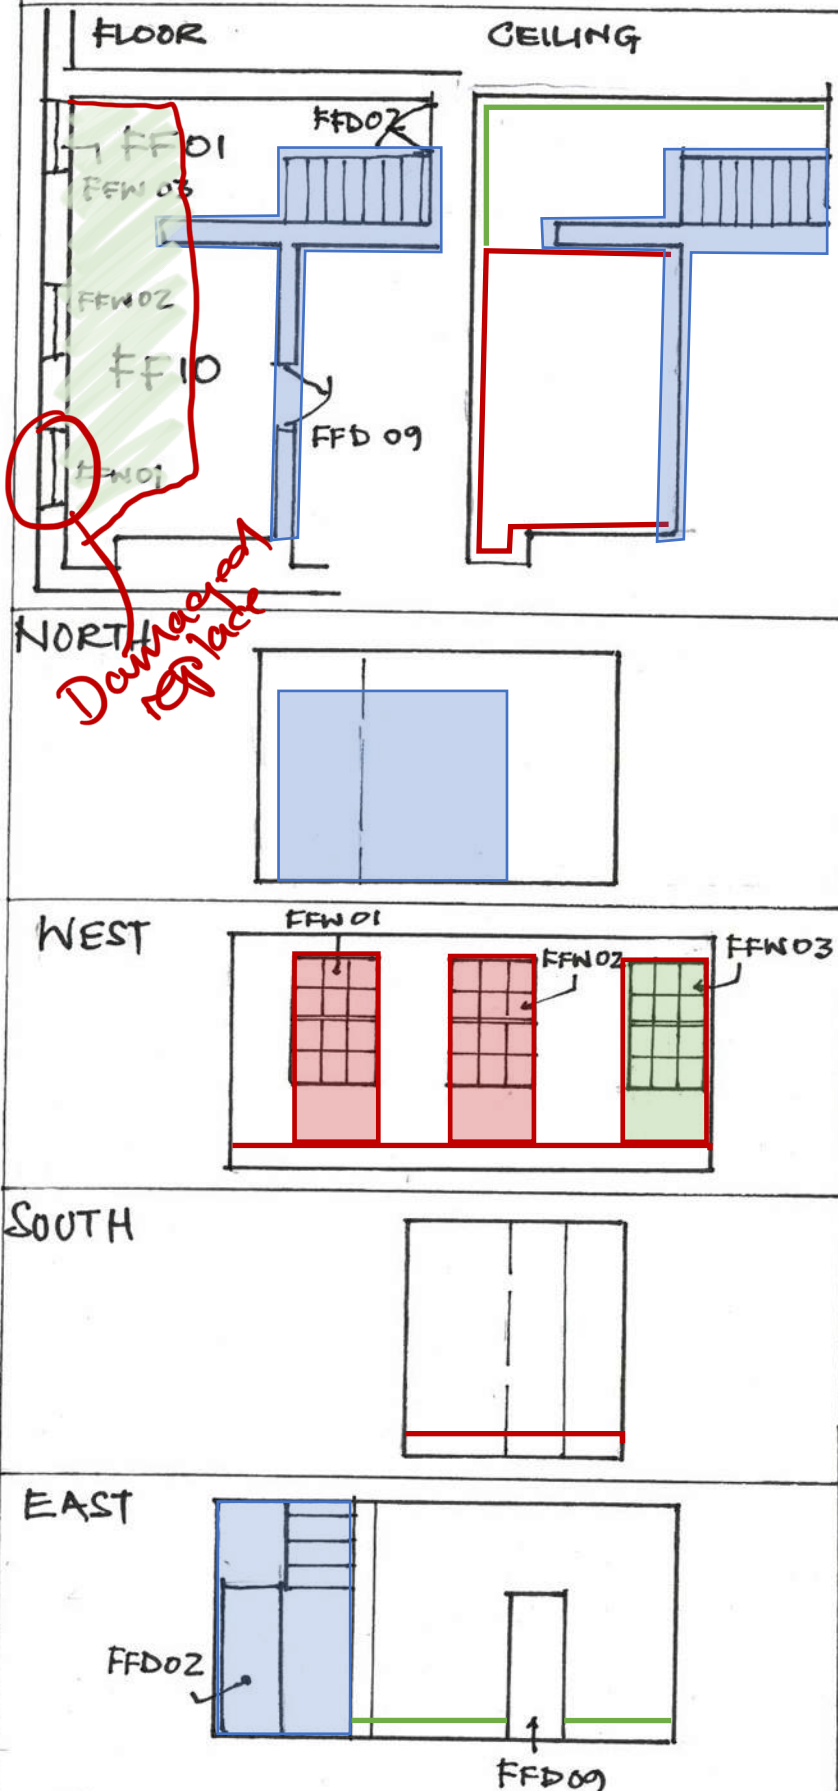
## FIRST FLOOR ROOMS FF01 & FF10

West elevation- Existing: FF01 former 6 over 6 pane sash replaced with 12 pane casement – upper 9 panes fixed. Bottom 3 panes top openers With wide architrave and painted timber canted casing. High skirting board. FF10 high status coving preserved, 2 windows both 6 over 6 pane sashes (early) with wide architraves and plinths. Canted painted timber casings with recessed timber panels below window. (Latter aspects similar for FFW03). High skirtings.

South elevation- Existing. In room FF01 large modern opening to west and stairs to south. No coving. Modern skirting board. FF10 has chimney breast with later additions to southeast. High status coving and skirting preserved.

Floor Plan - Existing: FF01 lino over medium wide timber boards. FF10 narrower T&G boards (some missing).

Proposed: F01 bath placed under window FFW03 – reposition? Retain and repair wall features. Replace window FFW03 with 6 over 6 sash (see window and door schedule). FF10 Two windows – FFW01, top sash survives but lower sash to be replaced with detail to match, type X in window schedule. Window FFW02 lower sash with lambs' tongue bars retain. Replace upper sash as lower sash in FFW01, retain all frames/boxes, casings and architraves and skirtings. Coving retained.

Proposed: East partition removed will reveal chimney breast coving to be retained. Retain skirtings.

Proposed: Replace missing boards.

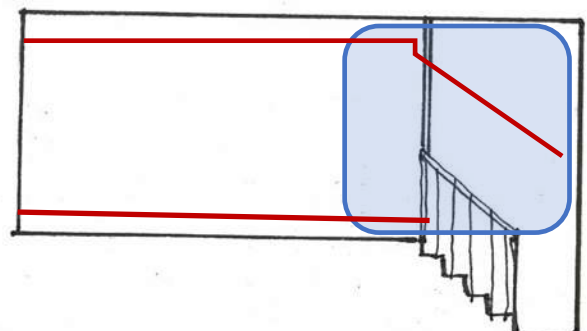
East elevation- Existing: Plaster – moisture damaged. Early 9" Torus skirting. Remnants of early coving

Floor Plan - Existing: Timber floorboard, with large section of damage and missing – tongue and groove.

Proposed Repair and replace coving and skirting where damaged, like for like.

Proposed: Replace missing boards after installation of fire protection/noise attenuation measures. Ensure skirtings are safeguarded.

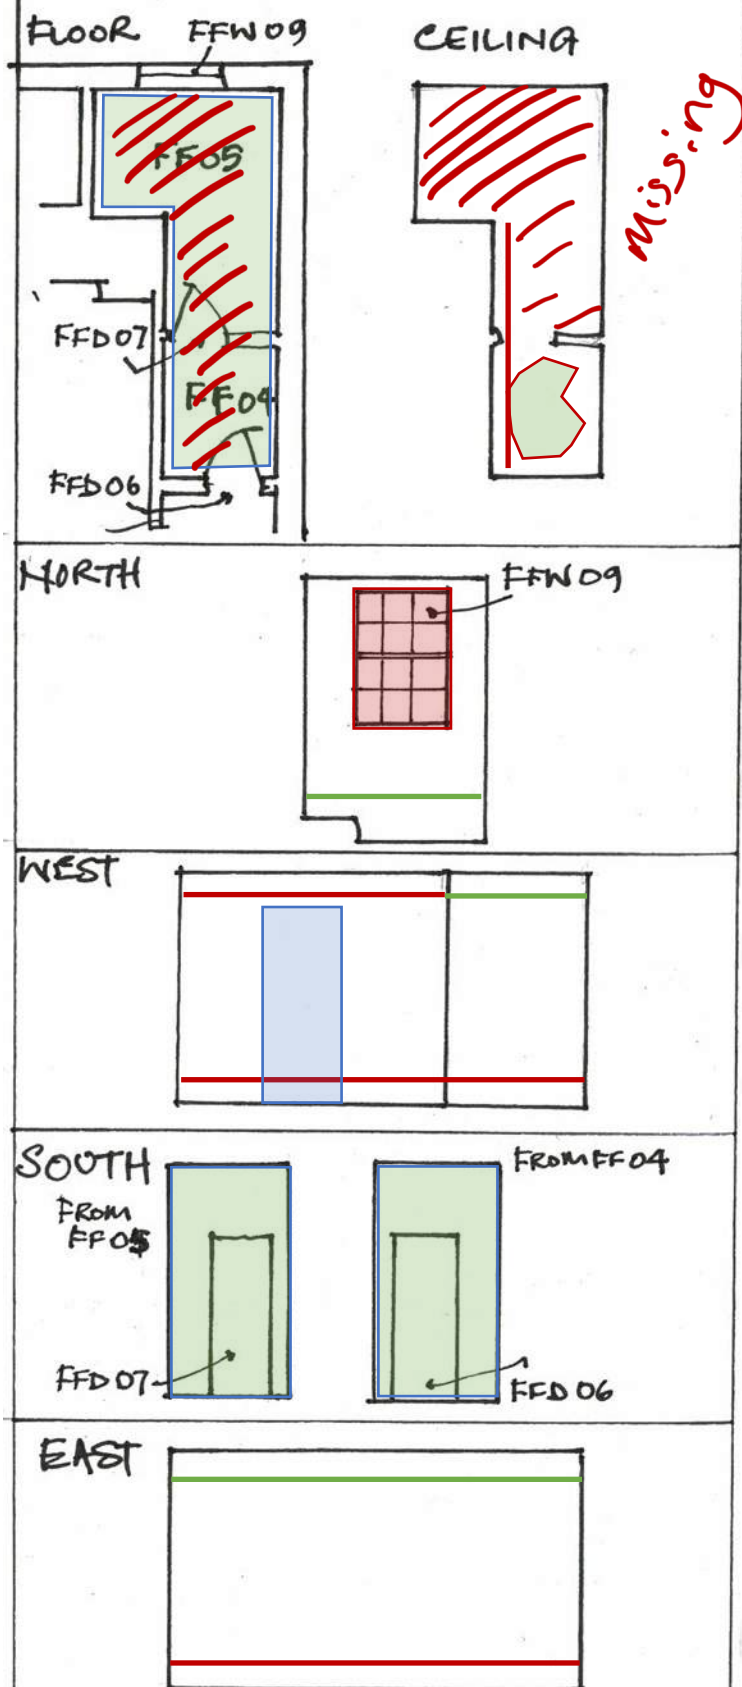
## ROOMS FF04 & FF05

Ceiling Plan - Existing: FF04 has suspended plasterboard ceiling damaged and missing in parts. No complete lengths of coving - early fragments survive in west wall. FF05 Suspended ceiling with plaster board, early coving survives on west wall.

Floor Plan - Existing. Narrow T&G boards. Some missing in both rooms.

Proposed: Retain early coving and install matching coving where missing in both rooms. Remove plasterboard and repair underlying lath and plaster. New store partition without coving. Existing and new decorative cornice to east and west walls safeguarded.

Proposed: Add high Torus skirting to match east and west walls. Repair plaster. Repair and refurbish existing sash. Sink units to be installed under window – conflict with sash height?

Proposed: This partition to be retained or replaced like for like? (See door schedule). Safeguard coving and skirtings.

Proposed: Repair, plaster. Retain skirting. Install early coving type where missing.

Proposed: Retain floorboards and install new boards to match. After installing services and fire/noise measures within ceiling void. Ensure M & E follows existing bathroom service routes. Fire & noise protection measures in floor void.

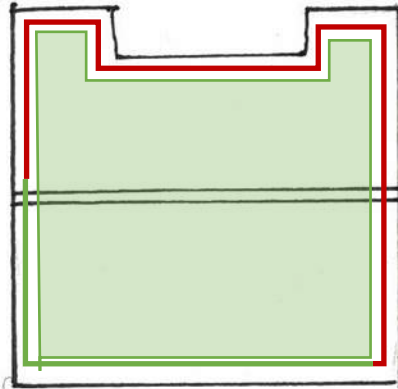
CEILING

Ceiling Plan - Existing: FF08 and FF09 has plaster board over early lath and plaster ceiling. Early coving to north part of west wall, north, east and west walls. No coving to central partition

Proposed: Retain central partition. Remove plaster board, examine/repair lath and plaster ceiling, retain early coving runs and add matching coving where missing. No coving to central partition. Ceiling heights match

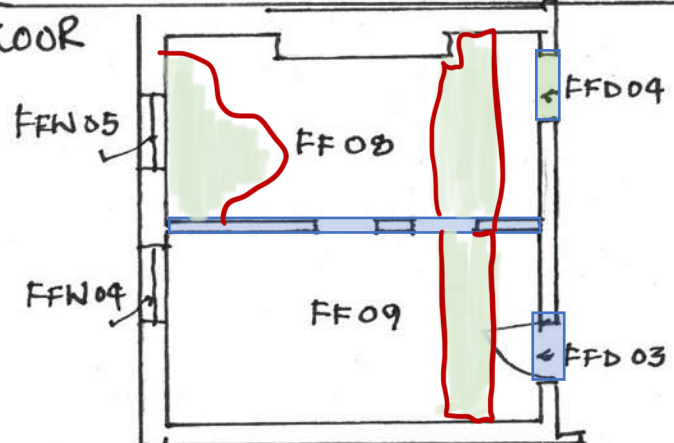
FLOOR

Floor Plan - Existing: FF08 – plywood laid on T&G boards - missing to east. FF09 T&G boards in tact. Slate hearth to chimney in FF08.
