# Fraser House Outline Structural Engineering Proposals

Ref: LM21346-DYSE-XX-ZZ-RP-S-0002

Rev: P02

Date: 13/12/2022

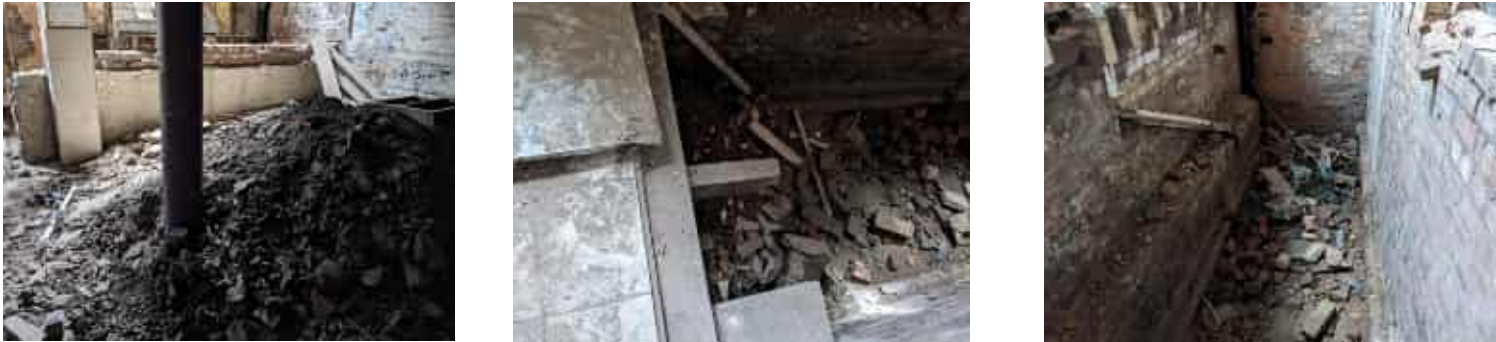
Various Lower Ground Photos.

- General Floor Commentary
1. Floor generally level, with minor undulations noted predominately at board joints.
  2. Columns generally in fair condition given the age of the building.
  3. Existing floor boards circa 70mm thick.
  4. Boxing to timber beams recessed, unclear what size and depth.
  5. Overboard thickness 20mm.
  6. Flooring has local over boarding.
  7. Condition of lintels unknown, no access.
  8. Ceiling infill, assume plaster board.

- Defects Reference
- 1.0 - Debris pile preventing access.
  - 2.0 - Fall to existing floor (mm)

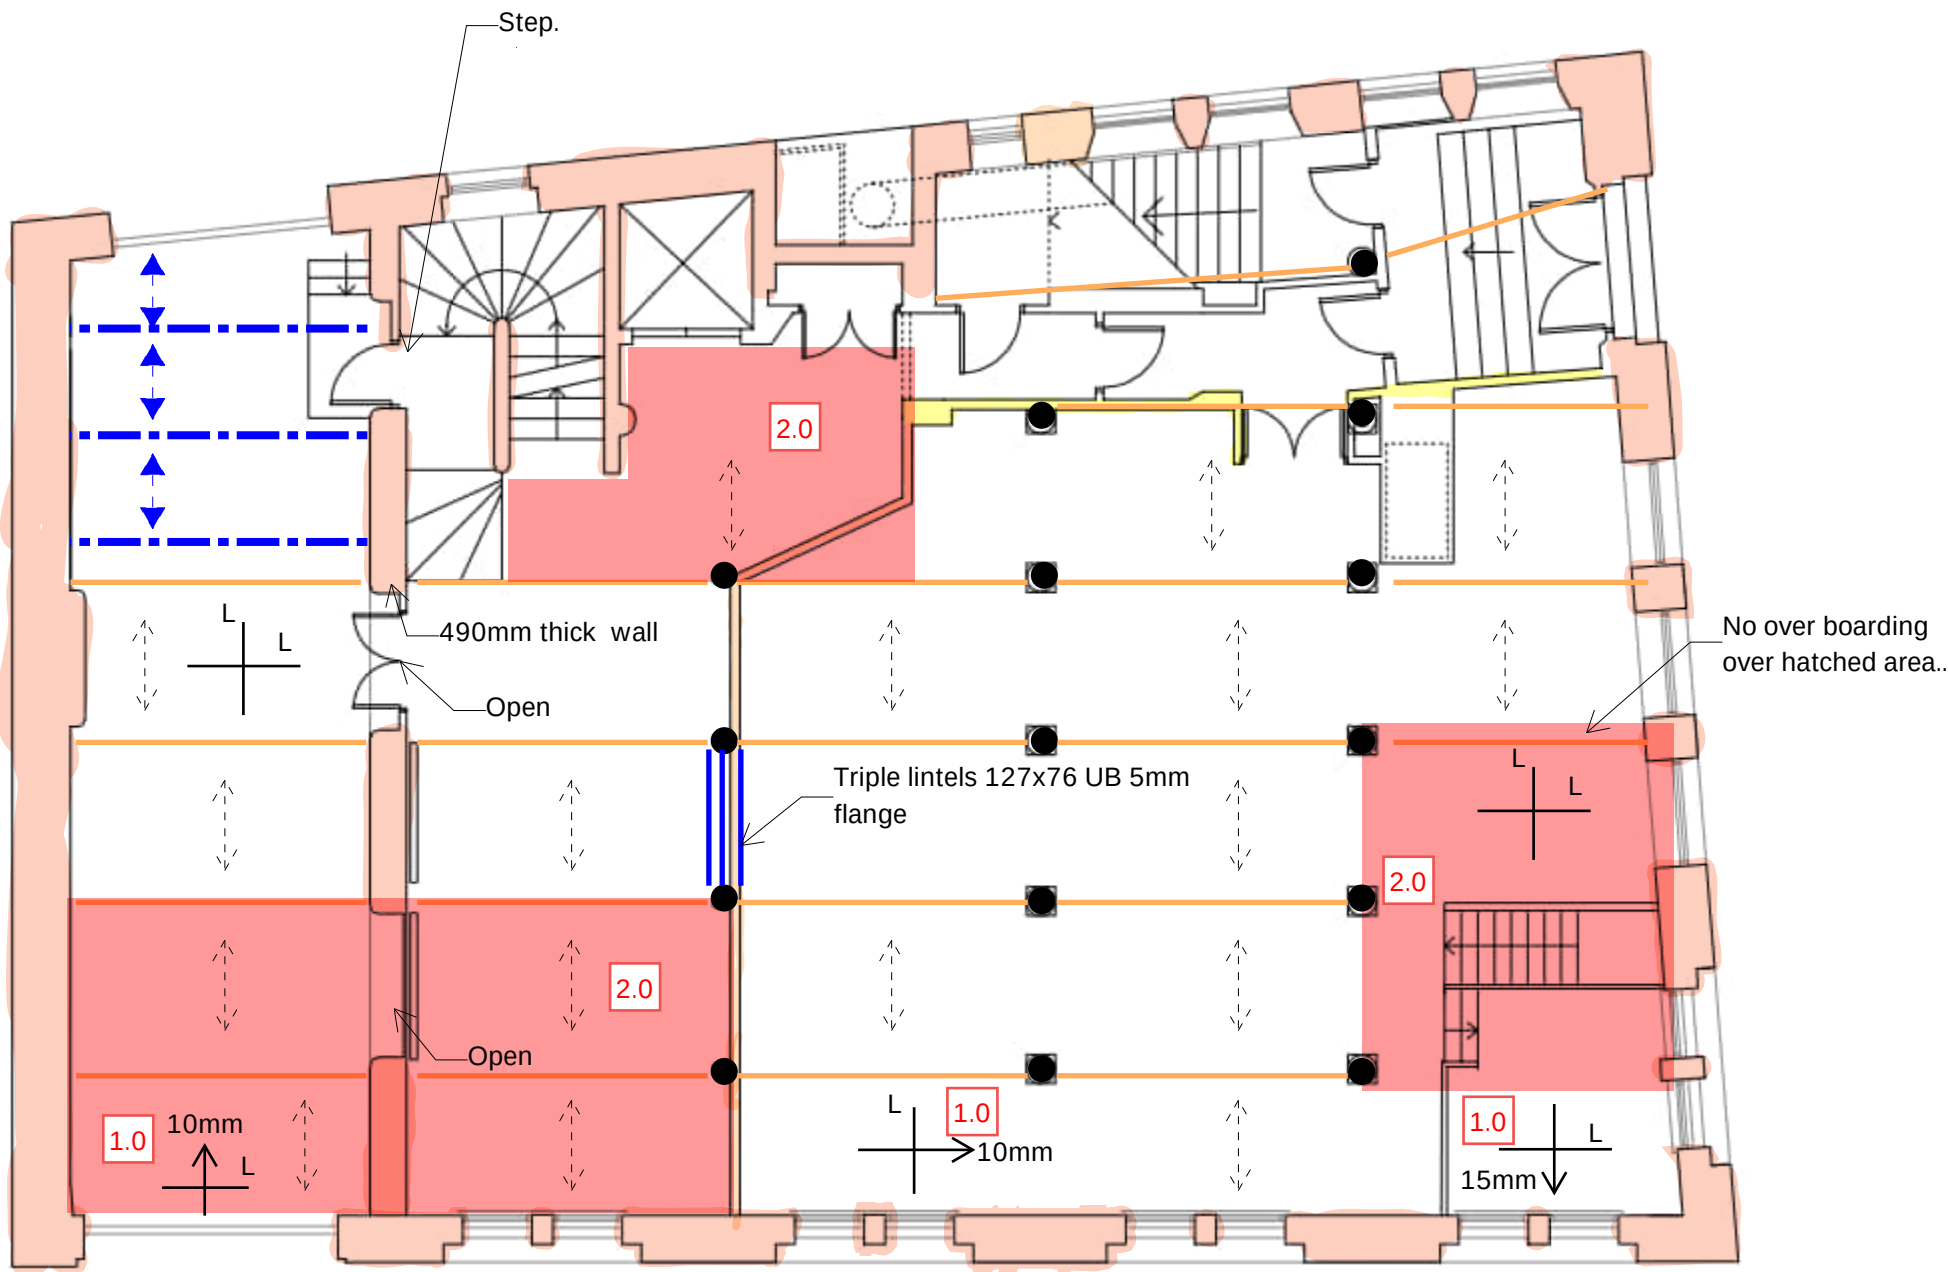
Existing Upper Ground Floor Layout Indicating Structure Over

1. Floor generally level, with minor undulations noted predominately at board joints.
2. Columns generally in fair condition given the age of the building.
3. Existing floor boards circa 74mm thick.
4. Boxing to timber beams makes it difficult to tell if continuous or not.
5. Overboard thickness 20mm.
6. Flooring has local over boarding.
7. Masonry in fair condition with small diameter holes throughout.

- 1.0 - Undulation to flooring (yellow hatch).
- 2.0 - Fall to existing floor (mm)
- 3.0 - New timber lintel.
- 4.0 - Steel lintel, fair condition.

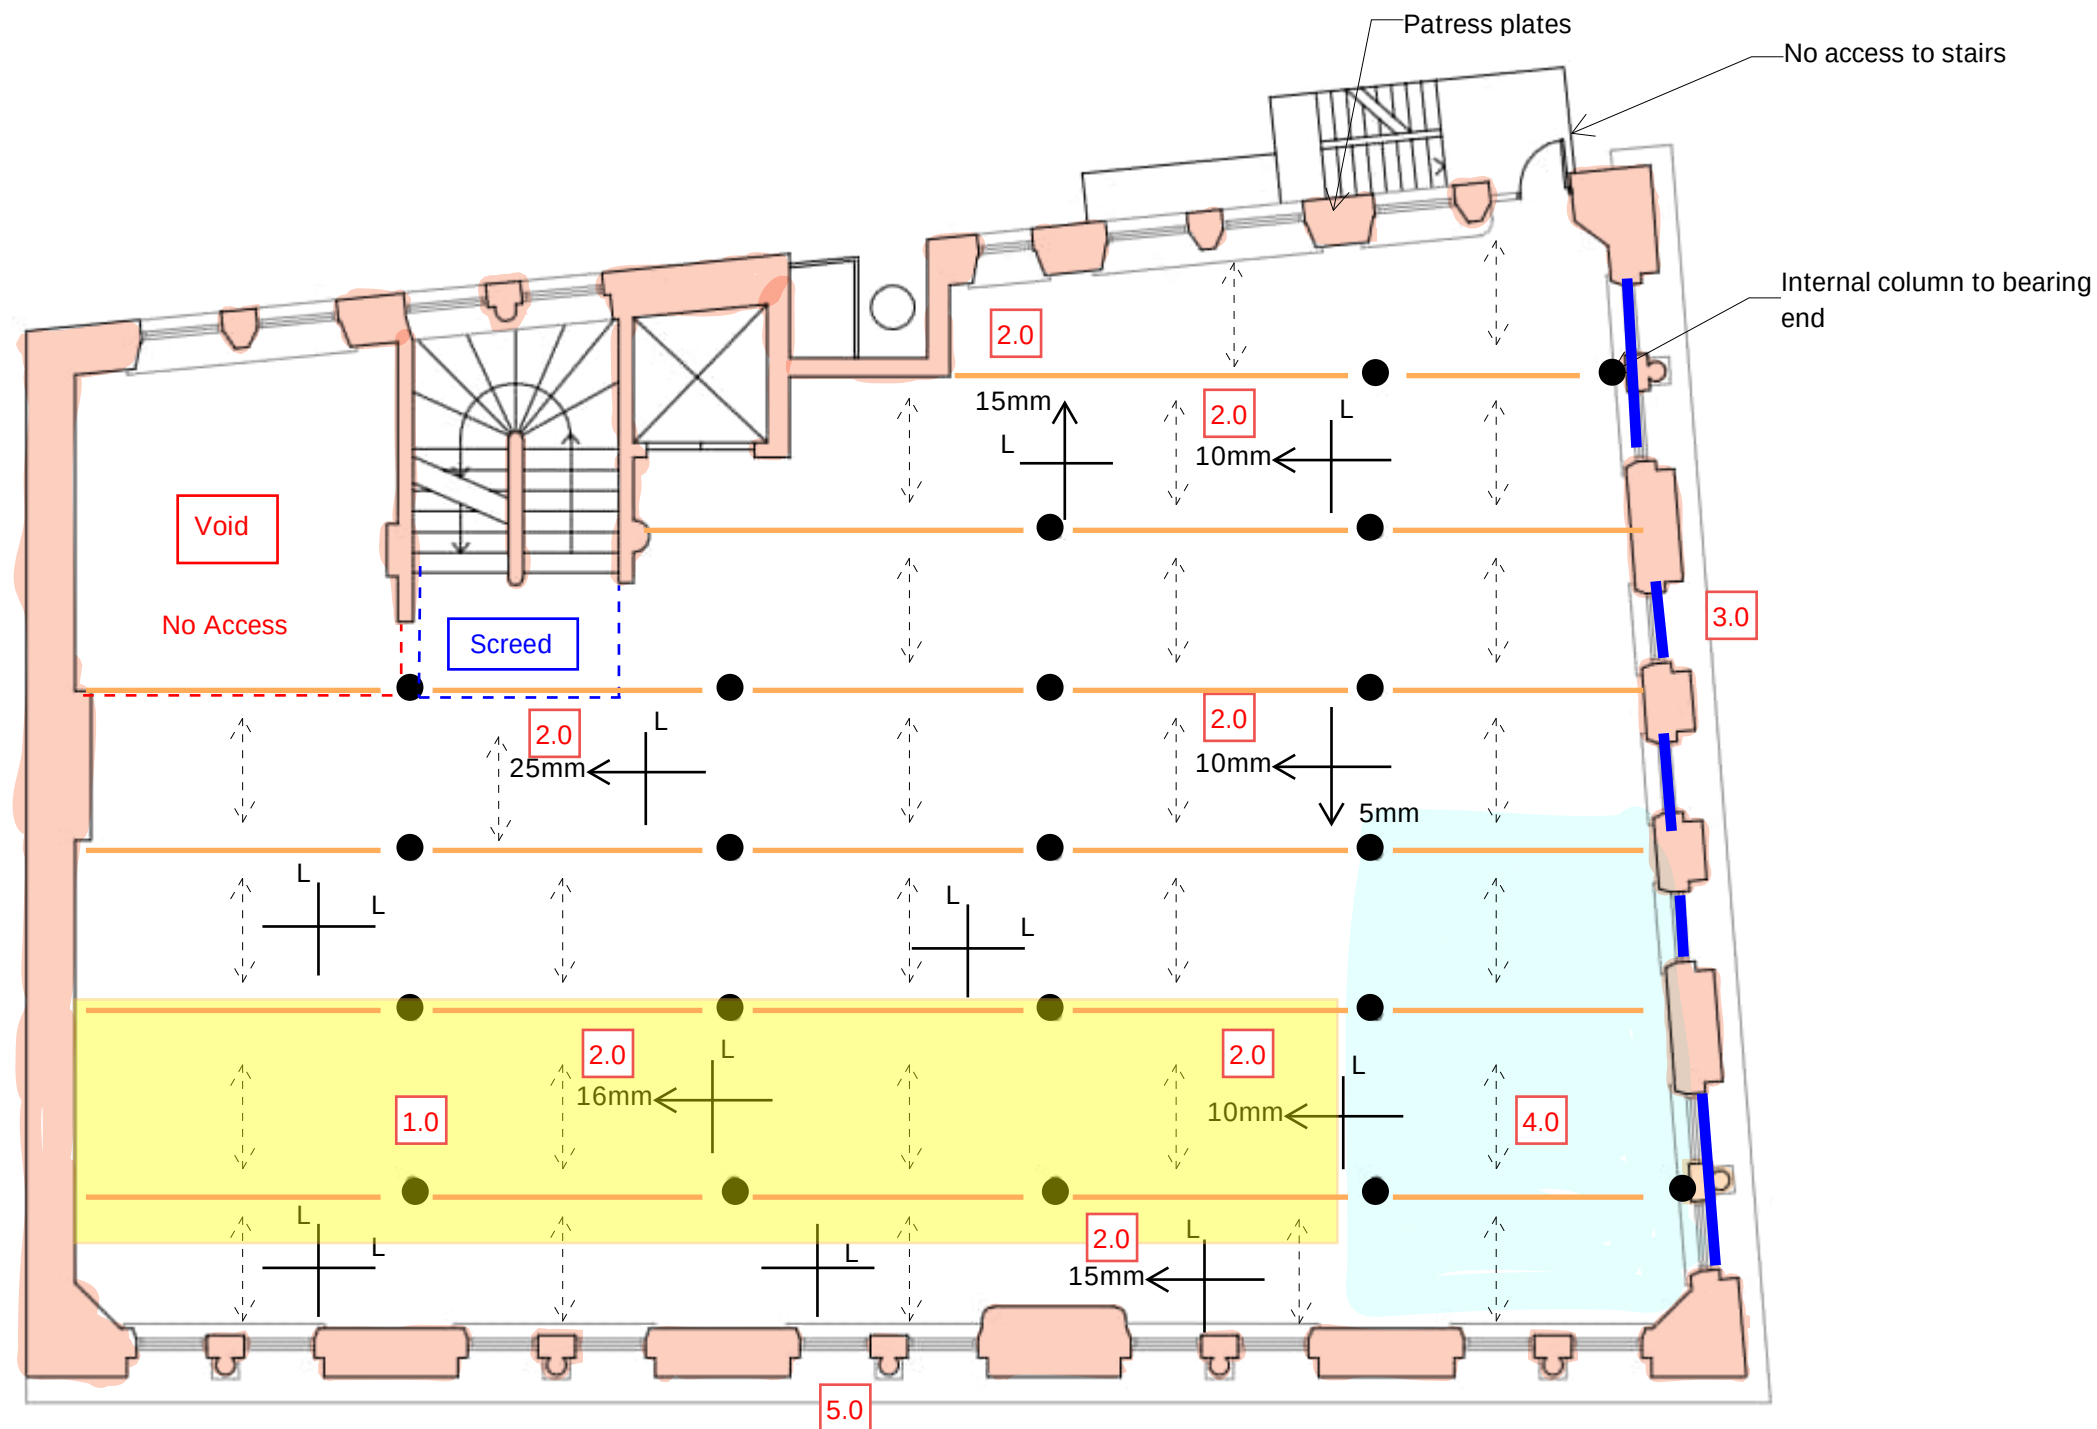
### Existing First Floor Layout Indicating Structure Over

1. Floor generally level, with minor undulations noted predominately at board joints.
2. Columns generally in fair condition given the age of the building.
3. Existing floor boards circa 77mm thick.
4. Boxing to timber beams makes it difficult to tell if continuous or not.

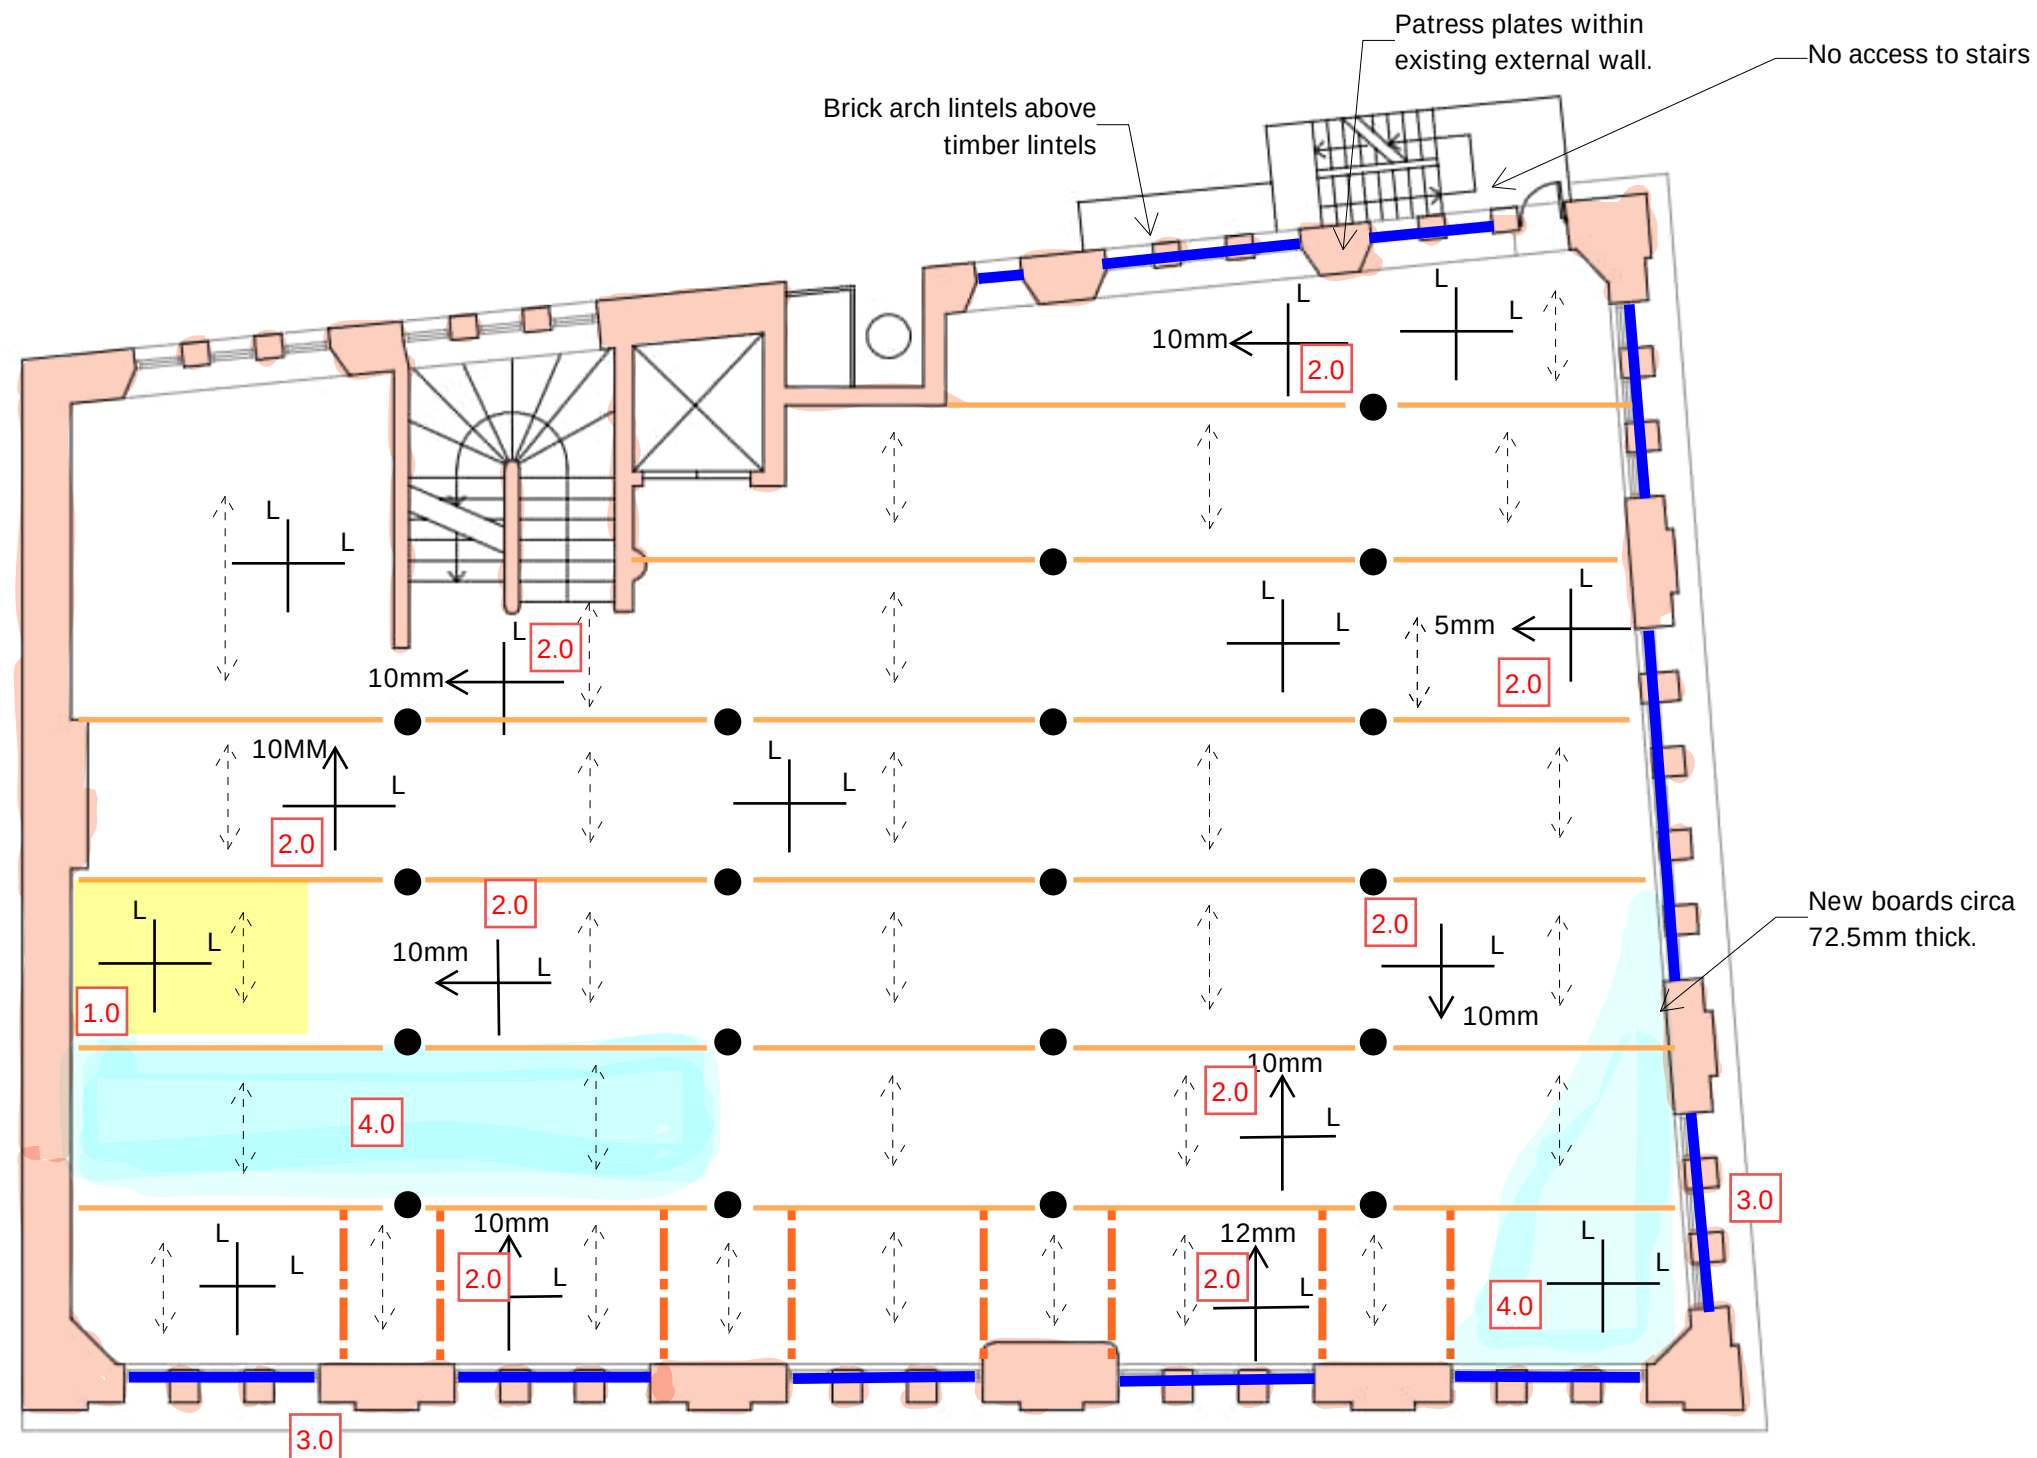
**Existing Third Floor Layout Indicating Structure Over**  
NTS.

1. Floor generally level, with minor undulations noted predominately at board joints.
2. Columns generally in fair condition given the age of the building.
3. Existing floor boards circa 64mm thick.
4. Boxing to timber beams prevented a visual assessment of the timber condition.
5. Boarding to ridge beams and hip beams prevented a visual assessment of the existing structure.

1.0 Cranked frame with minor rusting at bearing end with contact to masonry wall.

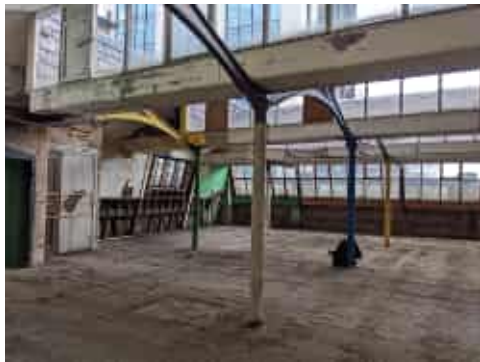
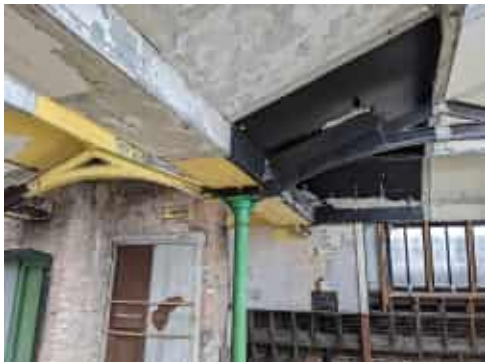
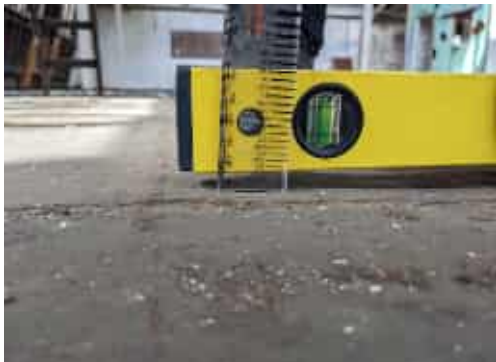
Various Fourth Floor Photos

1.0 Cranked frame with minor rusting at bearing end with contact to masonry wall.
