## CCTV SURVEY INSPECTION REPORT

| <b>Client:</b> | Kellen Homes Limited |
| <b>Location:</b> | Bennett St, Manchester |

**Project Name:** KELLEN\_HOMES\_BENNETT\_STREET\_MANCHESTER\_14\_07\_2022  
**Project Date:** 14/07/2022  
**Inspection Standard:** MSCC5 Sewers & Drainage GB (SRM5 Scoring)

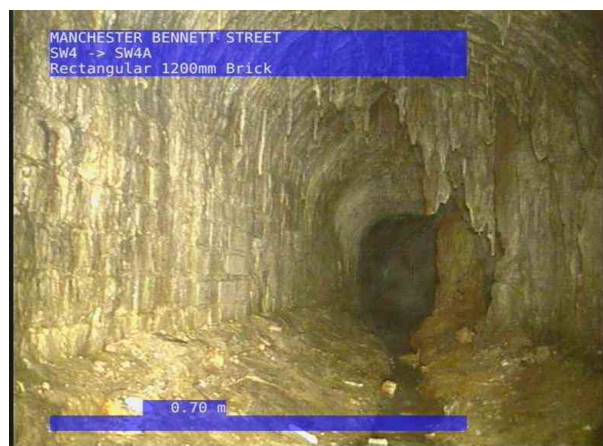
| Scale: | 1:50 | Position [m] | Code | Observation | MPEG | Photo | Grade |
|---|---|---|---|---|---|---|---|
| | | 0.70 | S01 DEE | Attached deposits, encrustation from 9 o'clock to 3 o'clock, 5% cross-sectional area loss, start | 00:00:14 | SW4X_19<br>342451-eb<br>a2-4aeb-9 | |
| | | 4.29 | F01 DEE | Attached deposits, encrustation from 9 o'clock to 3 o'clock, 5% cross-sectional area loss, finish | 00:00:43 | | 3 |

SW4X\_19342451-eba2-4aeb-90f1-b38667470ab7\_20220714  
\_100113\_847.jpg, 00:00:14, 0.70 m  
Attached deposits, encrustation from 9 o'clock to 3 o'clock, 5%  
cross-sectional area loss, start

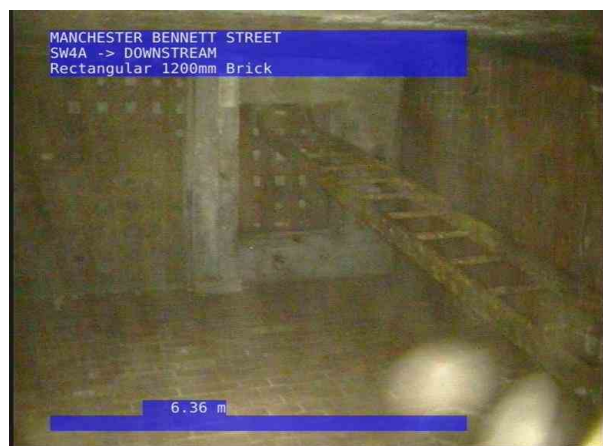
SW4AX\_53ac047a-fb86-4483-b433-5af403bff074\_20220714\_100413\_580.jpg, 00:01:11, 6.36 m  
General remark, BURRIED & UNCHARTED MH

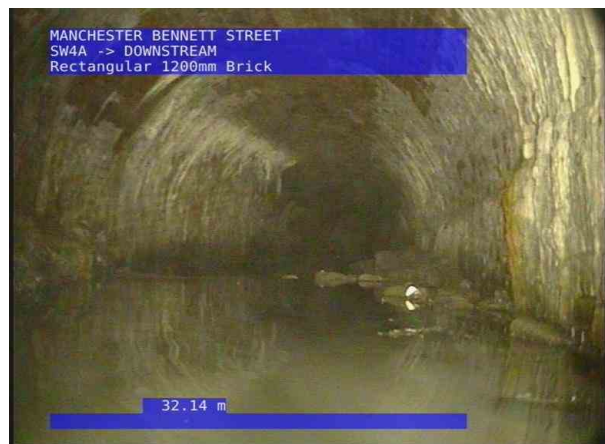
SW4AX\_0de353f5-b381-4786-9876-cd161d4f69a8\_20220714\_101113\_509.jpg, 00:06:31, 32.14 m  
Finish node, other special chamber, reference:  
DOWNSTREAM, MEETS UP WITH THE D/S FROM MH SW01

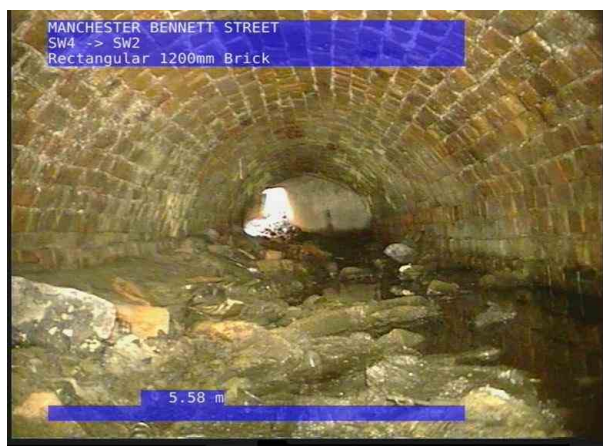
SW2X\_a88a306d-51f2-4a36-a121-17afa1dd8b30\_20220715\_100125\_460.jpg, 00:00:53, 5.58 m  
General photograph taken at this point

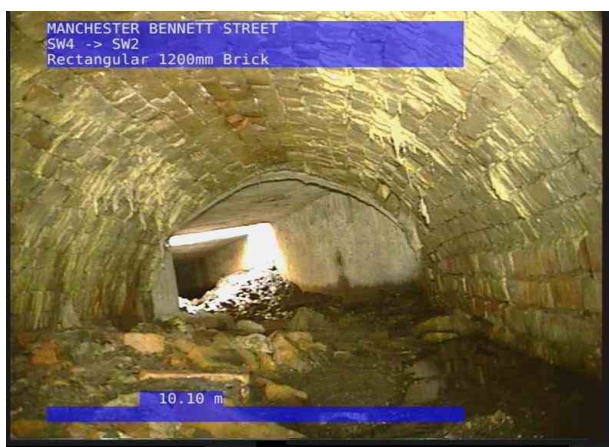
SW2X\_758cbab1-3929-4c78-9e62-1d542afddf8b\_20220715\_100531\_529.jpg, 00:03:30, 10.10 m  
General photograph taken at this point

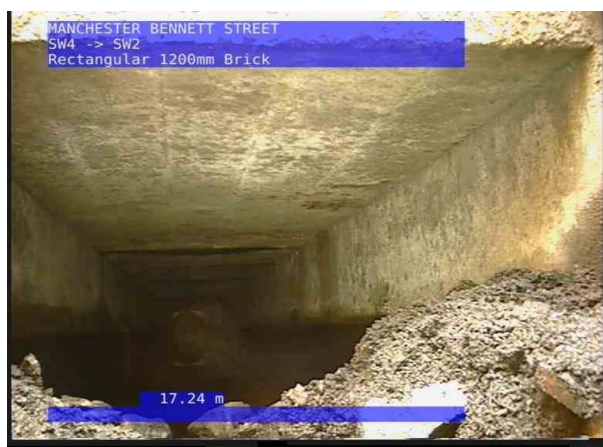
SW2X\_03b77516-945e-4afe-8fc8-261587b59a41\_20220715\_100736\_650.jpg, 00:05:23, 17.24 m  
Finish node, manhole, reference: SW2

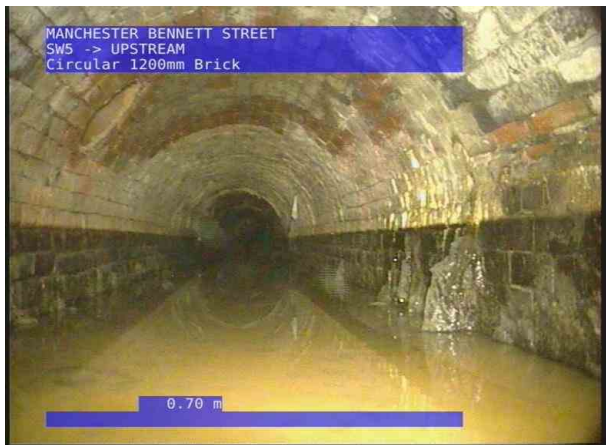
UPSTREAMX\_0f054834-1235-4c44-bcf4-d188cfb6a589\_2022  
0715\_101954\_356.jpg, 00:00:00, 0.00 m  
Water level, 10% of the vertical dimension

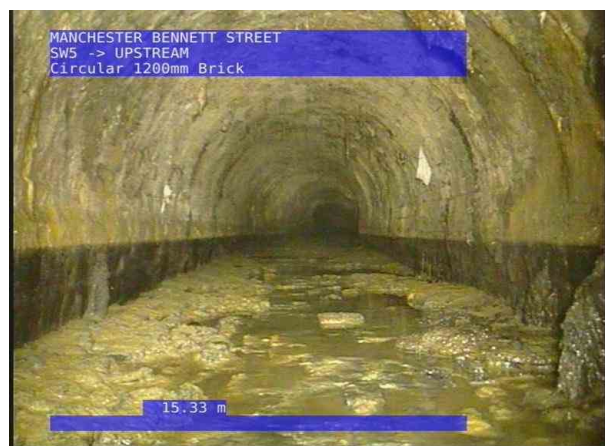
UPSTREAMX\_6f20c8d0-bca2-4553-87b5-30119180304b\_202  
20715\_102623\_179.jpg, 00:05:48, 15.33 m  
Attached deposits, encrustation from 12 o'clock to 12 o'clock,  
5% cross-sectional area loss, start

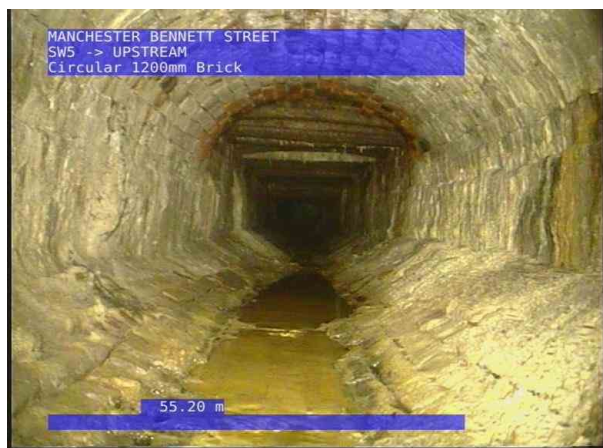
UPSTREAMX\_f8c24418-a13f-4c55-a70c-192bd851e9d4\_202  
20715\_103934\_959.jpg, 00:17:58, 55.20 m  
Finish node, other special chamber, reference: UPSTREAM,  
OFF SITE BOUNDRY

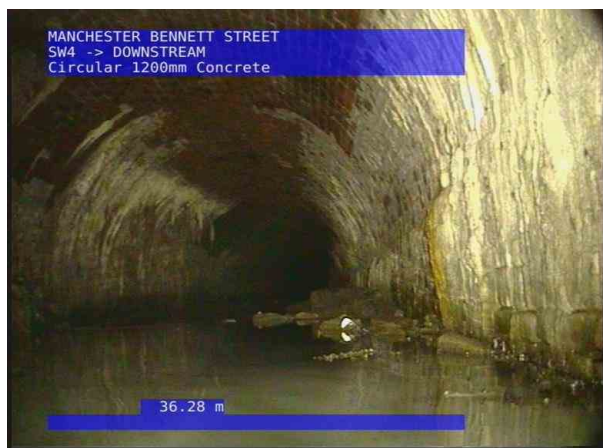
SW4X\_cc0334c9-a616-4d7a-b5a4-fc2cd2ed6b95\_20220715\_110755\_523.jpg, 00:08:28, 36.28 m  
Finish node, other special chamber, reference: DOWNSTREAM, DOWNSTREAM

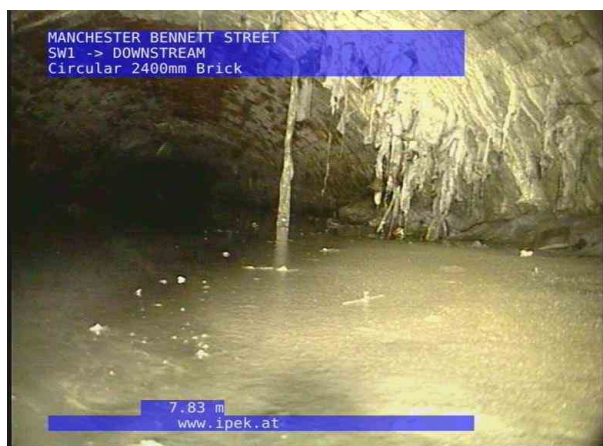
SW1X\_9257f822-01cf-4014-b656-a857d9433486\_20220715\_113351\_988.jpg, 00:03:51, 7.83 m  
General photograph taken at this point

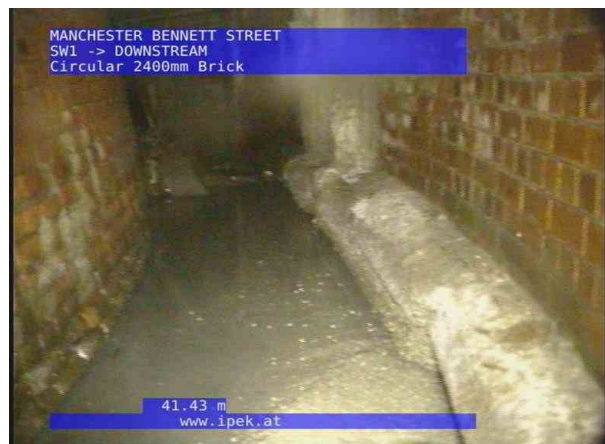
SW1X\_1c0b4acb-78a6-4cd2-92f4-c5eb4298fc5d\_20220715\_114657\_886.jpg, 00:16:17, 41.43 m  
Finish node, other special chamber, reference: DOWNSTREAM, PAST SITE BOUNDARY

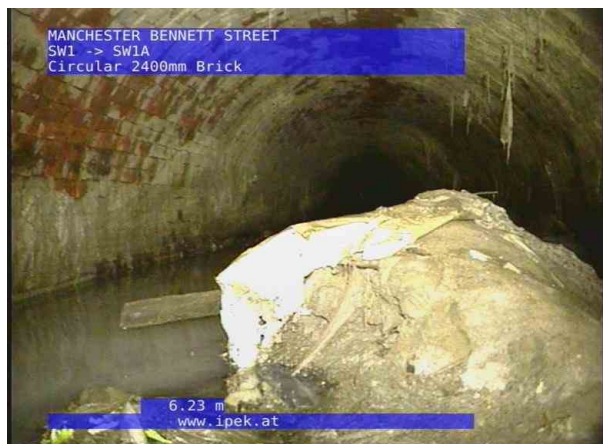
| Scale: 1:666 | Position [m] | Code | Observation | MPEG | Photo | Grade |
|---|---|---|---|---|---|---|
| | 6.23 | DES | Settled deposits, fine, 20% cross-sectional area loss | 00:01:45 | SW1AX_a<br>6df3ce6-3<br>909-4ee5- | 4 |

SW1AX\_a6df3ce6-3909-4ee5-a819-268de26b1f8f\_20220715\_115405\_753.jpg, 00:01:45, 6.23 m  
Settled deposits, fine, 20% cross-sectional area loss

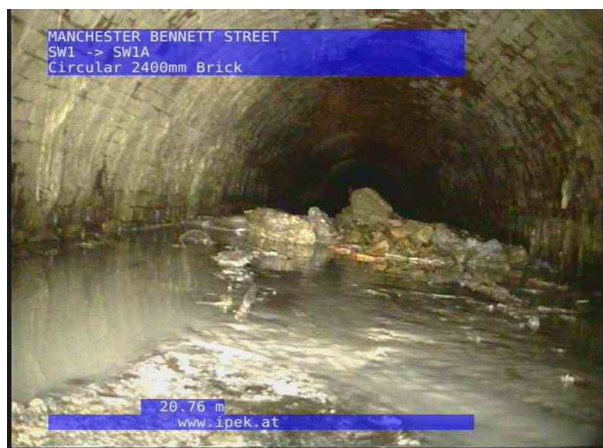
SW1AX\_cdd2f7ca-cae7-4fd5-9e3d-e8352e386c80\_20220715\_115619\_017.jpg, 00:03:54, 20.76 m  
General photograph taken at this point

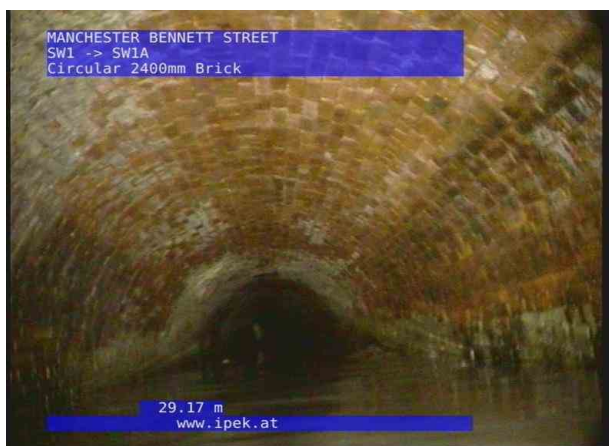
SW1AX\_74a04495-4103-4d1c-ab52-734cdbbd4411\_20220715\_115745\_020.jpg, 00:05:17, 29.17 m  
General photograph taken at this point

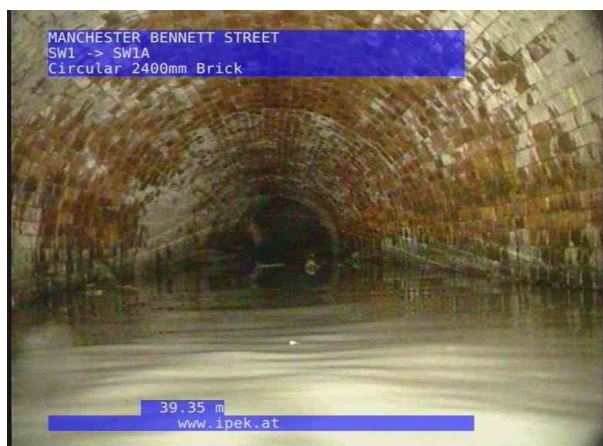
SW1AX\_a26abe26-c0ce-46fd-98eb-8decddb769ee\_20220715\_115857\_518.jpg, 00:06:26, 39.35 m  
General photograph taken at this point

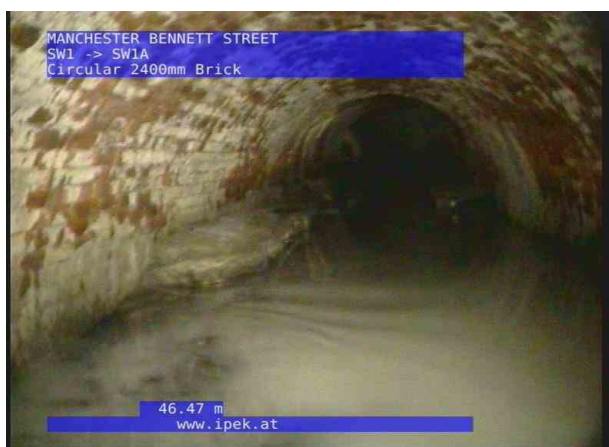
SW1AX\_aea19967-7b06-49a4-aa6d-ee918ba4c89e\_20220715\_115939\_510.jpg, 00:07:05, 46.47 m  
General photograph taken at this point

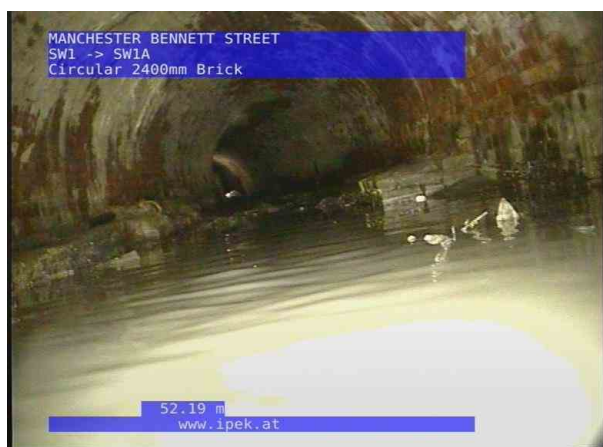
SW1AX\_4fad7681-9e2d-4f25-99cb-29527700c703\_20220715\_120110\_395.jpg, 00:08:32, 52.19 m  
General photograph taken at this point

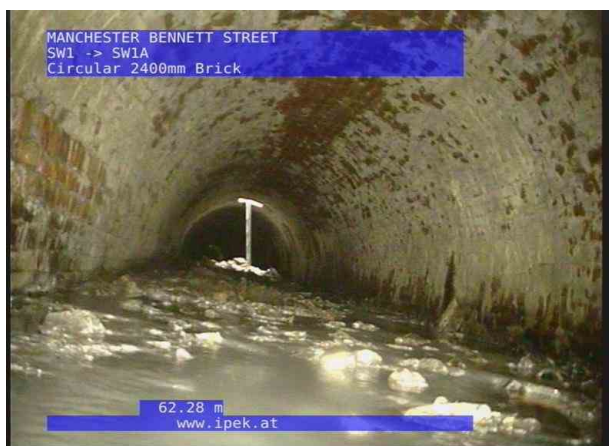
SW1AX\_5d5f9808-6255-4d0e-a705-2aded9e0055c\_20220715\_120455\_338.jpg, 00:12:10, 62.28 m  
General photograph taken at this point

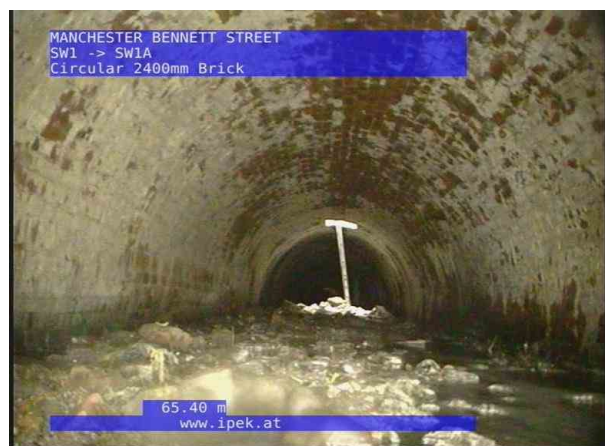
SW1AX\_159c681b-d58a-44f0-80ac-01975f994ab5\_20220715\_120628\_265.jpg, 00:13:40, 65.40 m  
General photograph taken at this point

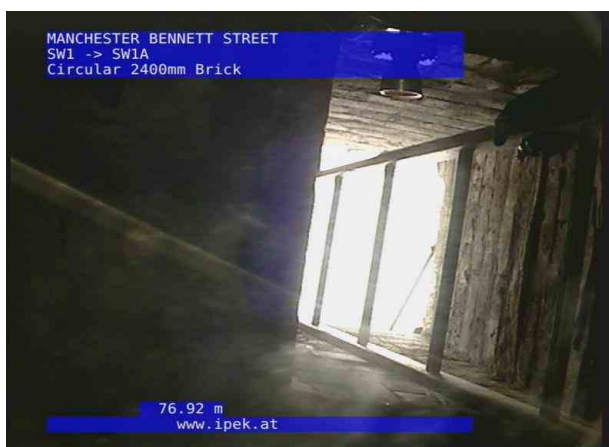
SW1AX\_9850a96d-4115-417e-8810-21b0ce4ed79d\_20220715\_120924\_196.jpg, 00:16:25, 76.92 m  
Finish node, manhole, reference: SW1A

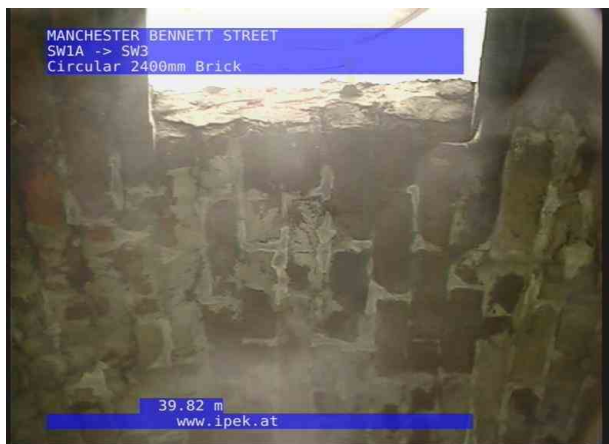
SW3X\_57952078-1d68-4ba7-b292-18cdd75c891a\_20220715  
\_121341\_818.jpg, 00:02:55, 39.82 m  
Finish node, manhole, reference: SW3

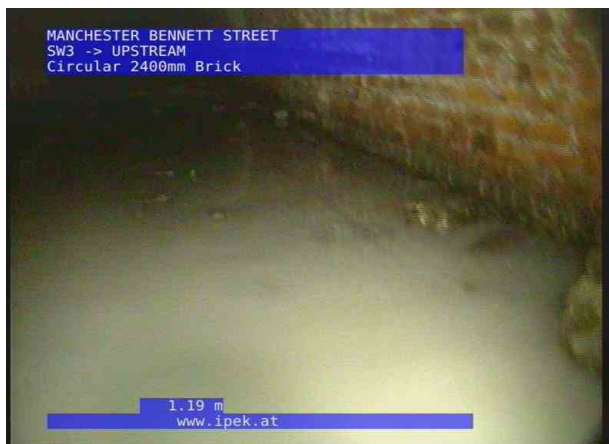
UPSTREAMX\_50a2cfb6-3f6b-4ba0-82b9-e550f7aa14be\_2022  
0715\_121842\_483.jpg, 00:00:05, 0.00 m  
Water level, 20% of the vertical dimension

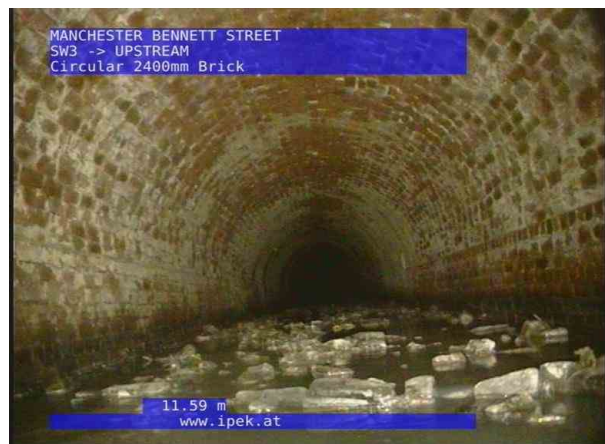
UPSTREAMX\_67eee176-bff3-4f92-9ae6-0b6158698897\_202  
20715\_121910\_913.jpg, 00:00:34, 11.59 m  
General photograph taken at this point

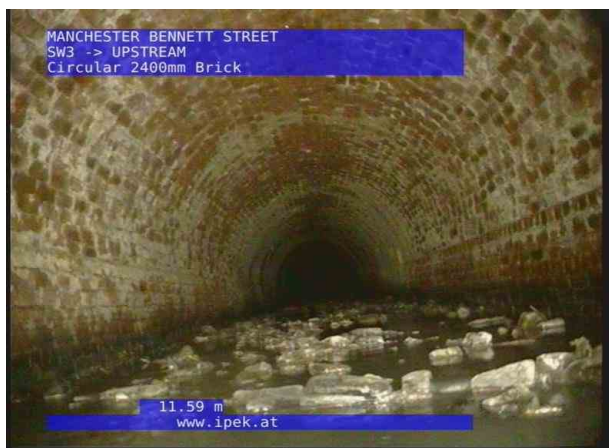
UPSTREAMX\_d8ca8c72-0342-45da-812e-e34441bc84d0\_20  
220715\_121913\_157.jpg, 00:00:34, 11.59 m  
General photograph taken at this point

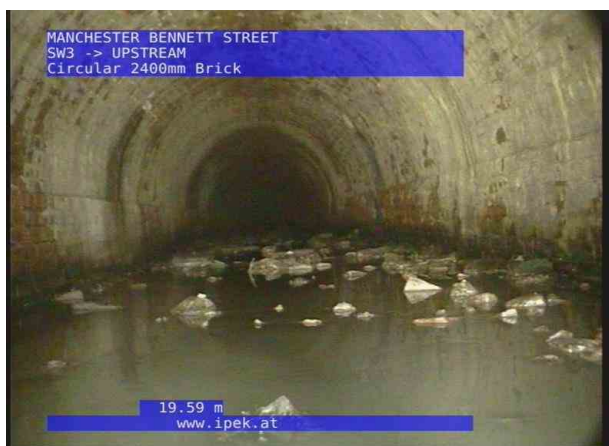
UPSTREAMX\_32bf50d0-b516-4fa1-8732-27822a097698\_2020715\_122024\_832.jpg, 00:01:39, 19.59 m  
General photograph taken at this point

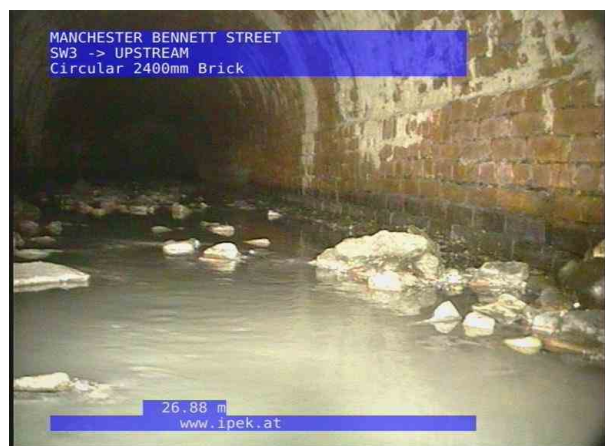
UPSTREAMX\_cf584fb5-071d-4d3b-b908-37a0bdbf0491\_2020715\_122113\_496.jpg, 00:02:24, 26.88 m  
General photograph taken at this point

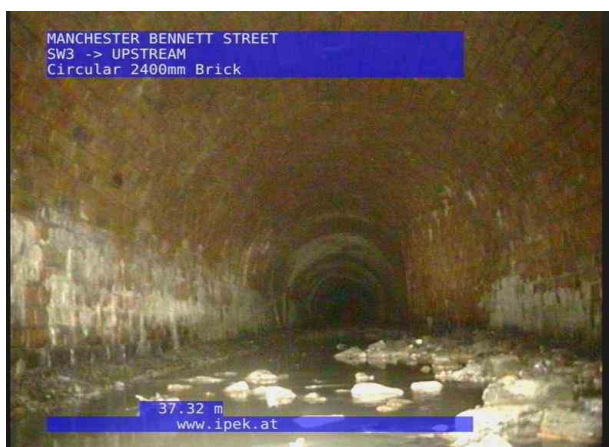
UPSTREAMX\_c7f00fb7-635e-4c32-bf34-896a78fbaeab\_2020715\_122212\_114.jpg, 00:03:20, 37.32 m  
General photograph taken at this point

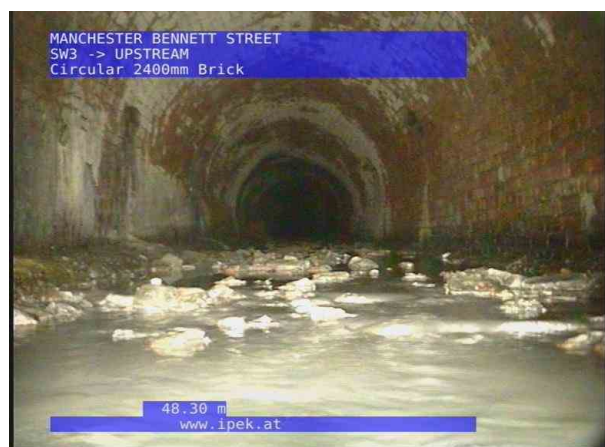
UPSTREAMX\_cde35371-6273-421e-b332-15f942e4a8cb\_2020715\_122315\_200.jpg, 00:04:19, 48.30 m  
General photograph taken at this point

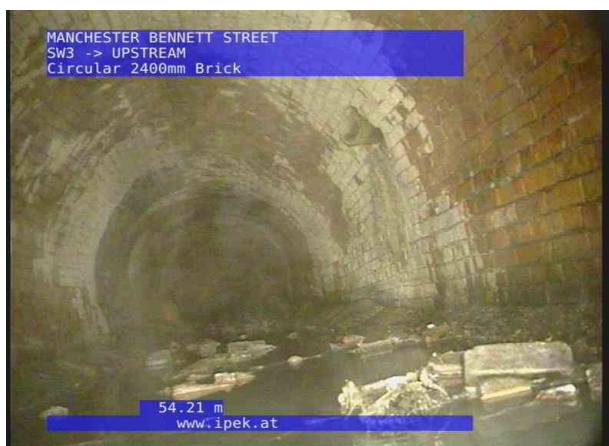
UPSTREAMX\_dfbf69c7-bc0a-4c33-b12f-5eabe869bd7c\_2022  
0715\_122414\_593.jpg, 00:05:15, 54.21 m  
General photograph taken at this point

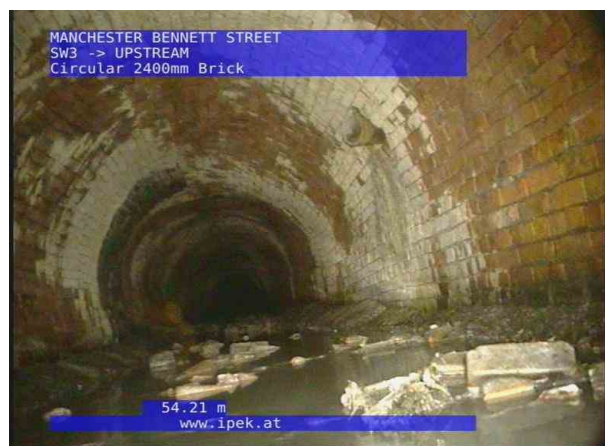
UPSTREAMX\_991564bf-0861-4d4b-a1df-d86103db70fa\_202  
20715\_122425\_384.jpg, 00:05:16, 54.21 m  
Connection other than junction at 2 o'clock, 150mm dia
