# Hutton + Rostron Environmental Investigations Limited

## Mindel House, Manchester: Plaster condition survey

Site note 4 for 8 April and 27 July 2021, job no. 212.57  
REVISION B - 25.04.22

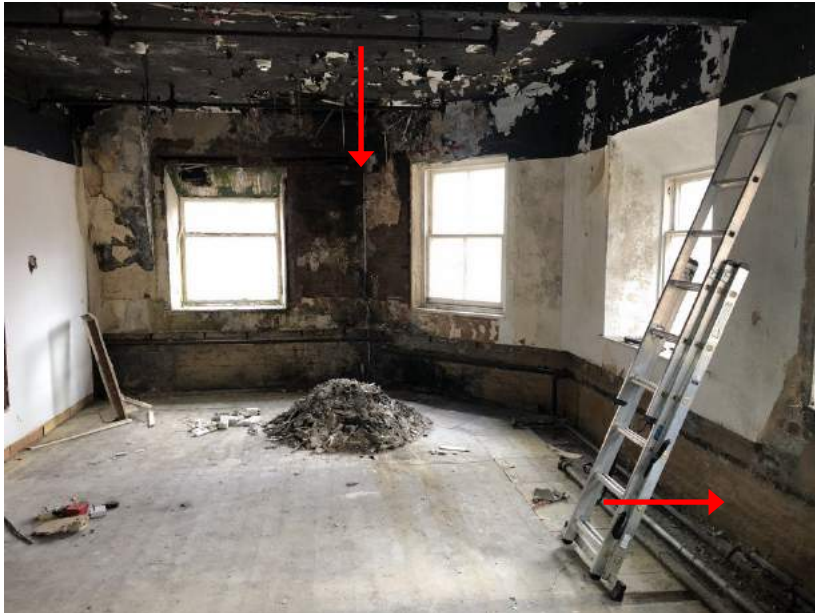
**Fig 1:**

Fourth Floor, MS-401; showing wet and largely debonded lime plaster in the area of ongoing water penetration

- 3 Areas of ongoing water penetration: The lime plaster to the external walls subject to ongoing water penetration should be removed back to the brick substrate. Ideally, at this stage, any damp masonry should be left exposed as long as necessary to allow adequate drying before re-plastering. Lath and plaster in these areas should be carefully cut back to sound material. Allowance should be made for additional decay in the laths and the softwood studwork whilst water penetration continues and whilst residual moisture remains in the structure. Lime plaster should only be reinstated to these areas following drying. H+R can undertake drying monitoring at an appropriate stage in the redevelopment, if instructed. Alternatively, ventilated dry-linings could be considered

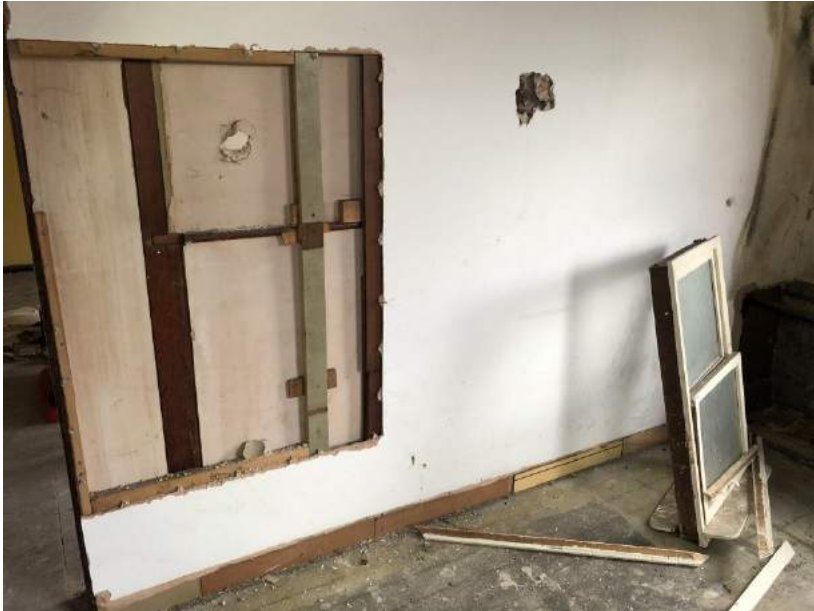
**Fig 3:**

Fourth Floor, MS-401; showing modern plasterboard lining to stud partition

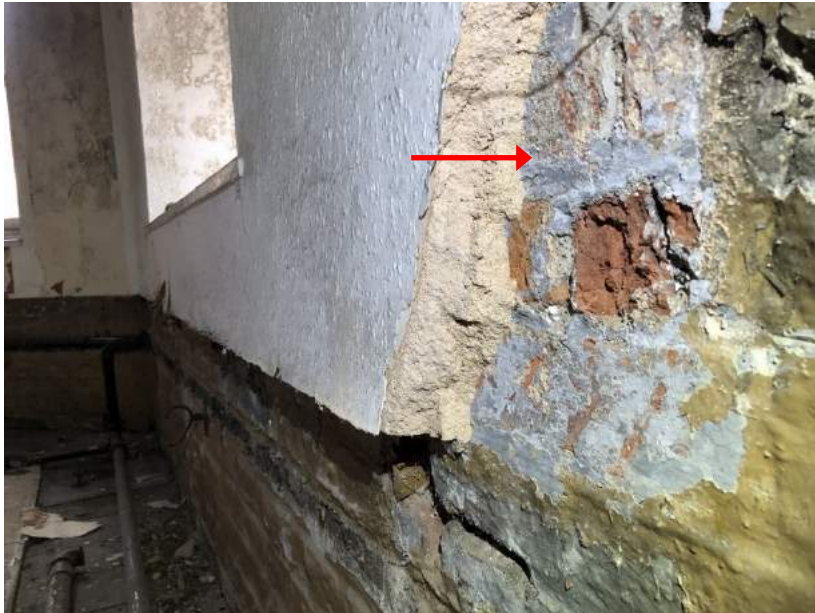
**Fig 5:**

Fourth Floor, MS-401; showing previous blue and gold paint schemes to the upper brick wall behind the non-original lime plaster

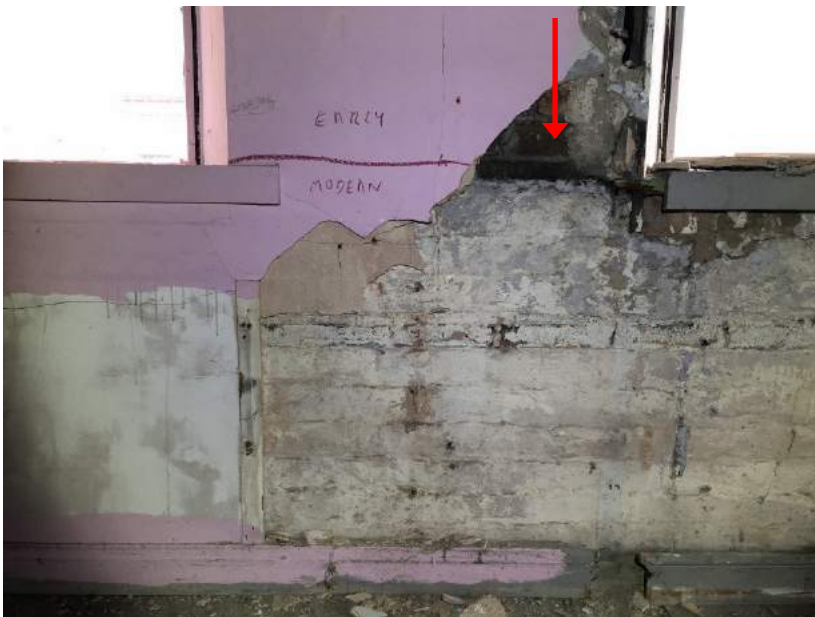
**Fig 6:**

Fourth Floor, MS-402; showing the separation line between the upper lime plaster and lower gypsum. Note that there is no earlier decorative finish behind the lime plaster

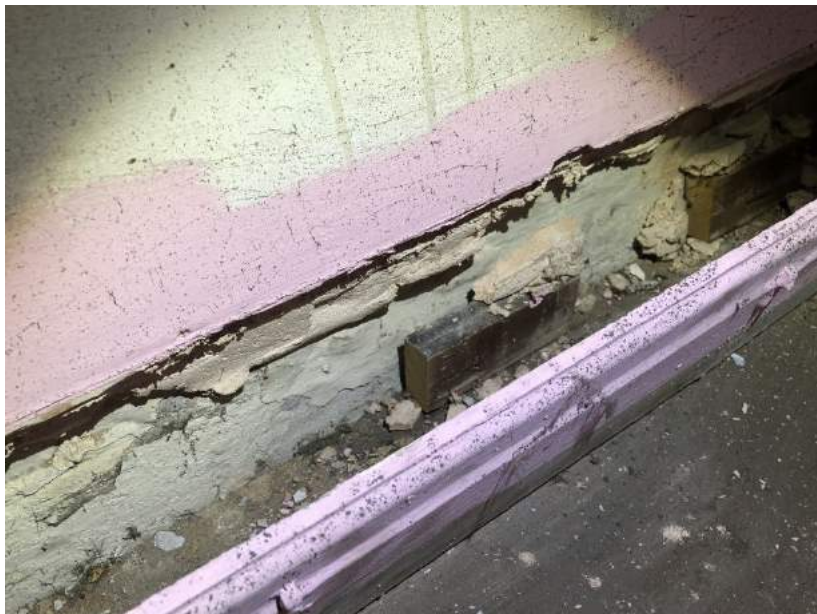
**Fig 7:**

Fourth Floor, MS-402; showing the softwood skirting board that was fixed to timber blocking. The skirting board appears to have been applied at the same period as the gypsum i.e. it is non-original

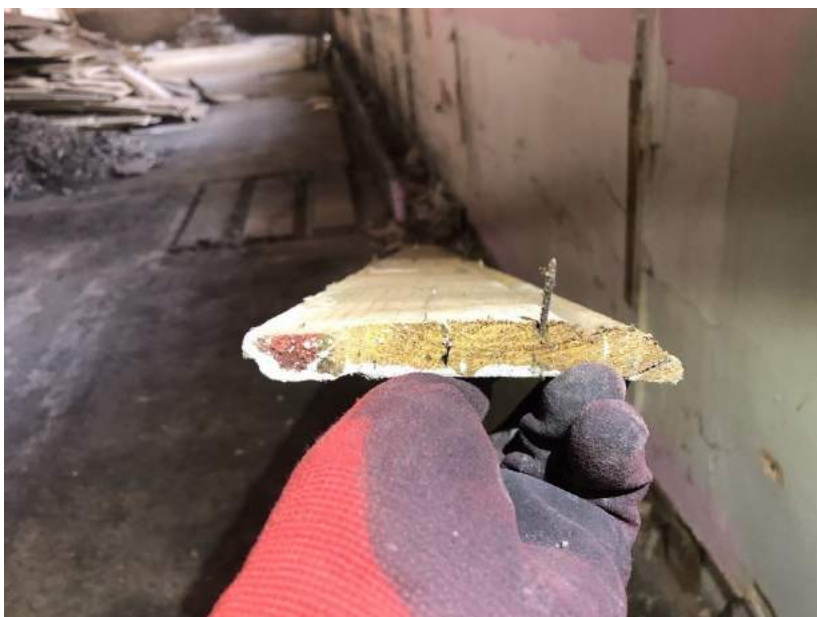
**Fig 8:**

Fourth Floor, MS-402; showing the profile of a removed section of softwood skirting board. This reversible/dual purpose moulding is of mid-late 20th century

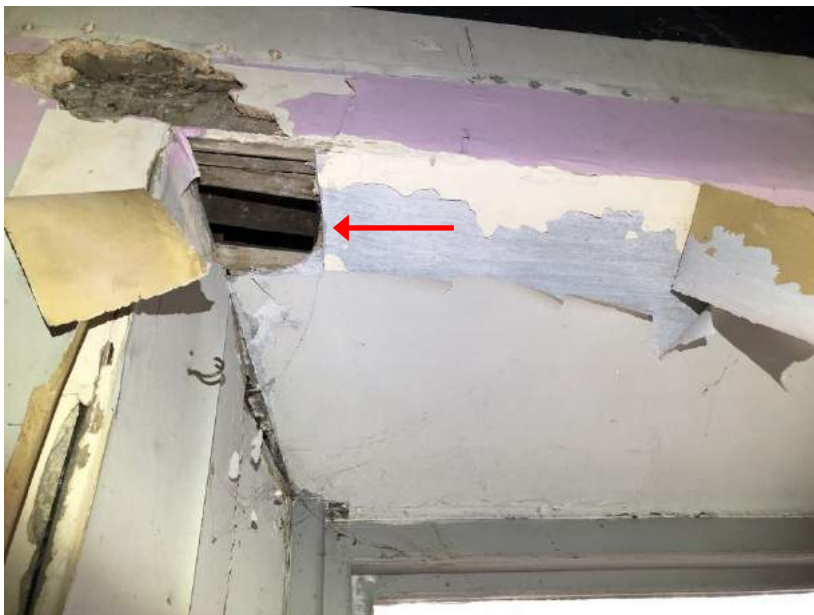
**Fig 10:**

Fourth Floor, MS-402; showing localised mechanical damage to the lath and lime plaster soffit over MS-4W20

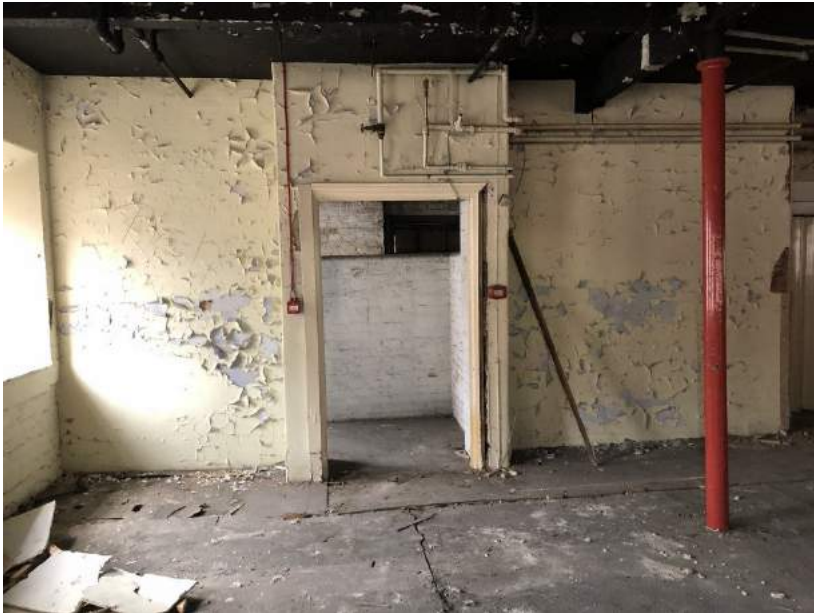
**Fig 11:**

Fourth Floor, MS-402; showing the non-original internal wall that was finished with gypsum plaster

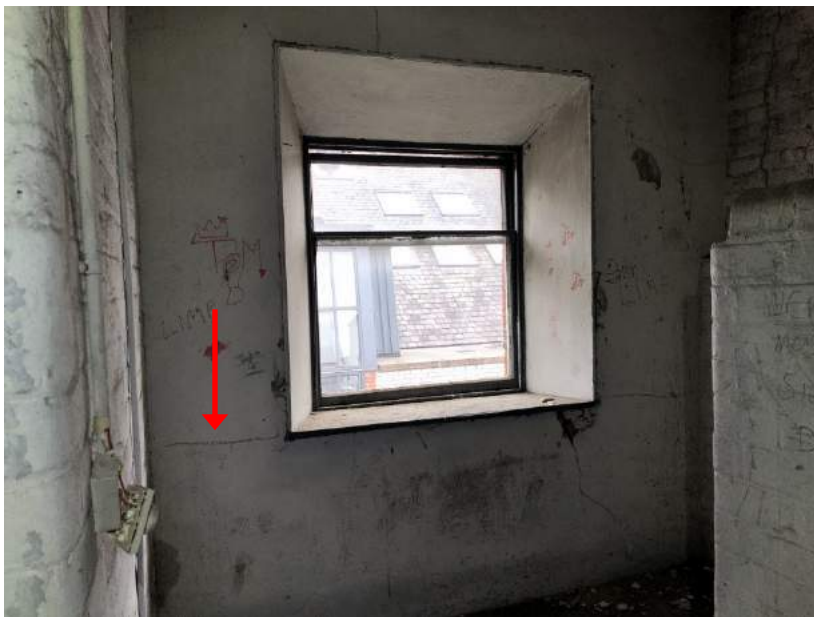
**Fig 12:**

Fourth Floor, MS-405; showing the separation line between the upper lime plaster and lower gypsum plaster

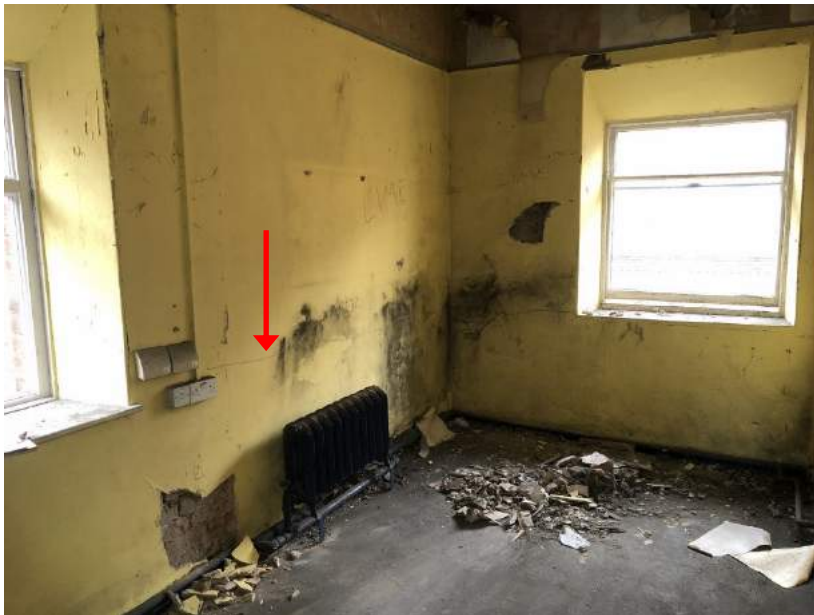
**Fig 14:**

Fourth Floor, MS-412; showing the  
separation line between the upper lime  
plaster and lower gypsum plaster

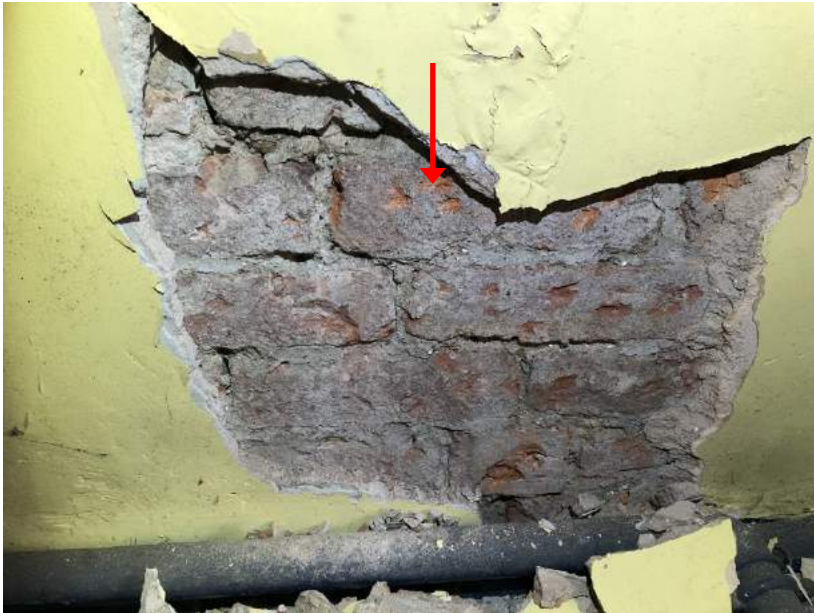
**Fig 15:**

Fourth Floor, MS-412; showing an area of removed gypsum plaster. Note that a 'key' had been prepared to the brickwork prior to application of the plaster. Also note that there was no previous decoration to the brickwork

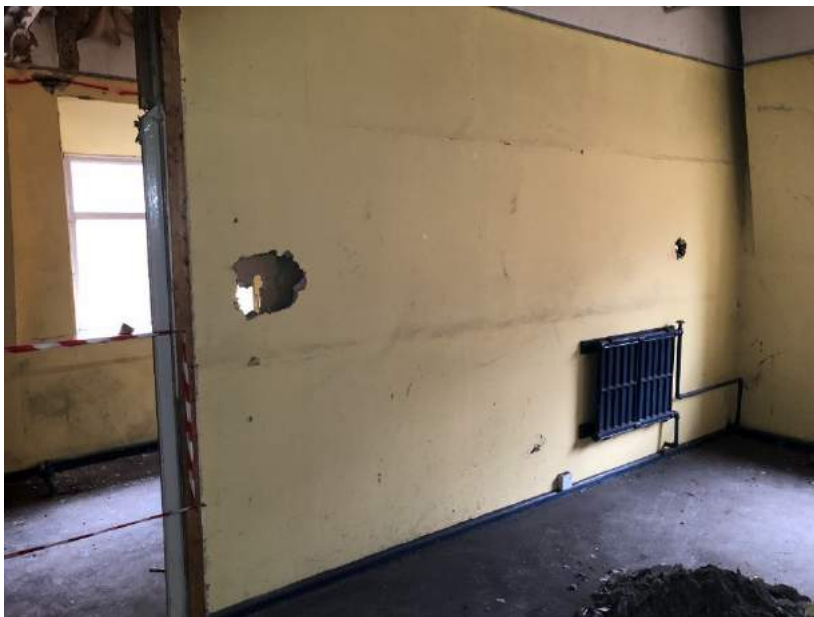
**Fig 16:**

Fourth Floor, MS-404; showing a non-original internal partition that was lined with plasterboard. Note that the skirting board applied over the plasterboard was the same as in MS-412 i.e. non-original

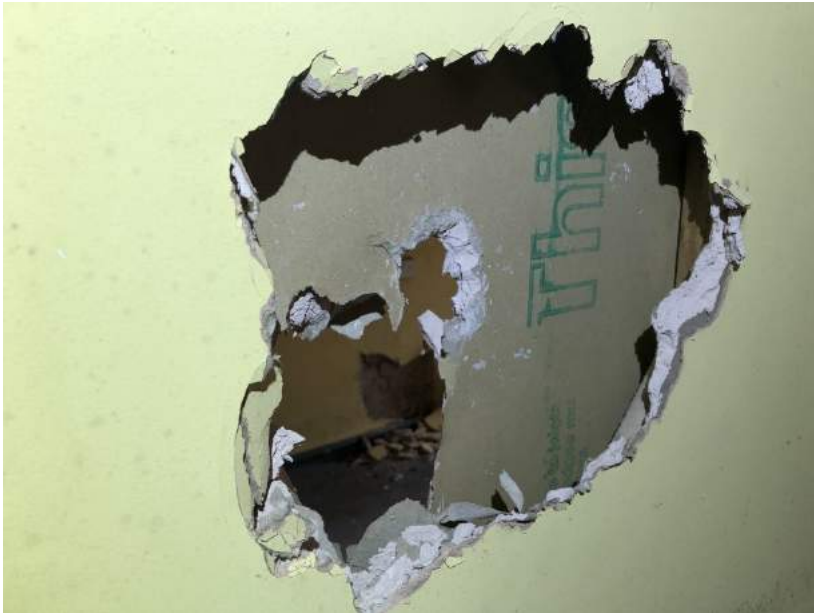
**Fig 17:**

Fourth Floor, MS-404; showing a close-up of the plasterboard that was applied to either side of this stud partition

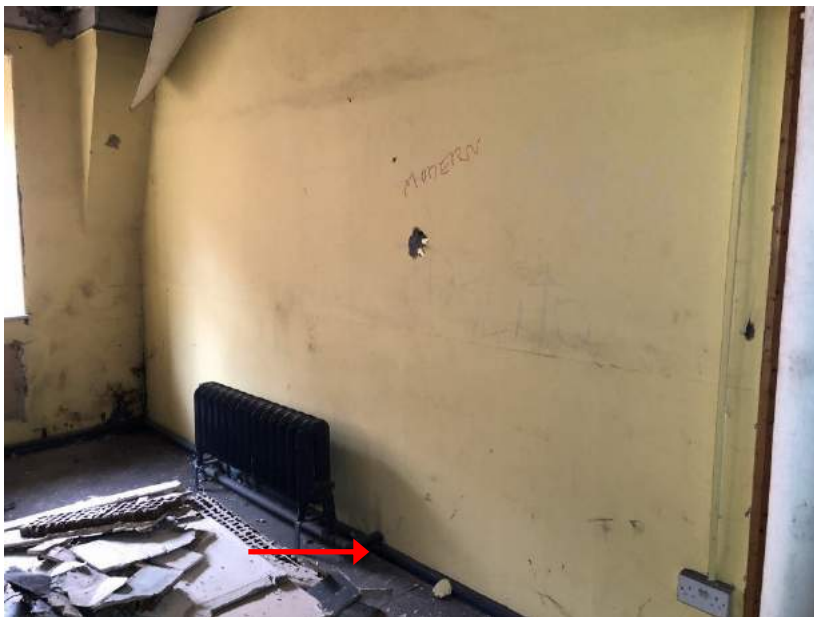
**Fig 18:**

Fourth Floor, MS-404; showing a non-original internal partition that was lined with plasterboard. Note that the skirting board applied over the plasterboard was the same as in MS-412 i.e. non-original

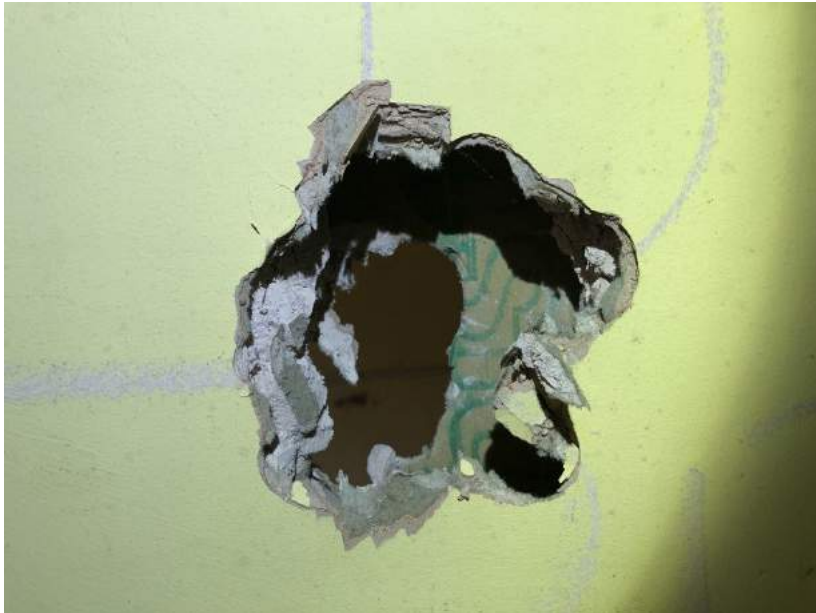
**Fig 19:**

Fourth Floor, MS-404; showing a close-up of the plasterboard that was applied to either side of this stud partition

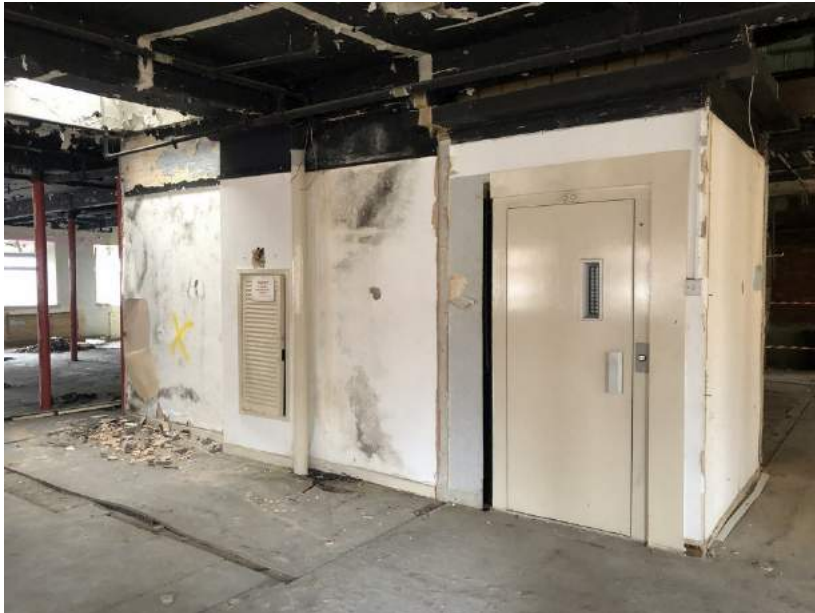
**Fig 23:**

Fourth Floor, Goods lift; showing largely non-original plasterboard linings around the central goods and passenger lift shafts. The lime plaster behind was largely damp and had debonded from the substrate

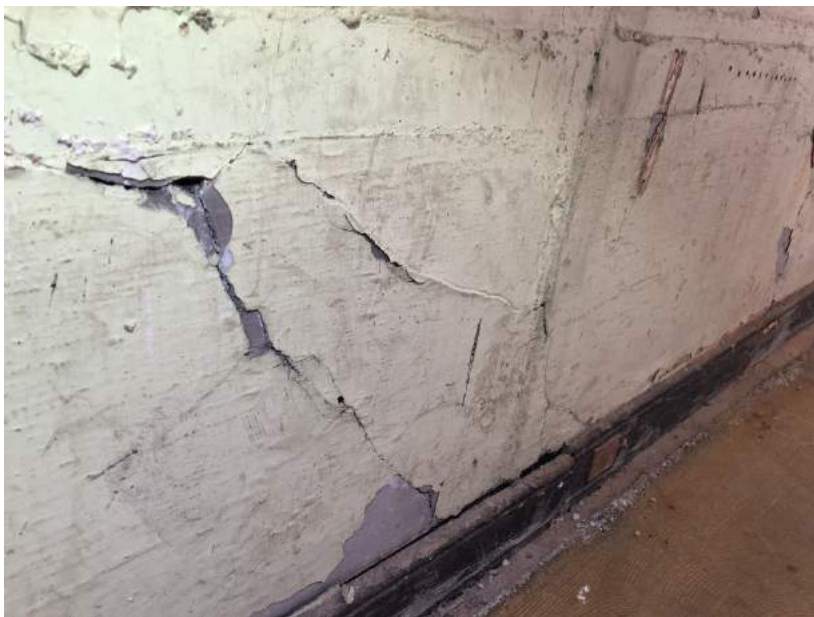
**Fig 26:**

Third Floor, MS-305-MS-308; showing a typical example of where the lime plaster had cracked and debonded from the brick substrate

- 1 Preparation: Areas of defective, loose and salt-damaged plaster should be carefully cut back to the sound plaster or brick substrate. The brick substrate should be hand cleaned by wire brush to remove debris and any salts and prepared for application by raking out the mortar joints to a depth of around 10mm to provide a 'key' for the new plaster. Remove any built-in bonding timbers and brick-up/fill with lime mortar

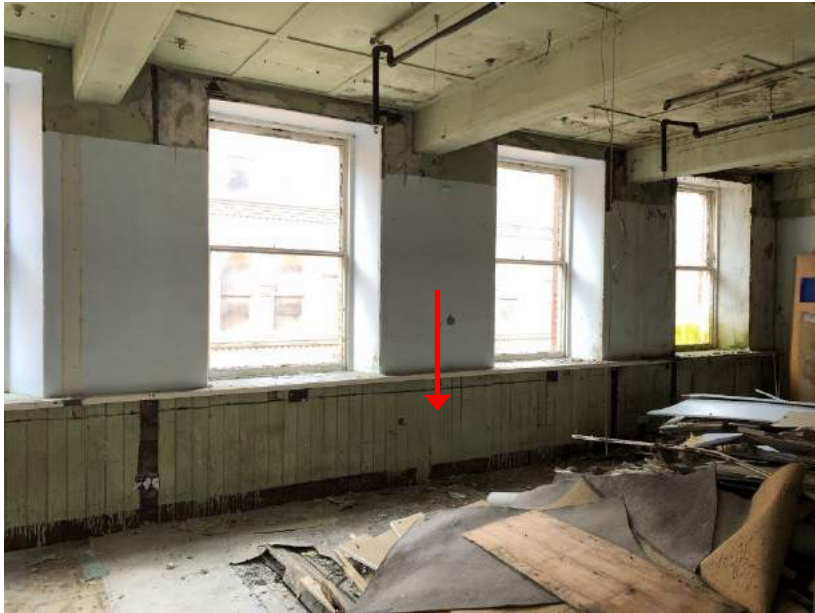
**Fig 31:**

Third Floor, MS-320; showing lime plaster finish with non-original t&g boarding at low-level

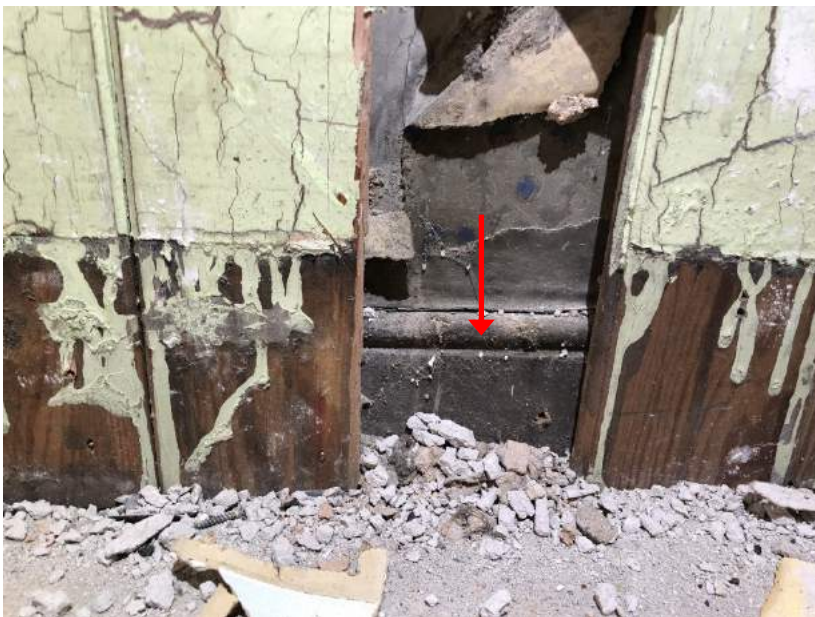
**Fig 32:**

Third Floor, MS-320; showing earlier softwood skirting board and wallpaper to the lime plaster behind the panelling

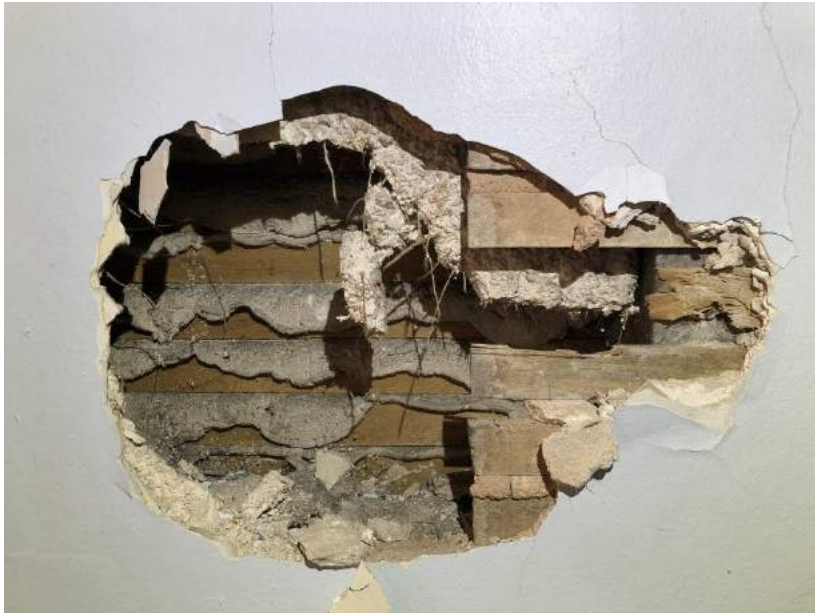
**Fig 35:**

Third Floor, MS-320; a close-up of the lath and plaster and hessian 'scrim' fibrous lime plaster

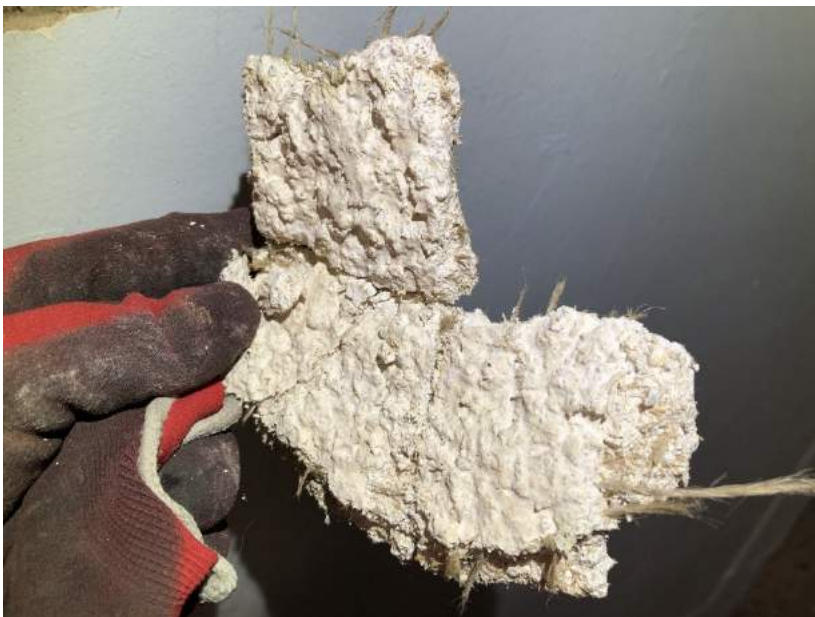
**Fig 36:**

Third Floor, MS-320; showing a removed section of hessian 'scrim' fibrous lime plaster

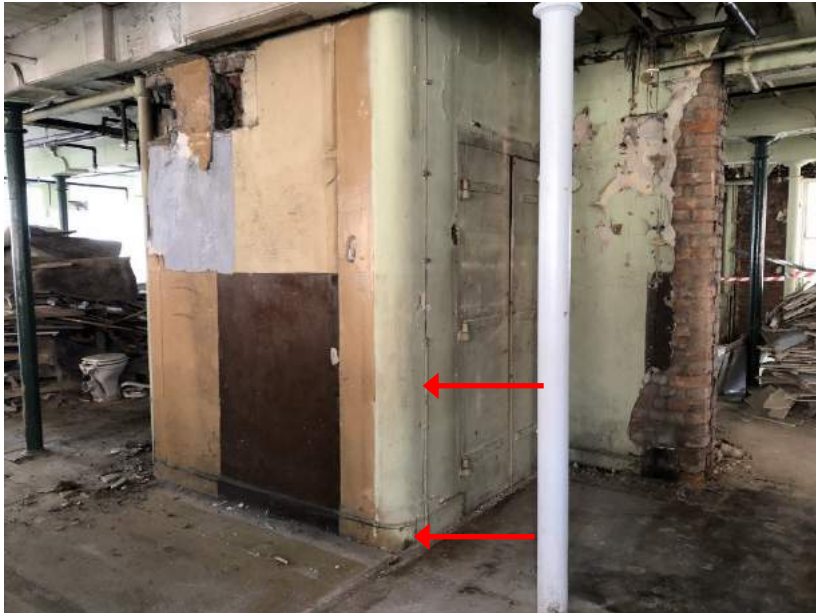
**Fig 39:**

Third Floor, Goods lift; showing largely early/original lime plaster with a softwood skirting board

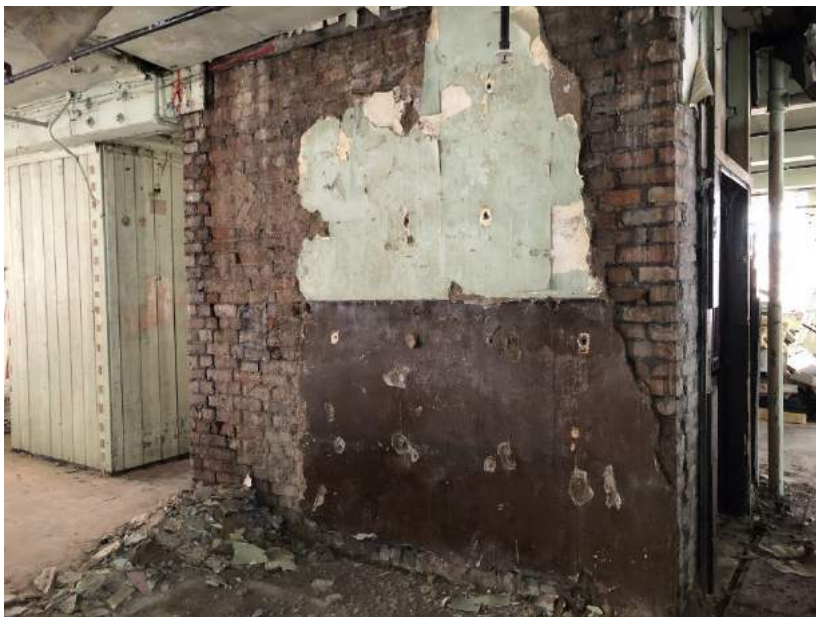
**Fig 40:**

Third Floor, Goods lift; showing significant debonding of the lime plaster caused by ongoing water penetration

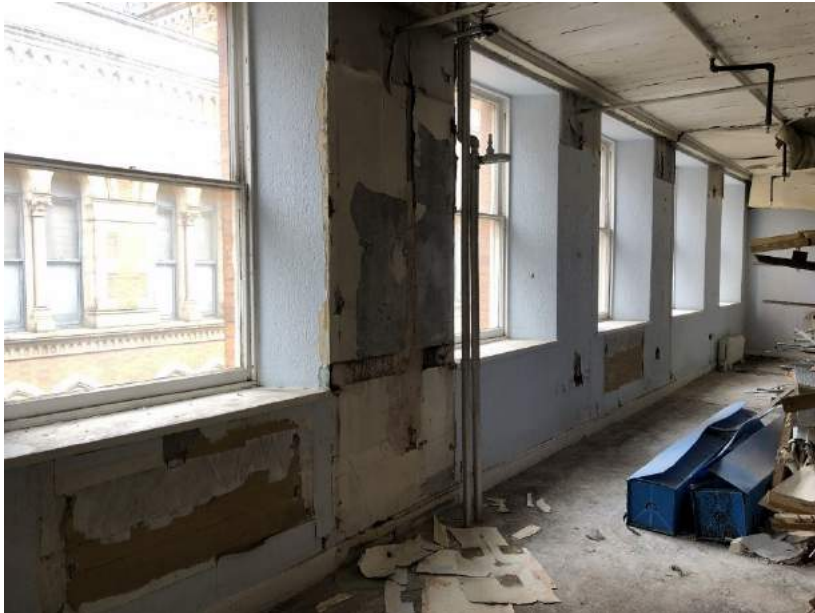
**Fig 43:**

Second Floor, MS-204; showing lime plaster with a softwood skirting board to the external wall

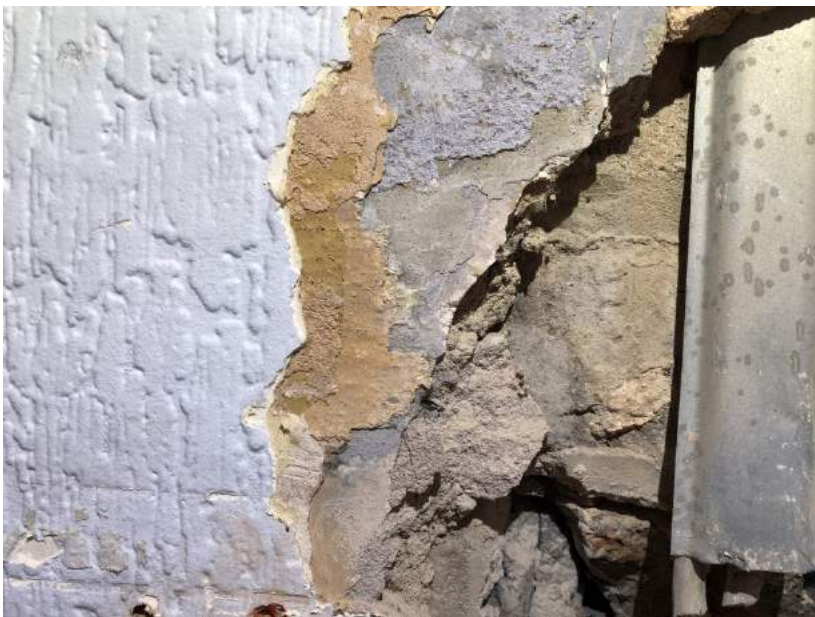
**Fig 44:**

Second Floor, MS-204; showing a close-up of the numerous paint and wallpaper finishes over the early/original lime plaster

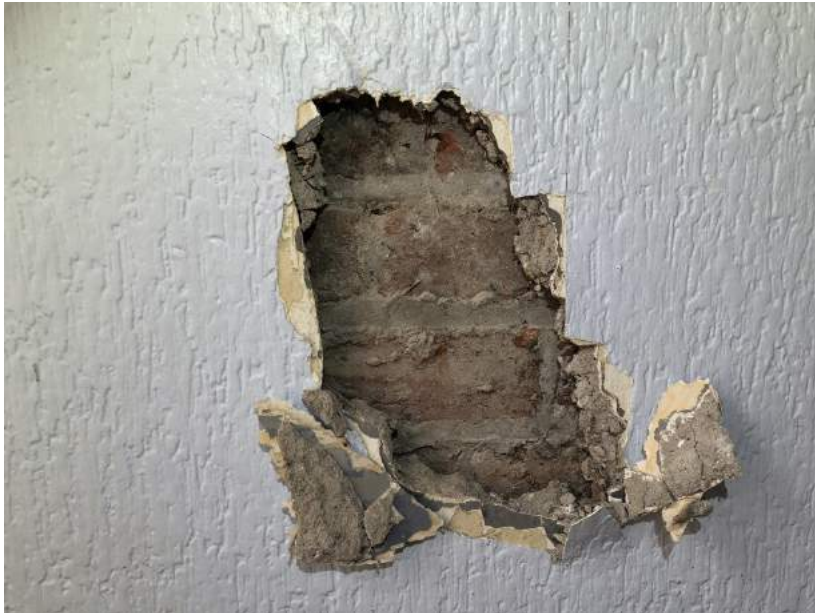
**Fig 45:**

Second Floor, MS-204; showing a section of removed lime plaster. Note that there had been no previous decorative finishes to the brick substrate

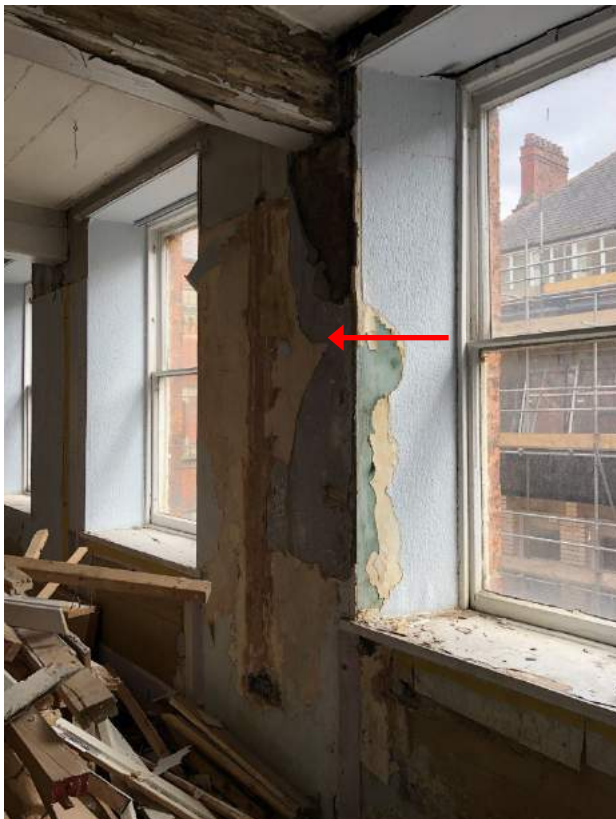
**Fig 46:**

Second Floor, MS-207; showing localised debonding of the lime plaster in an area of historical water penetration

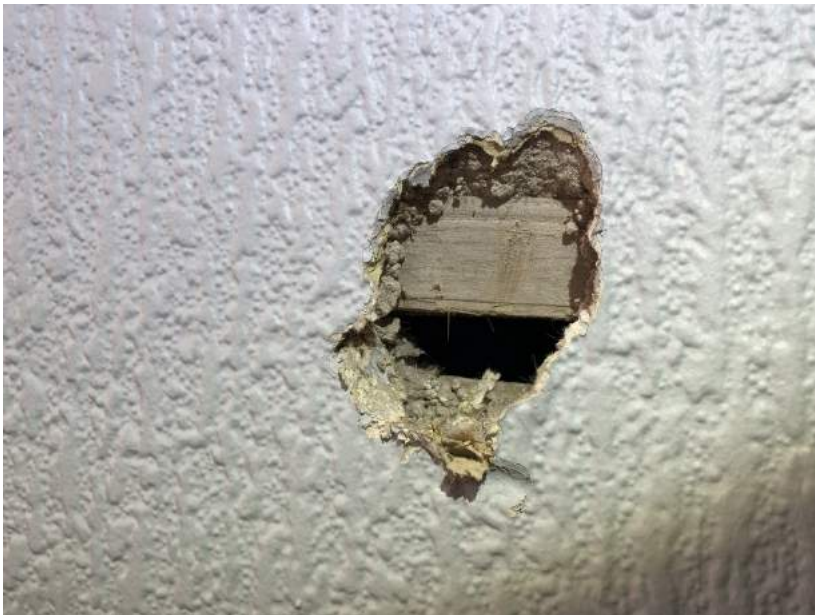
**Fig 54:**

Second Floor, MS-218; showing a close-up of the lath and plaster finish to the separating partition to MS-202. Lath and plaster was damp and partially decayed in the area of ongoing water penetration

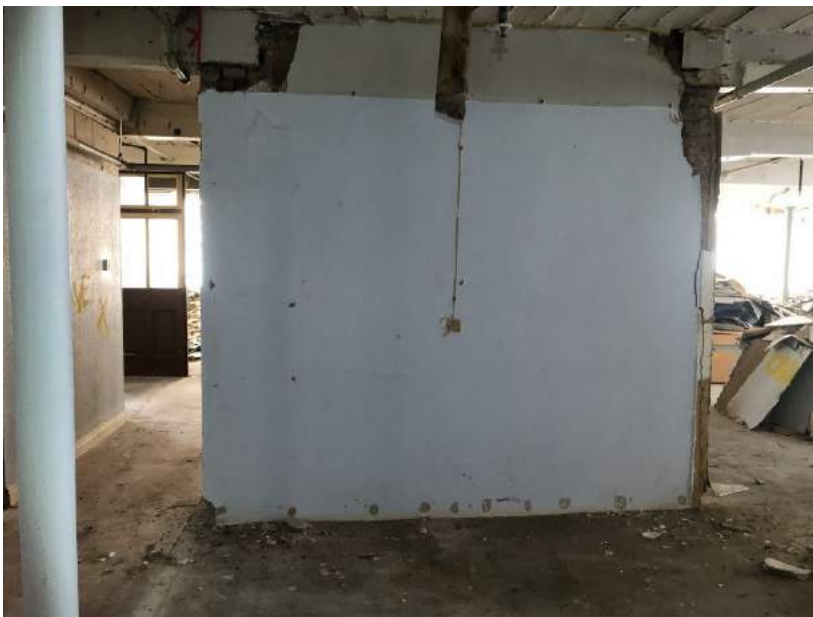
**Fig 56:**

Second Floor, Good lift; showing lime plaster. The plaster was wet and largely debonded from the brick substrate due to ongoing water penetration

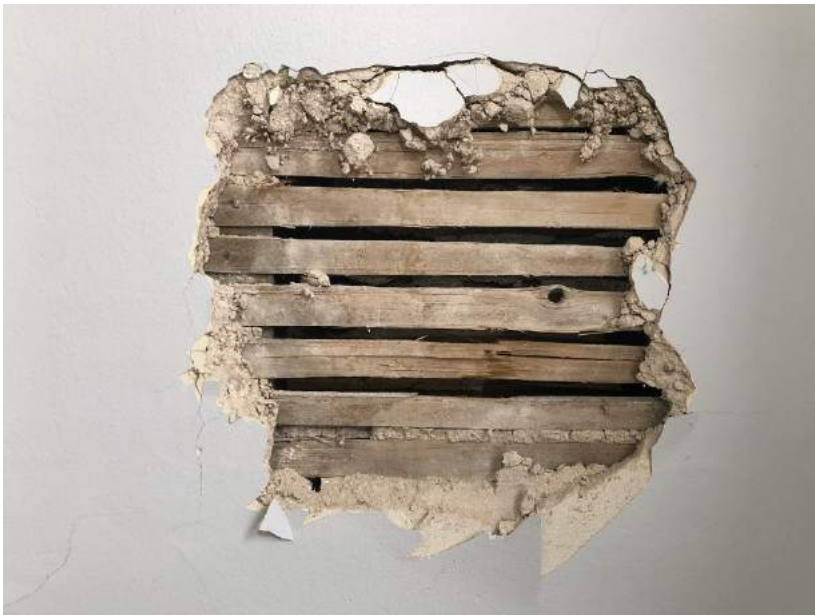
**Fig 58:**

First Floor, MS-101; showing a close-up of the lath and lime plaster finishes to the internal partition between MS-119

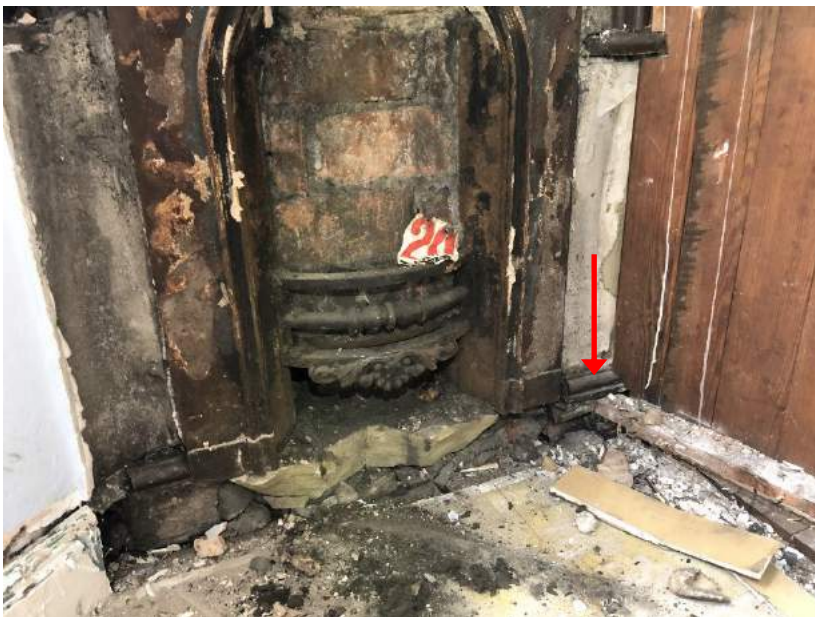
**Fig 60:**

First Floor, MS-101; showing the softwood skirting board that pre-dates the installation of the timber partition

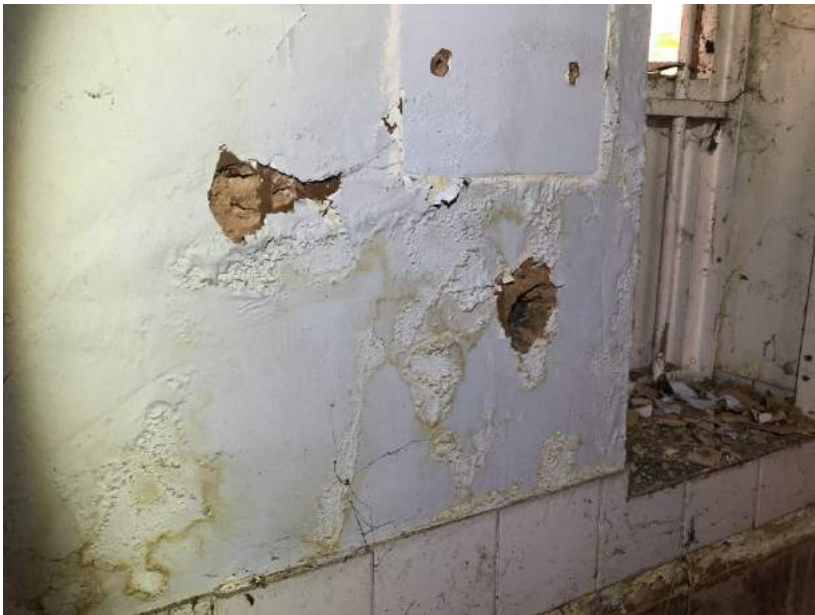
**Fig 64:**

First Floor, MS-1110 to MS115;  
showing the use of gypsum plaster  
over the earlier lime plaster. The  
masonry was saturated and the plaster  
had largely debonded in this area

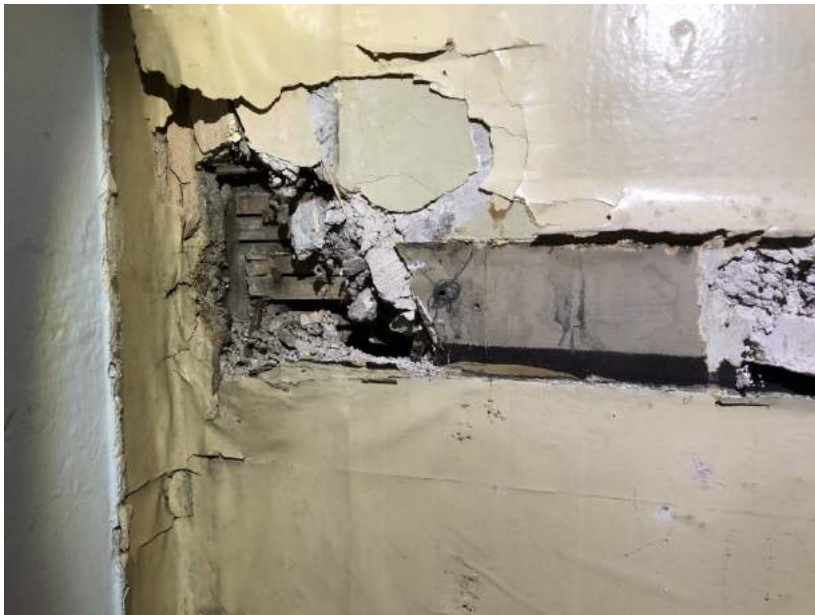
**Fig 66:**

First Floor, MS-115; showing lath and lime plaster linings to the internal partition. The lath and plaster was damp and partially decayed where abutting the external wall

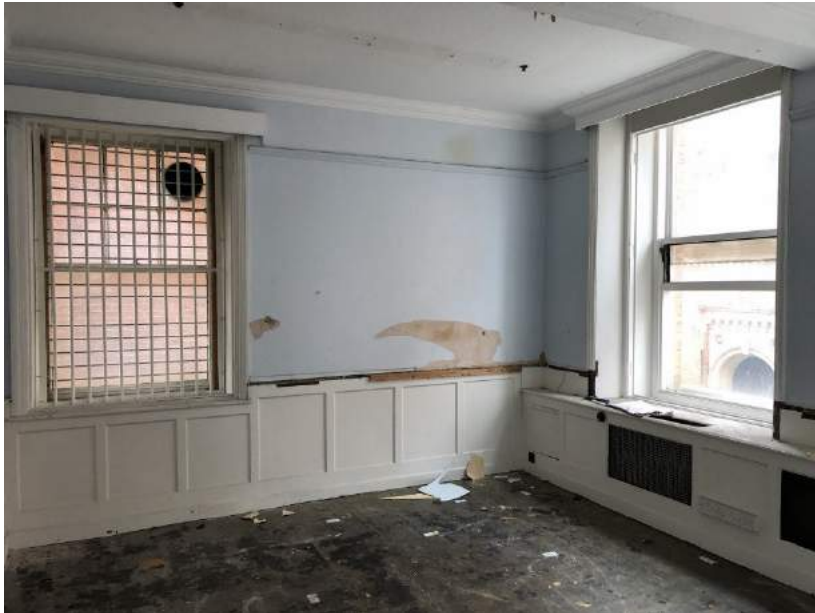
**Fig 67:**

First Floor, MS-117; showing non-original timber boxing and panelling that concealed earlier lime plaster with a softwood skirting

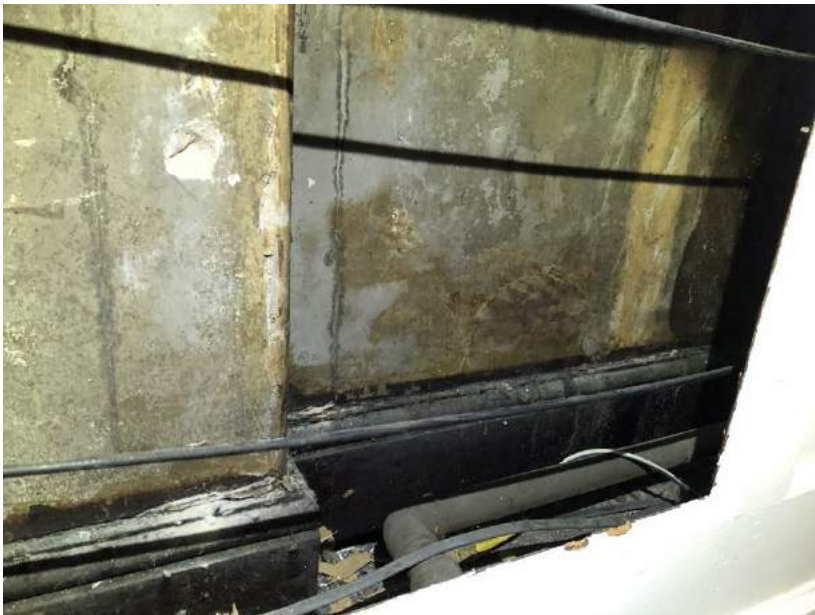
**Fig 68:**

First Floor, MS-117; showing the earlier lime plaster and skirting board as viewed through the boxing

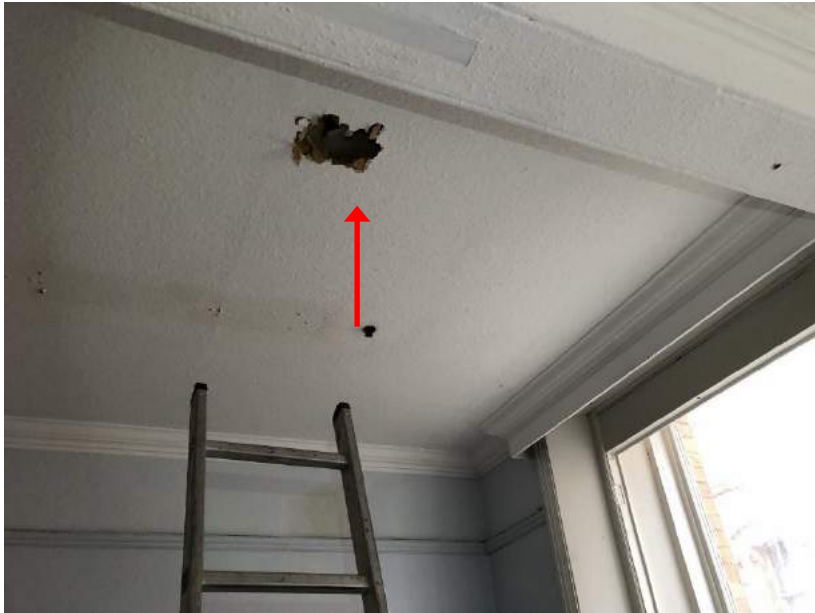
**Fig 69:**

First Floor, MS-117; showing a small opening through the ceiling to determine construction

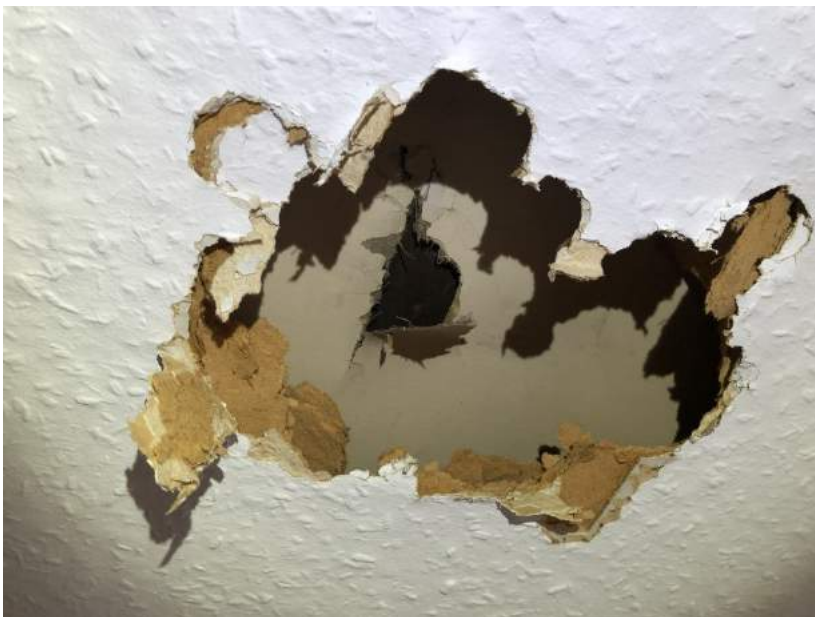
**Fig 70:**

First Floor, MS-117; showing non-original plasterboard supported on softwood battens fixed to the underside to the millboards. Note the earlier wallpaper to the underside of the millboards

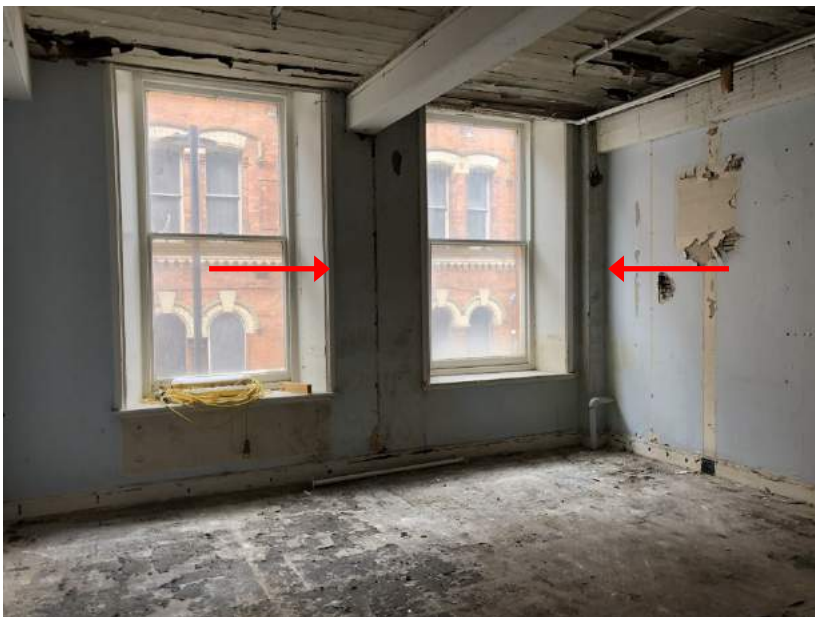
**Fig 72:**

First Floor, MS-118; showing the area of ongoing water penetration. The lime plaster had deteriorated and the lath and plaster partition was damp and partially decayed where abutting the external wall

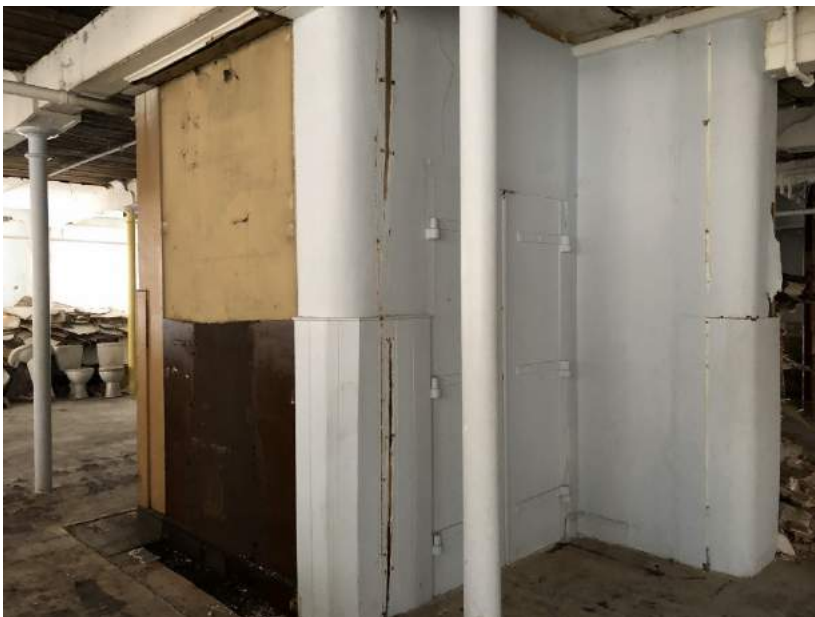
**Fig 74:**

First Floor, Goods lift; showing lime plaster applied to the brickwork. The lime plaster had debonded in areas of ongoing water penetration

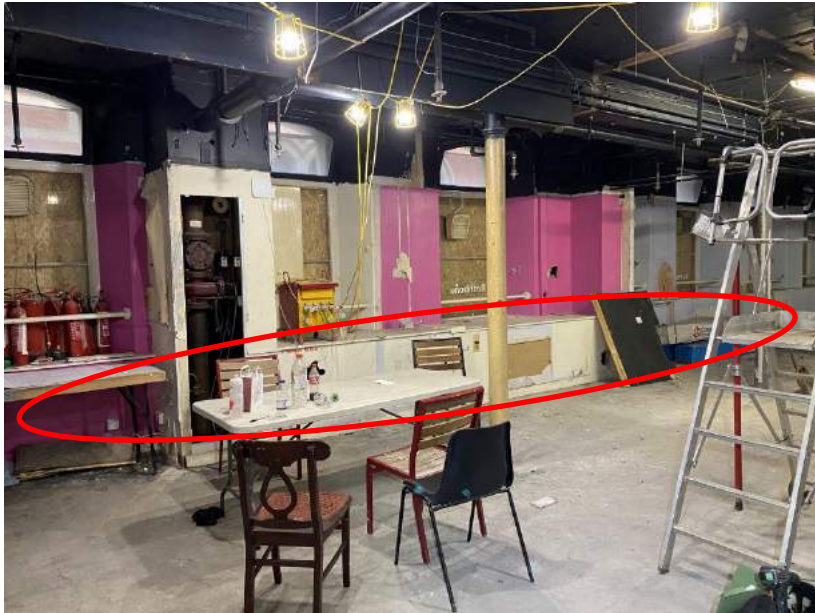
**Fig 75:**

Upper Ground Floor, MS-UG04;  
showing non-original fibreboard boxing  
with skirting board below window sills.  
The upper walls were plastered with  
lime

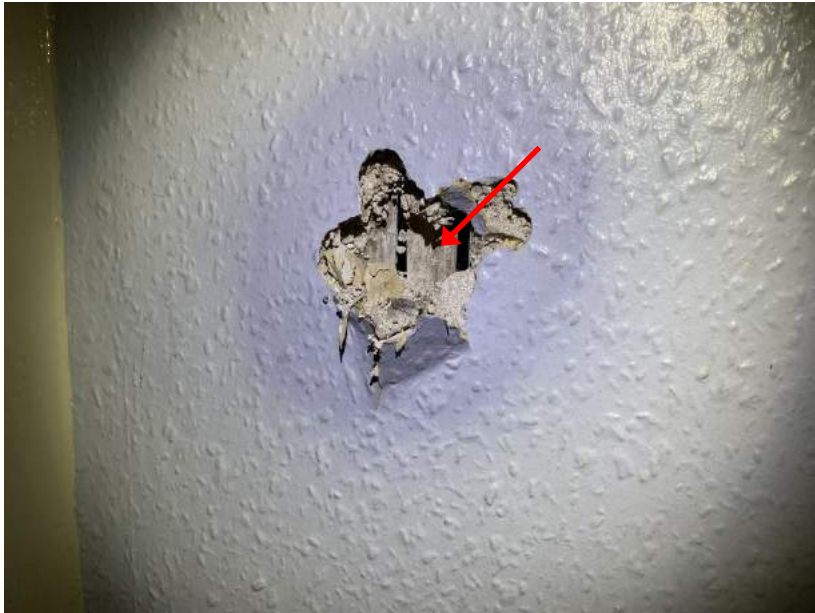
**Fig 77:**

Upper Ground Floor, MS-UG08;  
showing a close-up of the lath and  
plaster to a window reveal concealed  
by wood-chip wallpaper

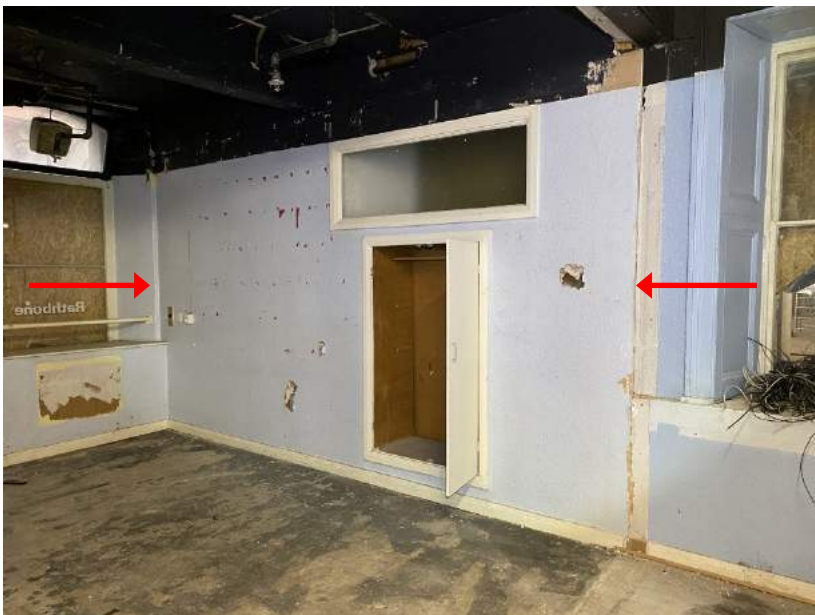
**Fig 78:**

Upper Ground Floor, MS-UG09;  
showing plasterboard dry lining  
concealing windows MS-UGW15 and  
MS-UGW16
