# Hutton + Rostron Environmental Investigations Limited

## Mindel House, Manchester: Plaster condition survey

Site note 4 for 8 April and 27 July 2021, job no. 212.57  
REVISION B - 25.04.22

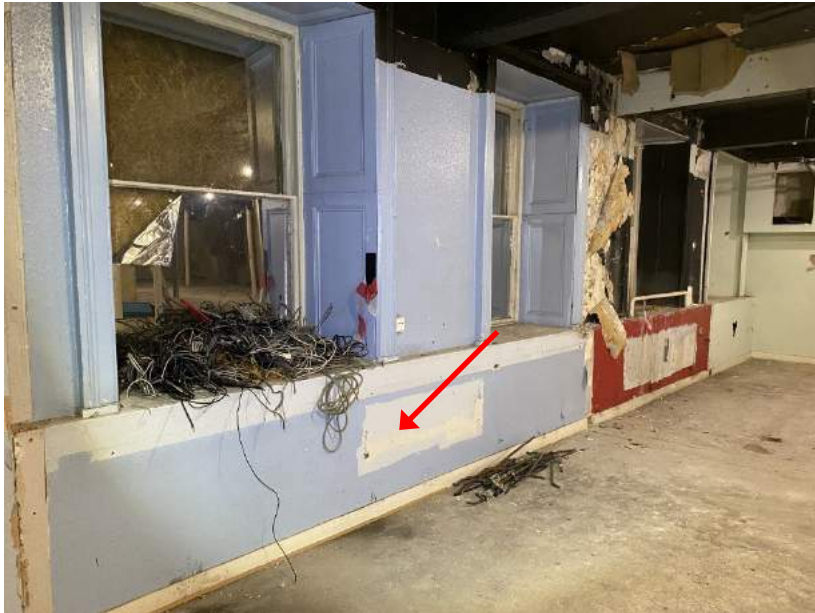
**Fig 79:**

Upper Ground Floor, MS-UG12;  
showing non-original fibreboard boxing  
with skirting board below window sills.  
The upper walls were plastered with  
lime. Note that the window reveals  
were panelled with softwood timber

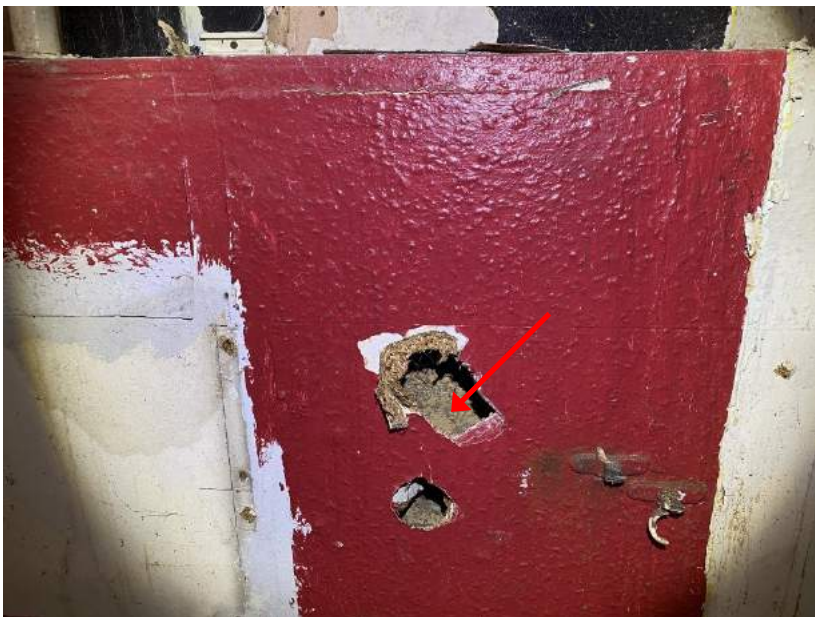
**Fig 80:**

Upper Ground Floor, MS-UG12;  
showing a close-up of plaster visible  
through an opening in the non-original  
chipboard boxing

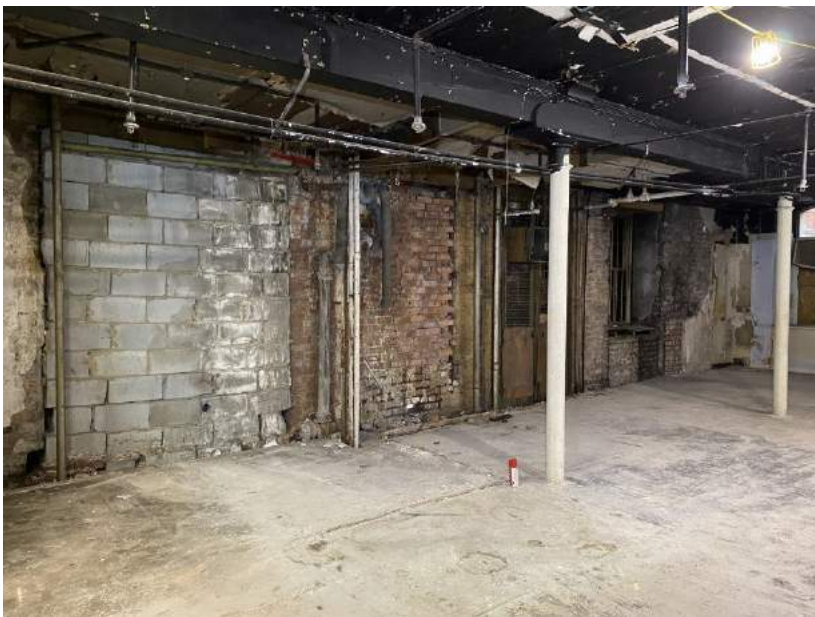
**Fig 82:**

Upper Ground Floor; showing a general view of the area subject to water penetration at the centre of the south-west elevation. There were no retained original plaster finishes to this wall

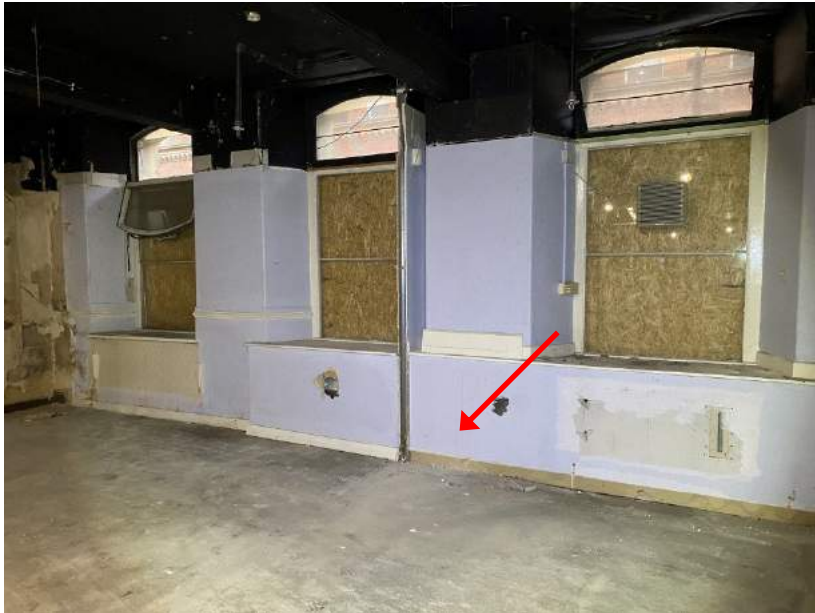
**Fig 83:**

Upper Ground Floor, MS-UG21;  
showing non-original plasterboard  
boxing at low-level. The wall behind  
was plastered with lime

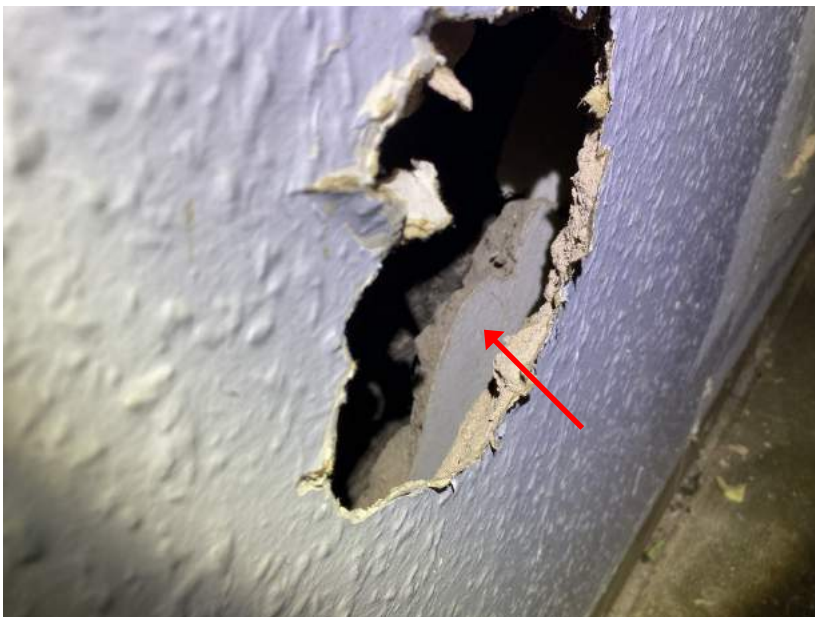
**Fig 84:**

Upper Ground Floor, MS-UG21;  
showing lime plaster visible within the  
plasterboard boxing. The plaster had  
debonded from the brick substrate in  
this location

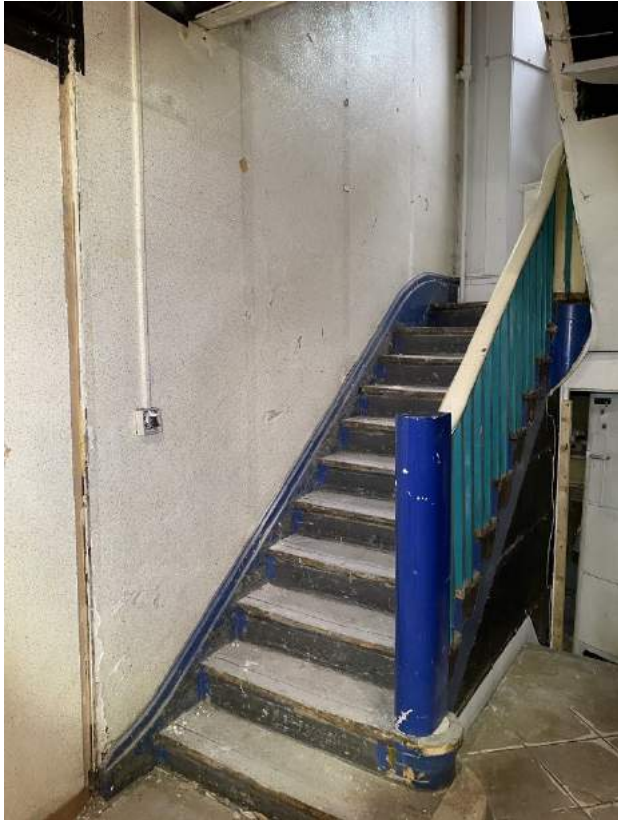
**Fig 85:**

Upper Ground Floor, MS-UG01;  
showing lath and plaster to the partition  
of the northern stairwell. A terrazzo  
effect finish (possibly from the 1980's)  
had been applied over a plaster skim

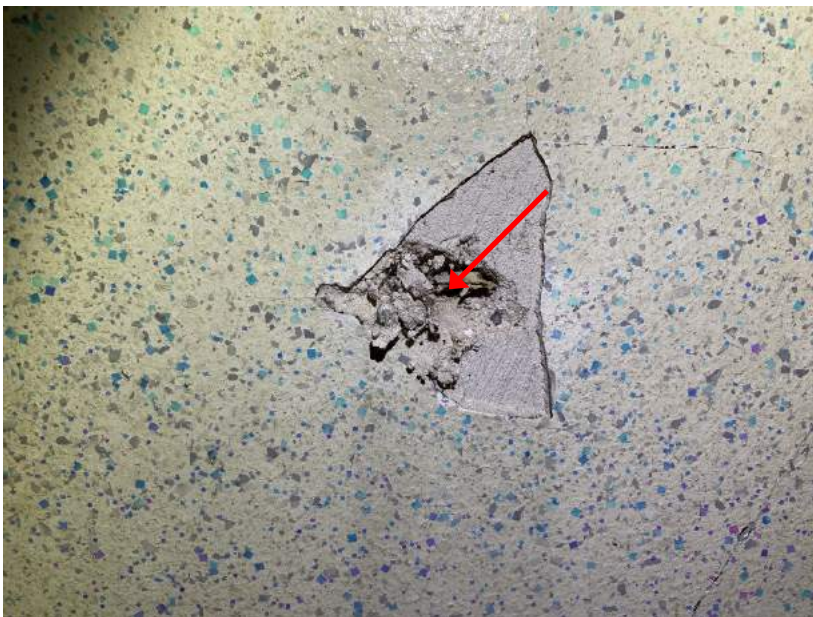
**Fig 86:**

Upper Ground Floor, MS-UG01;  
showing a close up of the lath and  
plaster visible behind the terrazzo  
effect wall finish

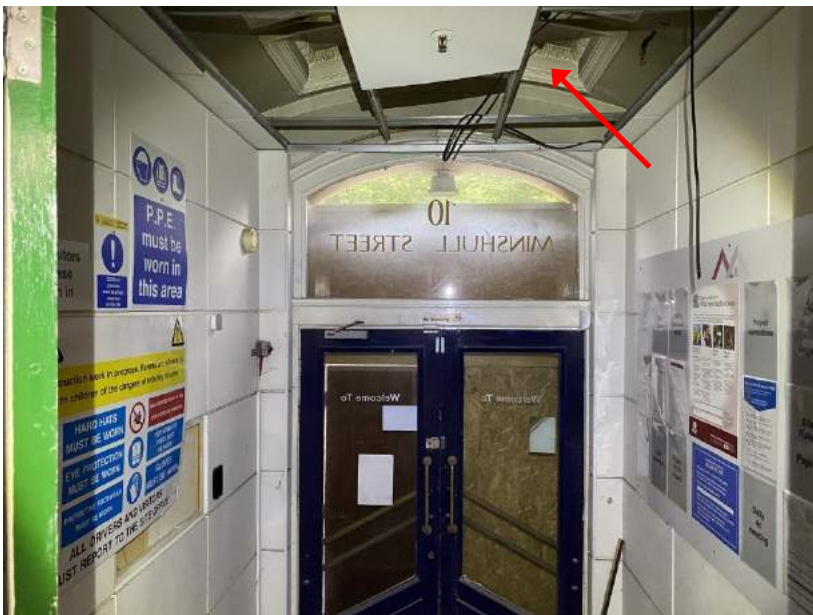
**Fig 88:**

Upper Ground Floor, Entrance lobby; showing an early/original ornamental barrel ceiling that appeared to be in good condition. The stud partitions either side of the lobby were lined with lath and plaster. However, non-original wall finishes concealed the lath and plaster

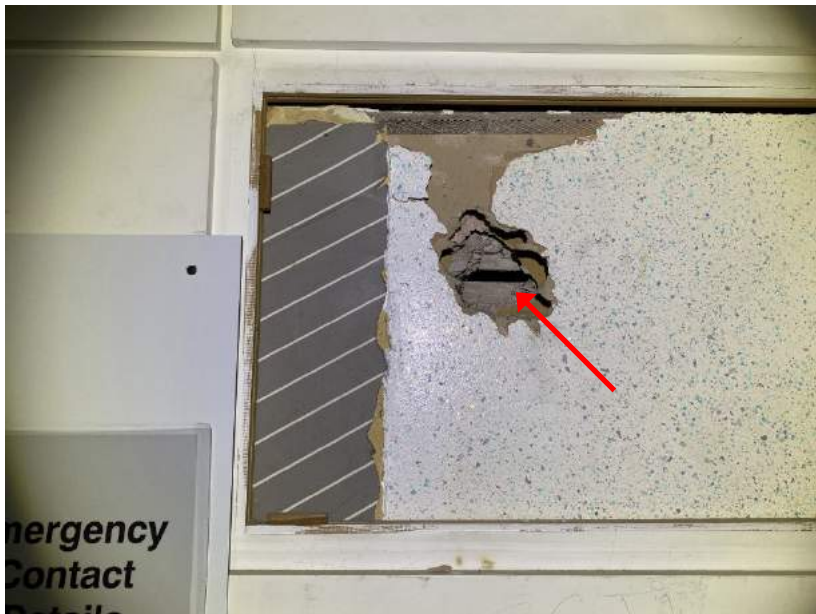
**Fig 89:**

Upper Ground Floor, Entrance lobby;  
showing lath and plaster visible behind  
the numerous non-original wall finishes

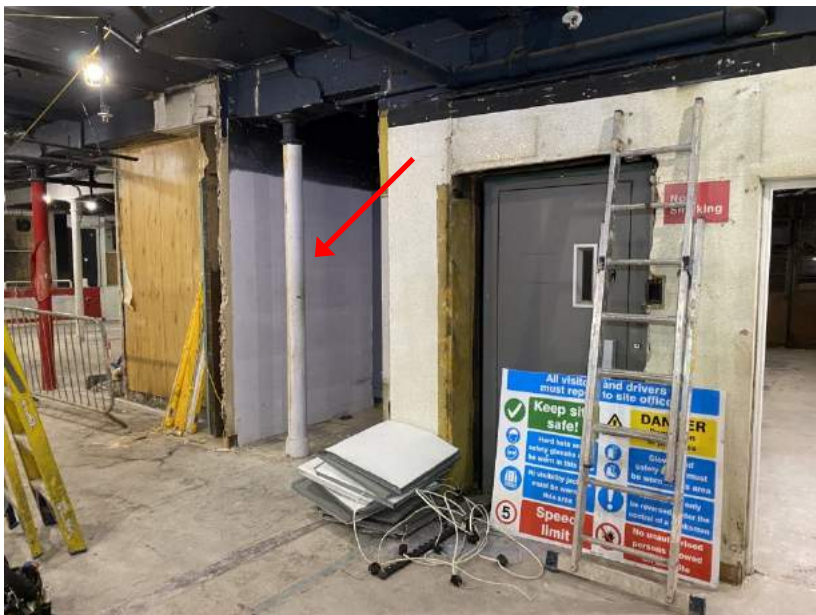
**Fig 90:**

Upper Ground Floor, Goods lift;  
showing a general view of the retained  
non-original finishes that largely  
conceal the lime plaster finishes of the  
goods lift. A small partition of lath and  
plaster also remained to the rear of the  
goods lift (arrowed)

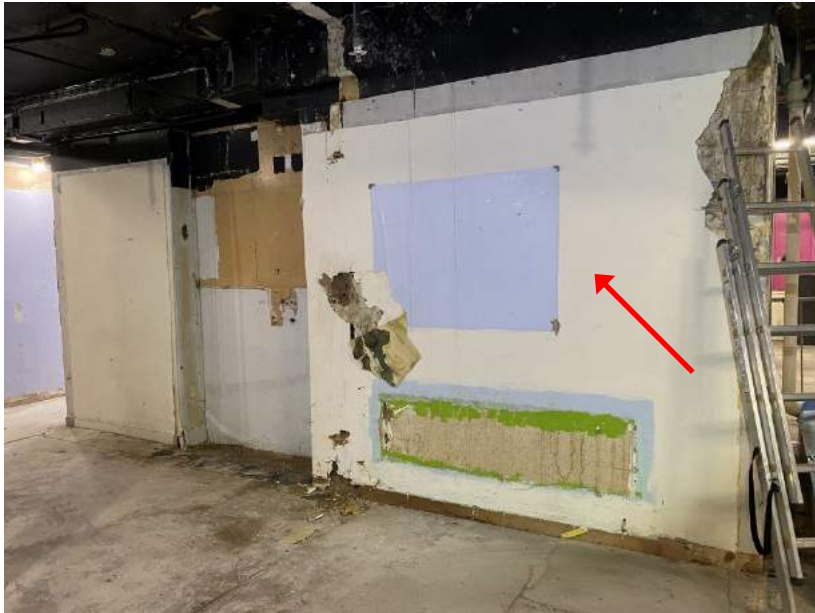
**Fig 91:**

Upper Ground Floor, Goods lift;  
showing the south west wall of the  
goods lift. The lime plaster finishes  
were largely damp and had debonded  
from the brick substrate

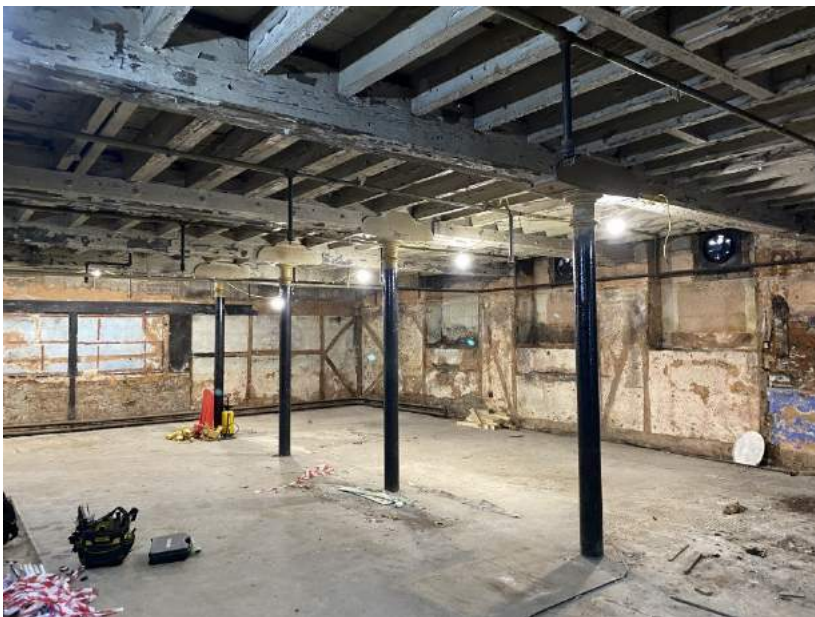
**Fig 92:**

Lower Ground Floor; showing a  
general view of the external walls. As  
the walls are below ground level they  
are susceptible to damp and any  
retained plaster had largely debonded.  
The small amount of plaster that  
remained was non-original

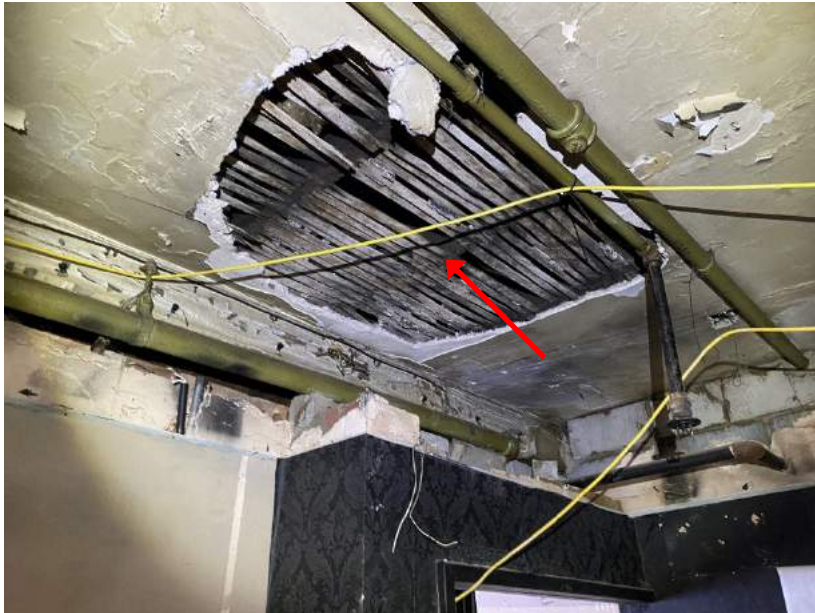
**Fig 95:**

Lower Ground Floor; showing an example of debonded ceiling plaster. Where visible, plaster 'keys' were in poor condition and additional areas of plaster were at risk of debonding

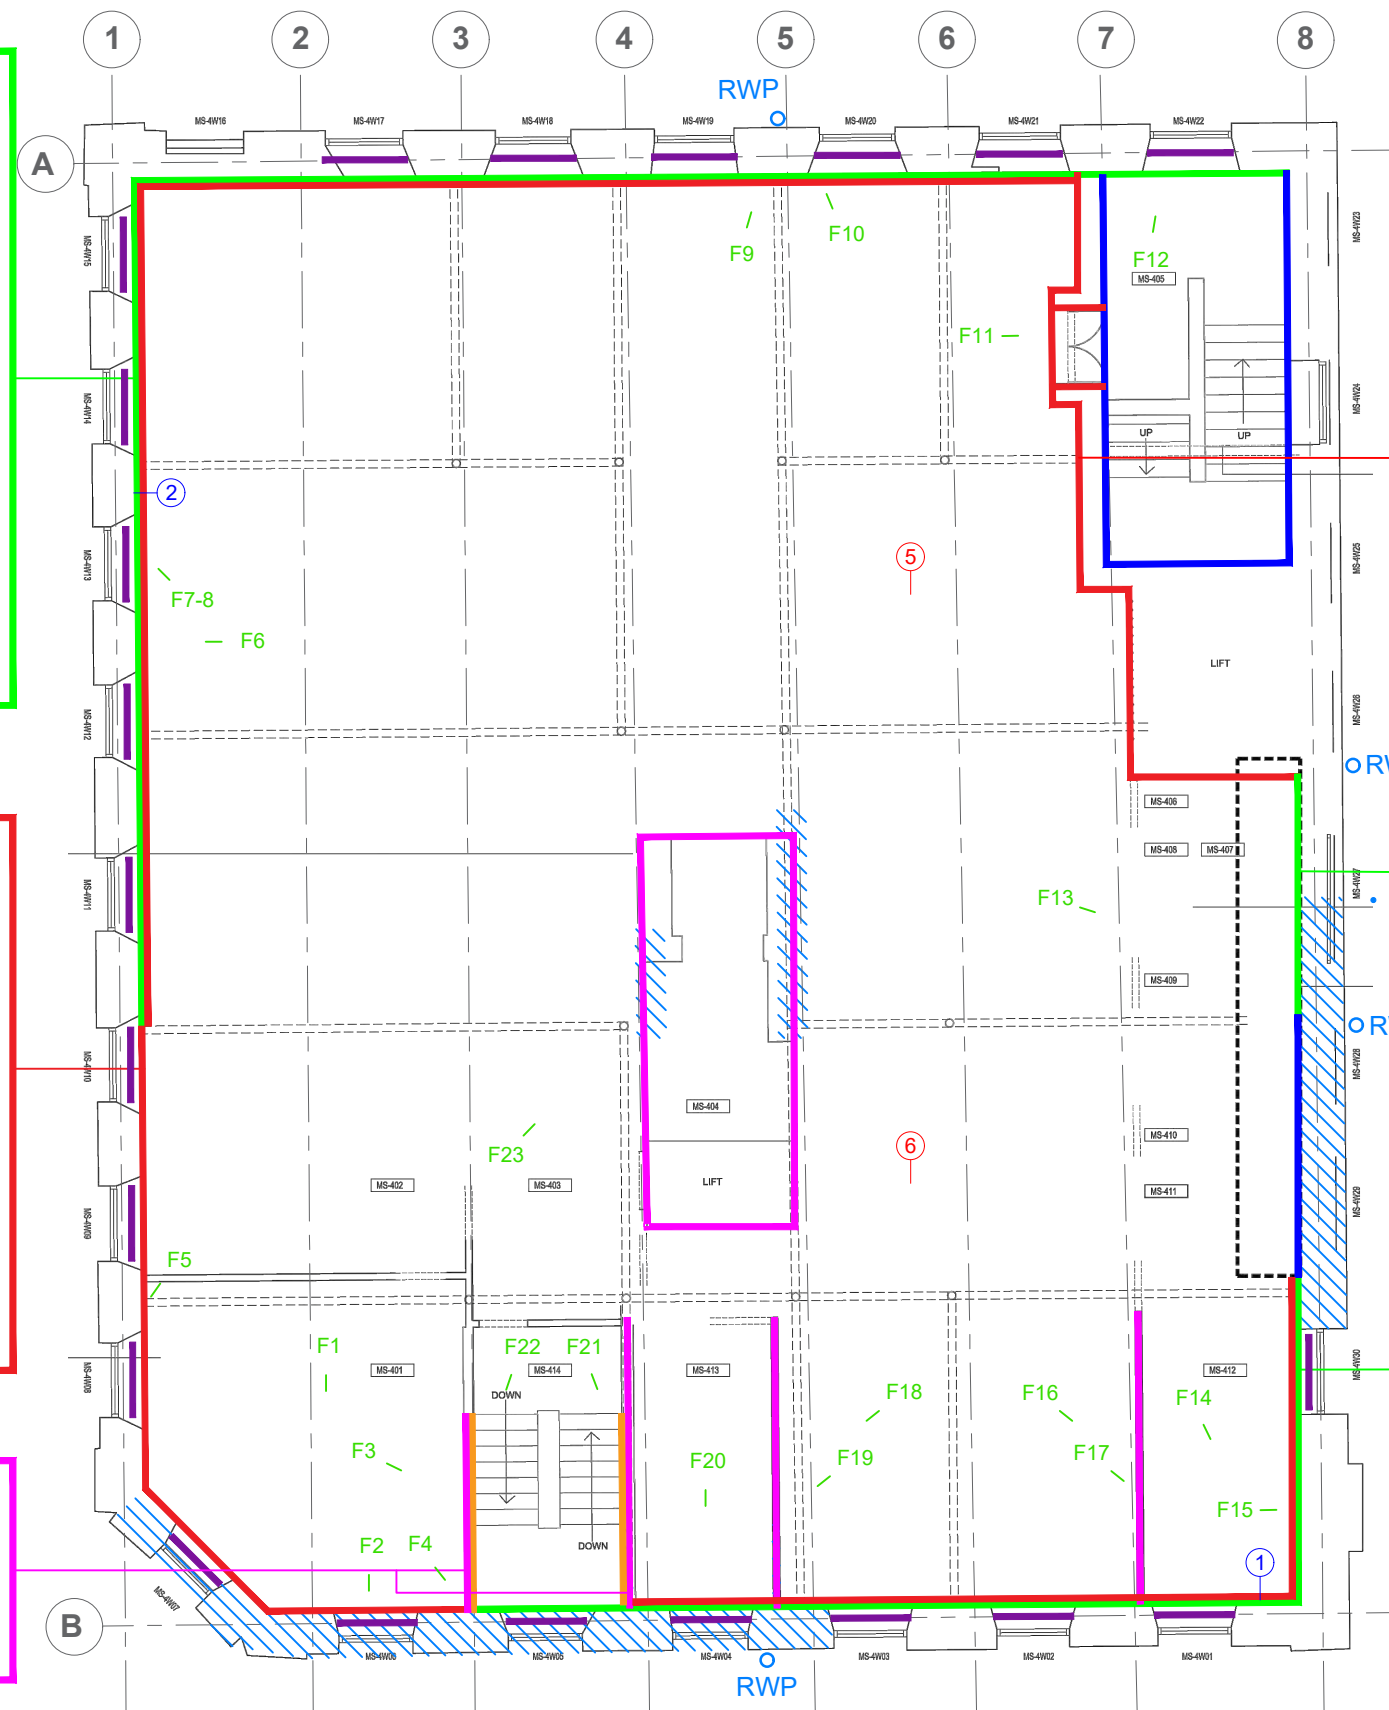
## Mindel House, Manchester - Fourth Floor

Plaster condition: Lime plaster generally in fair condition with localised areas of debonding particularly at low level. Lath and plaster generally in fair condition. Plaster damp and laths heavily decayed in areas of water penetration

Skirting board condition: Generally in fair condition but partially decayed in areas of water penetration

Plaster condition: Wet and largely debonded

Condition: Generally in fair condition but damp and partially decayed by wet rot against external wall

Plaster condition: Generally in fair condition

Plaster condition: Generally in fair condition but wet and largely debonded in areas of water penetration. Lath and plaster heavily decayed by wet rot

Panelling and skirting condition: Timbers generally damp and heavily decayed in areas of water penetration

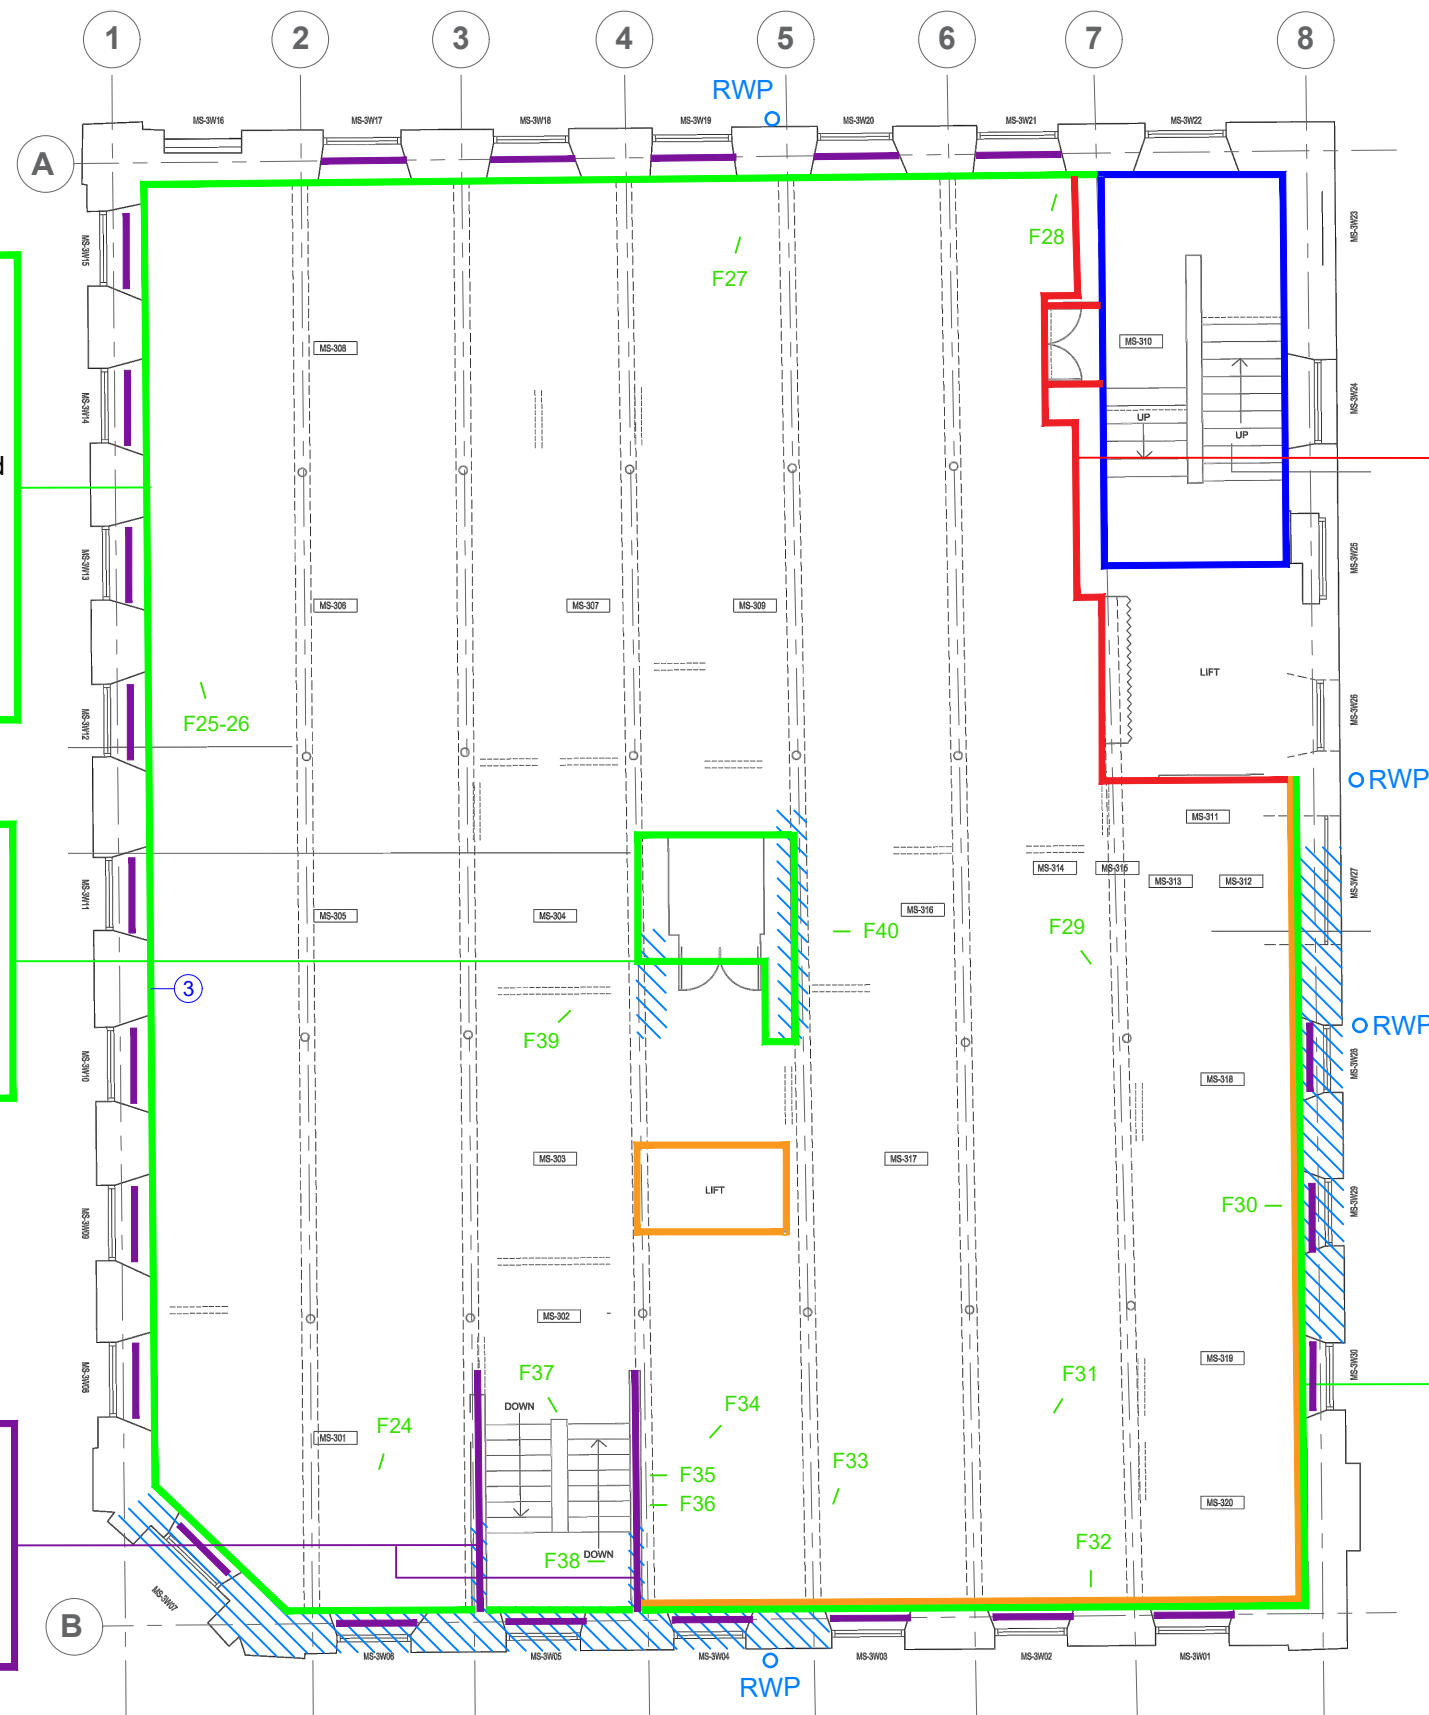
**Mindel House, Manchester - Third Floor**  
Plaster condition survey  
8 April 2021

Plaster condition: Lime plaster generally in fair condition with localised areas of debonding

Skirting board condition: Generally in fair condition but partially decayed in areas of water penetration

Plaster condition: Wet and largely debonded

Condition: Generally in fair condition but damp and partially decayed by wet rot against external wall

Plaster and skirting condition: Generally in fair condition

Plaster condition: Generally in fair condition but wet and largely debonded in areas of water penetration

Skirting board condition: Generally in fair condition but heavily decayed in areas of water penetration

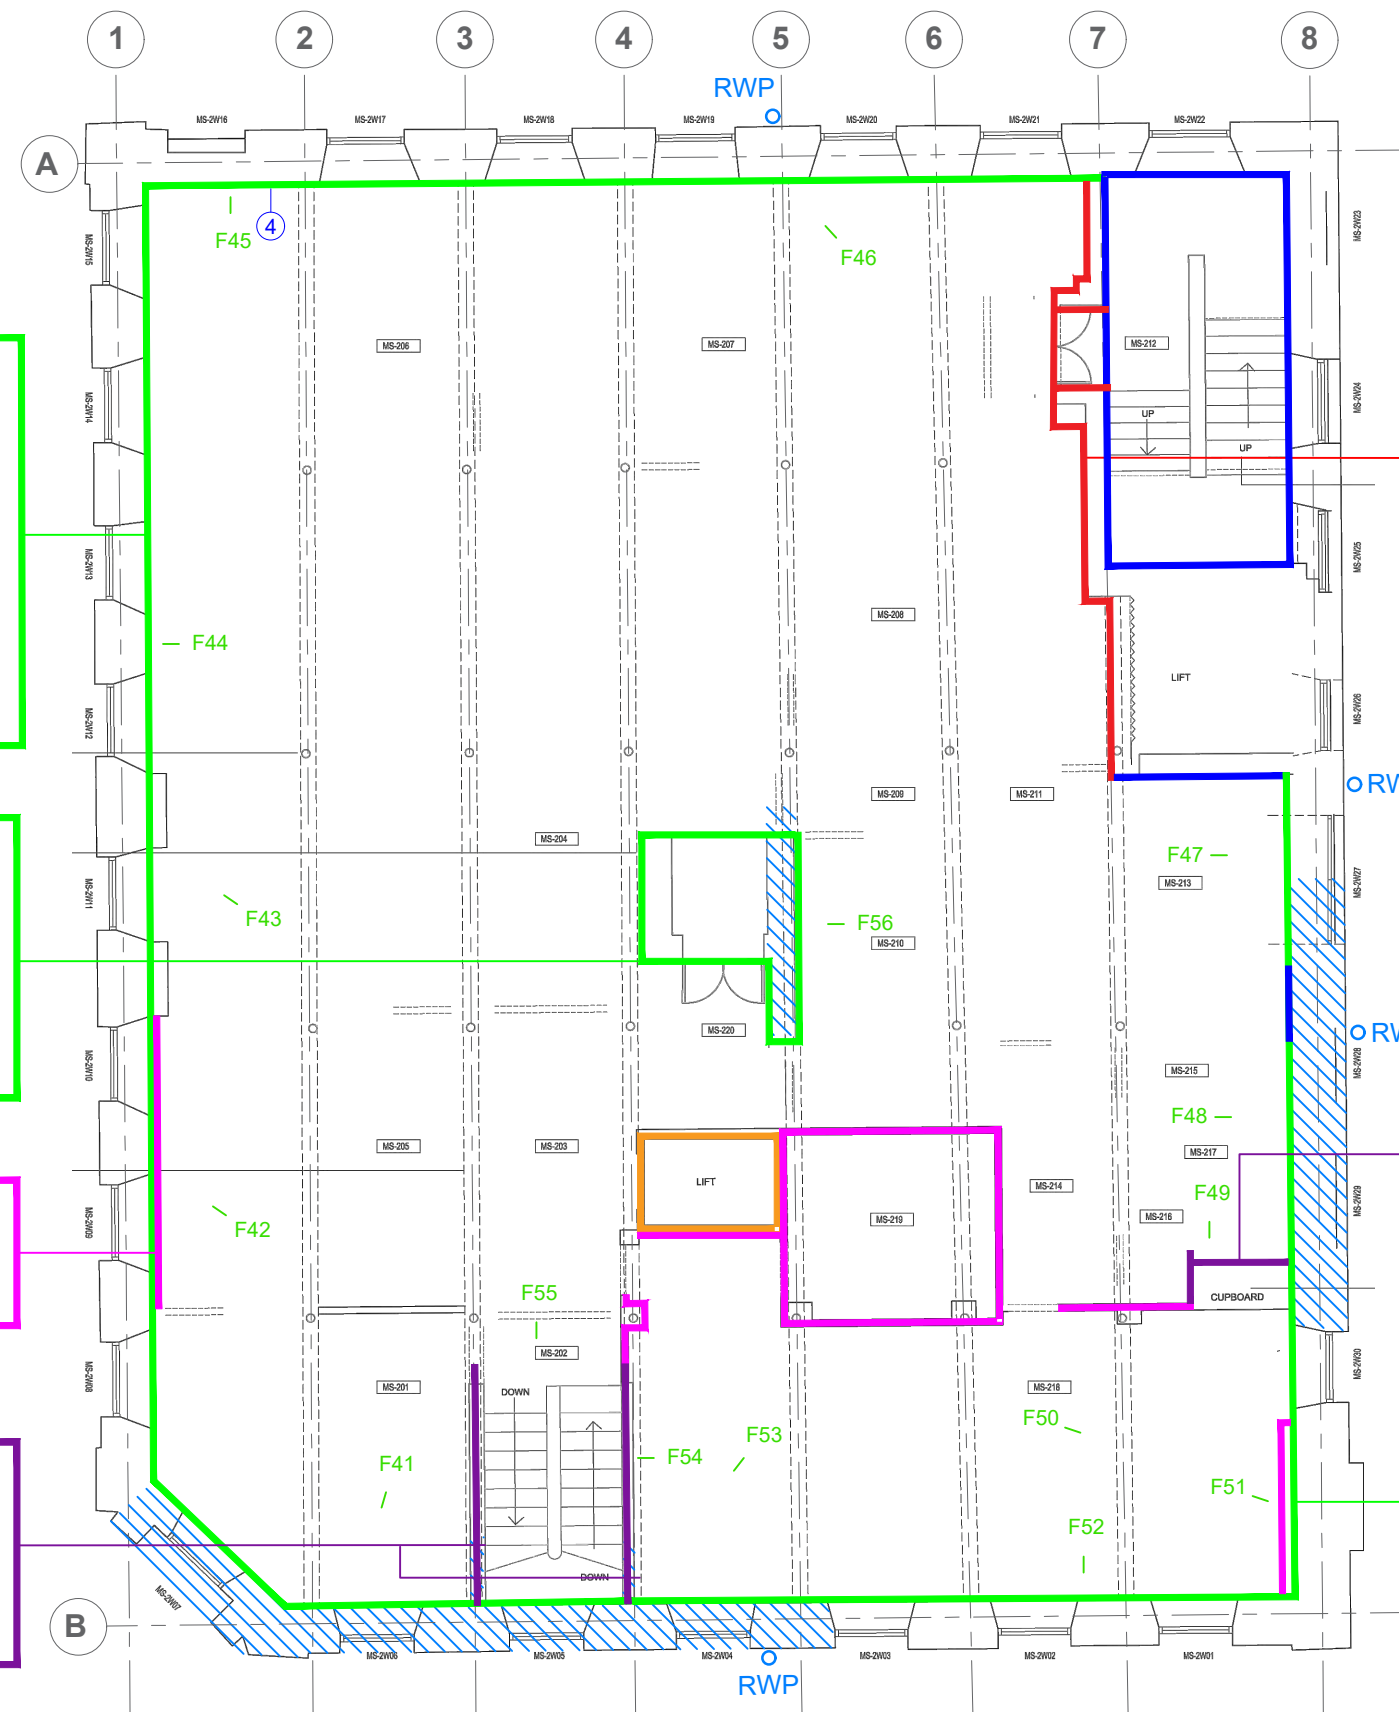
**Mindel House, Manchester - Second Floor**  
Plaster condition survey  
8 April 2021

Plaster condition: Lime plaster generally in fair condition with localised areas of debonding. Lath and plaster partially decayed in localised areas

Plaster condition: Wet and largely debonded

Lath and plaster condition: Concealed by modern plasterboard. Probably damp and partially decayed in area of water penetration

Condition: Inaccessible. Probably in fair condition but damp and partially decayed by wet rot against external wall

Plaster condition: Generally in fair condition

Lime plaster condition: Generally in fair condition but wet and largely debonded in areas of water penetration

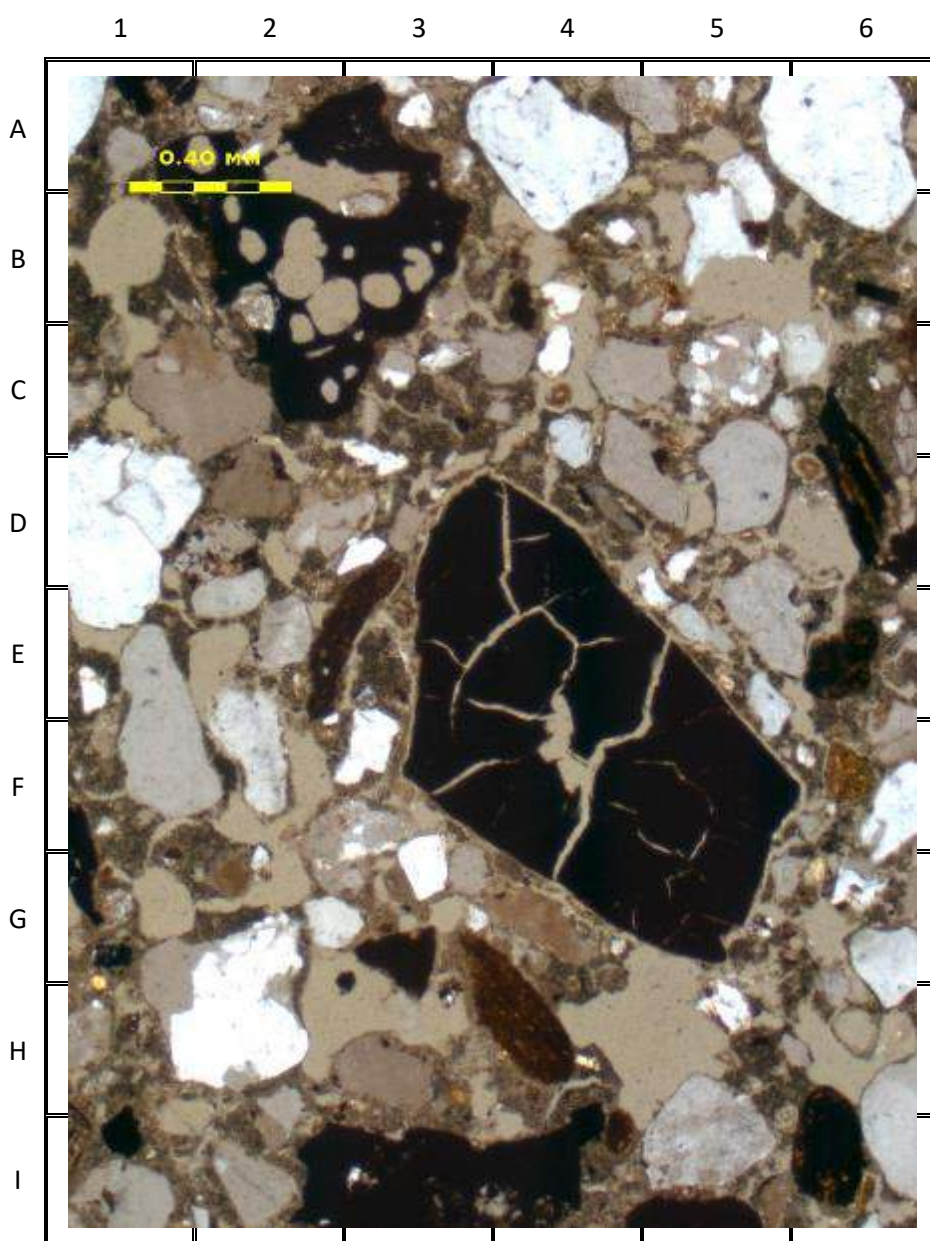
Figure C1

Thin section, oblique polars: Low magnification view showing the large-scale structure of the sample. A coal fragment with abundant internal shrinkage cracking occurs in E/F4. A fragment of carbonaceous ash occurs in D2/3. Much of the field of view is occupied by quartz sand particles that appear various shades of grey surrounded by small amounts of carbonated lime matrix. Abundant voids infilled with the green fluorescent resin used during the preparation of the thin section are visible throughout the field of view for example around H5 and B/C5.

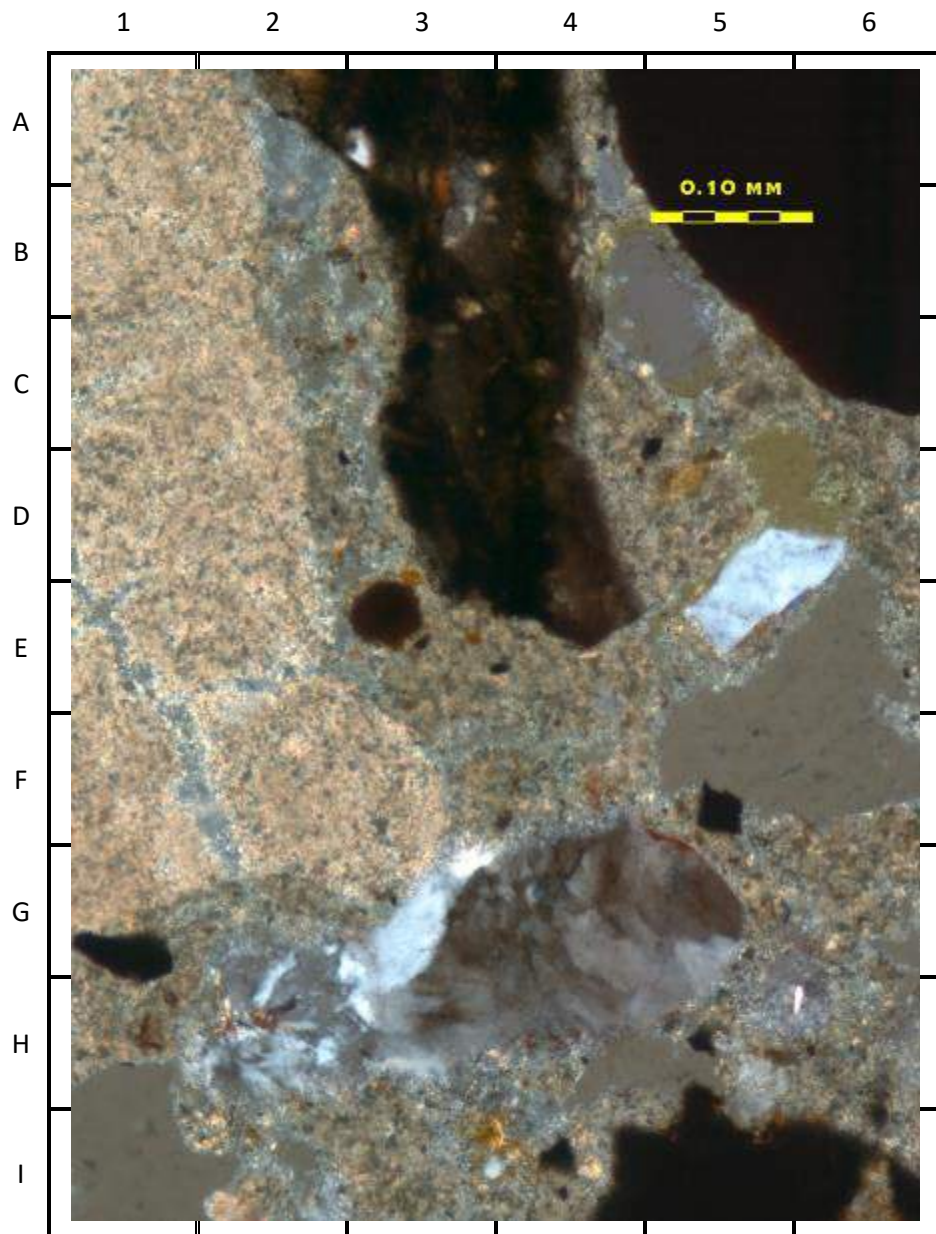
Figure C2

Thin section, oblique polars: A fragment of undispersed lime is centred around C/D1. Particles of ash occur in A3 and A6. Areas of carbonated lime matrix are visible for example in I3 and E/F4 and a quartz sand particle can be seen in G/H4.

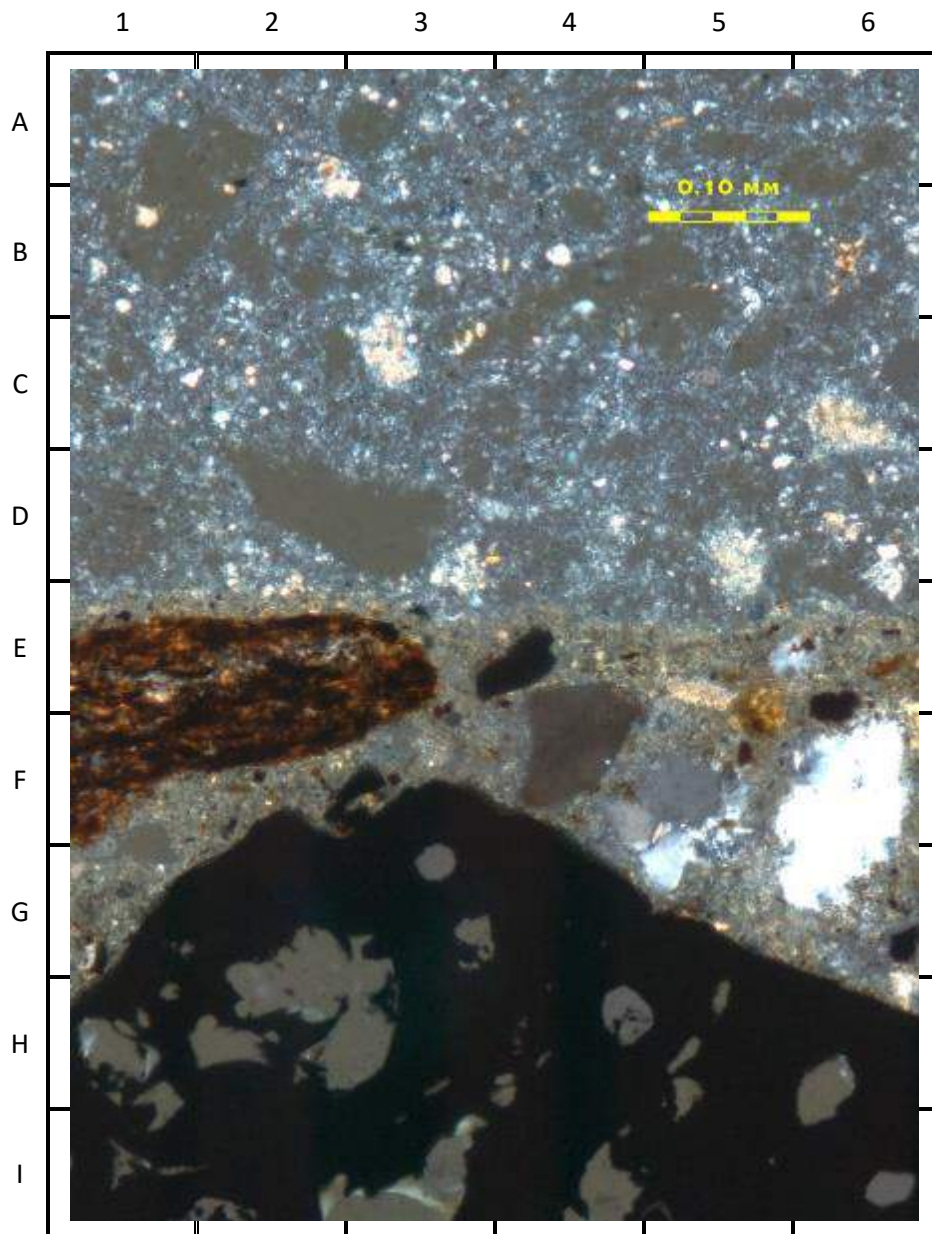
Figure C3

Thin section, crossed polars: View showing a cross section through the contact between the surface gypsum plaster layers in the upper half of the field of view and the base coat plaster in the bottom half of the field of view. The gypsum plaster layer is composed mainly of microcrystalline gypsum crystals visible for example around B/C1. The base coat plaster contains particles of carbonaceous ash visible for example in H3/4 and quartz particles visible for example in F6 that are surrounded by a carbonated lime matrix that can be seen for example in G1.

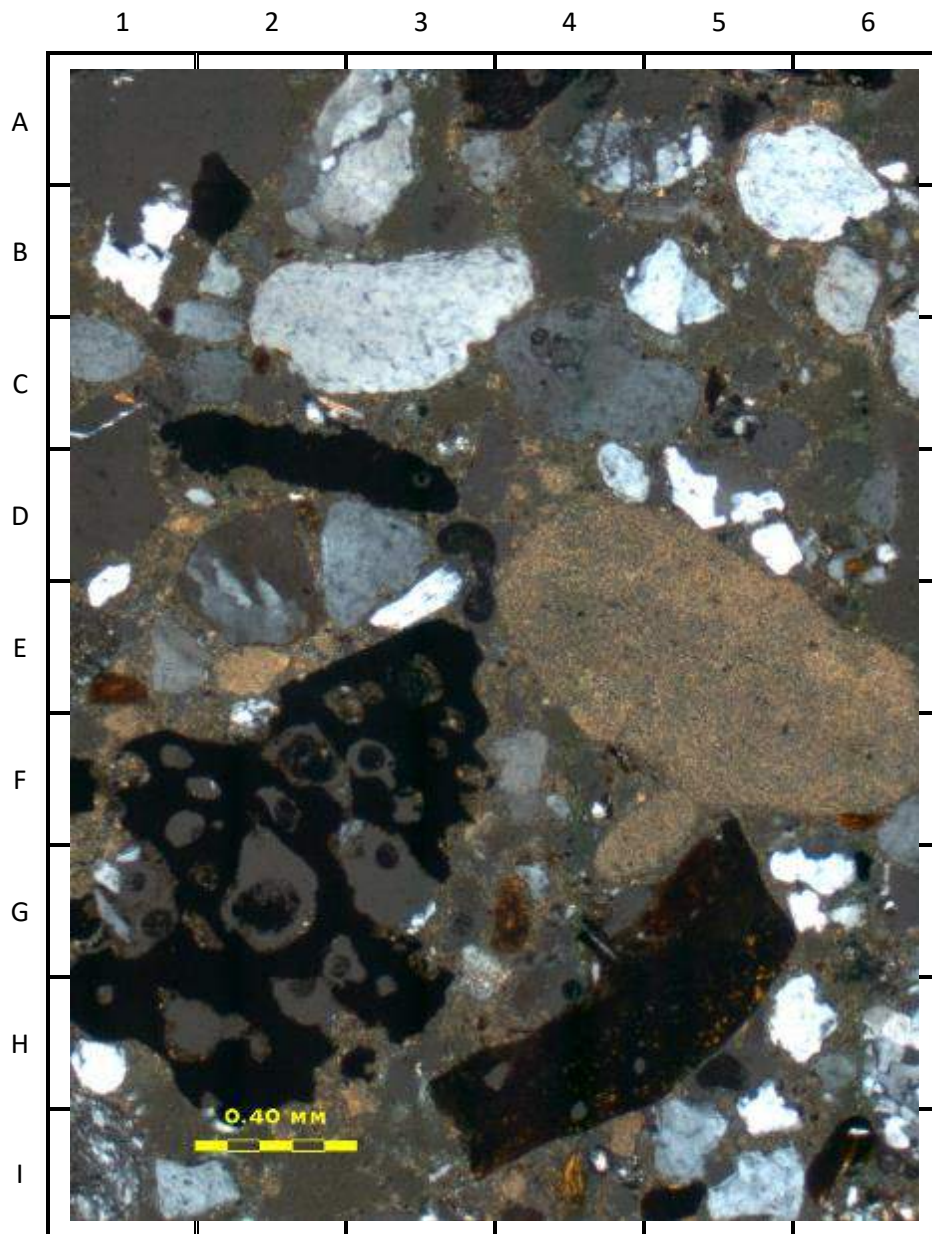
Figure C4

Thin section, oblique polars: A fragment of carbonaceous ash occurs in F/G2. A particle of undispersed lime occurs in E5. Quartz sand particles appear various shades of grey and can be seen throughout the field of view for example in B/C3. The aggregate particles are surrounded by carbonated lime matrix.

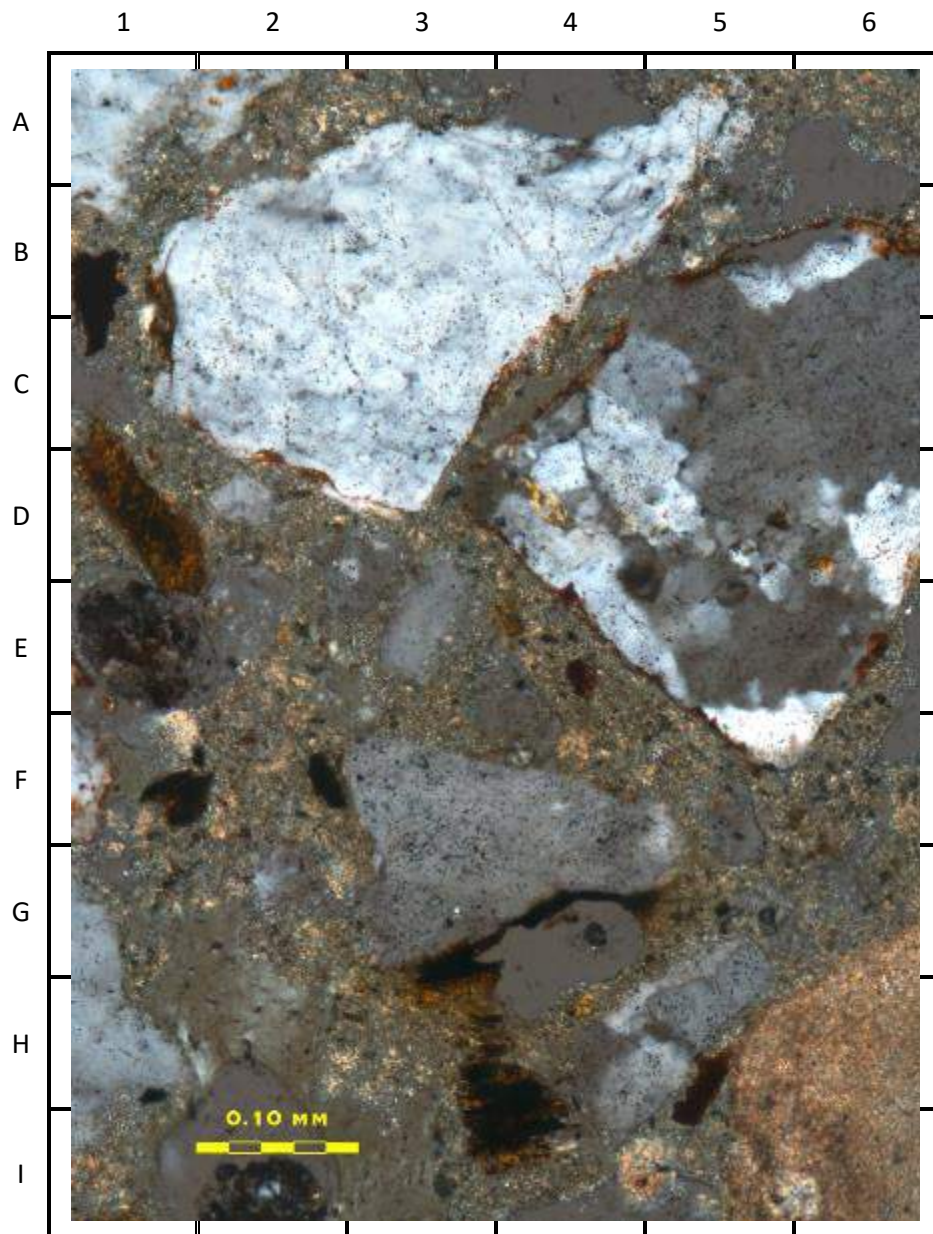
Figure C5

Thin section, oblique polars: Quartz particles with small amounts of reddish brown clay around their surfaces are centred on B/C3 and D5/6. Areas of carbonated lime matrix occur for example in F2. A fragment of undispersed lime occurs in H/I6.

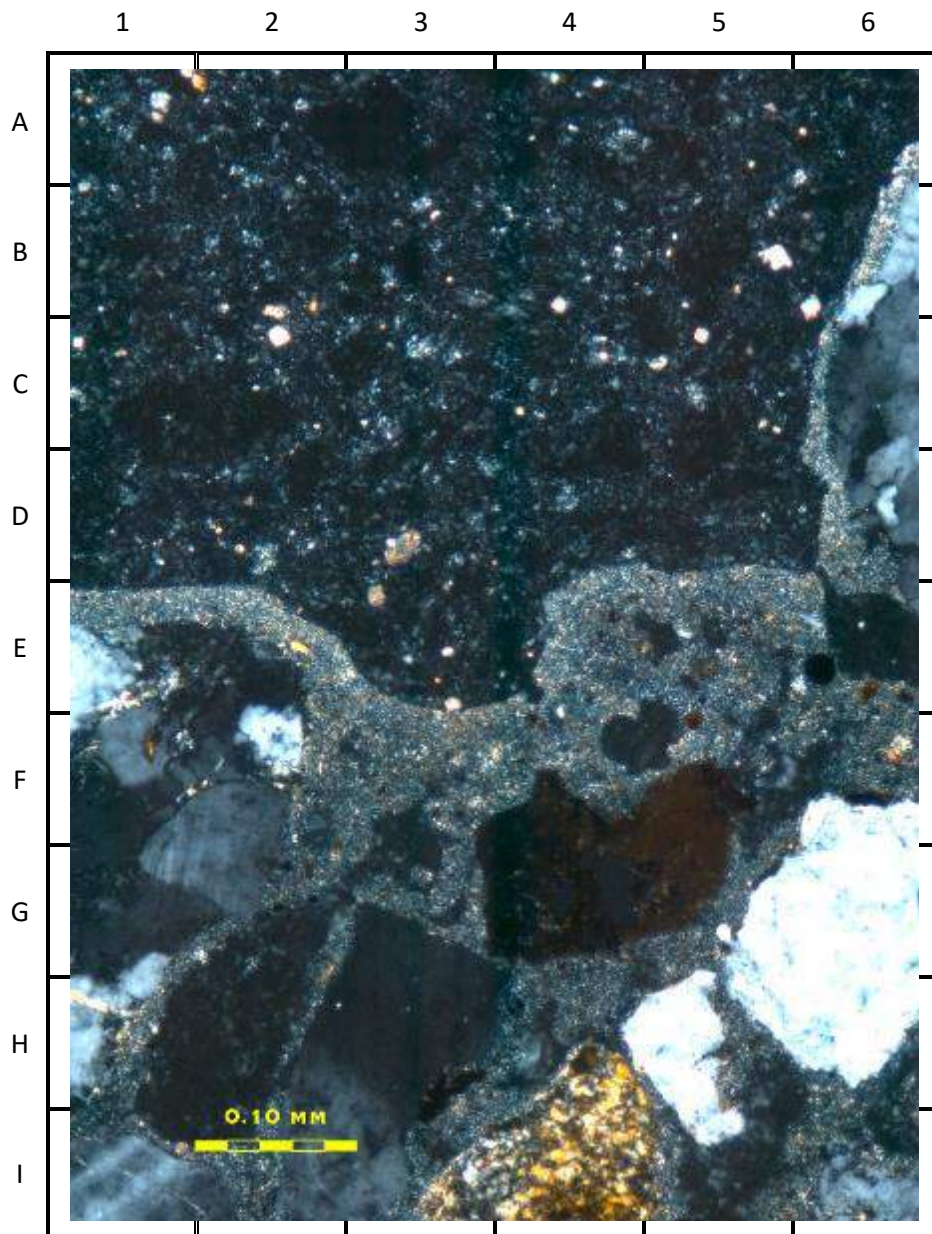
Figure C6

Thin section, crossed polars: View showing a cross section through the contact between the gypsum plaster layer in the upper half of the field of view and the lime based base coat plaster in the lower half of the field of view. The base coat plaster contains quartz sand particles visible for example in F1 and H3 that are surrounded by carbonated lime matrix visible for example in E/F5. The gypsum plaster layer is composed almost entirely of microcrystalline gypsum, visible for example around C3/4.
