# Hutton + Rostron Environmental Investigations Limited

## Mindel House, Manchester: Plaster condition survey

Site note 4 for 8 April and 27 July 2021, job no. 212.57  
REVISION B - 25.04.22

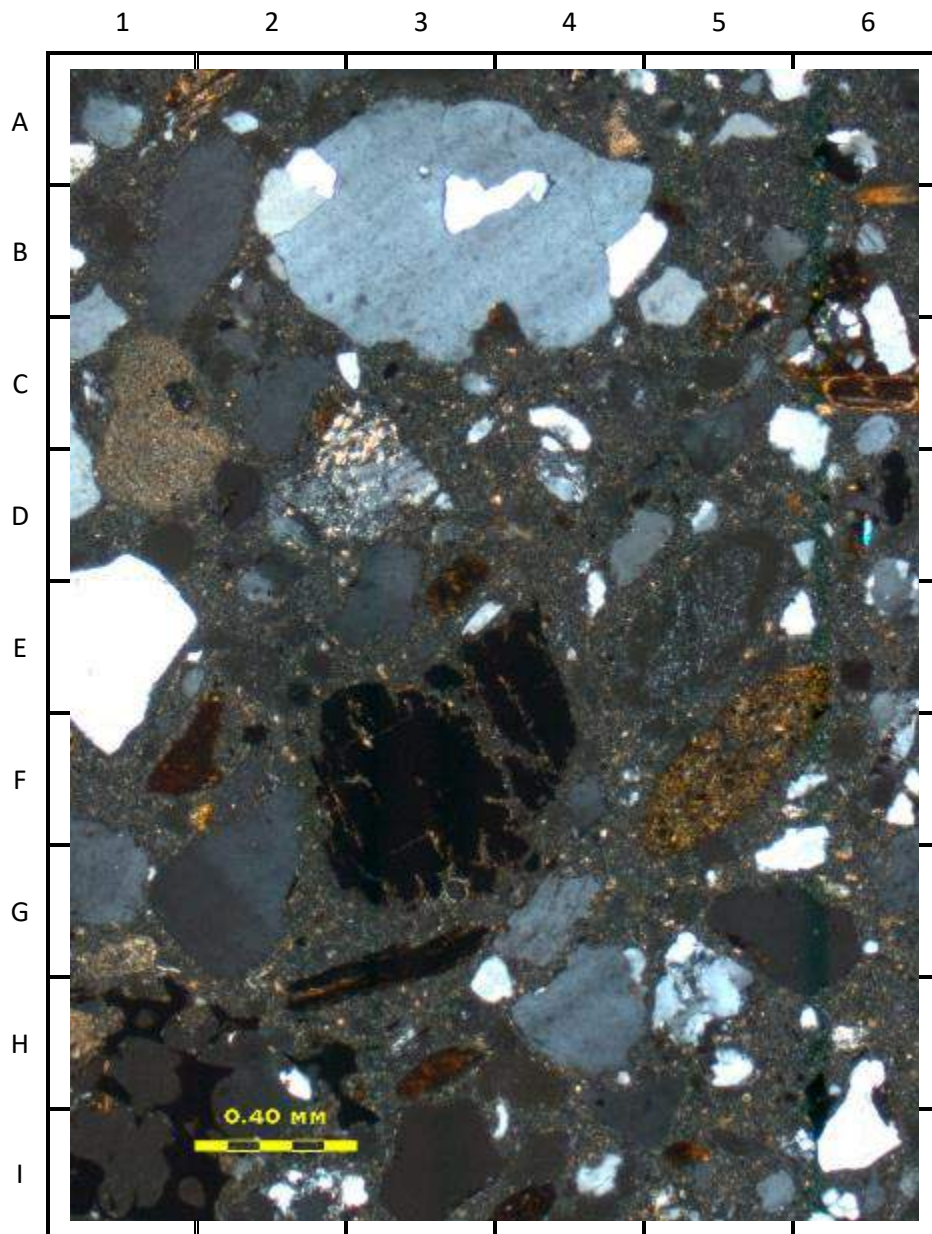
Figure C7

Thin section, crossed polars: Low magnification view showing the large-scale structure of the sample. A fragment of coal with abundant internal shrinkage cracking occurs in F3. Quartz sand particles appear various shades of grey and occur throughout the field of view. The aggregate particles are surrounded by porous, carbonated lime matrix. A fragment of undispersed lime occurs in C/D1.

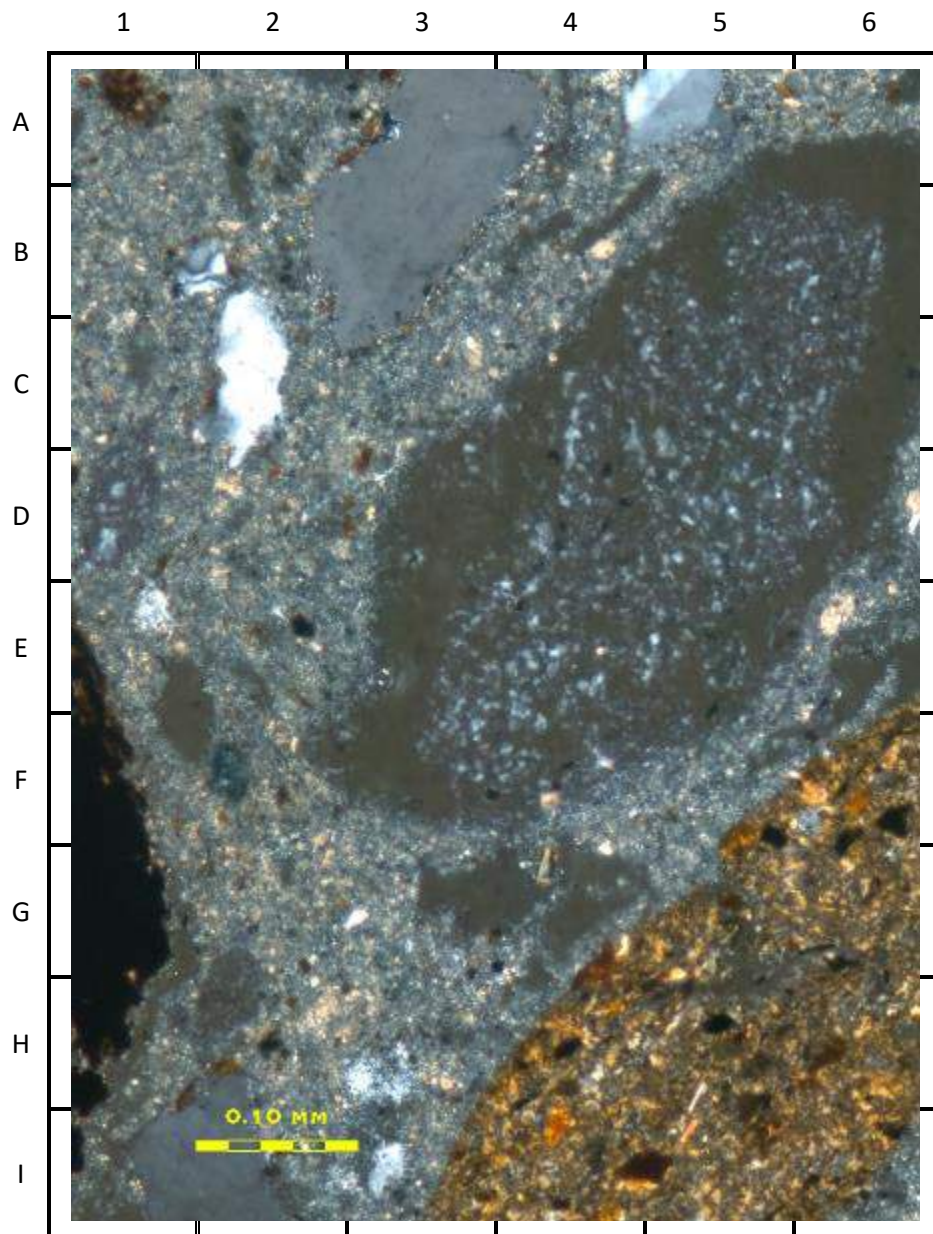
Figure C8

Thin section, oblique polars: View showing the typical appearance of the fragments of gypsum that occur in the lime matrix in the base coat plaster. The gypsum fragment is partially dissolved around its margins and is centred on D5. Typical areas of carbonated lime matrix occur for example in B1 and G2/3. A fragment of mudstone occurs in H5/6 and a quartz particle occurs in B3.

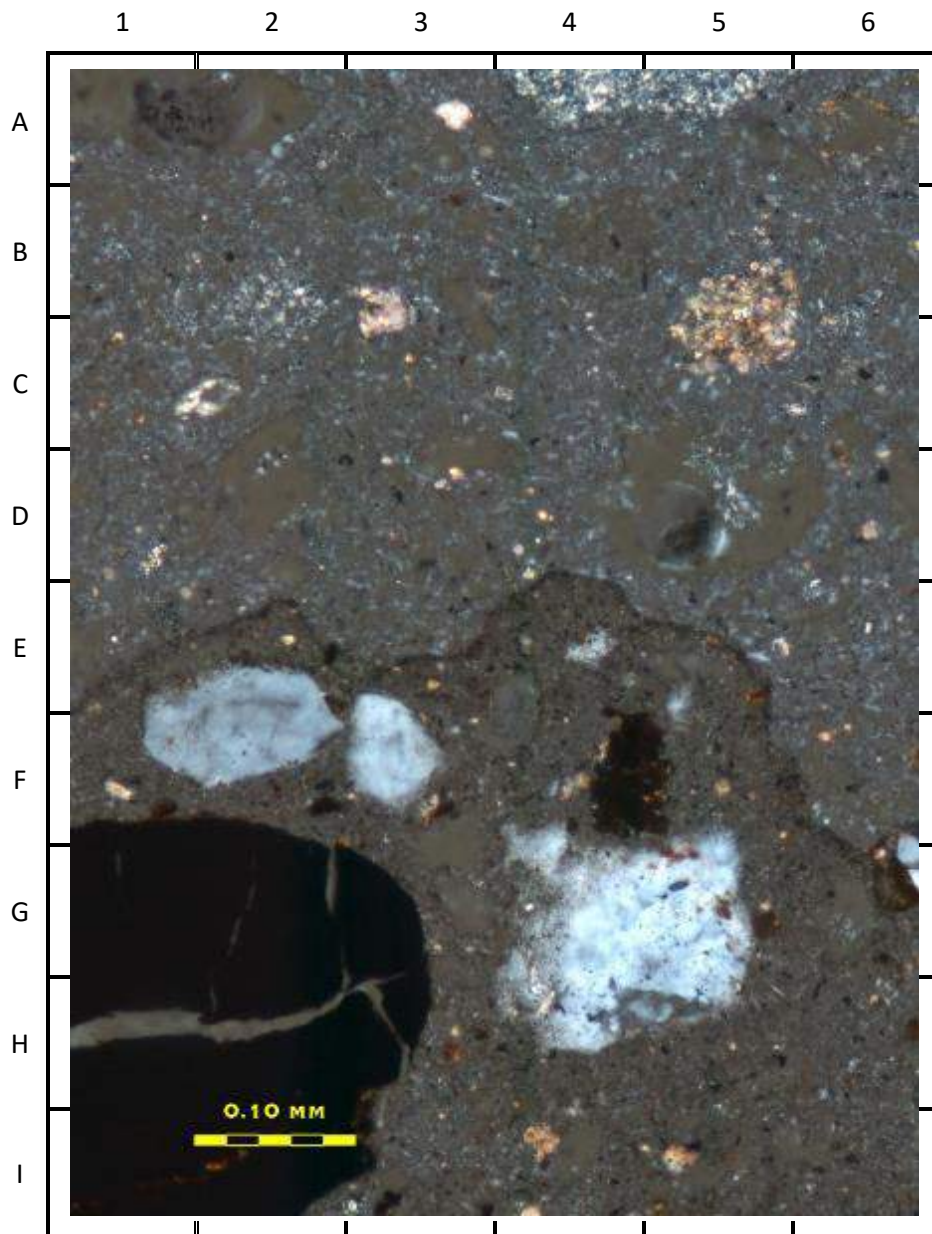
Figure C9

Thin section, crossed polars: View showing a cross section through the contact between the surface gypsum plaster layers and the base coat plaster. The gypsum plaster layer is composed mainly of microcrystalline gypsum visible for example around B1/2. A coal fragment in the surface of the base coat plaster is centred around H1/2. Quartz particles occur for example in F2 and G5.

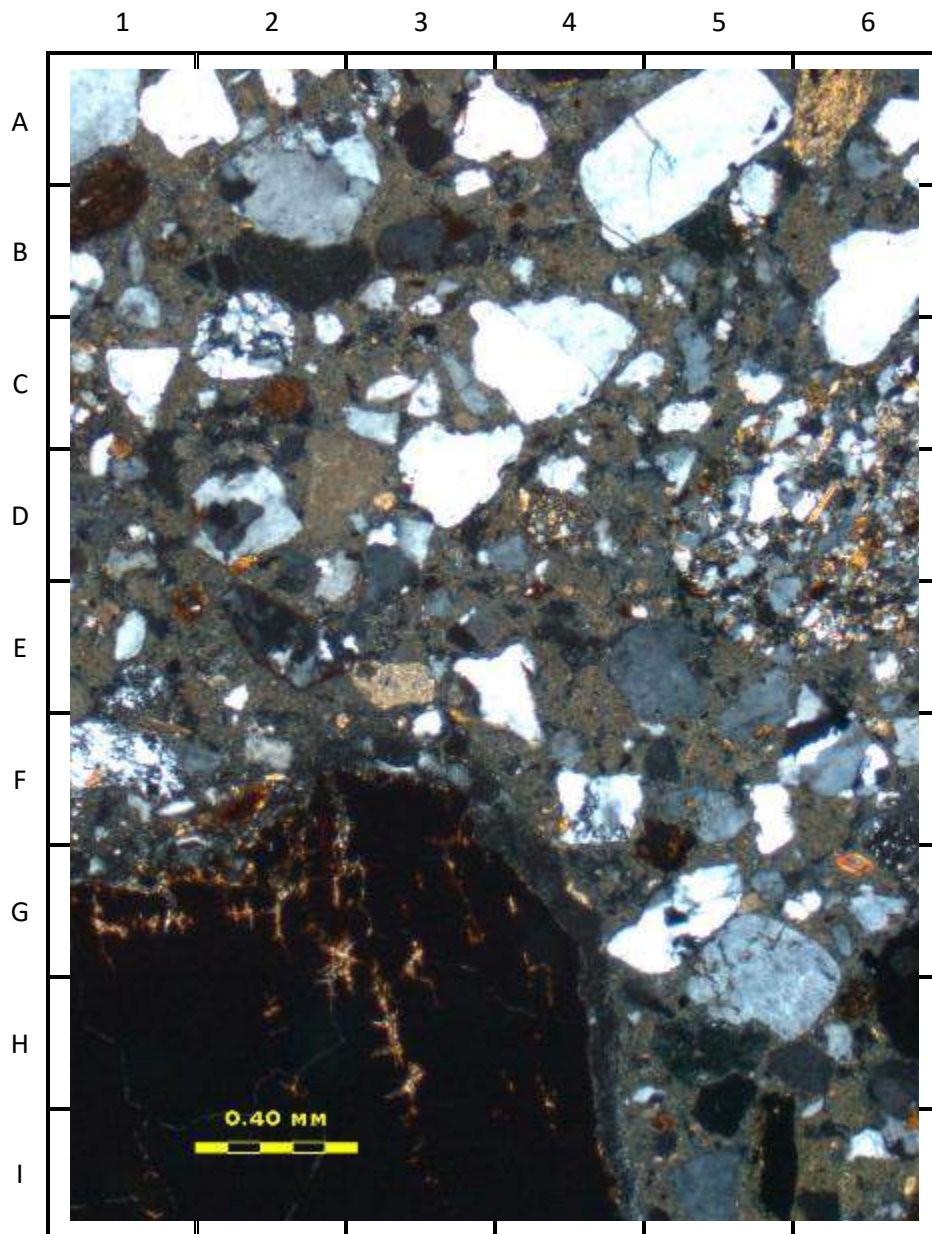
Figure C10

Thin section, crossed polars: A coal fragment with abundant internal shrinkage cracking is centred around H2/3. The majority of the field of view is occupied by carbonated lime matrix surrounding quartz particles appearing various shades of grey. A fragment of undispersed lime can be seen in D3.

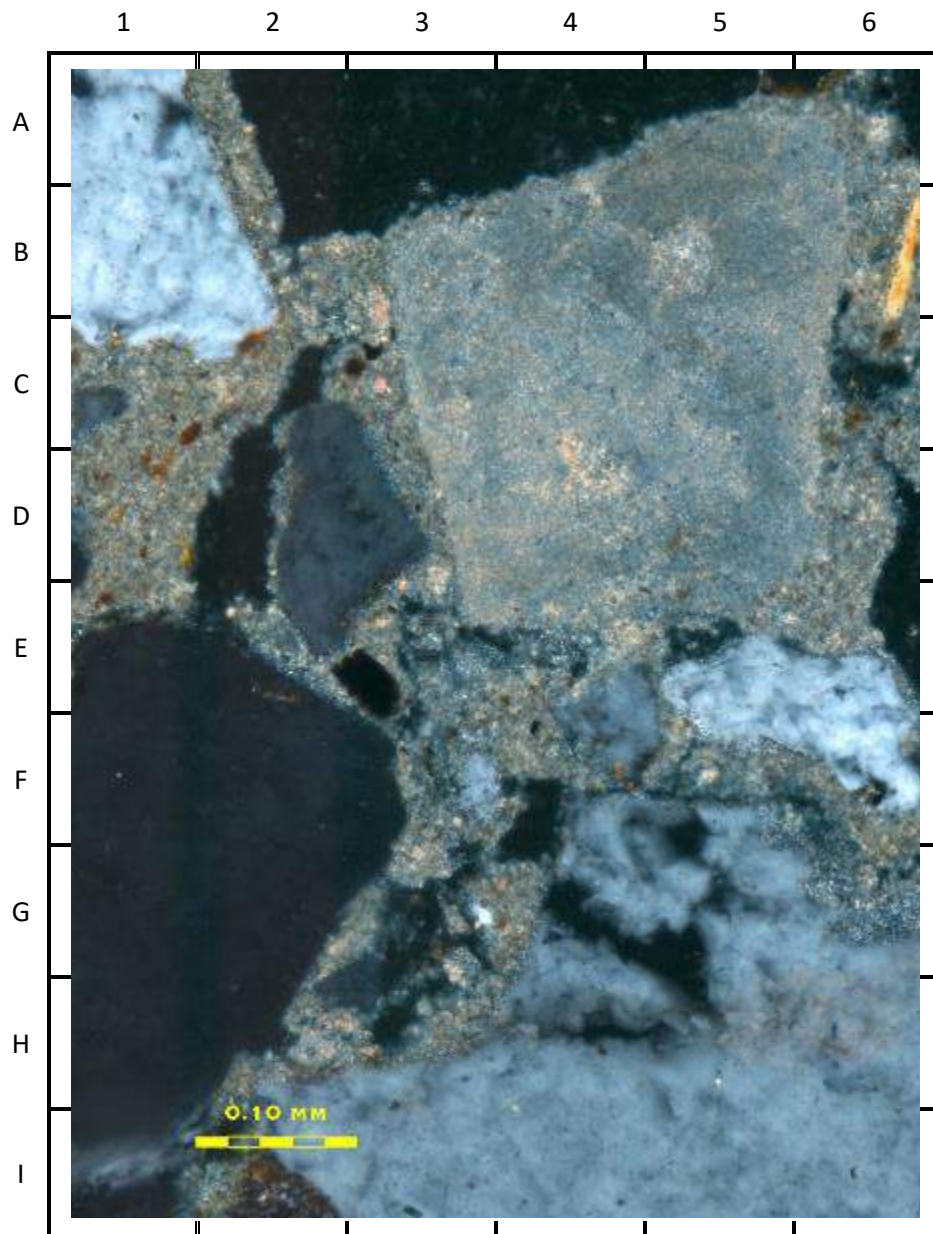
Figure C11

Thin section, crossed polars: View showing the typical appearance of the base coat plaster in thin section. A fragment of undispersed lime is centred on C5. Quartz particles occur in B1, G1 and H5. The aggregate particles are surrounded by carbonated lime matrix visible for example in D1.

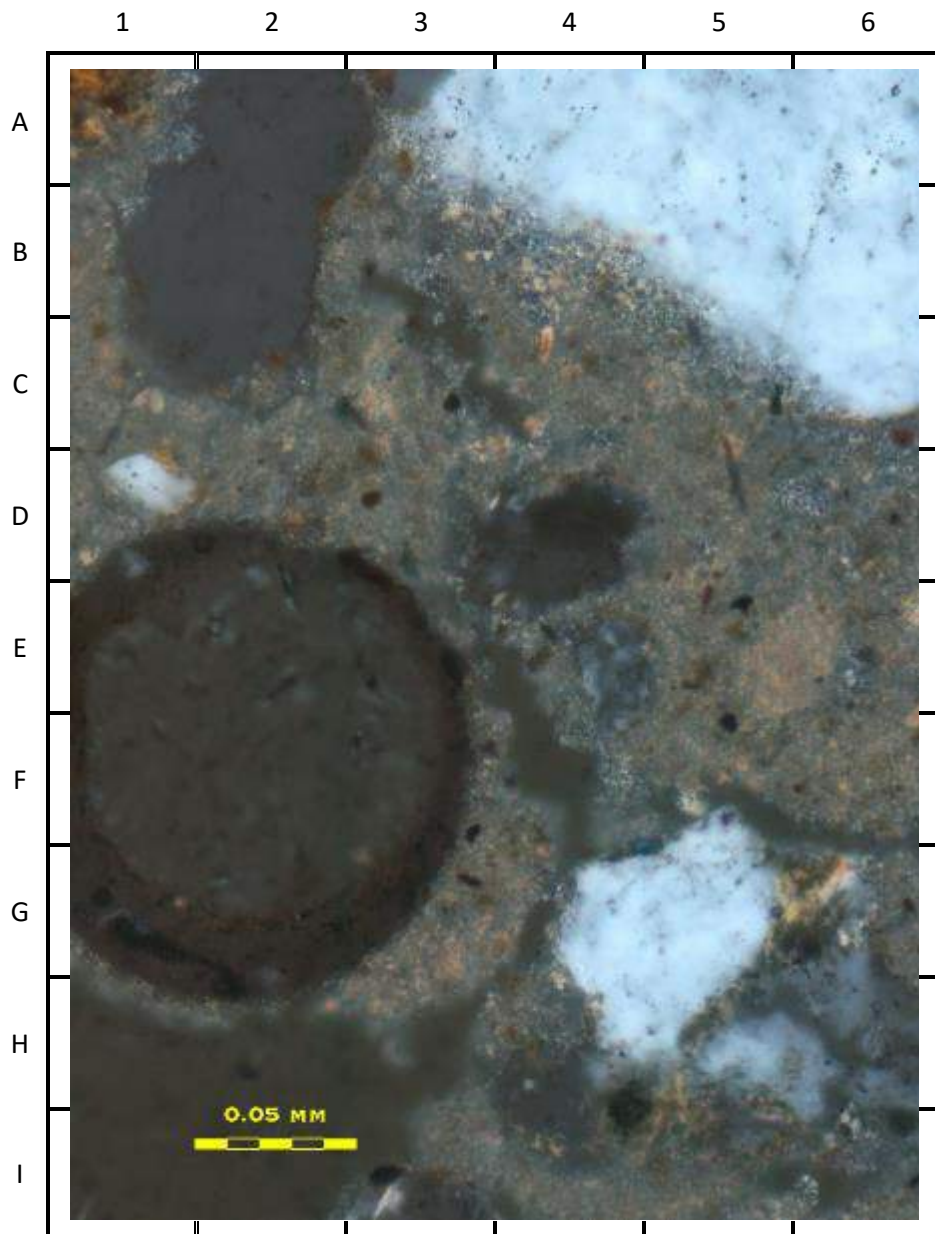
Figure C12

Thin section, crossed polars: A fragment of ash is centred around F2. Carbonated lime matrix can be seen for example in C1 and E6. Quartz particles occur in A2, A5 and G/H5.

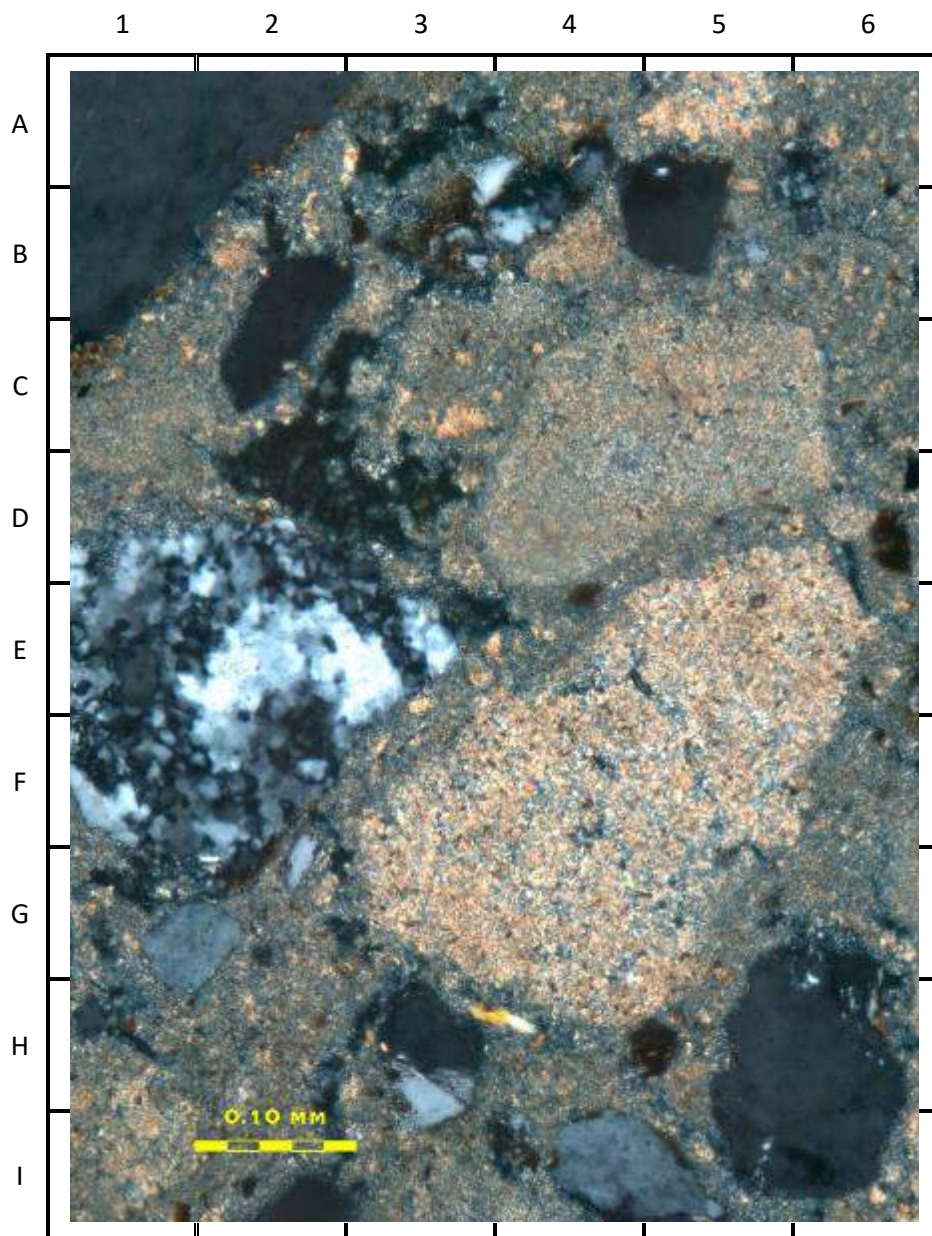
Figure C13

Thin section, crossed polars: A fragment of undispersed lime occurs in C5. Carbonated lime matrix is visible for example in C2 and B6. A quartzite particle occurs in E2 and a quartz particle occurs in A1.

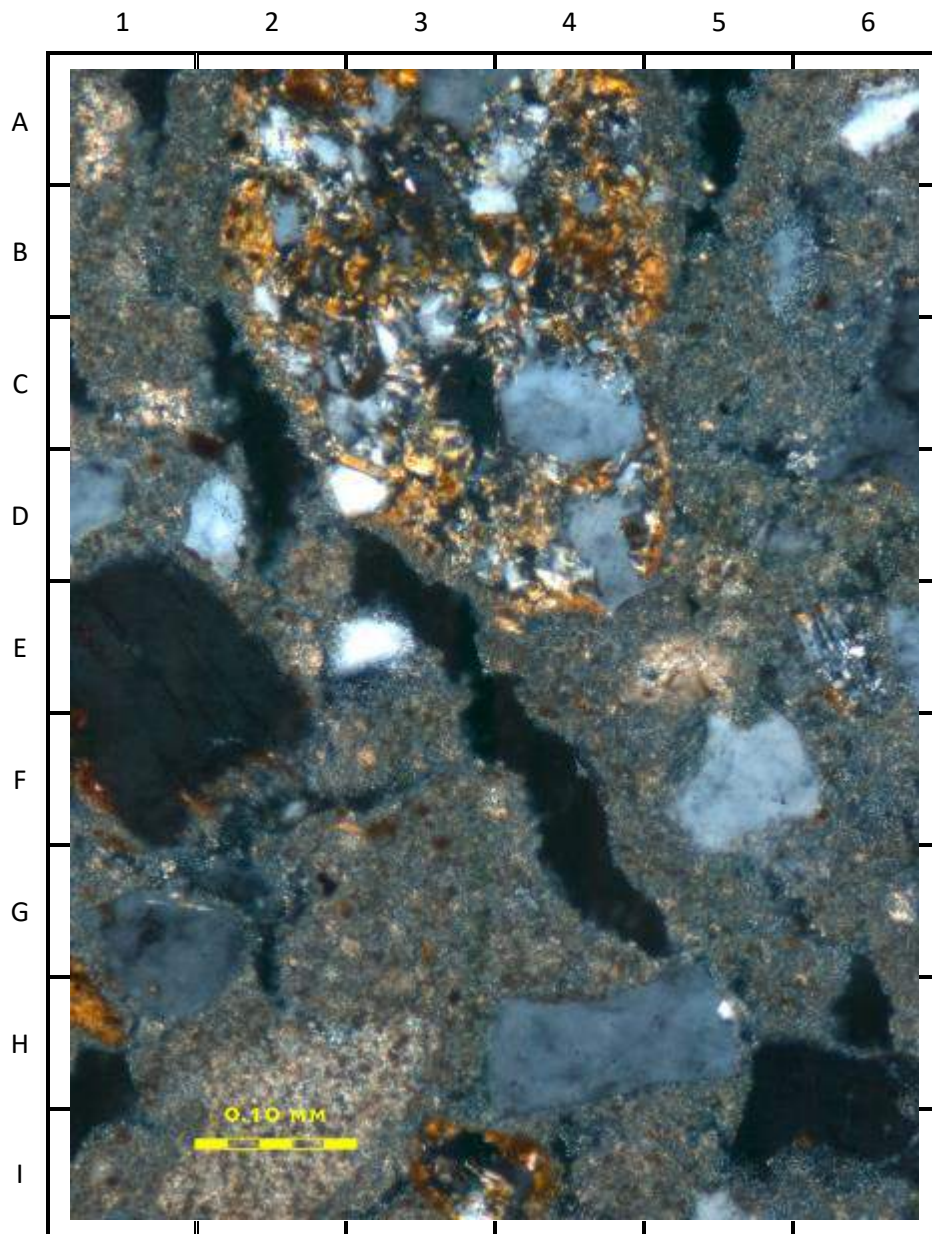
Figure C14

Thin section, oblique polars: A fragment of argillaceous sandstone occurs in B3. A coal fragment occurs in E1. Much of the field of view is occupied by carbonated lime matrix visible for example in G3 and C5/6. Quartz particles occur for example around G/H1 and H4/5.

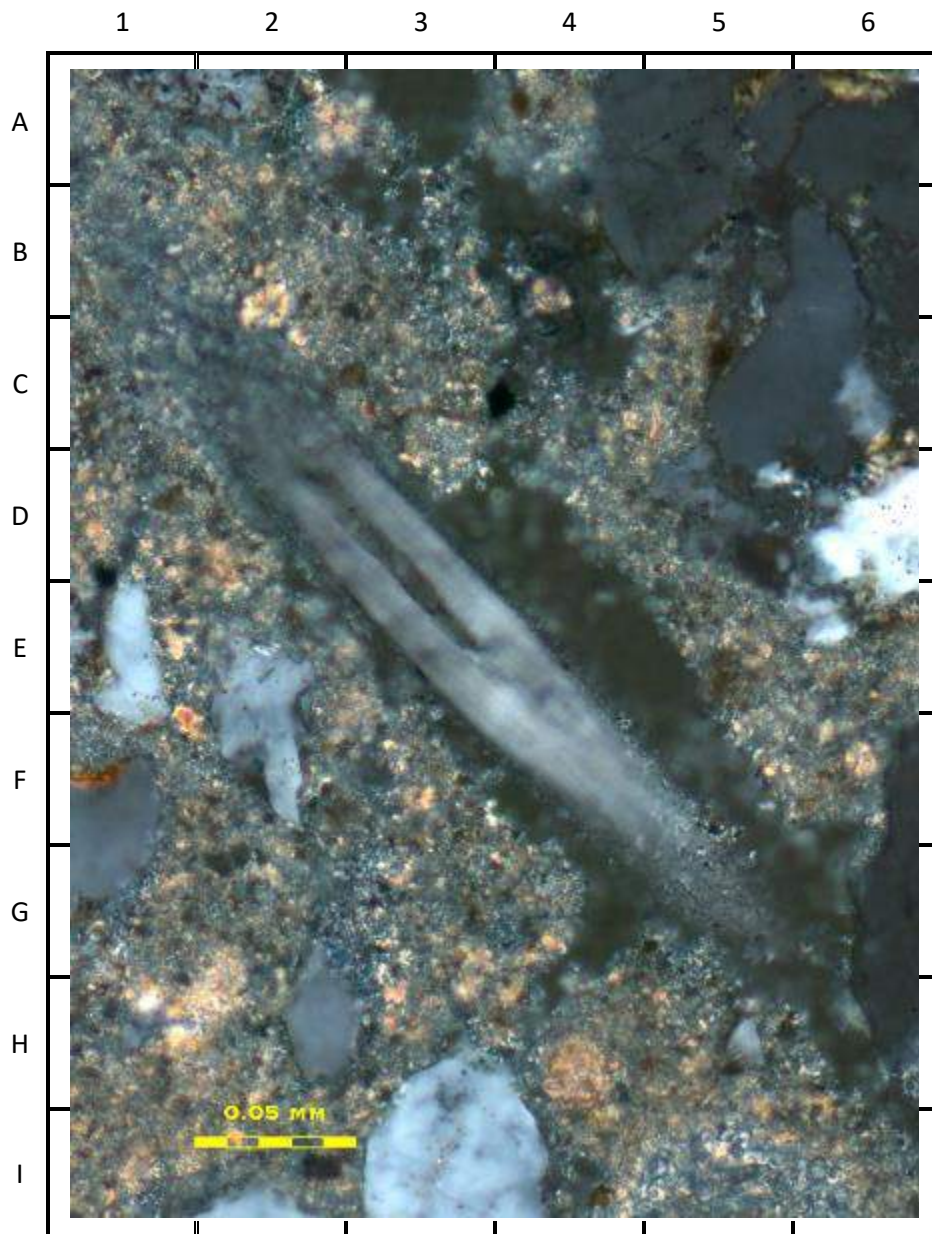
Figure C15

Thin section, oblique polars: View showing the typical appearance of the animal hairs. The hairs are hollow and can be seen from C2 to G5. Carbonated lime matrix can be seen for example around B2 and H1. Quartz particles occur in I3 and C6.

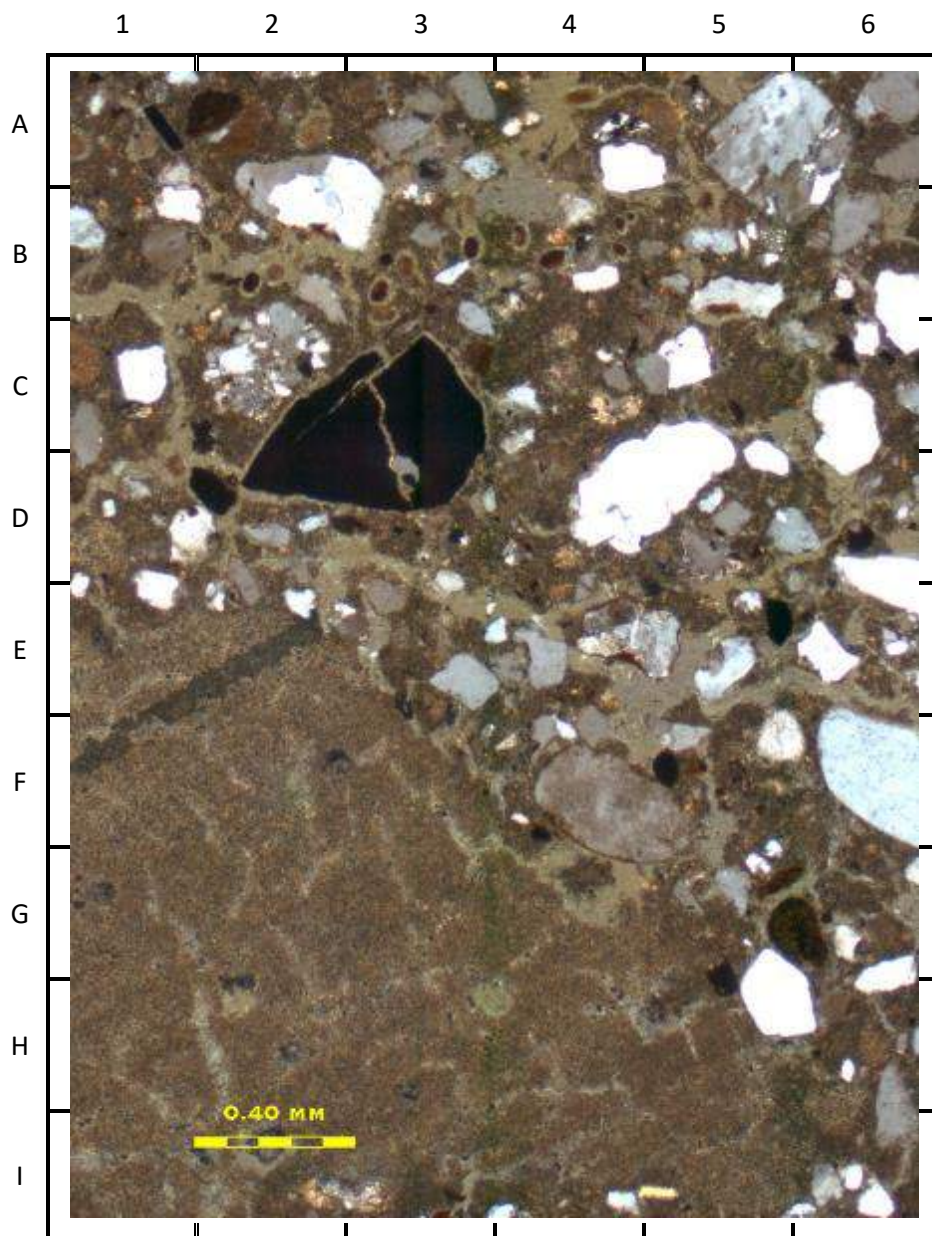
Figure C16

Thin section, oblique polars: The field of view is dominated by a lime lump centred around H1/2. The upper half of the field of view is dominated by porous, carbonated lime matrix surrounding quartz particles that appear various shades of grey.

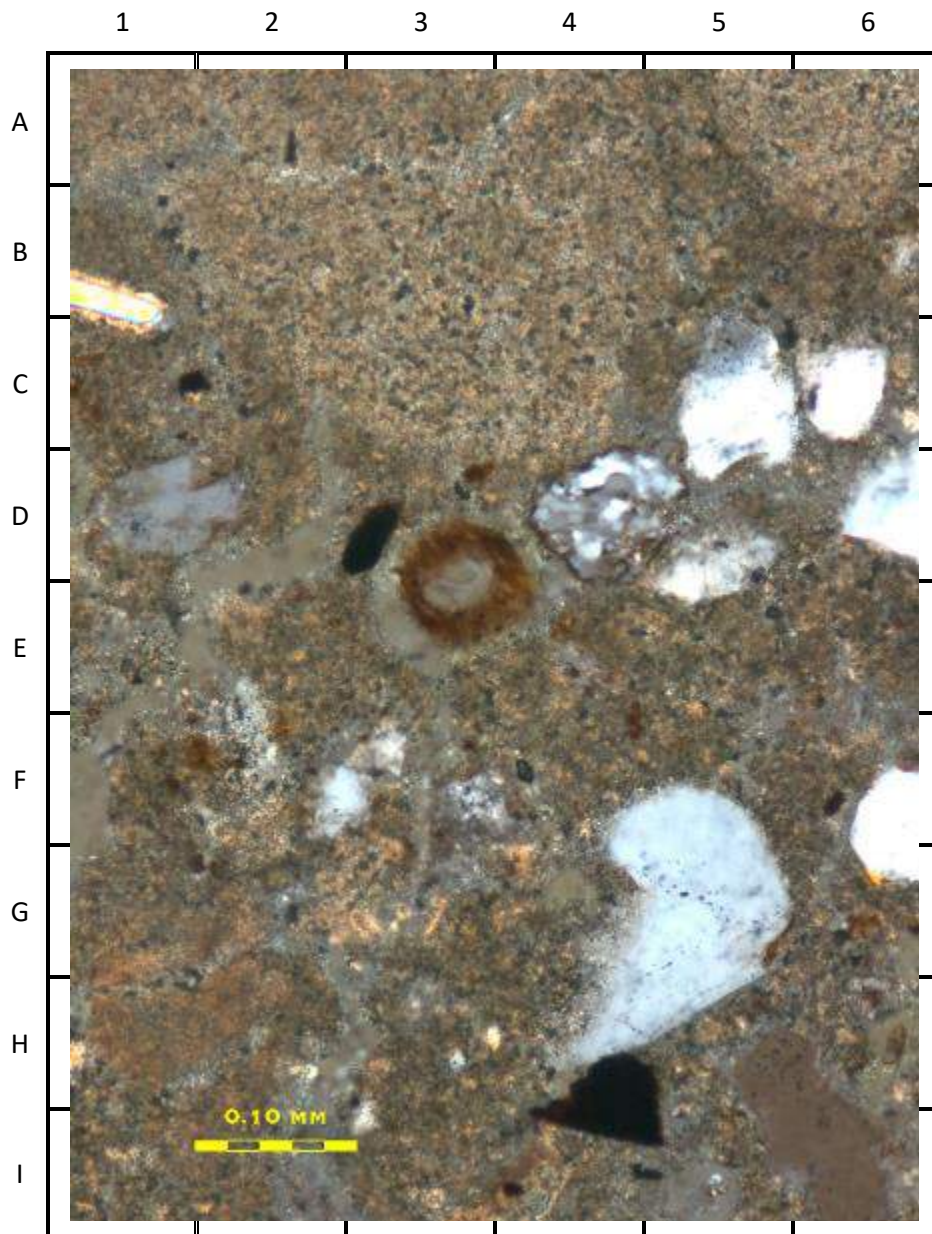
Figure C17

Thin section, oblique polars: View showing the typical appearance of the base coat plaster in thin section. The base coat plaster contains abundant lime lumps visible for example around A3/4 and A6. Typical areas of carbonated lime matrix occur for example around E/F5. A camel hair resembling horse hair occurs in E3/4. Quartz particles can be seen for example in G5 and C5.

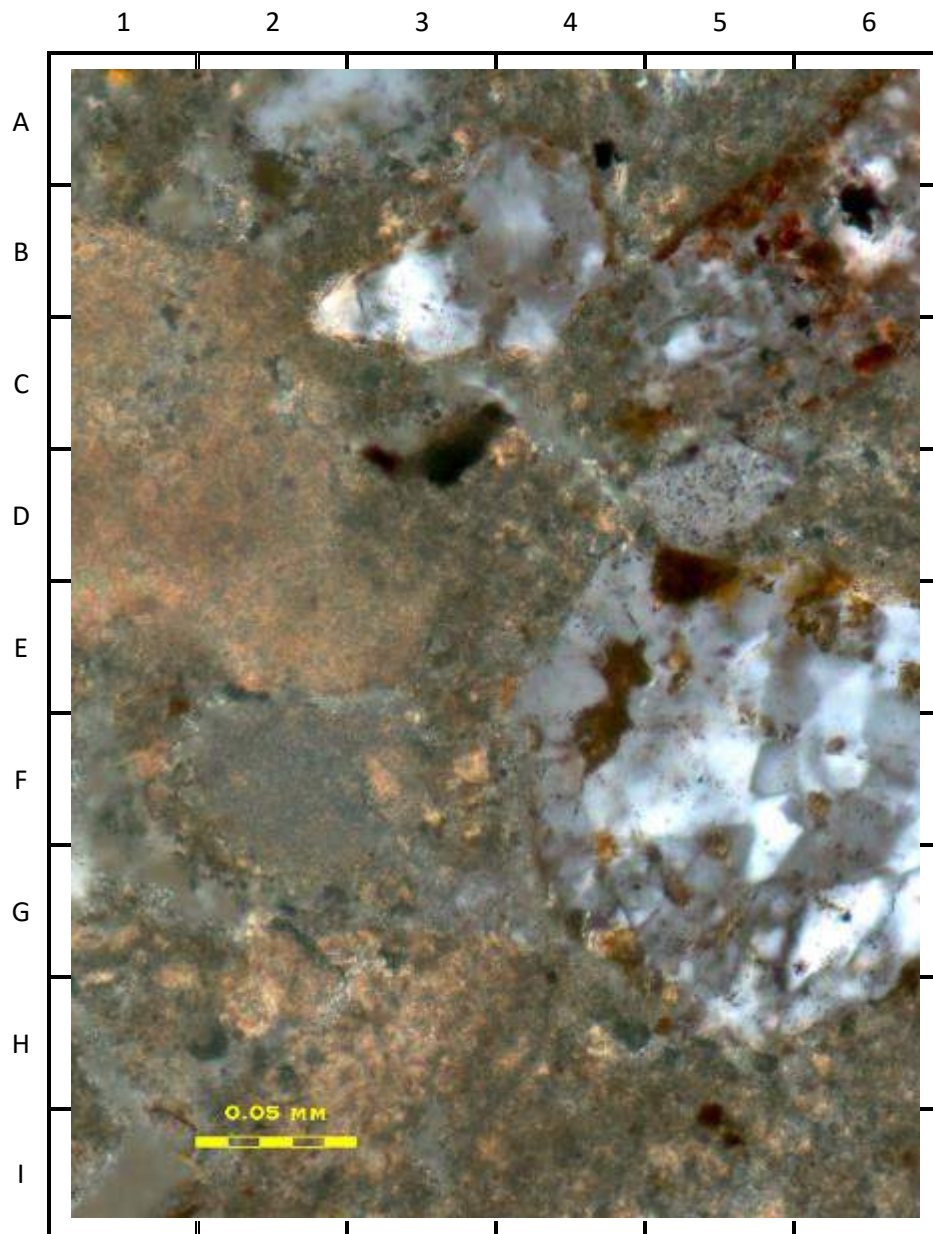
Figure C18

Thin section, oblique polars: View showing an area of the base coat plaster in thin section. Fragments of undispersed lime occur in C/D1 and H2/3. A quartzite particle can be seen in F/G5. Areas of porous, carbonated lime matrix occur for example in I4 and E4.
