# ASBESTOS DEMOLITION SURVEY

110 Brunswick Street, Manchester, M13 9ST

PR-102

| Site Description | Former Community Centre |

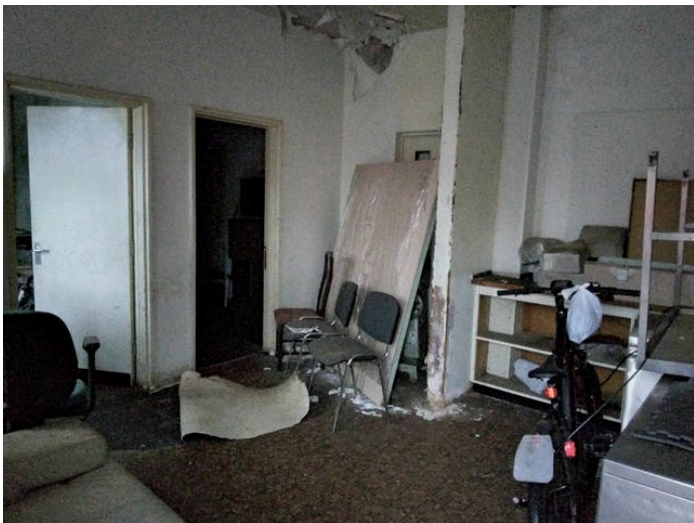
| Location Notes | Concrete ceiling with plaster skim coating, masonry and plaster walls, timber skirting boards, modern lino floor covering, bitumen adhesive to concrete floor, metal window frames, timber window sills inspected beneath, metal pipework and radiator, timber vertical boxing housing metal and plastic pipework. | | |

| Recommendation | Remove | | |

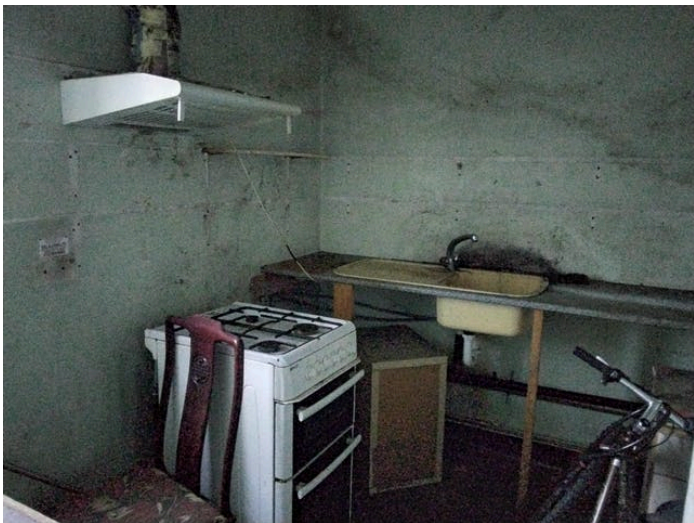
| Location Notes | Concrete ceiling with plaster skim coating, masonry and plaster walls, timber skirting boards, green vinyl tile floor covering, bitumen adhesive to concrete floor, metal window frames, timber window sills inspected beneath, metal pipework and radiator, resin / plastic sink unit. | | |

| Recommendation | Remove | | |

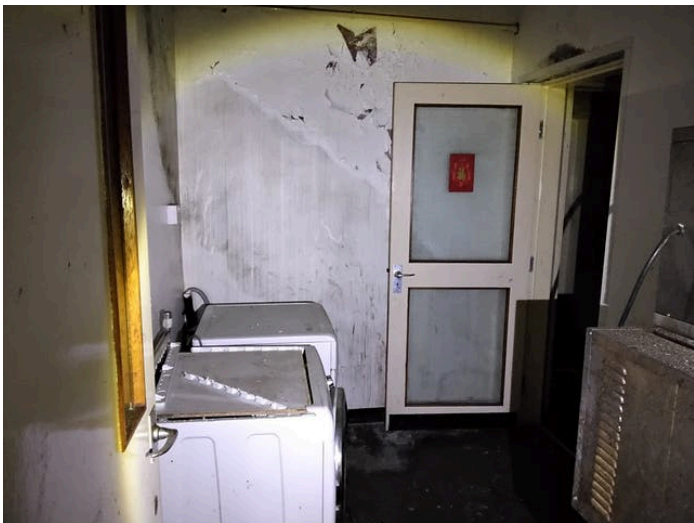
| Location | 003 - Circulation | Item | |

| Location Notes | Concrete ceiling with plaster skim coating, masonry and plaster walls, timber skirting boards, modern lino floor covering, bitumen adhesive to concrete floor, metal pipework and radiator. | | |

| Recommendation | Remove | | |

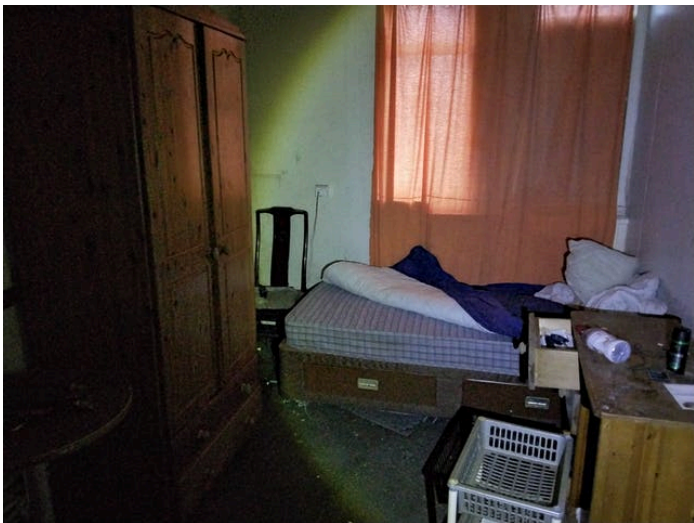
| Location Notes | Concrete ceiling with plaster skim coating, masonry and plaster walls, timber skirting boards, modern lino over green vinyl tile floor covering, bitumen adhesive to concrete floor, metal window frames, timber window sills inspected beneath, metal pipework and radiator. | | |

| Recommendation | Remove | | |

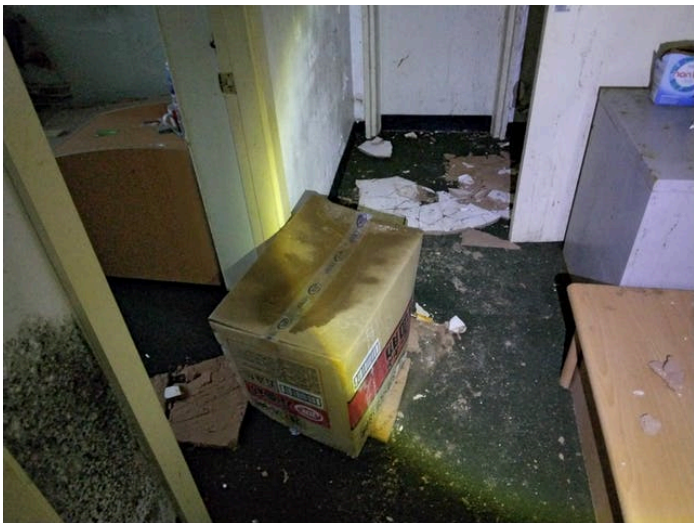
| Location Notes | Concrete ceiling with plaster skim coating, masonry and plaster walls, timber skirting boards, modern lino over green vinyl tile floor covering, bitumen adhesive to concrete floor, metal pipework and radiator. | | |

| Recommendation | Remove | | |

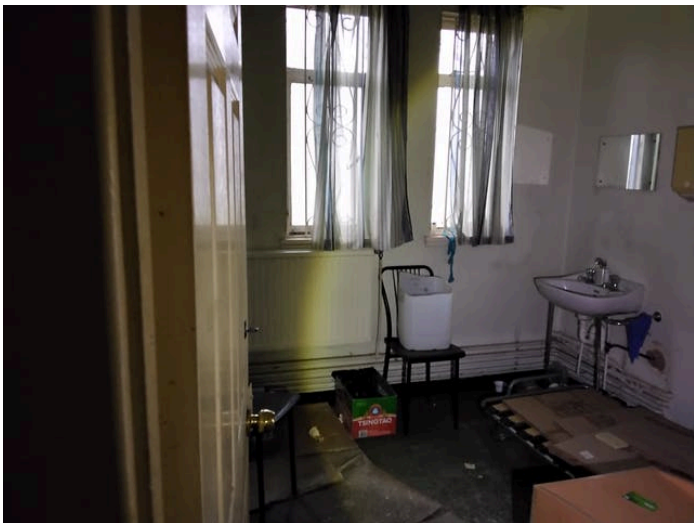
| Location Notes | Concrete ceiling with plaster skim coating, masonry and plaster walls, timber skirting boards, carpet flooring over green vinyl tile floor covering, bitumen adhesive to concrete floor, metal window frames, timber window sills inspected beneath, metal pipework and radiator. | | |

| Recommendation | Remove | | |

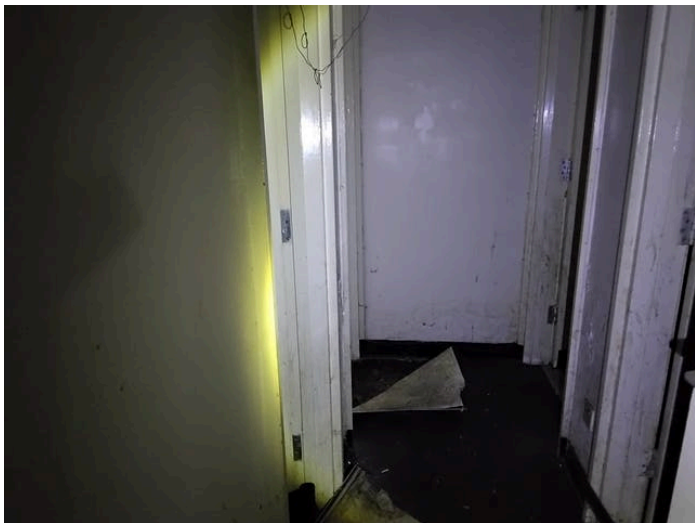
| Location | 007 - Circulation | Item | |

| Location Notes | Plasterboard ceiling, masonry and plaster walls, timber skirting boards, modern lino floor covering, bitumen adhesive to concrete floor, timber doors and casings. | | |

| Recommendation | Remove | | |

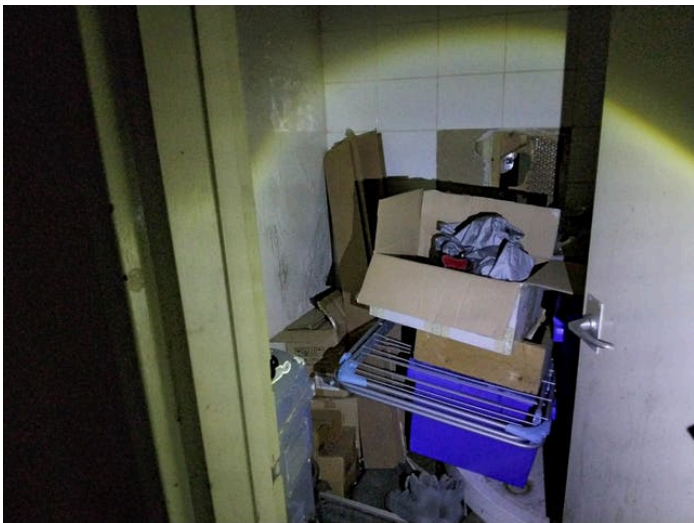
| Location | 008 - Shower Room | Item | |

| Location Notes | Plasterboard ceiling, masonry and plaster walls, ceramic tiled walls, timber skirting boards, modern lino floor covering, bitumen adhesive to concrete floor, timber doors and casings. | | |

| Recommendation | Remove | | |

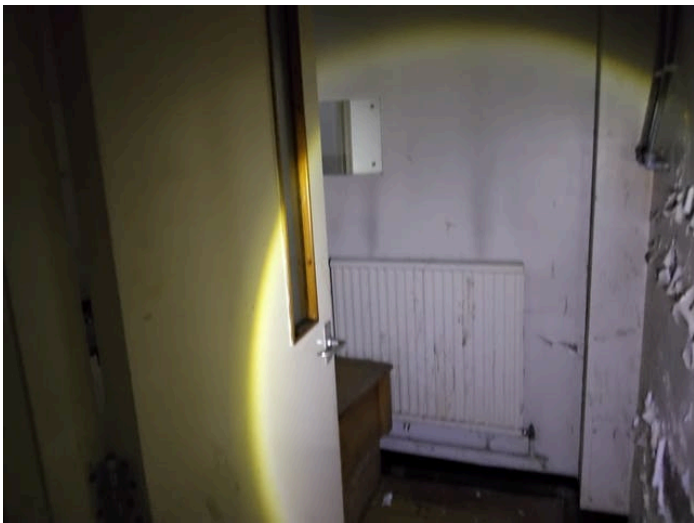
| Location Notes | Concrete ceiling with plaster skim coating, masonry and plaster walls, ceramic tiled walls, timber skirting boards, modern lino floor covering, bitumen adhesive to concrete floor, timber doors and casings, metal pipework and radiator, timber boxing inspected within ceramic toilet cistern, plastic toilet seat, plastic soil pipe, metal window frame, timber window sill. | | |

| Recommendation | Remove | | |

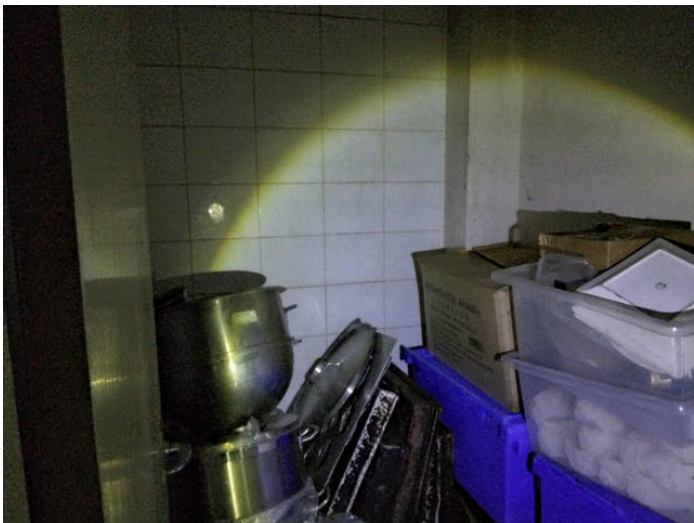
| Location | 011 - Shower Room | Item | |

| Location Notes | Plasterboard ceiling, masonry and plaster walls, ceramic tiled walls, timber skirting boards, modern lino floor covering, bitumen adhesive to concrete floor, timber doors and casings. | | |

| Recommendation | Remove | | |

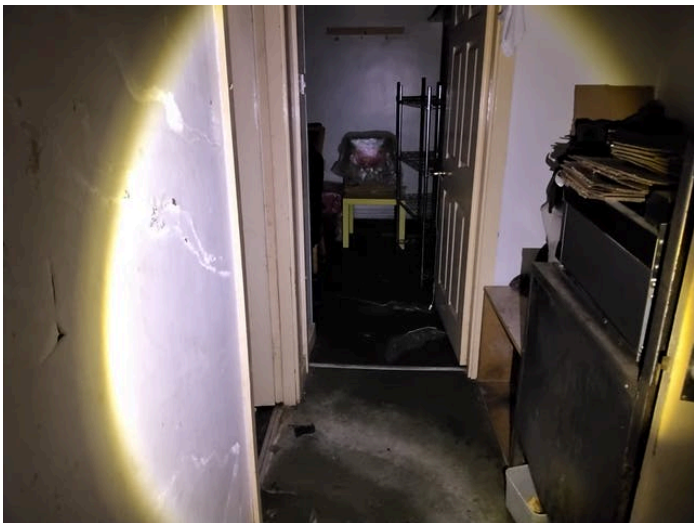
| Location Notes | Concrete and plasterboard ceiling with plaster skim coating, masonry and plaster walls, timber skirting boards, modern floor covering over green vinyl tile floor covering, bitumen adhesive to concrete floor, metal pipework and radiator, timber doors and casings. | | |

| Recommendation | Remove | | |

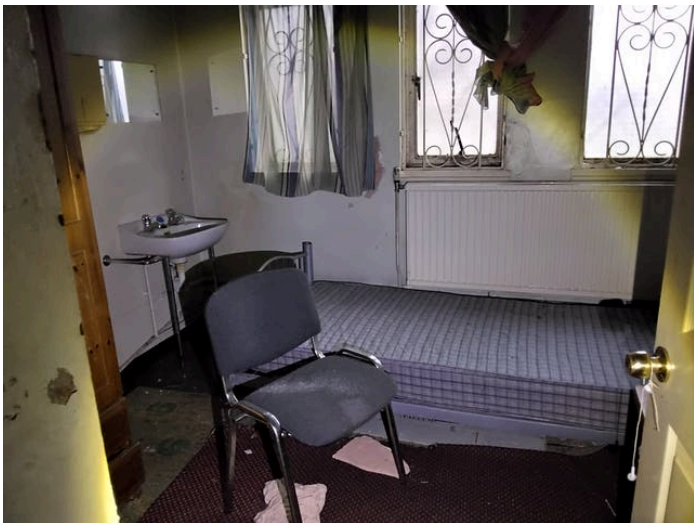
| Location Notes | Concrete and plasterboard ceiling with plaster skim coating, masonry and plaster walls, timber skirting boards, modern floor covering over green vinyl tile floor covering, bitumen adhesive to concrete floor, metal pipework and radiator, timber doors and casings, metal window frame, timber window sill. | | |

| Recommendation | Remove | | |

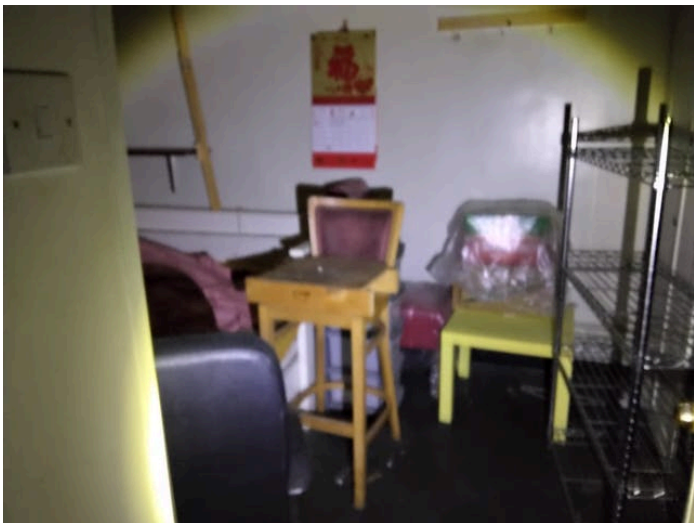
| Location Notes | Concrete and plasterboard ceiling with plaster skim coating, masonry and plaster walls, timber skirting boards, modern floor covering over green vinyl tile floor covering, bitumen adhesive to concrete floor, metal pipework and radiator, timber doors and casings, metal window frame, timber window sill. | | |

| Recommendation | Remove | | |

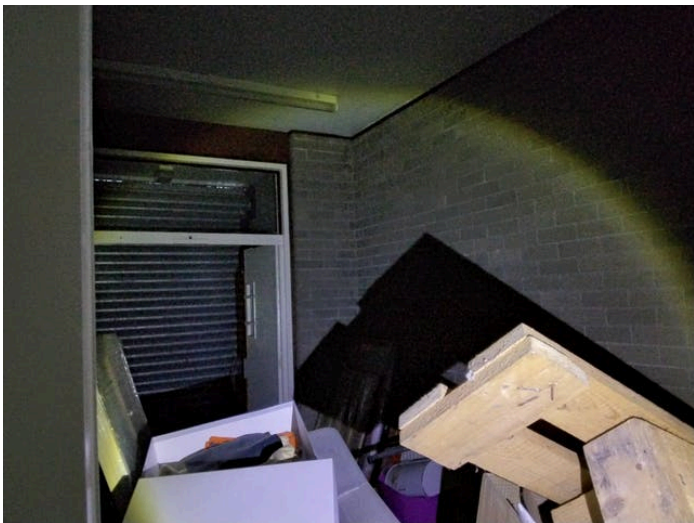
| Location Notes | Concrete and plasterboard ceiling with plaster skim coating, masonry and plaster walls, timber skirting boards, modern floor covering over green vinyl tile floor covering, bitumen adhesive to concrete floor, metal pipework and radiator, timber doors and casings, metal window frame, timber window sill, metal roller shutter door. | | |

| Recommendation | Remove | | |

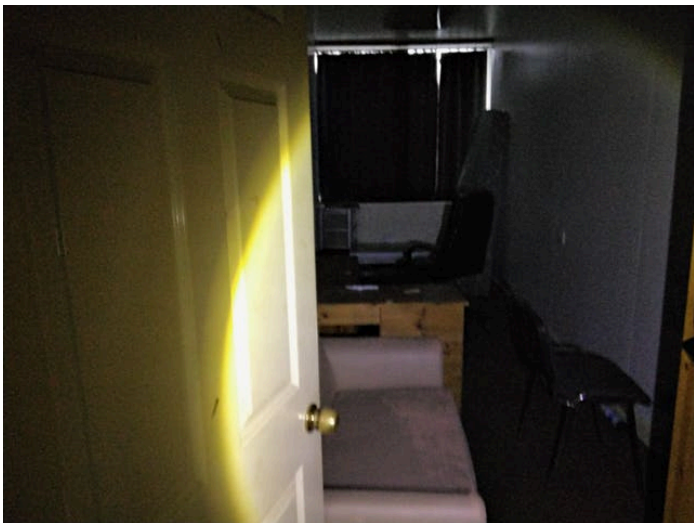
| Location Notes | Concrete and plasterboard ceiling with plaster skim coating, masonry and plaster walls, plasterboard partition walls, timber skirting boards, modern floor covering over green vinyl tile floor covering, bitumen adhesive to concrete floor, metal pipework and radiator, timber doors and casings, metal window frame, timber window sill. | | |

| Recommendation | Remove | | |

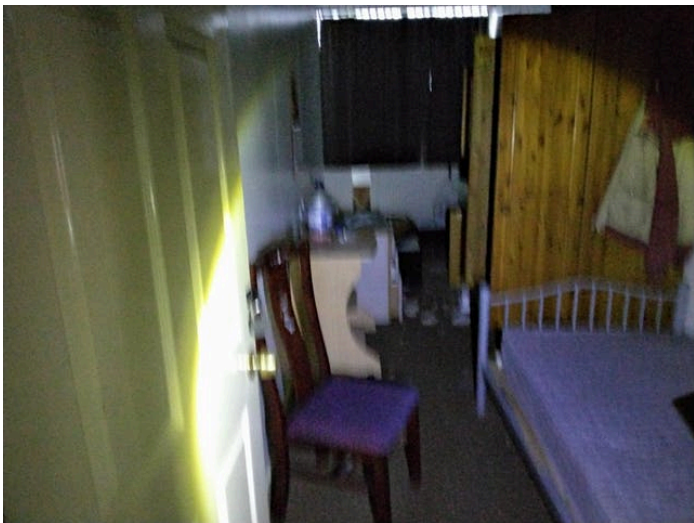
| Location Notes | Concrete and plasterboard ceiling with plaster skim coating, masonry and plaster walls, plasterboard partition walls, timber skirting boards, modern floor covering over green vinyl tile floor covering, bitumen adhesive to concrete floor, metal pipework and radiator, timber doors and casings, metal window frame, timber window sill. | | |

| Recommendation | Remove | | |

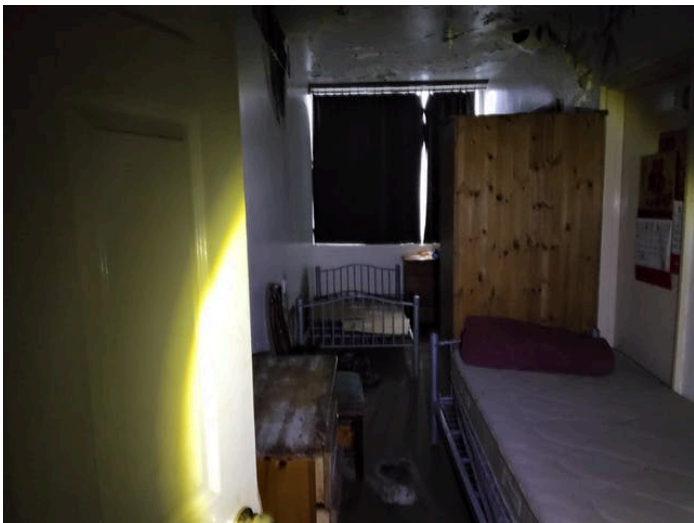
| Location Notes | Concrete and plasterboard ceiling with plaster skim coating, masonry and plaster walls, plasterboard partition walls, timber skirting boards, modern floor covering over green vinyl tile floor covering, bitumen adhesive to concrete floor, metal pipework and radiator, timber doors and casings, metal window frame, timber window sill. | | |

| Recommendation | Remove | | |

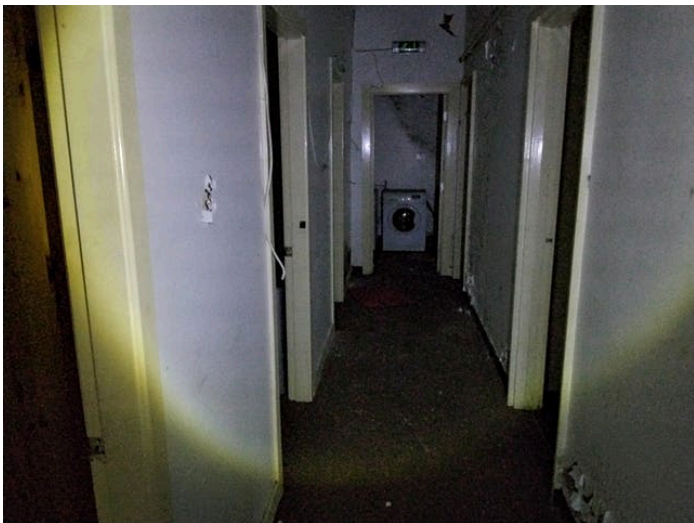
| Location Notes | Concrete ceiling with plaster skim coating, high level plasterboard ceiling inspected above to timber joists and underside of roof deck, masonry and plaster walls, timber skirting boards, modern lino over green vinyl tile floor covering, bitumen adhesive to concrete floor. | | |

| Recommendation | Remove | | |
