## WINDOW AND CEILING PLASTER CONDITION SURVEY

51-53 RICHMOND STREET, MANCHESTER

JOB NO. 213-41

29 NOVEMBER 2022

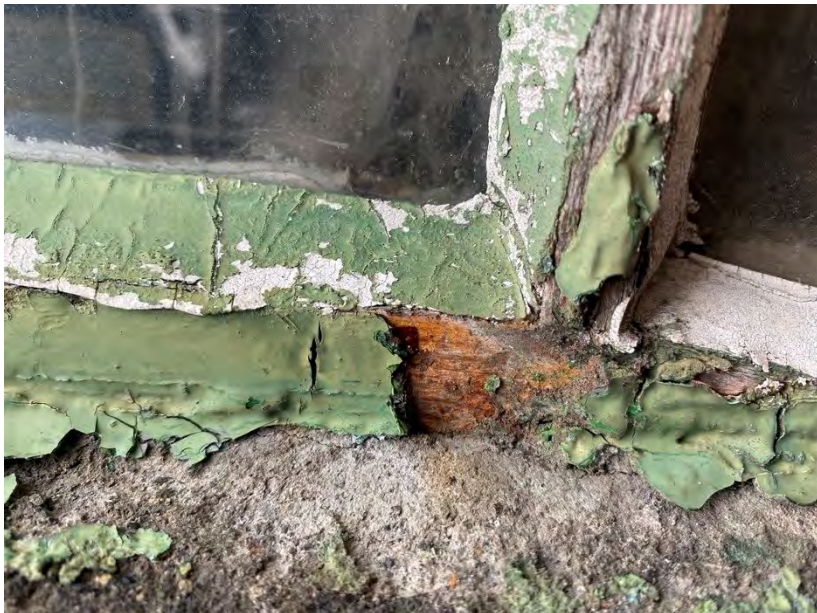
**Fig 5:**

North-west elevation, W0.02; showing build-up of green decorative finishes. Note the orange undercoat/primer

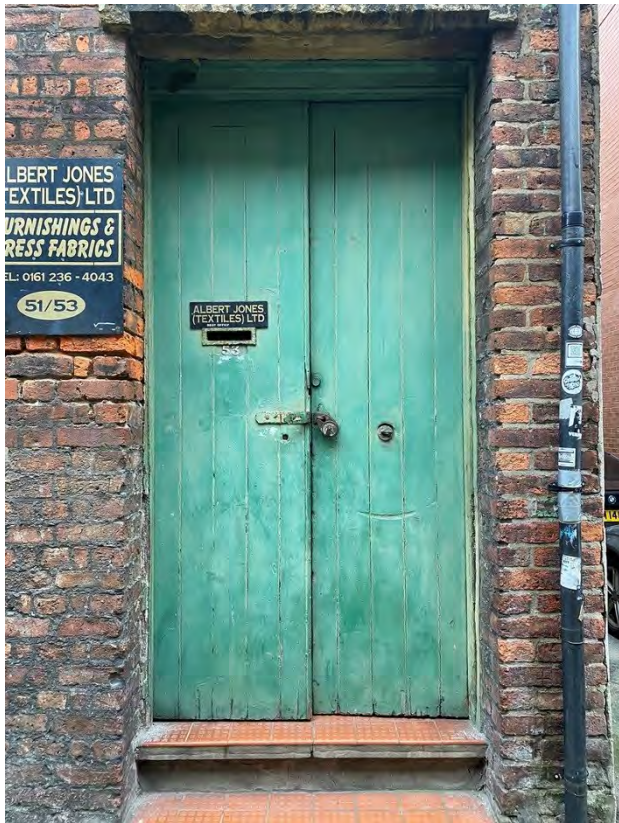
**Fig 17:**

North-west elevation, D.05; showing the tongue and groove softwood entrance door

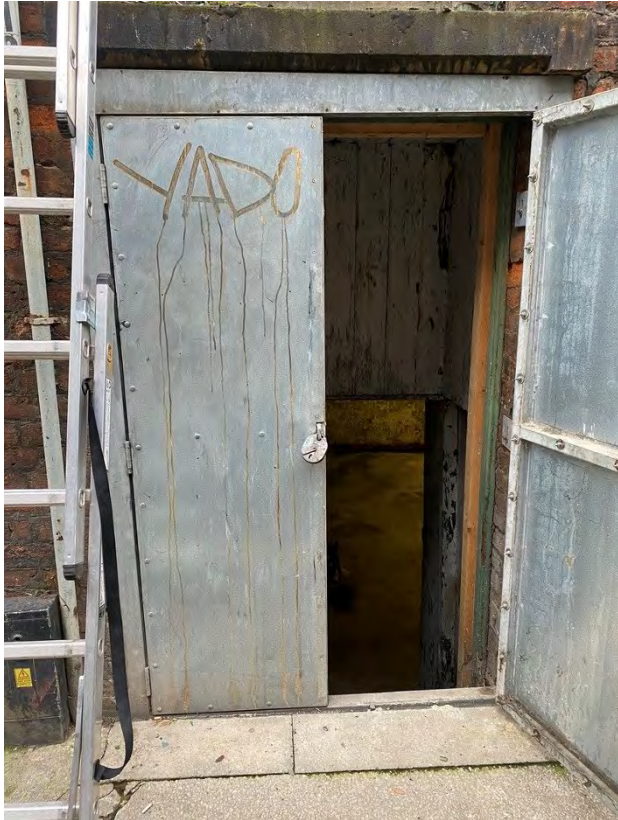
**Fig 19:**

North-west elevation, D.03; showing metal security doors to the lower ground floor

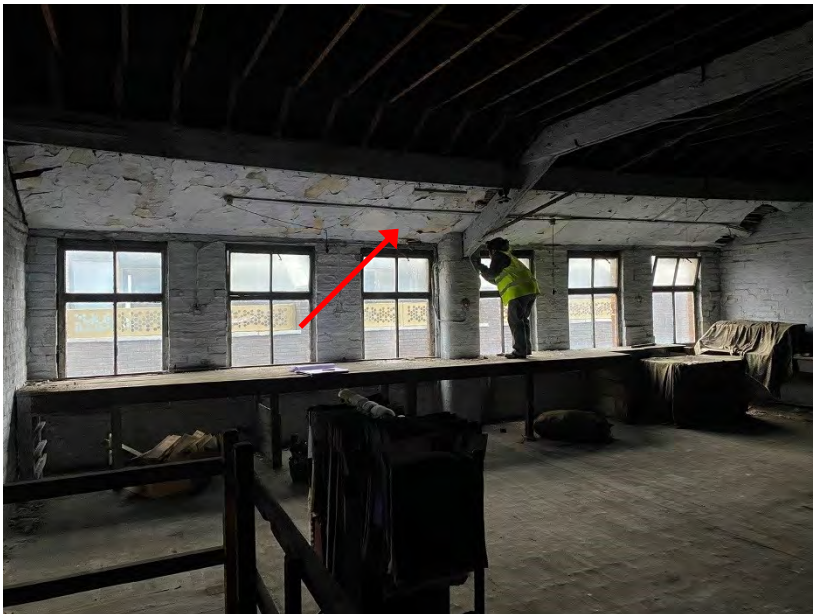
**Fig 30:**

Second floor; showing inspection of the softwood hopper windows to the front elevation

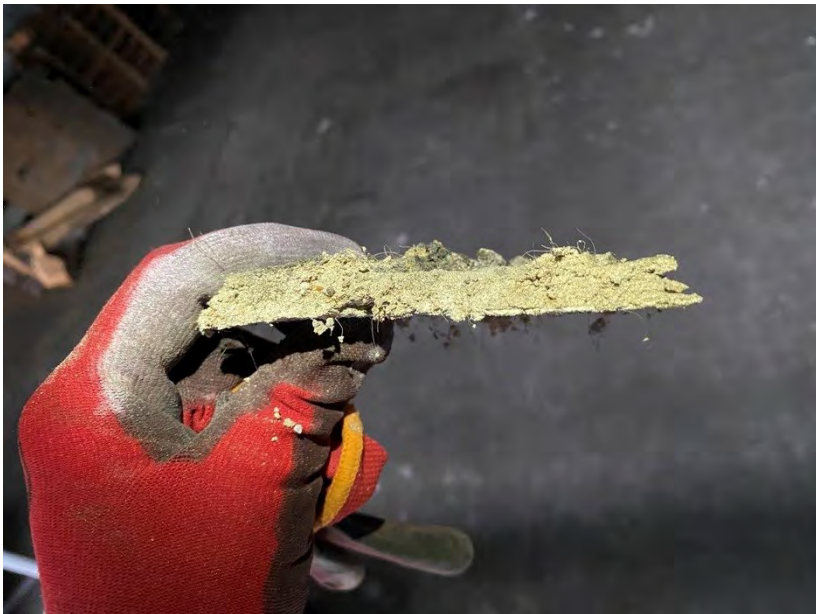
**Fig 32:**

Second floor; showing a removed piece of lime plaster with hair

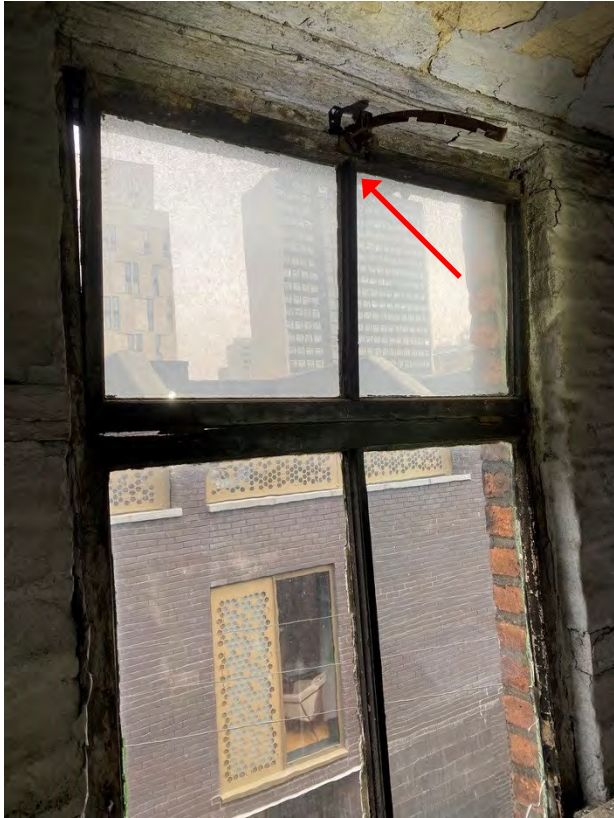
**Fig 33:**

Second floor, W2.05; showing softwood hopper window with metal quadrant stay. The majority of hoppers were inoperable

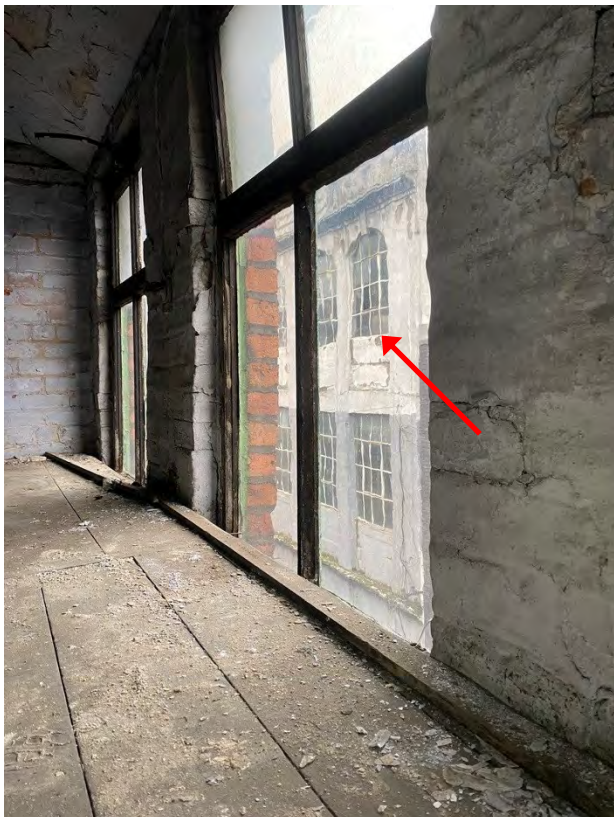
**Fig 34:**

Second floor, W2.05; showing 'ripples/waves' in the glass typical in old 19th century windows

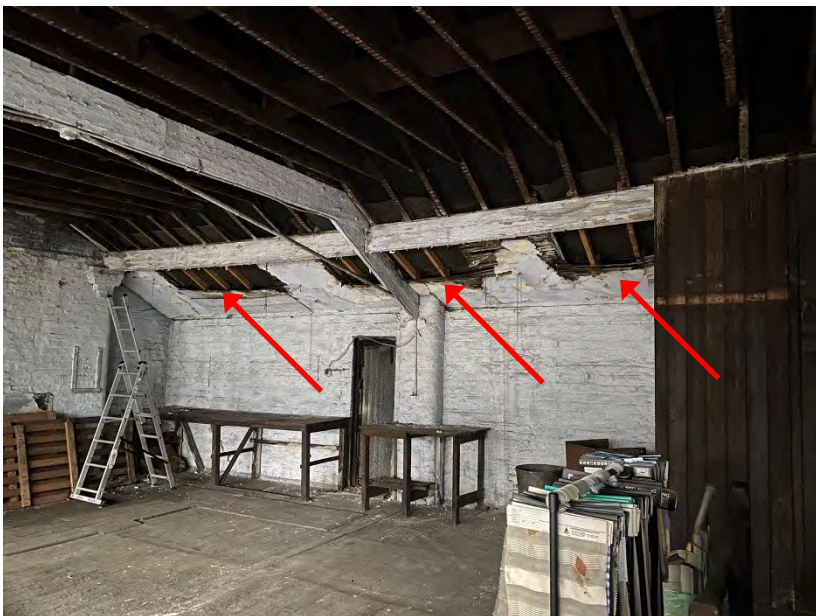
**Fig 38:**

Second floor; showing lath and plaster applied to the underside of the common rafters. Note the new rafters applied over former skylight openings

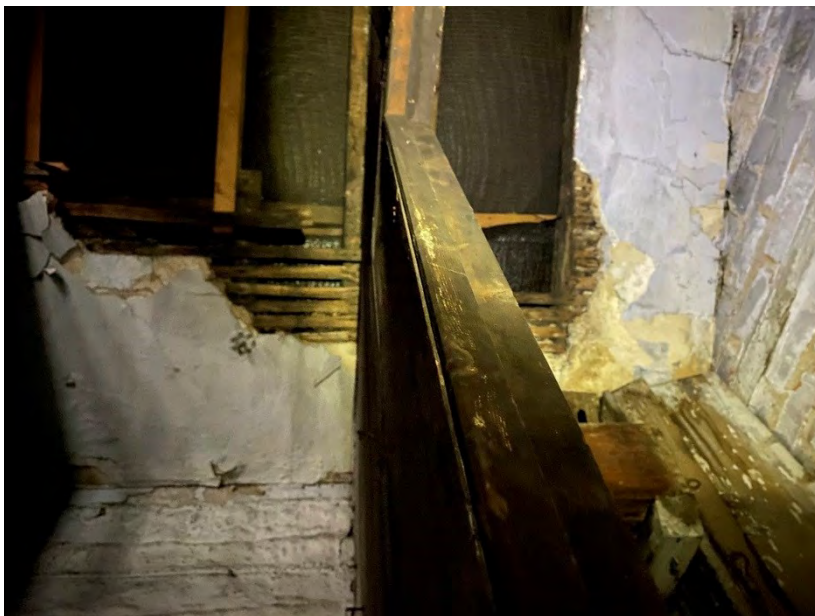
**Fig 42:**

Second floor; showing cracking through the plaster over the toilet

- 1 Repairs: Allow for localised repairs to the lath and plaster ceiling in the areas identified on the drawings. Carefully release the defective plaster from the laths. Replace any partially decayed laths. A conservation plasterer should replaster with a lime, sand hair mix to match the existing. Ensure the floor voids are carefully cleared of any remaining loose debris and dust without damaging the plaster 'keys'. Ensure any new ceiling finishes applied over the lath and plaster are fixed to the underside of the floor joists

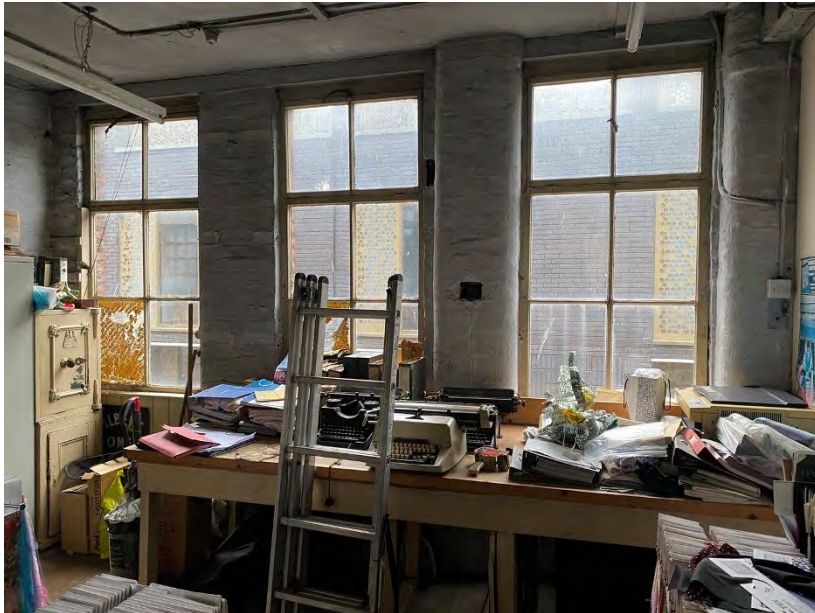
**Fig 43:**

First floor; showing softwood hopper windows to the front elevation. No major damp or decay was detected where accessible

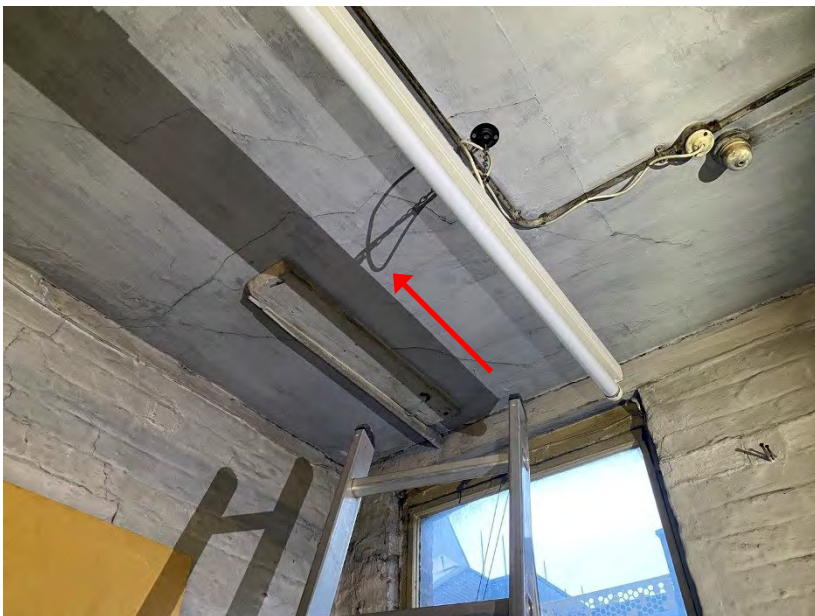
**Fig 44:**

First floor; showing minor cracking in the ceiling. Tactile assessment suggested there was no risk of imminent failure

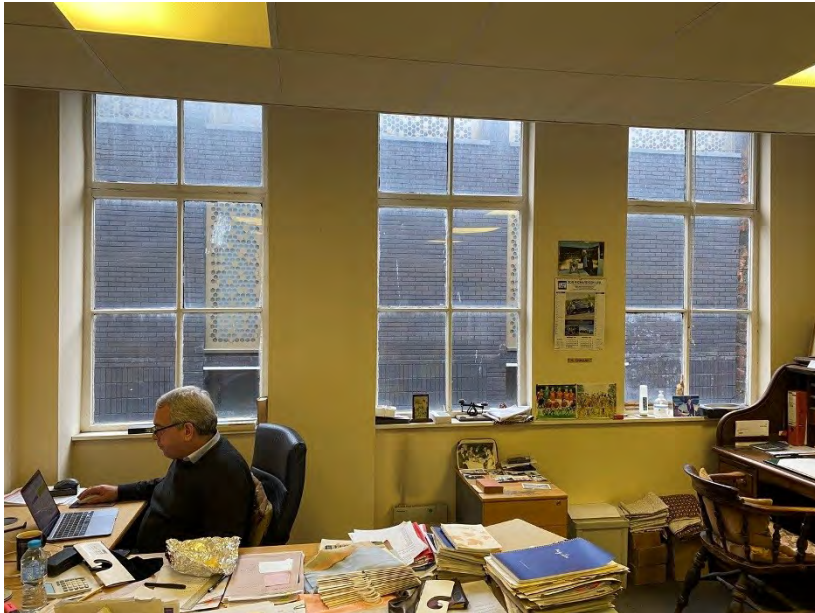
**Fig 45:**

First floor; showing softwood hopper windows to the front elevation. No major damp or decay was detected where accessible

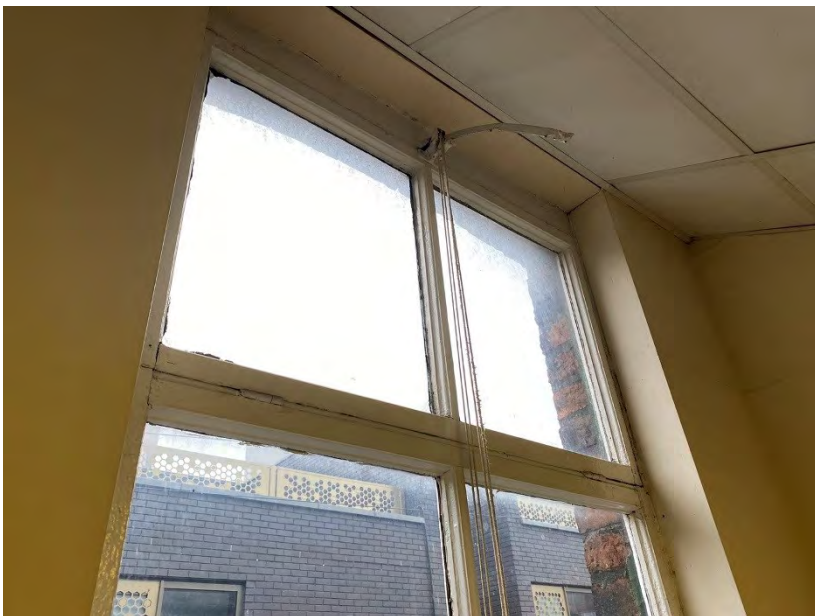
**Fig 46:**

First floor, W1.01; showing an operable hopper window with intact metal quadrant stay

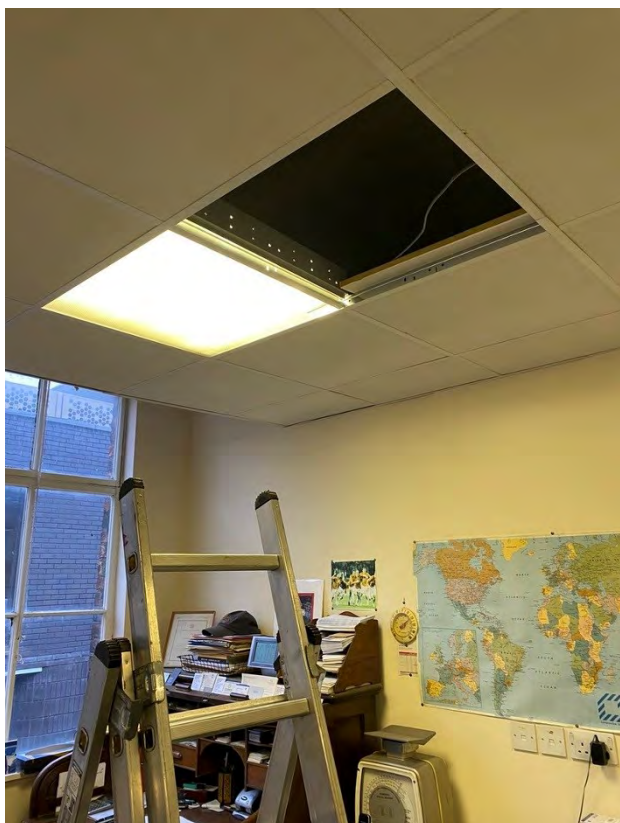
**Fig 48:**

First floor, Office; showing inspection of the void above the modern suspended ceiling

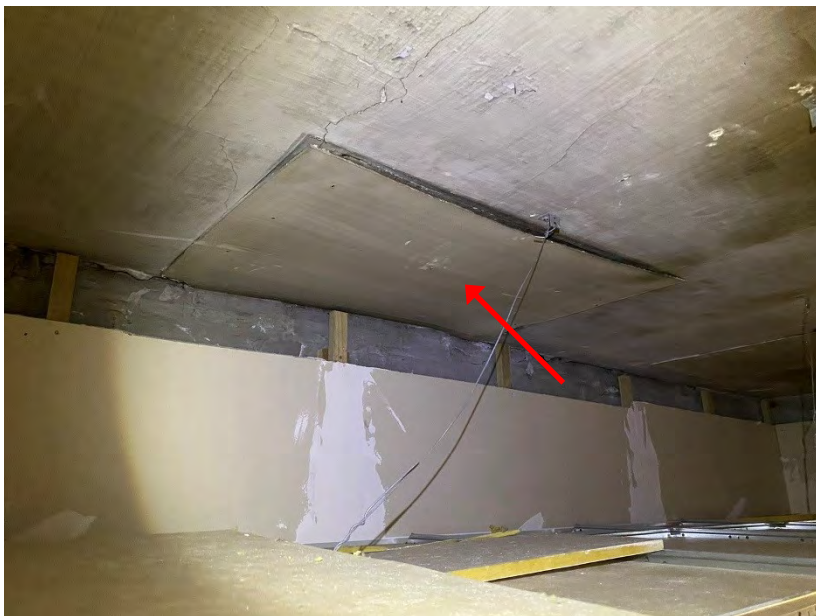
**Fig 50:**

First floor, Office; showing ceiling/floor hatch

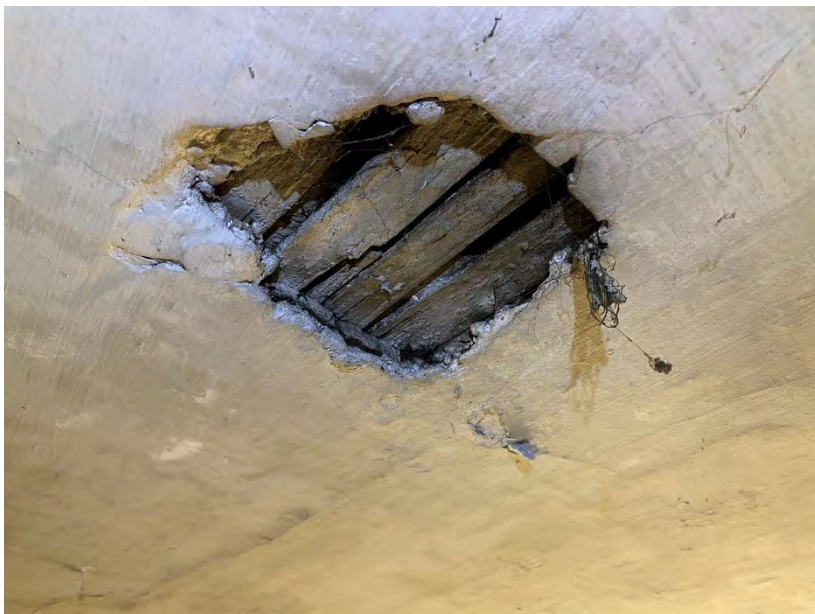
**Fig 52:**

First floor; showing isolated area of missing plaster. The remaining plaster had a good bond to the laths

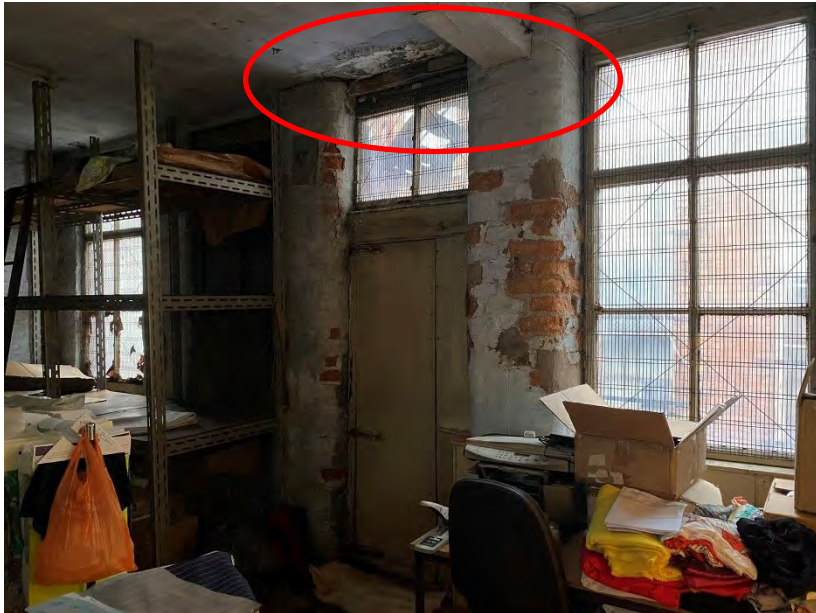
**Fig 53:**

First floor; showing area subject to water penetration to the rear elevation

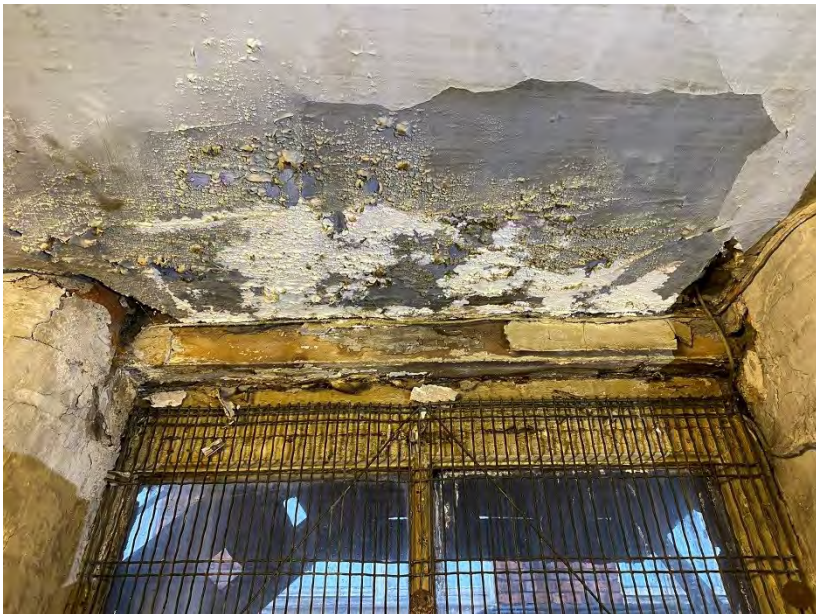
**Fig 54:**

First floor; showing damp and partially decayed lath and plaster ceiling over W1.09. The window was damp but no significant decay was detected

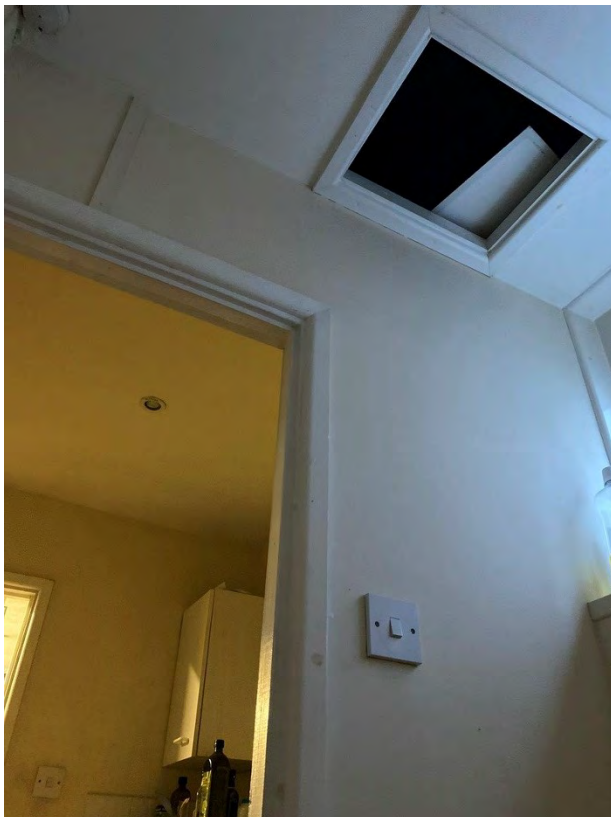
**Fig 56:**

First floor, Toilet; showing inspection of the void above the modern suspended ceiling

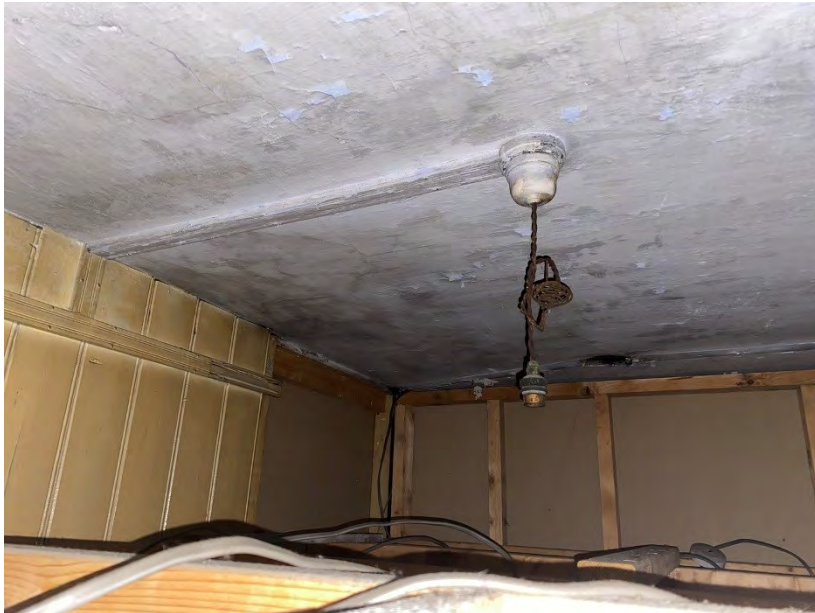
**Fig 57:**

First floor, Toilet; showing a view of the lath and plaster ceiling above. There was no obvious cracking in the plaster

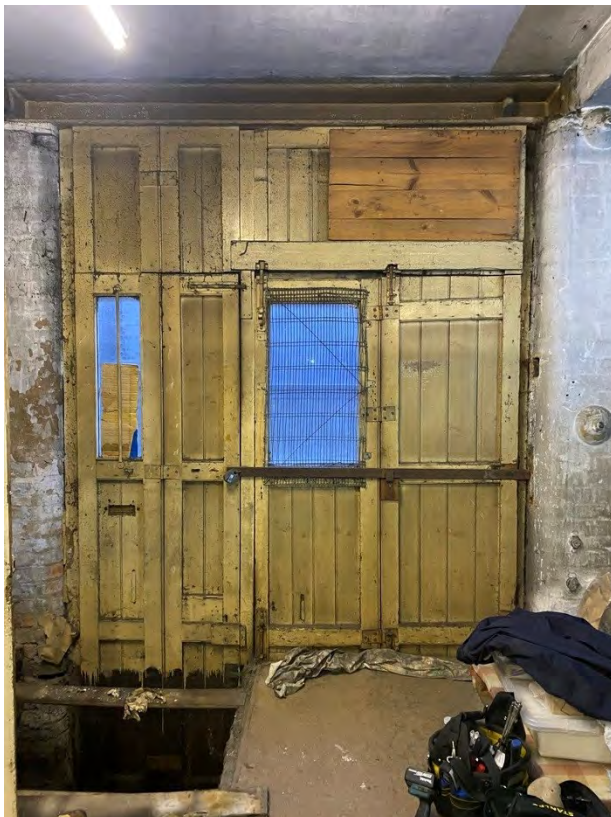
**Fig 58:**

Upper ground floor; showing D.045 and D.05. There was no significant damp or timber decay in the doors. However, doors had suffered localised surface damage from historical use

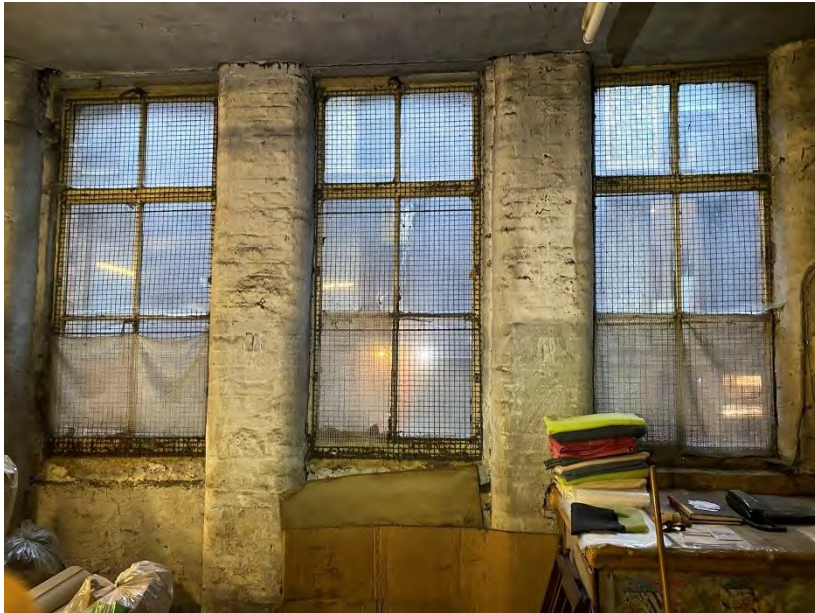
**Fig 59:**

Upper ground floor, W0.01-W0.03; showing a general view of the softwood hopper windows. No major decay was detected internally or externally

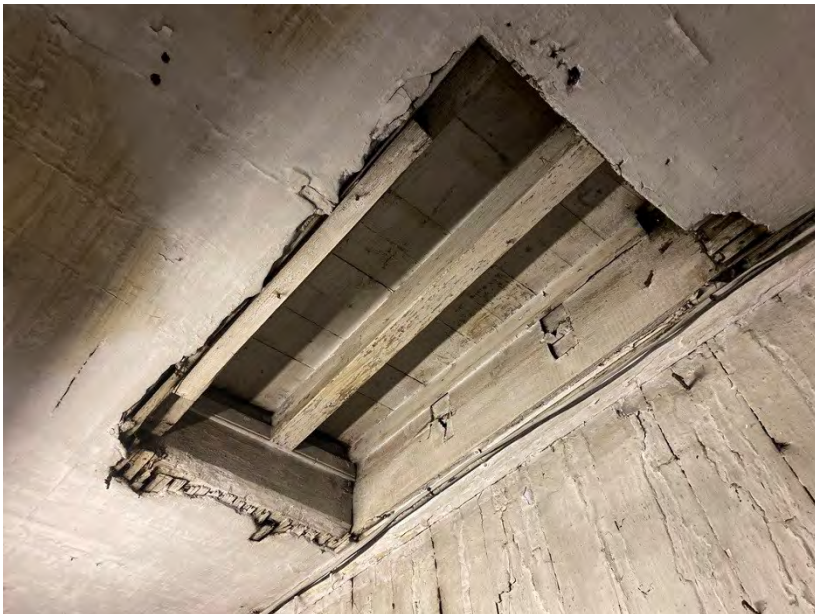
**Fig 60:**

Upper ground floor; showing impact damage to the plaster surrounding the floor/ceiling hatch

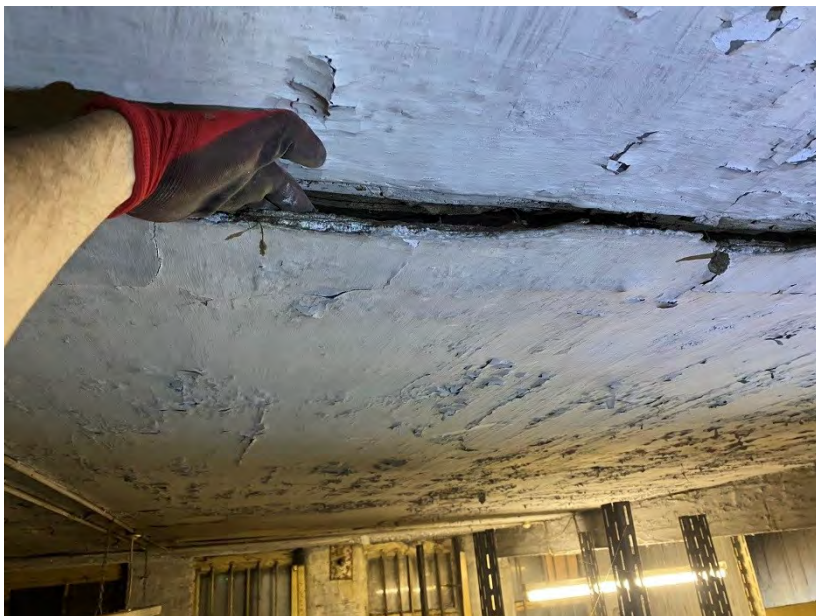
**Fig 62:**

Upper ground floor; showing large crack and area of loose plaster directly beneath the Office. Plaster was vulnerable to detachment in this area

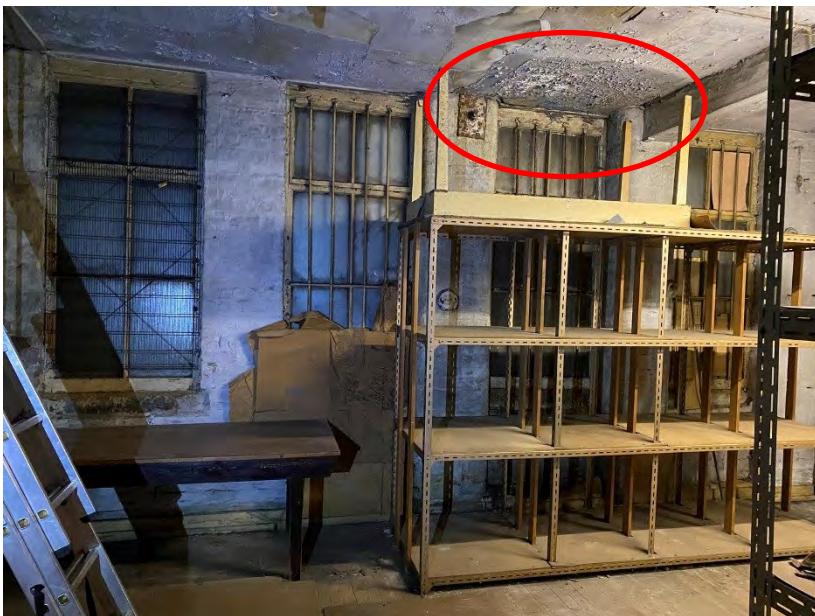
**Fig 64:**

Upper ground floor; showing area subject to water penetration. Windows were inaccessible for tactile assessment but they were vulnerable to damp and decay in this location

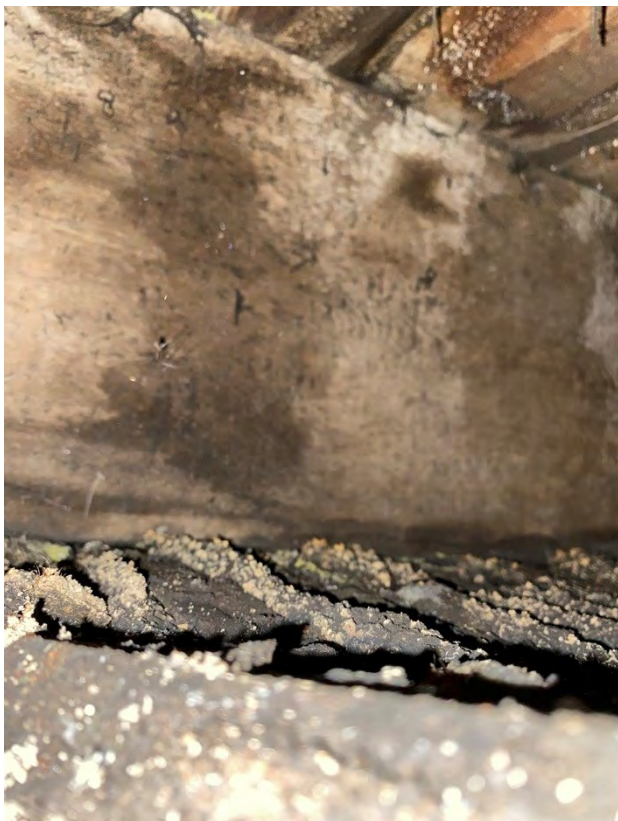
**Fig 66:**

Upper ground floor; showing a view inside the floor/ceiling void. This area of ceiling was vulnerable to detachment due to the additional weight of the water

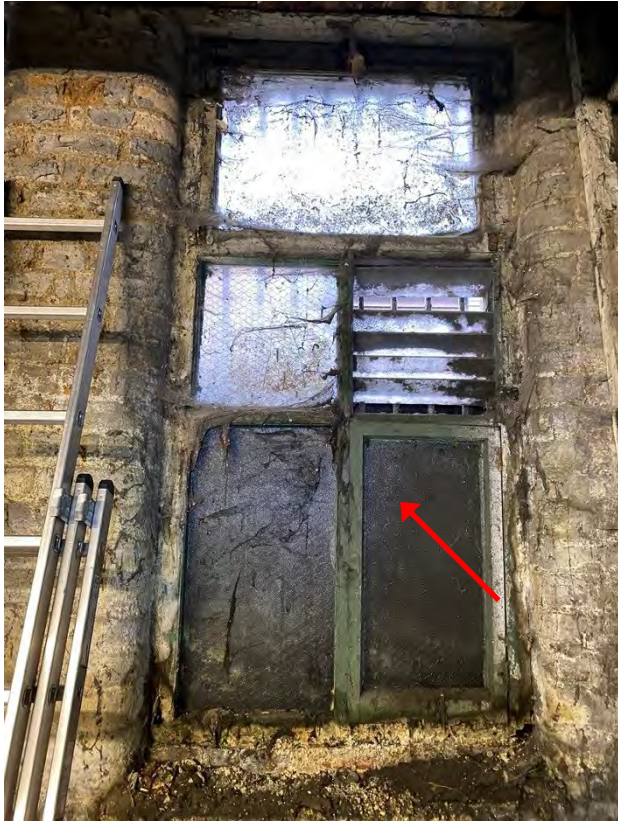
**Fig 67:**

Lower ground floor, WB.01; showing altered window which included a louvered window and chicken-wire glass. This glass may date from the late 19th century

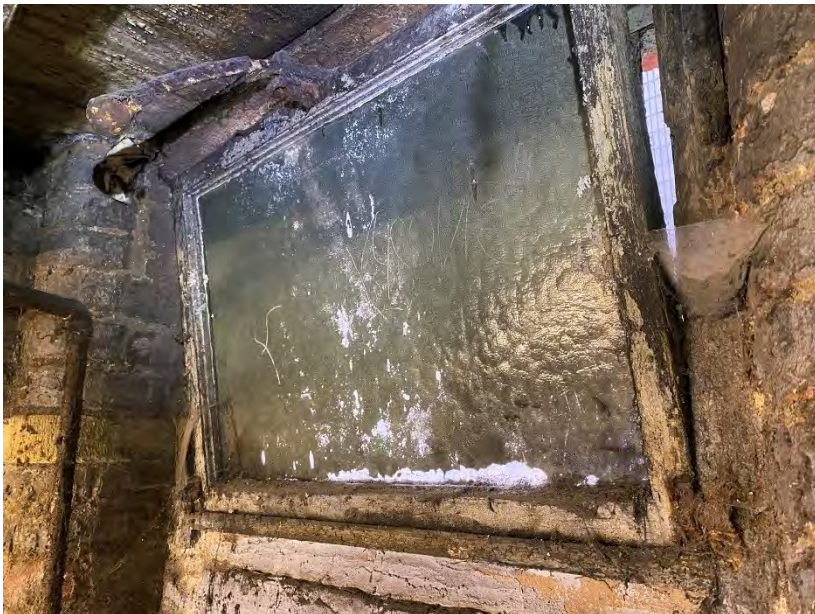
**Fig 68:**

Lower ground floor, WB.02; showing an operable hopper window. No significant decay was detected in this window. However, the lower portions of the window have been removed and the opening bricked-up

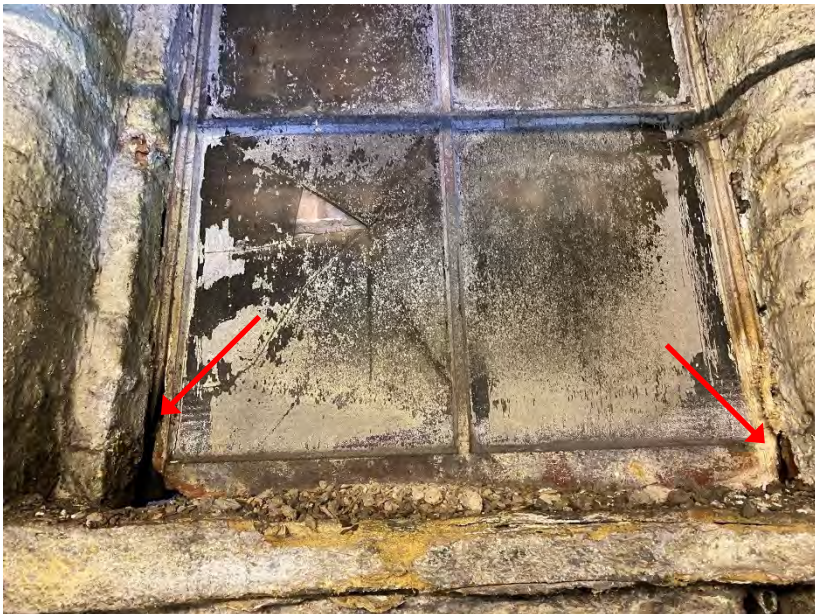
**Fig 70:**

Lower ground floor, WB.07; showing an example of decay in the base of the frame

- 2 Repairs: Repairs should be undertaken by a conservation joiner. Decayed joinery should be cut back to 'sound' material and new timber appropriately jointed so that the frames are renewed to their original form. No preservation or chemical remedial treatments are required. Renewed elements or splices to partially decayed softwood frames should be replaced with a suitably specified durable softwood timber species (H+R should be requested to advise further on specification) or Accoya (Acetylated Pine species). Splices should be arranged so that water drains outwards from the component and away from the interior of the building. A suitably specified elastic epoxy resin should be used between the splice repair and sound timber, following the manufacturer's recommendations. Epoxy fillers should only be used for very small areas of the surface imperfections so long as the moisture content of the associated timber is less than 20 per cent w/w. Broken glazing should be replaced as necessary with a suitably specified heritage glass. Natural linseed oil putty should be used for the glazing compound and a traditional burnt sand mastic for the perimeter sealant, applied in accordance with best practice. Existing historical ironmongery should be retained and like for like replacements sought where missing/damaged

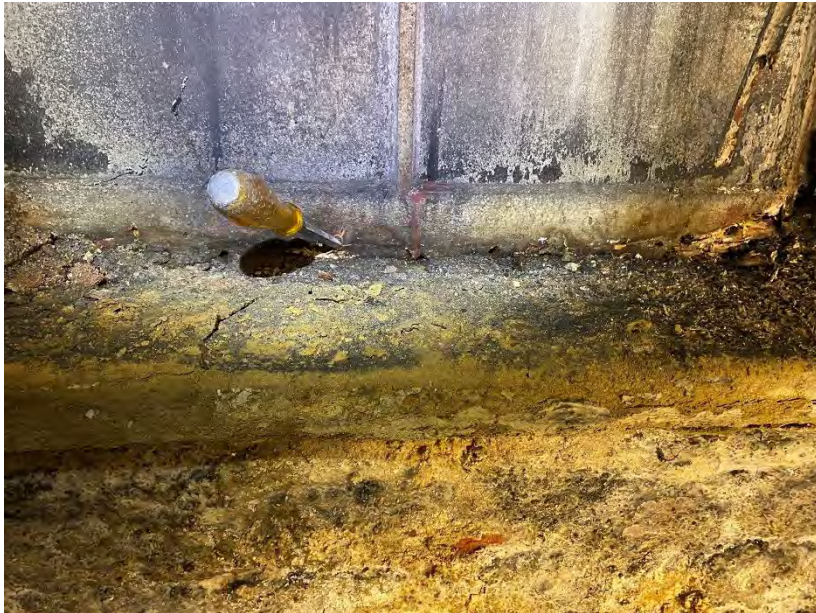
**Fig 71:**

Lower ground floor, WB.08; showing decay in the bottom rail

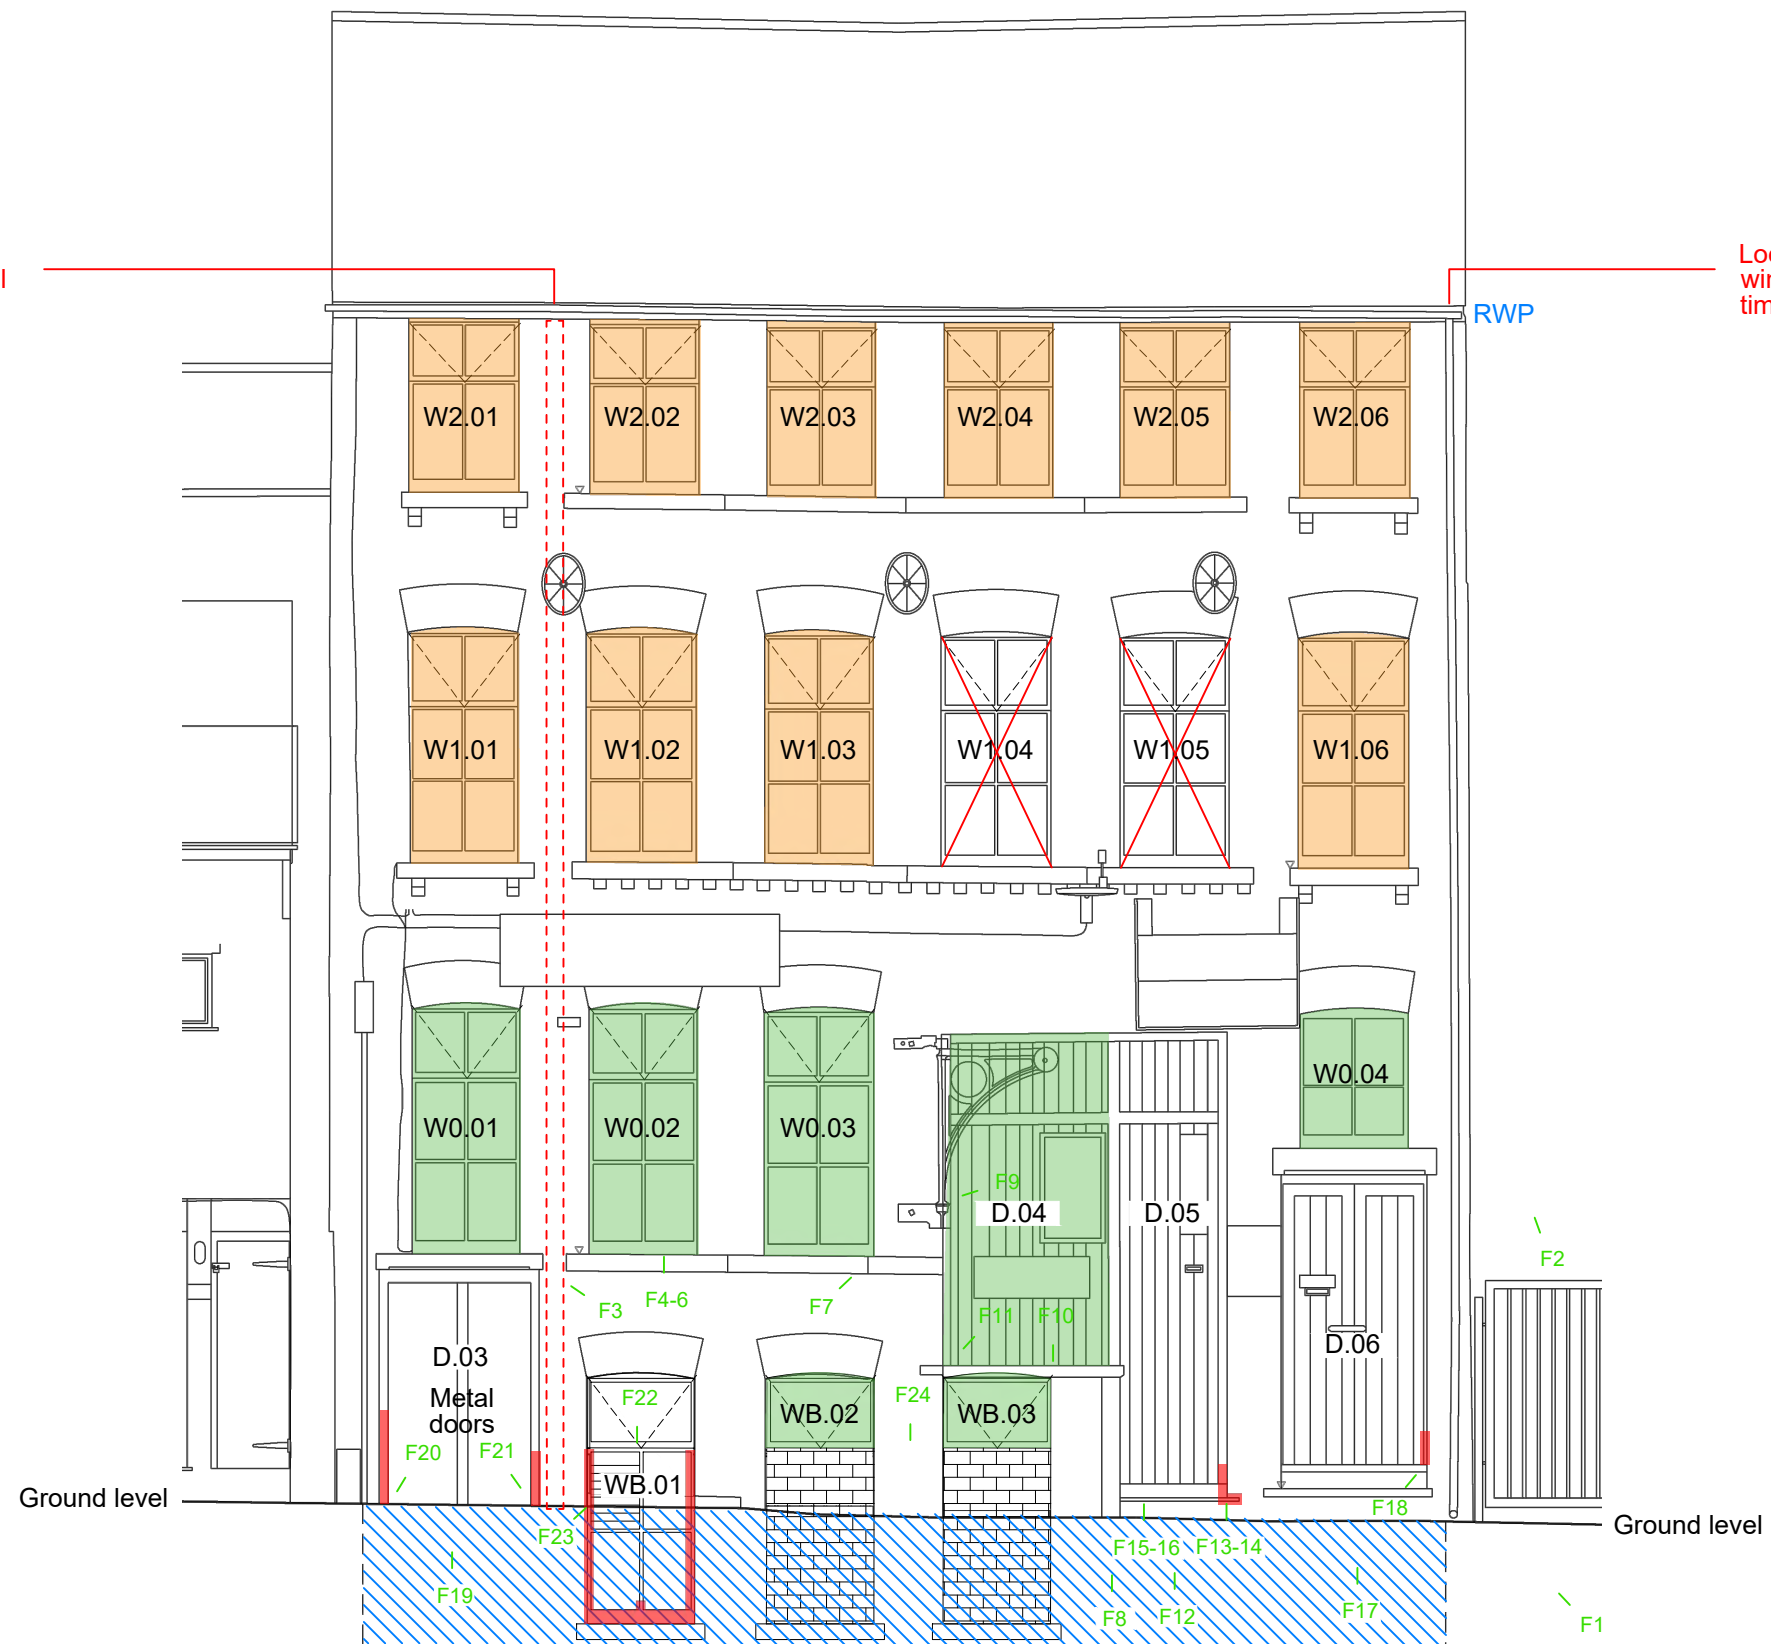
**51-53 Richmond Street, Manchester - Front (North-west) elevation**  
**WINDOW AND CEILING PLASTER CONDITION SURVEY**  
 29 November 2022

Earlier location of downpipe. Adjacent windows at a heightened risk of historical timber decay

Location of current downpipe. Adjacent windows at a heightened risk of historical timber decay
