2<sup>ND</sup> RECONNAISSANCE DAMP AND TIMBER DECAY SURVEY

GREAT NORTHERN, MANCHESTER

JOB NO. 211.18

30 MAY-1 JUNE 2022

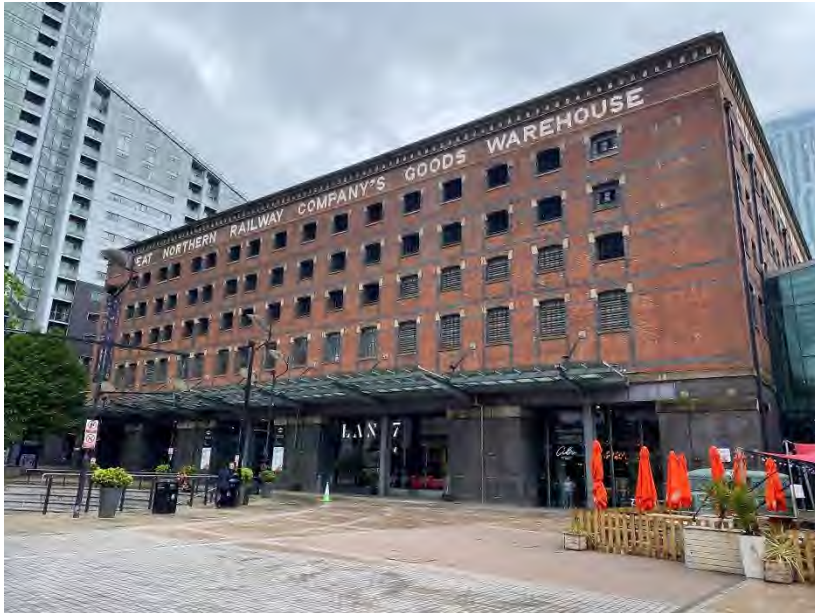
**Fig 15:**

North elevation; showing a general view of the principal elevation

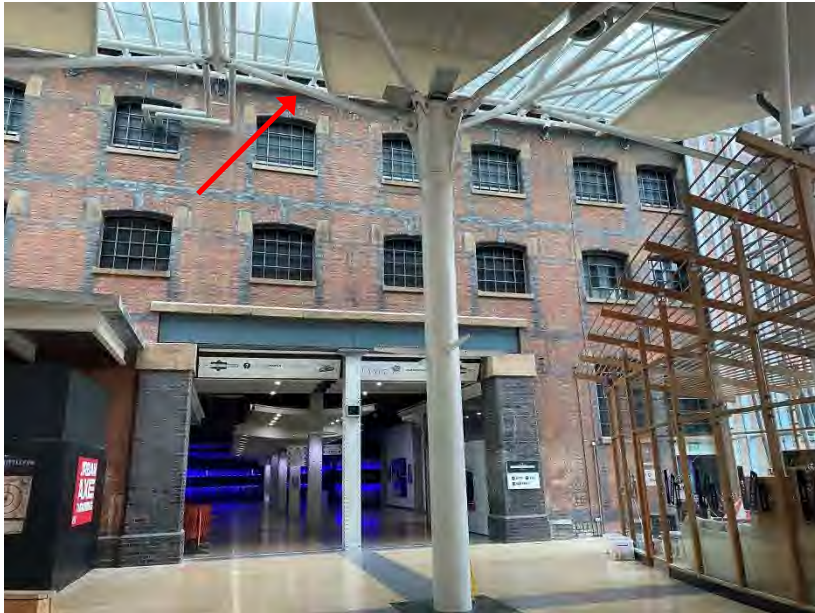
**Fig 21:**

South elevation; showing a general view of the rear elevation as viewed within the steel glazed link. There was no evidence of water penetration via the junction of the glazed roof

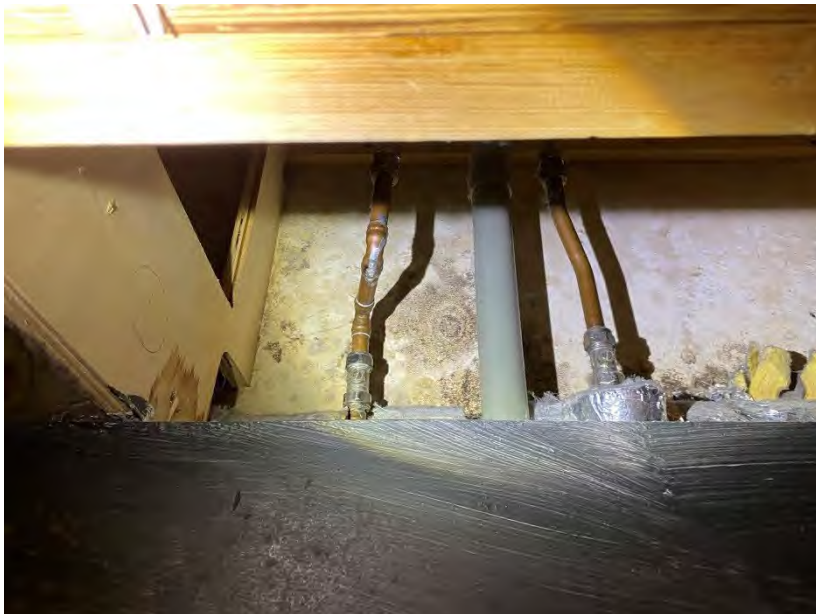
**Fig 50:**

Ground Floor, Manchester 235 Casino;  
showing surface mould contamination  
to the wall finishes beneath the sink

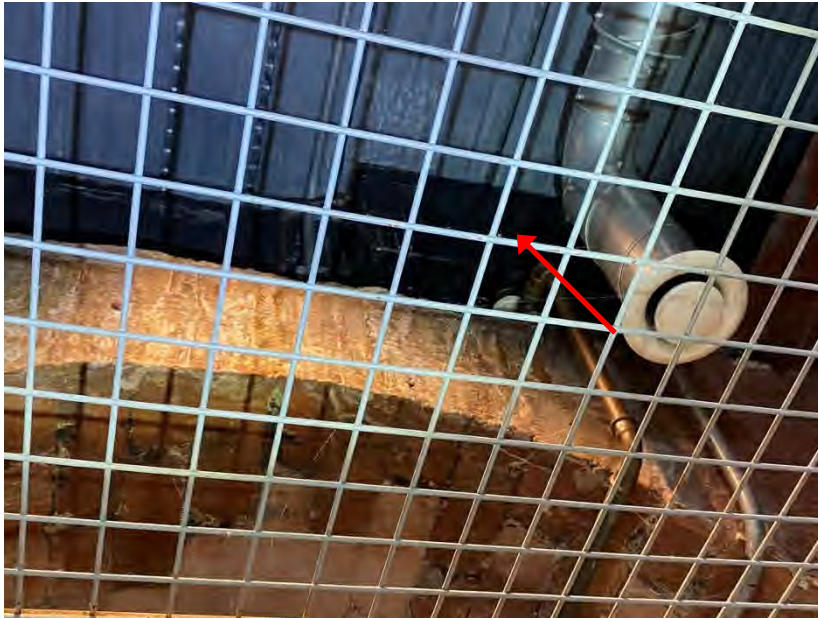
**Fig 53:**

Ground Floor Mezzanine, CIBO;  
showing the plumbing leak from the  
water tank above the urinals

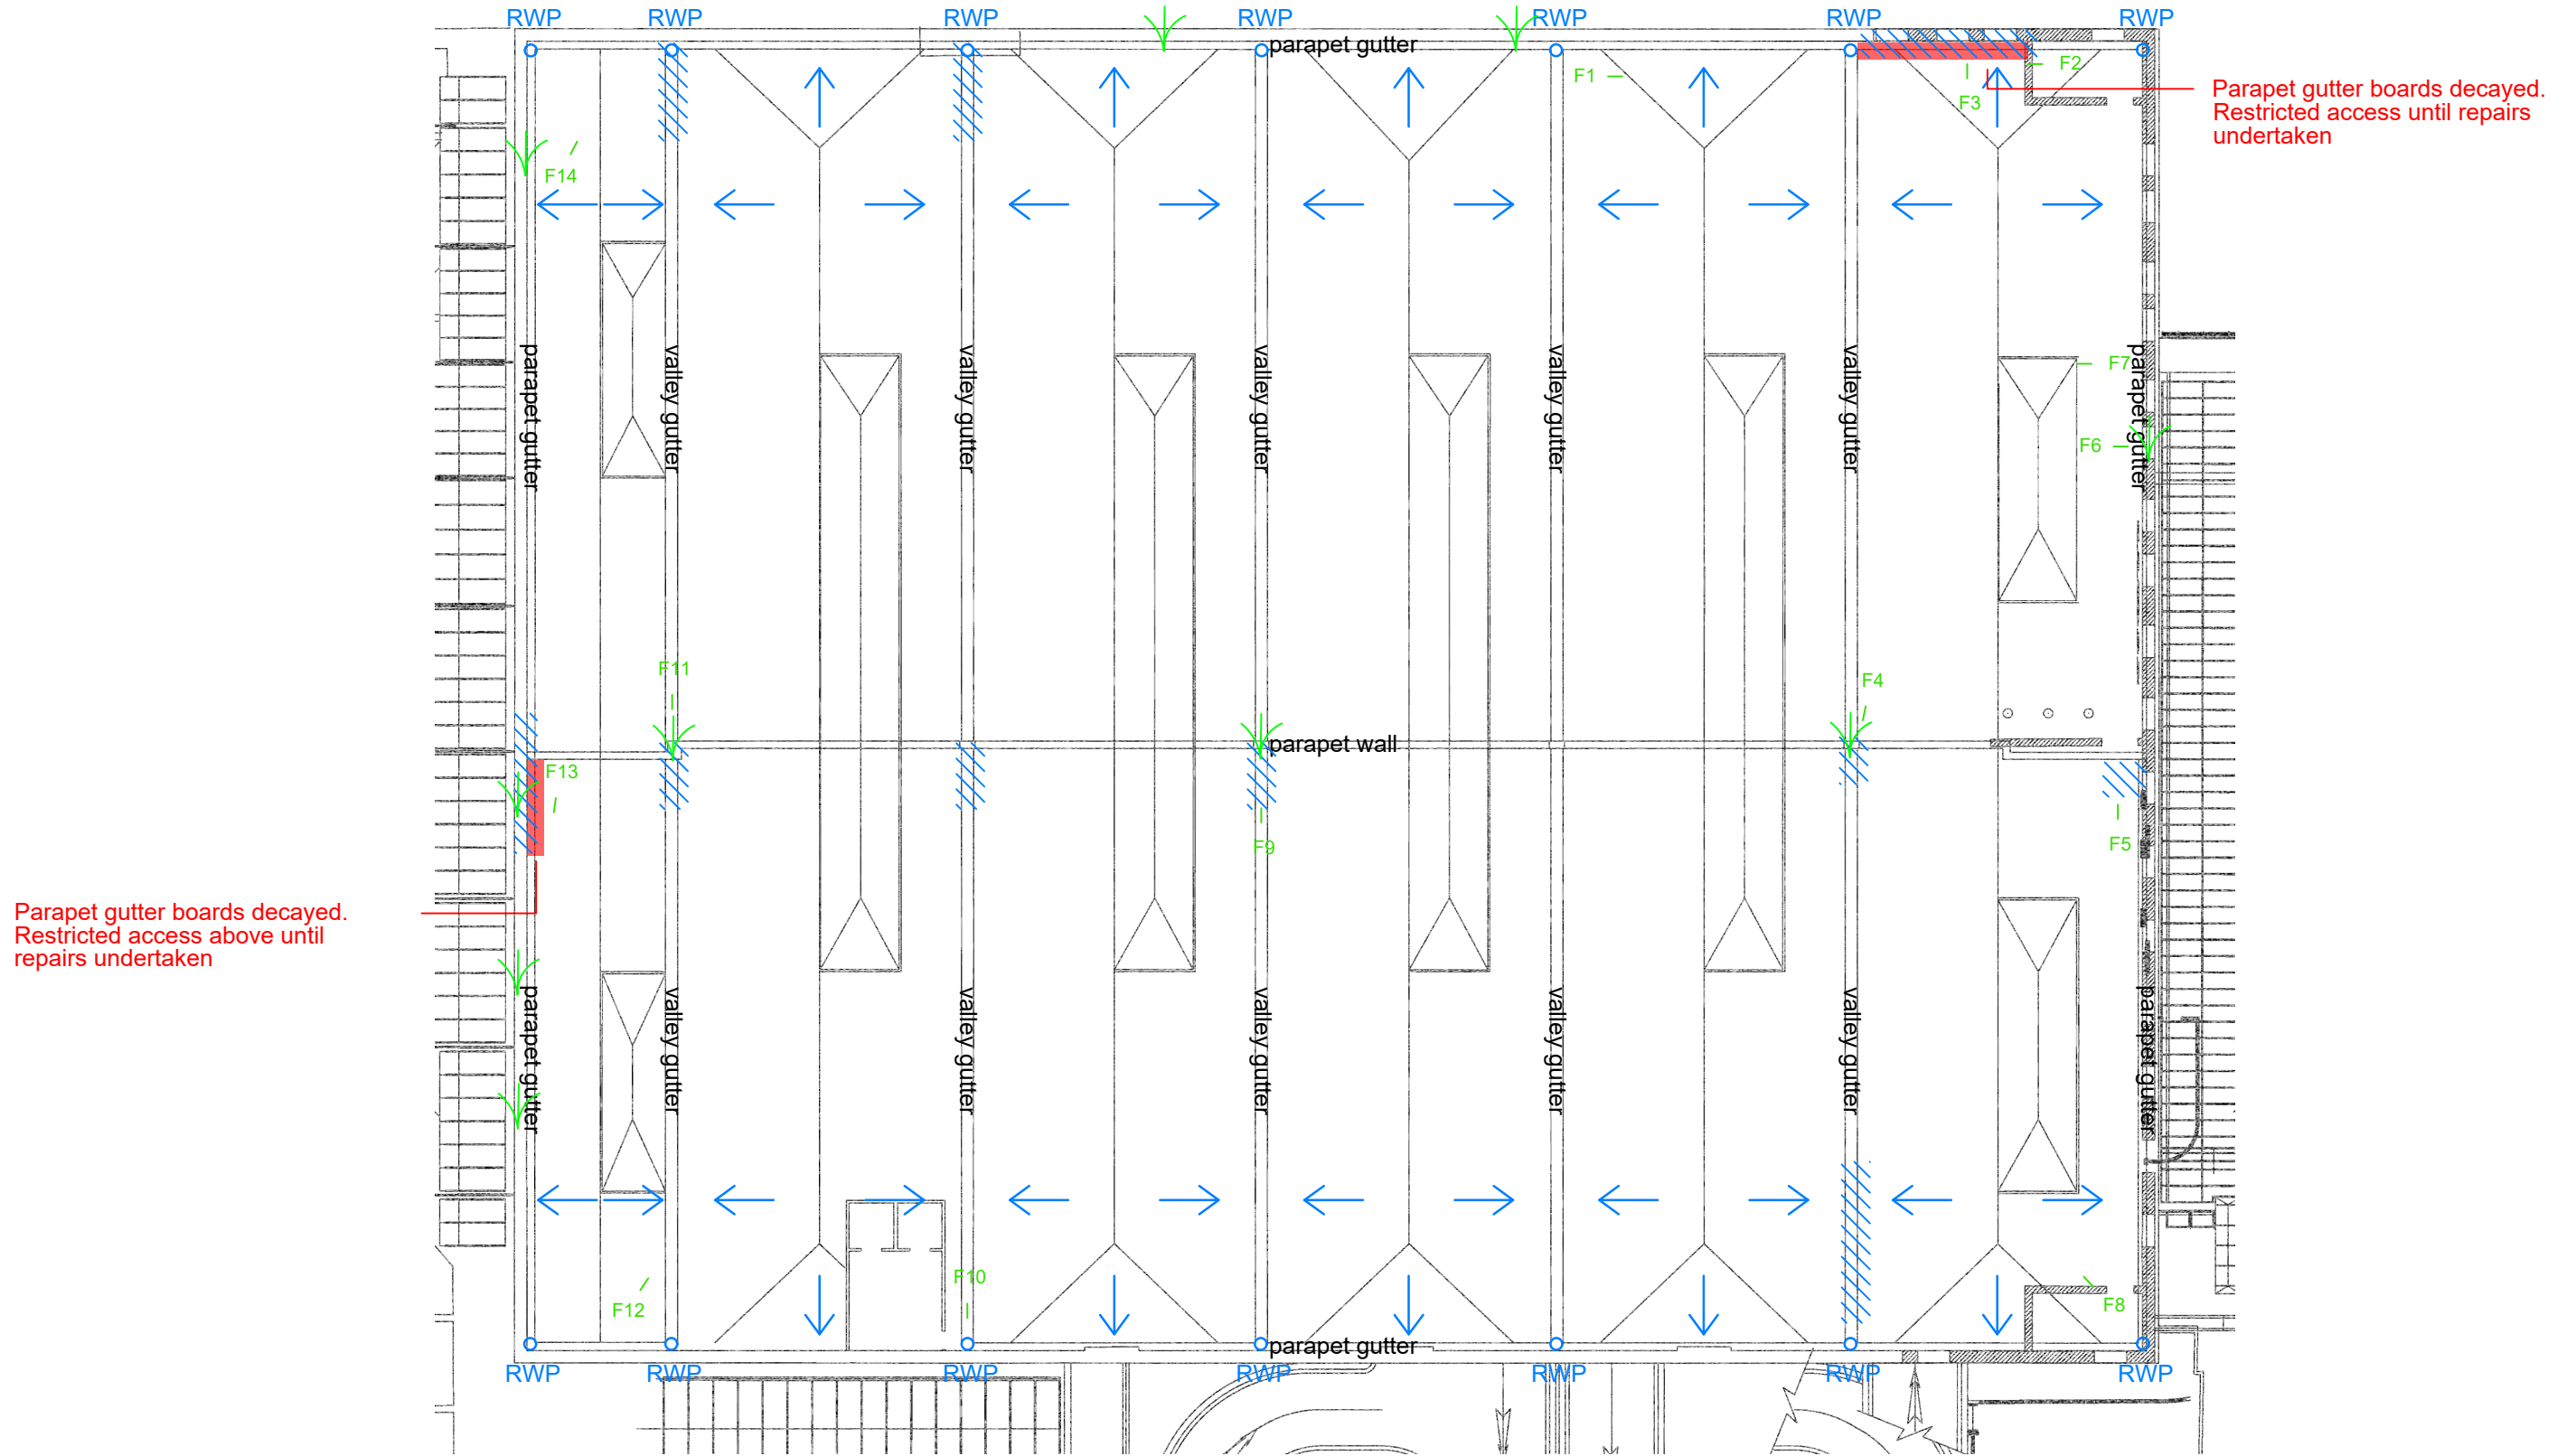
**Great Northern, Manchester - Roof coverings**  
**2nd RECONNAISSANCE DAMP AND TIMBER DECAY SURVEY**  
**30 May-1 June 2022**

- 2      Gutters: Although generally free from biological debris there were some areas of build-up and broken slates allowing rainwater to pool within the EPDM lined valley and parapet gutters. In some localised areas the plywood gutter boarding and upstand was 'spongy' underfoot, notably at the southern end of the east parapet for approximately 3m and centre of the north parapet for 2m. The gutter boards were partially decayed in these areas and potentially at risk of failure/collapse if too highly loaded by persons accessing the roof or by snow

- 3      Parapets: The coping stone butt joints were heavily washed-out throughout the perimeter parapet walls and central parapet wall. There was no DPC beneath the copings to the central parapet wall. There was craze cracking throughout the render to the inside face of the parapets which is shrinkage related. However, in some areas the render was defective and had separated from the brickwork revealing washed-out mortar joints behind. Some lead flashings had also separated from the base of the parapet. These defects were allowing water penetration and presenting a hazard to the softwood roof structure beneath. There were multiple buddleia and ferns growing from the central and perimeter parapets, evidence of high moisture levels within the masonry

*Access onto the two areas of decayed gutter should be prohibited until temporary repairs are undertaken or propping has been undertaken from beneath*

*H+R to carry out detailed investigation of parapet walls and provide recommendations on appropriate repairs*
