# EXTENDED PHASE 1 HABITAT SURVEY & DAYTIME BAT SURVEY

## AMBROSE STREET AND POTTERY LANE, GREATER MANCHESTER

AUGUST 2022

**RACHEL  
HACKING  
ECOLOGY**

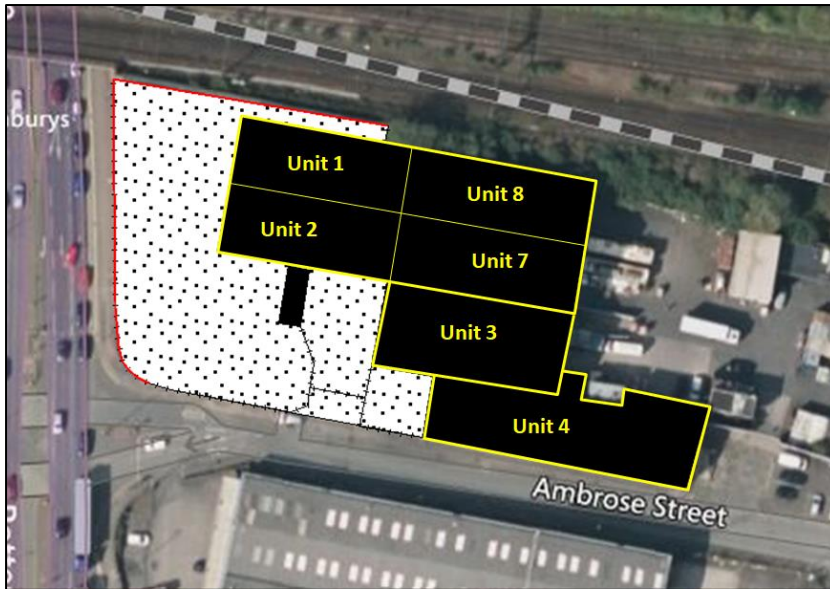
- 3.7 A large warehouse building exists on the site split into several units internally (see Figure 2). All the units on site were the subject of a daytime bat survey and were fully accessible. Units 5 and 6 lie outside of the redline boundary and so are not included in this assessment.

Figure 2 shows the location of the buildings on site
