## GLENDENE, WYTHENSHAW

### Remediation Method Statement

Report Ref: BEK-22097-1 (Rev A)

November 2022

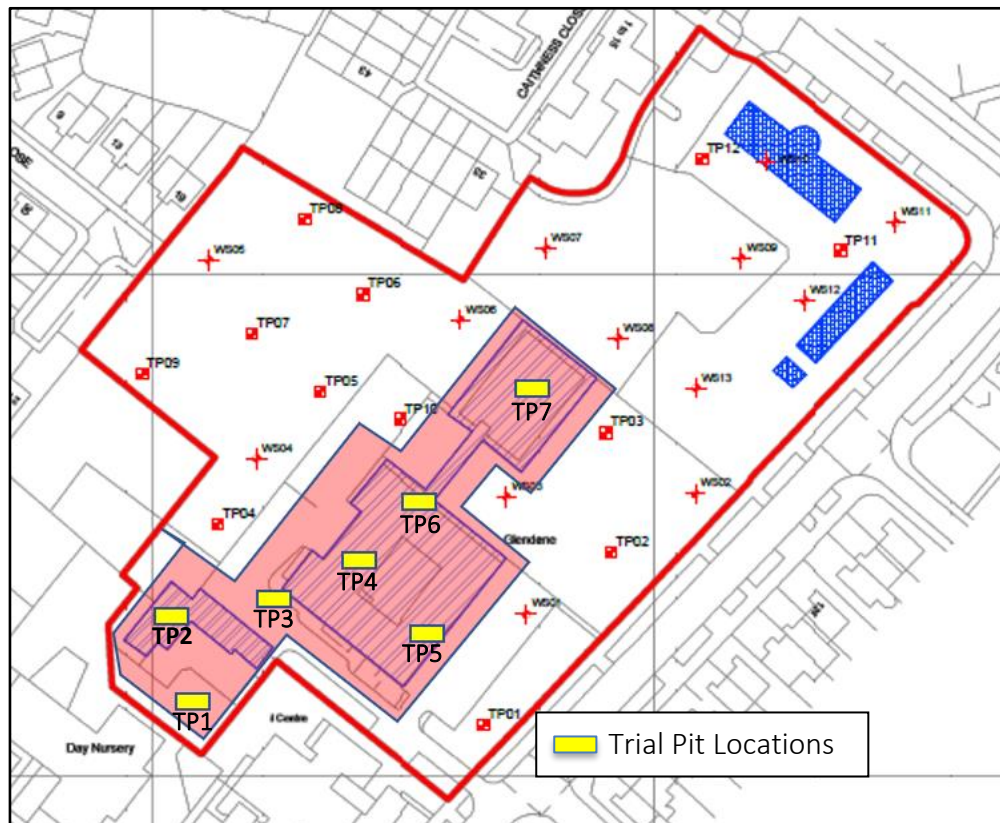
Figure 1: Additional Site Investigation Locations

2.3.1 BEK attended site on 27<sup>th</sup> October 2022 to carry out further site investigation works to provide additional information pertaining to the ground conditions/chemical nature of the soils for the areas previously noted to be inaccessible (footprint of now demolished buildings) during the WML investigation.

2.3.2 The site investigation works comprised the excavation of 7no. trial pits excavated within the south/central areas of the site which were noted to be inaccessible during previous site investigation works.
