## **Mayfield Regeneration**

### **Geoenvironmental and Geotechnical Desk Study Report**

10 August 2017

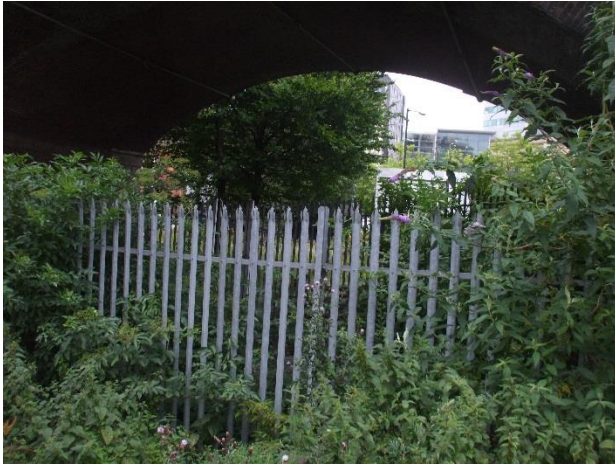
Photograph 1

- Area west of Wyre Street / north of arches: Overgrown with long grass and birch trees, Heras fenced off
- Under arches: Full of rubble / overgrown (Photograph 1)

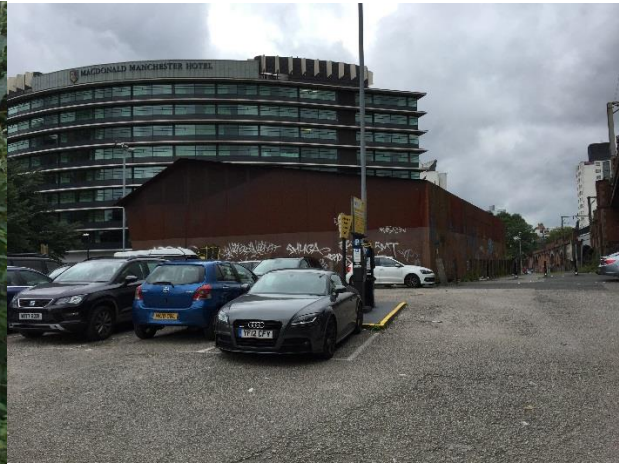
Photograph 2

- Between Wyre Street, Travis Street and Baring Street: Car park with tarmac surface. Brown metal building in western area – substation. A GIP 2009 borehole was undertaken in this car park, but unable to locate well cover. (Photograph 2)

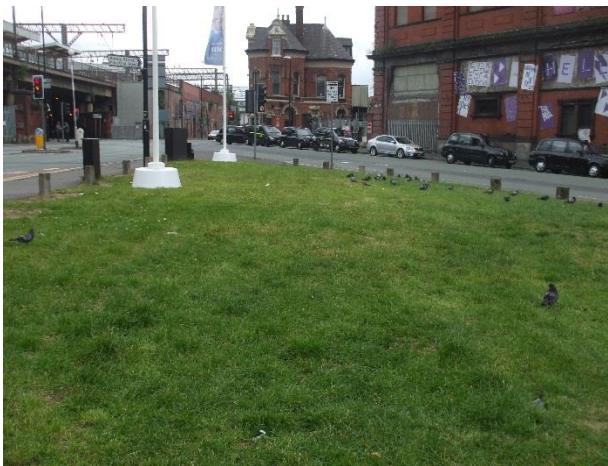
Photograph 3

- Triangular parcel of land to north of Travis Street and east of Baring Street. Grassed area. Historical maps indicate that a garage was historically present, and obstructions (thought to be the garage slab) were encountered during the GIP 2009 GI. Well cover present from GIP 2009 GI. (Photograph 3)

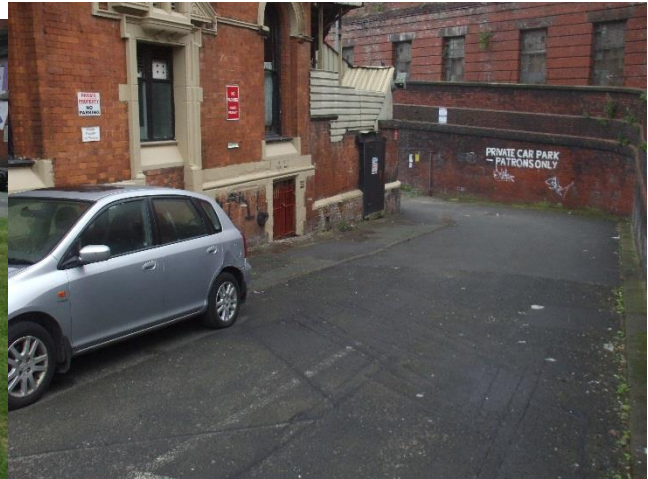
Photograph 4

- Area to the north of former Mayfield Station building:
  - Western side: Star and Garter pub, still in use – listed building. Tarmac car park to the east (access via Neild Street). GIP 2009 borehole cover present in car park. (Photograph 4)

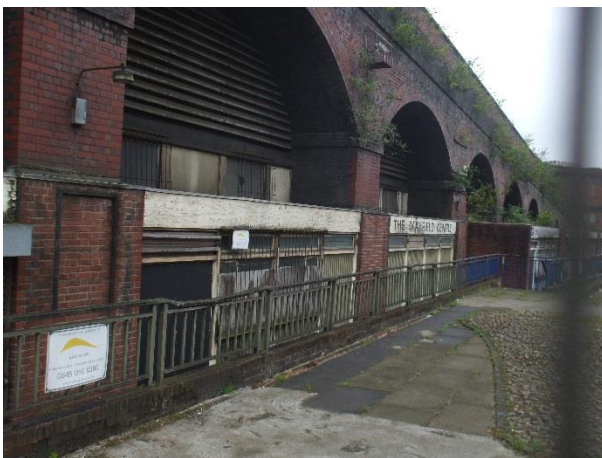
Photograph 5

- Row of 1 storey units present against the Mayfield Station building. Uses include a garage, storage, substation. (Photograph 5)
- Temperance Street: Series of arches on both sides of the road, however only the southern set are onSite.

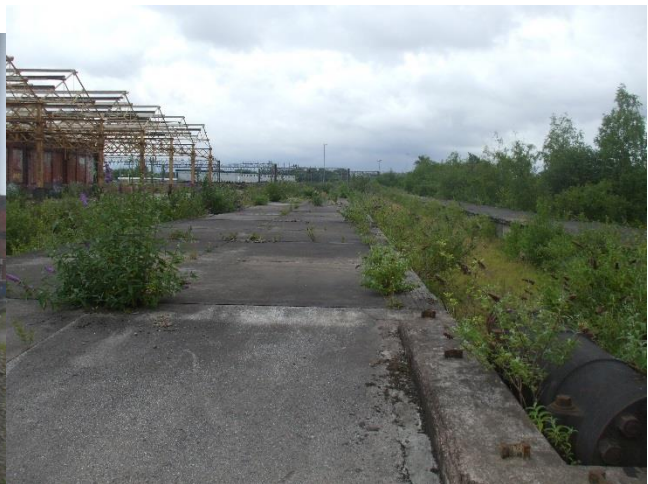
Photograph 6

- Arch 6: U+I security offices
  - Arch 7: Art exhibition company
  - Arch 8: Theatre set manufacturer
- Upper level of old Mayfield Station building (Photograph 6):

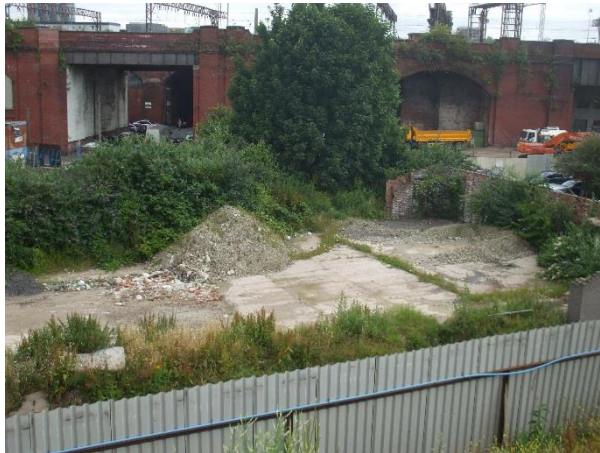
Photograph 23

- East of square warehouse: Unoccupied yard with piles of demolition rubble and brick walls of historic buildings. (Photograph 23)
- South of square warehouse: Concrete retaining wall with Hilclare car park and skips beyond.

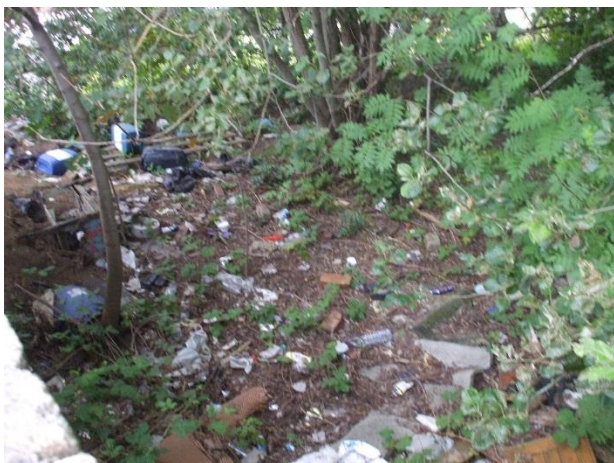
Photograph 24

- East of Manor Street: Wooded area with large amount of fly tipping (Photograph 24)
- East of Hilclare car park and west of Hoyle Street: 'Delaney' Site. Yard area, hoarded off. Material stockpiles ~3 to 5 m high comprising both apparently screened and unscreened material, demolition rubble, piles of whole bricks (Photograph 25)

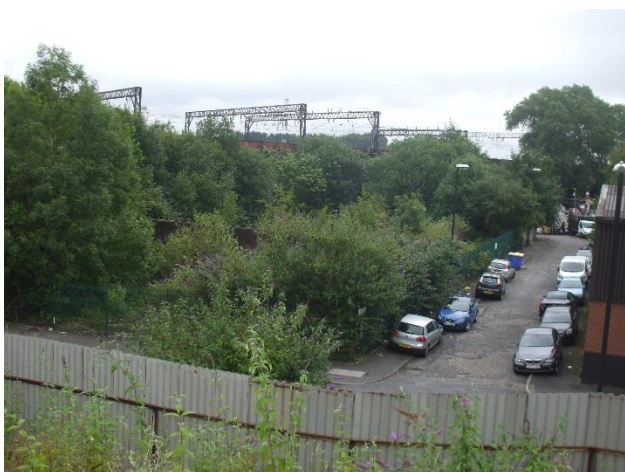
Photograph 26

- Between Hoyle Street, Chapelfield Road, River Street and Rachel Street
  - Former morgue. Extremely overgrown; no access. Fenced off. (Photograph 26)
  - Brick walls of derelict building visible
