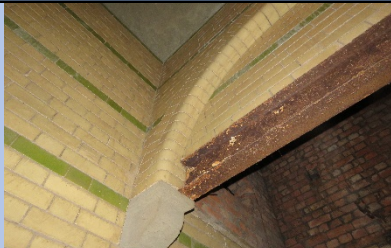
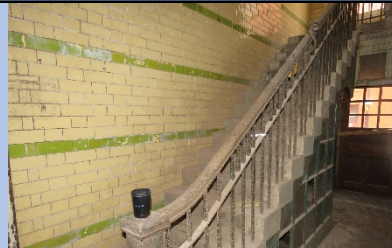
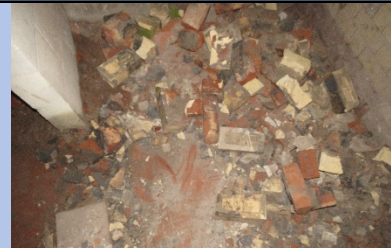
| Room Ref. | Element | Description / Item | Condition | Action | Photographs | | |
|---|---|---|---|---|---|---|---|
| | Misc. | 2no. stone corbels<br>Stair balusters and handrail.<br>Misc. demolition waste.<br>Misc. M&E | | <ul style="list-style-type: none"> <li>Record condition of timber handrail.</li> <li>Remove all flaking paint from stair balusters.</li> <li>Protect handrail.</li> <li>Remove all waste and debris.</li> <li>Remove all redundant M&amp;E.</li> </ul> | | | |

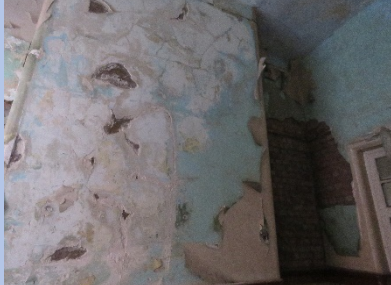
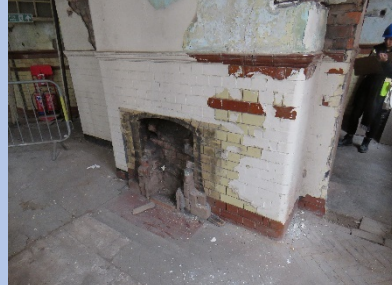
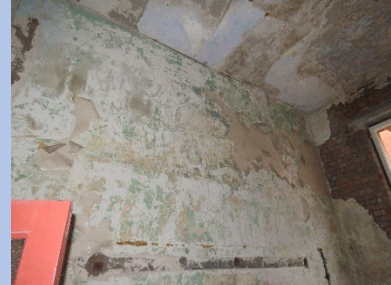
| Room Ref. | Element | Description / Item | Condition | Action | Photographs | | |
|---|---|---|---|---|---|---|---|
| 0.03 | Walls | Glazed brick partially painted to cill height.<br>Plaster on brick with paint or wallpaper finish.<br>Note surviving stencilling adjacent to fireplace. | Fair | Enabling works <ul style="list-style-type: none"> <li>Remove flaking paint with hand tools and any remaining paint using peelaway.</li> </ul> Proposed works <ul style="list-style-type: none"> <li>Existing glazed bricks cleaned and retained.</li> <li>Plaster to be stripped from existing masonry walls back to brickwork.</li> <li>Brickwork wall to be cleaned.</li> </ul> | | | |

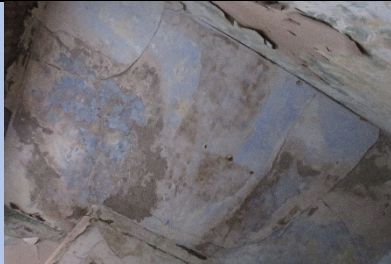
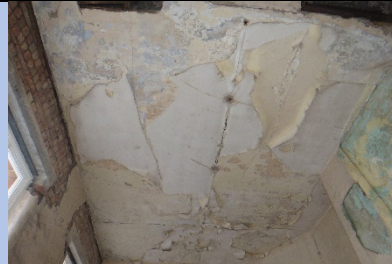
| Room Ref. | Element | Description / Item | Condition | Action | Photographs | | |
|---|---|---|---|---|---|---|---|
| | Ceiling | Plaster to lath with paint finish.<br>Cornice survives. | Fair | Enabling works <ul style="list-style-type: none"> <li>Hammer test remaining plaster and remove any bossed plaster.</li> <li>Remove flaking paint.</li> </ul> Proposed works <ul style="list-style-type: none"> <li>Existing lath and plaster ceiling, repaired (NBS:M20/587) and to receive intumescent paint coatings (NBS:Z12/212).</li> <li>Cornice to be repaired and reinstated where missing</li> </ul> | | | |

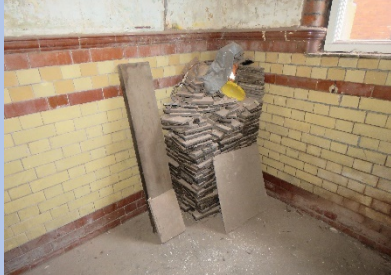
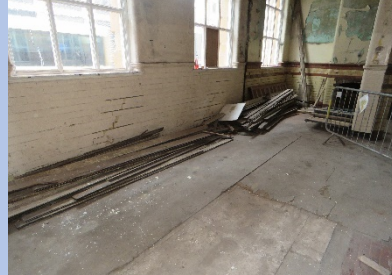
| Room Ref. | Element | Description / Item | Condition | Action | Photographs | | |
|---|---|---|---|---|---|---|---|
| | Floor | Wood block, partially lifted.<br>Plyboard over wood block to some areas. | Fair | Enabling works <ul style="list-style-type: none"> <li>Remove plyboard.</li> <li>Quantify and lift all wood block, store on pallet in room.</li> </ul> Proposed works <ul style="list-style-type: none"> <li>Existing timber block (parquet) to be removed for use elsewhere in the building</li> <li>Loose floor coverings removed to all other rooms.</li> <li>Remaining floor covering to be cleaned.</li> </ul> | | | |

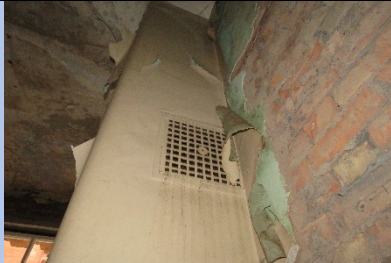
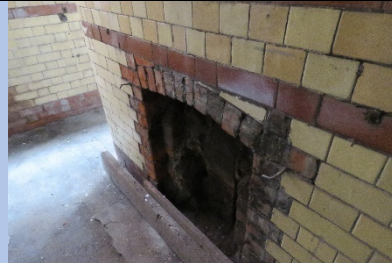
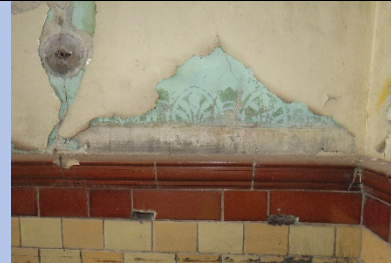
| Room Ref. | Element | Description / Item | Condition | Action | Photographs | | |
|---|---|---|---|---|---|---|---|
| | Misc. | Fireplace with glazed brick / infill.<br>3no. vents to chimney stacks.<br>Misc. pipes / conduit. | | <ul style="list-style-type: none"> <li>Remove infill to fireplace and store in heritage store.</li> <li>Remove paint from vent grilles.</li> <li>Remove all pipes / conduit.</li> </ul> | | | |

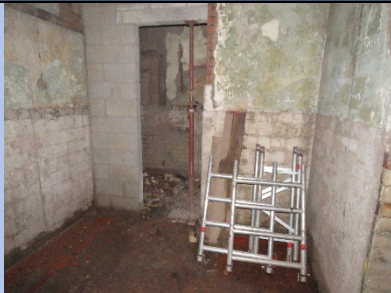
| Room Ref. | Element | Description / Item | Condition | Action | Photographs | | |
|---|---|---|---|---|---|---|--|
| 0.01c | Walls | Plaster on brick or tile adhesive over glazed brick. | Poor | Enabling works <ul style="list-style-type: none"> <li>Remove flaking paint with hand tools and any remaining paint using peelaway. Install protection.</li> </ul> Proposed works <ul style="list-style-type: none"> <li>Existing glazed bricks cleaned and retained</li> <li>Plaster to be stripped from existing masonry walls back to brickwork</li> </ul> | | | |

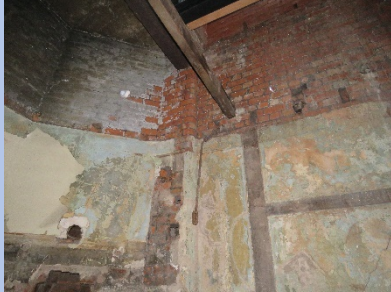
| Room Ref. | Element | Description / Item | Condition | Action | Photographs | | |
|---|---|---|---|---|---|---|--|
| | Ceiling | Remnant of ceiling joists. Exposed concrete and steel beams. | Fair | Enabling works <ul style="list-style-type: none"> <li>Remove timber joists</li> </ul> Proposed works <ul style="list-style-type: none"> <li>Existing lath and plaster ceiling, repaired (NBS:M20/587) and to receive intumescent paint coatings (NBS:Z12/212).</li> <li>Cornice to be repaired and reinstated where missing</li> <li>Steel beams to be treated with specification advised by Architect.</li> </ul> | | | |

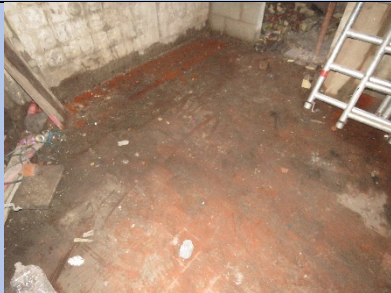
| Room Ref. | Element | Description / Item | Condition | Action | Photographs | | |
|---|---|---|---|---|---|---|--|
| | Floor | Red quarry tile. | | <ul style="list-style-type: none"> <li>Loose floor coverings removed to all other rooms.</li> <li>Existing timber block (parquet) to be removed for use elsewhere in the building</li> </ul> | | | |

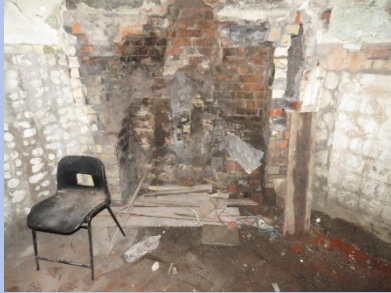
| Room Ref. | Element | Description / Item | Condition | Action | Photographs | | |
|---|---|---|---|---|---|---|--|
| | Misc. | Misc. demolition and builders waste. | | <ul style="list-style-type: none"> <li>Remove all items from room.</li> </ul> | | | |

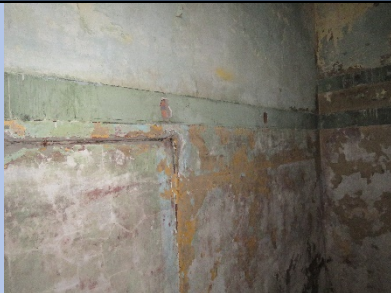
| Room Ref. | Element | Description / Item | Condition | Action | Photographs | | |
|---|---|---|---|---|---|--|--|
| 0.05 | Walls | Plaster on brick with paint or finish. | Fair | Enabling works <ul style="list-style-type: none"> <li>Remove flaking paint with hand tools and any remaining paint using peelaway. Install protection.</li> </ul> Proposed works <ul style="list-style-type: none"> <li>Plaster to be stripped from existing masonry walls back to brickwork</li> </ul> | | | |

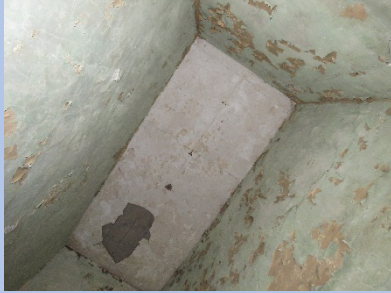
| Room Ref. | Element | Description / Item | Condition | Action | Photographs | | |
|---|---|---|---|---|---|--|--|
| | Ceiling | Plaster on concrete with paint finish. | | Enabling works <ul style="list-style-type: none"> <li>Hammer test remaining plaster and remove any bossed plaster.</li> <li>Remove flaking paint.</li> </ul> Proposed works <ul style="list-style-type: none"> <li>Existing lath and plaster ceiling, repaired (NBS:M20/587) and to receive intumescent paint coatings (NBS:Z12/212).</li> <li>Cornice to be repaired and reinstated where missing</li> </ul> | | | |

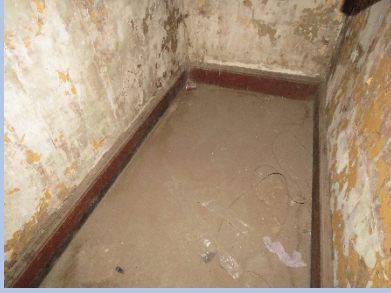
| Room Ref. | Element | Description / Item | Condition | Action | Photographs | | |
|---|---|---|---|---|---|--|--|
| | Floor | Wood block. | Fair | Enabling works <ul style="list-style-type: none"> <li>Quantify wood block, store on pallet.</li> </ul> Proposed works <ul style="list-style-type: none"> <li>Existing timber block (parquet) to be removed for use elsewhere in the building</li> <li>Loose floor coverings removed to all other rooms.</li> </ul> | | | |

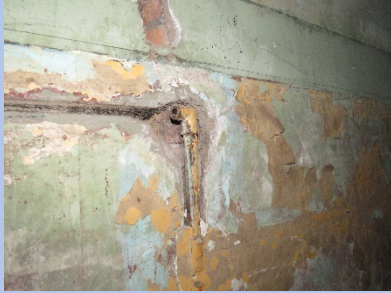
| Room Ref. | Element | Description / Item | Condition | Action | Photographs | | |
|---|---|---|---|---|---|--|--|
| | Misc. | Iron panel to hatch.<br>Misc. embedded pipe / conduit to wall. | | <ul style="list-style-type: none"> <li>Remove flaking paint and protect metalwork.</li> <li>Remove embedded pipe / conduit and fill holes.</li> </ul> | | | |

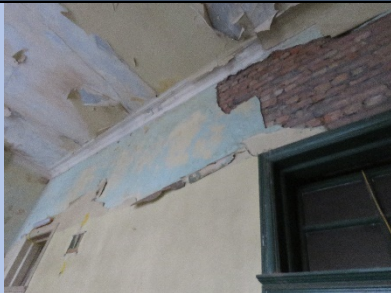
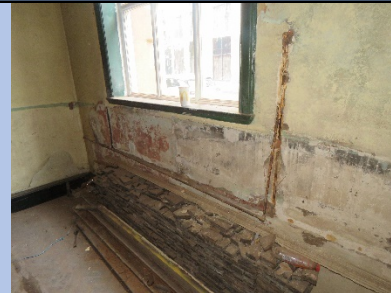
| Room Ref. | Element | Description / Item | Condition | Action | Photographs | | |
|---|---|---|---|---|---|---|---|
| 0.07 | Walls | Plaster on brick with paint finish. | Fair | Proposed works <ul style="list-style-type: none"> <li>Plaster to be stripped from existing masonry walls back to brickwork.</li> </ul> | | | |

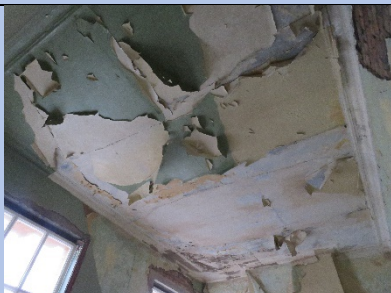
| Room Ref. | Element | Description / Item | Condition | Action | Photographs | | |
|---|---|---|---|---|---|---|---|
| | Ceiling | Plaster on lath with paint finish. Cornice survives | | Enabling works <ul style="list-style-type: none"> <li>Hammer test remaining plaster and remove any bossed plaster.</li> <li>Remove flaking paint.</li> </ul> Proposed works <ul style="list-style-type: none"> <li>Existing lath and plaster ceiling, repaired (NBS:M20/587) and to receive intumescent paint coatings (NBS:Z12/212).</li> <li>Cornice to be repaired and reinstated where missing.</li> </ul> | | | |

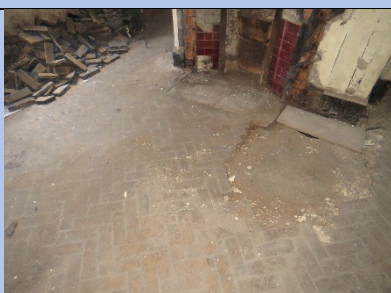
| Room Ref. | Element | Description / Item | Condition | Action | Photographs | | |
|---|---|---|---|---|---|---|---|
| | Floor | Wood block, partially lifted. | Fair | Enabling works <ul style="list-style-type: none"> <li>Remove all debris.</li> <li>Quantify and lift all wood block, store on pallet in room.</li> </ul> Proposed works <ul style="list-style-type: none"> <li>Existing timber block (parquet) to be for use elsewhere in the building</li> <li>Loose floor coverings removed to all other rooms.</li> <li>Remaining floor covering to be cleaned.</li> </ul> | | | |

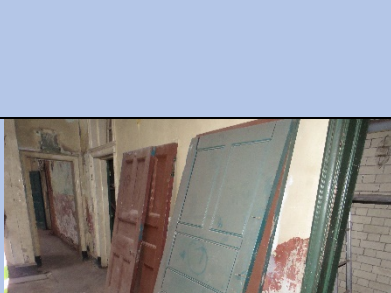
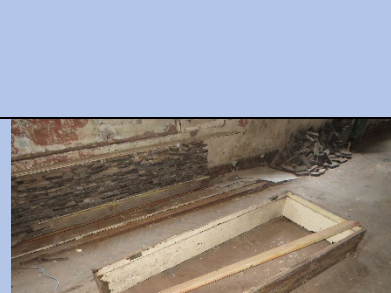
| Room Ref. | Element | Description / Item | Condition | Action | Photographs | | |
|---|---|---|---|---|---|---|---|
| | Joinery | Skirting<br>Door architrave<br>Hatch to entrance<br>5no. doors | | Proposed works <ul style="list-style-type: none"> <li>Remove skirting with plaster to walls and do not reinstate.</li> <li>Doors and architraves to be removed, except for door into small office which is to remain.</li> <li>Replace existing ply shelf with new timber.</li> </ul> | | | |

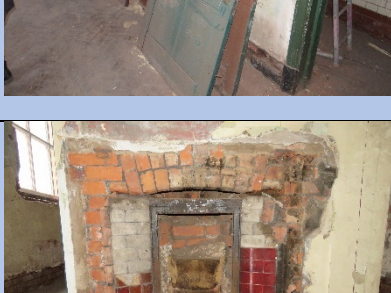
| Room Ref. | Element | Description / Item | Condition | Action | Photographs | | |
|---|---|---|---|---|---|---|---|
| | Misc. | Red glazed tile to fireplace.<br>Timber cupboard and shelves.<br>Ventilation grille.<br>Redundant M&E | | <ul style="list-style-type: none"> <li>Tidy fireplace,</li> <li>Clean down timber shelving.</li> </ul> | | | |

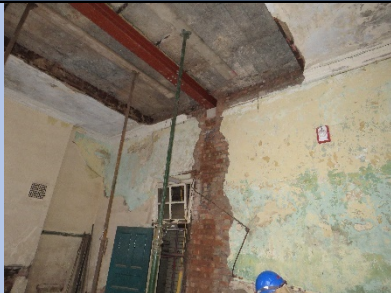
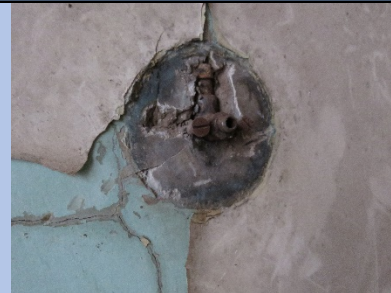
| Room Ref. | Element | Description / Item | Condition | Action | Photographs | | |
|---|---|---|---|---|---|---|---|
| 0.08 | Walls | Plaster on brick with paint finish. | Fair | <ul style="list-style-type: none"> <li>Plaster to be stripped from existing masonry walls back to brickwork</li> </ul> | | | |

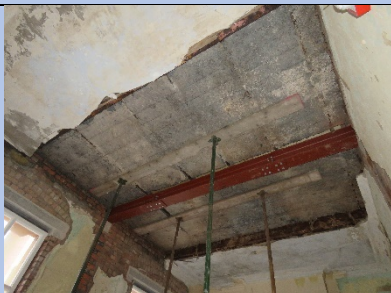
| Room Ref. | Element | Description / Item | Condition | Action | Photographs | | |
|---|---|---|---|---|---|---|---|
| | Ceiling | Plaster on lath with paint finish. Cornice partially survives<br>Exposed concrete slab with new steel beams. | | <p>Enabling works</p> <ul style="list-style-type: none"> <li>Hammer test remaining plaster and remove any bossed plaster.</li> <li>Remove flaking paint.</li> </ul> <p>Proposed works</p> <ul style="list-style-type: none"> <li>Existing lath and plaster ceiling, repaired (NBS:M20/587) and to receive intumescent paint coatings (NBS:Z12/212).</li> <li>Cornice to be repaired and reinstated where missing</li> </ul> | | | |

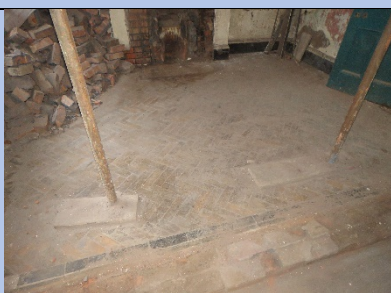
| Room Ref. | Element | Description / Item | Condition | Action | Photographs | | |
|---|---|---|---|---|---|---|---|
| | Floor | Wood block, partially lifted and stored in 0.07.<br>Glazed tile to hearth. | Fair | <p>Enabling works</p> <ul style="list-style-type: none"> <li>Remove all debris.</li> <li>Quantify and lift all wood block, store on pallet.</li> <li>Carefully remove glazed tiles and store</li> </ul> <p>Proposed works</p> <ul style="list-style-type: none"> <li>Existing timber block (parquet) to be removed for use elsewhere in the building</li> <li>Loose floor coverings removed to all other rooms.</li> <li>Remaining floor to be cleaned.</li> </ul> | | | |

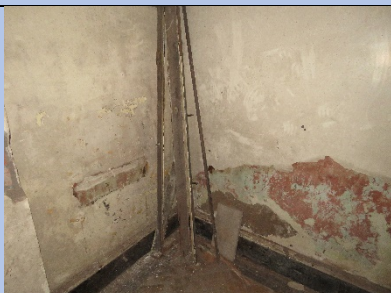
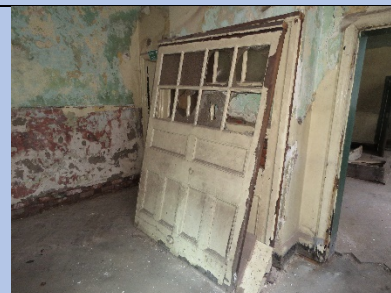
| Room Ref. | Element | Description / Item | Condition | Action | Photographs | | |
|---|---|---|---|---|---|---|---|
| | Joinery | Skirting<br>Door architrave<br>Hatch to entrance<br>2no. doors<br>2no. timber glazed partitions<br>Misc. pile of timber. | | <p>Proposed works</p> <ul style="list-style-type: none"> <li>Skirting remain in small section only. Remove with plaster to walls and do not reinstate.</li> <li>Doors and architraves to be removed, including glazed over light to door.</li> <li>Glazed partition to be set aside for reuse</li> <li>Misc pile of timber may be reused for repairs elsewhere.</li> </ul> | | | |

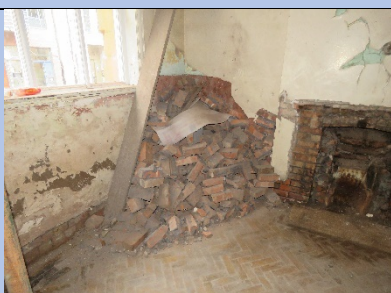
| Room Ref. | Element | Description / Item | Condition | Action | Photographs | | |
|---|---|---|---|---|---|---|---|
| | Misc. | 2no. ventilation grilles.<br>Pile of demolition waste.<br>Redundant M&E pipes and conduit. | | <ul style="list-style-type: none"> <li>Remove all demolition waste.</li> <li>Remove all redundant M&amp;E and fill holes.</li> </ul> | | | |

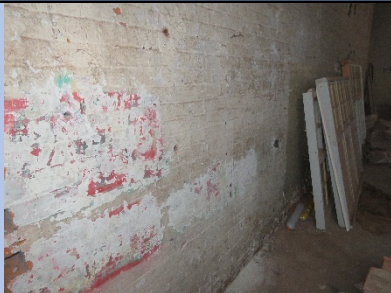
| Room Ref. | Element | Description / Item | Condition | Action | Photographs | | |
|---|---|---|---|---|---|---|---|
| G.017 Inc. 0.2a, 0.18, 0.19b and R2 | Walls | Painted brick, minor holes. | Fair | Enabling works <ul style="list-style-type: none"> <li>Remove flaking paint.</li> <li>Fill holes with salvaged red brick and mortar.</li> </ul> Proposed works <ul style="list-style-type: none"> <li>Existing walls stripped back to masonry</li> </ul> | | | |

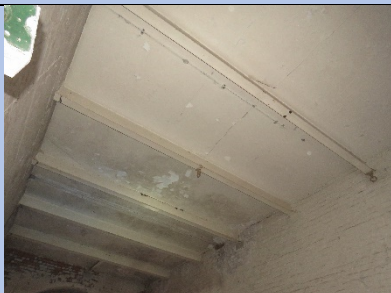
| Room Ref. | Element | Description / Item | Condition | Action | Photographs | | |
|---|---|---|---|---|---|---|---|
| | Ceiling | Plaster on concrete with paint finish. Painted steel beams. | Fair | Enabling works <ul style="list-style-type: none"> <li>Hammer test remaining plaster and remove any bossed plaster.</li> <li>Remove flaking paint.</li> </ul> Proposed works <ul style="list-style-type: none"> <li>Existing exposed concrete soffit to be retained, repaired to SE details and painted in intumescent paint to NBS:Z12/211.</li> </ul> | | | |

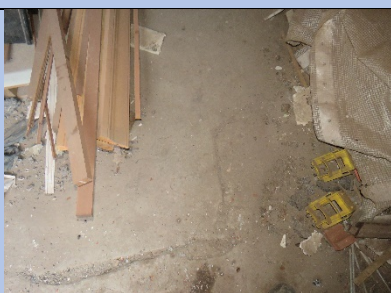
| Room Ref. | Element | Description / Item | Condition | Action | Photographs | | |
|---|---|---|---|---|---|---|---|
| | Floor | Exposed concrete floor. | Fair | Enabling works <ul style="list-style-type: none"> <li>Remove all debris</li> </ul> Proposed works <ul style="list-style-type: none"> <li>Install reclaimed timber parquet flooring. ALLIED LONDON COMMENT: This specification should be reviewed with Purcell prior to works commencing.</li> </ul> | | | |

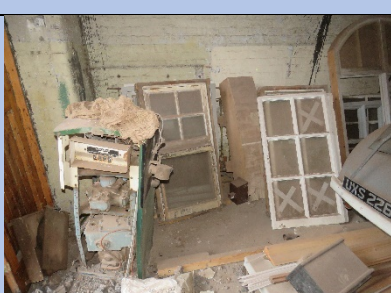
| Room Ref. | Element | Description / Item | Condition | Action | Photographs | | |
|---|---|---|---|---|---|---|---|
| | Misc. | Historic hook fixing to beam.<br>Radiators.<br>General construction materials and salvaged materials.<br>Incoming gas | | <ul style="list-style-type: none"> <li>Retain hook to beam (check fixing to beam and replace with new fixings if required).</li> <li>Remove all construction waste.</li> <li>Catalogue all salvaged / stored materials and store in heritage store.</li> <li>Protect gas pipe.</li> <li>Sweep down van and install protection.</li> </ul> | | | |

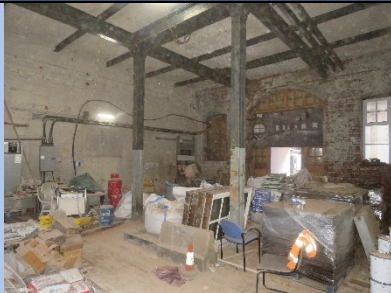
| Room Ref. | Element | Description / Item | Condition | Action | Photographs | | |
|---|---|---|---|---|---|---|---|
| Unit G 0.2 | Walls | Painted brick, minor holes. | Fair | <p>Enabling works</p> <ul style="list-style-type: none"> <li>Remove flaking paint.</li> <li>Fill holes with salvaged red brick and mortar.</li> </ul> <p>Proposed works</p> <ul style="list-style-type: none"> <li>Existing walls stripped back to masonry</li> <li>Existing exposed steel columns and beams to be painted with intumescent paint as NBS:M61/120.</li> </ul> | | | |

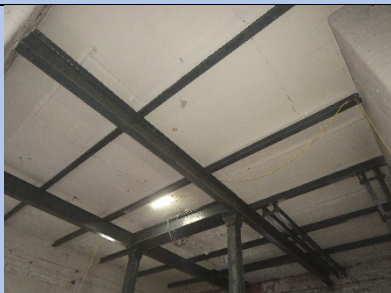
| Room Ref. | Element | Description / Item | Condition | Action | Photographs | | |
|---|---|---|---|---|---|---|---|
| | Ceiling | Plaster on concrete with paint finish. Painted steel beams. | Fair | <p>Enabling works</p> <ul style="list-style-type: none"> <li>Hammer test remaining plaster and remove any bossed plaster.</li> <li>Remove flaking paint.</li> </ul> <p>Proposed works</p> <ul style="list-style-type: none"> <li>Existing exposed concrete soffit to be retained, repaired to SE details and painted in intumescent paint to NBS:Z12/211.</li> </ul> | | | |

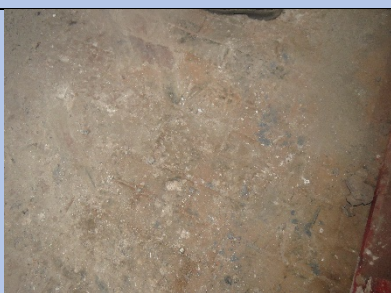
| Room Ref. | Element | Description / Item | Condition | Action | Photographs | | |
|---|---|---|---|---|---|---|---|
| | Floor | Exposed / painted concrete floor. Herringbone brick to entrance. | Fair | <p>Enabling works</p> <ul style="list-style-type: none"> <li>Remove all debris.</li> <li>Clean and protect brick floor.</li> </ul> <p>Proposed works</p> <ul style="list-style-type: none"> <li>Install reclaimed timber parquet flooring. ALLIED LONDON COMMENT: This specification should be reviewed with Purcell prior to works commencing.</li> </ul> | | | |

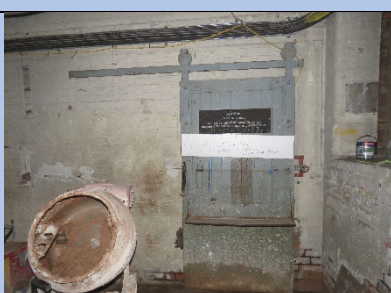
| Room Ref. | Element | Description / Item | Condition | Action | Photographs | | |
|---|---|---|---|---|---|---|---|
| | Joinery | 2no. doors<br>2no. timber partitions<br>Misc. pile of timber. | | <p>Proposed works</p> <ul style="list-style-type: none"> <li>Misc timber to be used for repairs where necessary, otherwise scrapped</li> <li>Timber partitions not present.</li> <li>Sliding door to be removed, catalogued, and stored in heritage store.</li> </ul> <p><i>NOTE: Space being used as builders store, unclear which items below in this space. Above notes provisional for pricing only.</i></p> | | | |

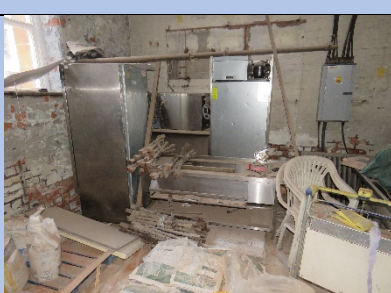
| Room Ref. | Element | Description / Item | Condition | Action | Photographs | | |
|---|---|---|---|---|---|---|---|
| | Misc. | Historic hook fixing to beam. Radiators. General construction materials and salvaged materials. | | <ul style="list-style-type: none"> <li>Retain hook to beam (check fixing to beam and replace with new fixings if required).</li> <li>Remove all construction and kitchen unit waste.</li> <li>Catalogue all salvaged / stored materials</li> </ul> | | | |

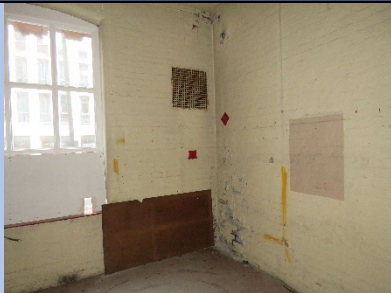
| Room Ref. | Element | Description / Item | Condition | Action | Photographs | | |
|---|---|---|---|---|---|---|---|
| 0.25<br>(hotel recep.) | Walls | Paint on brick.<br>Minor holes to brick. | Fair | Enabling works <ul style="list-style-type: none"> <li>Fill holes to brick with salvaged red brick and mortar.</li> </ul> Proposed works <ul style="list-style-type: none"> <li>Existing walls stripped back to masonry (level of stripping back to be agreed)</li> <li>New black metal crittal style external entrance screen to courtyard and street entrance to be supplied and installed. Refer to Purcell drawing 3205 &amp; 3208.</li> <li>Reclaimed masonry wall to form working fireplace recess.</li> <li>New fire rated black metal crittal style door to be supplied and installed to lift lobby. Refer to Purcell drawing 3208.</li> <li>Existing timber sliding doors refurbished and rehung</li> </ul> | | | |

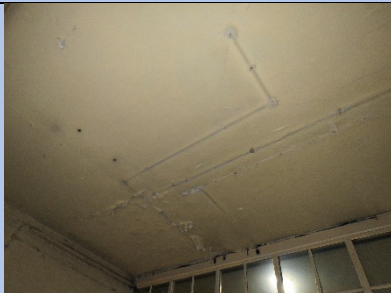
| Room Ref. | Element | Description / Item | Condition | Action | Photographs | | |
|---|---|---|---|---|---|---|---|
| | Ceiling | Plaster on concrete with paint finish.<br>Steel beams. | Fair | Enabling works <ul style="list-style-type: none"> <li>Hammer test remaining plaster and remove any bossed plaster.</li> <li>Remove flaking paint.</li> <li>De-rusted areas corroded steelwork.</li> </ul> Proposed works <ul style="list-style-type: none"> <li>Existing lath and plaster ceiling repaired to non-visual grade, to achieve required fire separation.</li> <li>Existing ceiling to receive coating of intumescent paint spec tbc.</li> <li>Steel beams to receive intumescent paint NBS:M61/120.</li> <li>Provide new suspended ceiling refer to (Ceiling type CT10 refer to drawing 2251)</li> </ul> | | | |

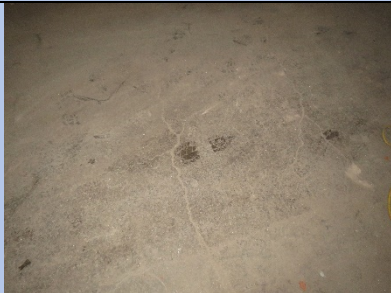
| Room Ref. | Element | Description / Item | Condition | Action | Photographs | | |
|---|---|---|---|---|---|---|---|
| | Floor | Exposed concrete floor with minor area dug out. | Poor | Enabling works <ul style="list-style-type: none"> <li>Clear all debris.</li> </ul> Proposed works <ul style="list-style-type: none"> <li>Install reclaimed parquet floor on resilient layer NBS:M10/295A with inset timber block border detail to reception desk location. Architect to confirm reception desk dimensions and exact location.</li> </ul> | | | |

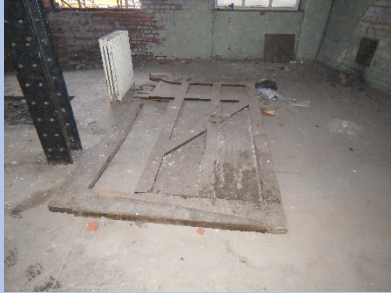
| Room Ref. | Element | Description / Item | Condition | Action | Photographs | | |
|---|---|---|---|---|---|---|---|
| | Joinery | Door architrave.<br>Timber partition<br>Large sliding timber doors. | | <ul style="list-style-type: none"> <li>Remove redundant timber door.</li> </ul> <p><i>NOTE: Access not available at time of survey</i></p> | | | |

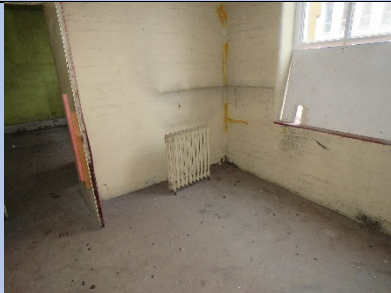
| Room Ref. | Element | Description / Item | Condition | Action | Photographs | | |
|---|---|---|---|---|---|---|---|
| | Misc. | Wall vent<br>Radiator<br>Ventilation control plate.<br>Lift door. | | <ul style="list-style-type: none"> <li>Retain wall vent and control plate and clean.</li> <li>Record radiator and relocate to heritage store.</li> <li>Retain lift door.</li> </ul> | | | |

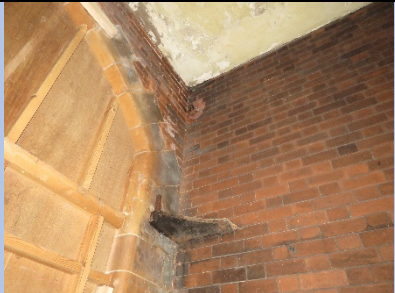
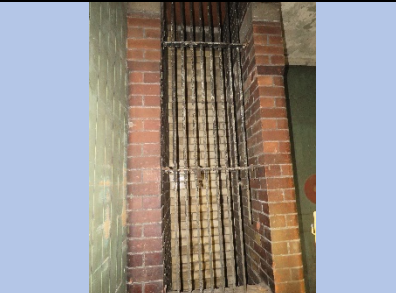
| Room Ref. | Element | Description / Item | Condition | Action | Photographs | | |
|---|---|---|---|---|---|---|--|
| | Misc. | Door brackets.<br>Metal panels. | | <ul style="list-style-type: none"> <li>Clean down and remove flaking paint.</li> <li>Paint door brackets (should have been completed under TC5).</li> <li>Paint metal panel in black RAL 9005.</li> </ul> | | | |
