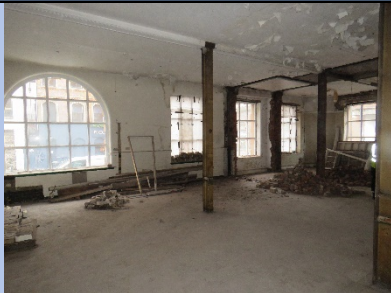
| Room Ref. | Element | Description / Item | Condition | Action | Photographs | | |
|---|---|---|---|---|---|---|---|
| 0.29 | Walls | Plaster on brick with paint or wallpaper finish. Some glazed brick with paint or plaster over. | Fair | <ul style="list-style-type: none"> <li>Existing walls stripped back to masonry (level of stripping back to be agreed) and glazed brickwork (use of peelaway required).</li> <li>New black metal crittal style external entrance screen to courtyard and street entrance.</li> <li>Reclaimed masonry wall to form working fireplace recess.</li> <li>New fire rated black metal crittal style door to lift lobby.</li> <li>Existing timber sliding doors refurbished, cleaned and rehung.</li> </ul> | | | |

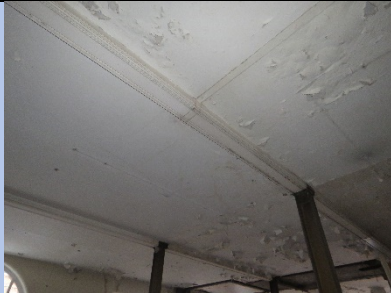
| Room Ref. | Element | Description / Item | Condition | Action | Photographs | | |
|---|---|---|---|---|---|---|---|
| | Ceiling | Plaster on lath with paint finish. | Fair | <ul style="list-style-type: none"> <li>Hammer test remaining plaster and remove any bossed plaster.</li> <li>Remove flaking paint.</li> <li>Existing lath and plaster ceiling repaired to non-visual grade to achieve required fire separation.</li> <li>Existing ceiling to receive coating of intumescent paint. Architect to confirm specification.</li> </ul> | | | |

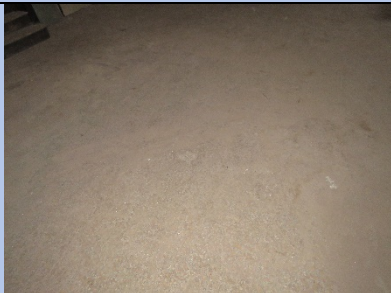
| Room Ref. | Element | Description / Item | Condition | Action | Photographs | | |
|---|---|---|---|---|---|---|---|
| | Floor | Terrazzo. Woodblock | Fair | <ul style="list-style-type: none"> <li>Remove all debris, clean and install protection to terrazzo.</li> <li>Quantify wood block, lift and store on pallet.</li> <li>Reclaimed timber block parquet laid on resilient layer</li> <li>Inset timber block border detail to reception desk location. Architect to confirm reception desk dimensions and location.</li> </ul> | | | |

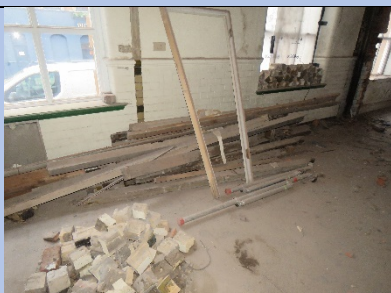
| Room Ref. | Element | Description / Item | Condition | Action | Photographs | | |
|---|---|---|---|---|---|---|---|
| | Joinery | Misc. joinery.<br>Fire surround.<br>Cornice<br>Skirting<br>Picture rail<br>Timber and glazed screens<br>Original double door. | | <ul style="list-style-type: none"> <li>Misc joinery to be reused where possible, otherwise scrapped.</li> <li>Skirting &amp; picture rails to be removed.</li> <li>Glazed screening to be set aside for reuse.</li> </ul> | | | |

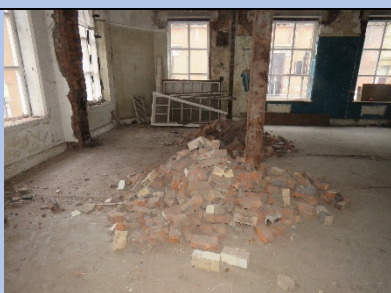
| Room Ref. | Element | Description / Item | Condition | Action | Photographs | | |
|---|---|---|---|---|---|---|---|
| | Misc. | Piles of brick from demolition.<br>Misc. construction materials<br>Fireplace.<br>1no. vent. | | <ul style="list-style-type: none"> <li>Remove loose debris and brickwork and discard or store on pallets.</li> </ul> | | | |

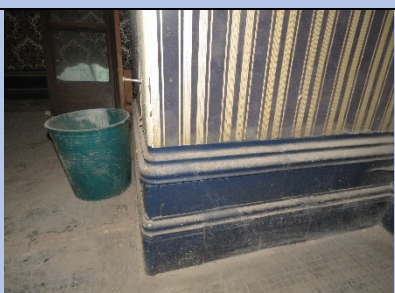
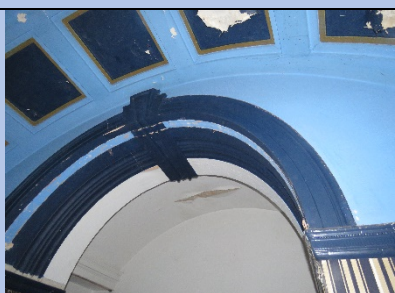
| Room Ref. | Element | Description / Item | Condition | Action | Photographs | | |
|---|---|---|---|---|---|---|---|
| | Misc. | Decorative arch to opening. | | <ul style="list-style-type: none"> <li>N/A</li> </ul> | | | |

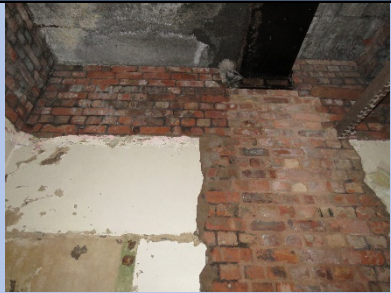
| Room Ref. | Element | Description / Item | Condition | Action | Photographs | | |
|---|---|---|---|---|---|---|--|
| 033 | Walls | Plaster on brick with paint finish. | Poor | <ul style="list-style-type: none"> <li>Hammer test remaining plaster and remove any bossed plaster.</li> <li>Remove flaking paint.</li> <li>Fill any holes with salvaged red brick and mortar.</li> <li>Replace missing lime plaster to specification M20/210.</li> </ul> | | | |

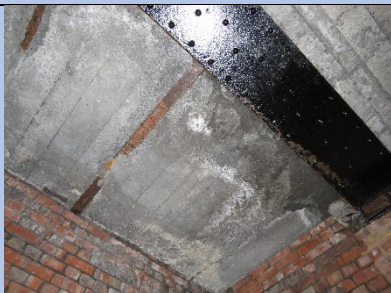
| Room Ref. | Element | Description / Item | Condition | Action | Photographs | | |
|---|---|---|---|---|---|---|--|
| | Ceiling | Exposed concrete and steel beam. Timber ceiling joist. | Fair | <ul style="list-style-type: none"> <li>Remove 2no. timber ceiling joists.</li> <li>Existing exposed concrete soffit to be retained, repaired to SE details.</li> <li>Steel beams to receive intumescent paint NBS:M61/120.</li> <li>Install new suspended ceiling on MF grid consisting of 2 layers 15mm fireboard and skim in preparation for decoration (NBS tbc).</li> </ul> | | | |

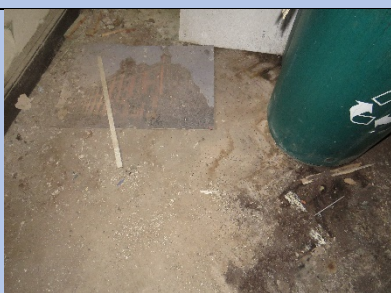
| Room Ref. | Element | Description / Item | Condition | Action | Photographs | | |
|---|---|---|---|---|---|---|--|
| | Floor | Wood block. | Fair | <ul style="list-style-type: none"> <li>Quantify wood block, lift and store on pallet.</li> <li>Existing timber boards and existing timber block (parquet) to be taken up, refurbished, re-laid and re-sealed.</li> </ul> | | | |

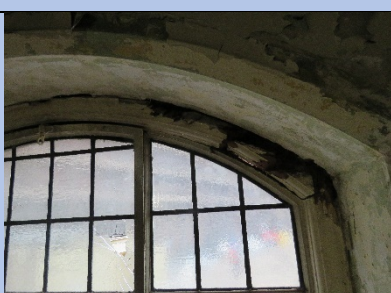
| Room Ref. | Element | Description / Item | Condition | Action | Photographs | | |
|---|---|---|---|---|---|---|--|
| | Joinery | Skirting<br>Door architrave<br>Door<br>Window and frame. | | <ul style="list-style-type: none"> <li>Skirtings to be reinstated complete around perimeter.</li> <li>Doors and architraves to be removed and replaced with new fire doors.</li> </ul> | | | |

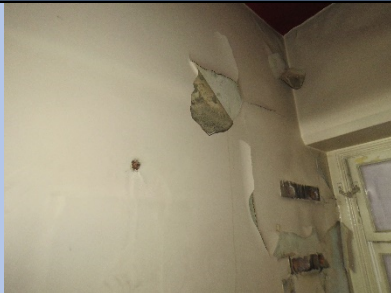
| Room Ref. | Element | Description / Item | Condition | Action | Photographs | | |
|---|---|---|---|---|---|---|--|
| 0.49 | Walls | Plaster on brick with paint finish. | Poor | <ul style="list-style-type: none"> <li>• Hammer test remaining plaster and remove any bossed plaster.</li> <li>• Remove flaking paint.</li> <li>• Fill any holes with salvaged red brick.</li> <li>• Replace missing lime plaster to specification M20/210.</li> </ul> | | | |

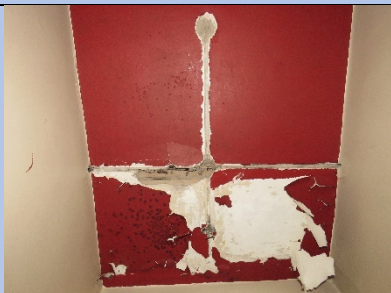
| Room Ref. | Element | Description / Item | Condition | Action | Photographs | | |
|---|---|---|---|---|---|---|--|
| | Ceiling | Plaster on lath with paint finish. | Fair | <ul style="list-style-type: none"> <li>• Hammer test remaining plaster and remove any bossed plaster.</li> <li>• Remove flaking paint.</li> <li>• Existing lath and plaster ceiling to be repaired and to receive intumescent paint coatings to Architects specification</li> </ul> | | | |

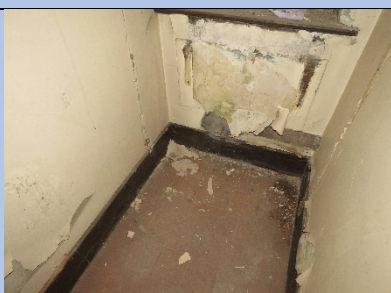
| Room Ref. | Element | Description / Item | Condition | Action | Photographs | | |
|---|---|---|---|---|---|---|--|
| | Floor | Red quarry tile. | Fair | <ul style="list-style-type: none"> <li>• Remove all debris and clean.</li> <li>• Retain red quarry tile finish and protect.</li> </ul> | | | |

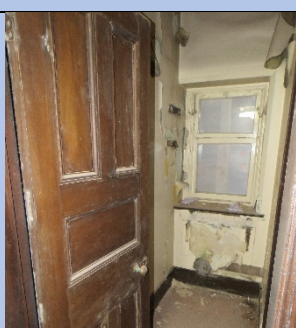
| Room Ref. | Element | Description / Item | Condition | Action | Photographs | | |
|---|---|---|---|---|---|---|--|
| | Joinery | Skirting<br>Door architrave<br>Door | | <ul style="list-style-type: none"> <li>• Skirting to be reinstated fully (render and timber)</li> <li>• Inner door to be retained and refurbished (to architects' specification).</li> <li>• Outer door to be replaced with new fire door (set aside existing for reuse).</li> </ul> | | | |

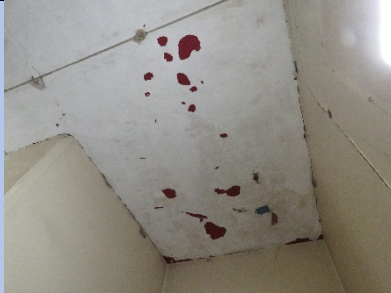
| Room Ref. | Element | Description / Item | Condition | Action | Photographs | | |
|---|---|---|---|---|---|---|---|
| | Ceiling | Plaster on lath with paint finish. | Fair | <ul style="list-style-type: none"> <li>Hammer test remaining plaster and remove any bossed plaster.</li> <li>Remove flaking paint.</li> <li>Existing lath and plaster ceiling to be repaired and to receive intumescent paint coatings to Architects specification.</li> </ul> | | | |

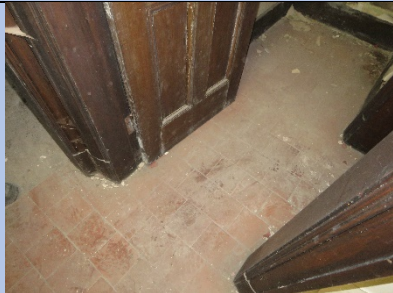
| Room Ref. | Element | Description / Item | Condition | Action | Photographs | | |
|---|---|---|---|---|---|---|---|
| | Floor | Exposed concrete with adhesive residue.<br>Red quarry tile. | Fair | <ul style="list-style-type: none"> <li>Remove all adhesive.</li> <li>Remove all debris, clean and protect.</li> <li>Concrete to be repaired where necessary.</li> <li>Quarry tiles to be cleaned and protected.</li> </ul> | | | |

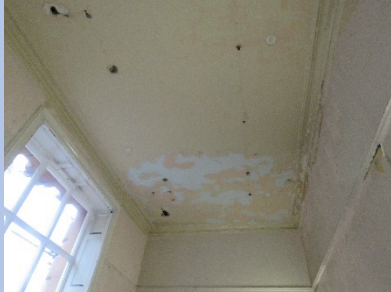
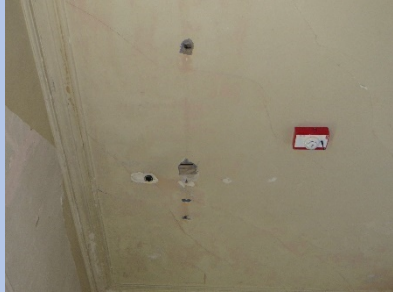
| Room Ref. | Element | Description / Item | Condition | Action | Photographs | | |
|---|---|---|---|---|---|---|---|
| | Ceiling | Plaster on lath with paint finish. Cornice survives. | Fair | <ul style="list-style-type: none"> <li>• Hammer test remaining plaster and remove any bossed plaster.</li> <li>• Remove flaking paint.</li> <li>• Existing lath and plaster ceiling to be repaired and to receive intumescent paint coatings to Architect specification. Cornice to be repaired and reinstated where missing.</li> </ul> | | | |

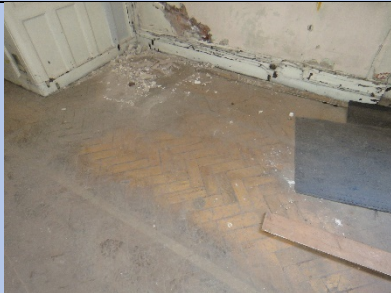
| Room Ref. | Element | Description / Item | Condition | Action | Photographs | | |
|---|---|---|---|---|---|---|---|
| | Floor | Woodblock. Red quarry tile to fireplace. | | <ul style="list-style-type: none"> <li>• Remove all debris.</li> <li>• Quantify wood block, lift and store on pallet.</li> <li>• Clean and protect red quarry tile.</li> <li>• Existing timber boards and existing timber block (parquet) to be refurbished, re-laid and re-sealed.</li> </ul> | | | |

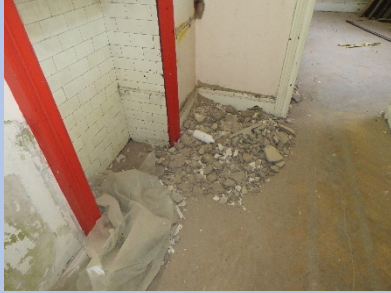
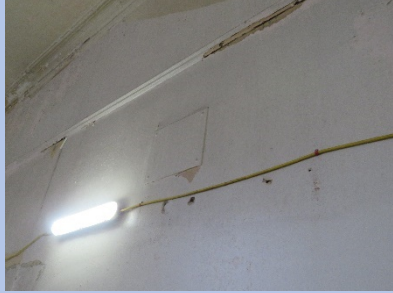
| Room Ref. | Element | Description / Item | Condition | Action | Photographs | | |
|---|---|---|---|---|---|---|---|
| | Misc. | Vent to wall covered over.<br>Redundant M&E conduit.<br>Misc. builders waste | | <ul style="list-style-type: none"> <li>• Remove covering to ventilation grille and clear all debris and fill holes.</li> <li>• Remove conduit and fill holes.</li> <li>• Remove all demolition / builders waste.</li> </ul> | | | |

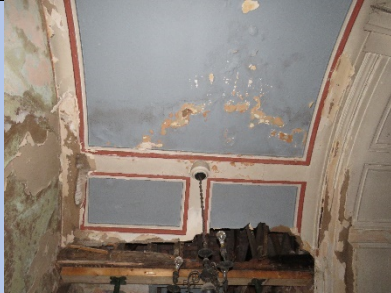
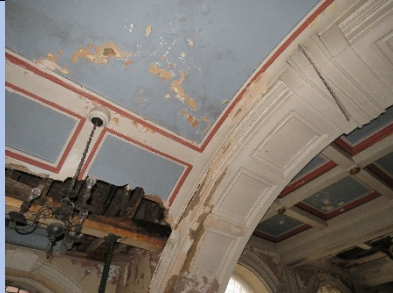
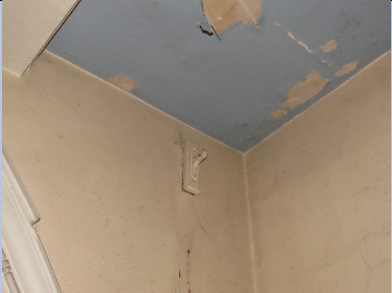
| Room Ref. | Element | Description / Item | Condition | Action | Photographs | | |
|---|---|---|---|---|---|---|---|
| | Ceiling | Plaster on lath with paint finish, barrel vaulted and coffered. | Fair | <ul style="list-style-type: none"> <li>• Hammer test remaining plaster and remove any bossed plaster.</li> <li>• Remove flaking paint.</li> <li>• Existing lath and plaster ceiling, repaired and reinstated where missing and to receive intumescent paint coatings. Cornice to be repaired and reinstated where missing</li> </ul> | | | |

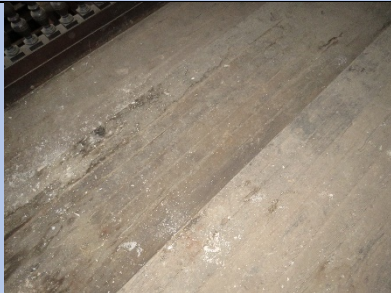
| Room Ref. | Element | Description / Item | Condition | Action | Photographs | | |
|---|---|---|---|---|---|---|---|
| | Floor | Timber floorboards | Fair | <ul style="list-style-type: none"> <li>• Remove all debris, clean and protect.</li> <li>• Existing timber boards to be taken up, refurbished, re-laid and re-sealed.</li> </ul> | | | |

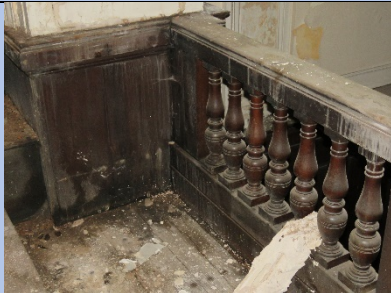
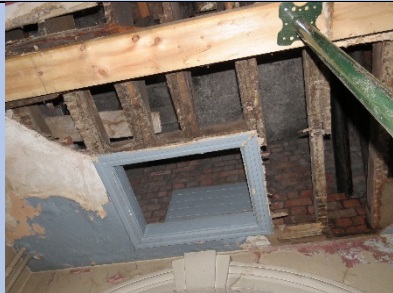
| Room Ref. | Element | Description / Item | Condition | Action | Photographs | | |
|---|---|---|---|---|---|---|---|
| | Joinery | Skirting<br>Wall panelling.<br>Handrail and balusters<br>Ceiling hatch. | | <ul style="list-style-type: none"> <li>• Skirting, wall panelling and handrails all refurbished by specialist</li> <li>• Ceiling hatch to be reinstated</li> </ul> | | | |

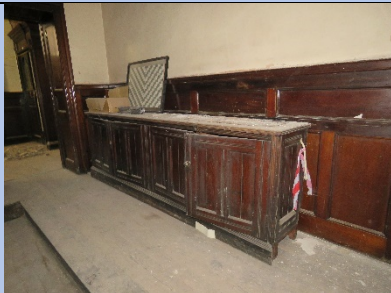
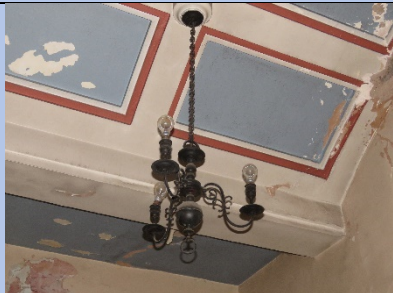
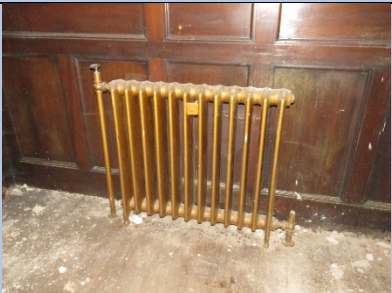
| Room Ref. | Element | Description / Item | Condition | Action | Photographs | | |
|---|---|---|---|---|---|---|---|
| | Misc. | Timber cupboard.<br>2no. light fittings.<br>1no. radiator and bracket.<br>2no. curtain brackets and intermediary chain.<br>Picture frame. | | <ul style="list-style-type: none"> <li>• Clean cupboard and retain in situ.</li> <li>• Protect light fittings in situ.</li> <li>• Retain radiator and pipework.</li> <li>• Record and remove curtain brackets and chain.</li> <li>• Picture frame to go in Heritage Store.</li> <li>• Remove all other waste.</li> </ul> | | | |

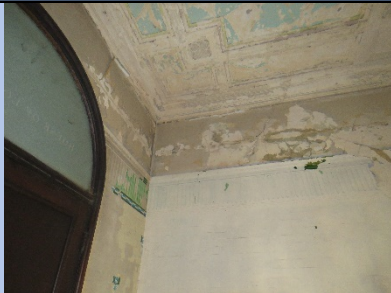
| Room Ref. | Element | Description / Item | Condition | Action | Photographs | | |
|---|---|---|---|---|---|---|---|
| S04 | Walls | Glazed tile, painted over. Plaster on brick with paint finish. Tiled skirting. Crack to wall. | Fair | <ul style="list-style-type: none"> <li>Remove all paint from glazed tiles with peelaway.</li> <li>Hammer test remaining plaster and remove any bossed plaster.</li> <li>Remove flaking paint.</li> <li>Protect all glazed tiles.</li> <li>CURTINS COMMENT: Quadriga to locally remove patch of plaster to enable review of crack please. (crack to wall).</li> <li>Repair lime plaster to plaster walls to specification NBS:M20/210</li> </ul> | | | |

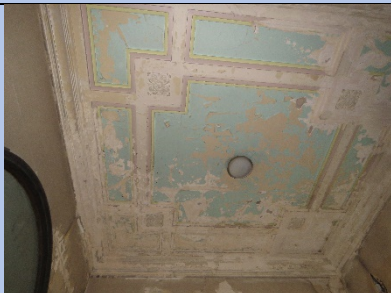
| Room Ref. | Element | Description / Item | Condition | Action | Photographs | | |
|---|---|---|---|---|---|---|---|
| | Ceiling | Plaster on lath with paint finish. Cornice and decorative relief of ceiling survives. | Fair | <ul style="list-style-type: none"> <li>Hammer test remaining plaster and remove any bossed plaster.</li> <li>Remove flaking paint.</li> <li>Existing lath and plaster ceiling to be repaired and to receive intumescent paint coatings to Architect specification. Cornice to be repaired and reinstated where missing.</li> </ul> | | | |

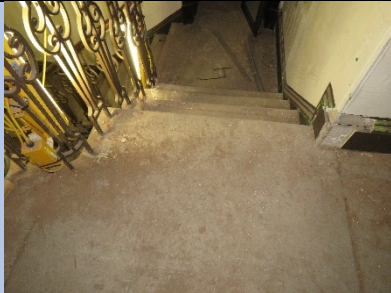
| Room Ref. | Element | Description / Item | Condition | Action | Photographs | | |
|---|---|---|---|---|---|---|---|
| | Floor | Stone slabs and steps. | Fair | <ul style="list-style-type: none"> <li>Remove all adhesive and protect flooring.</li> <li>Stone treads to be repaired &amp; infilled where damaged.</li> </ul> | | | |

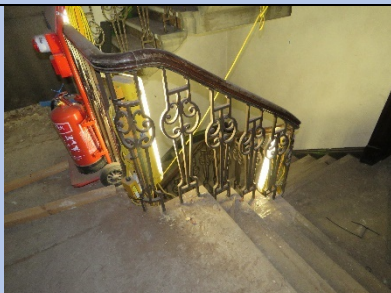
| Room Ref. | Element | Description / Item | Condition | Action | Photographs | | |
|---|---|---|---|---|---|---|---|
| | Misc. | Misc. waste. Cast steel balusters and timber handrail. Light switch. Light fitting & faceplate to ceiling. | | <ul style="list-style-type: none"> <li>Remove all waste.</li> <li>Remove flaking paint from balusters, record condition and install protection.</li> <li>Retain light switch.</li> <li>Remove signage to laylight.</li> <li>Remove light fitting and faceplate to ceiling.</li> <li>Fill any holes in walls / ceilings following removals.</li> </ul> | | | |

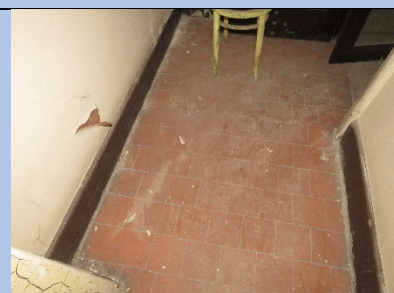
| Room Ref. | Element | Description / Item | Condition | Action | Photographs | | |
|---|---|---|---|---|---|---|---|
| | Floor | Red quarry tile.<br>Toilet base. | | <ul style="list-style-type: none"> <li>Remove toilet base &amp; fill hole remaining in floor.</li> <li>Remove all debris.</li> <li>Clean and protect tiled floor areas.</li> <li>Existing timber boards and existing timber block (parquet) to be taken up, refurbished, re-laid and re-sealed.</li> </ul> | | | |

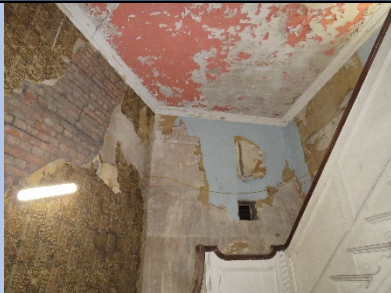
| Room Ref. | Element | Description / Item | Condition | Action | Photographs | | |
|---|---|---|---|---|---|---|---|
| S12 | Walls | Plaster on brick with wallpaper or paint finish.<br>Timber boarding to entrance. | Fair | <ul style="list-style-type: none"> <li>Hammer test remaining plaster and remove any bossed plaster.</li> <li>Remove flaking paint.</li> <li>Remove wallpaper.</li> <li>Large and structural holes to be infilled with reclaimed brickwork.</li> <li>Repair lime plaster as per specification NBS:M21/210.</li> </ul> | | | |

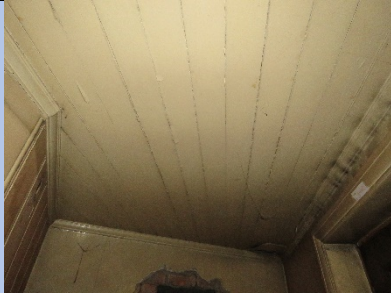
| Room Ref. | Element | Description / Item | Condition | Action | Photographs | | |
|---|---|---|---|---|---|---|---|
| | Ceiling | Plaster on lath with paint finish.<br>Timber boards.<br>Cornice survives. | Fair | <ul style="list-style-type: none"> <li>Hammer test remaining plaster and remove any bossed plaster.</li> <li>Remove flaking paint.</li> <li>Existing timber boarding to be repaired/reinstated where missing and to receive intumescent treatment as per specification Z12/213.</li> <li>(if present) Existing lath and plaster ceiling to be repaired and to receive intumescent paint coatings to Architect specification.</li> </ul> | | | |

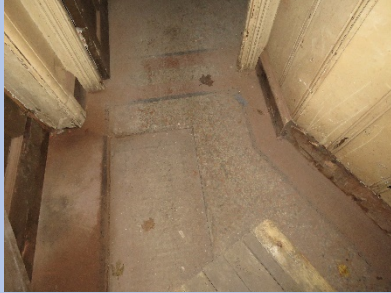
| Room Ref. | Element | Description / Item | Condition | Action | Photographs | | |
|---|---|---|---|---|---|---|---|
| | Floor | Terrazzo.<br>Timber stairs. | Fair | <ul style="list-style-type: none"> <li>Install plyboard to entrance mat recess.</li> <li>Remove all debris, clean, polish and install protection to terrazzo.</li> <li>Remove vinyl tread and nosings to stairs &amp; remove all adhesives.</li> <li>Remove all debris to stairs and install protection.</li> <li>Make cost allowance for floor to be levelled and prepared throughout with latex levelling screed and finished with polished screed as FIN04 2212. Item to be instructed by Architect if required.</li> </ul> | | | |

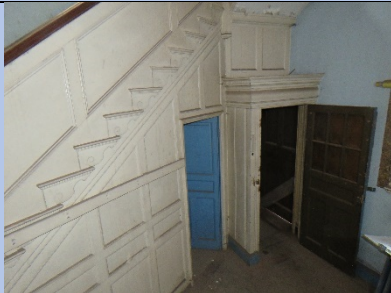
| Room Ref. | Element | Description / Item | Condition | Action | Photographs | | |
|---|---|---|---|---|---|---|---|
| | Joinery | Skirting<br>Timber stair and panelling.<br>Entrance vestibule.<br>Door architraves. | Fair | <ul style="list-style-type: none"> <li>Entrance vestibule and door to be removed.</li> <li>Stair and panelling removed.</li> <li>Skirtings to be reinstated/replaced to walls.</li> </ul> | | | |

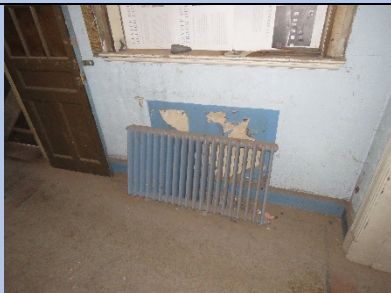
| Room Ref. | Element | Description / Item | Condition | Action | Photographs | | |
|---|---|---|---|---|---|---|---|
| | Misc. | 1no. radiator.<br>1no. window. | | <ul style="list-style-type: none"> <li>Record radiator and window before relocating to Heritage store.</li> </ul> | | | |
