# **BAA.2210 Victoria North HIF Infrastructure Main Works**

## **Emerging Water Technical Note**

Prepared by BAM Nuttall

25/11/22

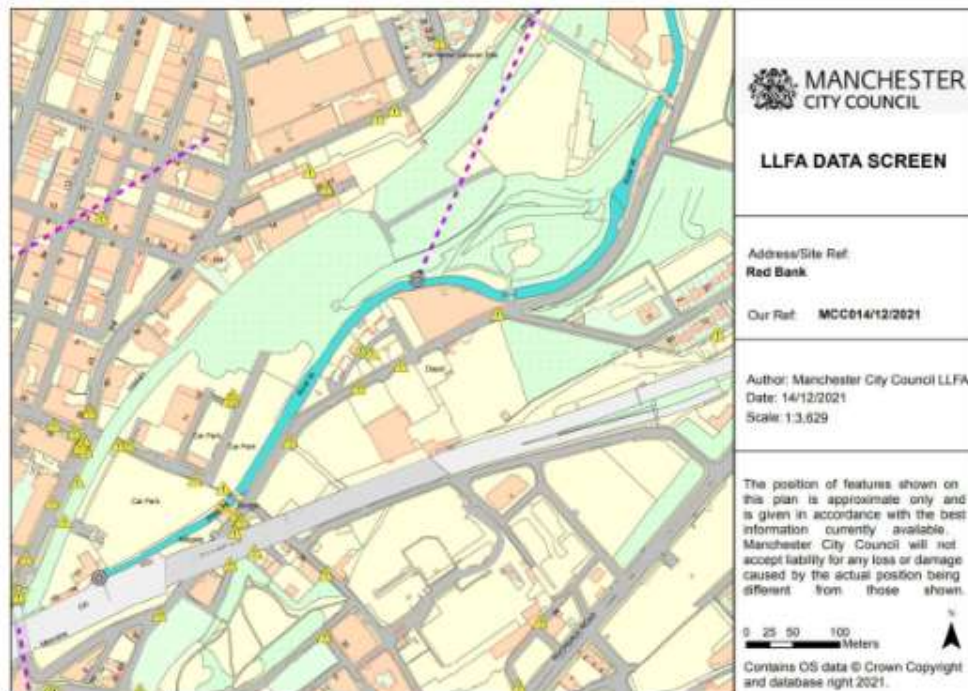
The below drawing was initially provided in an aid to the location of the Culvert. Surveys of existing drainage system to locate any connections to the culvert were undertaken without success.

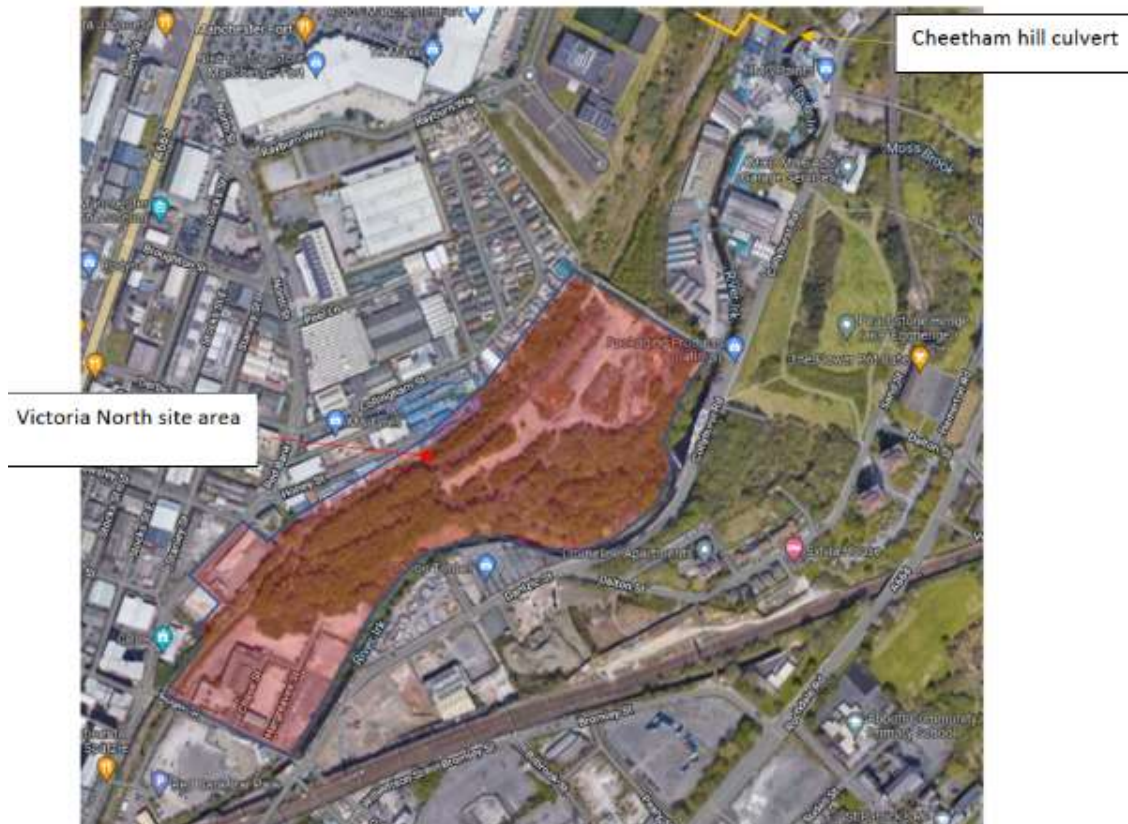
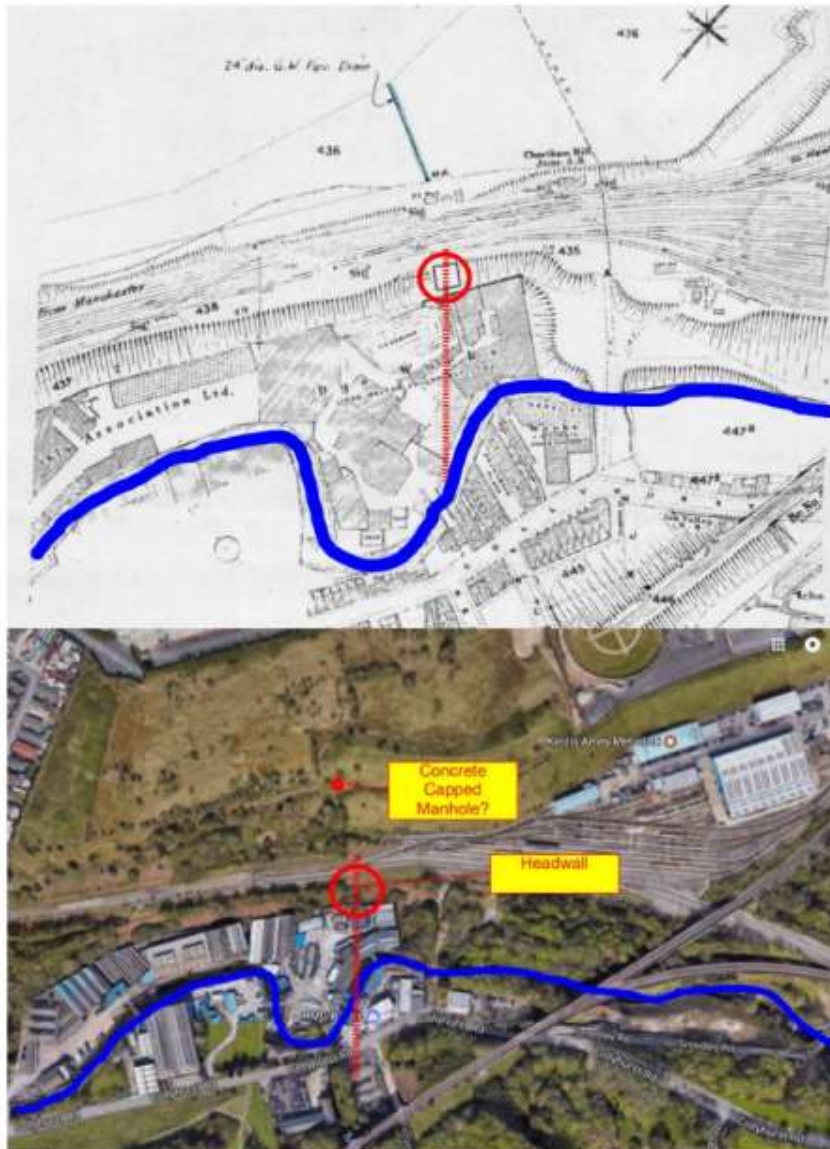
Following investigations and research on previous works undertaken in the wider area it has been discovered that the Cheetham hill culvert does not enter the Victoria North site area.

It was identified that the culvert now runs through the Packaging products site and outfalls into the river irk as shown below upstream of the Victoria North site area.

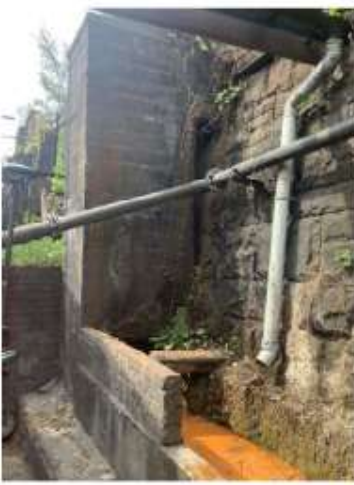
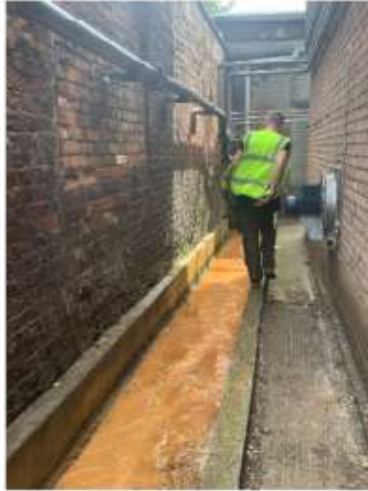
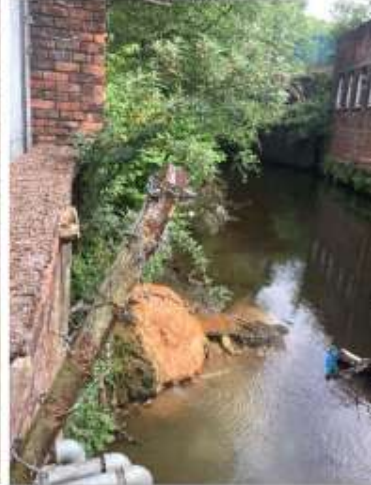
Photos taken 2022 Showing route of culvert to river outfall

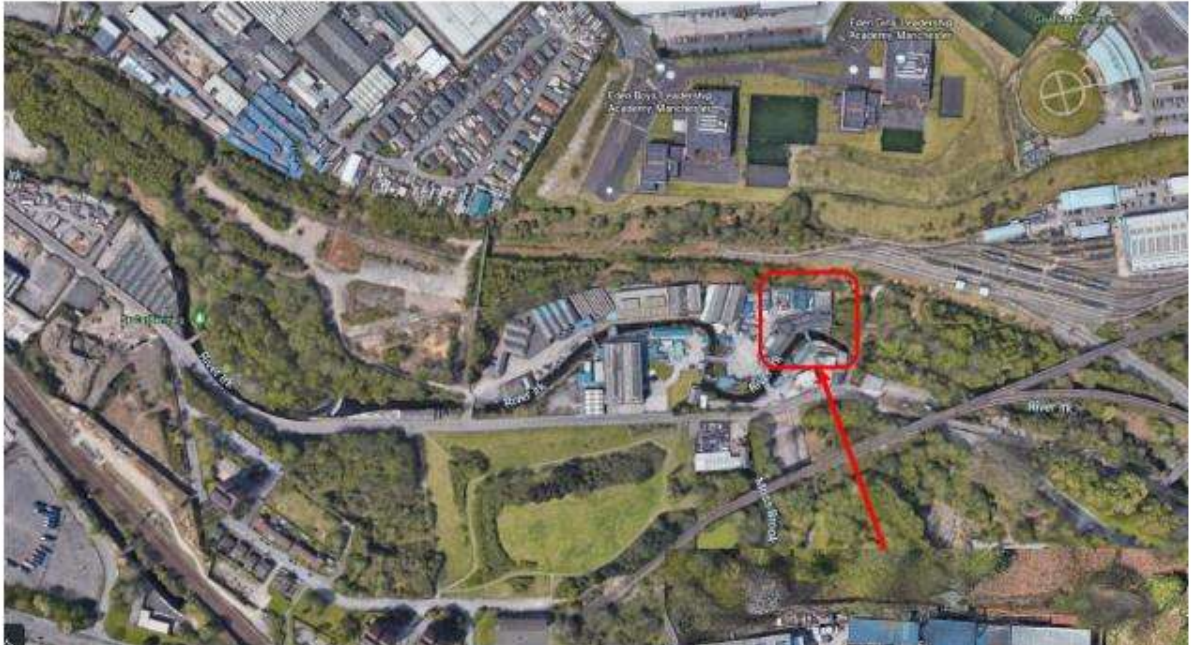
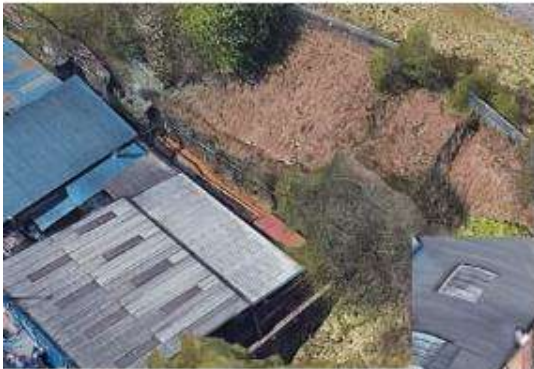
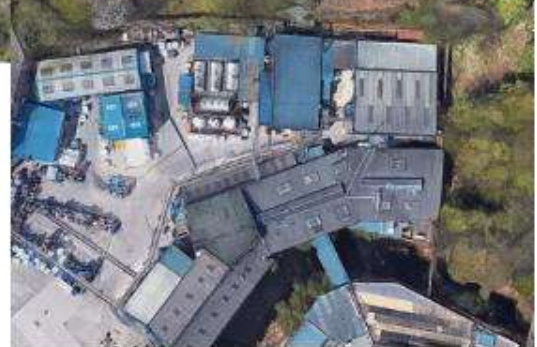
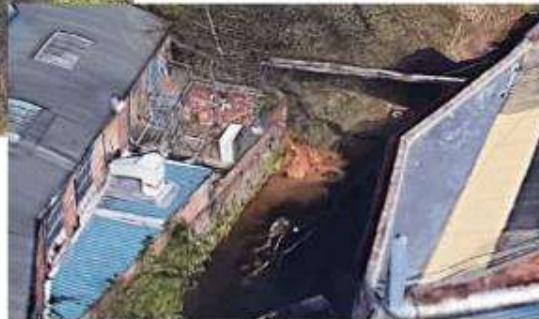
Google Earth screen shots showing location of Cheetham hill Culvert entering River Irk

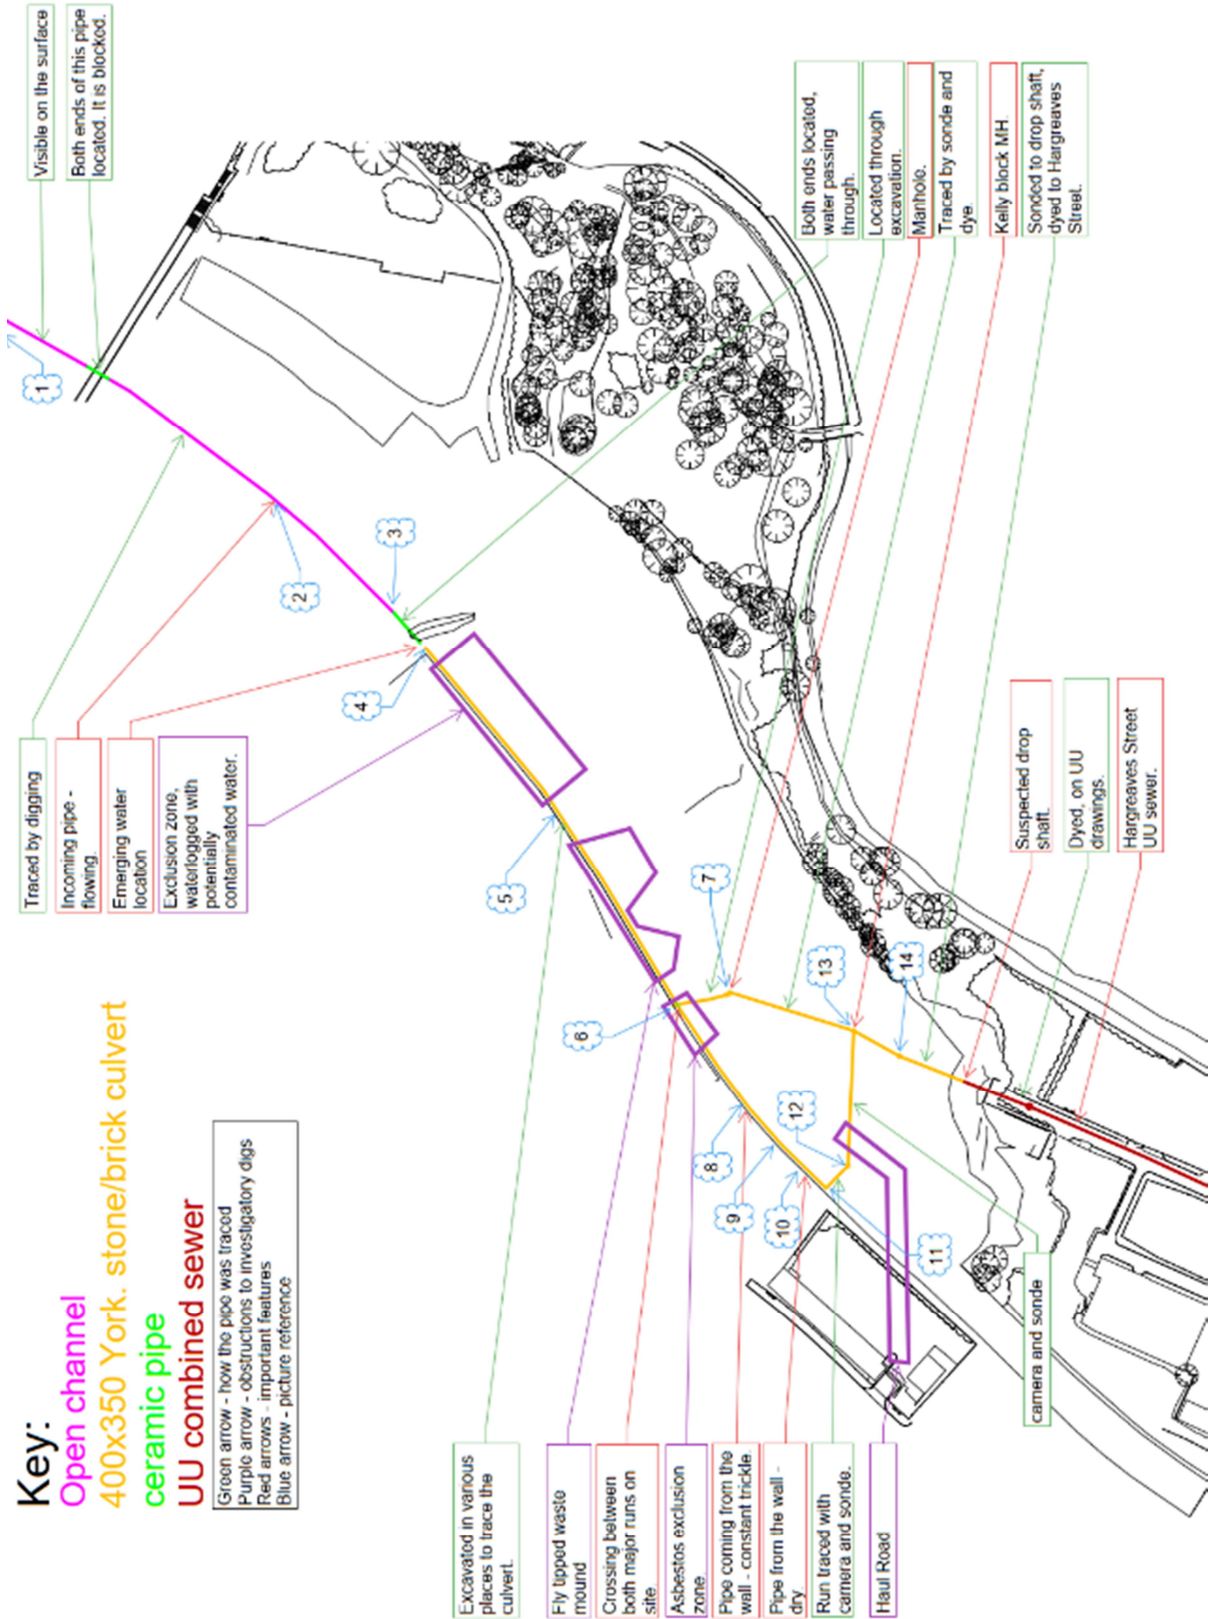
Fig. 14: 6m deep manhole which has water running through it. This manhole looks much more modern than the rest. Dye was put into the water in this chamber which was then seen on Hargreaves Street. We tried to sonde from this chamber but hit an obstruction. We suspect due to no water build up and the level difference between this chamber and Hargreaves Street that there is a drop shaft on this section.
