*Notes to be read in conjunction with Preliminary Drawing MCC\_B01\_R1\_DR\_B\_011\_S3.*

## 1.0 Roof

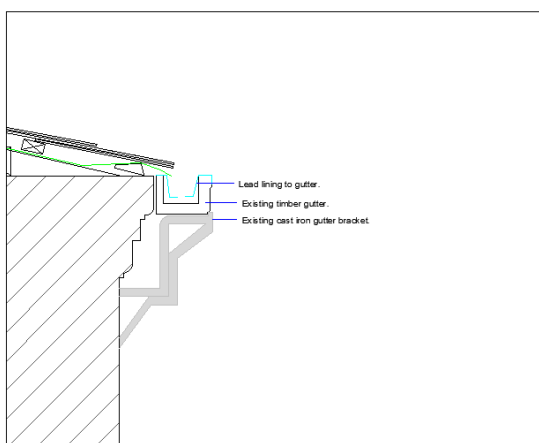
Eaves Detail - As Existing  
NTS

- o The slates have a maximum headlap of 75mm – *typically 130-150mm for a minimum roof pitch of 20°.*
  - o The slates/ underlay have a minimal overhang into the eaves gutters - *typically 45-55mm overhang in accordance with BS5534.*

- o A combination of the above causes overflowing of the gutters during heavy rainfall, saturation of the masonry, and water ingress, resulting damage to building fabric.

- g) Increase slate and underlay overhang into gutter to between 45-55mm in line with BS Standards.
- h) Lead detailing (stepped flashing, soakers, rolled lead ridge) to be replaced with new leadwork in accordance with Lead Sheet Association details – ***can lead alternatives be considered due to high incidences of theft (e.g. zinc)?***

- a) Supply and install new treated timber gutter to existing profile and dimensions; coated internally with a bitumen or similar.
- b) Increase height of lip to outer edge of gutter to eliminate any potential overshoot of rainwater discharge.
- c) Omit lead lining in any replacement to increase internal gutter capacity.
