**Re: Application Number: 124265/FO/2019 – Vacant Land Bounded By Ashton Old Road, Lees Street And Stanley Street , Manchester- Condition 18**

I am writing to seek discharge of Condition 18 related to the installation of the drainage on the scheme.

# Drainage Report

**RETURNFLOW LTD**  
**Surveyor: D Scallan**  
**info@returnflow.co.uk**  
**07547648371**

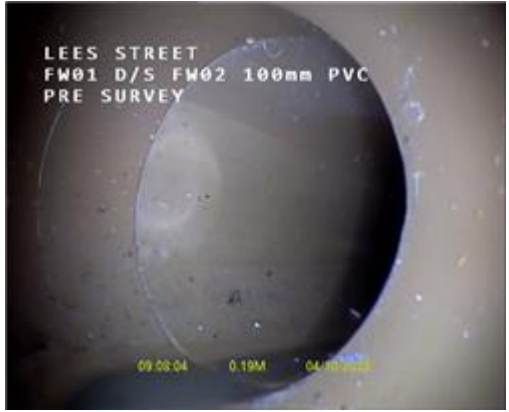
| Pos | Video Ref | Code | Description | Image |
|---|---|---|---|---|
| 00.19m | 0:00:03 | LRH | Line of drain/sewer deviates right [half] | Image Provided - Ref: 0_2<br> |

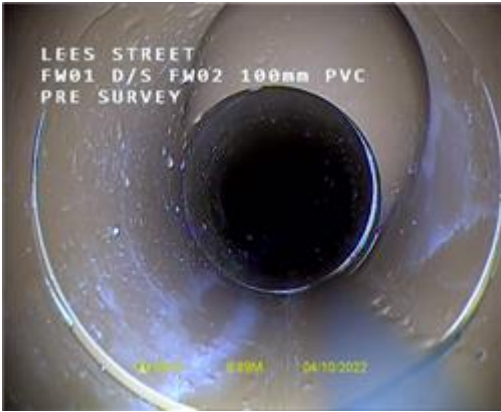
| Pos | Video Ref | Code | Description | Image |
|---|---|---|---|---|
| 09.89m | 0:01:00 | JN | Junction at 02 o'clock: 100mm Diameter | Image Provided - Ref: 0_5<br> |

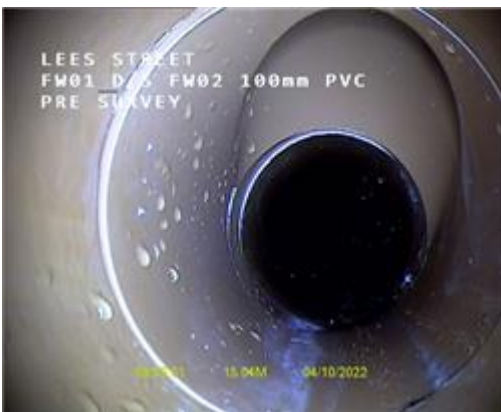
| Pos | Video Ref | Code | Description | Image |
|---|---|---|---|---|
| 15.04m | 0:01:31 | JN | Junction at 02 o'clock: 100mm Diameter | Image Provided - Ref: 0_6<br> |

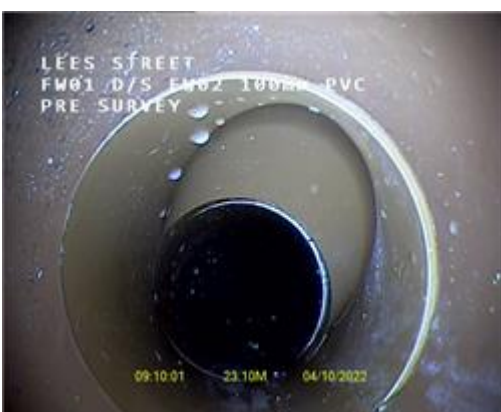
| Pos | Video Ref | Code | Description | Image |
|---|---|---|---|---|
| 23.10m | 0:02:01 | JN | Junction at 02 o'clock: 100mm Diameter | Image Provided - Ref: 0_7<br> |

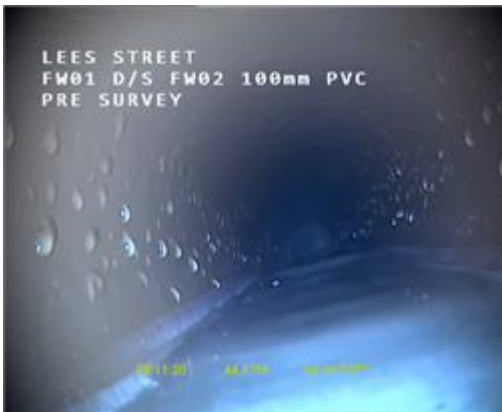
| Pos | Video Ref | Code | Description | Image |
|---|---|---|---|---|
| 44.00m | 0:03:30 | WL | Water level: 5% Height/Diameter | <p>Image Provided - Ref: 0_11</p> |

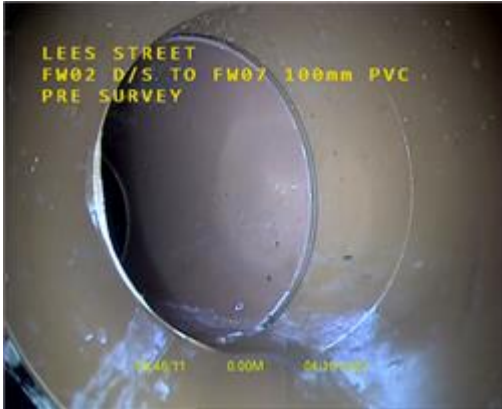
| Pos | Video Ref | Code | Description | Image |
|---|---|---|---|---|
| 00.10m | 0:00:04 | LLH | Line of drain/sewer deviates left [half] | Image Provided - Ref: 1_2<br> |

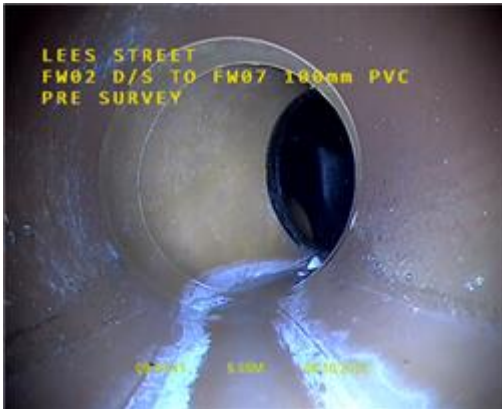
| Pos | Video Ref | Code | Description | Image |
|---|---|---|---|---|
| 05.85m | 0:00:34 | LRQ | Line of drain/sewer deviates right [quarter] | Image Provided - Ref: 1_3<br> |

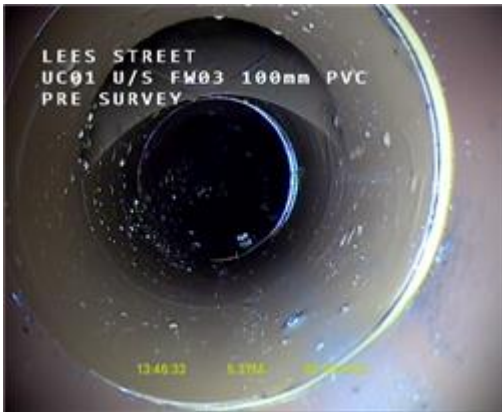
| Pos | Video Ref | Code | Description | Image |
|---|---|---|---|---|
| 05.37m | 0:00:24 | JN | Junction at 01 o'clock: 100mm Diameter | Image Provided - Ref: 4_2<br> |

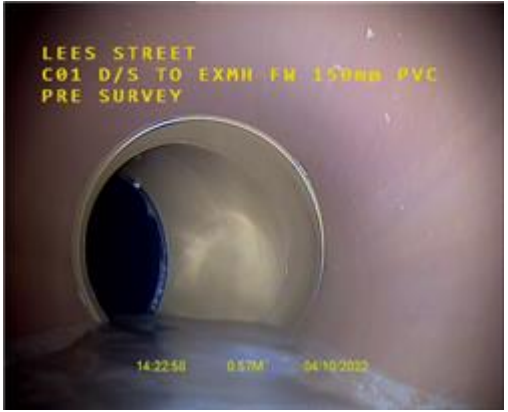
| Pos | Video Ref | Code | Description | Image |
|---|---|---|---|---|
| 00.57m | 0:00:06 | LLH | Line of drain/sewer deviates left [half] | <p>Image Provided - Ref: 9_2</p> |

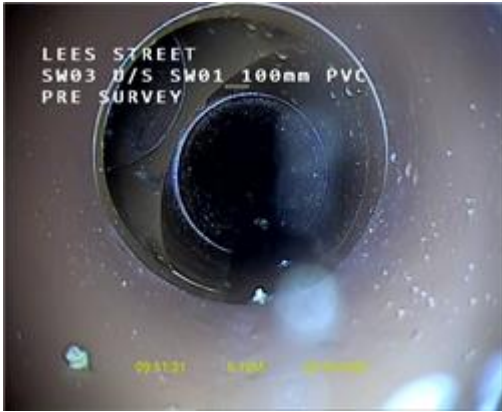
| Pos | Video Ref | Code | Description | Image |
|---|---|---|---|---|
| 05.18m | 0:00:27 | JN | Junction at 10 o'clock: 100mm Diameter | <p>Image Provided - Ref: 1_4</p> |

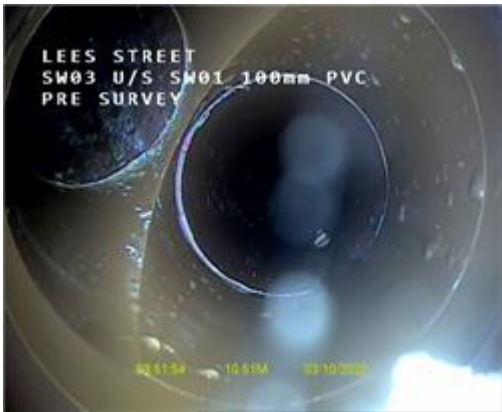
| Pos | Video Ref | Code | Description | Image |
|---|---|---|---|---|
| 10.51m | 0:00:51 | JN | Junction at 09 o'clock: 100mm Diameter | <p>Image Provided - Ref: 1_6</p> |

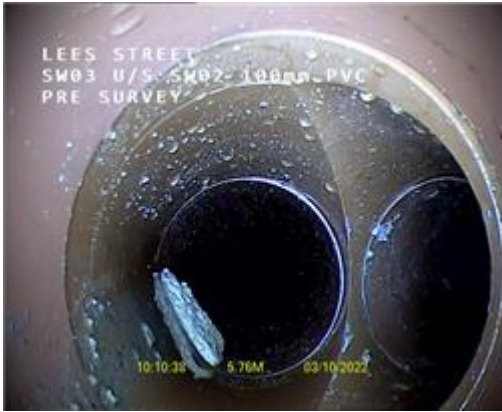
| Pos | Video Ref | Code | Description | Image |
|---|---|---|---|---|
| 05.76m | 0:00:40 | JN | Junction at 01 o'clock: 100mm Diameter | Image Provided - Ref: 2_4<br> |

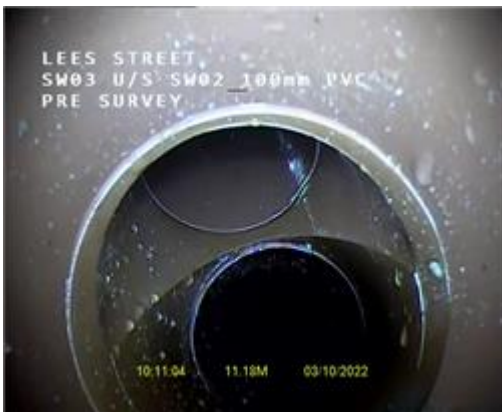
| Pos | Video Ref | Code | Description | Image |
|---|---|---|---|---|
| 11.18m | 0:01:05 | JN | Junction at 12 o'clock: 100mm Diameter | Image Provided - Ref: 2_6<br> |

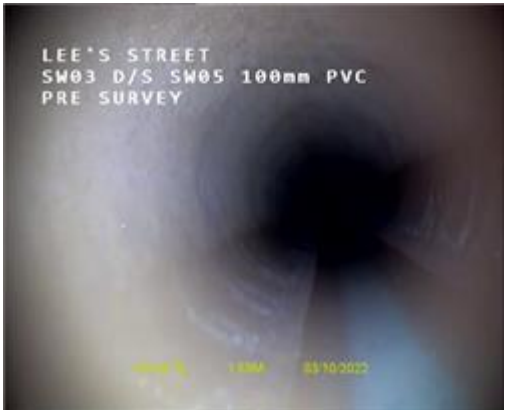
| Pos | Video Ref | Code | Description | Image |
|---|---|---|---|---|
| 01.63m | 0:00:17 | REM | General remark<br>GENERAL PHOTO | Image Provided - Ref: 0_2<br> |

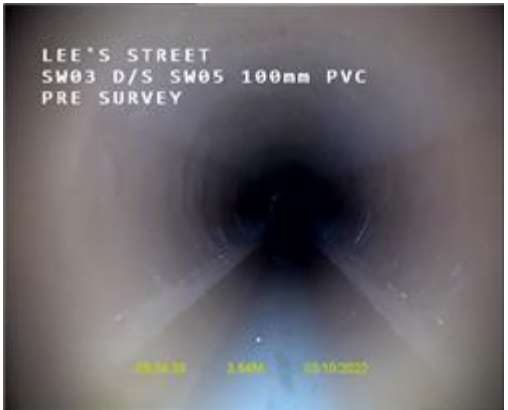
| Pos | Video Ref | Code | Description | Image |
|---|---|---|---|---|
| 03.64m | 0:00:29 | REM | General remark<br>GENERAL PHOTO | Image Provided - Ref: 0_3<br> |

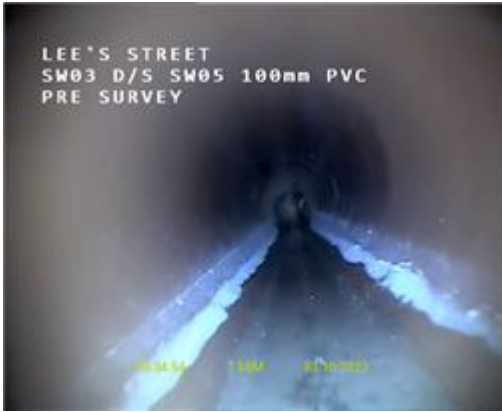
| Pos | Video Ref | Code | Description | Image |
|---|---|---|---|---|
| 07.58m | 0:00:45 | REM | General remark<br>GENERAL PHOTO | <p>Image Provided - Ref: 0_4</p> |

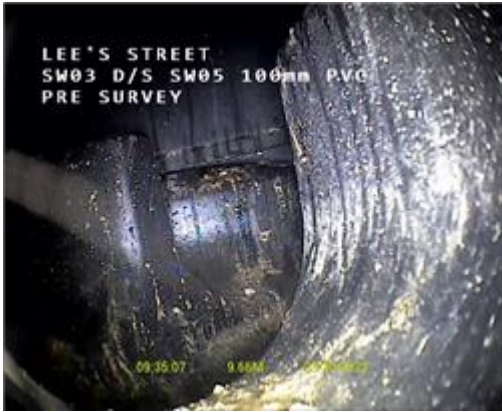
| Pos | Video Ref | Code | Description | Image |
|---|---|---|---|---|
| 09.66m | | MHF | Finish node type, manhole<br>SW05 | <p>Image Provided - Ref: 0_9999</p> |

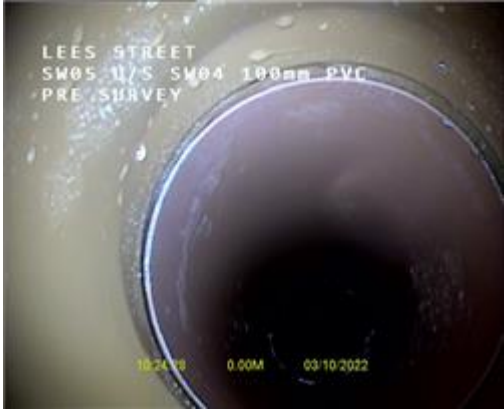
| Pos | Video Ref | Code | Description | Image |
|---|---|---|---|---|
| 00.00m | | MH | Start node type, manhole SW05 | Image Provided - Ref: 4_0<br> |

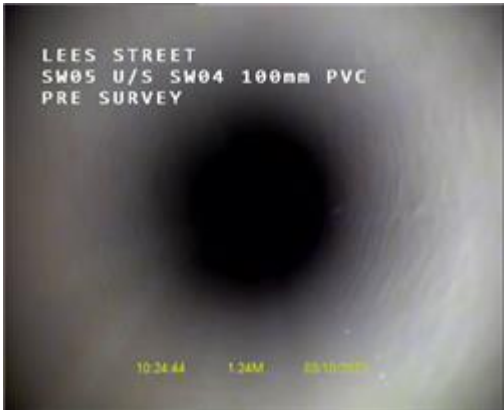
| Pos | Video Ref | Code | Description | Image |
|---|---|---|---|---|
| 01.24m | 0:00:15 | REM | General remark<br>GENERAL PHOTO | Image Provided - Ref: 4_2<br> |

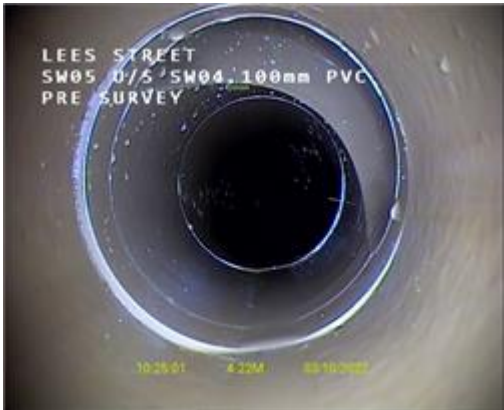
| Pos | Video Ref | Code | Description | Image |
|---|---|---|---|---|
| 04.22m | 0:00:32 | JN | Junction at 02 o'clock: 100mm Diameter | Image Provided - Ref: 4_3<br> |

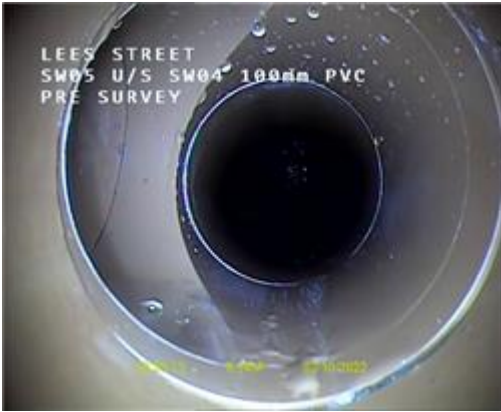
| Pos | Video Ref | Code | Description | Image |
|---|---|---|---|---|
| 06.24m | 0:00:45 | JN | Junction at 09 o'clock: 100mm Diameter | Image Provided - Ref: 4_4<br> |

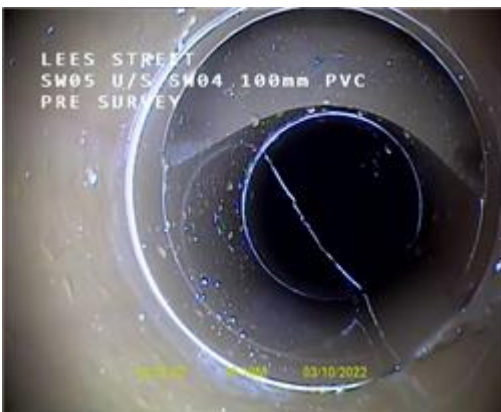
| Pos | Video Ref | Code | Description | Image |
|---|---|---|---|---|
| 10.10m | 0:01:04 | JN | Junction at 01 o'clock: 100mm Diameter | Image Provided - Ref: 4_5<br> |

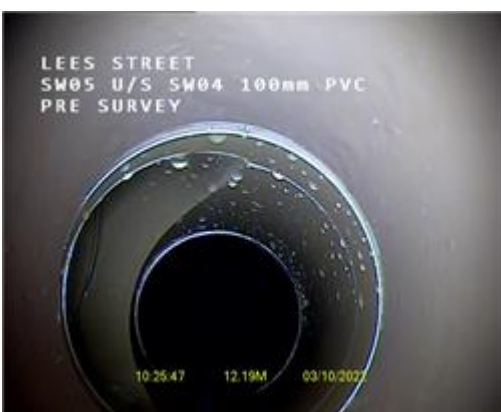
| Pos | Video Ref | Code | Description | Image |
|---|---|---|---|---|
| 12.19m | 0:01:18 | JN | Junction at 09 o'clock: 100mm Diameter | Image Provided - Ref: 4_6<br> |

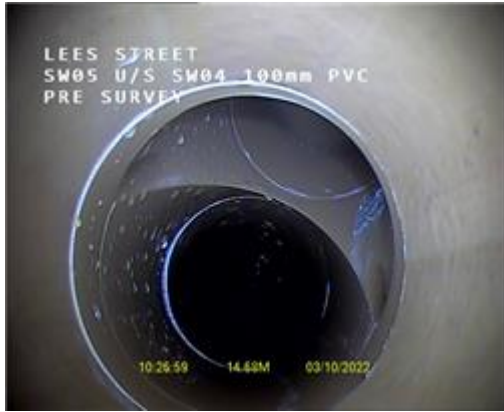
| Pos | Video Ref | Code | Description | Image |
|---|---|---|---|---|
| 14.68m | 0:01:31 | JN | Junction at 03 o'clock: 100mm Diameter | <p>Image Provided - Ref: 4_7</p> |

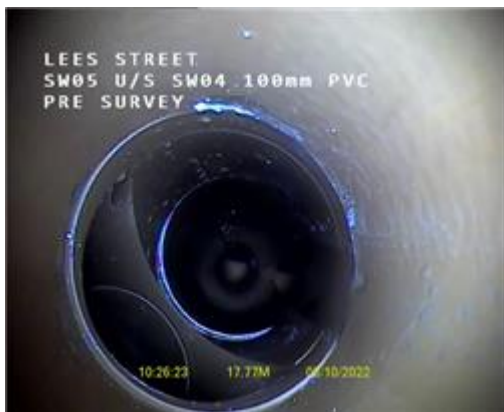
| Pos | Video Ref | Code | Description | Image |
|---|---|---|---|---|
| 17.77m | 0:01:54 | JN | Junction at 09 o'clock: 100mm Diameter | <p>Image Provided - Ref: 4_8</p> |

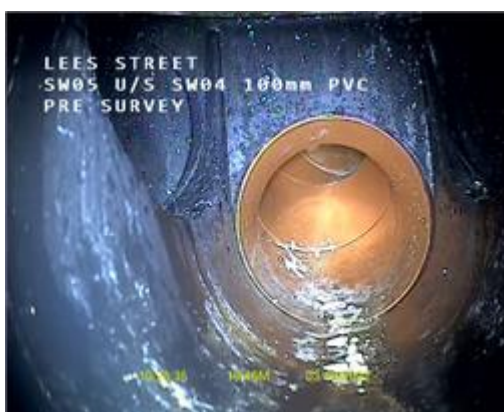
| Pos | Video Ref | Code | Description | Image |
|---|---|---|---|---|
| 19.46m | | MHF | Finish node type, manhole SW04 | <p>Image Provided - Ref: 4_9999</p> |

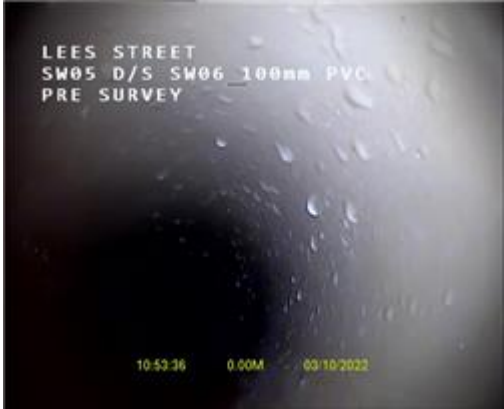
| Pos | Video Ref | Code | Description | Image |
|---|---|---|---|---|
| 00.00m | | MH | Start node type, manhole SW05 | Image Provided - Ref: 3_0<br> |

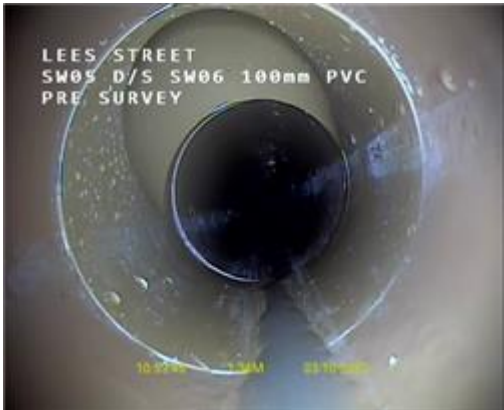
| Pos | Video Ref | Code | Description | Image |
|---|---|---|---|---|
| 01.34m | 0:00:07 | JN | Junction at 12 o'clock: 100mm Diameter | Image Provided - Ref: 3_2<br> |

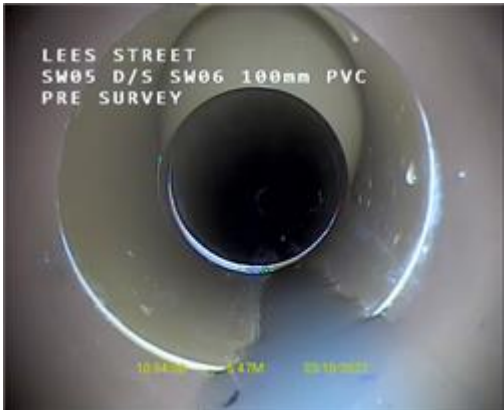
| Pos | Video Ref | Code | Description | Image |
|---|---|---|---|---|
| 05.47m | 0:00:24 | JN | Junction at 12 o'clock: 100mm Diameter | Image Provided - Ref: 3_3<br> |

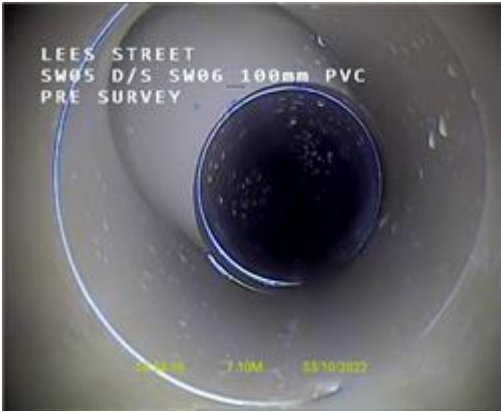
| Pos | Video Ref | Code | Description | Image |
|---|---|---|---|---|
| 07.10m | 0:00:29 | JN | Junction at 11 o'clock: 100mm Diameter | Image Provided - Ref: 3_4<br> |

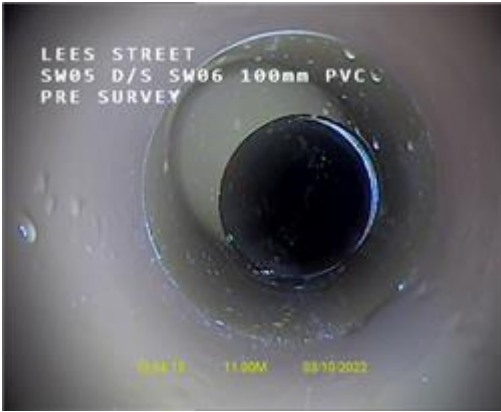
| Pos | Video Ref | Code | Description | Image |
|---|---|---|---|---|
| 11.00m | 0:00:42 | JN | Junction at 11 o'clock: 100mm Diameter | Image Provided - Ref: 3_5<br> |

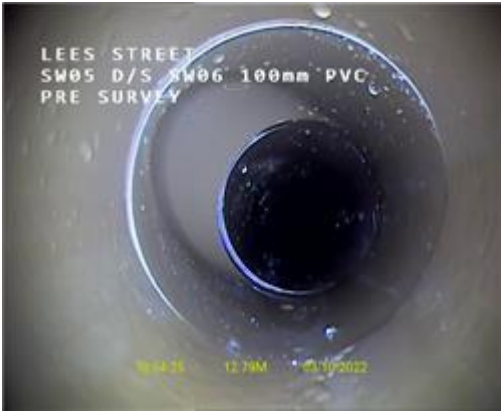
| Pos | Video Ref | Code | Description | Image |
|---|---|---|---|---|
| 12.79m | 0:00:48 | JN | Junction at 10 o'clock: 100mm Diameter | Image Provided - Ref: 3_6<br> |

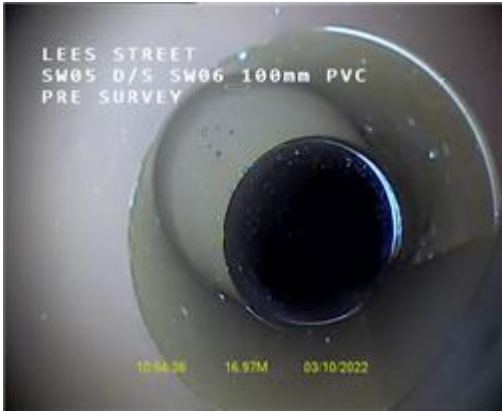
| Pos | Video Ref | Code | Description | Image |
|---|---|---|---|---|
| 16.97m | 0:01:00 | JN | Junction at 09 o'clock: 100mm Diameter | <p>Image Provided - Ref: 3_7</p> |

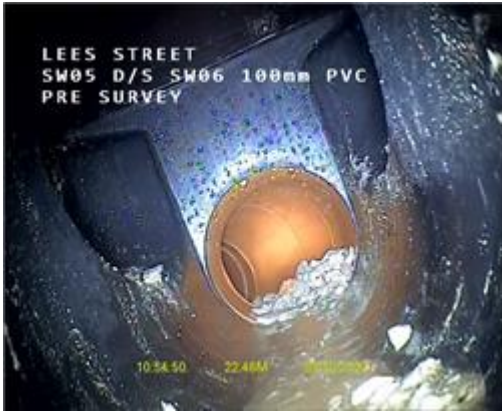
| Pos | Video Ref | Code | Description | Image |
|---|---|---|---|---|
| 22.46m | | MHF | Finish node type, manhole SW06 | <p>Image Provided - Ref: 3_9999</p> |

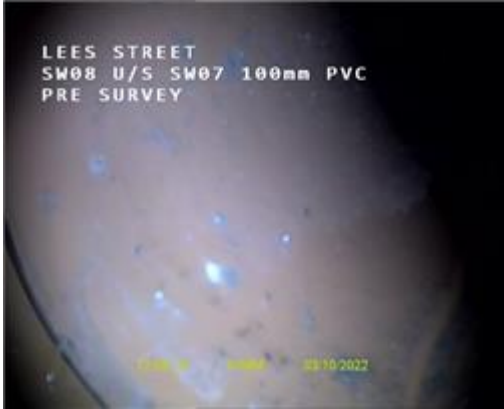
| Pos | Video Ref | Code | Description | Image |
|---|---|---|---|---|
| 00.00m | | MH | Start node type, manhole SW08 | Image Provided - Ref: 6_0<br> |

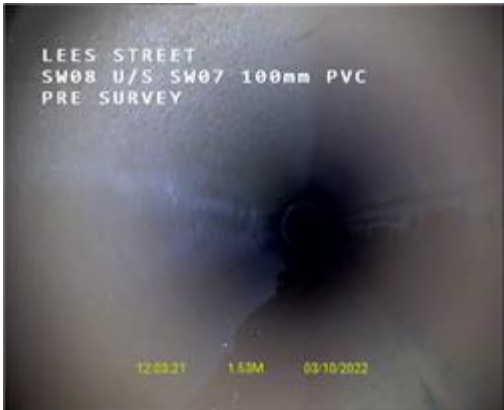
| Pos | Video Ref | Code | Description | Image |
|---|---|---|---|---|
| 01.53m | 0:00:09 | REM | General remark<br>GENERAL PHOTO | Image Provided - Ref: 6_2<br> |

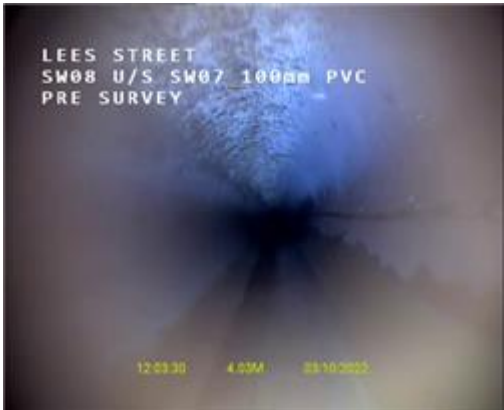
| Pos | Video Ref | Code | Description | Image |
|---|---|---|---|---|
| 04.03m | 0:00:19 | REM | General remark<br>GENERAL PHOTO | Image Provided - Ref: 6_3<br> |

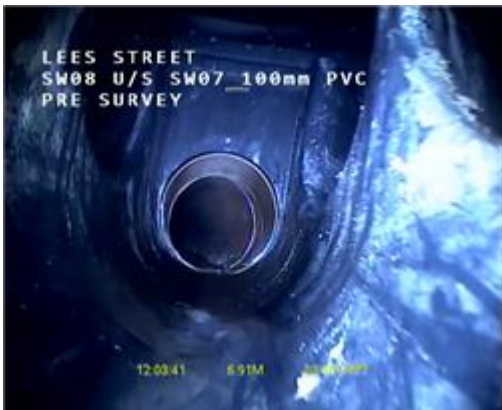
| Pos | Video Ref | Code | Description | Image |
|---|---|---|---|---|
| 06.91m | | MHF | Finish node type, manhole SW07 | <p>Image Provided - Ref: 6_9999</p> |

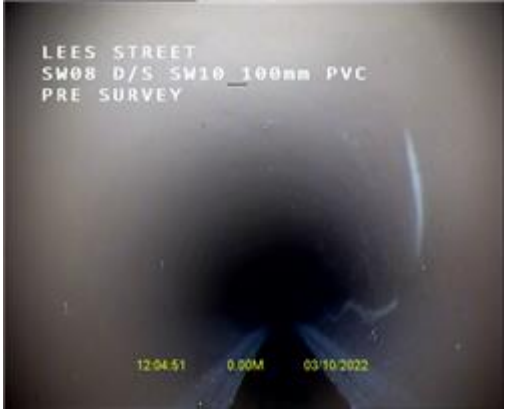
| Pos | Video Ref | Code | Description | Image |
|---|---|---|---|---|
| 00.00m | | MH | Start node type, manhole SW08 | Image Provided - Ref: 5_0<br> |

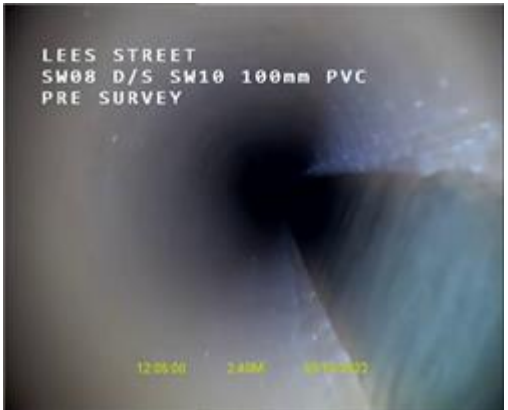
| Pos | Video Ref | Code | Description | Image |
|---|---|---|---|---|
| 02.40m | 0:00:09 | REM | General remark<br>GENERAL PHOTO | Image Provided - Ref: 5_2<br> |

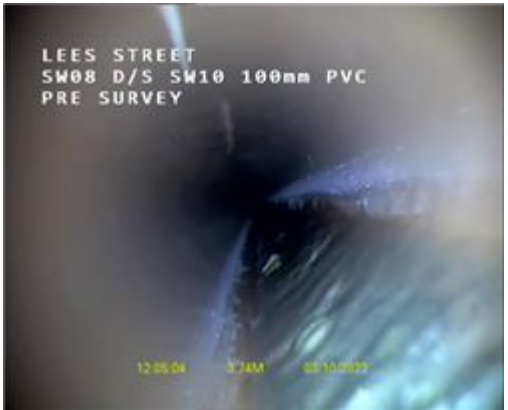
| Pos | Video Ref | Code | Description | Image |
|---|---|---|---|---|
| 03.74m | 0:00:13 | REM | General remark<br>GENERAL PHOTO | Image Provided - Ref: 5_3<br> |

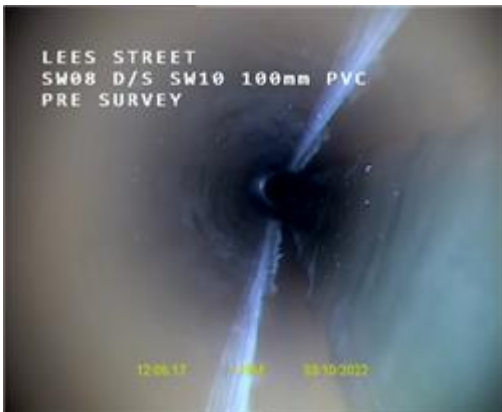
| Pos | Video Ref | Code | Description | Image |
|---|---|---|---|---|
| 07.39m | 0:00:26 | REM | General remark<br>GENERAL PHOTO | <p>Image Provided - Ref: 5_4</p> |

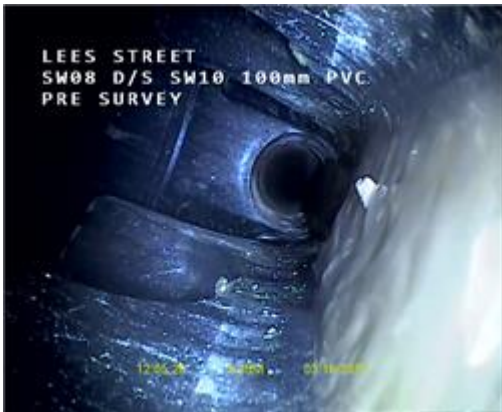
| Pos | Video Ref | Code | Description | Image |
|---|---|---|---|---|
| 08.35m | | MHF | Finish node type, manhole<br>SW10 | <p>Image Provided - Ref: 5_9999</p> |

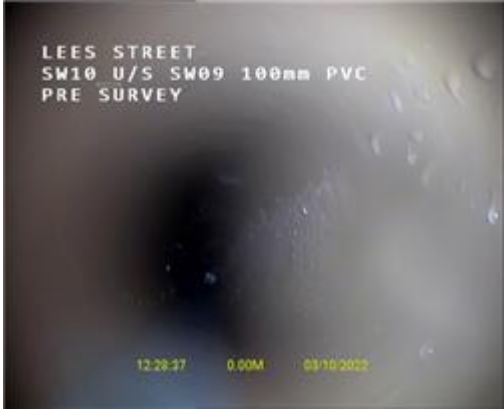
| Pos | Video Ref | Code | Description | Image |
|---|---|---|---|---|
| 00.00m | | MH | Start node type, manhole SW10 | Image Provided - Ref: 8_0<br> |

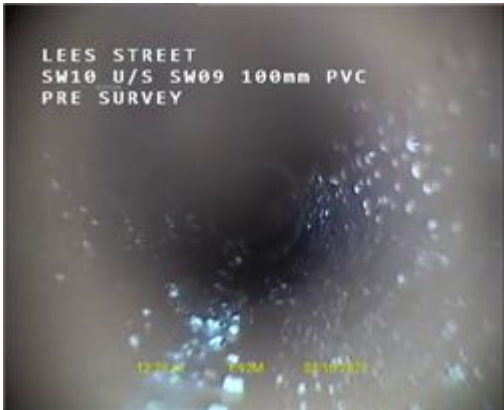
| Pos | Video Ref | Code | Description | Image |
|---|---|---|---|---|
| 01.92m | 0:00:10 | REM | General remark<br>GENERAL PHOTO | Image Provided - Ref: 8_2<br> |

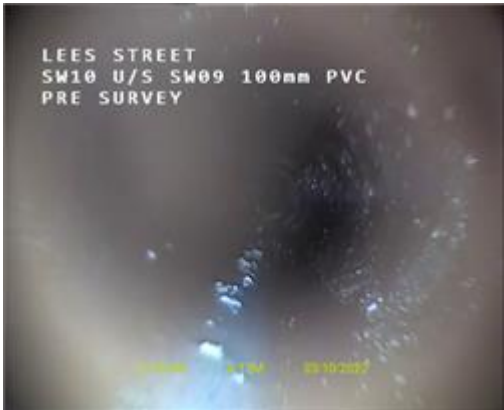
| Pos | Video Ref | Code | Description | Image |
|---|---|---|---|---|
| 04.12m | 0:00:17 | REM | General remark<br>GENERAL PHOTO | Image Provided - Ref: 8_3<br> |

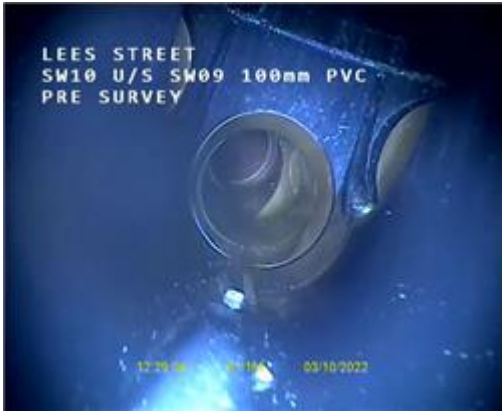
| Pos | Video Ref | Code | Description | Image |
|---|---|---|---|---|
| 06.81m | | MHF | Finish node type, manhole SW09 | <p>Image Provided - Ref: 8_9999</p> |

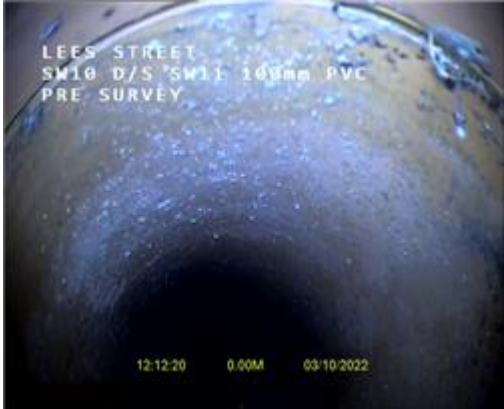
| Pos | Video Ref | Code | Description | Image |
|---|---|---|---|---|
| 00.00m | | MH | Start node type, manhole SW10 | Image Provided - Ref: 7_0<br> |

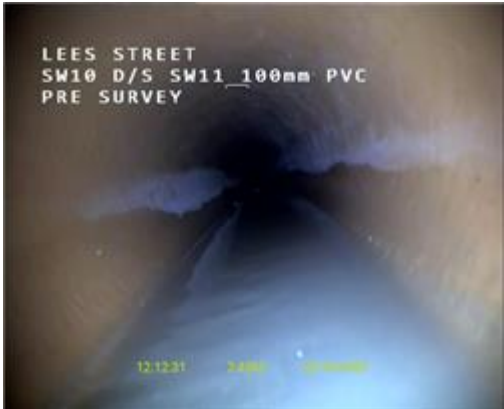
| Pos | Video Ref | Code | Description | Image |
|---|---|---|---|---|
| 02.40m | 0:00:00 | WL | Water level: 10% Height/Diameter | Image Provided - Ref: 7_1<br> |

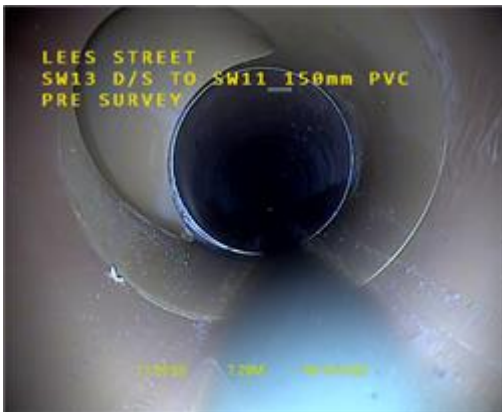
| Pos | Video Ref | Code | Description | Image |
|---|---|---|---|---|
| 07.29m | 0:00:32 | JN | Junction at 09 o'clock: 100mm Diameter | <p>Image Provided - Ref: 11_4</p> |

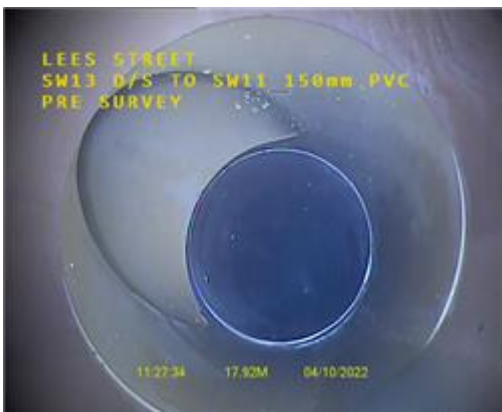
| Pos | Video Ref | Code | Description | Image |
|---|---|---|---|---|
| 17.92m | 0:01:16 | JN | Junction at 09 o'clock: 100mm Diameter | <p>Image Provided - Ref: 11_8</p> |

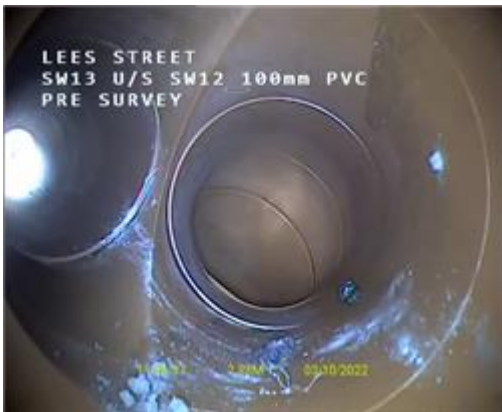
| Pos | Video Ref | Code | Description | Image |
|---|---|---|---|---|
| 02.88m | 0:00:31 | JN | Junction at 09 o'clock: 100mm Diameter | Image Provided - Ref: 13_3<br> |

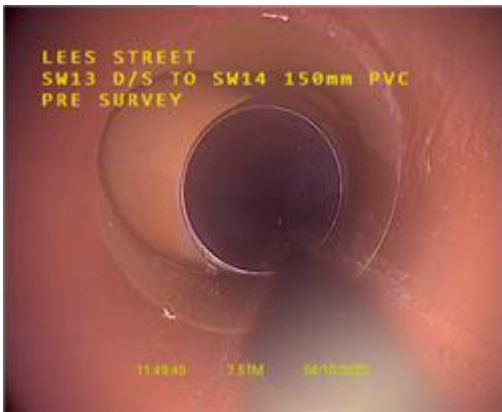
| Pos | Video Ref | Code | Description | Image |
|---|---|---|---|---|
| 07.51m | 0:00:37 | JN | Junction at 09 o'clock: 100mm Diameter | <p>Image Provided - Ref: 12_4</p> |

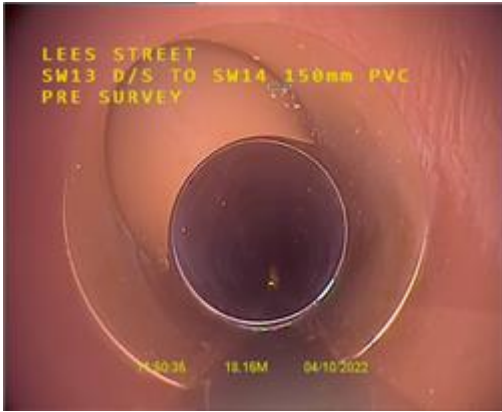
| Pos | Video Ref | Code | Description | Image |
|---|---|---|---|---|
| 18.16m | 0:01:34 | JN | Junction at 10 o'clock: 100mm Diameter | <p>Image Provided - Ref: 12_7</p> |

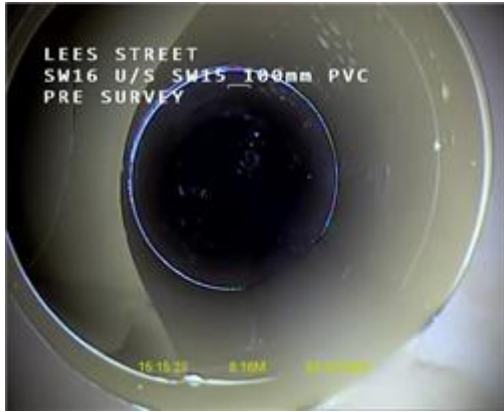
| Pos | Video Ref | Code | Description | Image |
|---|---|---|---|---|
| 08.16m | 0:00:27 | JN | Junction at 09 o'clock: 100mm Diameter | <p>Image Provided - Ref: 16_4</p> |

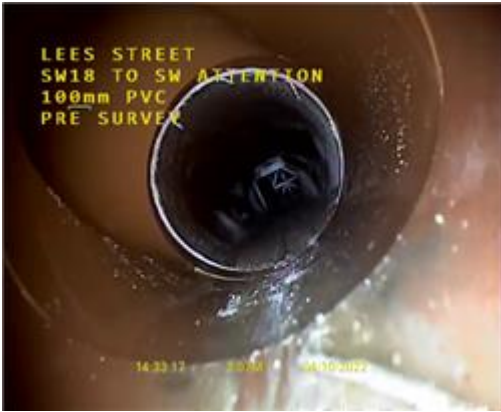
| Pos | Video Ref | Code | Description | Image |
|---|---|---|---|---|
| 03.07m | 0:00:22 | JN | Junction at 09 o'clock: 100mm Diameter | <p>Image Provided - Ref: 18_4</p> |

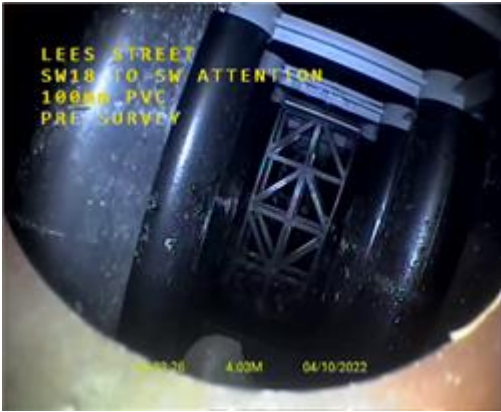
| Pos | Video Ref | Code | Description | Image |
|---|---|---|---|---|
| 04.03m | | SKF | Finish node type, soakaway SW ATTENTION | <p>Image Provided - Ref: 18_9999</p> |

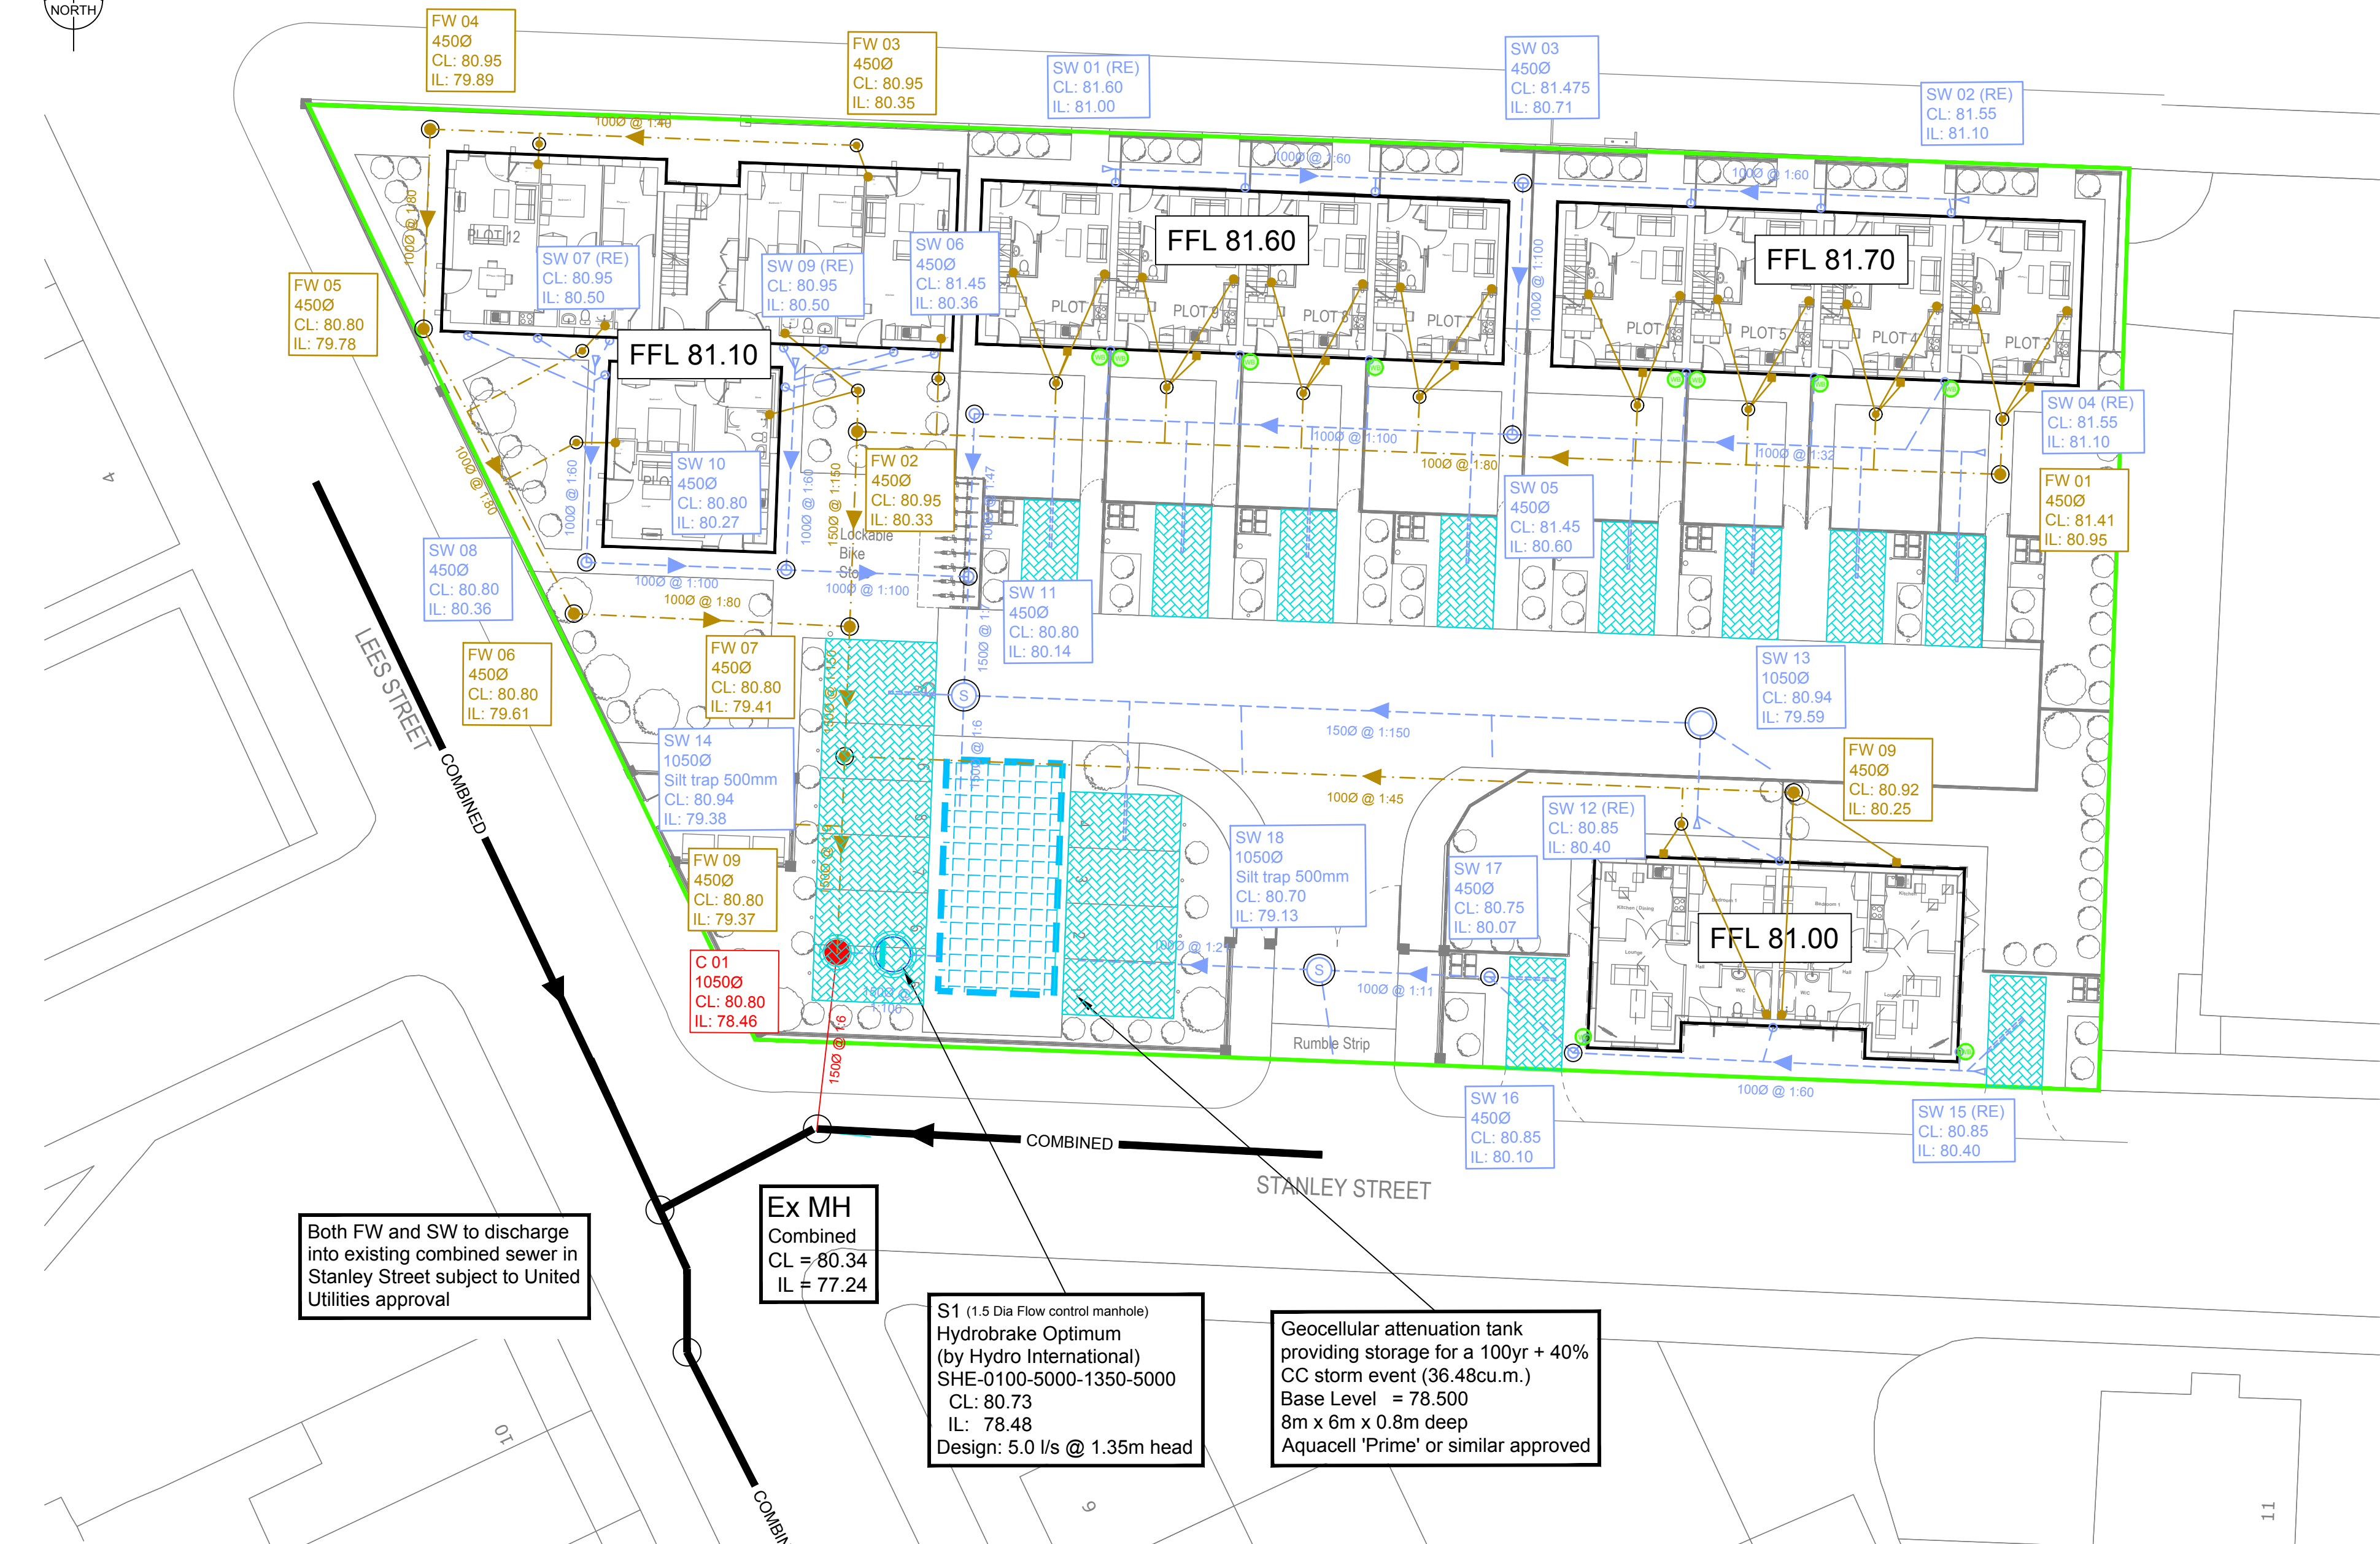
S1 (1.5 Dia Flow control manhole)  
Hydrobrake Optimum  
(by Hydro International)  
SHE-0100-5000-1350-5000  
CL: 80.73  
IL: 78.48  
Design: 5.0 l/s @ 1.35m head

Geocellular attenuation tank  
providing storage for a 100yr + 40%  
CC storm event (36.48cu.m.)  
Base Level = 78.500  
8m x 6m x 0.8m deep  
Aquacell 'Prime' or similar approved
