## ROOF CONDITION ASSESSMENT

GREAT NORTHERN & DEANSGATE TERRACES

MANCHESTER M3

Report Ref. 22029/1

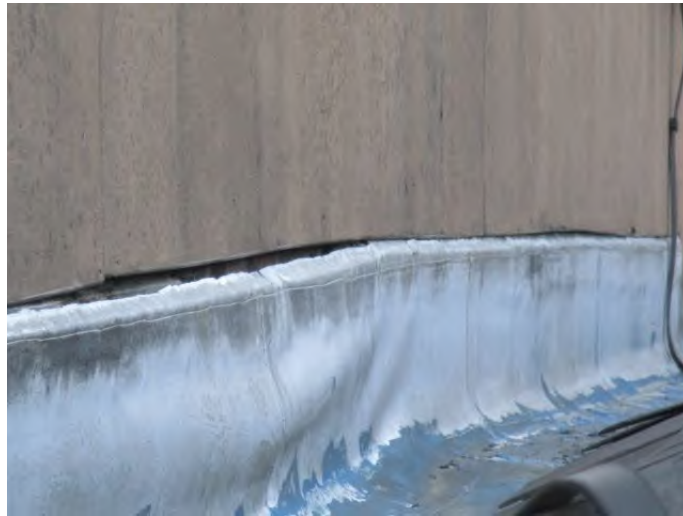
10. The single ply membrane was not weathered into the parapets in places.

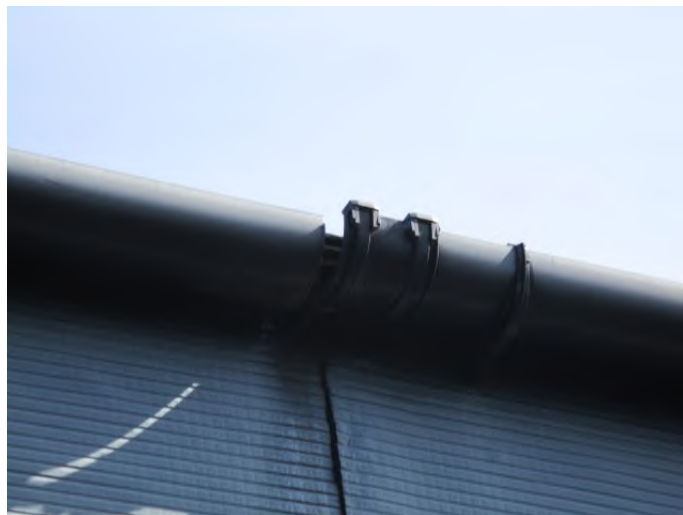
11. A joint in the gutter to the 'dormer' roof was open.

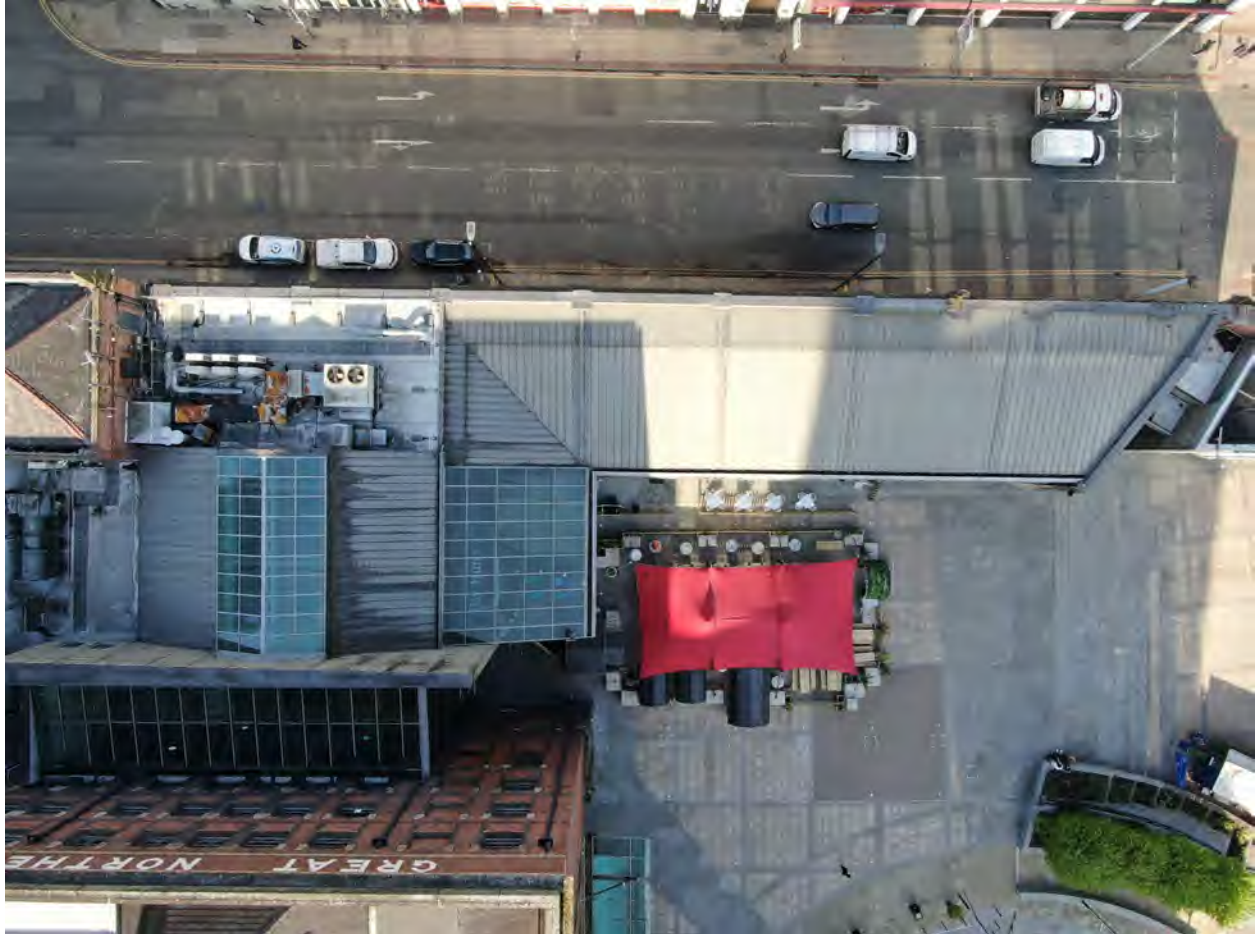
## Section 1 Red - Overview

Vegetation growth to parapet wall along with a large coverage of moss and bird faeces. Some localised oxidation has occurred to zinc sheet panel. Appears to be a build up of detritus material in the gutter which if left could prevent flow of rainwater.

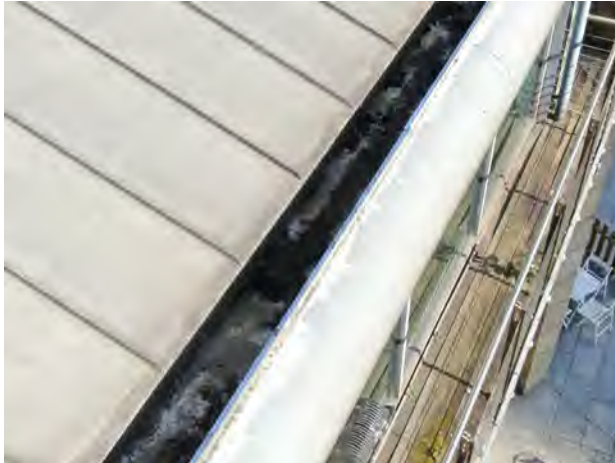
The gutter has a buildup of detritus material building up which requires cleaning out to ensure free flowing of rainwater.

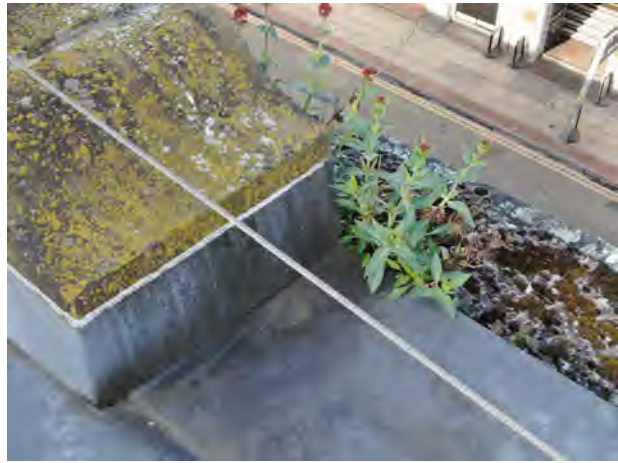
The coping has a build up of lichen and moss which needs removing together with vegetation growth.

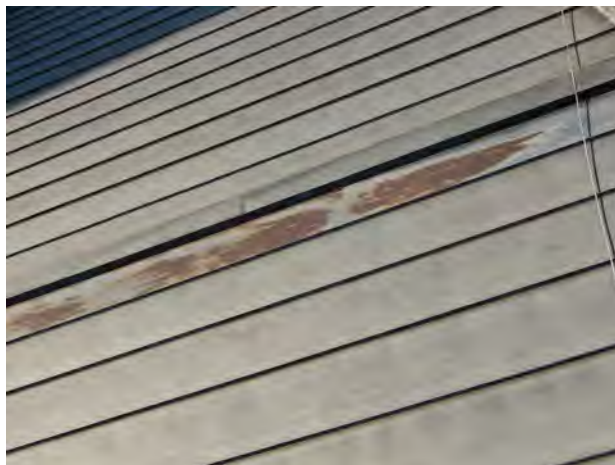
Zinc roof panels have signs of oxidization which requires treatment.

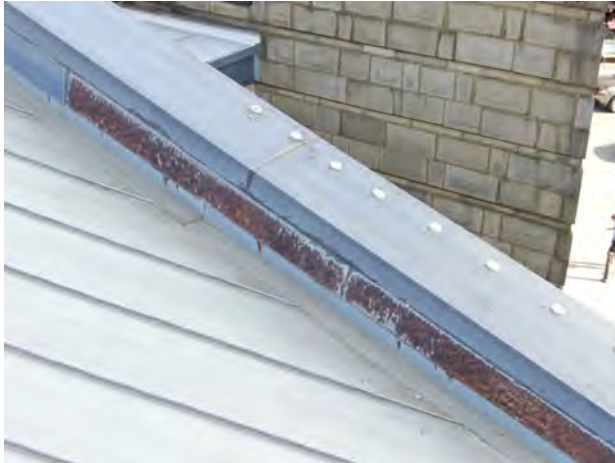
The flashing to the parapet is showing signs of corrosion which requires further, more detailed inspection. This is required to check the integrity of the flashing.

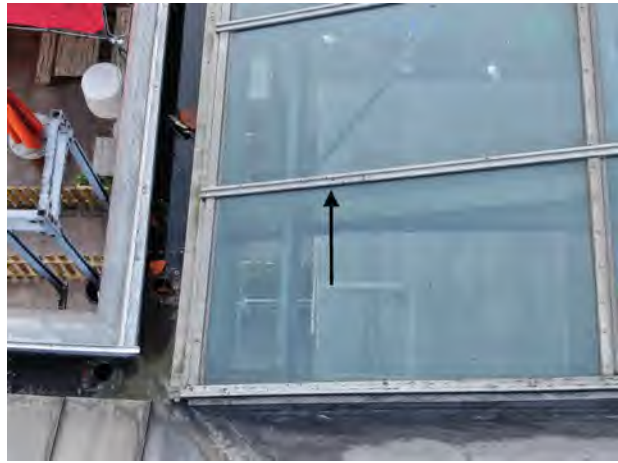
The aluminium roof light frame has missing rivets as highlighted. Some debris is noted in the gutter which should be removed.

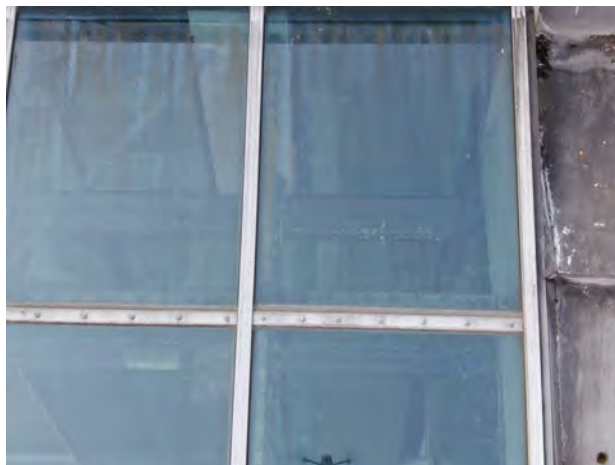
The lead flashing to the aluminium window frame appears to be cracking allowing potential for water ingress. This should be checked and repaired or replaced as necessary.

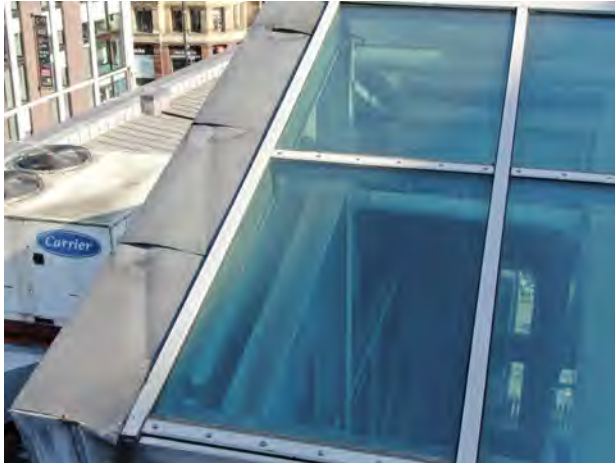
The zinc cover panels to the verge is deformed with gaps between joints. This requires repairing or replacement panels.

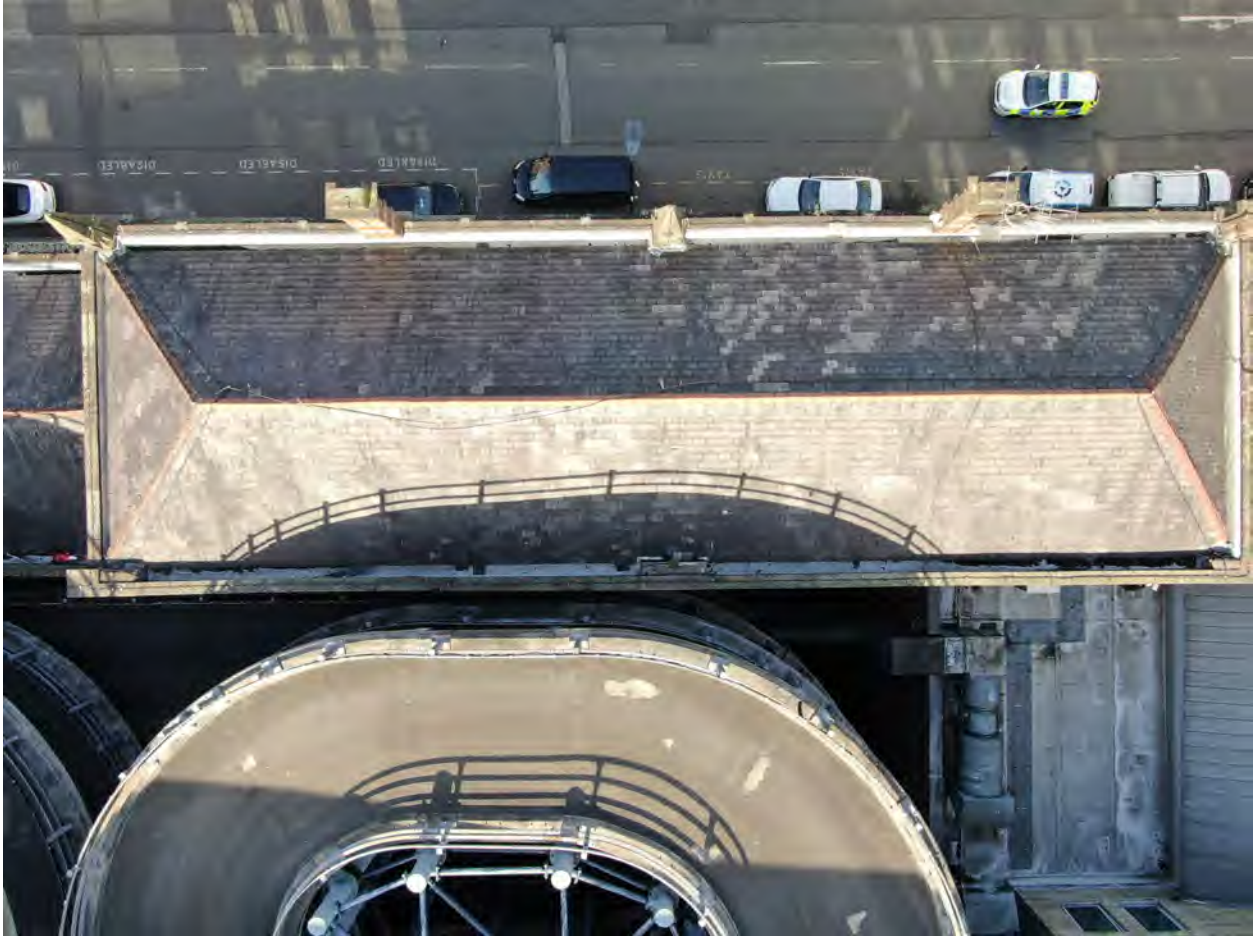
Approximately 28 slates are either cracked or dislodged. A loose slate has been highlighted and the lead flashing is in need of repair. A patch to the flashing on the up stand is loose fitting with the metal cover strip over broken. The gutter has had temporary repairs with flashband, this needs a more permanent solution. The gutter has a build up of detritus material which should be cleaned out. Mortar to ridge tiles is in poor condition and require re bedding and pointing. Concrete capping has broken off with brick below appearing to have dislodged. Debris and detritus material in gutter needs cleaning out. The lead guttering has peeled away and needs an urgent repair. The lead gutter/ flashing is damaged and in need of repair.

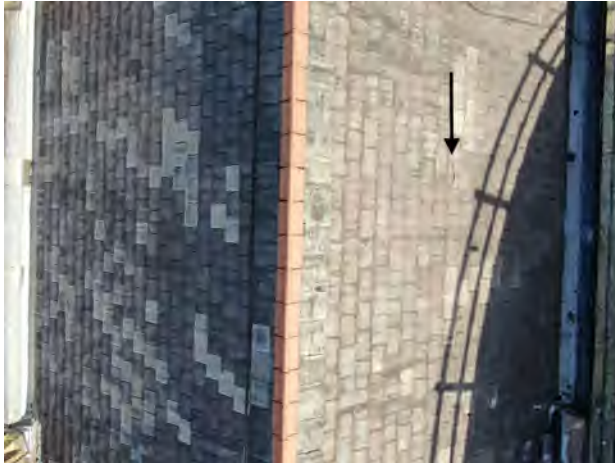
A slate has slipped and three slates are cracked.

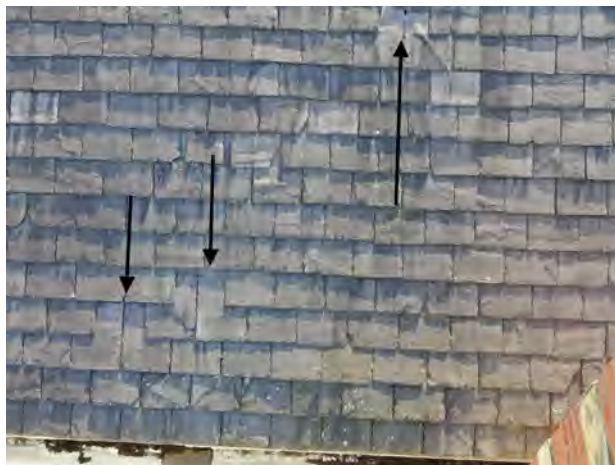
Three slates are missing and need replacing, A broken slate is noted in the gutter and should be removed.

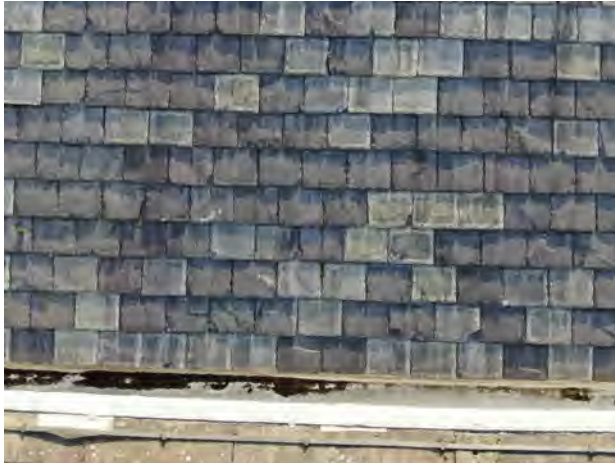
A buildup of detritus material is building up in the gutter and requires cleaning out.

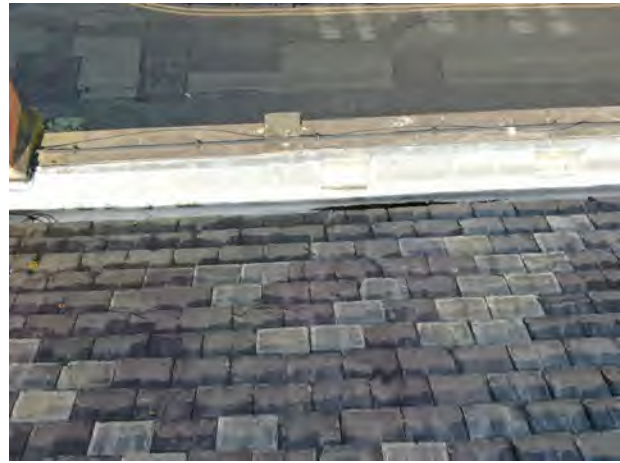
A slate is noted with significant chip damage. Loose cables are in the gutter and should be secured. A flashband repair has been undertaken to the gutter which is peeling. This should be repaired with a more permanent solution.

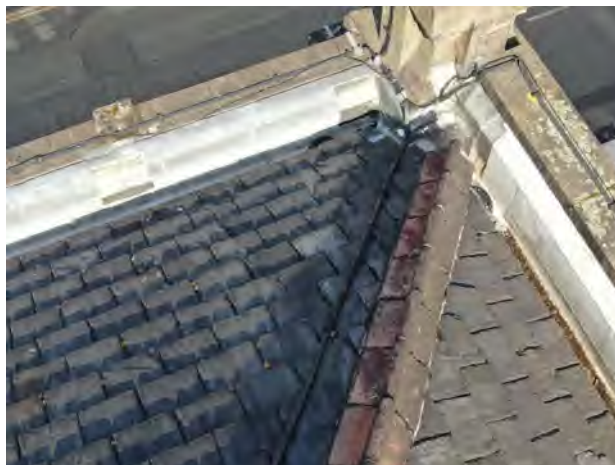
Detritus material should be removed from the gutter. Flashband has been used around the corner of the parapet gutter. This should be replaced with a more durable lead flashing.

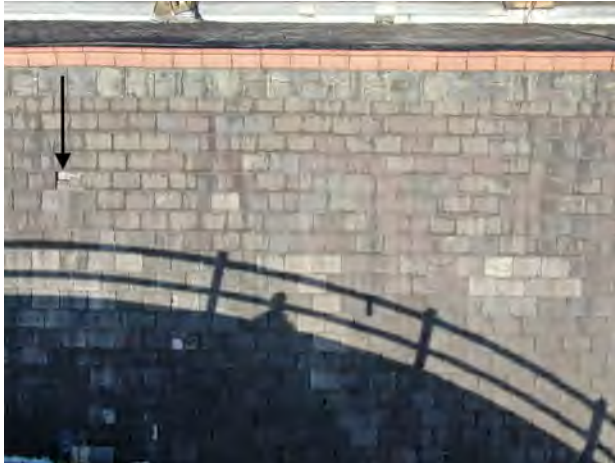
A slate has slipped and immediately above one is missing. A further slate has broken and slipped. These all require replacing.

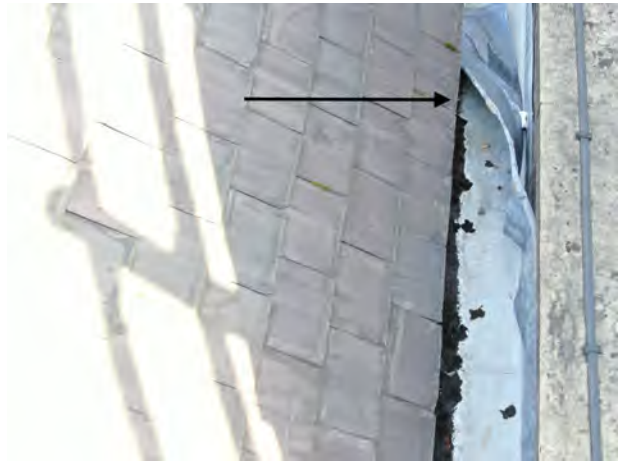
The lead flashing has peeled away from the parapet wall and requires refixing. Detritus material should be cleaned from the gutter.

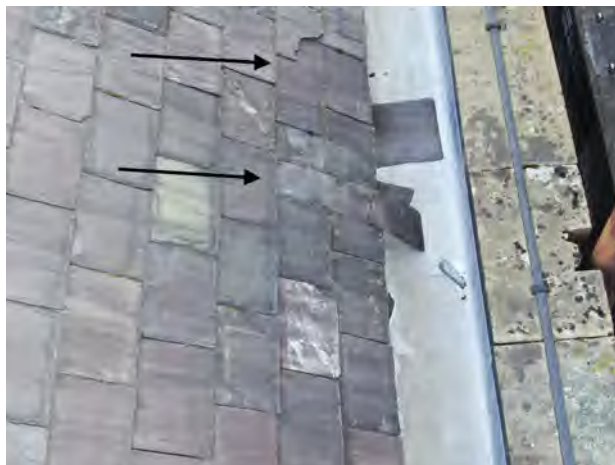
Three slates have broken and slipped into the gutter. These need to be replaced.

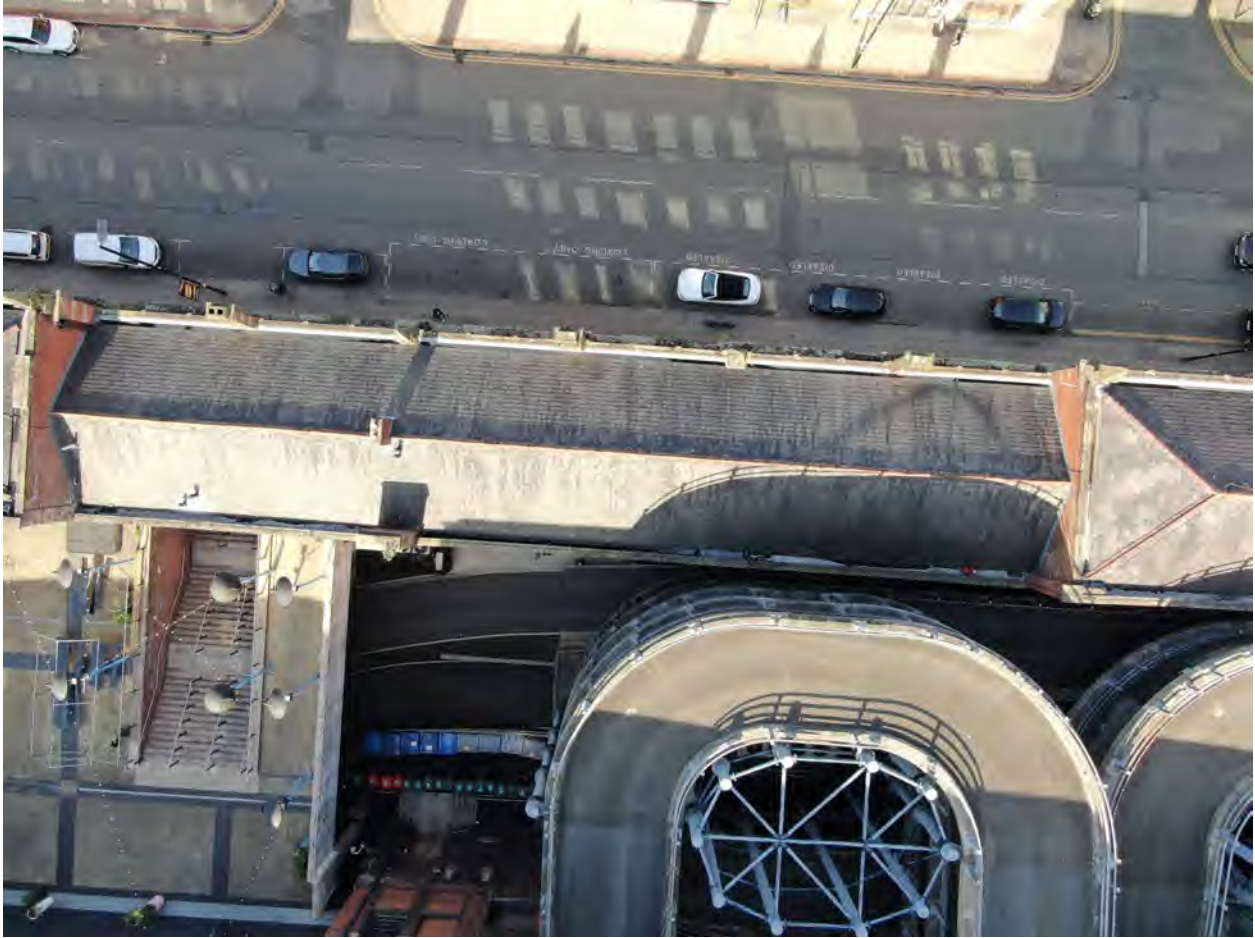
The slate roof is generally in good condition however it has been observed that approximately 20 tiles are either cracked, missing or dislodged. Various issues have been noted to the ridge tiles with deteriorating or missing mortar. Ridge tiles should be re-bedded and need re-pointing. Gutters have a build-up of detritus material which require cleaning out to ensure free flowing of rainwater to the downpipes. Some vegetation has been noted to a parapet which requires removal. Timber debris has been observed behind a chimney stack and a soil pipe has an open top which requires a bird cage. The chimney stacks need repointing where mortar is missing. Flashings have been dislodged and require repair.

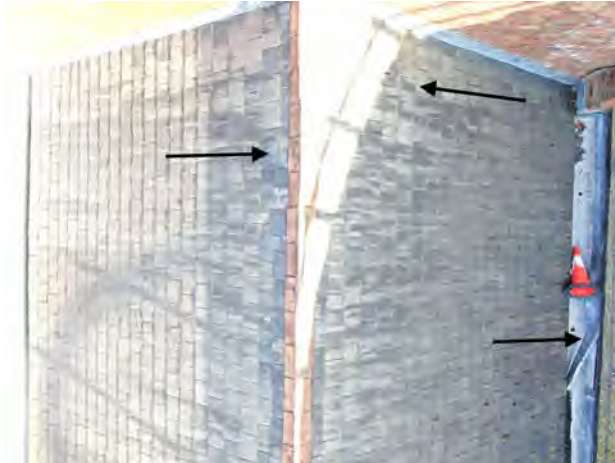
A slate is missing at ridge level. A slate has slipped on the opposing slope. Lead flashing has peeled in the gutter and a traffic cone needs to be removed.

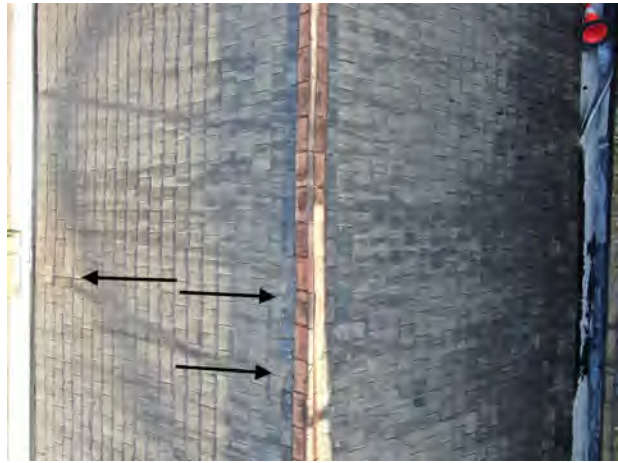
Four slates are missing and a number are dislodged at ridge level. Mortar to the ridge tiles is in poor condition and requires repointing and rebedding as required.

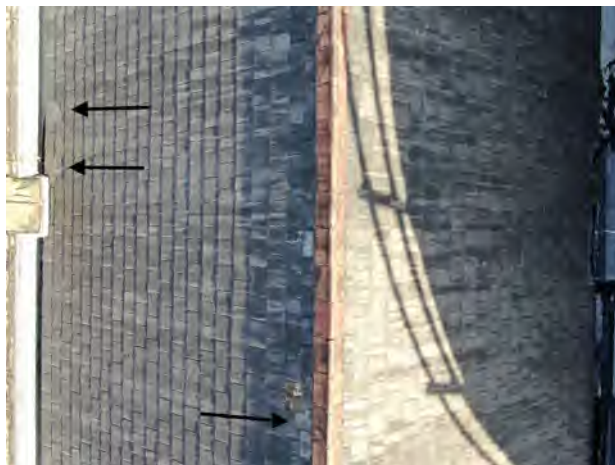
A slate is broken at ridge level, another is broken above gutter level and a further slate is missing. These all require replacing. Some vegetation is noted in the gutter and should be removed.

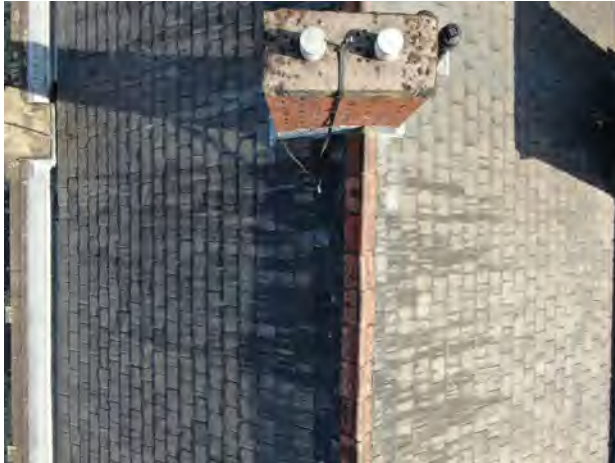
The concrete capping to the chimney stack is cracking. Buildup of moss and lichens should be removed. Ridge tiles to be repointed where mortar has deteriorated.

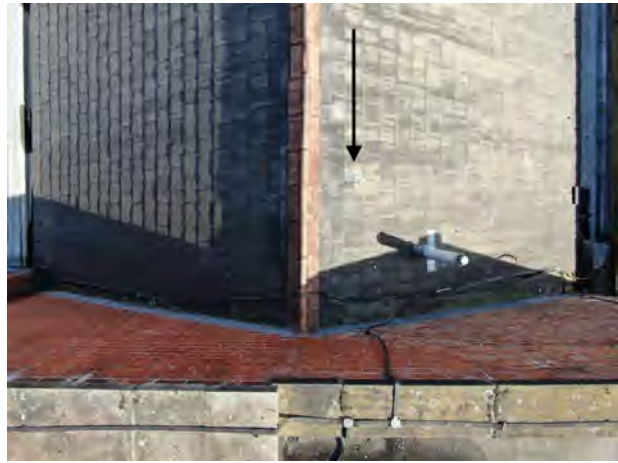
A slate is missing where highlighted which has slipped into the gutter.

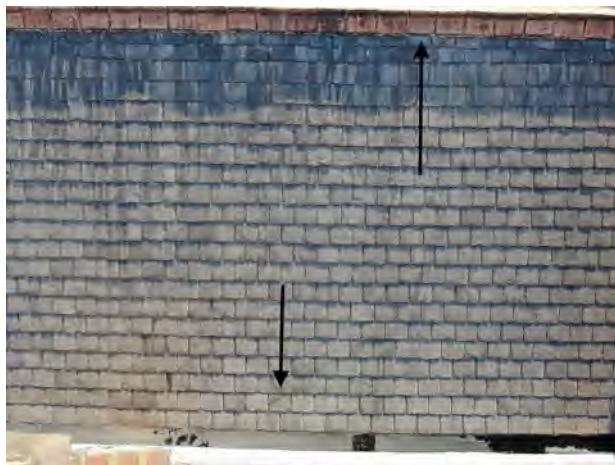
Bedding to the ridge tiles is in poor condition. Ridge tiles should be rebbed and pointed. The highlighted slate has a large crack and is close to failing.

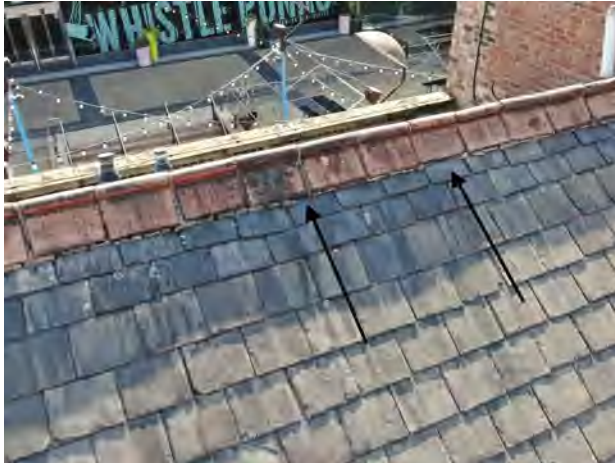
Mortar is missing to the ridge tiles. These should be rebedded and pointed.

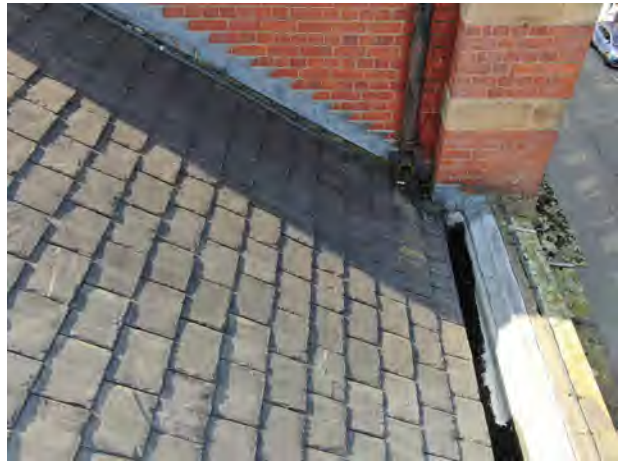
A buildup of detritus material in the gutter should be cleaned out. A large buildup of lichen and moss to the parapet should be removed.

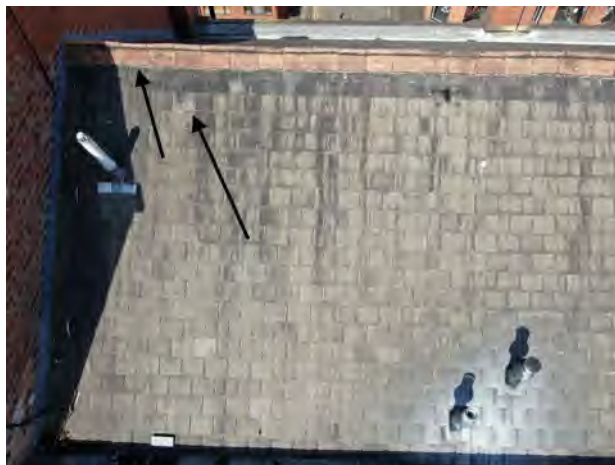
A slate at ridge level is cracked and one is missing lower down.

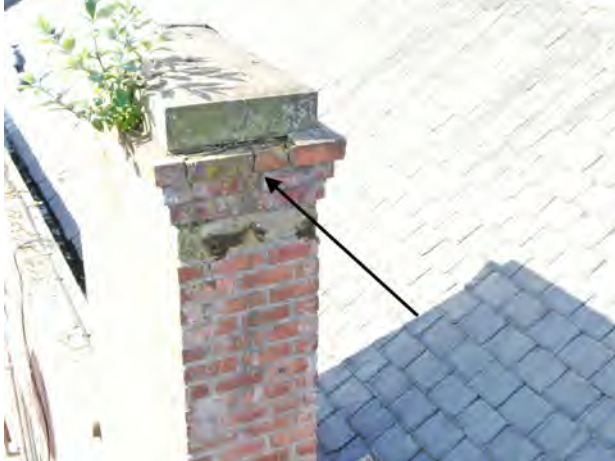
Vegetation around the chimney stack capping to be removed. Pointing to the stack is in a poor condition and needs repointing.

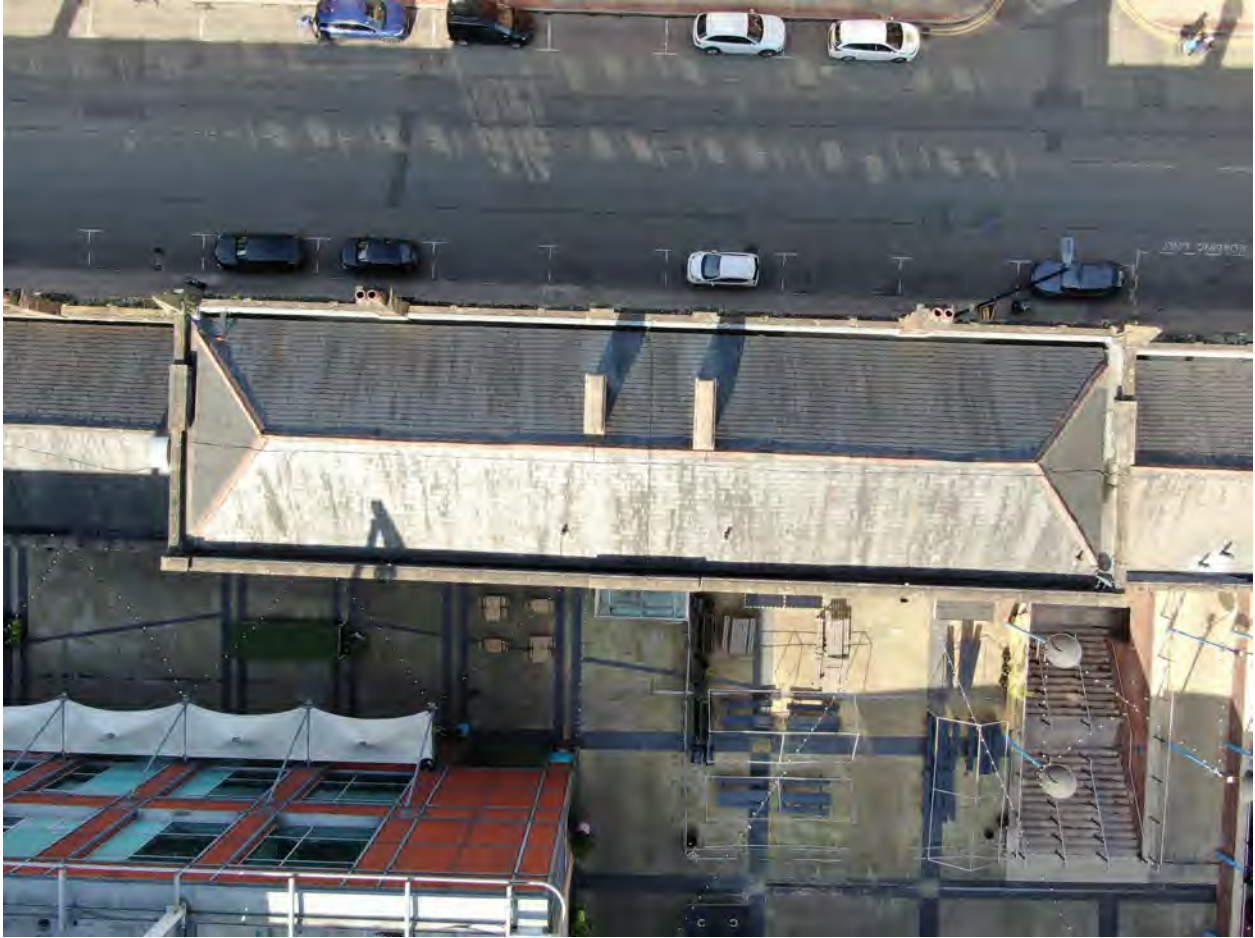
The roof has a approximately 20 slates either cracked, missing or dislodged. A number of ridge and hip tiles have defective mortar and require rebedding and repointing. Chimneys require flue terminals to open pots and repointing where there is loose or missing mortar. Cracked chimney capping requires repair. Some vent pipes are open and require bird cages. Parapet walls have a build-up of lichen which should be removed. Vegetation has also been noted to the parapet which should be removed. Cable ties are dislodged and require refixing.

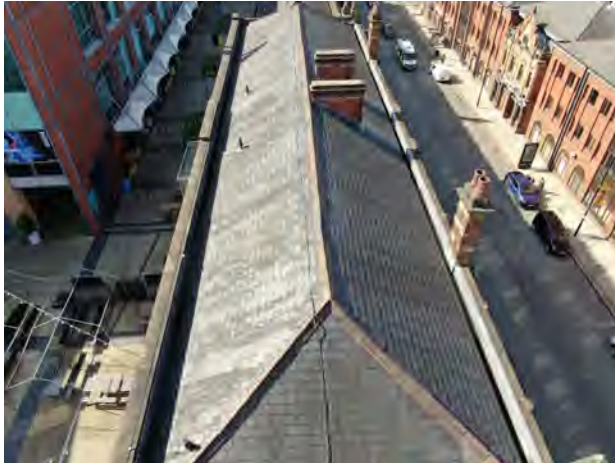
Open chimney pots require bird cages fitting.

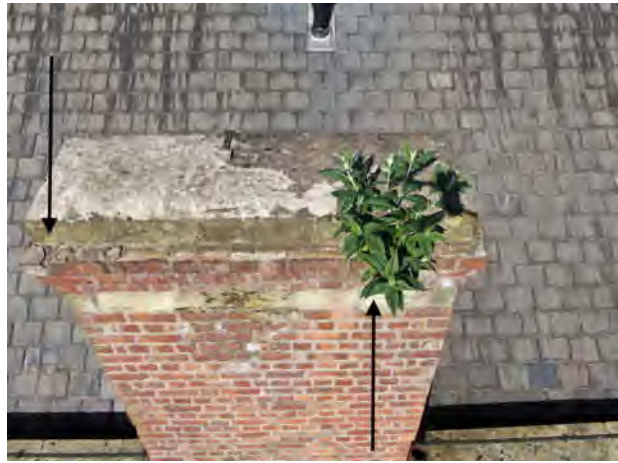
Vegetation to chimney stack to be removed. Haunching is breaking up or missing to capping and needs replacing.

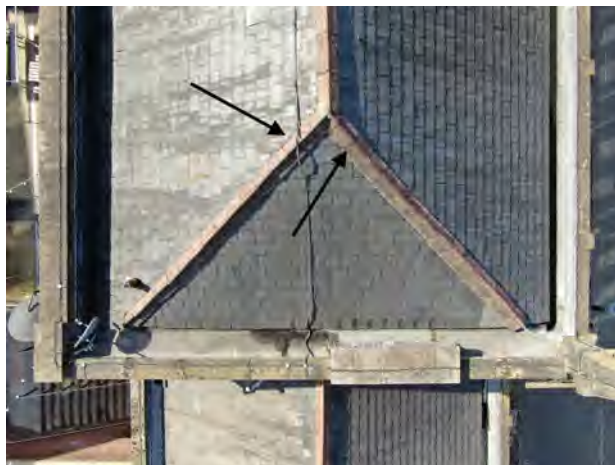
Mortar joints and bedding to hip tiles is missing. Hip tiles need rebedding and pointing.

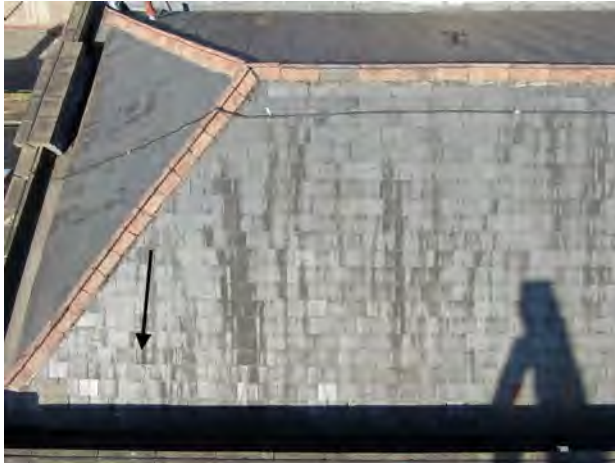
Two slates are broken and have slipped. Mortar to the ridge tiles is in poor condition and the tiles require re-bedding and pointing.

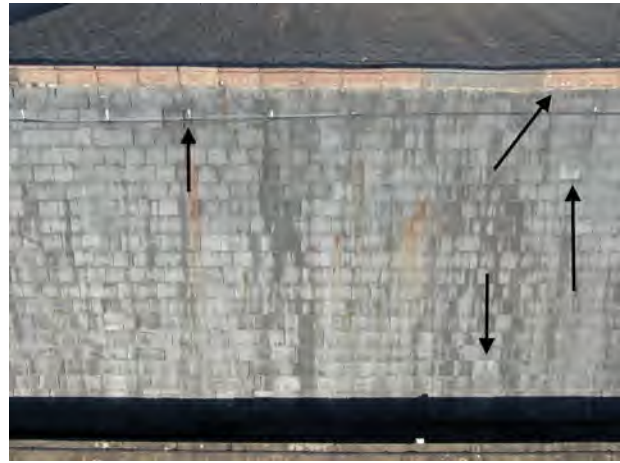
A slate is missing and another has slipped. Mortar is missing from the ridge tile bedding. Clips holding the lightening conductor have slipped and require refixing.

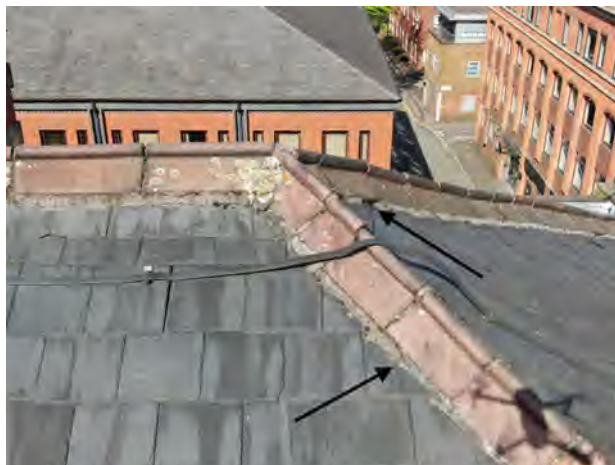
Bedding to the hip tiles is missing and mortar joints are in a poor condition. These need rebedding and pointing. There is a build up of lichen to the ridge/hip area which should be removed.

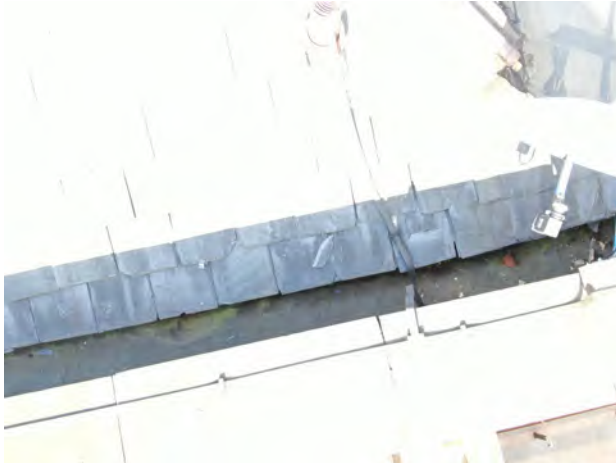
A slate is loose at gutter level. It appears this has been dislodged by the fixing for the lightning conductor.

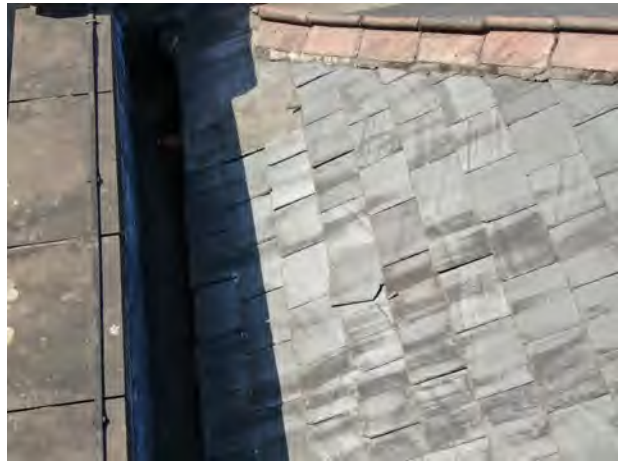
Two slates have slipped. Bedding to the hip tiles is in poor condition and needs replacing.

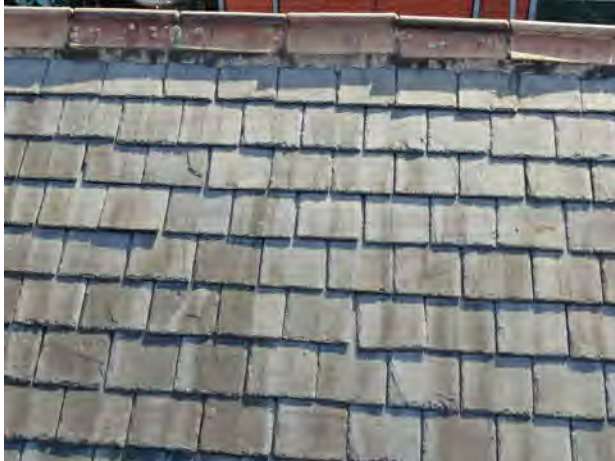
Mortar to the ridge tiles is in poor condition. These require rebedding and pointing.

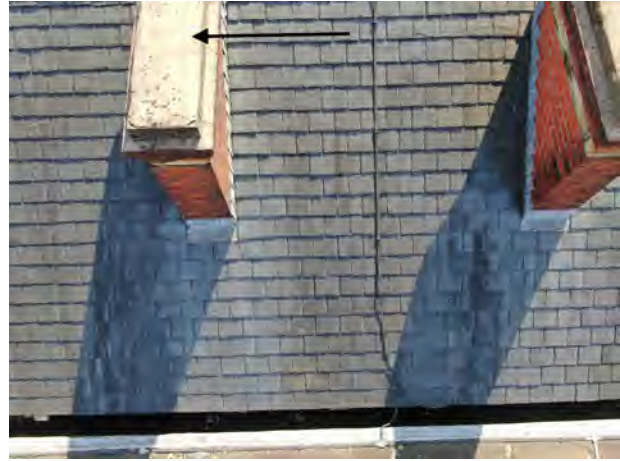
Capping and haunching to the chimney stack is cracked and needs repairing or replacing.

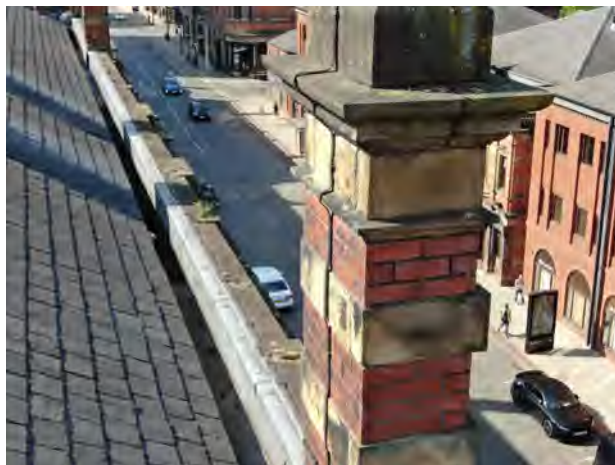
Vegetation to the parapet needs to be removed along with the large build up of lichen and moss.

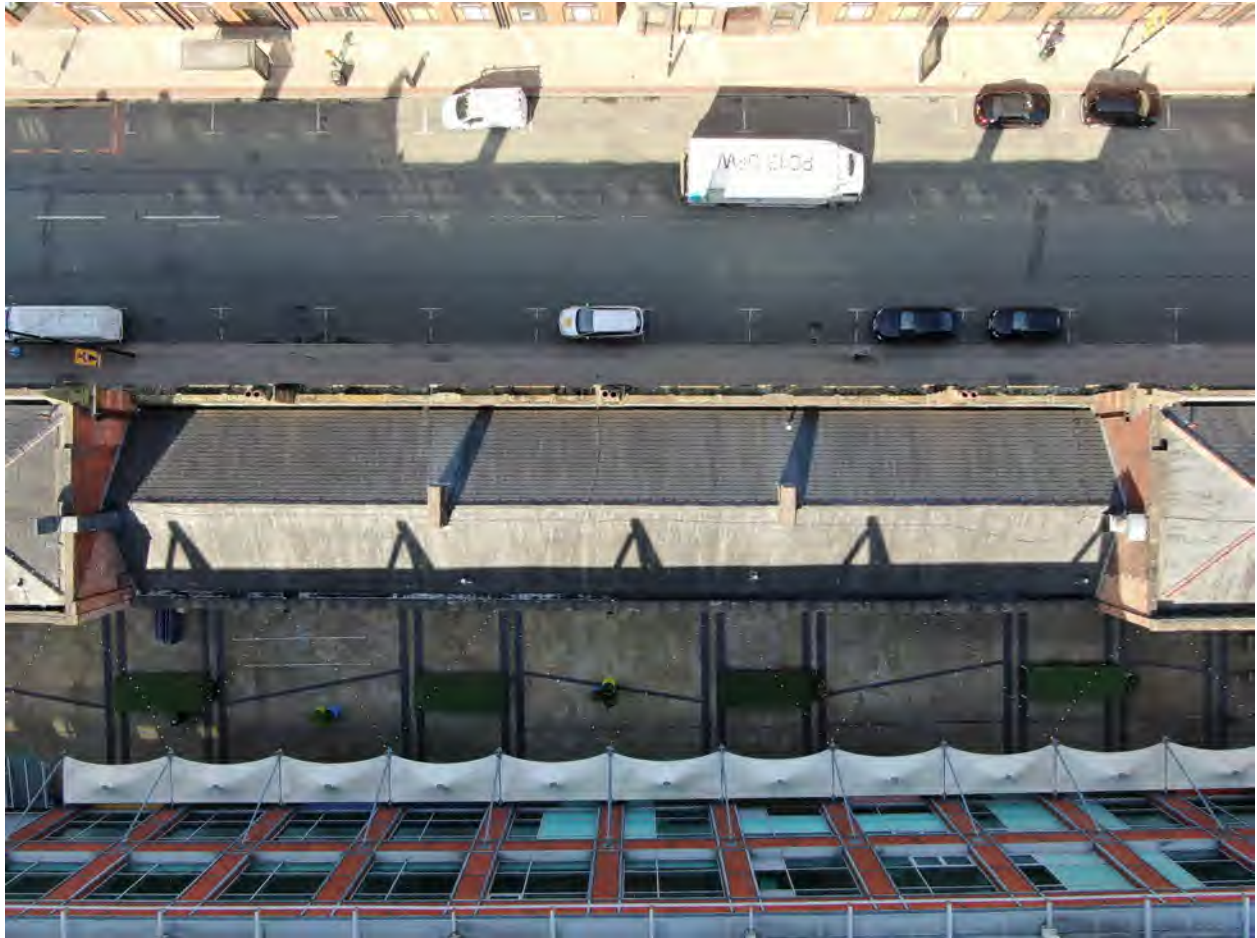
The slate roof is generally in very good condition with approximately 2 slates missing and one slate slipped / dislodged. Detritus material has been noted in the gutter which needs cleaning out. A cast iron rainwater downpipe from a hopper is showing signs of rust and may need replacing. It discharges onto the roof appears damp and the lead flashing may require attention to help drain the corner more efficiently. Sections of the parapet walls are showing signs of moss and lichen which should be cleaned off. Cable ties are dislodged and need refixing. A cracked chimney capping needs repairing.

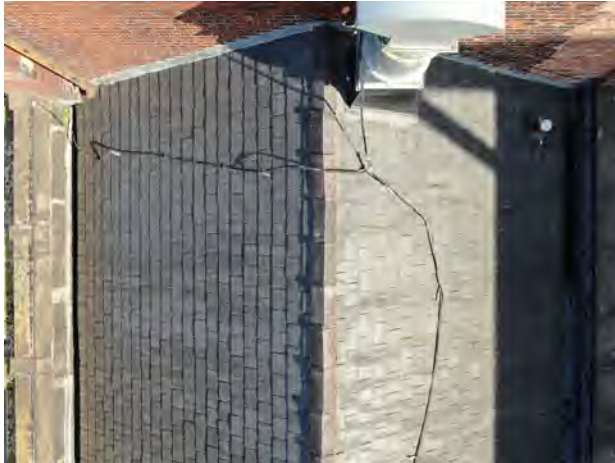
The lightning conductor is loose and requires securing.

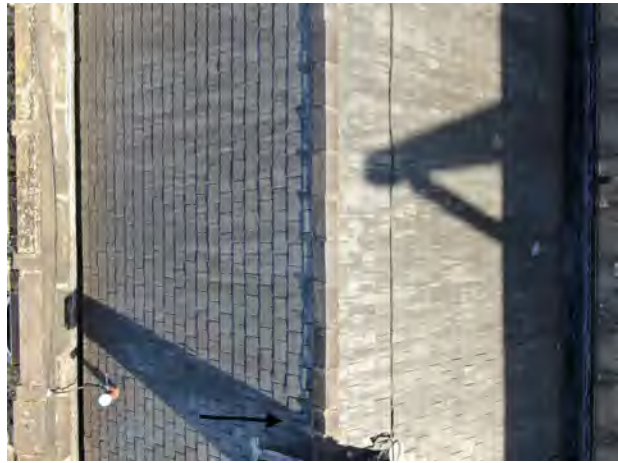
A slate is missing below the ridge.

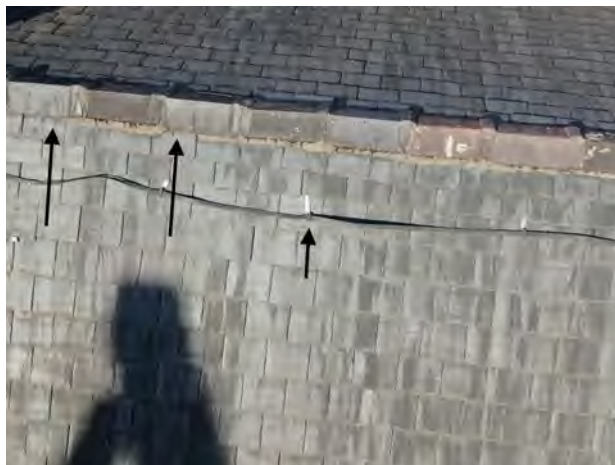
The clips holding the lightning conductor have slipped and need securing. Bedding to the ridge tiles is in poor condition and missing.

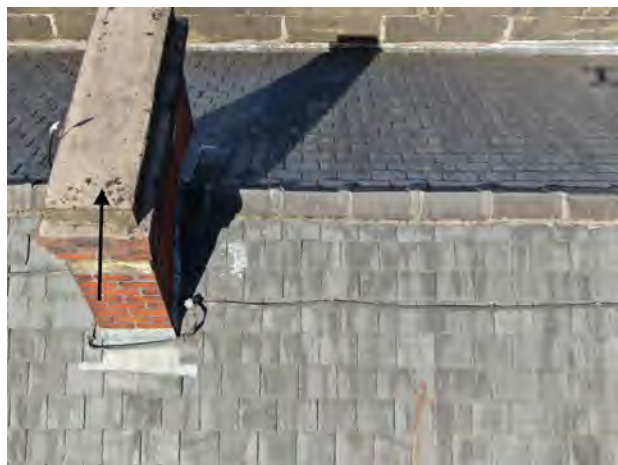
Capping and haunching to the chimney stack is cracked and needs repairing or replacing.

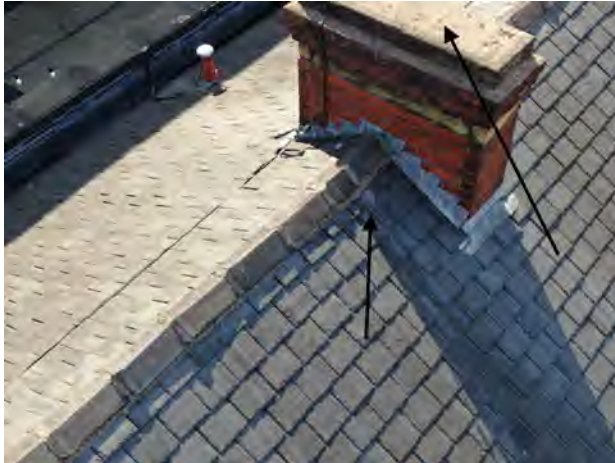
Capping to the chimney stack is cracked and needs repairing or replacing. Approximately two slates have slipped at ridge level.

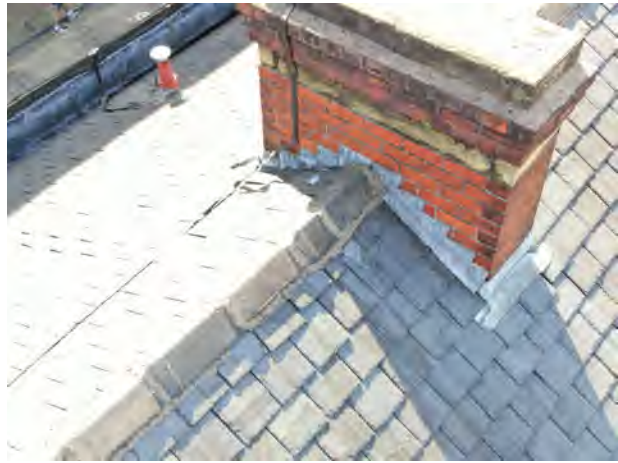
Capping to the chimney stack is cracked and needs repairing or replacing. Approximately two slates have slipped at ridge level.

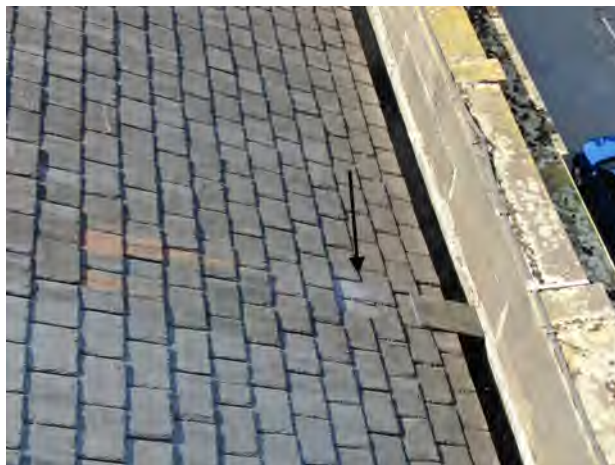
A slate has slipped into the gutter and needs refixing. The large build up of lichen to the parapet wall should be cleaned off.

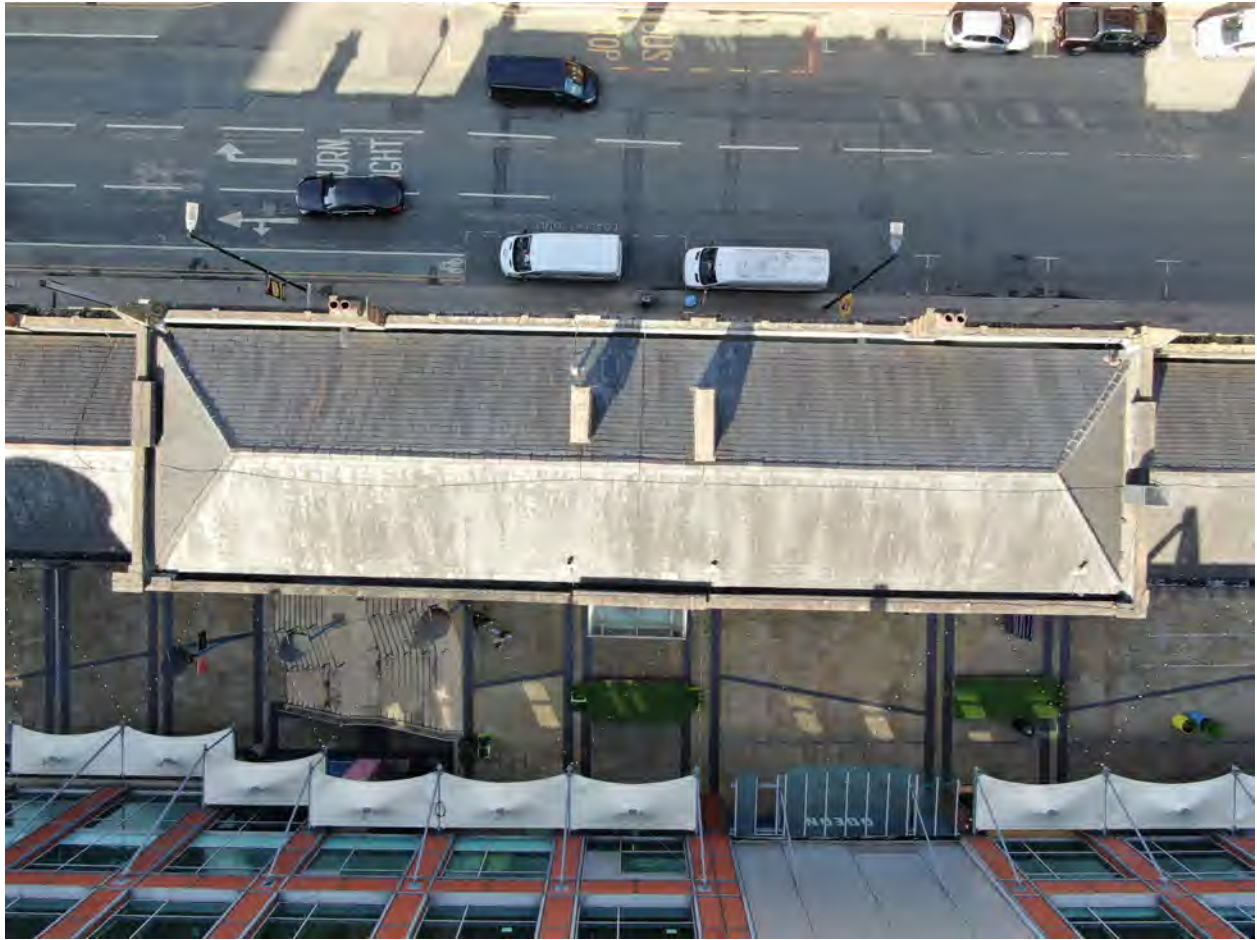
The roof has approximately 19 slates cracked, missing or dislodged. Mortar to ridge tiles is in poor condition and needs repointing and ridge tiles rebedding where required. Debris and detritus material in gutters requires clearing out. A number of ridge and hip tiles have defective mortar and require rebedding and repointing. Chimneys require flue terminals to open pots. Some vent pipes are open and require bird cages. Parapet walls have a build-up of lichen and moss which should be removed.

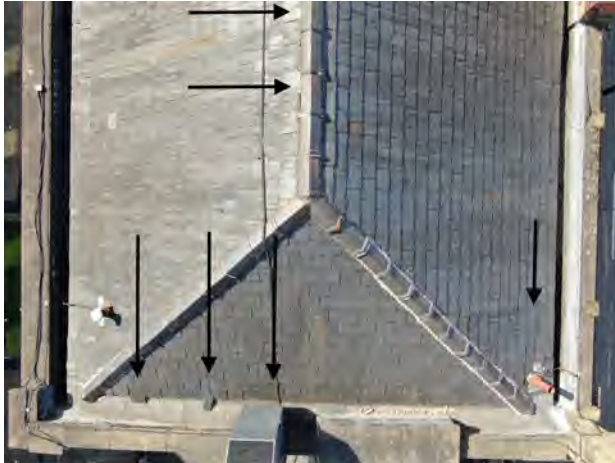
Bedding to the ridge is in poor condition with sections of mortar missing, On the hip a slate has slipped into the gutter, a slate has slipped adjacent to the lightening conductor and a further slate has cracked and part fallen into the gutter. A slate has slipped on the right slope and the vent pipe requires a flue terminal fitting.

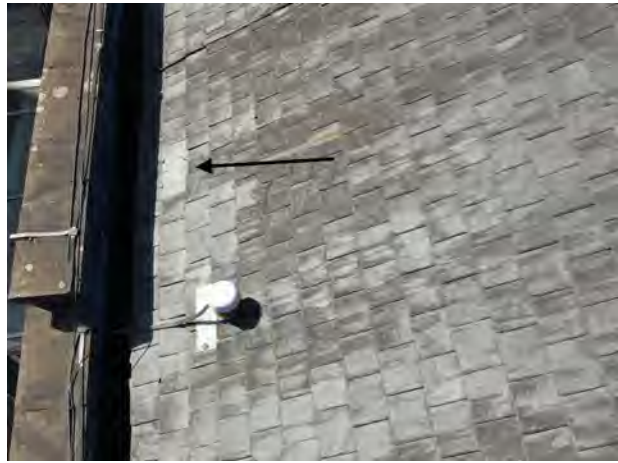
Approximately two slates are missing.
