## ROOF CONDITION ASSESSMENT

GREAT NORTHERN & DEANSGATE TERRACES

MANCHESTER M3

Report Ref. 22029/1

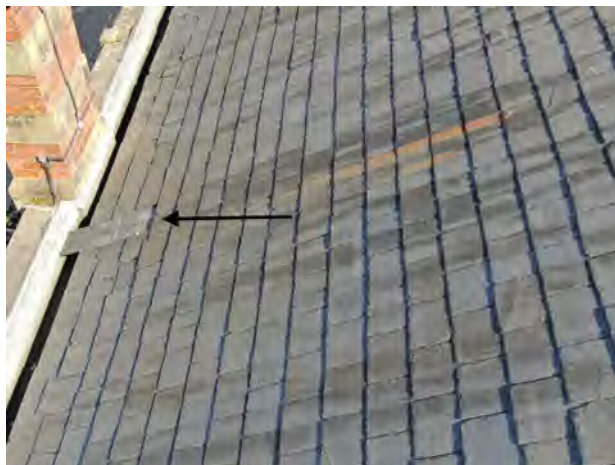
A slate has slipped and requires refixing.

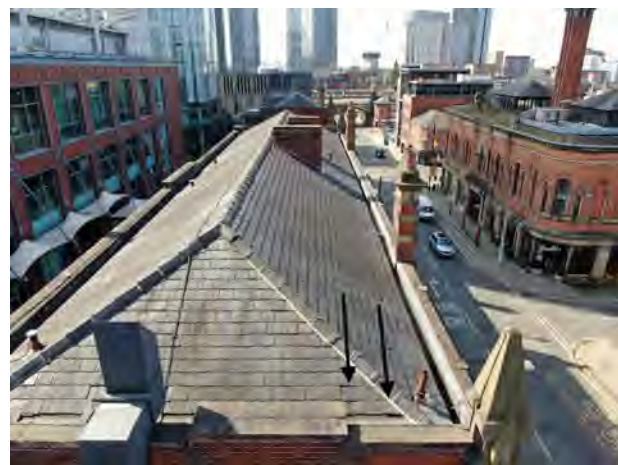
Approximately three slates are loose and one is broken. The open vent pipe requires a terminal fitting.

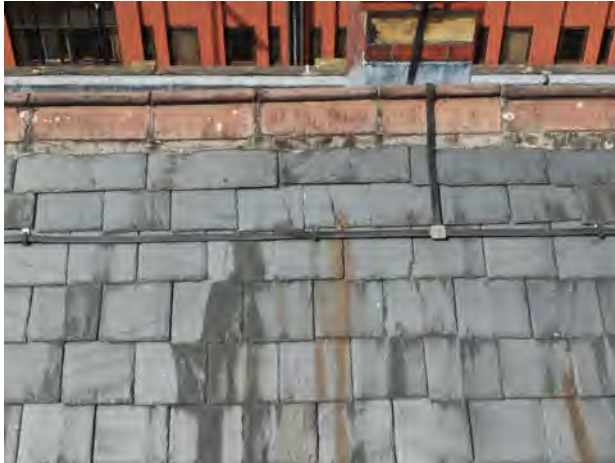
Mortar joints to the ridge tiles are in a poor condition and require repointing.

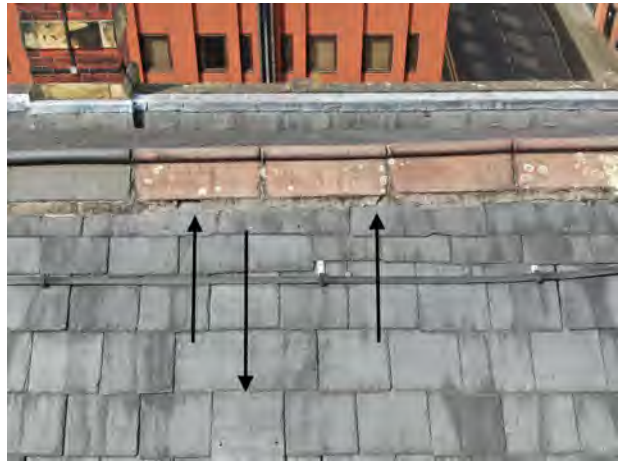
Bedding is missing to the ridge tiles. A slate has slipped.

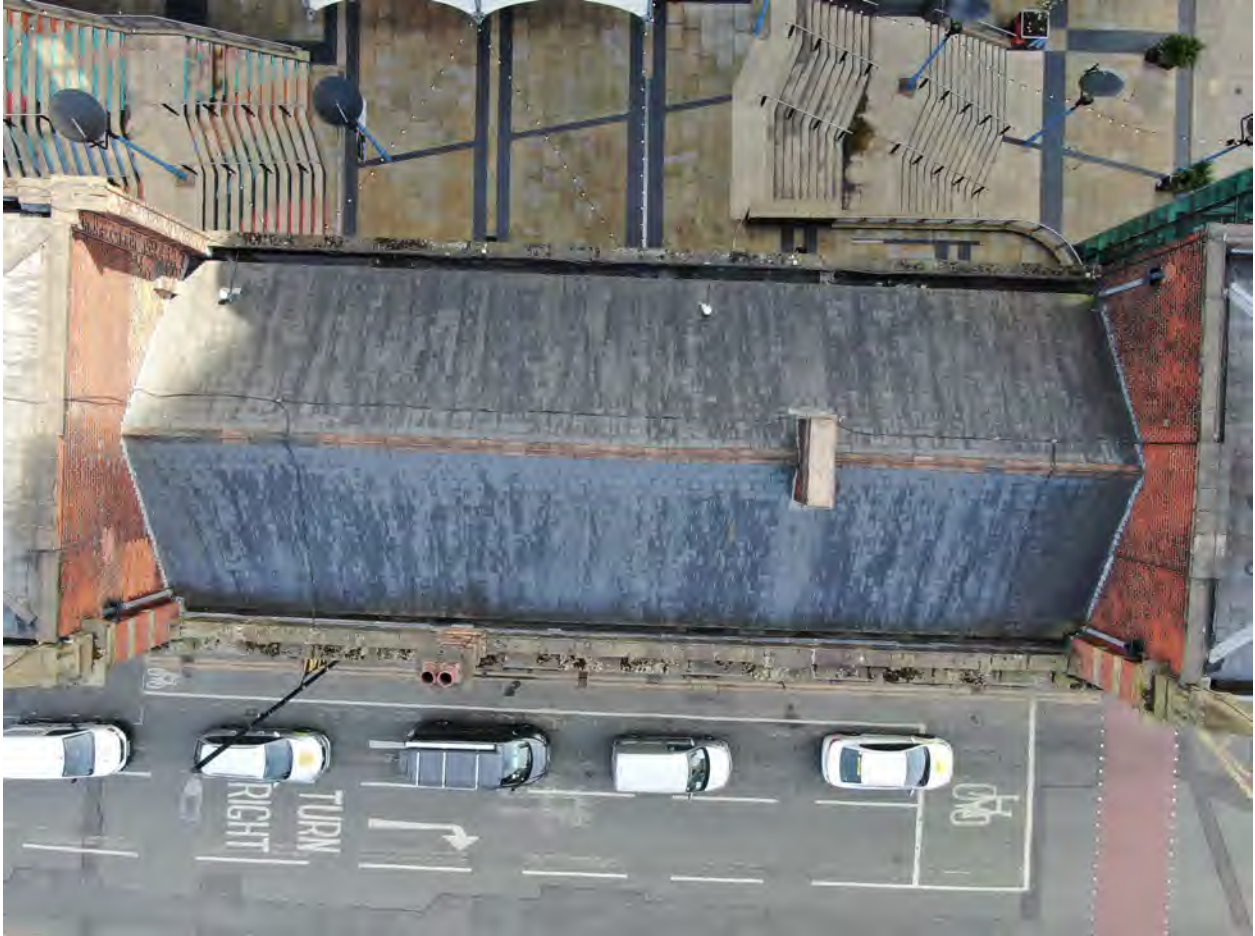
Approximately 4 slates are missing with 2 dislodged/slipped slates and a cracked slate. Mortar to ridge tiles is in poor condition and needs repointing and ridge tiles re-bedding where required. Debris and detritus material in gutters requires clearing out. Parapet walls have a build-up of lichen and moss which should be removed. Chimney stack requires localised repointing where mortar is missing and vegetation removed. Vegetation also requires removal from the gable wall above stepped flashing.

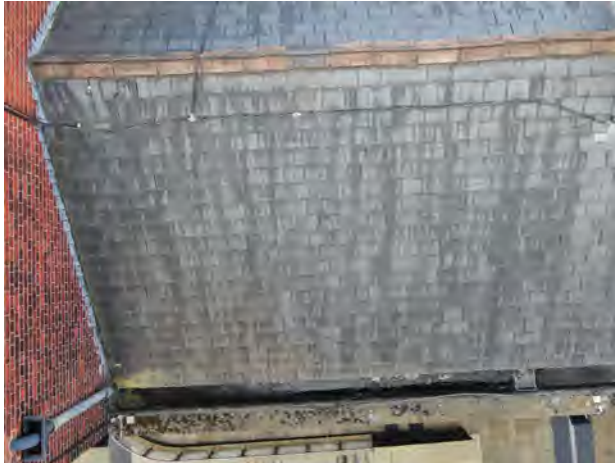
The gutter contains debris and detritus material which requires removal. Moss and lichen build up to the parapet wall should be cleaned off.

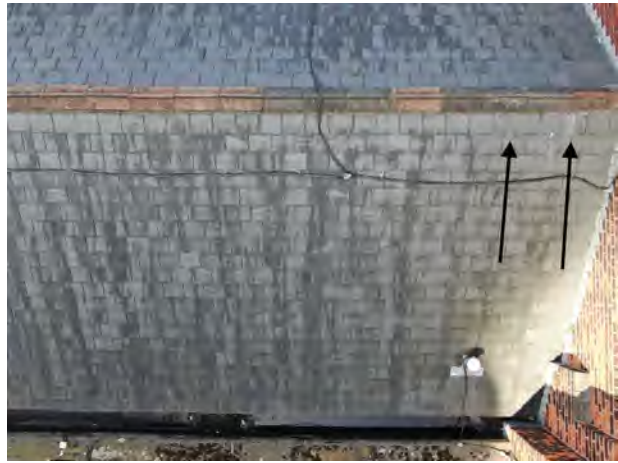
A slate has slipped and another broken at ridge level.

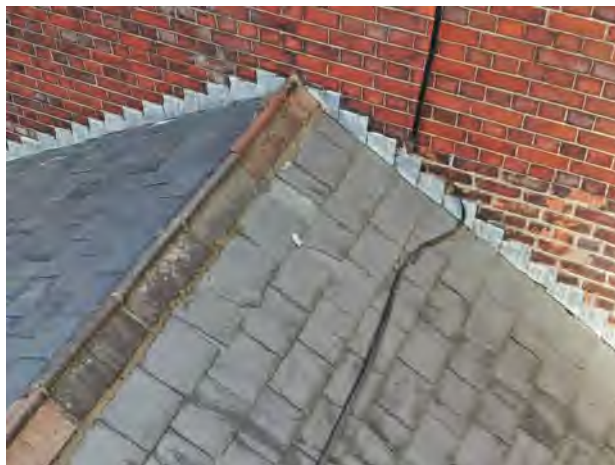
Bedding to ridge tiles is breaking up. Slates have become dislodged at ridge level and approximately two slates are cracked/broken.

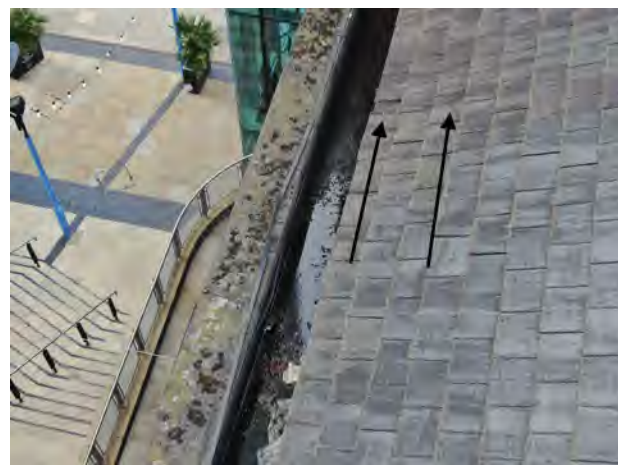
A slate is broken and another slate is cracked. Both require replacing. The gutter has a build up of detritus material which should be cleaned out.

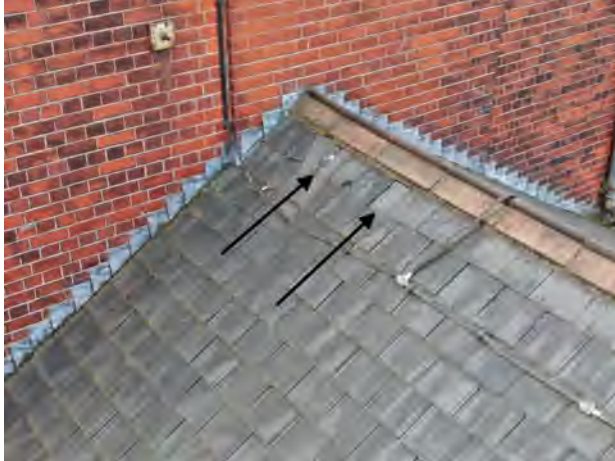
Approximately five slates are broken or missing below the ridge. These need replacing.

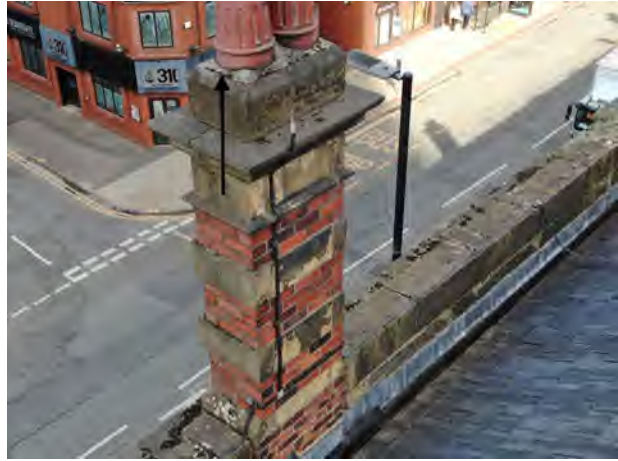
Haunching to the chimney pots is deteriorating and in need of replacement. Build up of lichen and moss to the parapet needs removing.

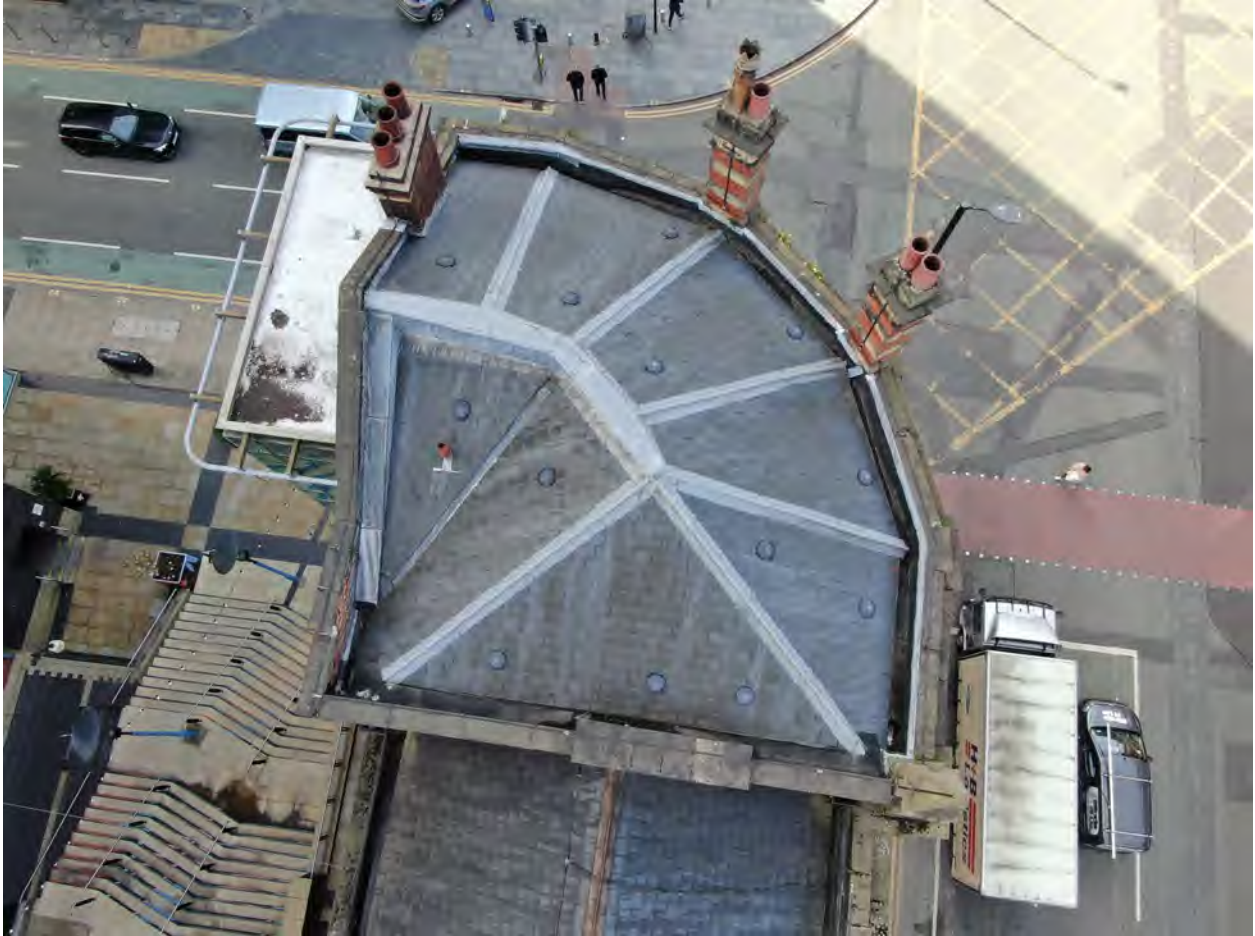
Dislodged flashing to parapet wall requires refixing. All slates appear visually in a good condition. Vegetation noted to chimney stack and below copings to parapet walls, this needs removing at the earliest opportunity. Open SVP requires bird cage terminal. Three areas of the parapet need attention to the mortar to prevent vegetation growth.

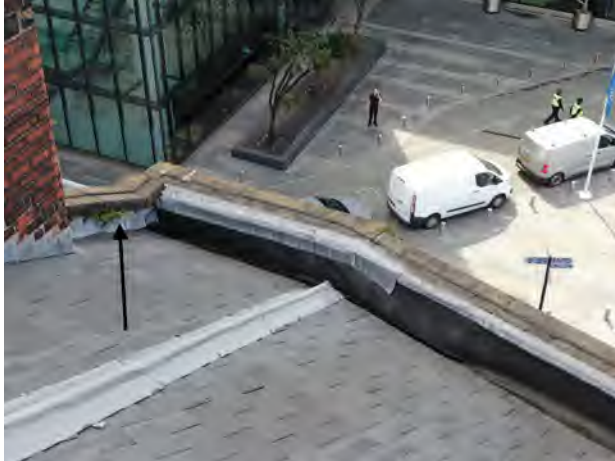
Vegetation beneath parapet wall to be removed. Lead flashing to coping to be redressed where it has peeled back.

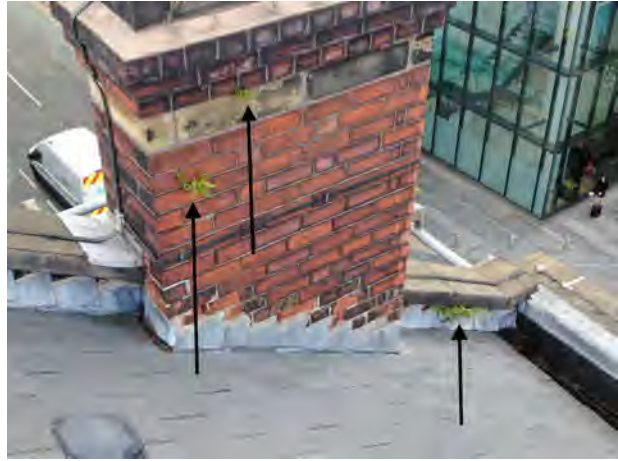
Vegetation to be removed from chimney stack and below parapet wall.

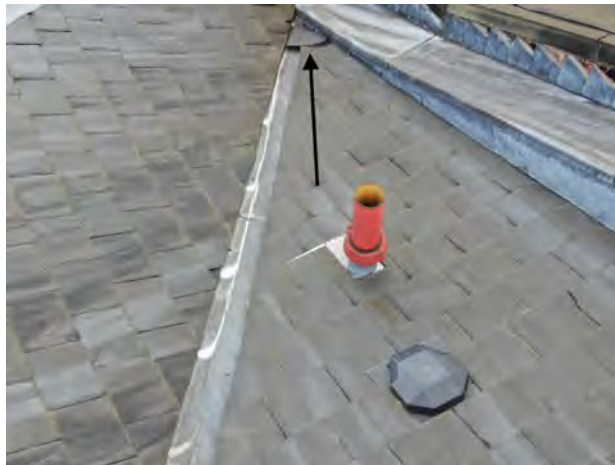
A broken slate needs removing from the valley. An open vent pipe requires a flue terminal fitting.

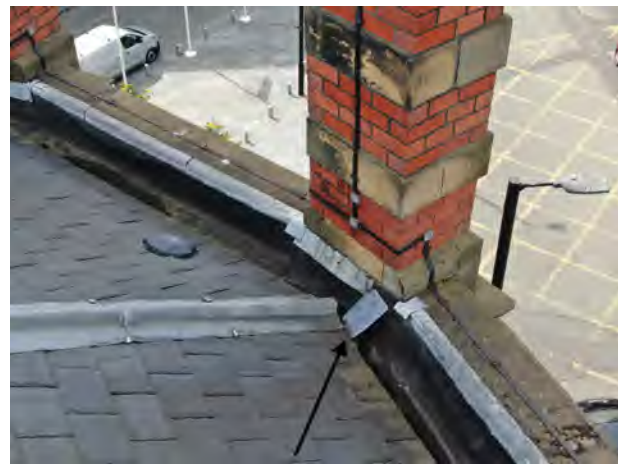
Lead flashing between the chimney stack and the parapet wall has failed and needs redressing.
